# National Transportation Safety Board

CEN16LA154

## **MATERIALS LABORATORY**

Factual Report 26-008

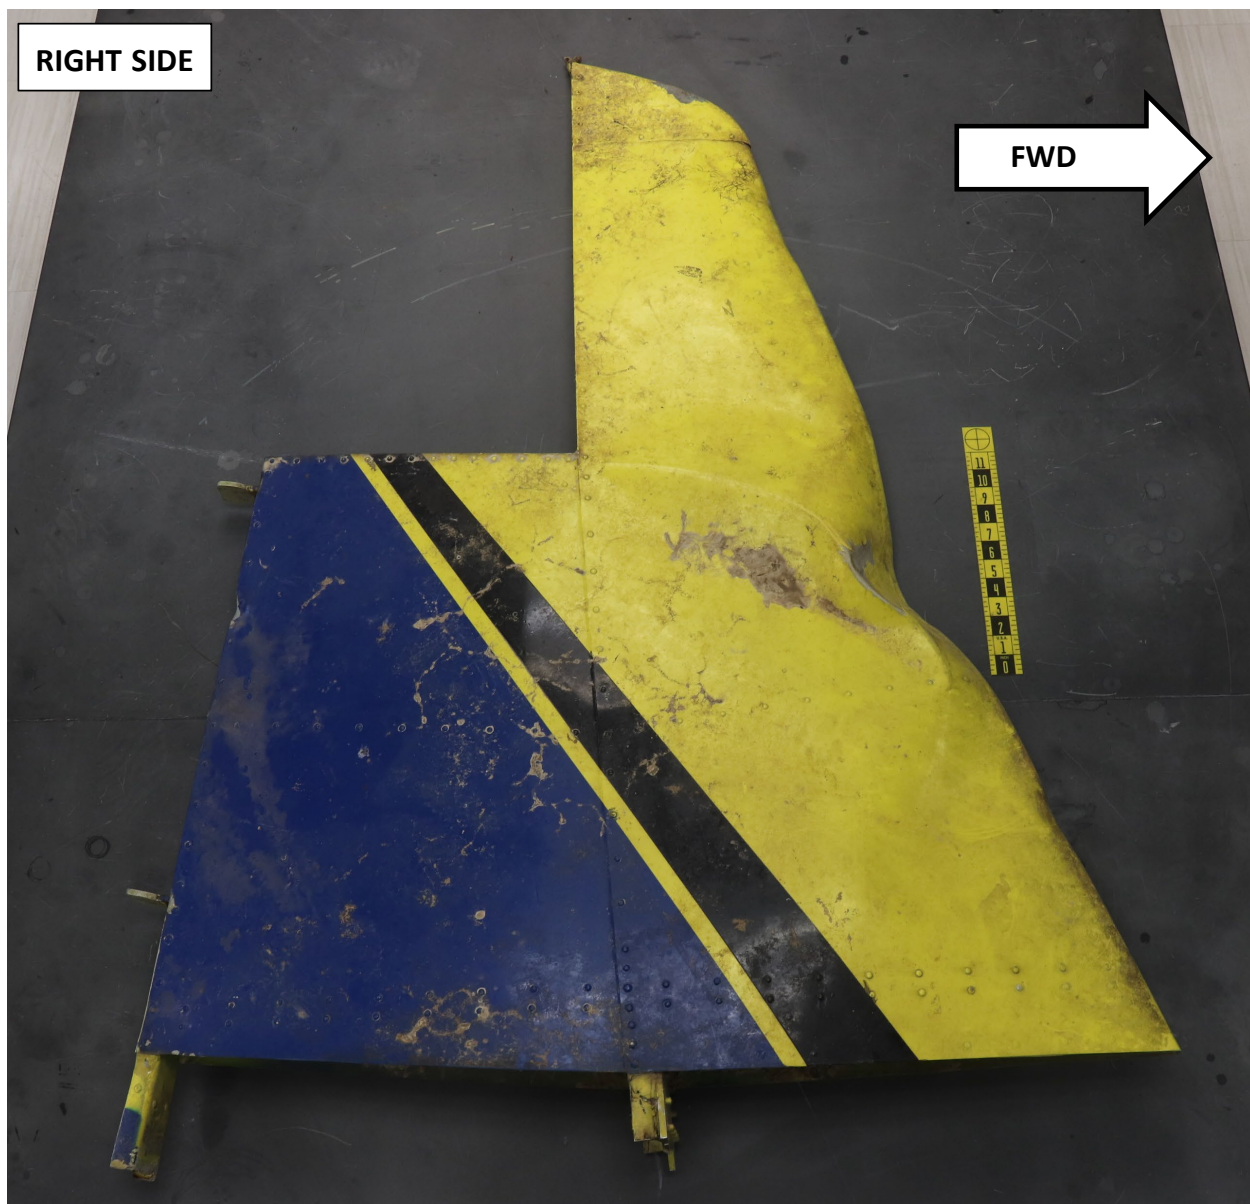
**Figure 2.** Overall photo of the right side of the vertical stabilizer.

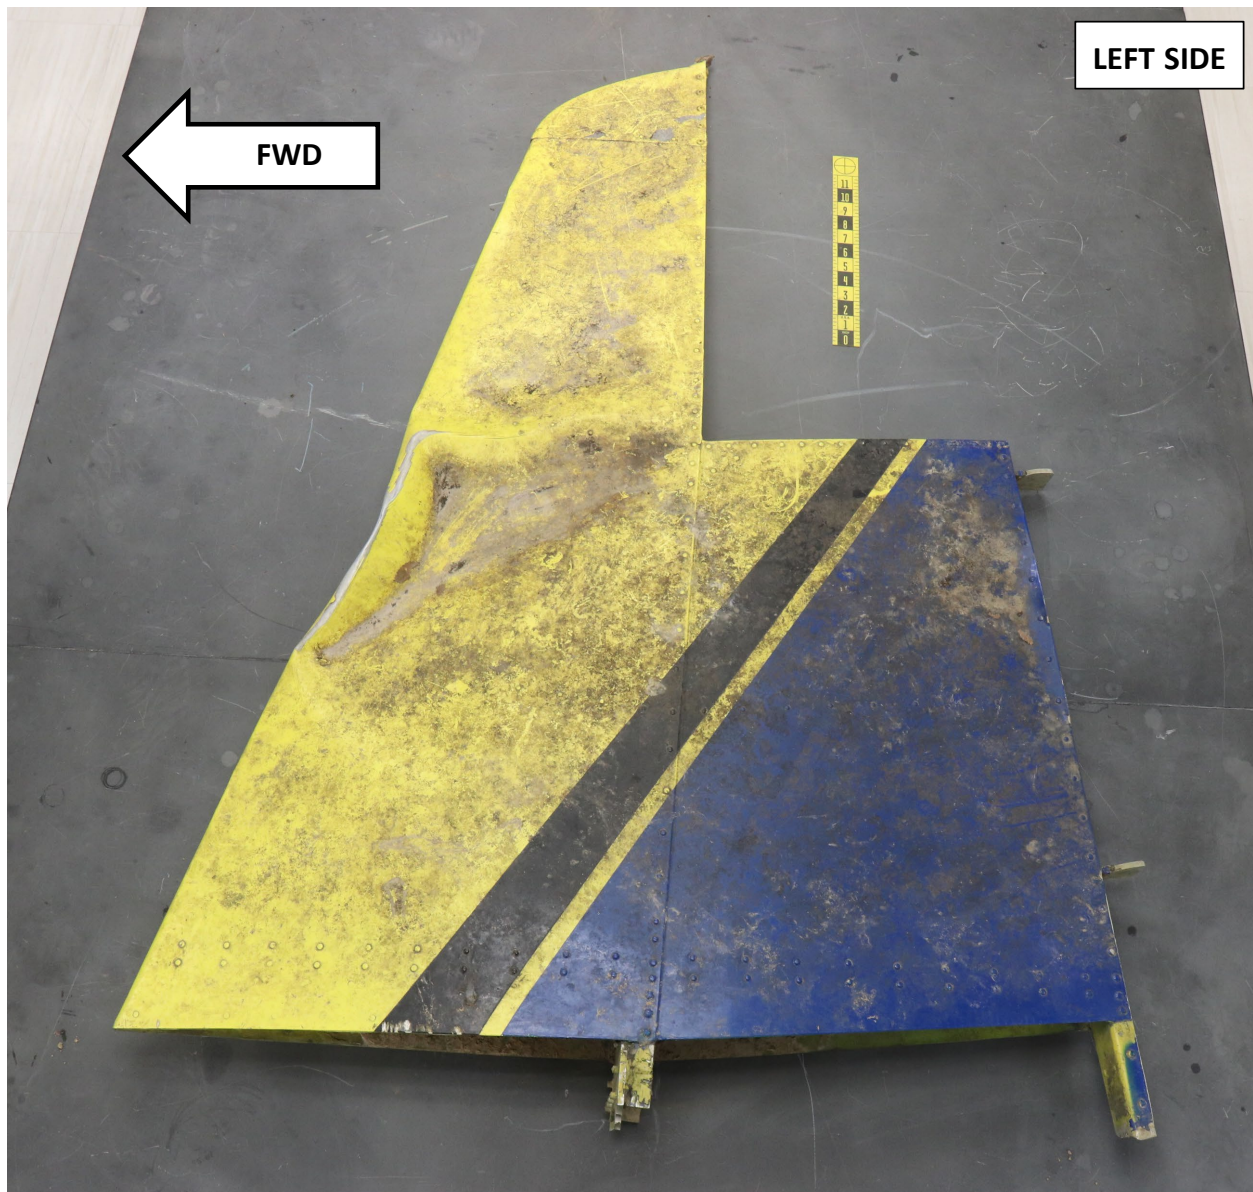
**Figure 3.** Overall photo of the left side of the vertical stabilizer.

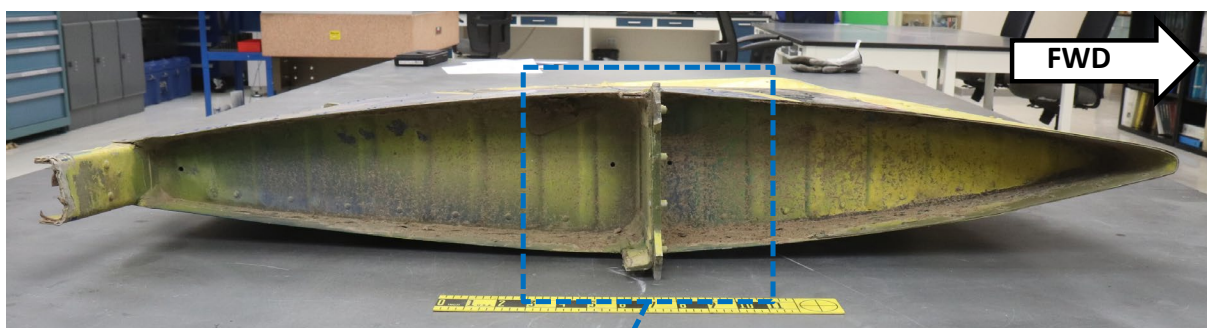
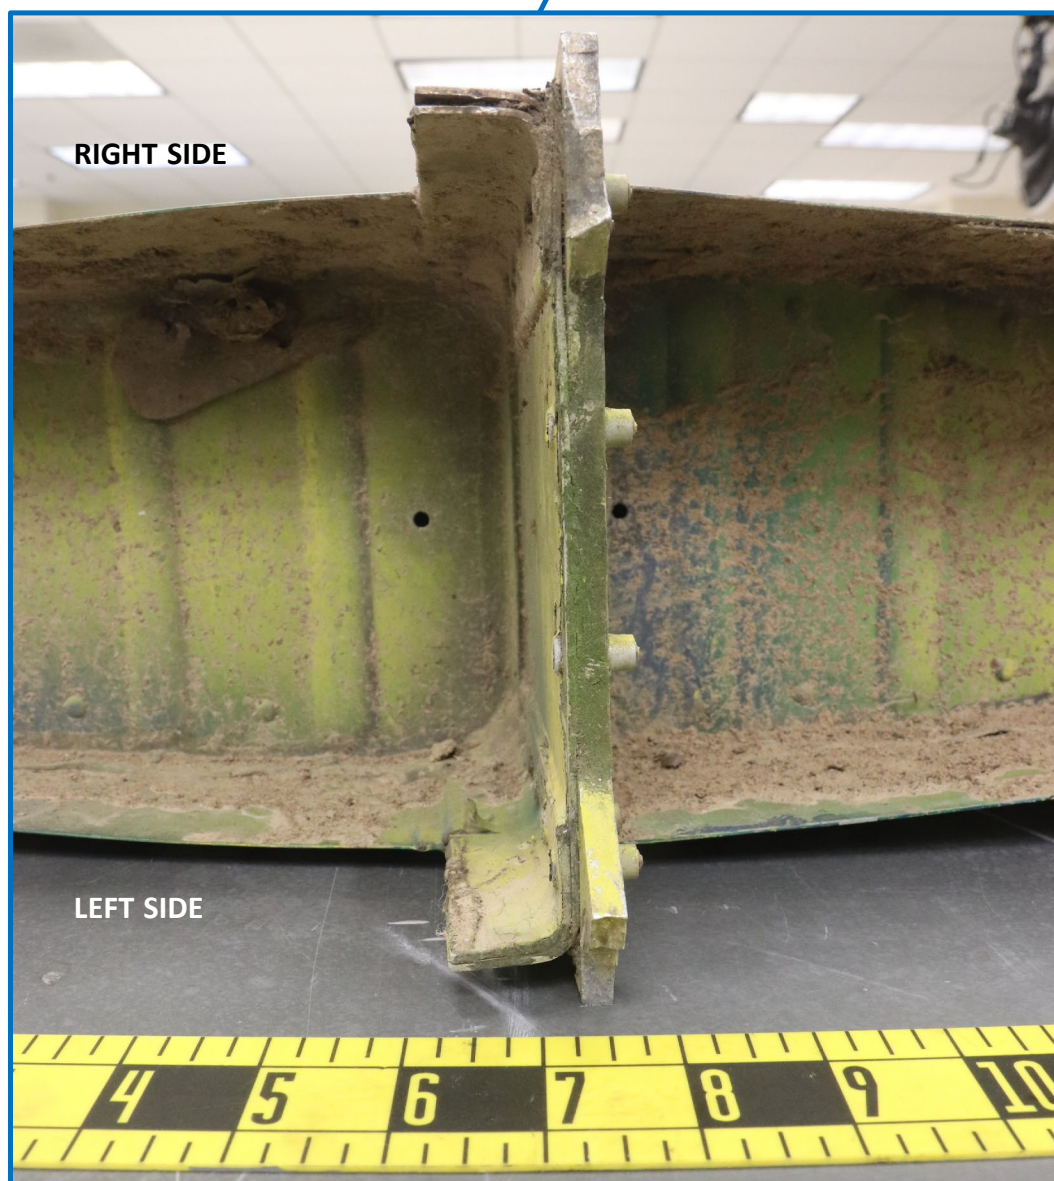
Overall photos of the right and left sides of the recovered vertical stabilizer are shown in Figures 2 and 3, respectively. Both lobes of the stabilizer fin attach plate of the forward fitting were fractured (Figures 4-6). The outboard halves of the fractures on both lobes were flat and roughly in-line with the paint line demarking the top of the mating fuselage structure; the right lobe fracture continued in a straight line through the length of the lobe while the left lobe fracture curved downwards and intersected the attachment hole (Figure 7).

In accordance with the terminating action of Air Tractor SL 155 and Federal Aviation Administration Airworthiness Directive 2003-07-04, a doubler should be attached to the forward spar assembly; no doubler was present and no evidence that one had been previously installed was observed. The forward fitting attached to forward spar measured approximately 0.25 inches thick, which is in original as-delivered condition for this serial number aircraft.

**Figure 4.** Macro photos of the fractures on the stabilizer fin attach plate.

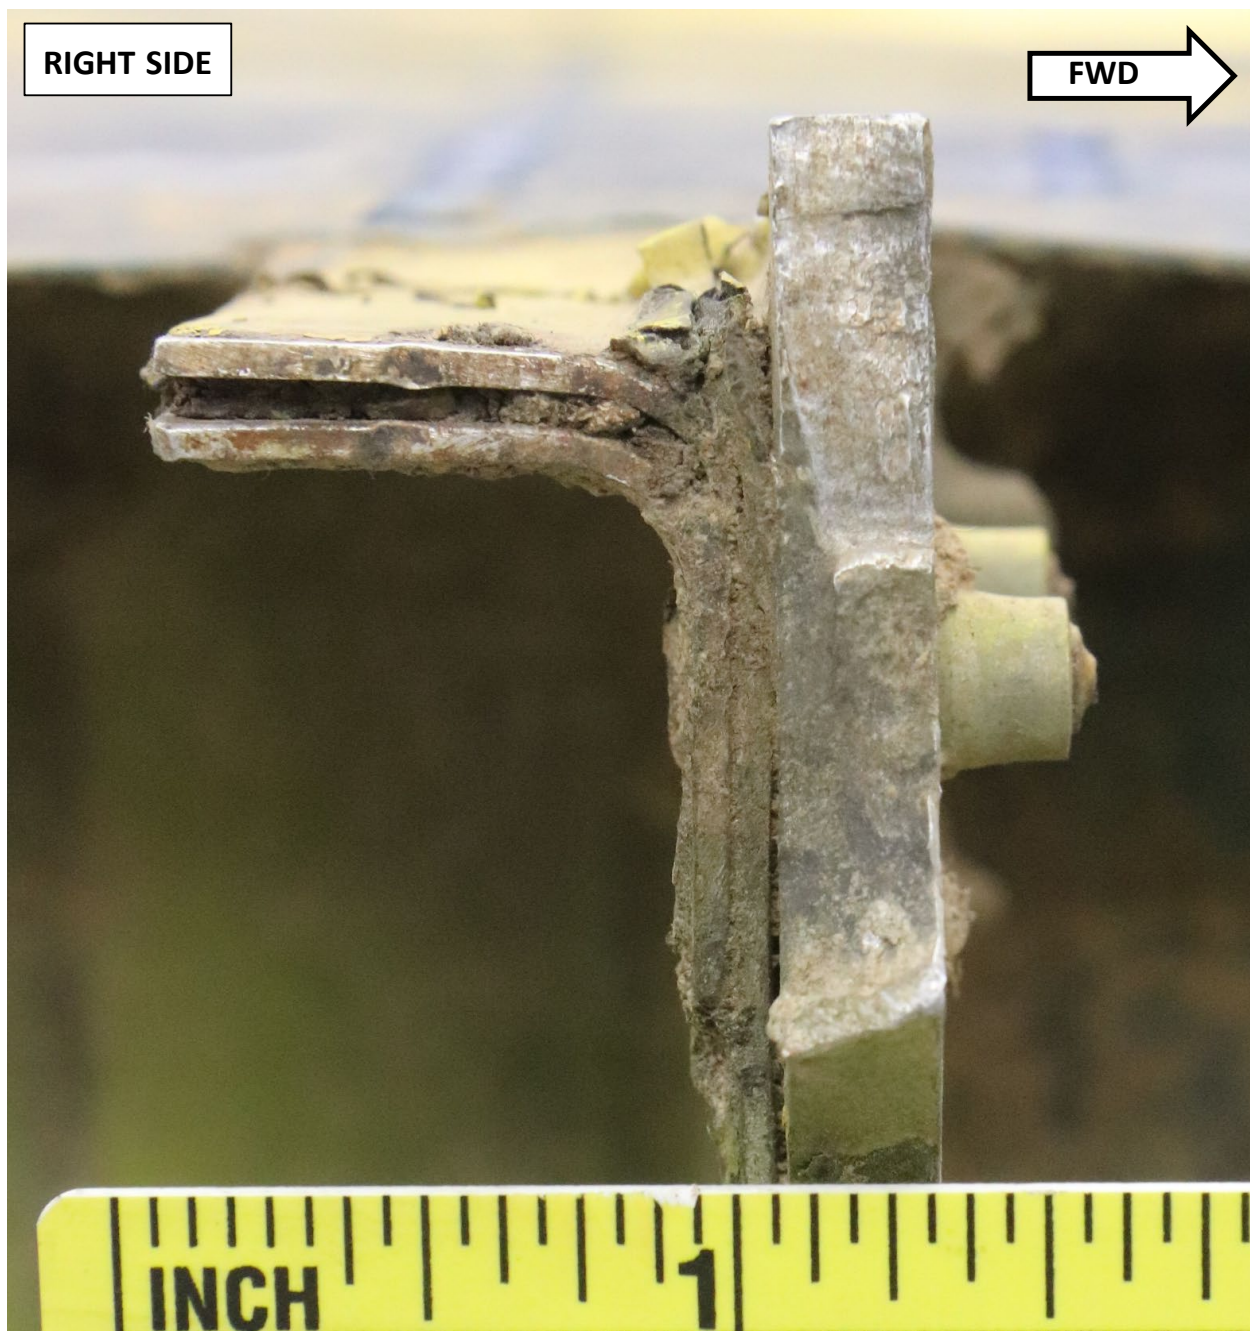
**Figure 5.** Close-up photo of the fracture surface on the separated right lobe of the stabilizer fin attach plate.

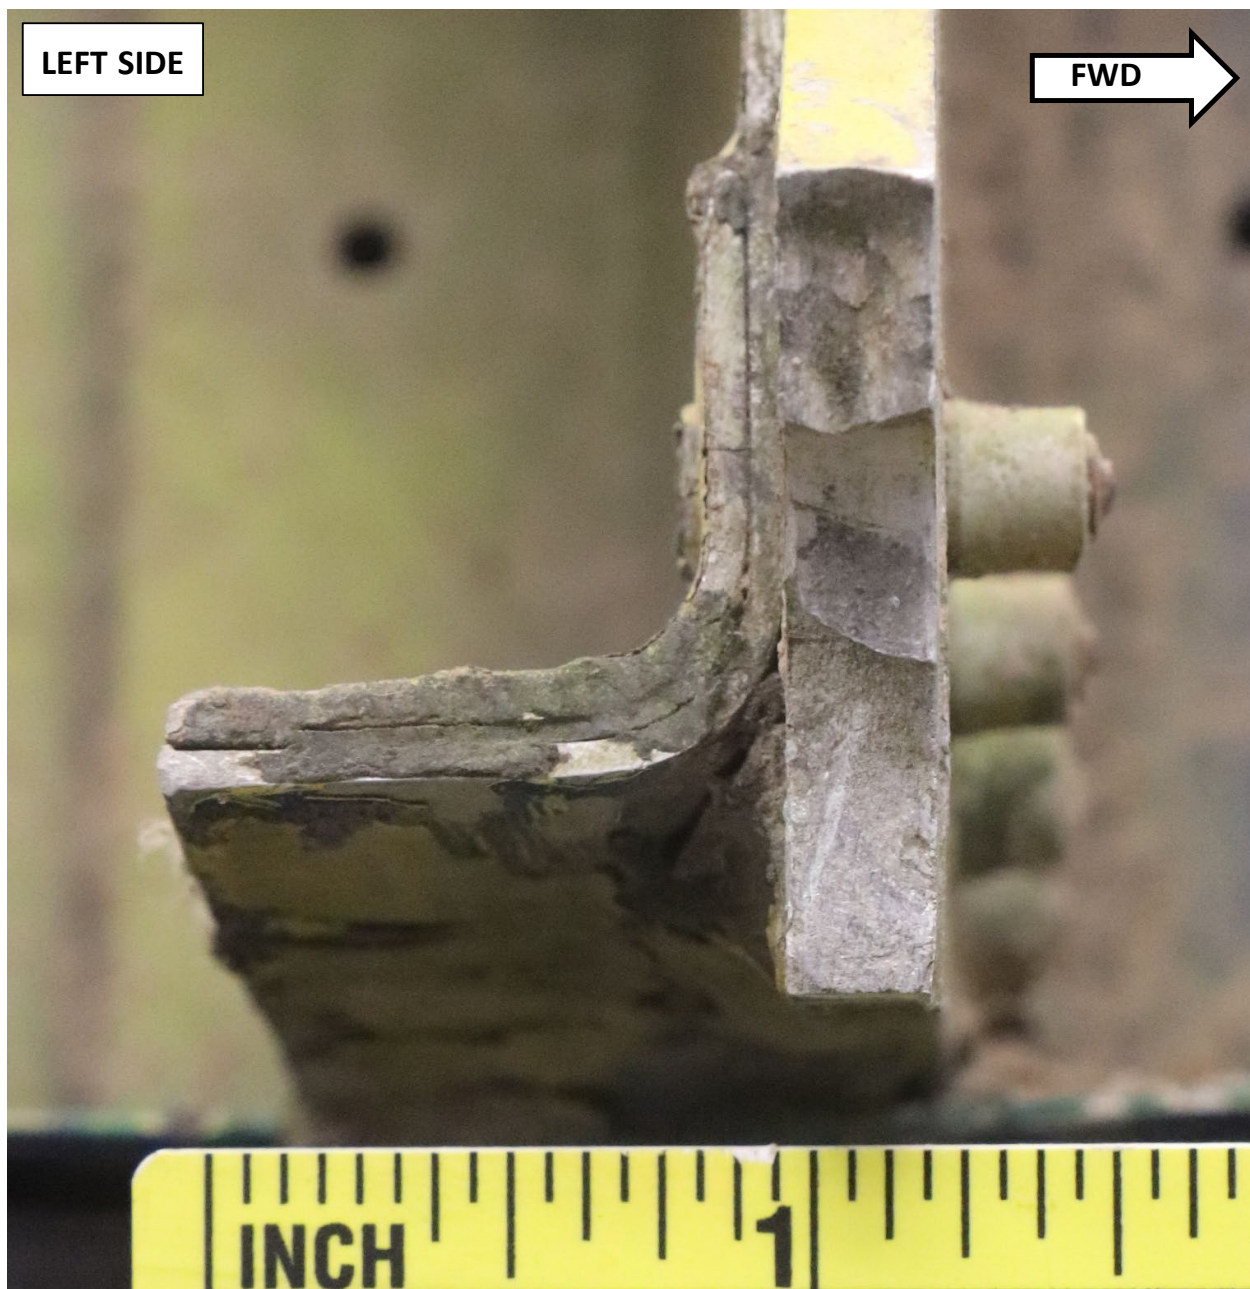
**Figure 6.** Close-up photo of the fracture surface on the separated left lobe of the stabilizer fin attach plate.

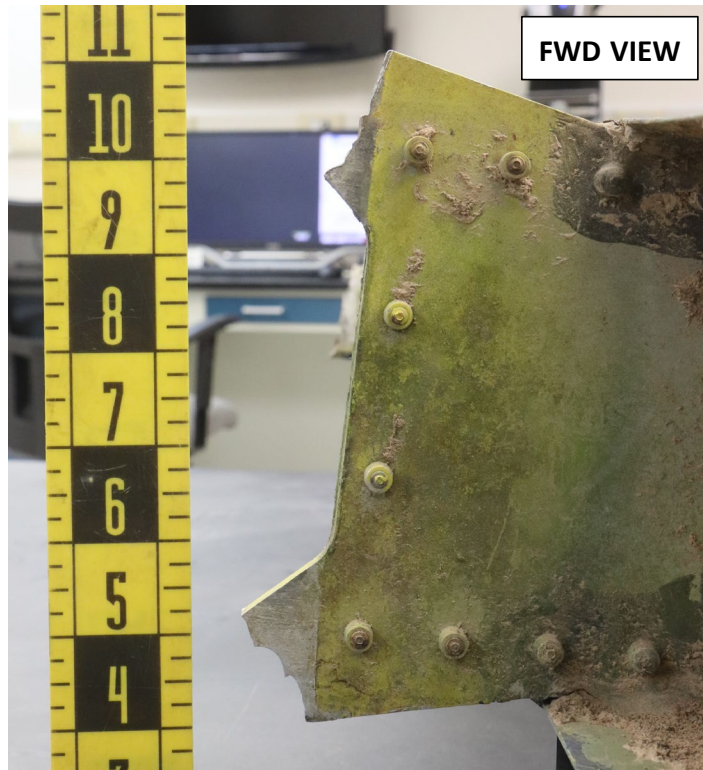
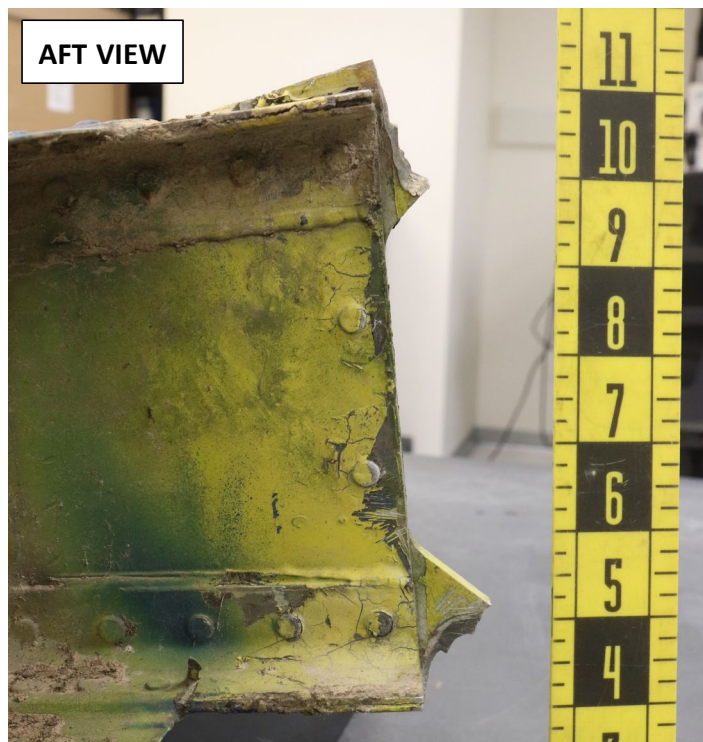
**Figure 7.** Macro photos of the stabilizer fin attach plate as viewed from the forward and aft directions.

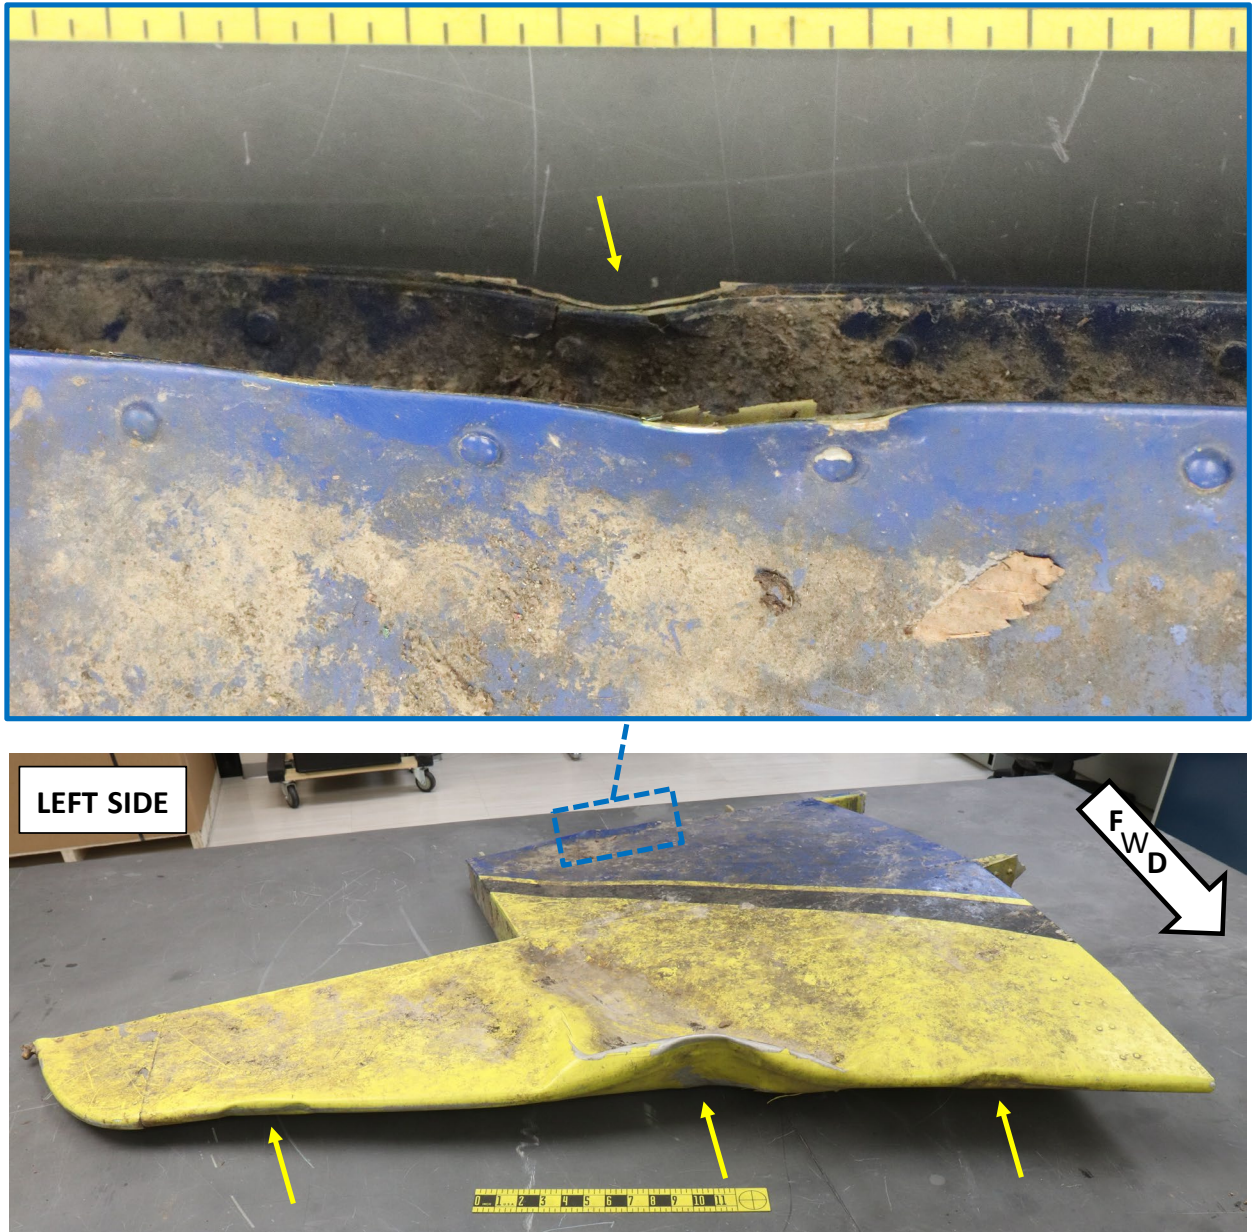
The remainder of the vertical stabilizer body was intact but had several types of damage in numerous places. Plastic deformation consistent with impact was observed along the leading and trailing edges (yellow arrows, Figure 8). A large area of buckling caused by one impact was observed at approximately mid-length on the leading edge (Figure 9). All the impact marks were bent towards the left, consistent with the right side of the stabilizer impacting first.

**Figure 8.** Macro and close-up photos of areas with plastic deformation on the leading and trailing edges of the stabilizer (yellow arrows).

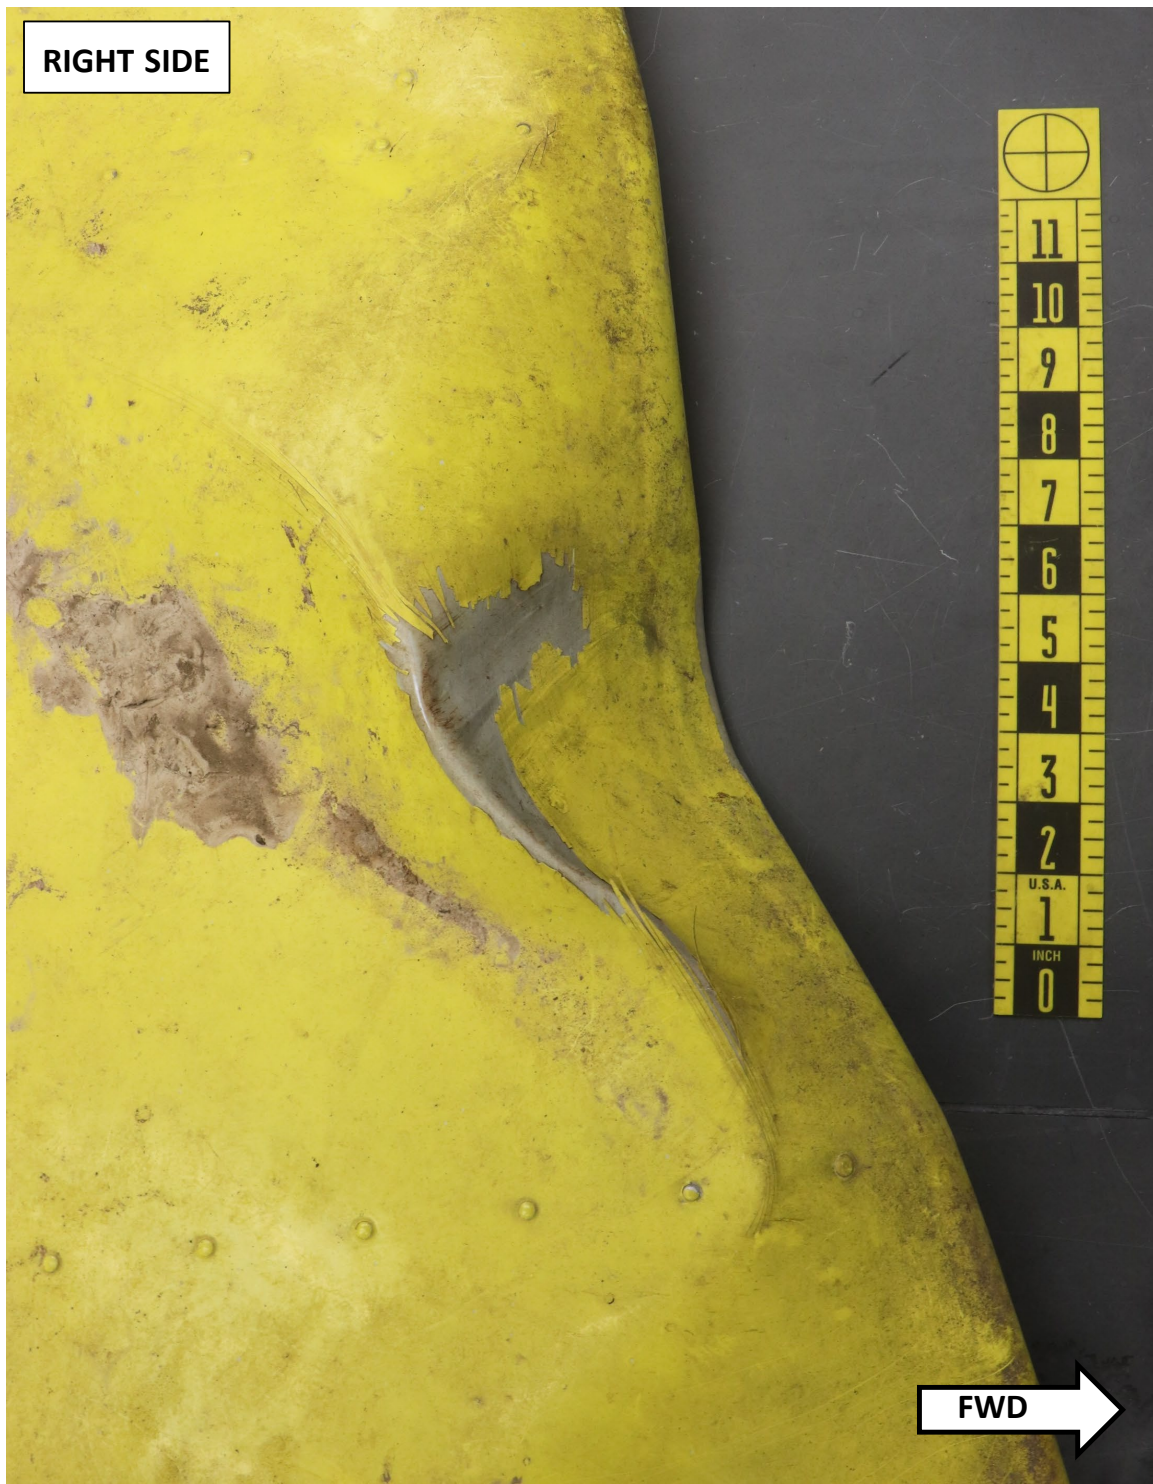
**Figure 9.** Close-up photo of a large area of buckling at approximately mid-length on the leading edge of the stabilizer.

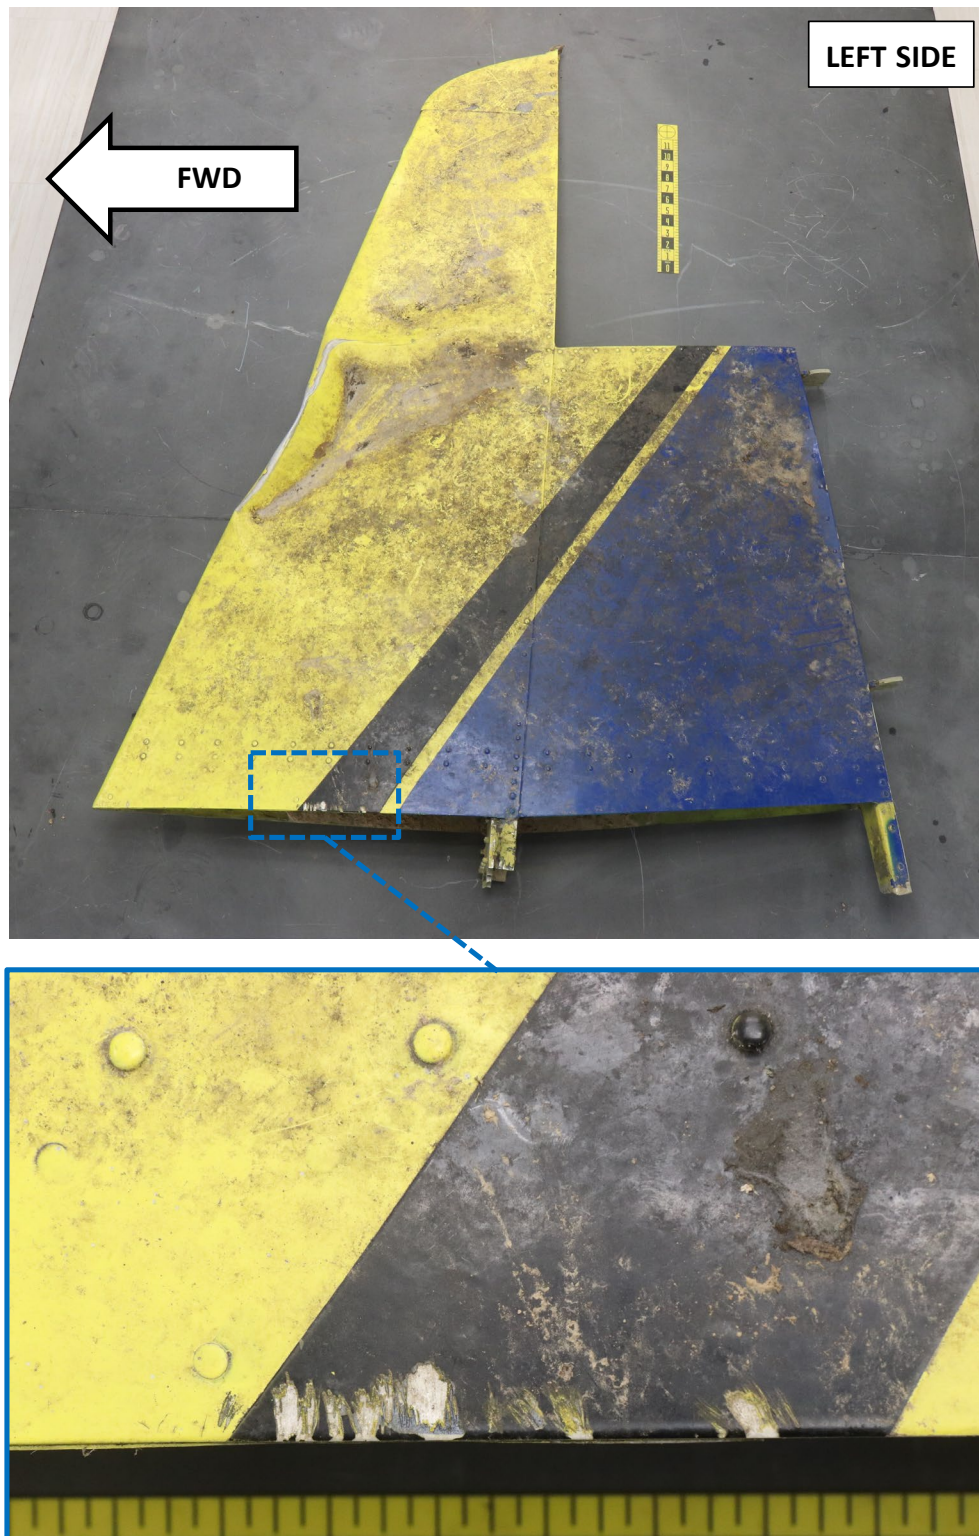
**Figure 10.** Macro and close-up photos of white transfer marks at the base of the stabilizer on the left side.

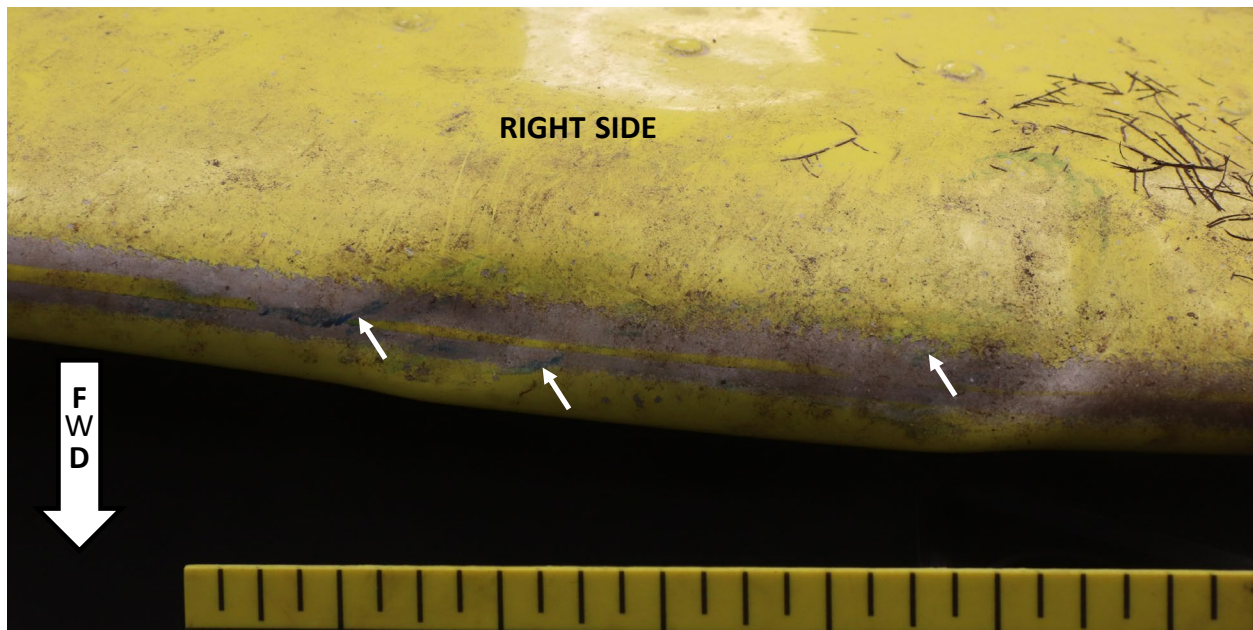
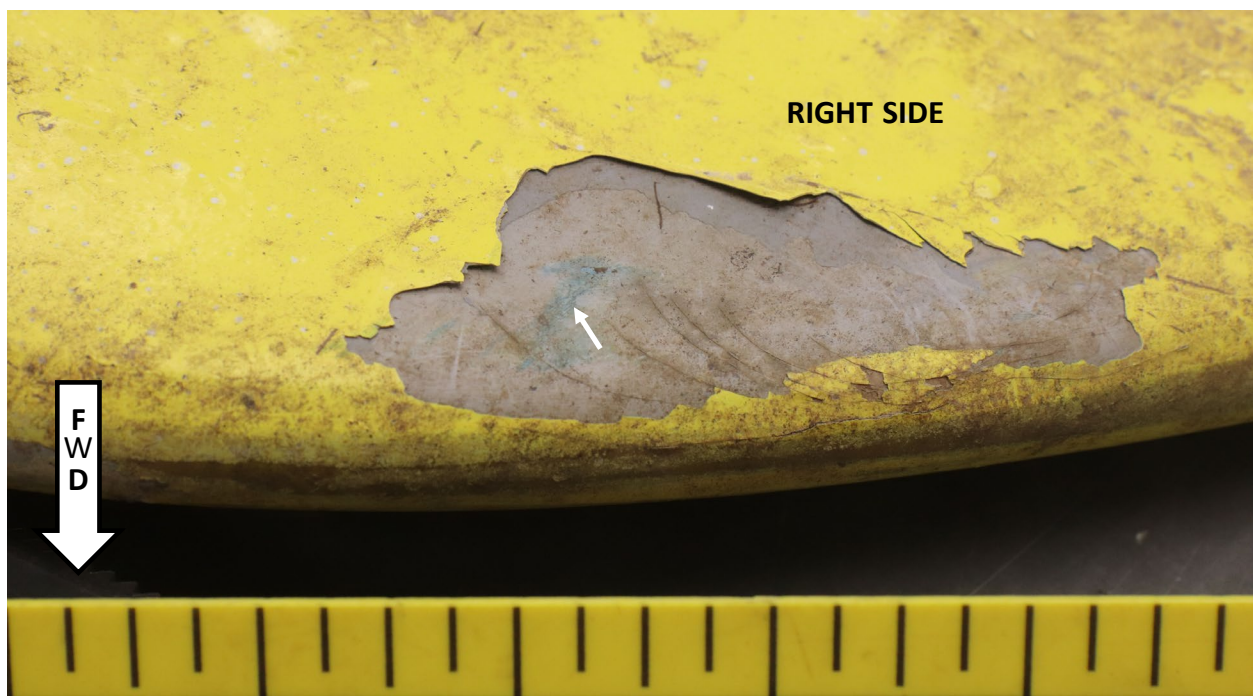
**Figure 11.** Close-up photos of blue paint smears in some of the leading-edge impact marks and on the top surface of the right side of the stabilizer.

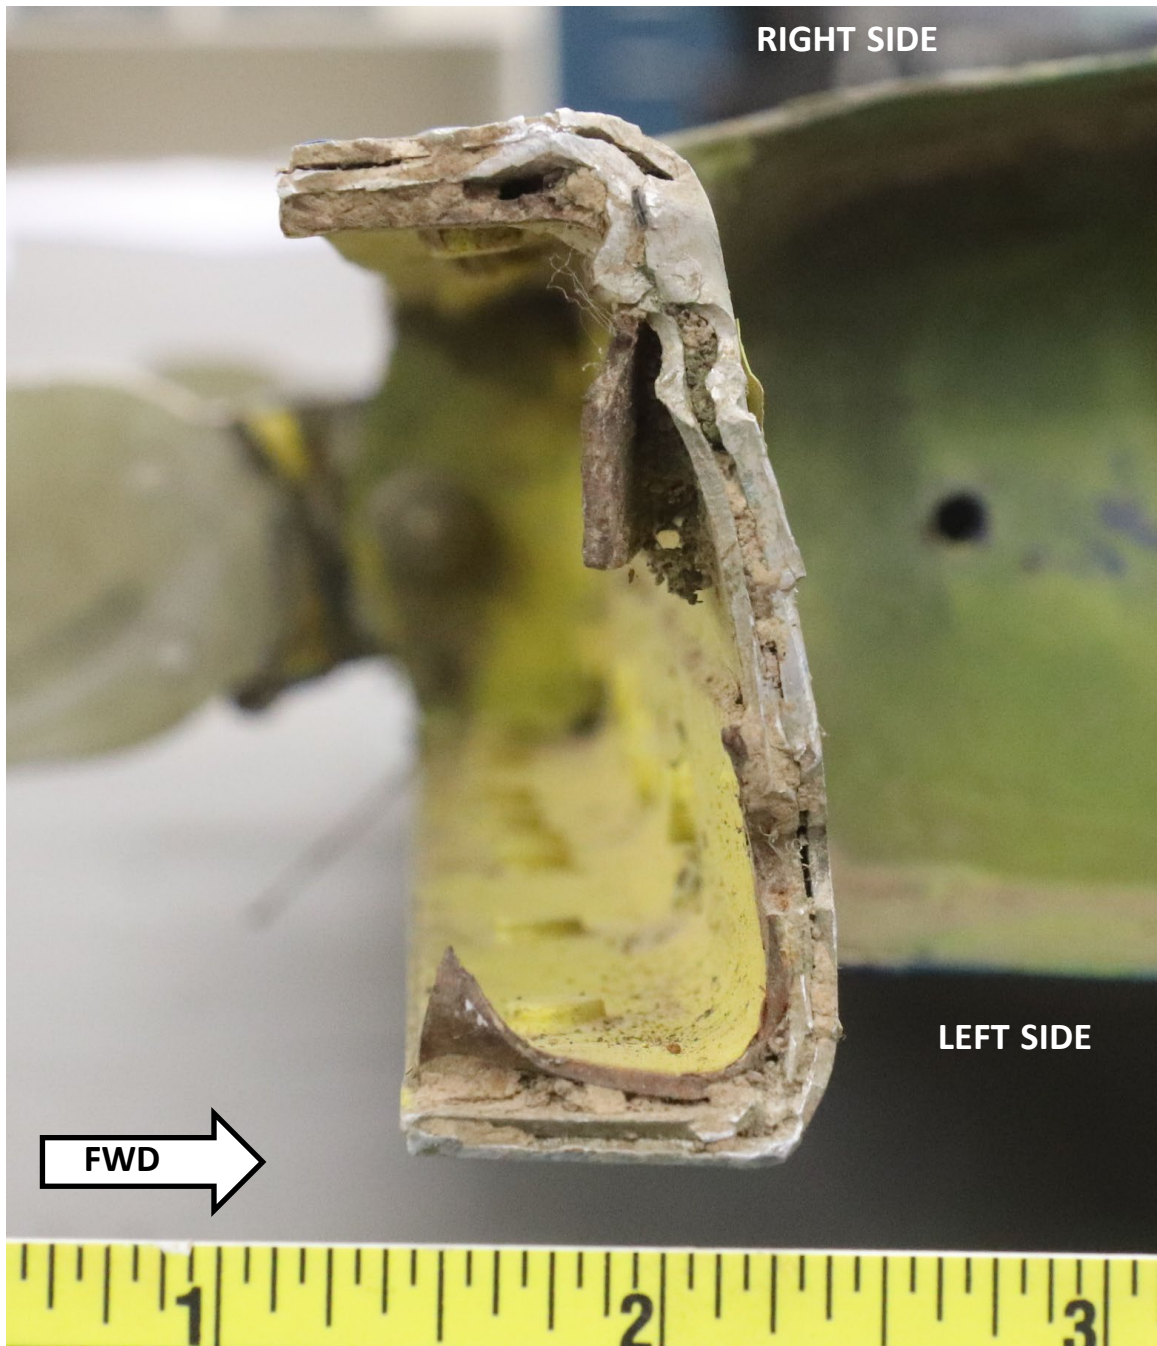
Additional contact marks were observed in several locations. There were white transfer marks on the left side base (Figure 10). Blue paint smears were visible in some of the leading-edge impact marks and on the top surface of the right side (Figure 11). The rear spar was twisted, with the right side shifted aft (Figure 12).

**Figure 12.** Close-up photo showing twisting of the rear spar of the stabilizer.

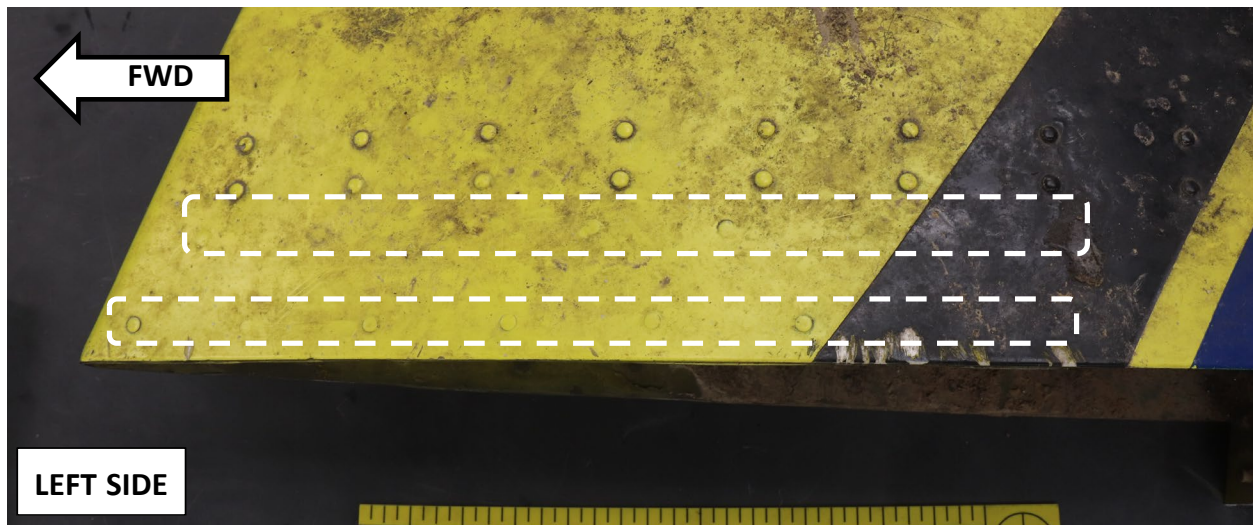
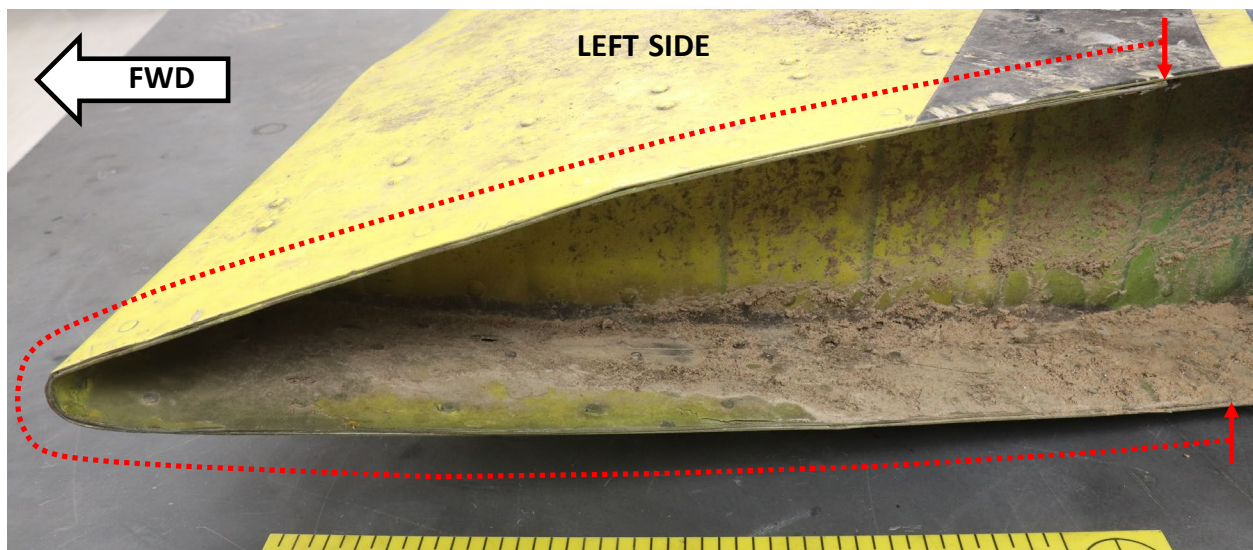
A doubler was observed at the base of the stabilizer along approximately a third of the chordwise length of the stabilizer (red dotted line, bottom photo, Figure 13). The doubler was assembled on the inner surface of the leading-edge skin and extended aft, with two rows of unevenly spaced rivets on either side of the stabilizer (white dashed boxes, top image, Figure 13). The doubler was a non-standard modification, with the purpose and date of installation unknown.

**Figure 13.** (Bottom) Close-up photo of a doubler at the base of the stabilizer along approximately a third of the overall depth of the stabilizer (red dotted line). (Top) Close-up photo of the two rows of unevenly spaced rivets on the left side of the stabilizer (white dashed boxes).

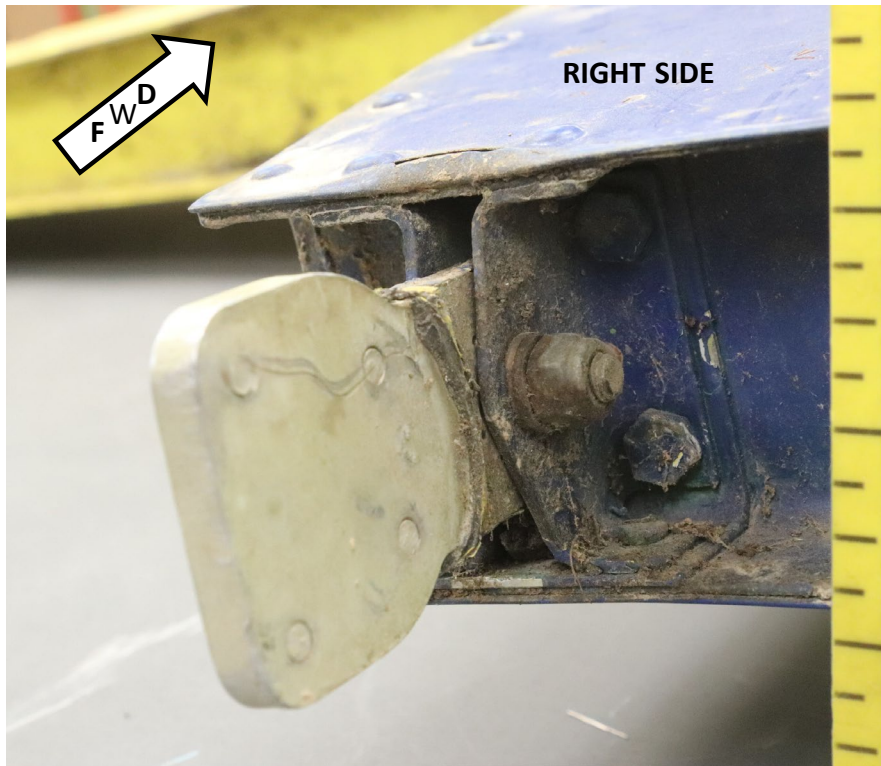
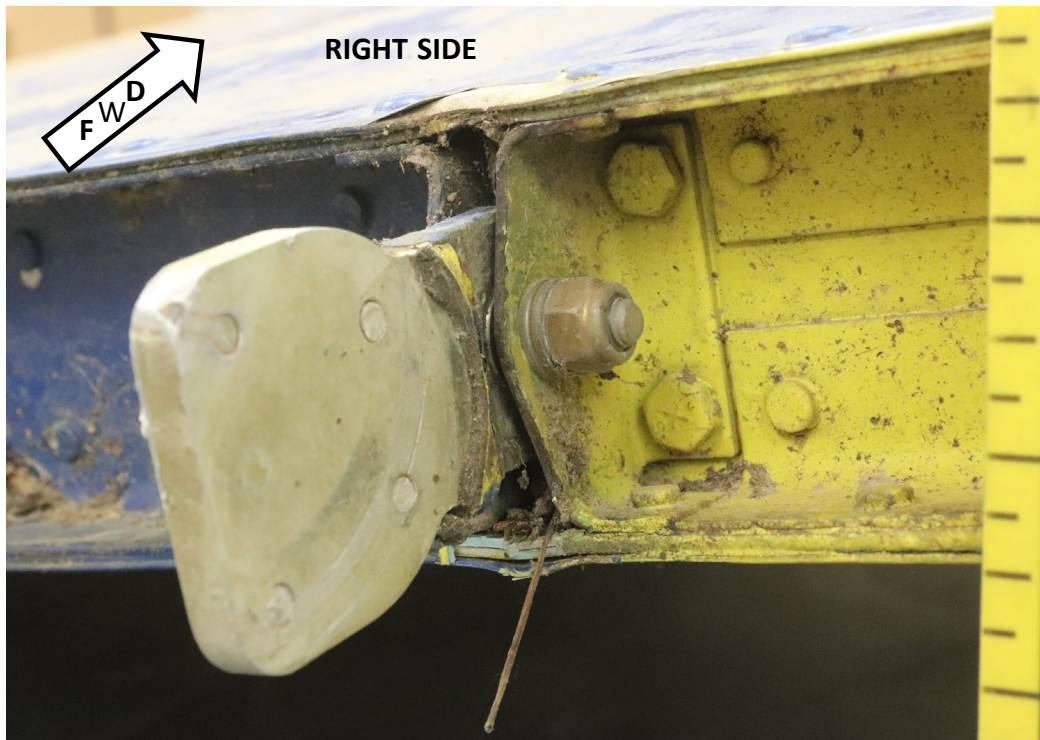
**Figure 14.** Close-up photos of the rudder attachment points at the trailing edge of the stabilizer.

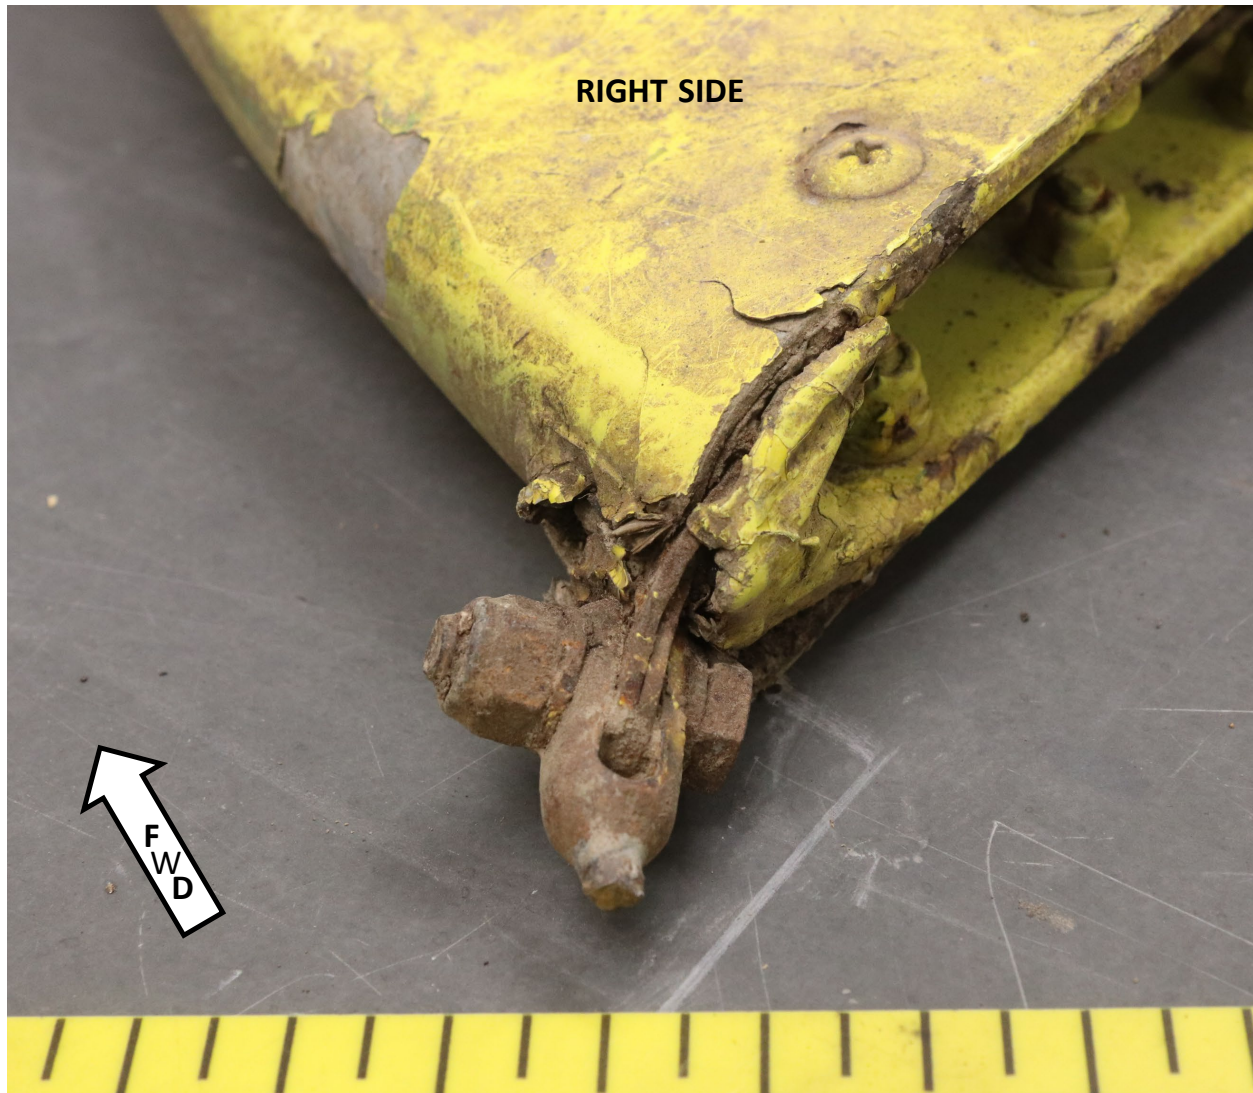
Both rudder attachment points at the trailing edge of the stabilizer were present and intact (Figure 14). The terminal from the wire deflector cable had fractured but was still assembled to the top of the stabilizer (Figure 15).

**Figure 15.** Close-up photo of the fractured terminal from the wire deflector cable of the stabilizer.
