# National Transportation Safety Board

CEN16LA154

## **MATERIALS LABORATORY**

Factual Report 26-008

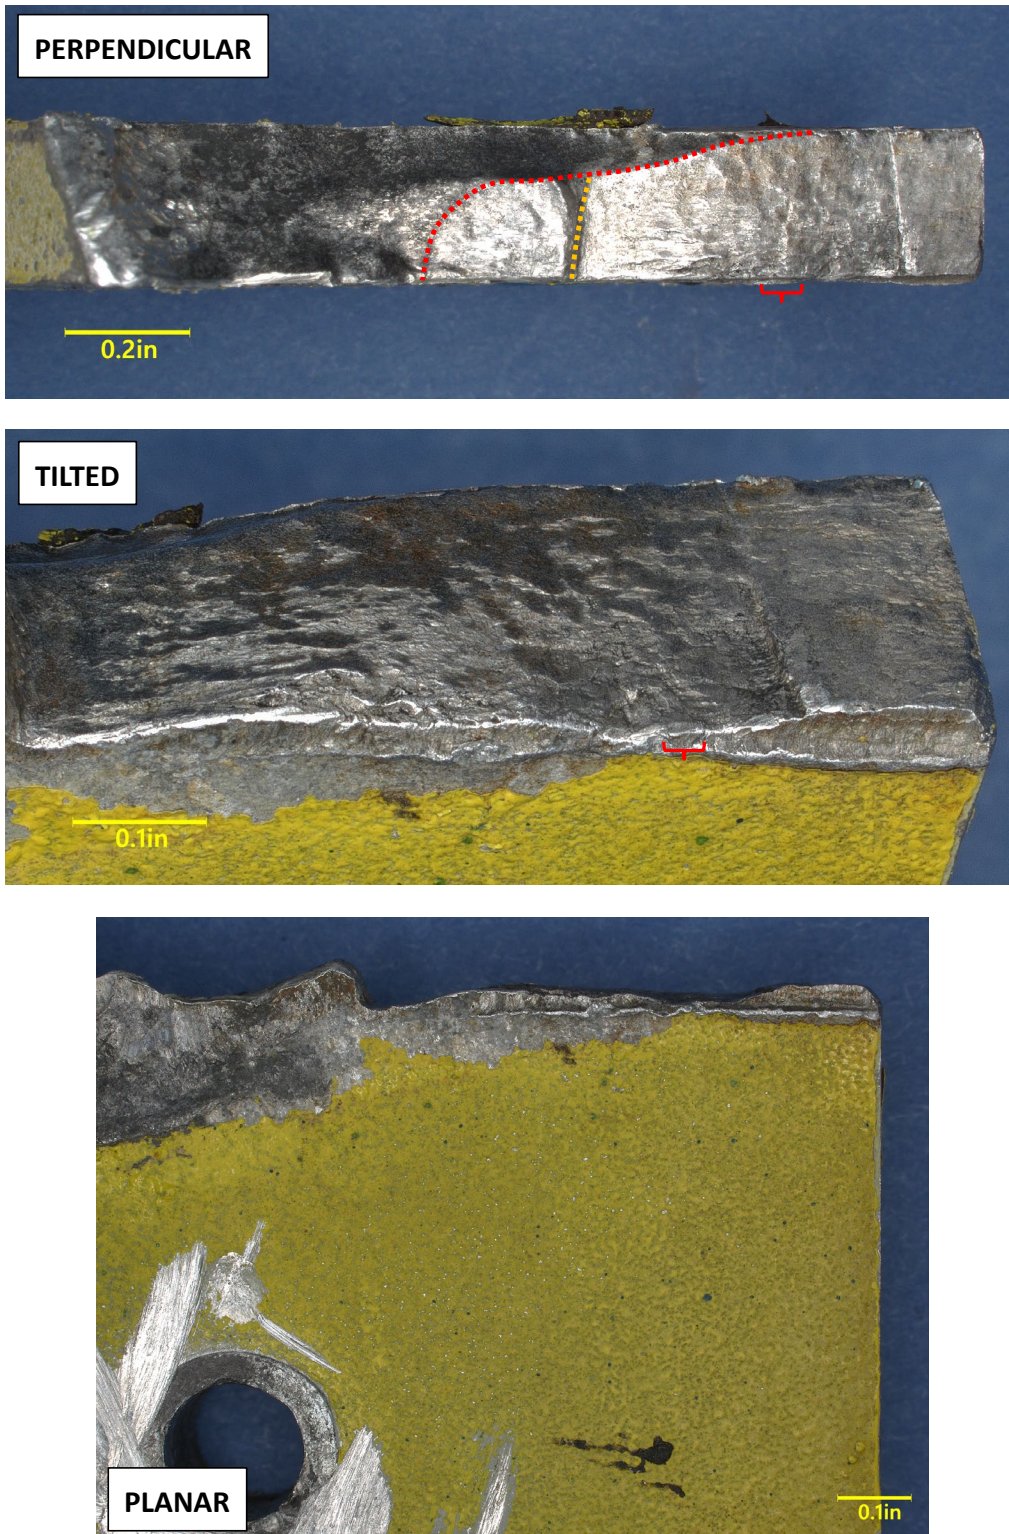
Both fracture surfaces had extensive post-fracture smearing damage. Thumbnail shaped areas were visible in the flat portions of both fracture surfaces (red dotted lines). Macro features within the thumbnails were consistent with fatigue cracking. The fatigue emanated from the forward face of the attach plate, approximately 0.25 inches and 0.10 inches inboard from the outboard edges of the right and left lobes, respectively (red brackets). Secondary fatigue cracking on parallel planes was observed adjacent to the main plane of fatigue cracking on both fracture surfaces (orange dotted lines). An uneven ridge of worn material was visible along the forward edge of the fracture surface on the right lobe, but could not be determined to have occurred pre or post fatigue initiation.

**Figure 16.** Digital microscope images of the fractured right lobe of the stabilizer fin attach plate. The red and orange dotted lines outline thumb-nail-shaped fatigue regions on the fracture surface. The red brackets indicate the location at the forward face of the attach plate from which macro features of fatigue emanated.

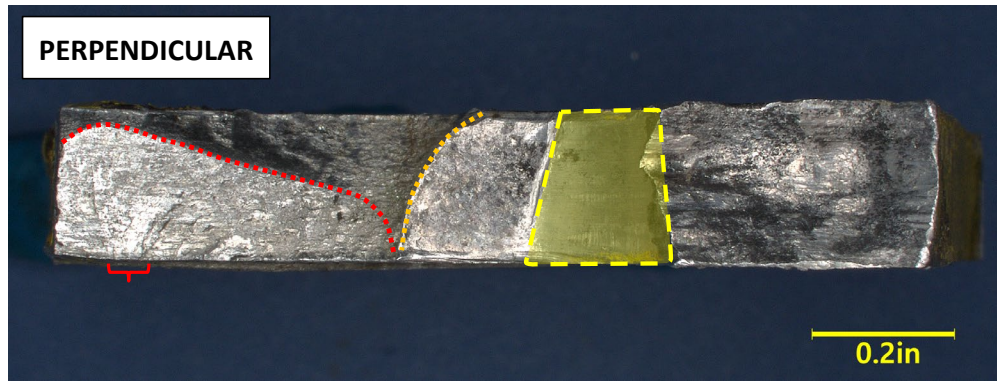
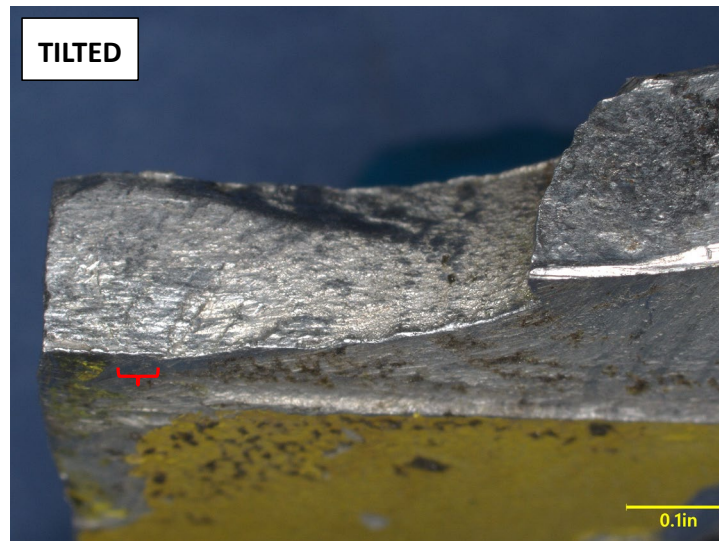
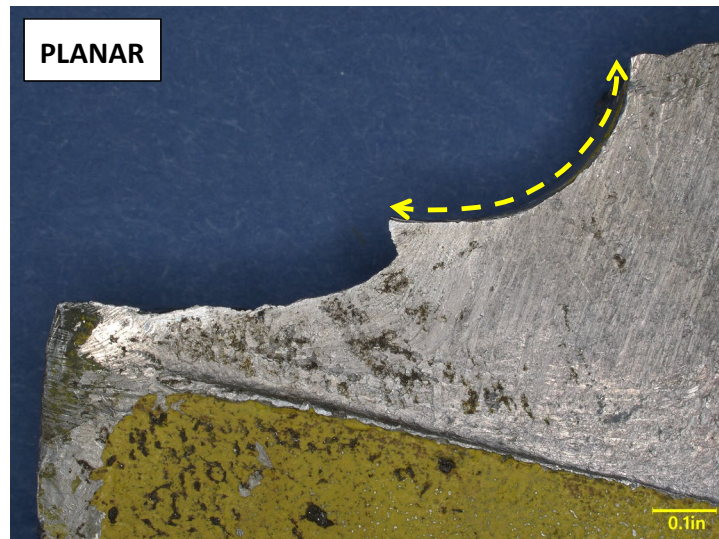
**Figure 17.** Digital microscope images of the fractured left lobe of the stabilizer fin attach plate. The red and orange dotted lines outline thumbnail-shaped fatigue regions on the fracture surface. The red brackets indicate the location at the forward face of the attach plate from which macro features of fatigue emanated. The yellow dashed lines indicate the edges of the attach hole.

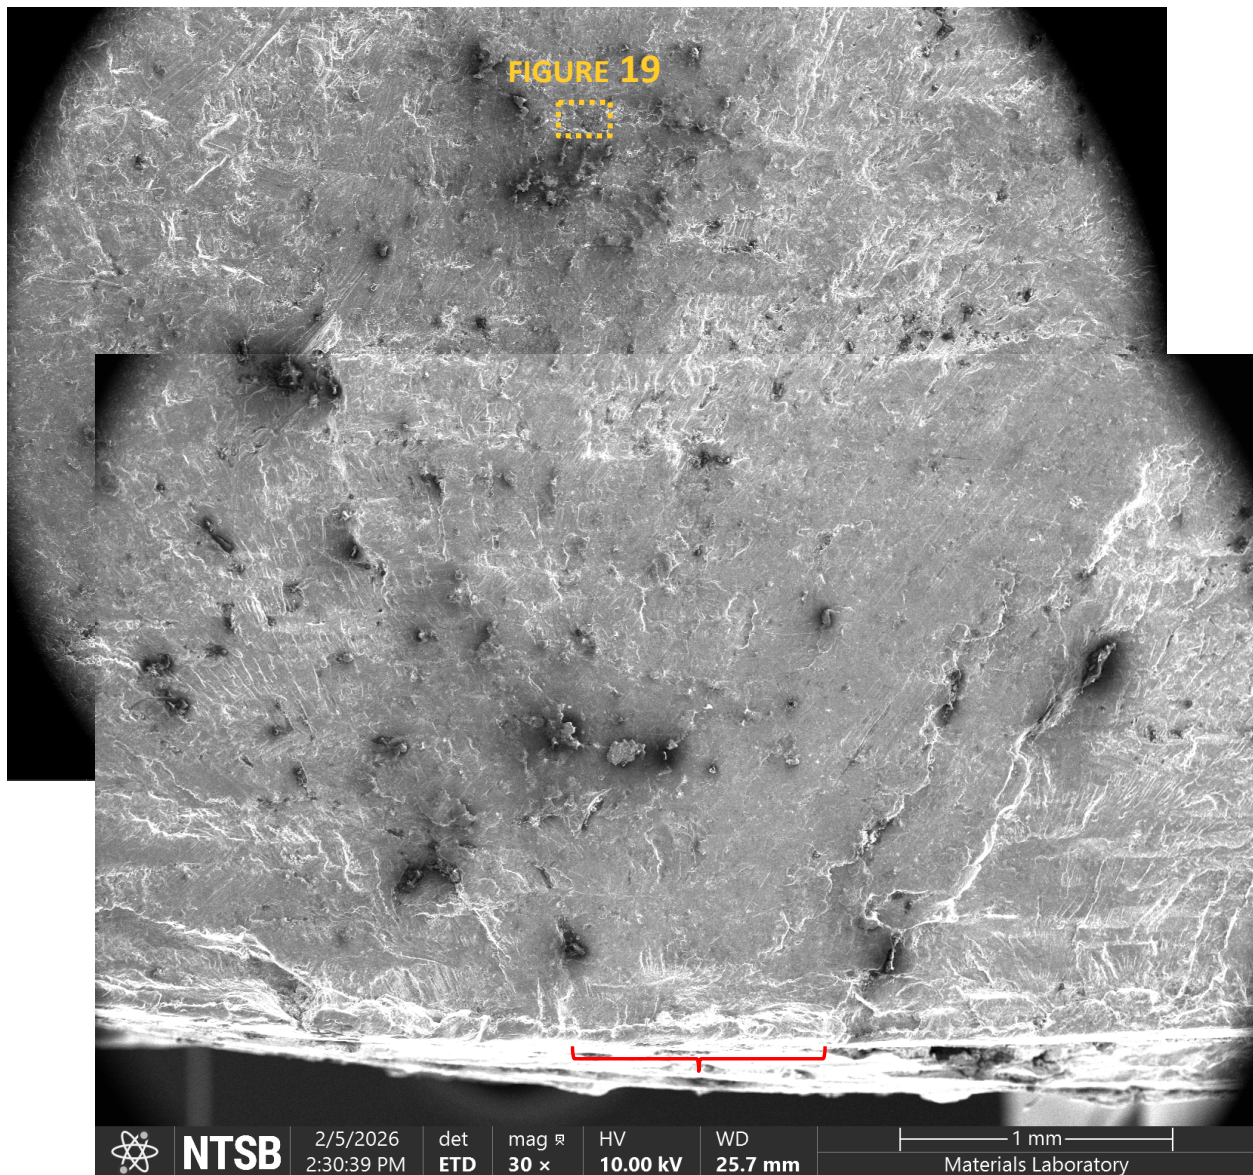
The lobe fracture surfaces were examined using a Thermo Scientific Apreo 2 field emission scanning electron microscope (SEM). SEM images of the right and left lobe fracture surfaces are shown in Figures 18-19 and Figures 20-21, respectively. River marks on the fracture surfaces were consistent with fatigue emanating from the forward faces of the lobes (red brackets, Figures 18 and 20). No distinct anomalies were observed at the origins of the fatigue cracking on either lobe. Smearing damage obscured most of the finer features on the fracture surfaces, but fatigue striations were observed within a few undamaged areas (Figures 19 and 21).

**Figure 18.** Secondary electron SEM images of the fractured right lobe of the stabilizer fin attach plate. The red bracket indicates the location at the forward face of the attach plate from which fatigue features emanated.

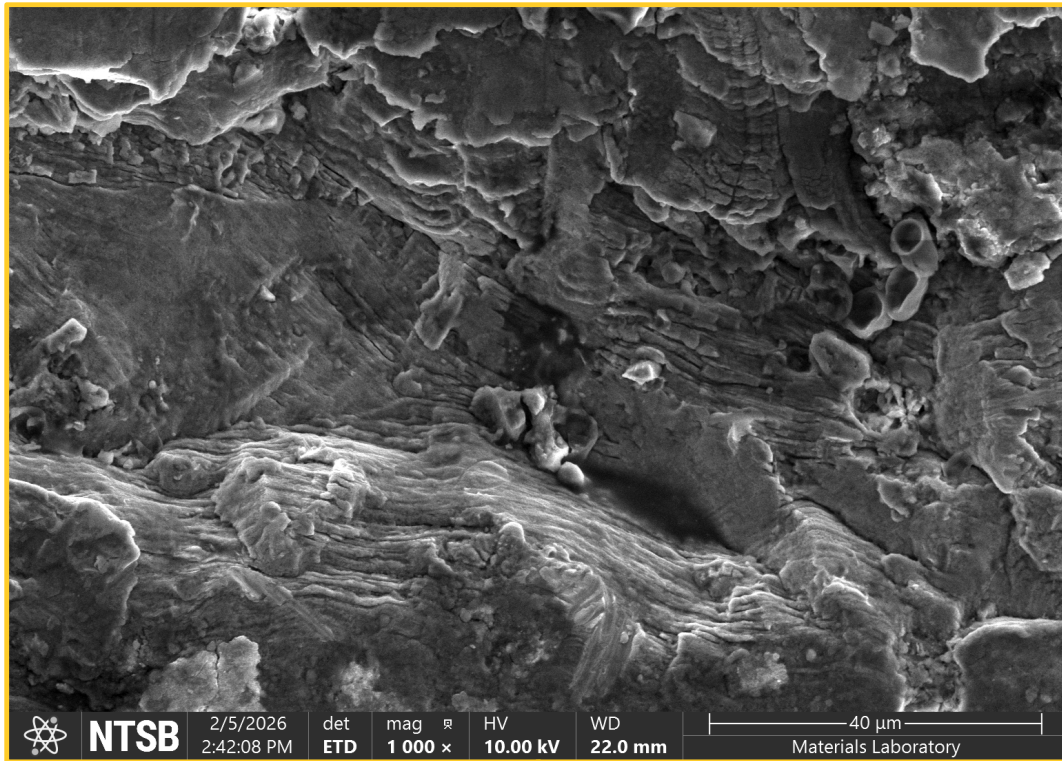
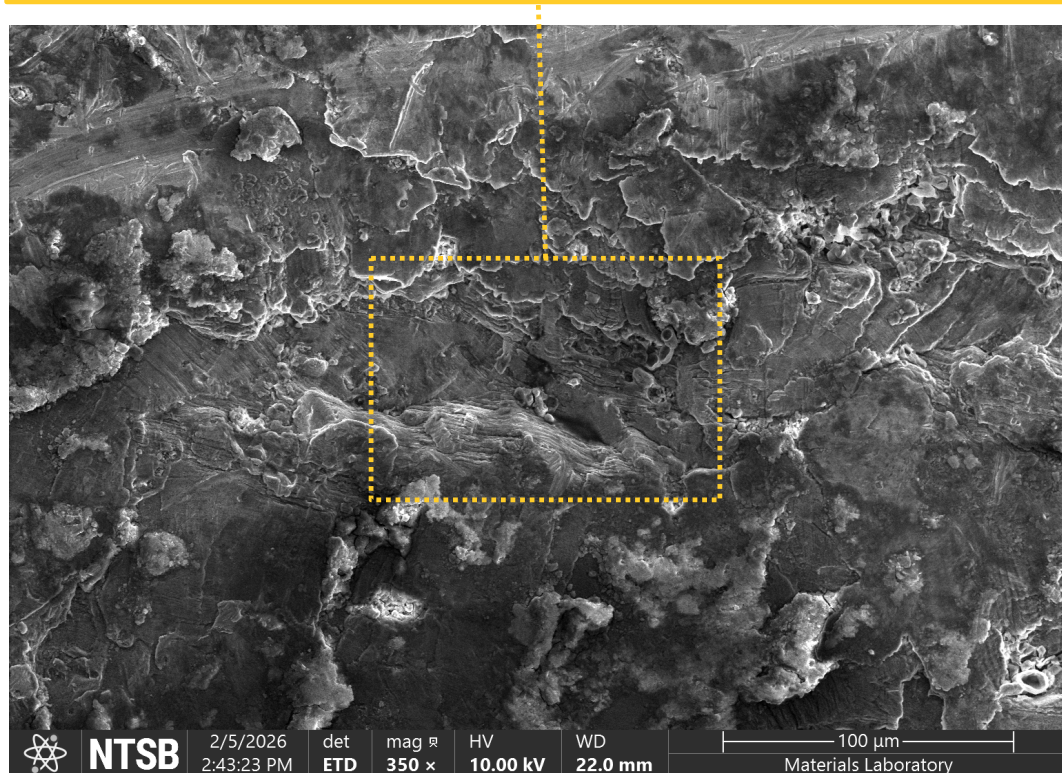
**Figure 19.** Secondary electron SEM images of fatigue striations observed on an undamaged area of the fractured right lobe of the stabilizer fin attach plate in the location indicated in Figure 18.

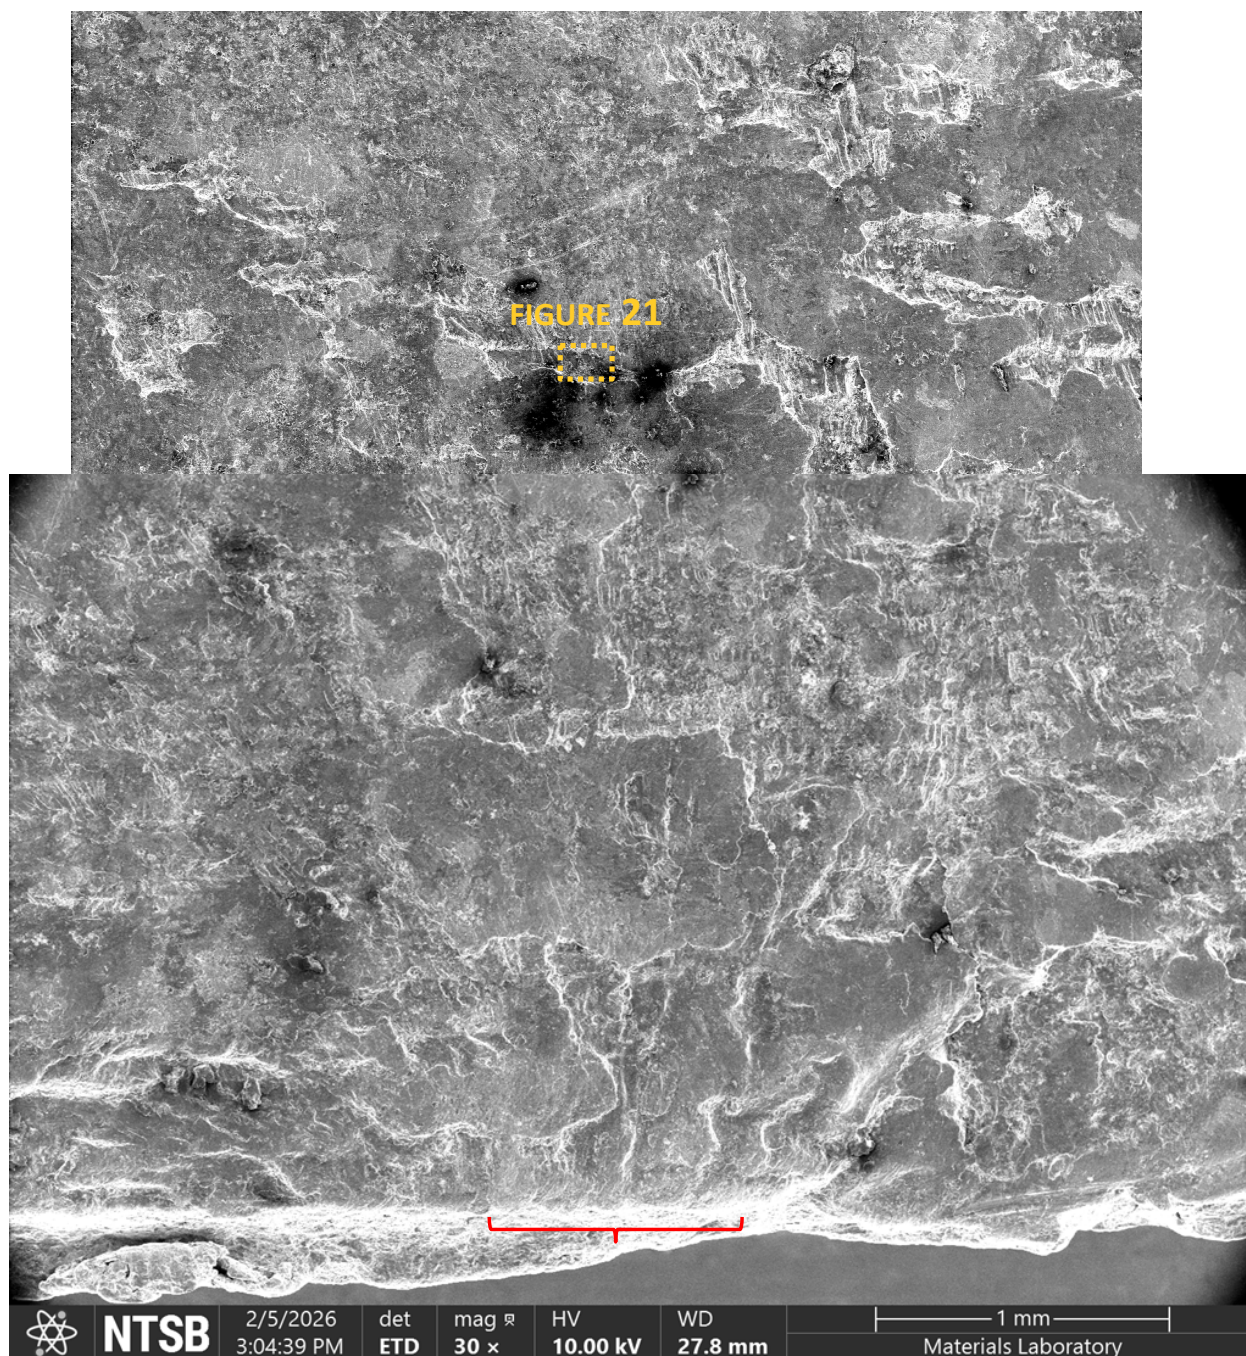
**Figure 20.** Secondary electron SEM images of the fractured left lobe of the stabilizer fin attach plate. The red bracket indicates the location at the forward face of the attach plate from which fatigue features emanated.

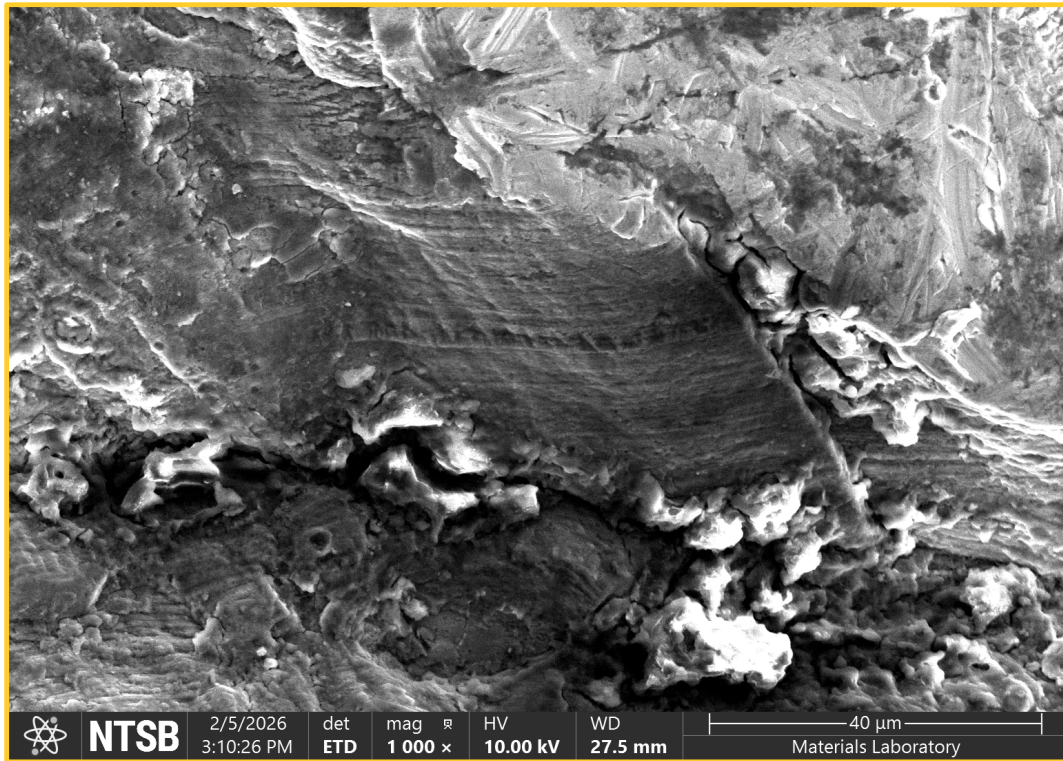
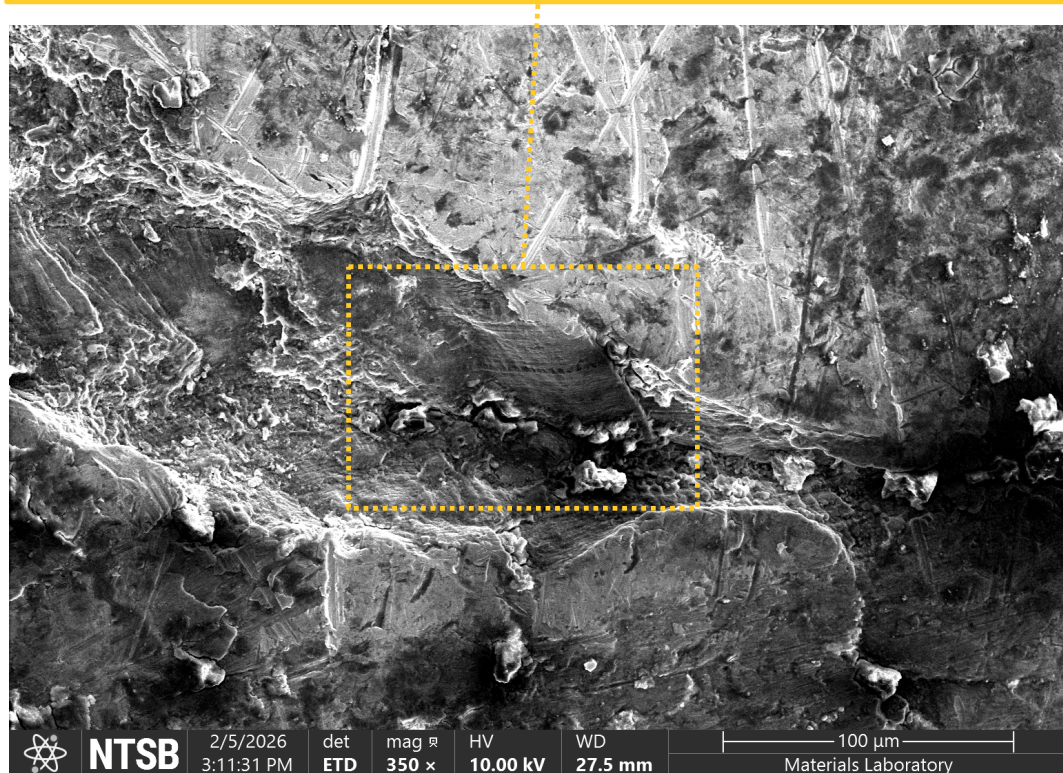
**Figure 21.** Secondary electron SEM images of fatigue striations observed on an undamaged area of the fractured left lobe of the stabilizer fin attach plate in the location indicated in Figure 20.

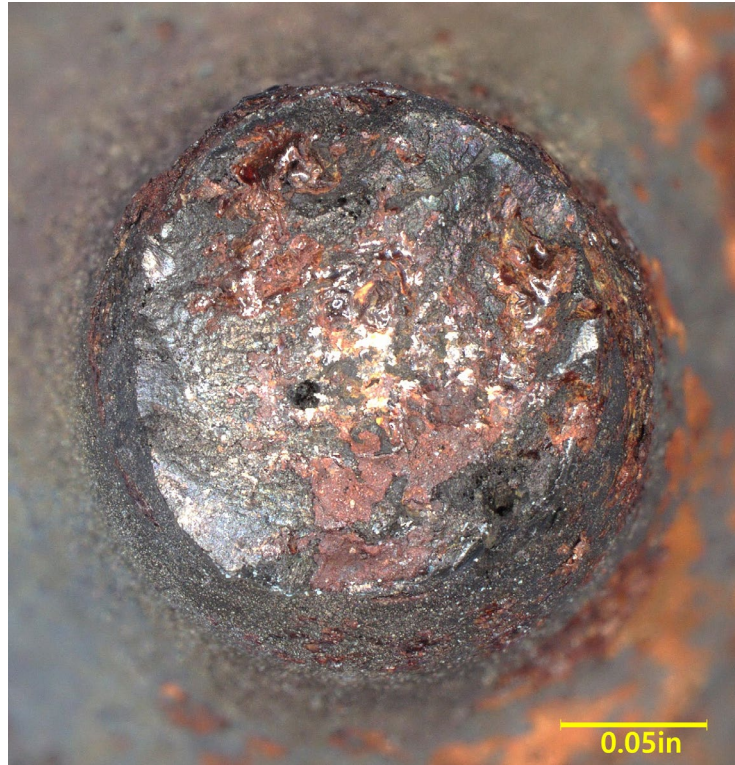
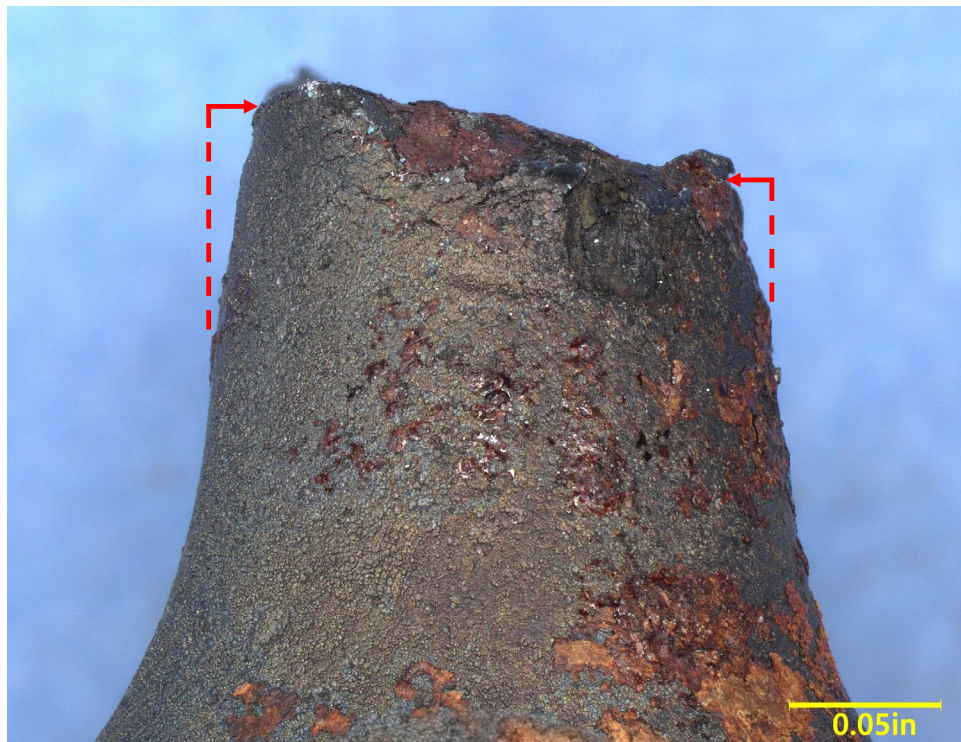
The surfaces of the terminal were heavily degraded, with extensive corrosion deposits. The separated terminal end had a reduced diameter (red dashed lines) from necking, consistent with plastic deformation during tensile overstress.

**Figure 22.** Digital microscope images of the fracture surface and profile of the separated deflector cable terminal end. The red dashed lines indicate the reduced diameter from necking of the terminal end.

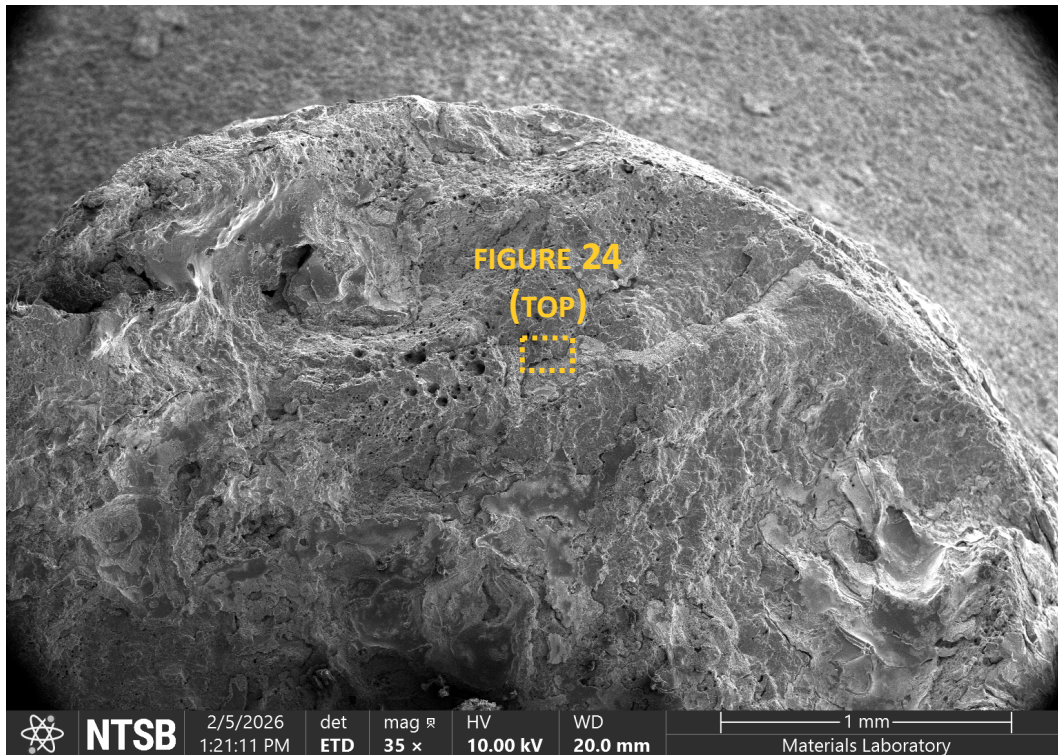
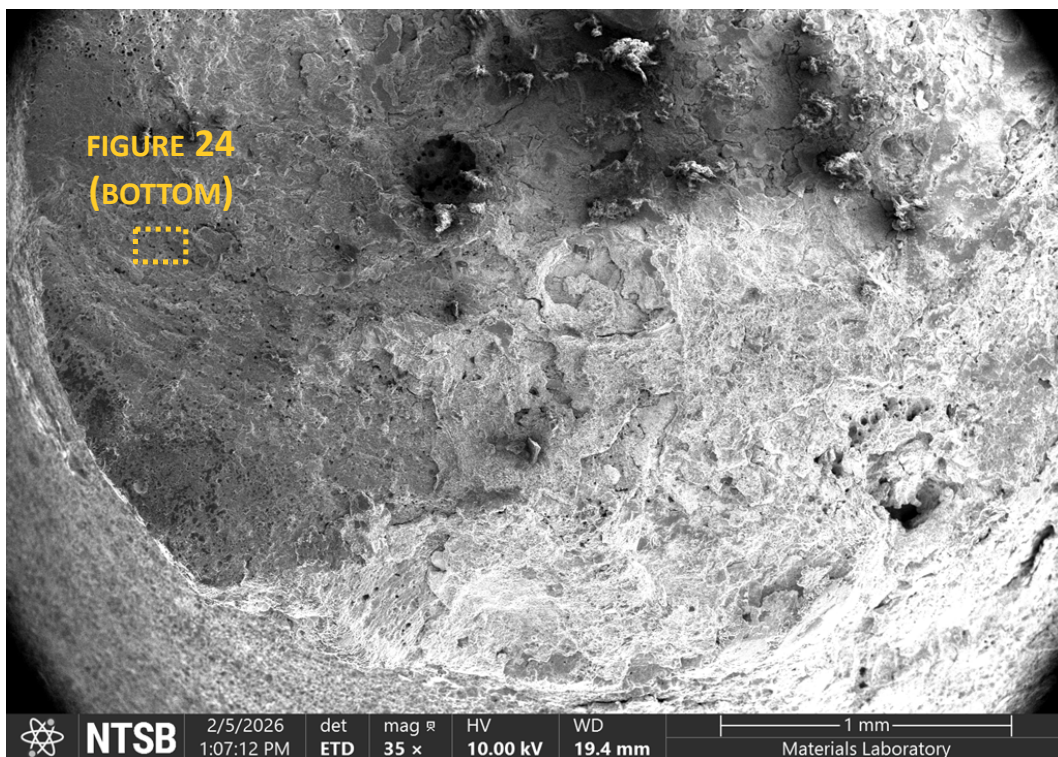
The terminal fracture surface was examined using a SEM (Figures 23 and 24). Corrosion deposits and secondary smearing damage obscured a significant amount of finer fracture surface features. Undamaged areas on the fracture surface had ductile dimples consistent with tensile overstress.

**Figure 23.** Secondary electron SEM images of the fracture surface on the separated deflector cable terminal end.

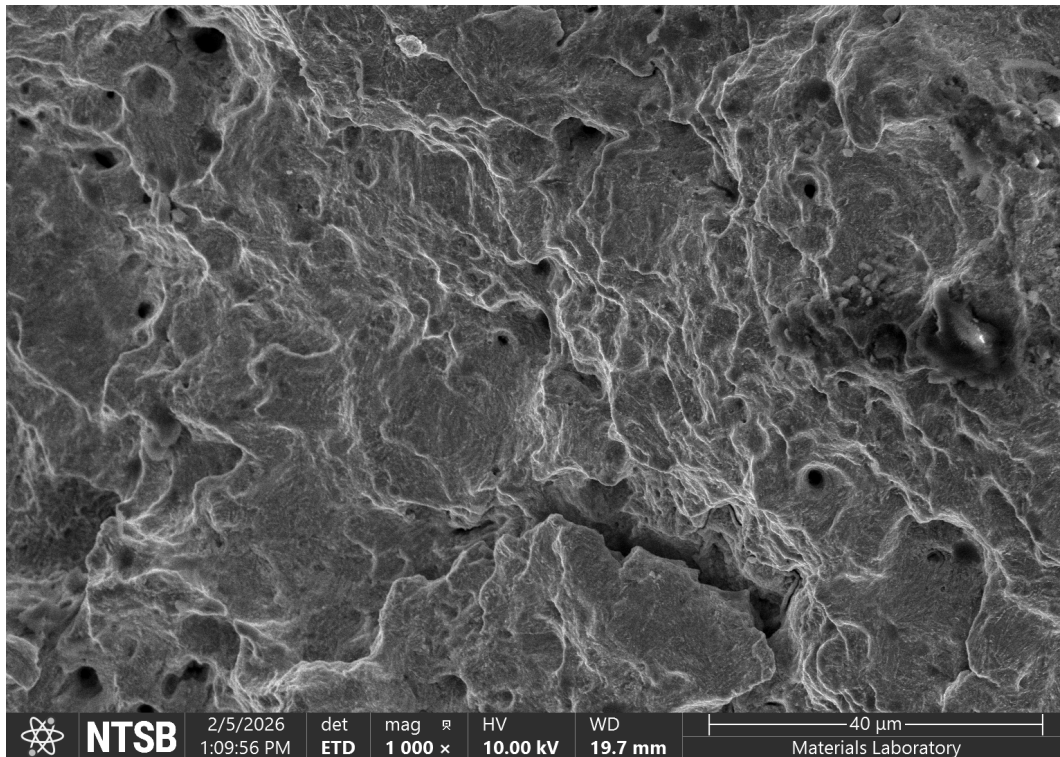
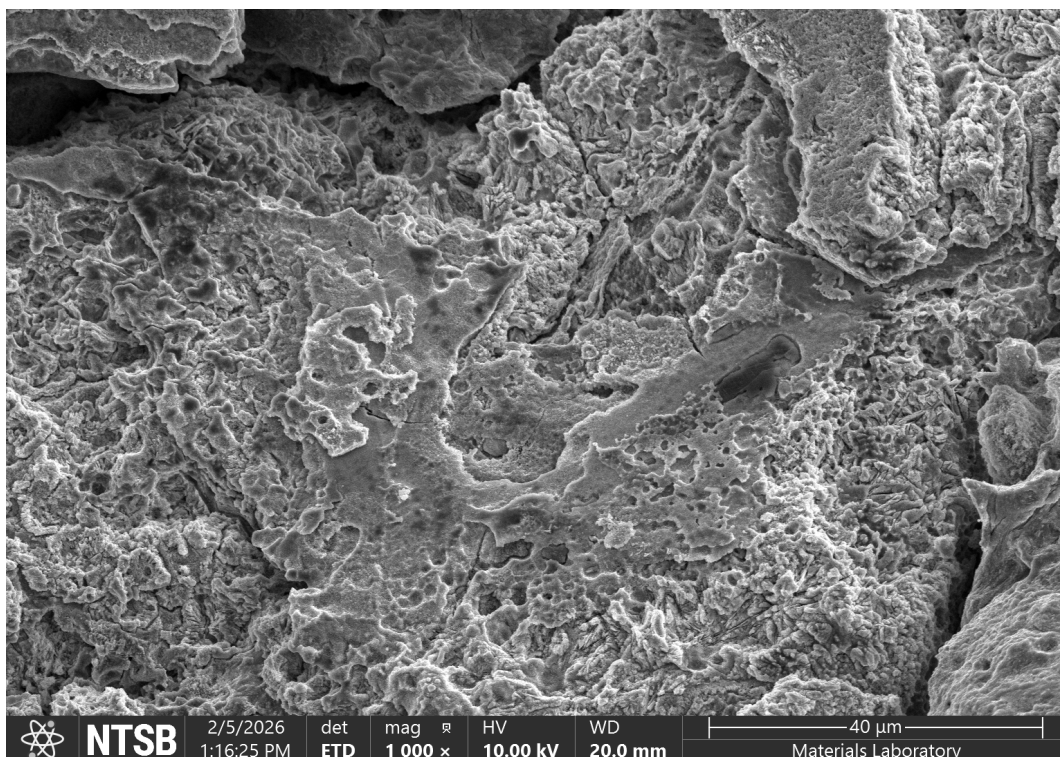
**Figure 24.** Secondary electron SEM images of ductile dimples on the fracture surface on the separated deflector cable terminal end in the locations indicated in Figure 23.
