**Air Tractor, Inc.**  
Accident Investigation

**AIRFRAME ACCIDENT REPORT**

**CEN16LA154**

**4/18/16**  
**Kilbourne, LA**

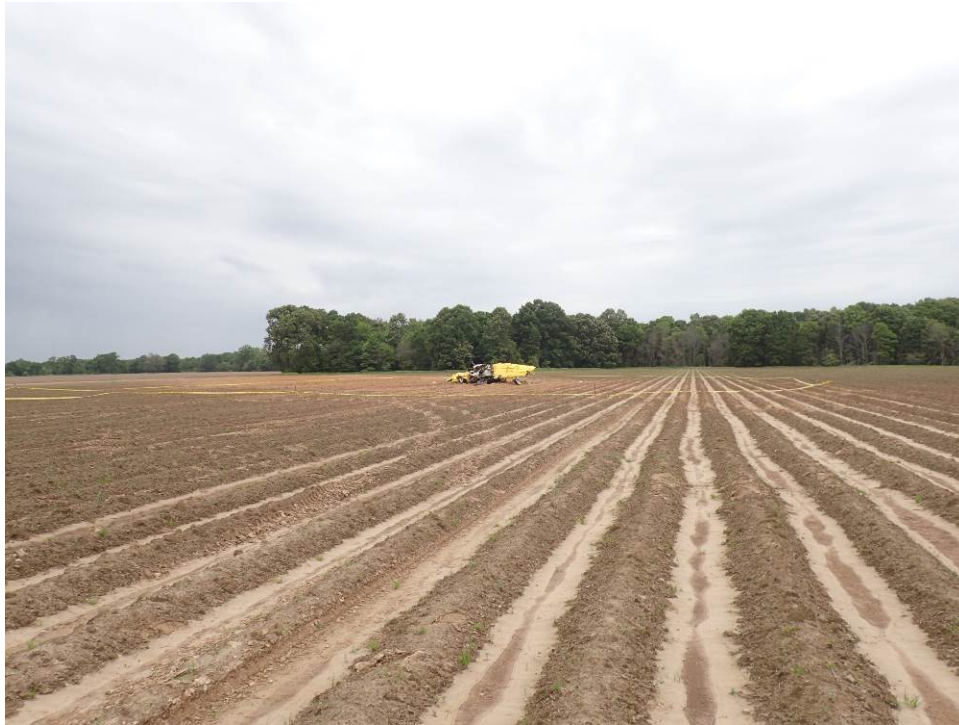
The wreckage was tightly confined to the immediate vicinity of the impact site. The fuselage was largely destroyed by impact forces and a post-crash fire. The fire had only damaged the inboard sections of the wings. The primary ground impact mark consisted of an impact crater in the soft soil that is consistent with a nose-in impact at modest speed. This impact crater contained pieces of the engine cowling, large pieces of the hopper top and lid, and pieces of

**Accident Scene as Approached from the South**

Radiating from the impact crater were two impressions in the soft earth that are consistent with the impact of the wing leading edges. These impact marks were oriented in a northwest-southeast direction. These impact marks were characterized by a shallow impression in the soil, along with yellow paint flakes. At the end of each of these marks were blue paint flakes and thick pieces of broken glass, consistent with the blue paint stripes and landing lights at the aircraft's wingtips.

From the information at the scene, this impact is consistent with the aircraft impacting the ground in a nose down (almost vertical, slightly inverted) attitude, wings roughly level with the righthand wingtip oriented toward the southeast. This would be a high angle, low speed impact. The evidence suggests an incipient stage stall/spin from low altitude. The aft fuselage and rudder showed signs of some momentum toward the lefthand side of the aircraft.

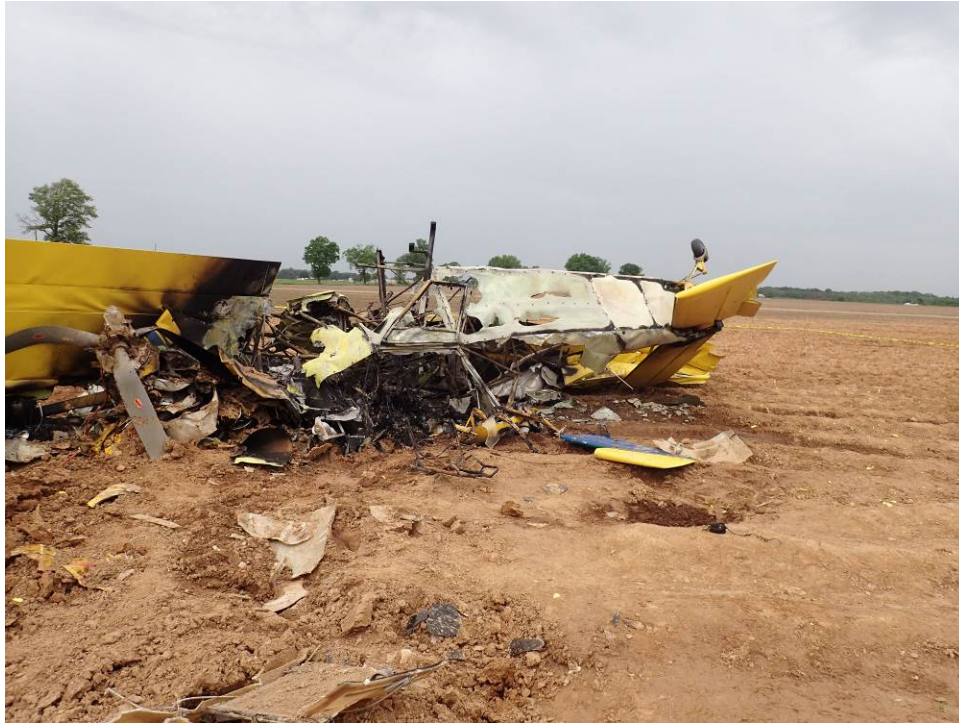
The fuselage was heavily damaged by impact and fire, particularly from the cockpit forward. Generally all non-metallic items in the cockpit were destroyed by fire. Aluminum items in this

area were either destroyed or severely heat damaged. Steel components were intact, but exhibited high-temperature surface corrosion.

**Fuselage Wreckage**

The seat, control stick and much of the cockpit overturn structure had been cut out by EMS personnel to aid in extrication of the pilot.

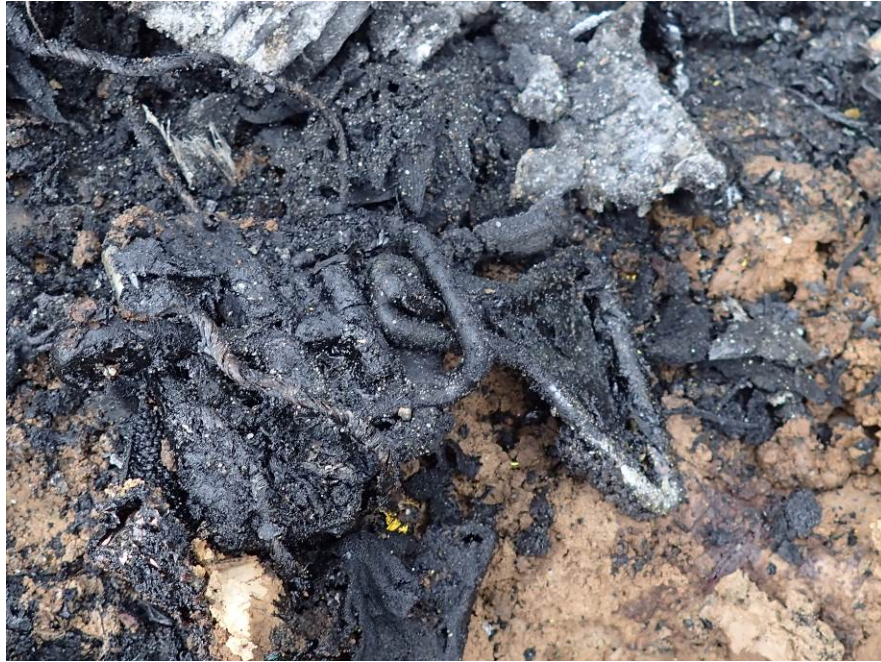
The lap belt buckle was found still latched with most of the webbing burned away. The shoulder harness buckles were not found properly installed on the lap belt buckle assembly. This would likely be indicative that the pilot was not wearing the shoulder harnesses at the time of the accident.

**Lap Belt Buckle Assembly**

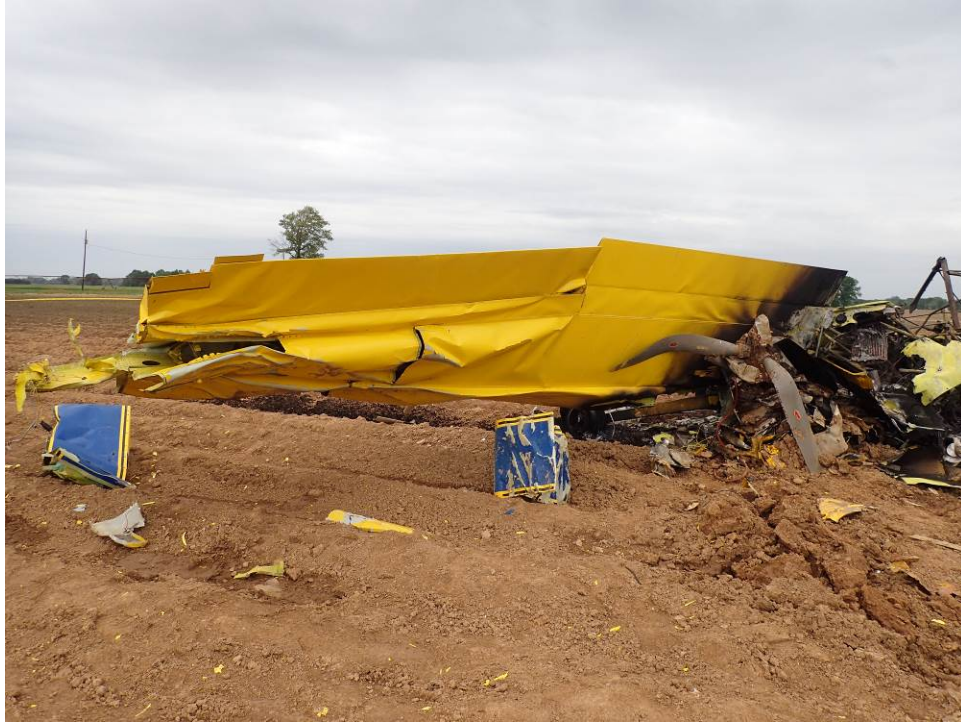
Both wings were substantially damaged. The leading edges on both wings were crushed aft from the impact. In the inboard section of the wings (containing the stronger fuel tank structure) the leading edges were crushed back to the wing main spar. Outboard of the fuel tank, the wings were crushed aft to the rear spar. The left hand wing received more damage than the righthand wing. This is typically consistent with the aircraft being slightly left-wing-low upon impact.

On both wings, the ailerons and flaps remained attached and installed. The tips of each wing (outboard of the ailerons) were separated from the wing structure and found adjacent to the main wreckage.

The inboard portion of the wings was heavily damaged by fire.

**Righthand Wing Wreckage**

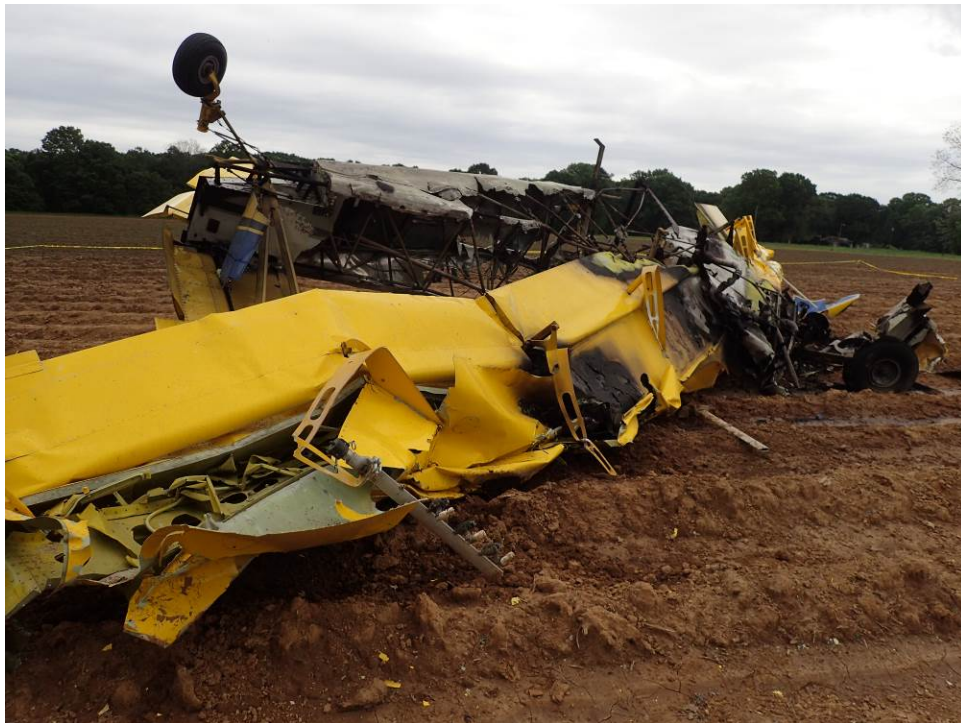
**Lefthand Wing Wreckage**

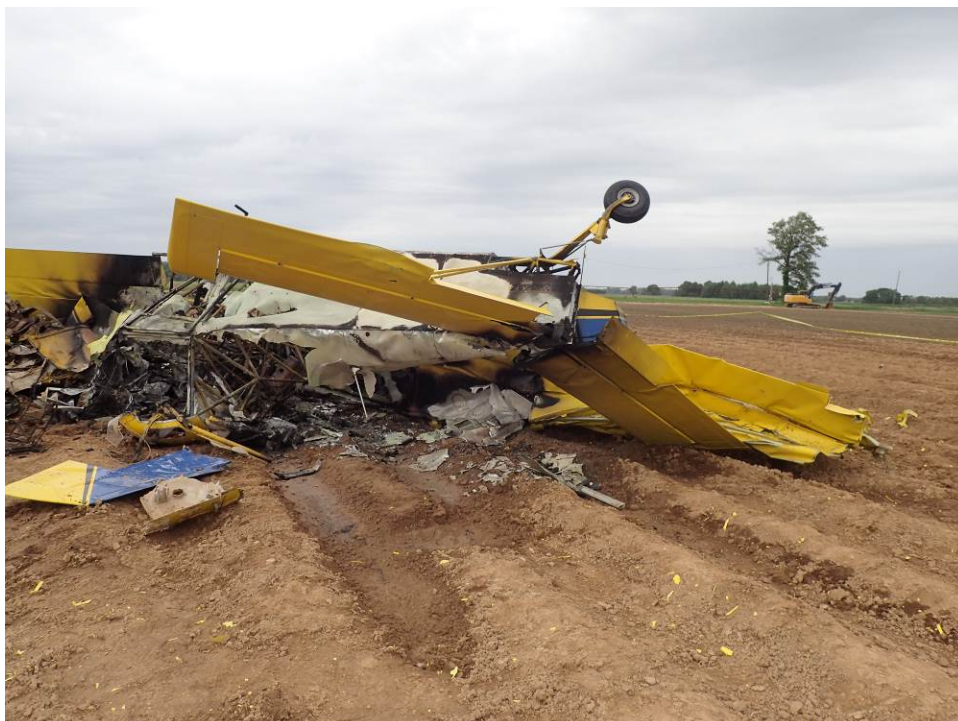
Both horizontal stabilizers and elevators remained in place on the aft fuselage. These surfaces received only minor damage. The rear spar attachment of the righthand horizontal stabilizer had been fractured at the fuselage. The front spar attachment of the righthand

horizontal stabilizer was intact but damaged. There was some damage to the trailing edge of the righthand elevator.

The front spar attachment of the lefthand horizontal stabilizer was fractured at the fuselage. The rear spar attachment was intact at the fuselage.

The rudder was present at the accident site. The rudder had been fractured chordwise just above the boost tab (servo tab). The bottom portion of the rudder remained attached to the bottom hinge point and rear spar of the vertical stabilizer.

The top portion of the rudder was found on the ground adjacent to the cockpit wreckage.

The piece of aft spar that was attached to the bottom portion of the rudder was the only component of the vertical stabilizer that was positively identified among the wreckage. Multiple pieces of fire-damaged aluminum were identified as possible vertical stabilizer components but could not be confirmed.

1. There were no witness reports of any components departing the aircraft in-flight.
2. The rudder was present at the accident scene.
3. A witness mark was found on the top fuselage skin that corresponded to the shape of the vertical stabilizer leading edge skin.
4. The wire deflector cable that was attached to the tip of the stabilizer was present at the accident scene.
5. The treeline, wooded area, and field to the north of the accident scene were searched for any evidence of aircraft components and none were found.

## Condition of Empennage Wreckage

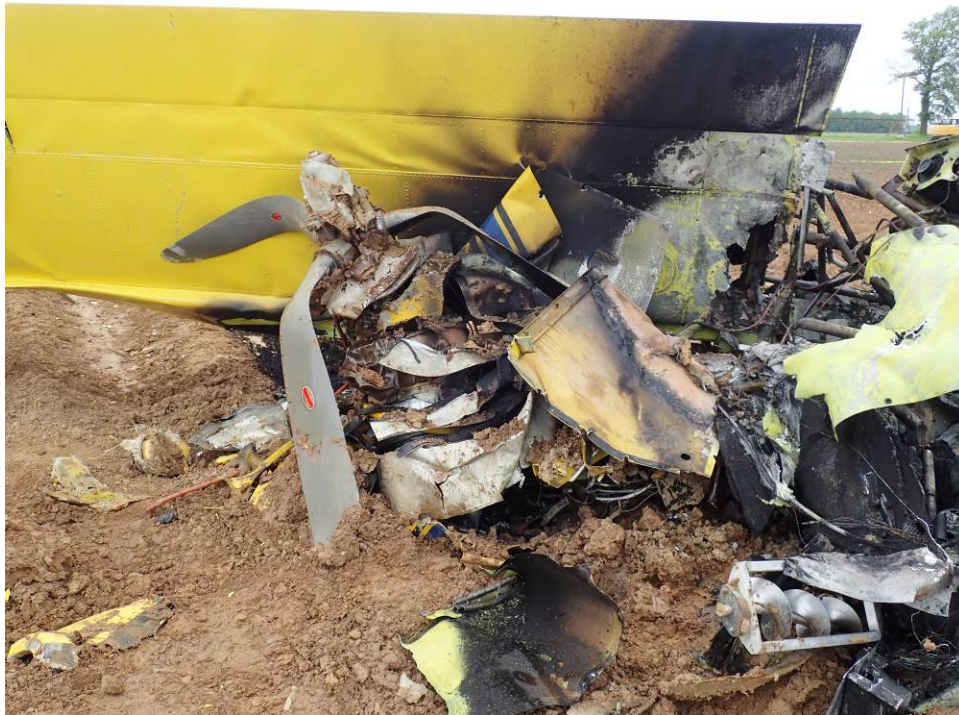
The engine and propeller were substantially damaged during the impact. The propeller remained attached to the engine flange. Two of the blades were bent aft. One blade was bent forward and twisted in its clamp. The propeller counterweight positions, as found, were consistent with a low-pitch blade angle. No significant chordwise scoring of the blades was noted, except some fresh markings at the blade roots where the blades enter the spinner.

The engine was found with the engine mount ring still installed. The engine dataplate confirmed that this was a Pratt & Whitney PT6A-34AG engine serial number PCE-PH0200. The engine had separated at the "F" Flange. Most of the rear engine-mounted accessory components had broken free of the accessory gearbox, including the FCU, high-pressure fuel pump, low-pressure fuel pump, and starter/generator. All of these accessory components were severely damaged. The safety wire on the fuel filter bowl on the high pressure fuel pump was broken, but the bowl did not seem to be unseated or damaged. After a discussion about the risk of contaminating the fuel filter, it was decided not to open this fuel bowl to check for the presence of fuel.

**Engine Wreckage as Found**

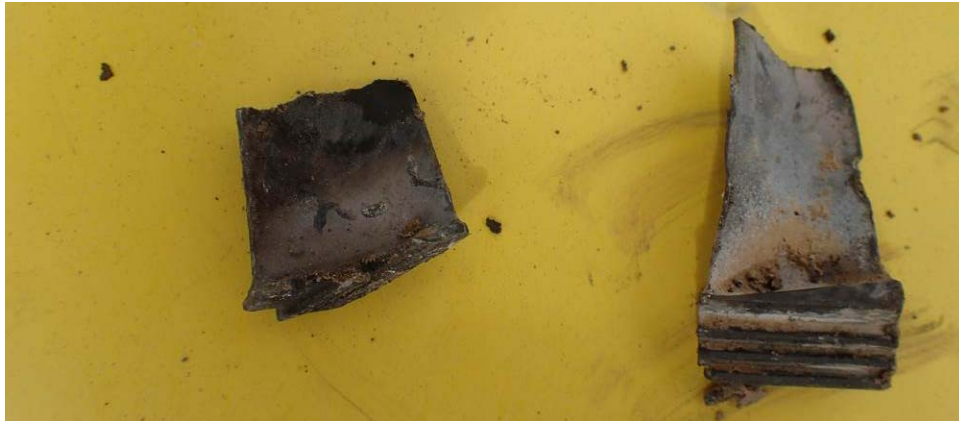
Two pieces of turbine blades were found on the ground when the engine was lifted and

removed. These were later confirmed to be Power Turbine (PT) blades.

**Power Turbine Blades**

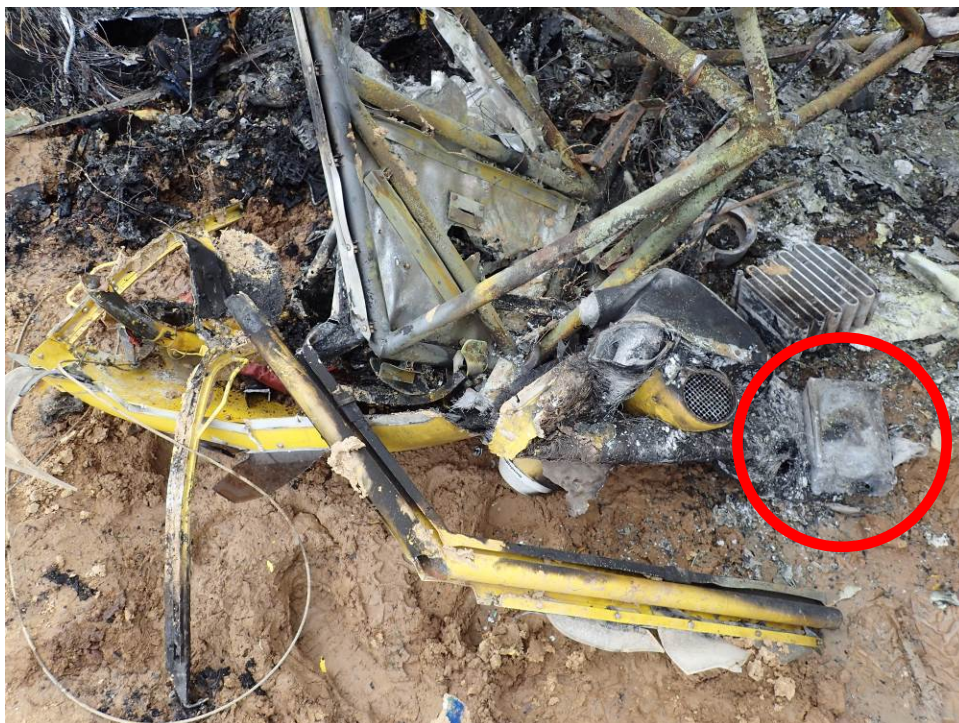
FAA Inspector Shawn Crump took possession of the CPU component of the agricultural GPS system. This unit appeared to be a Satloc Bantam system, but was badly damaged by fire.

**GPS Unit in Wreckage (circled)**
