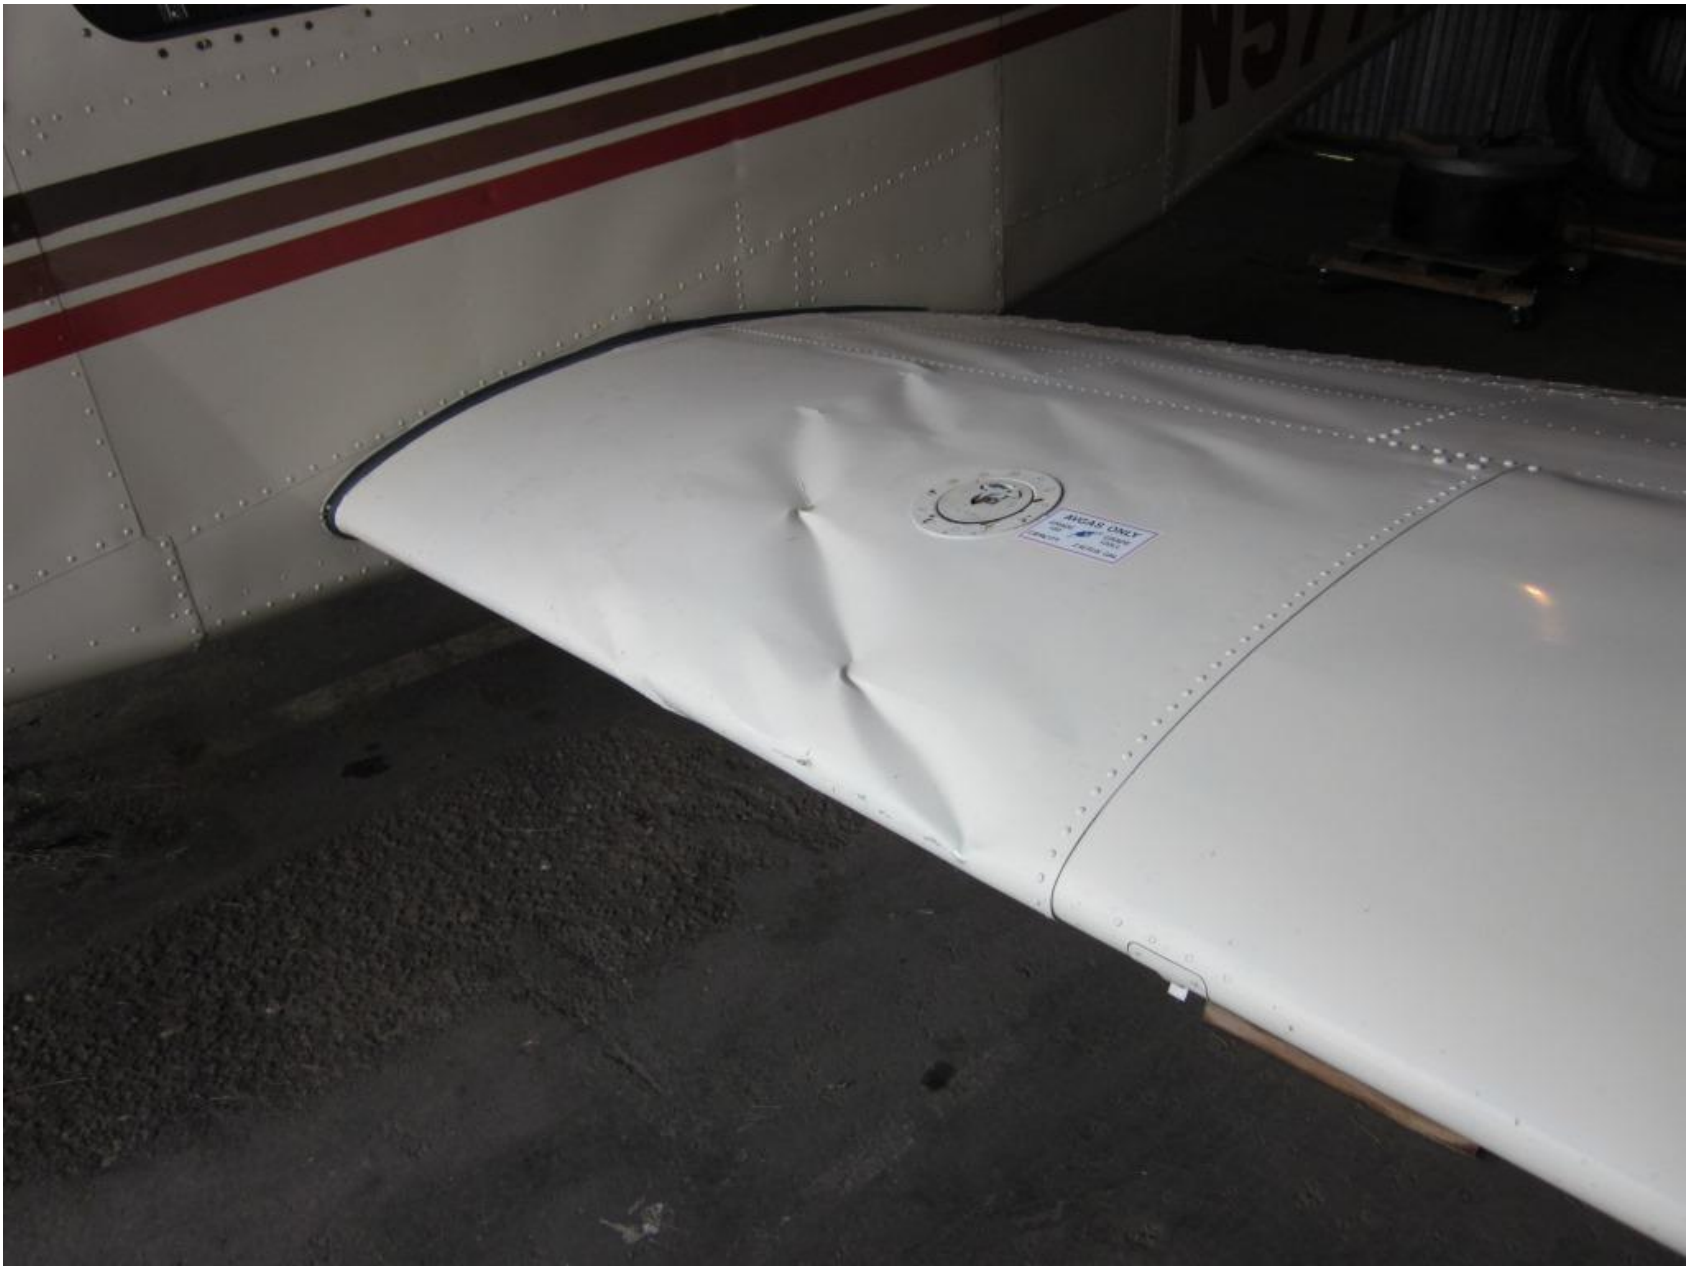
**Photo 1 – View of damage to the left wing**

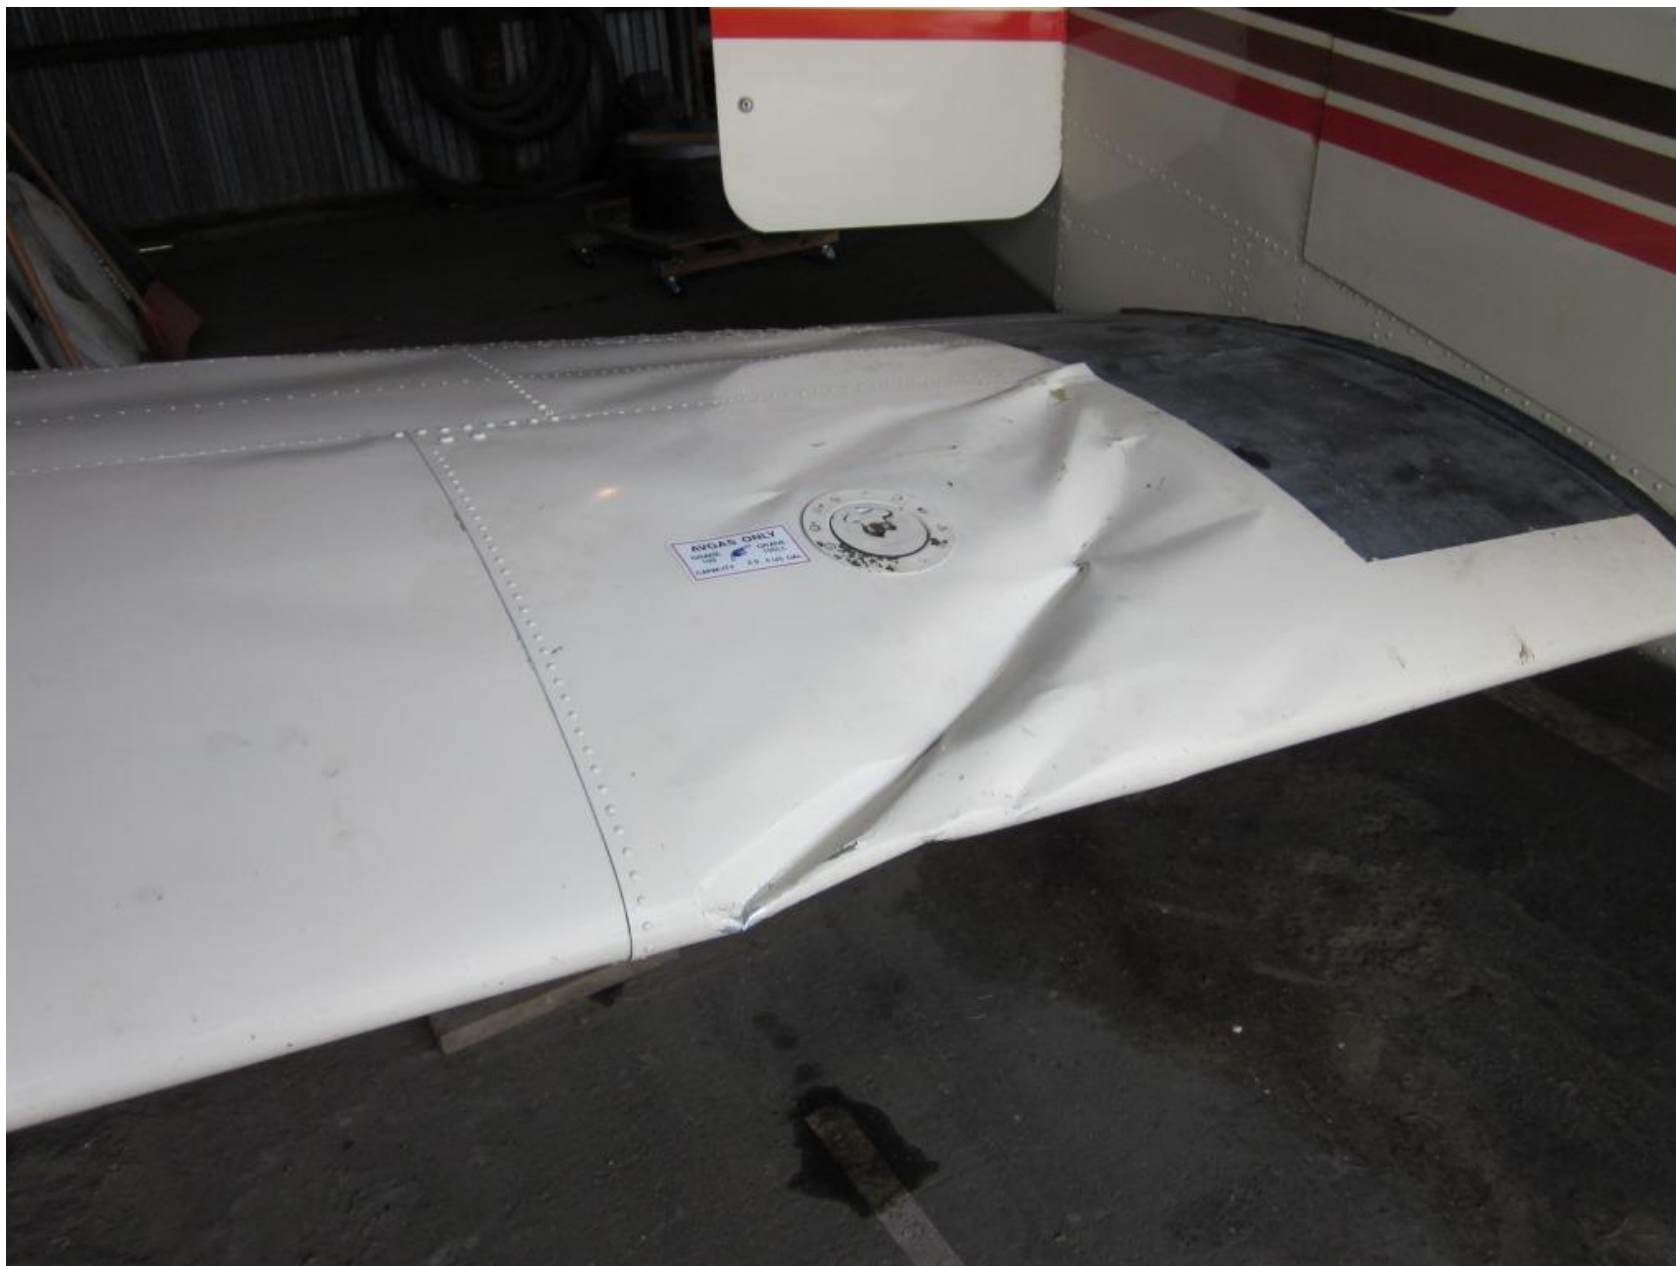
**Photo 2 – View of damage to the right wing**

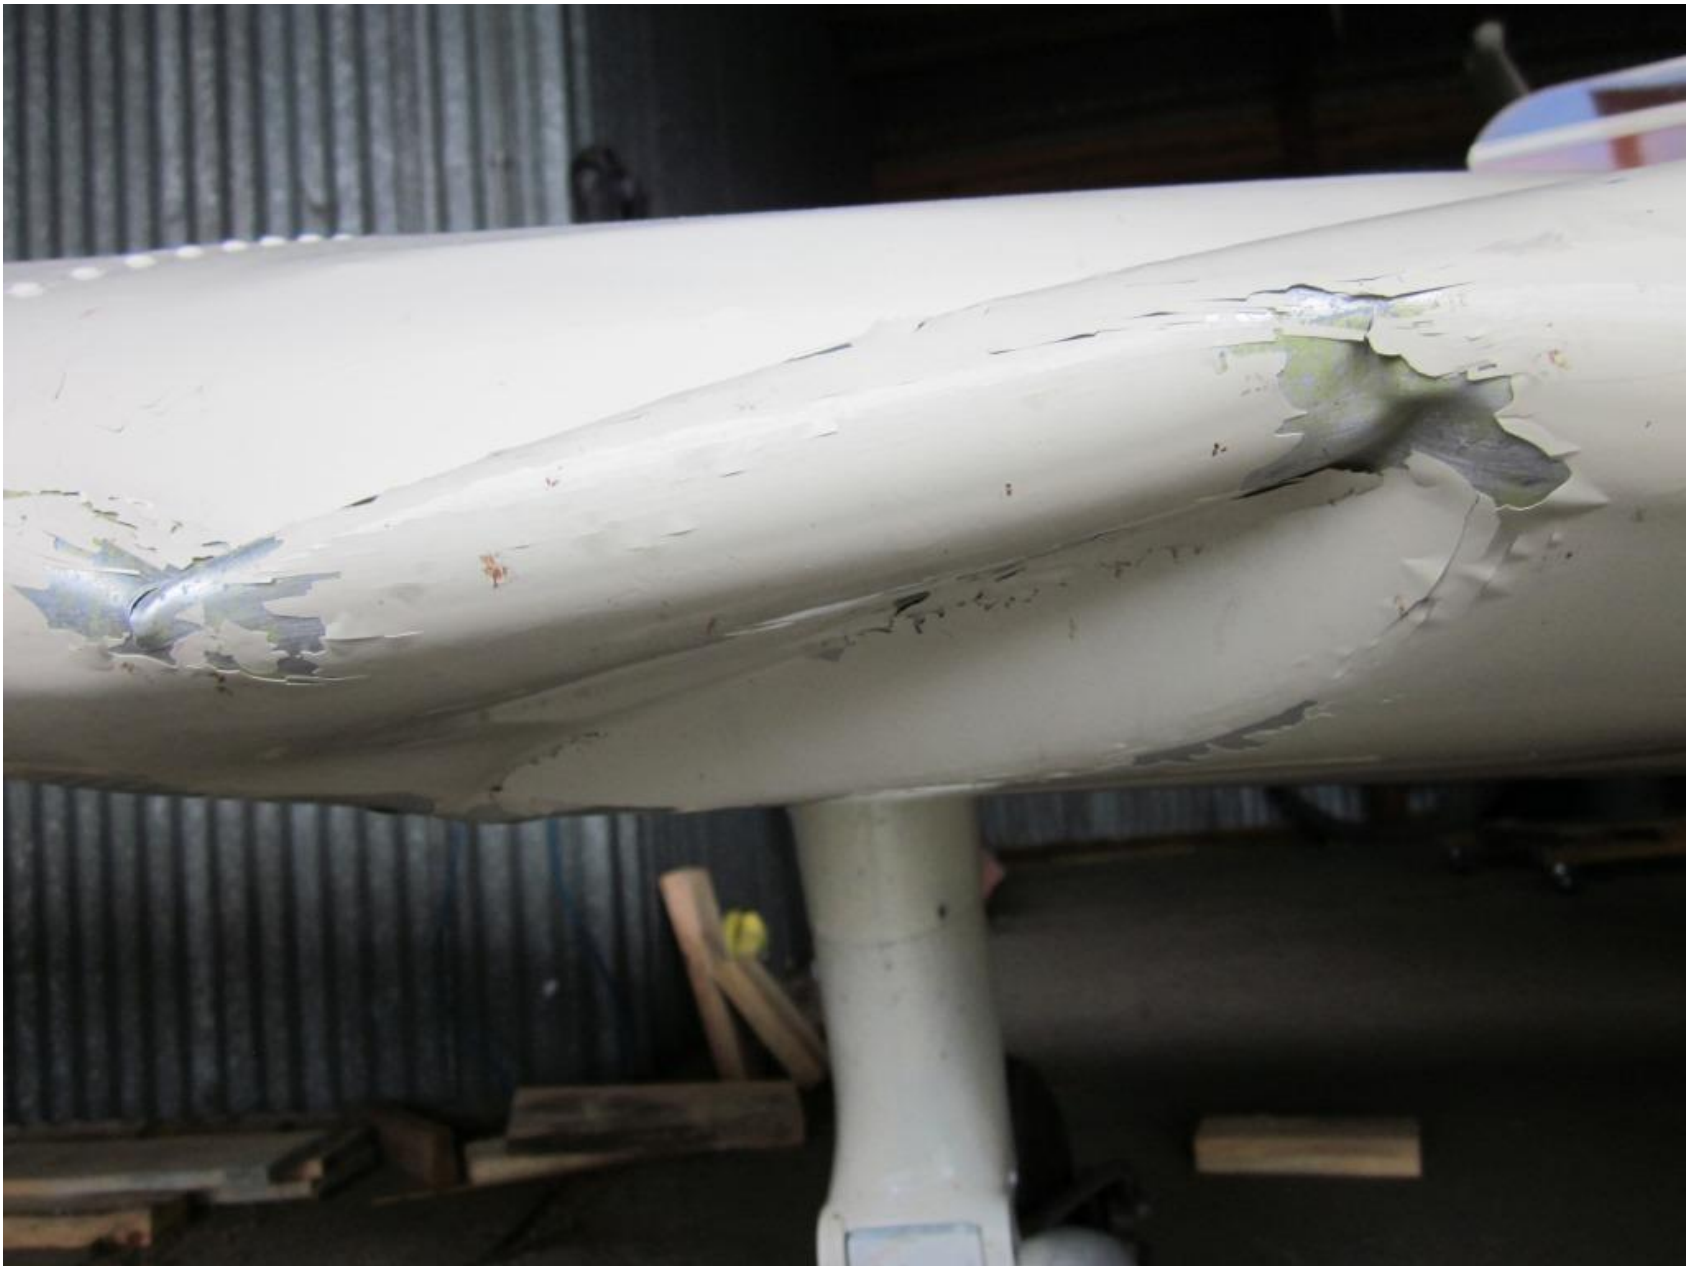
**Photo 3 – Leading edge damage to the right wing**

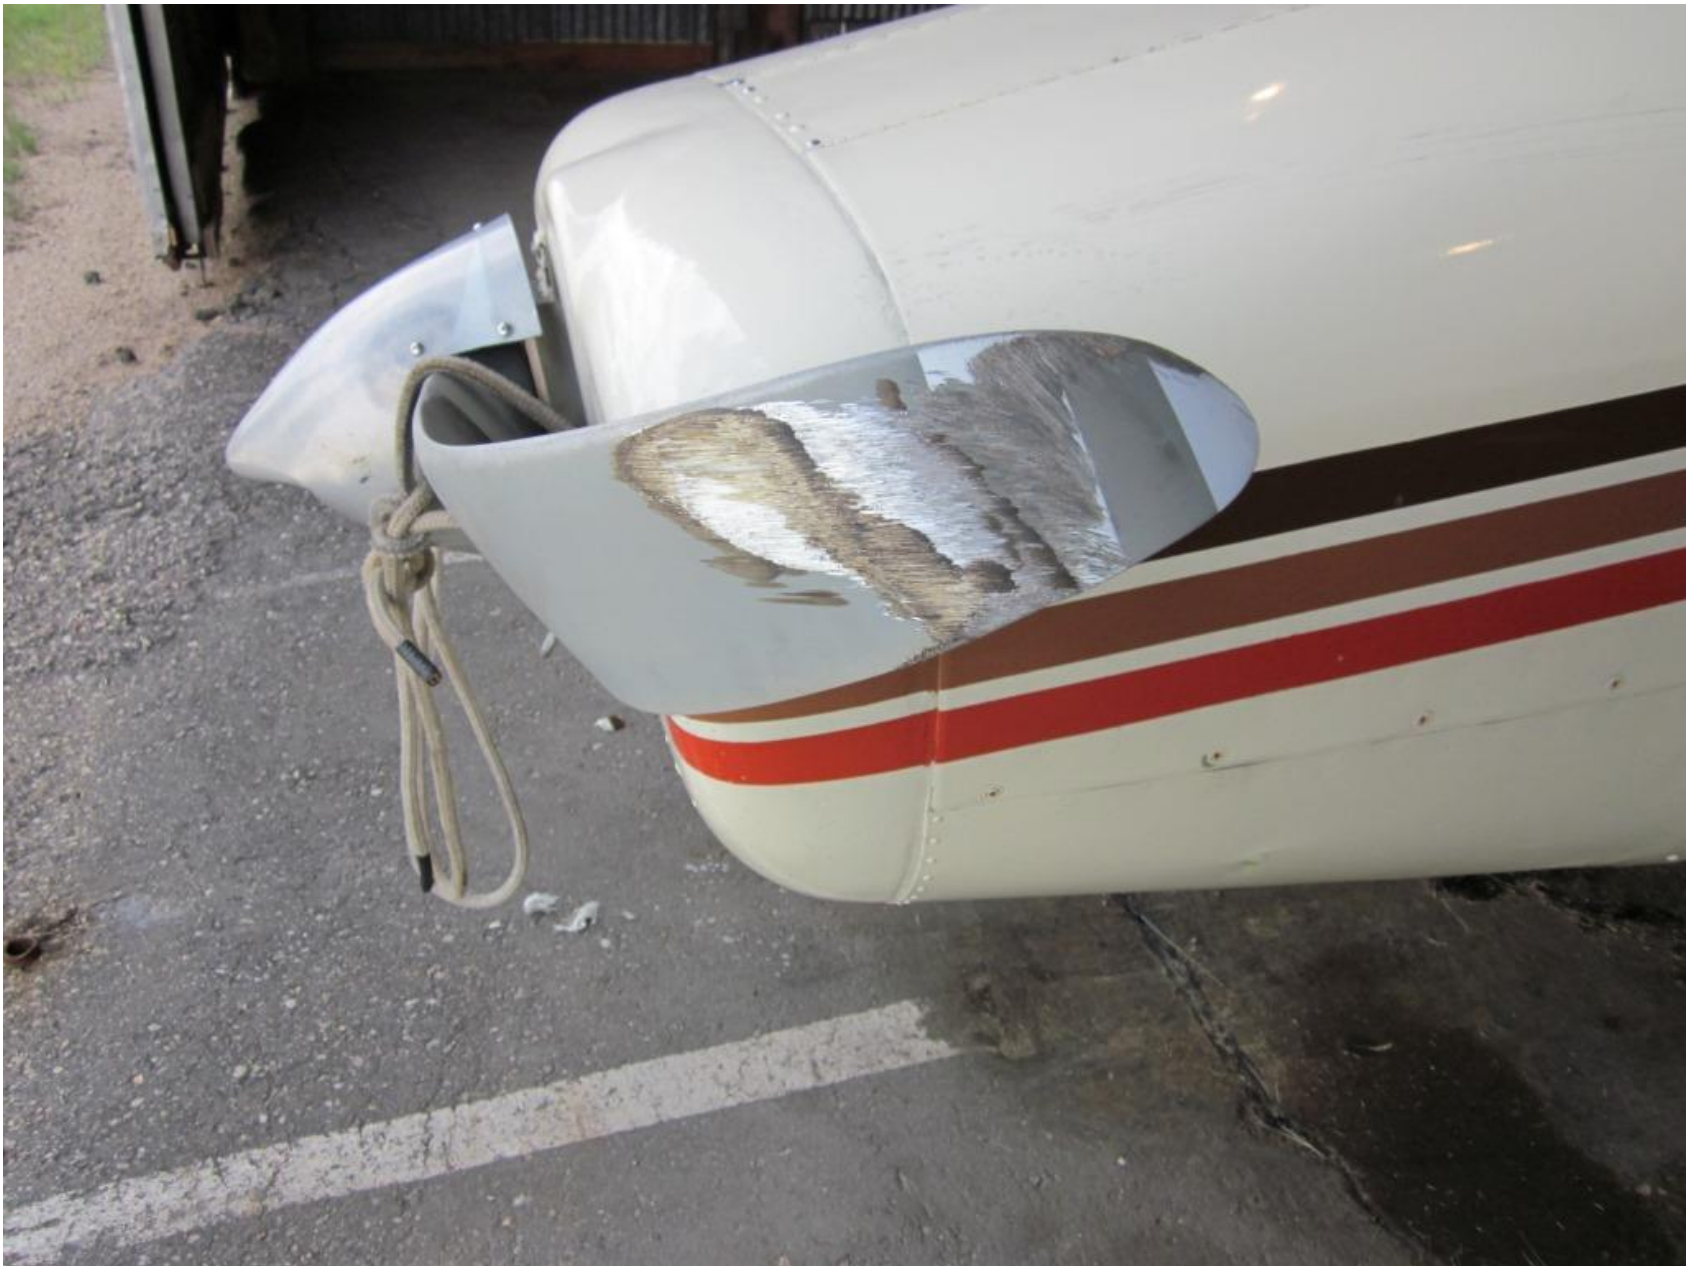
**Photo 4 – Impact marks on a propeller blade**

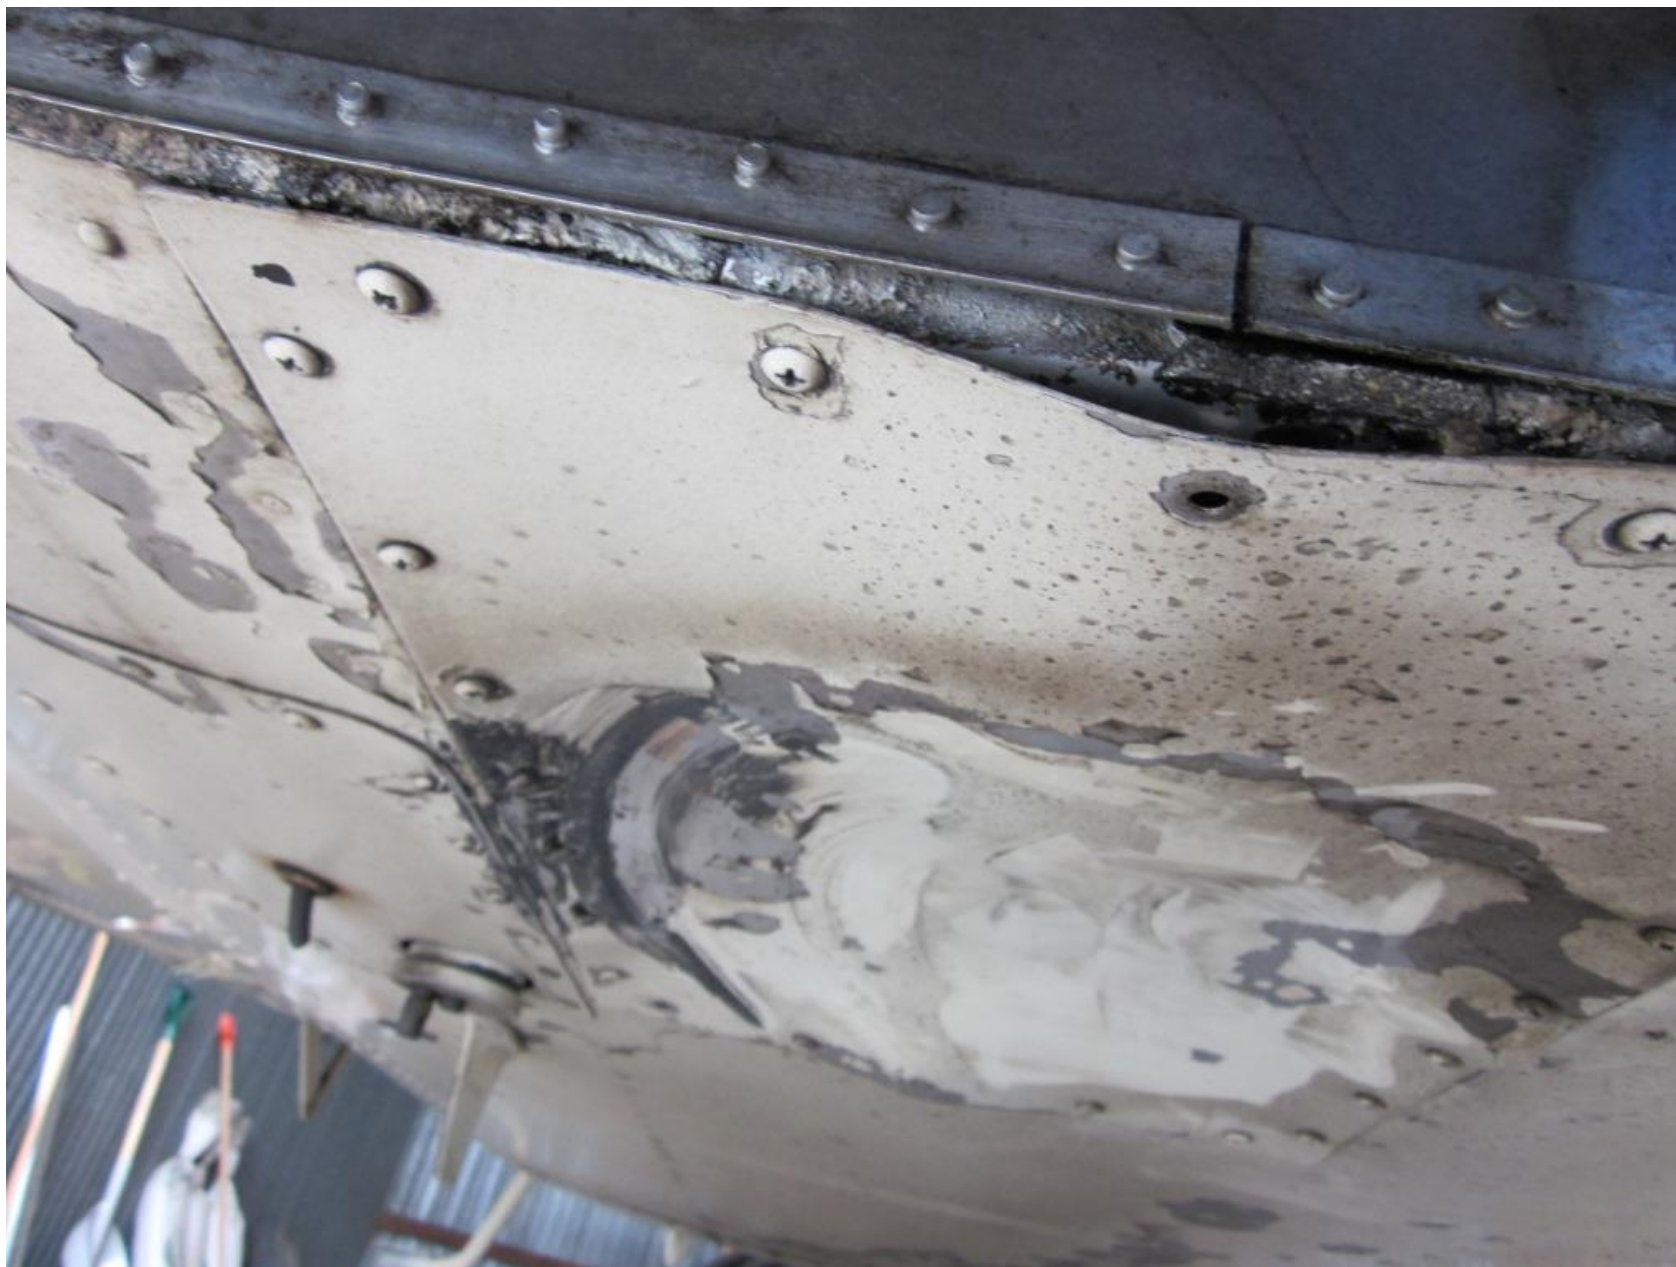
**Photo 5 – Indentation of belly skins from nose wheel**

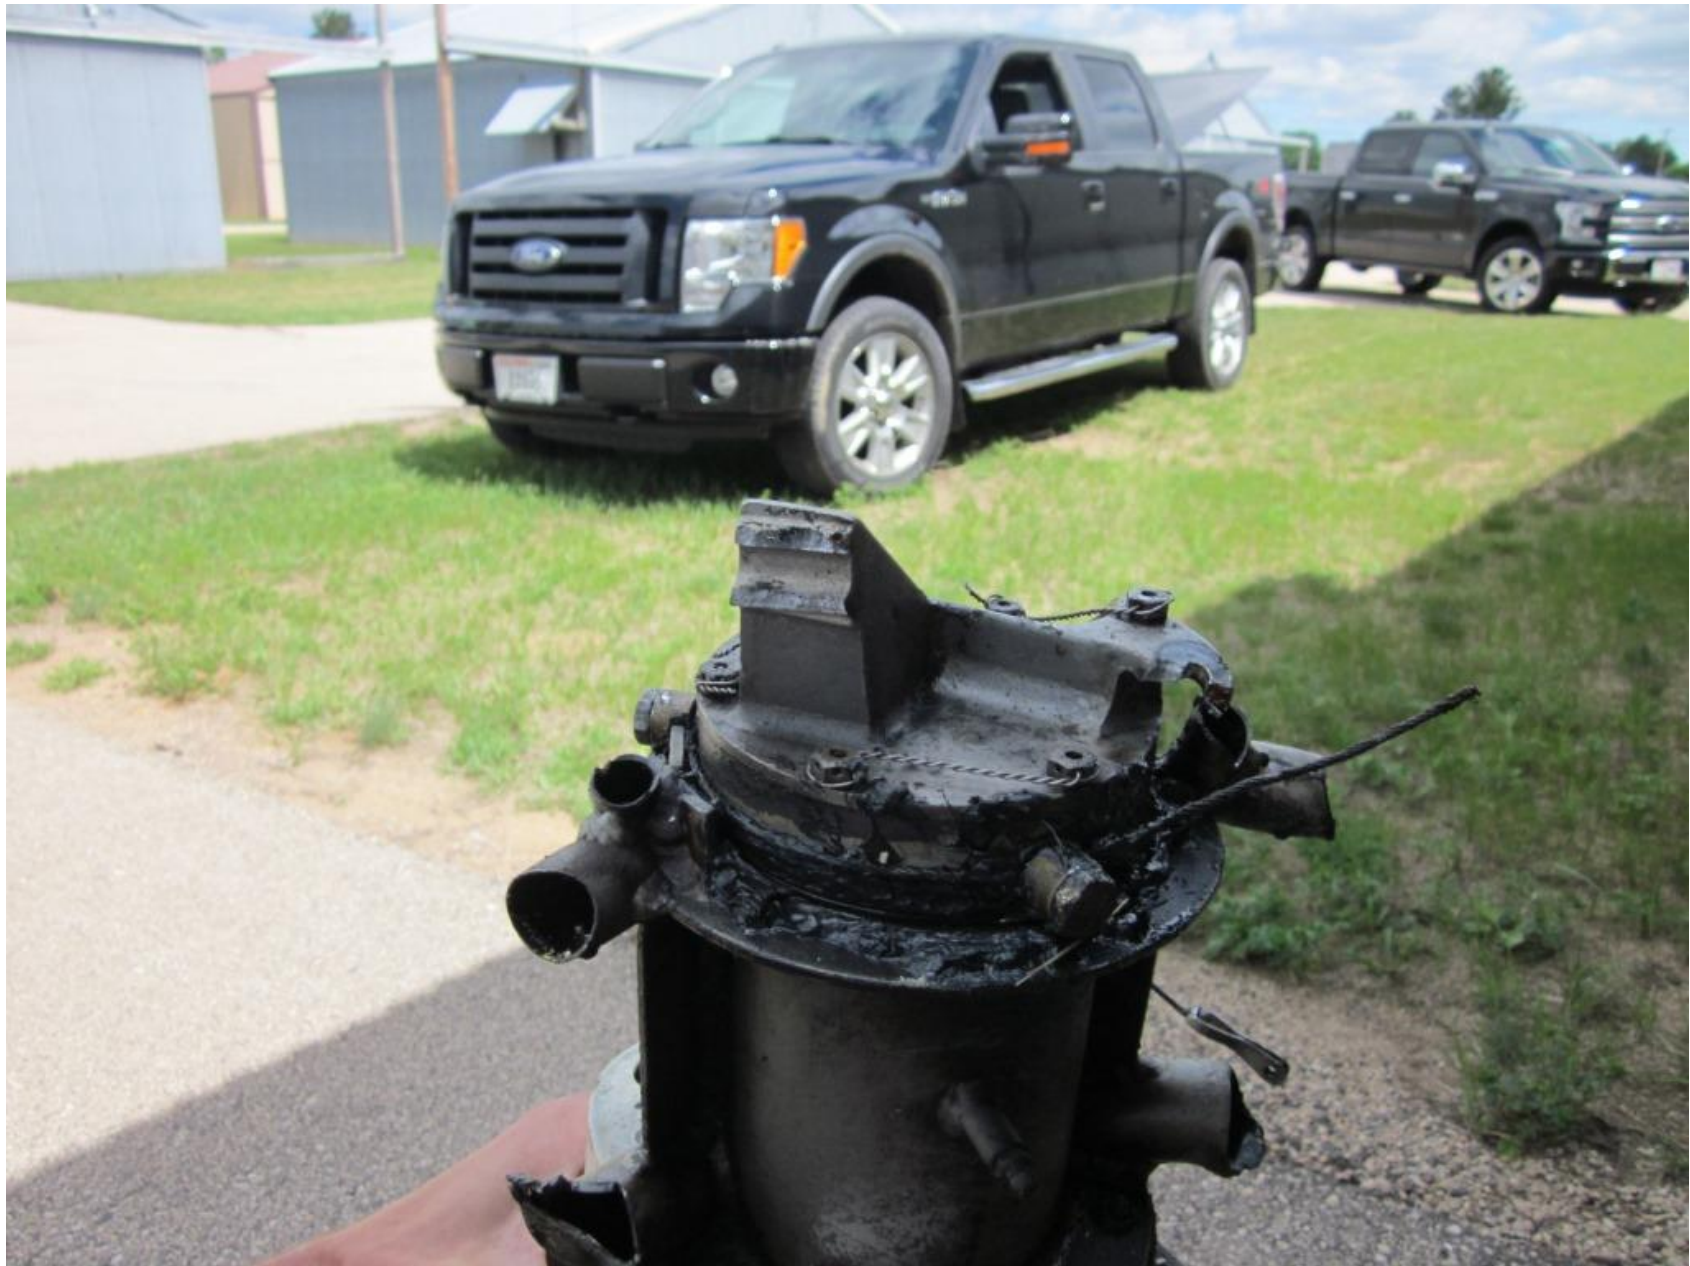
**Photo 6 – View of the fracture surfaces on the top of the broken nose gear**

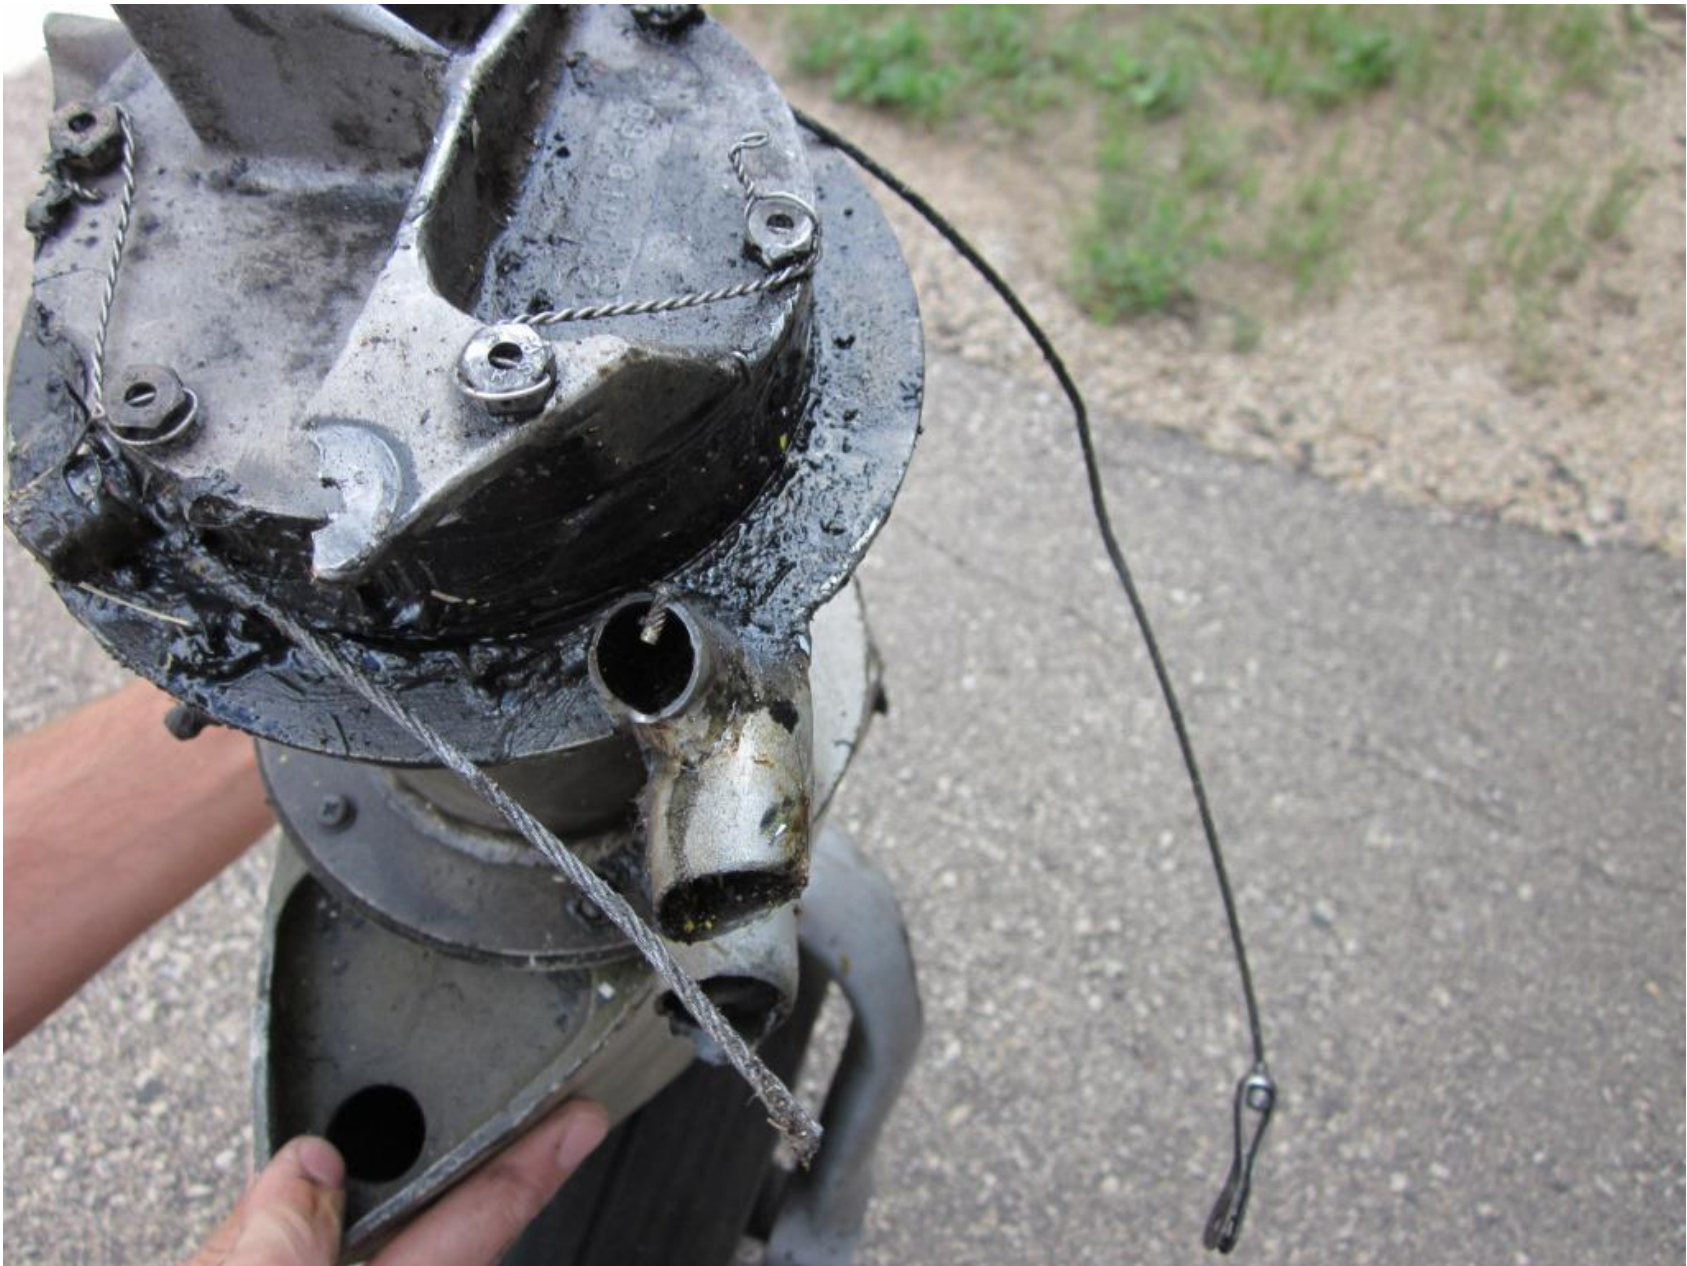
**Photo 7 – View of fracture surfaces on the bottom portion of nose gear**

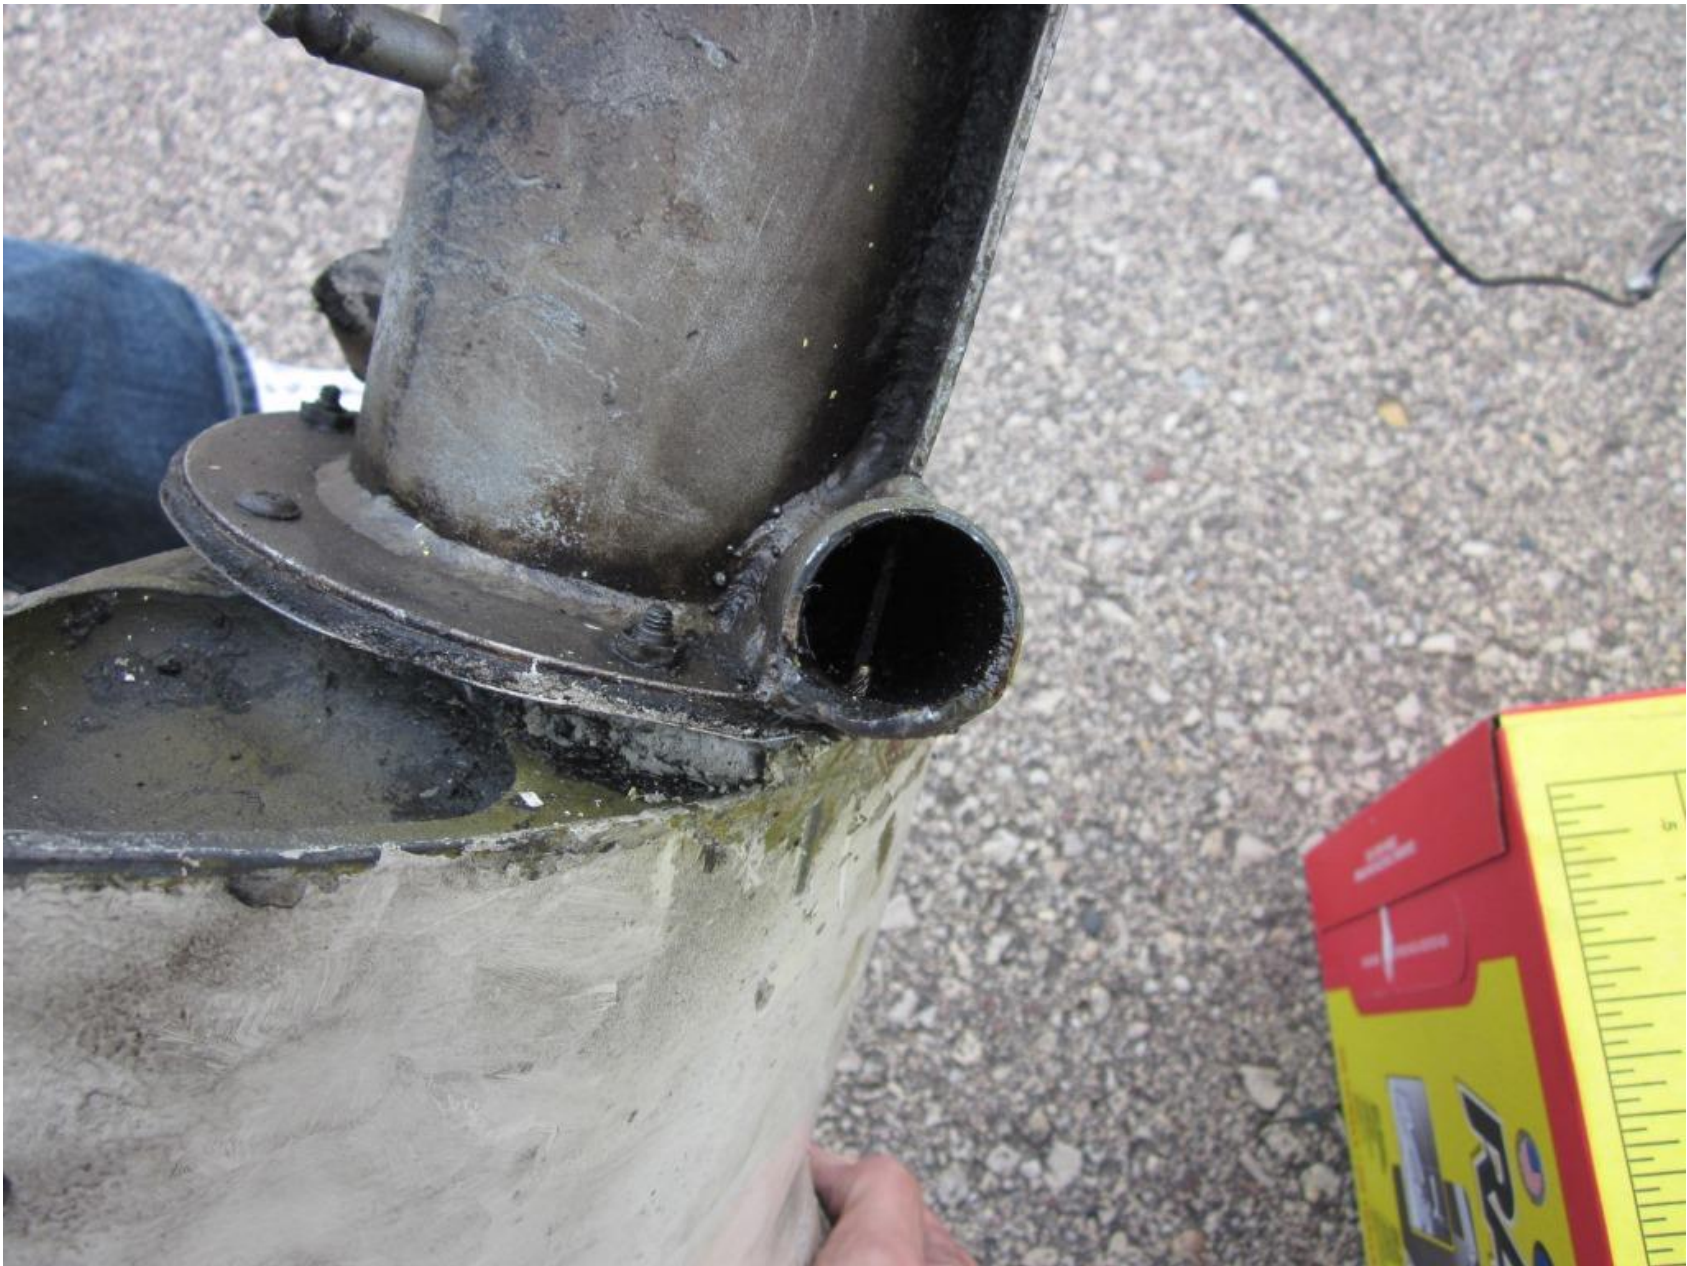
**Photo 8 – View of nose gear fracture surface**

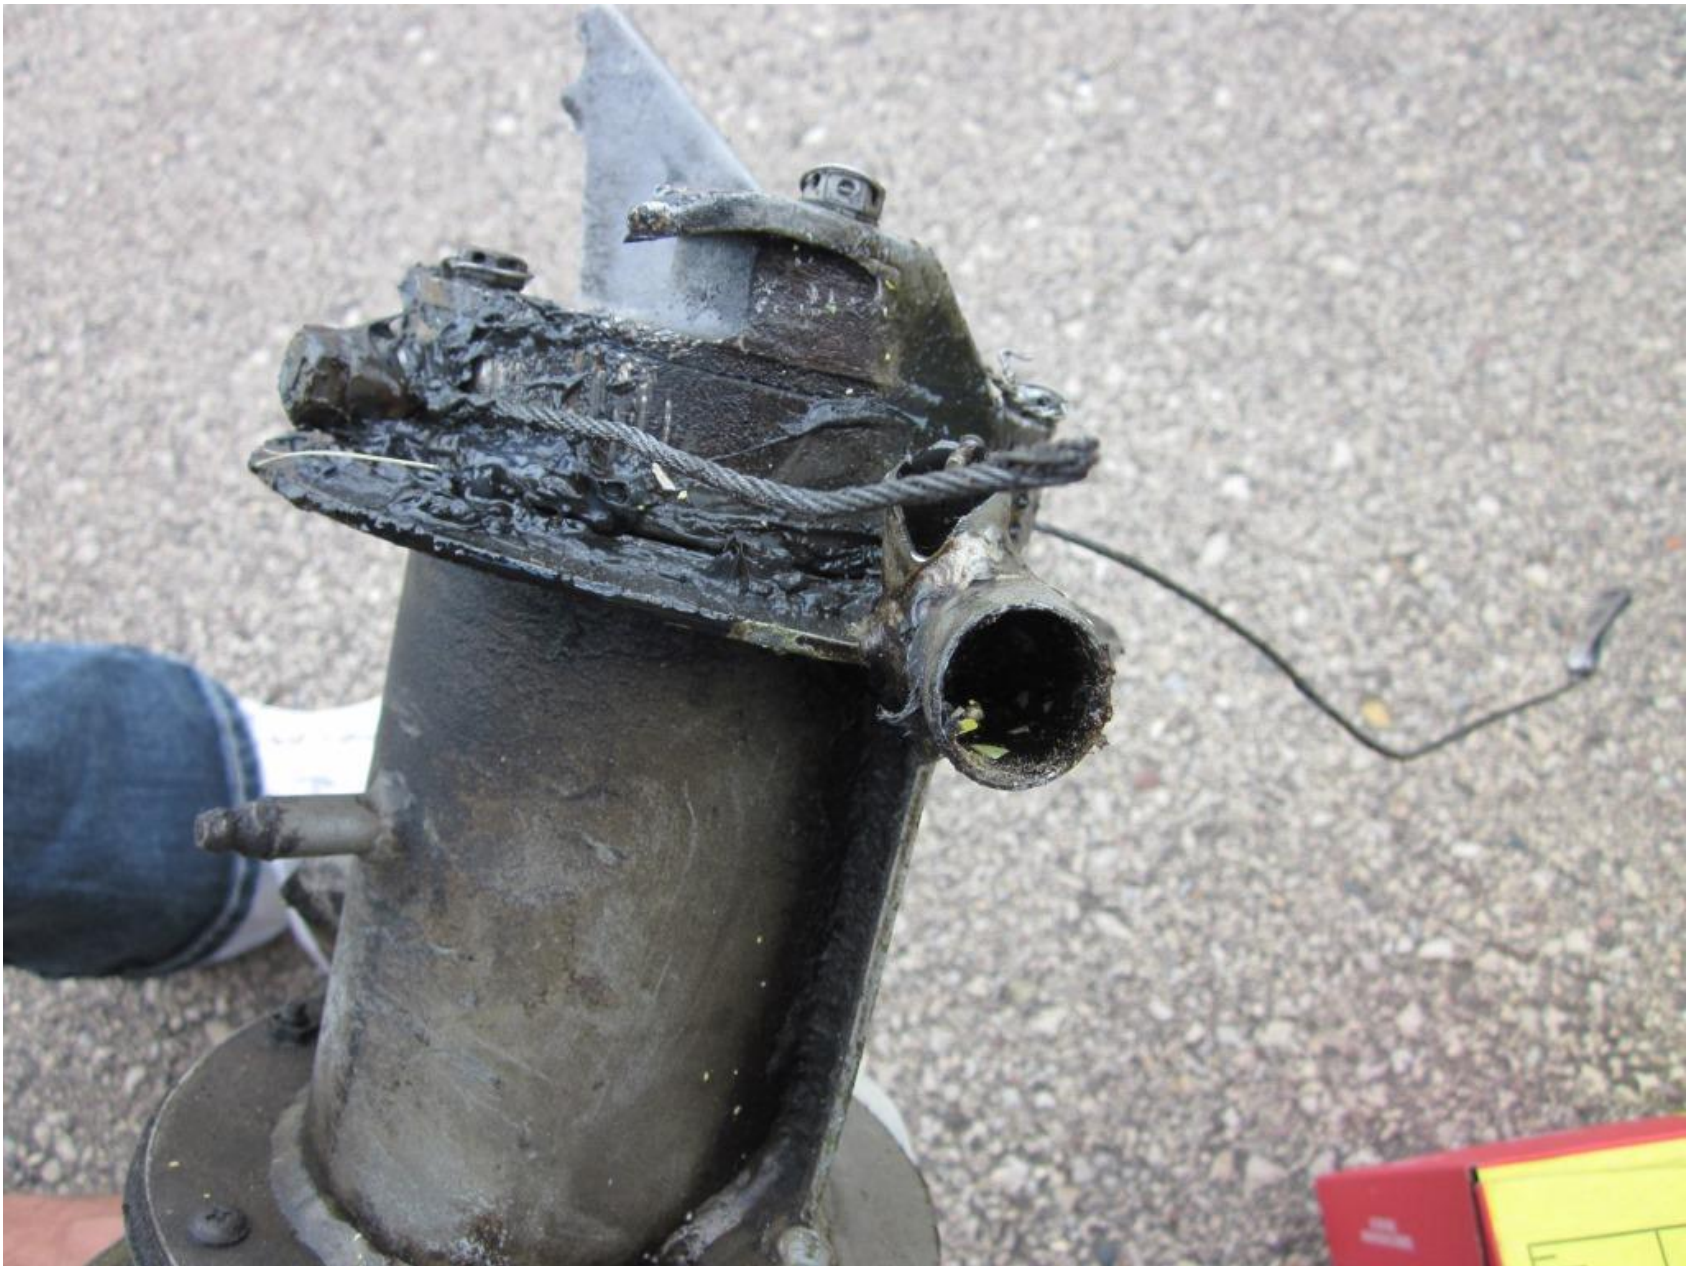
**Photo 9 - View of nose gear fracture surface**

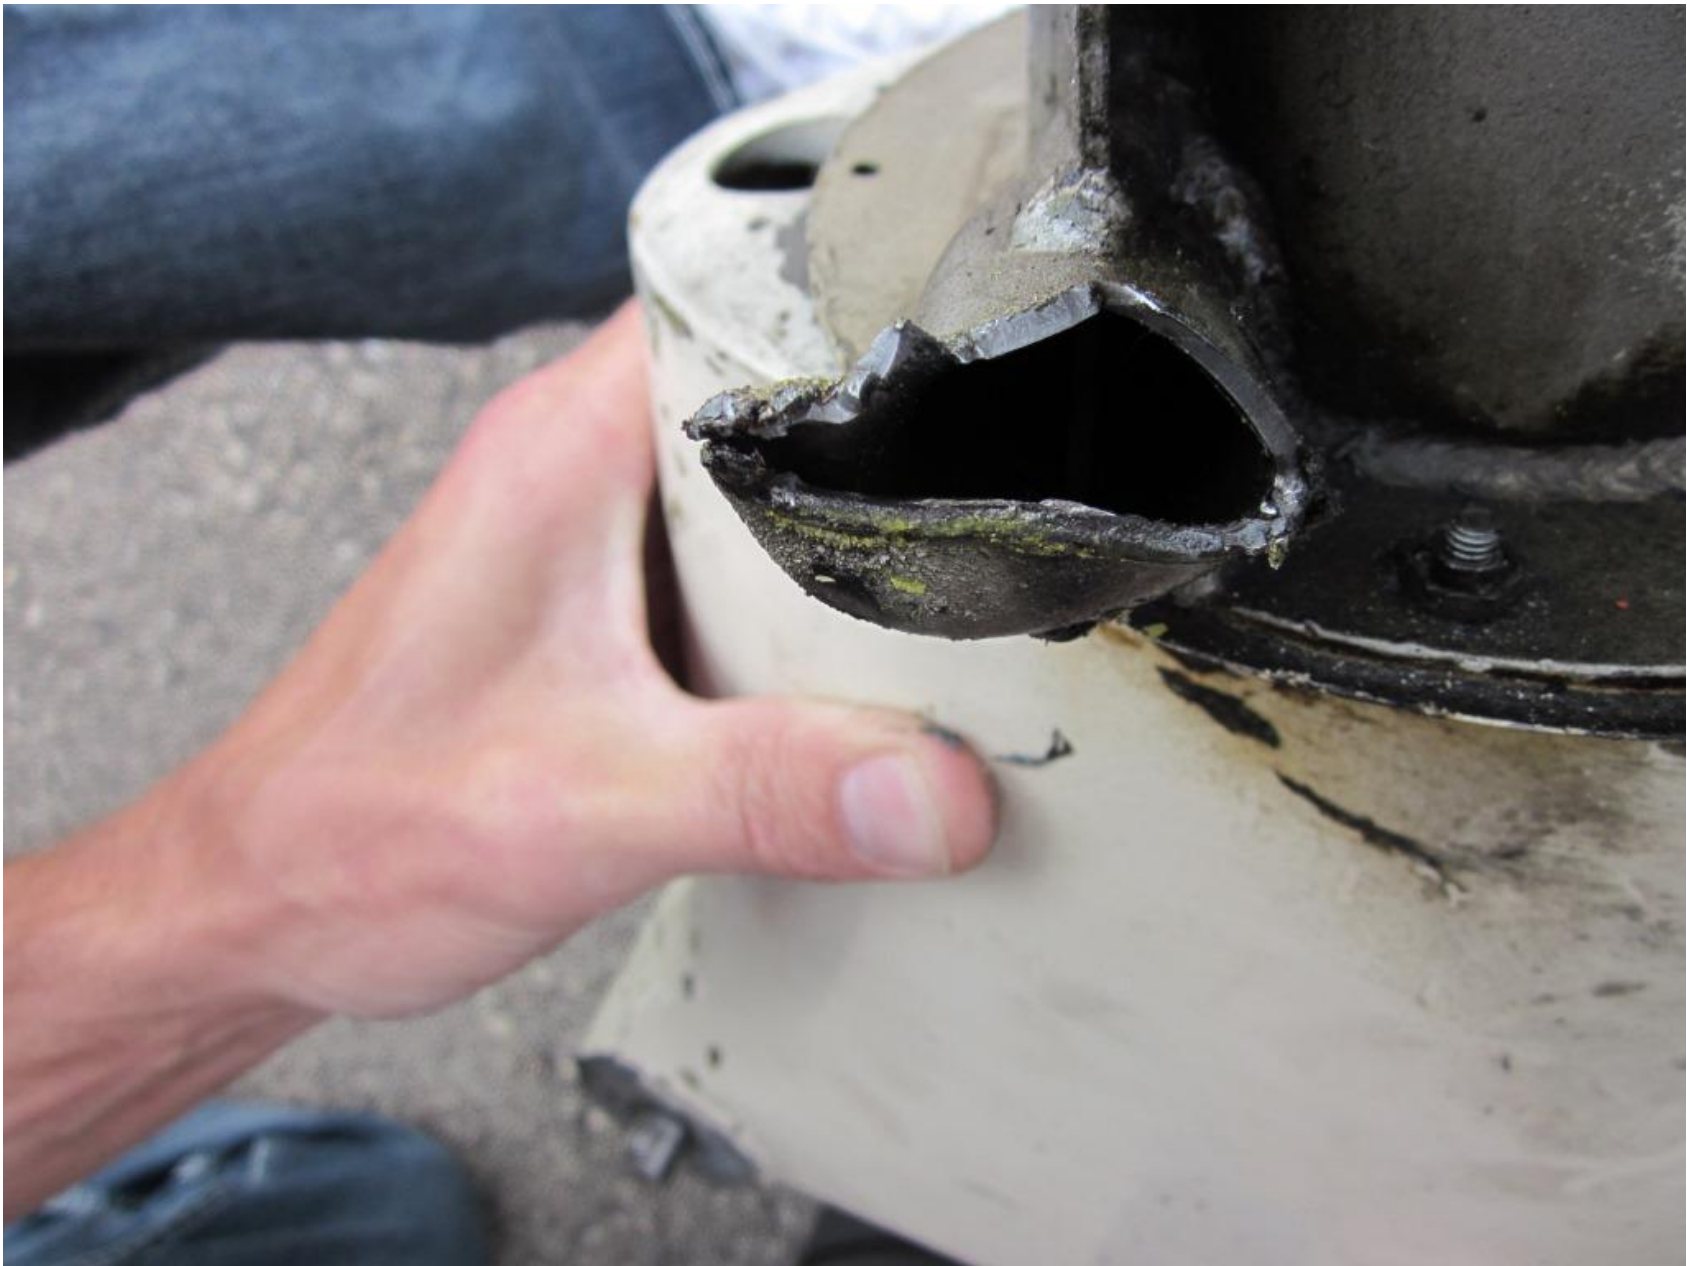
**Photo 10 - View of nose gear fracture surface**
