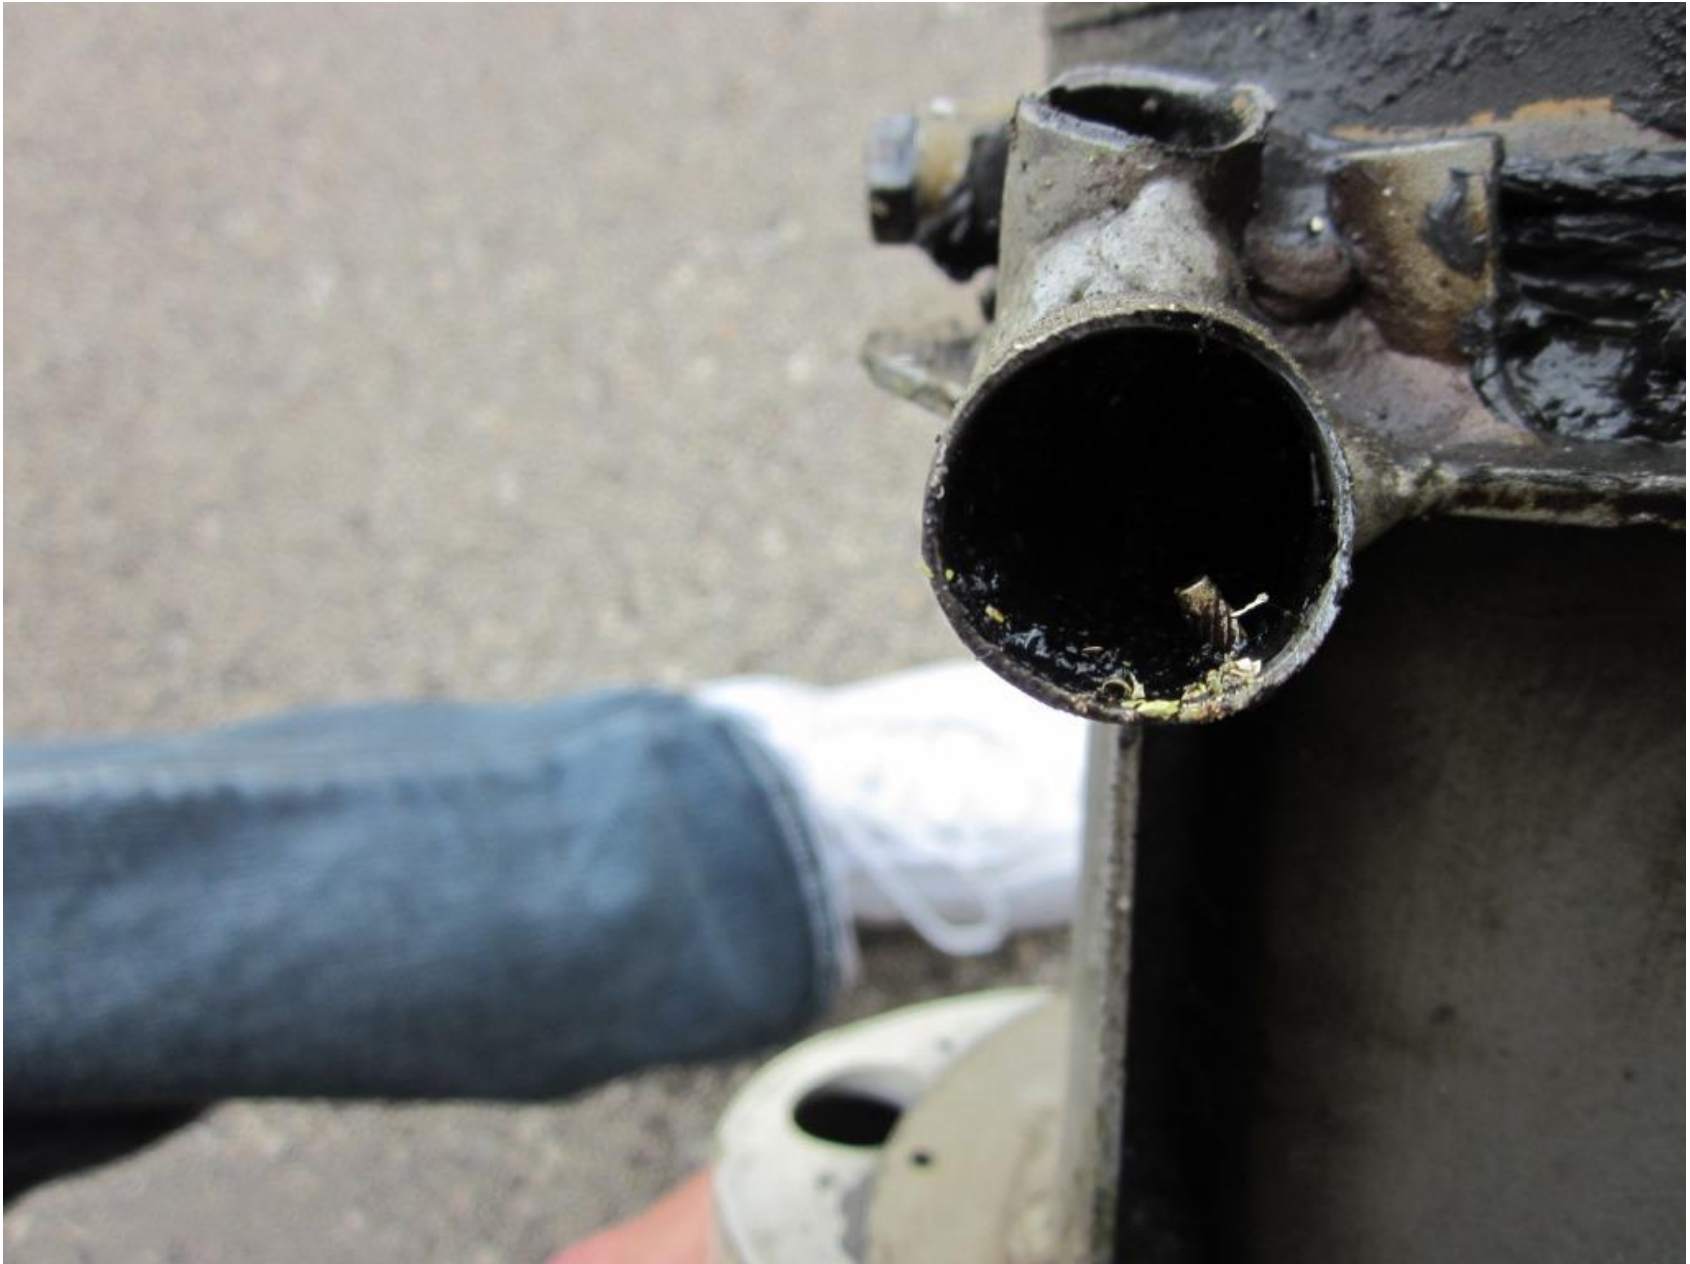
**Photo 11 - View of nose gear fracture surface**

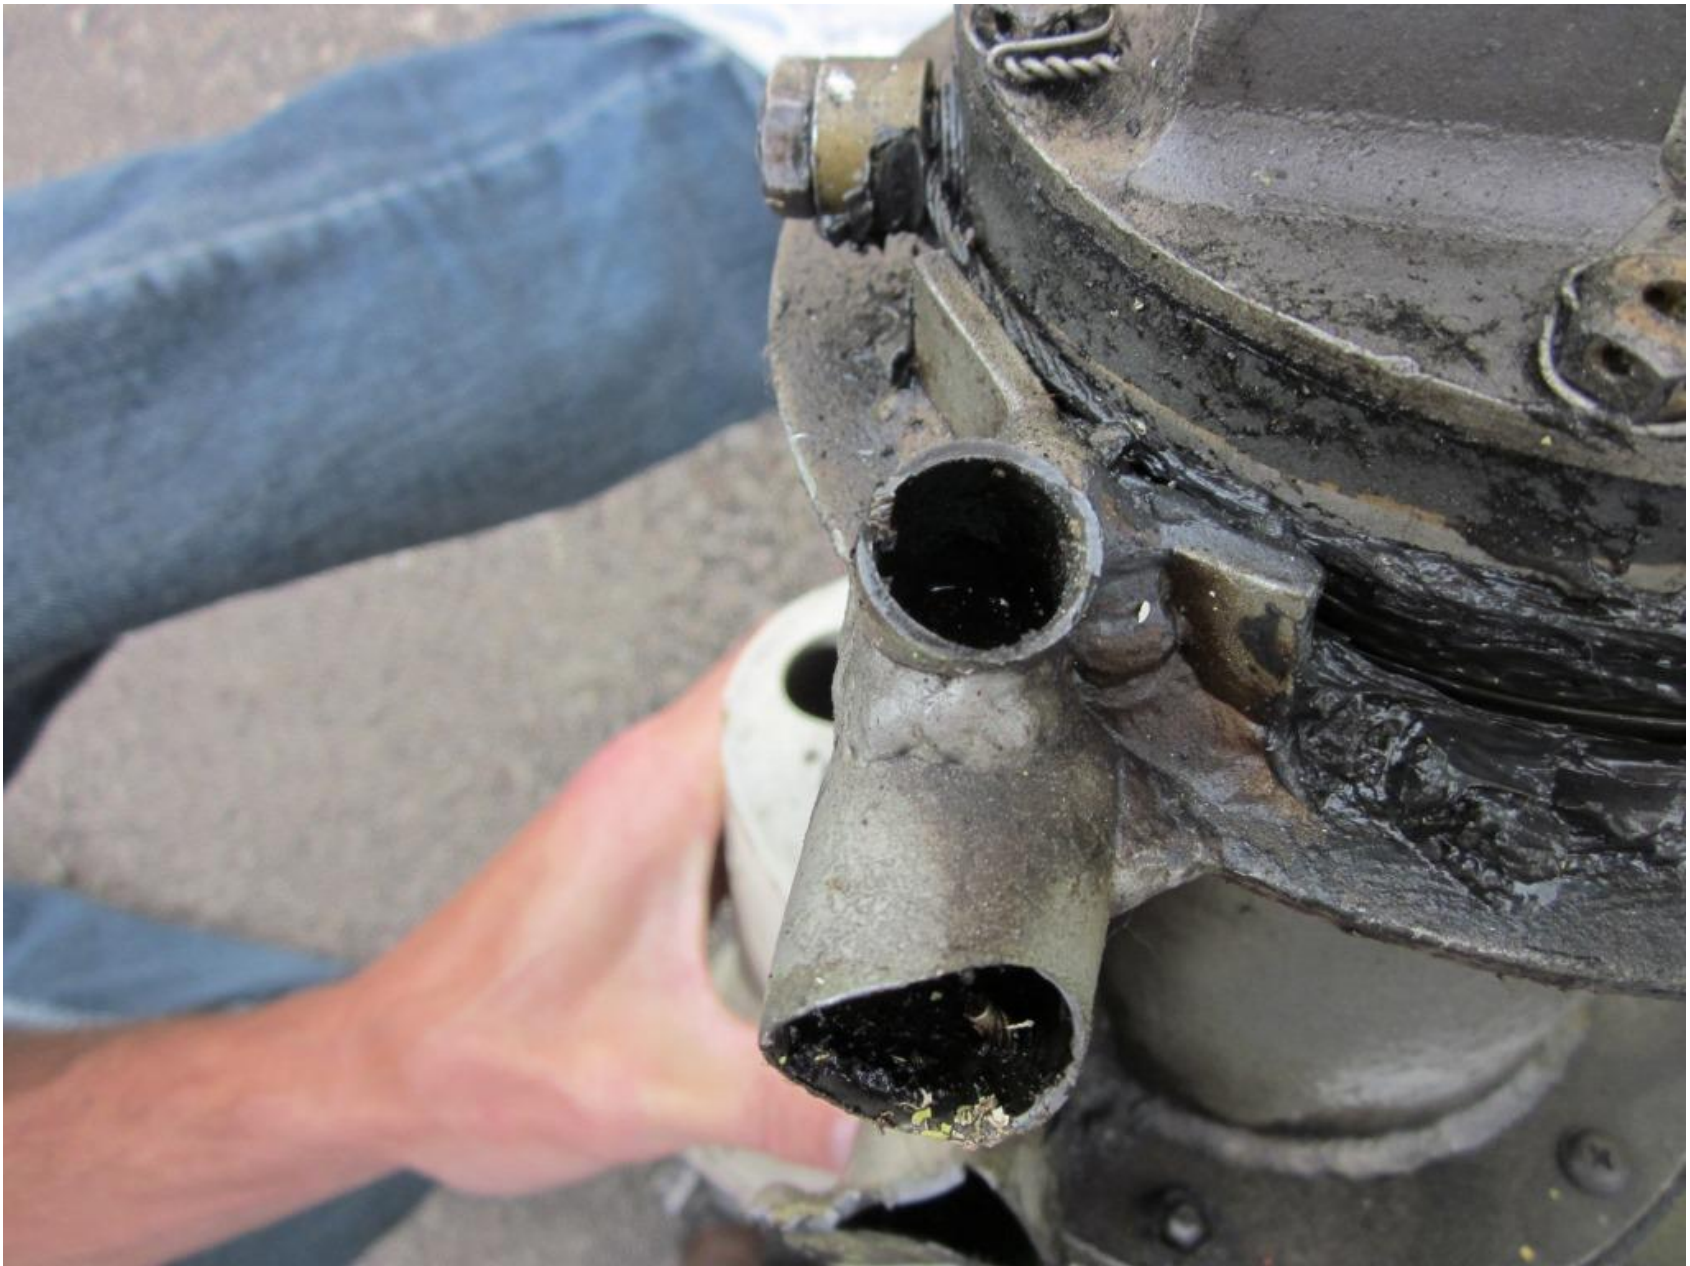
**Photo 12 - View of nose gear fracture surface**

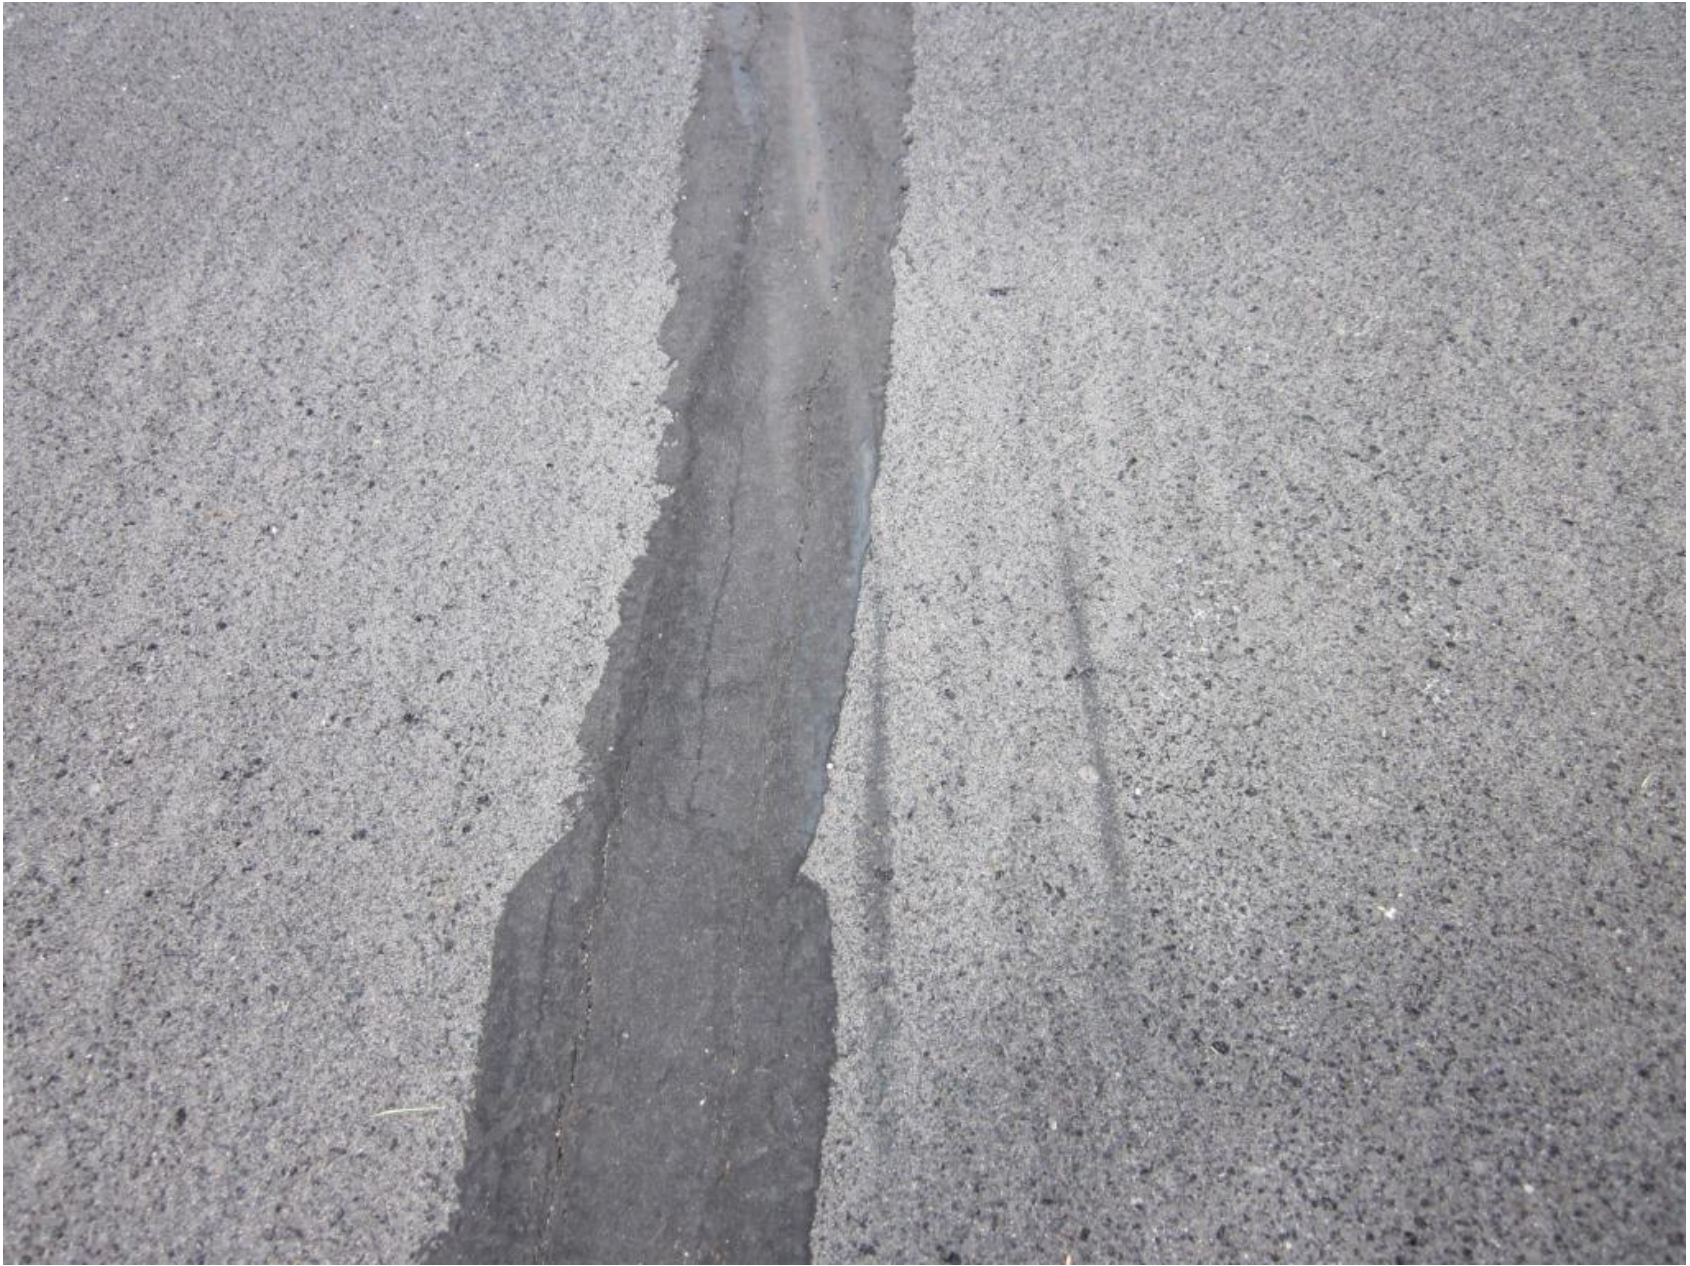
**Photo 14 – Nose gear tire mark**

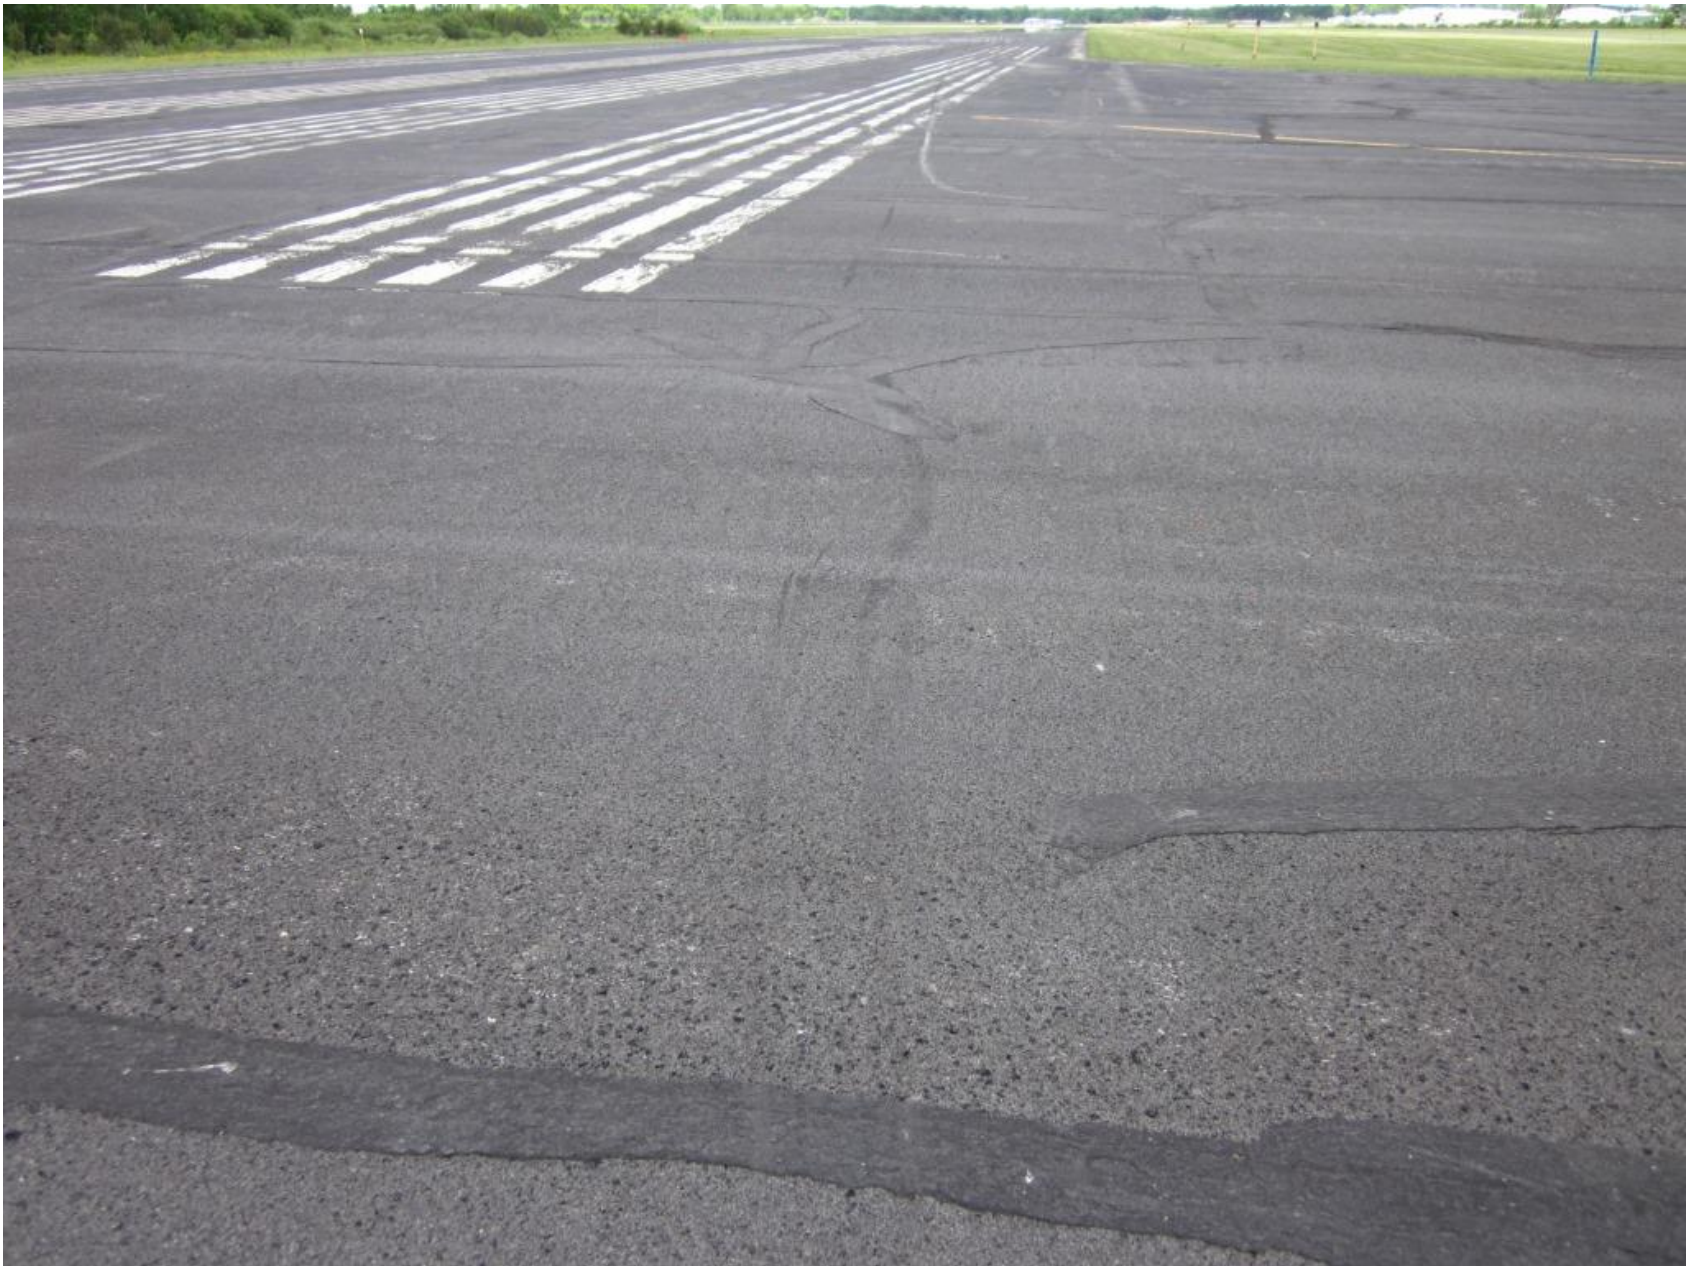
**Photo 15 – View of nose gear tire marks leading to the first propeller strike**

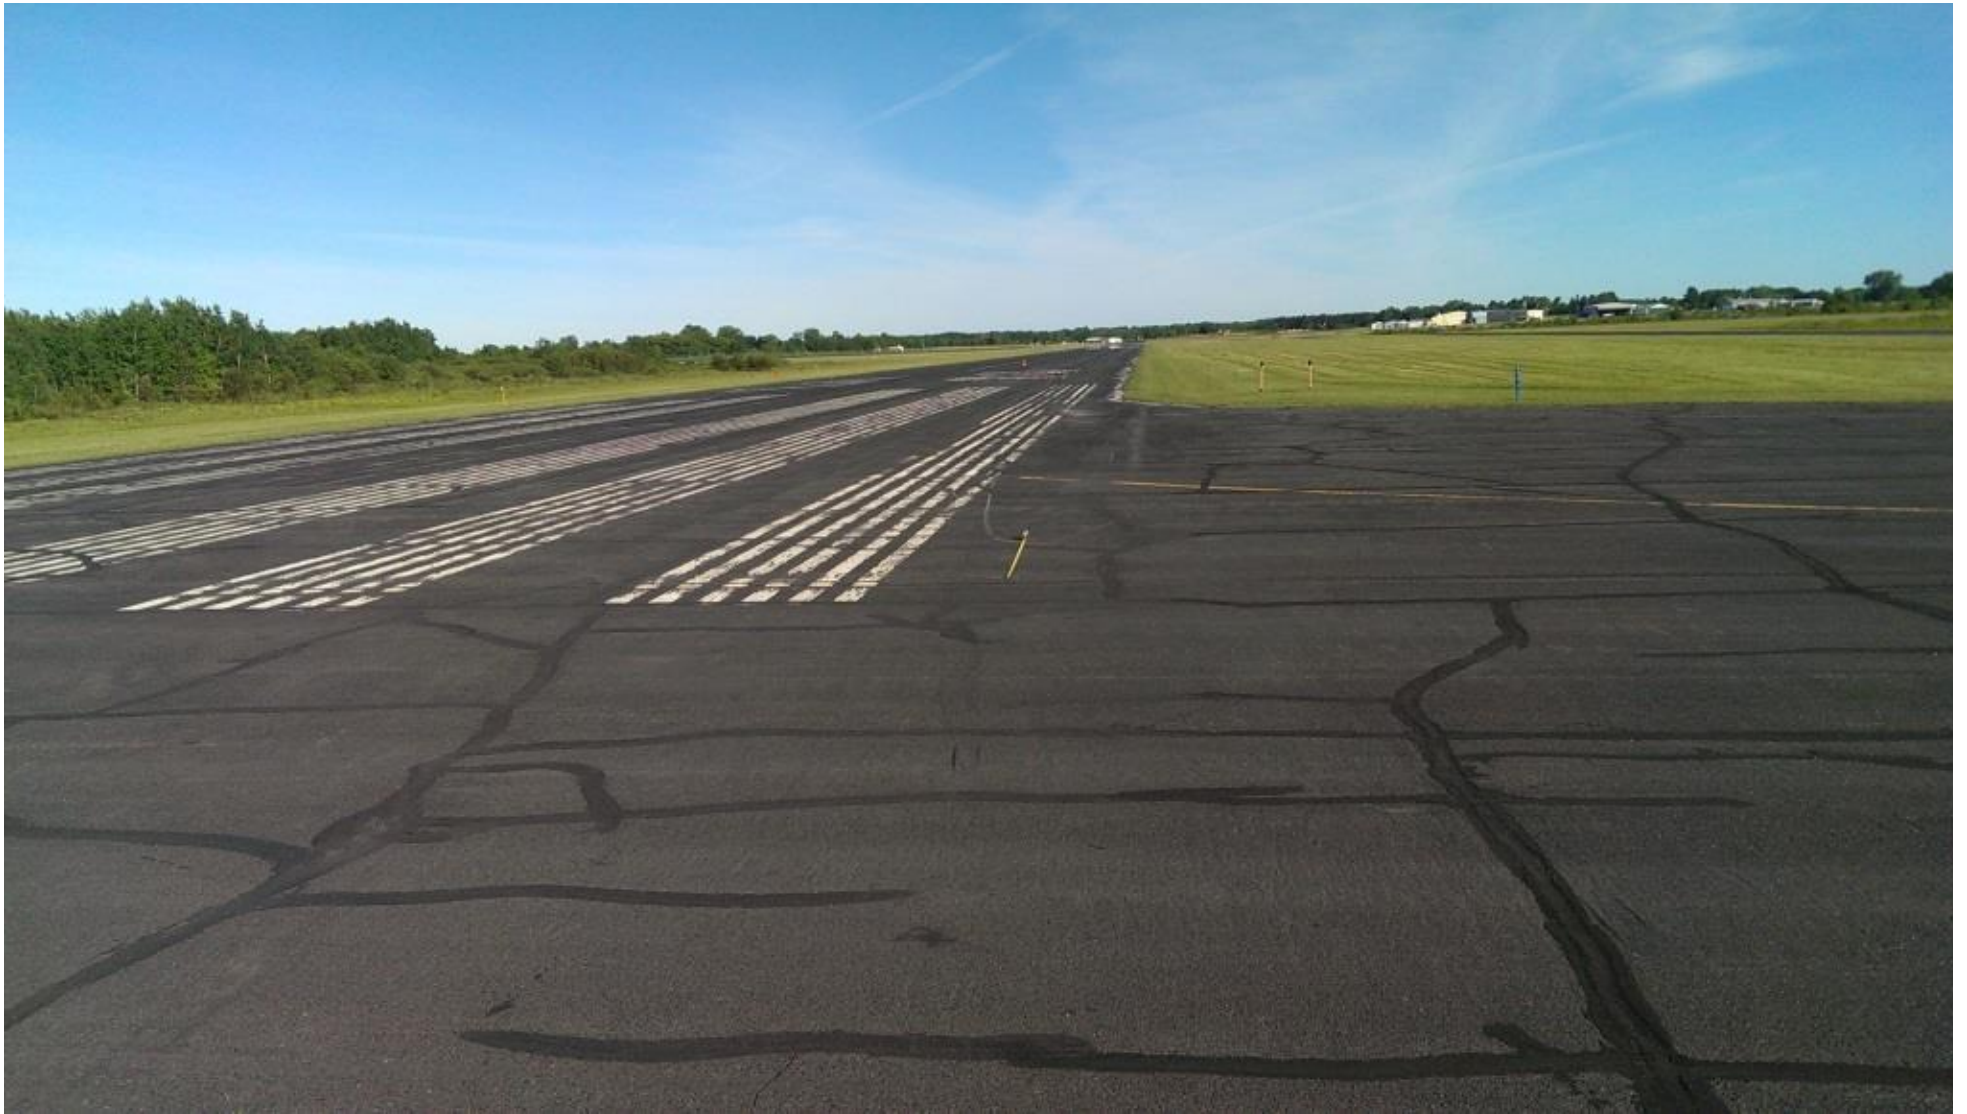
**Photo 16 – View of runway scrape marks from the propeller strikes to the airplane resting point on the runway**

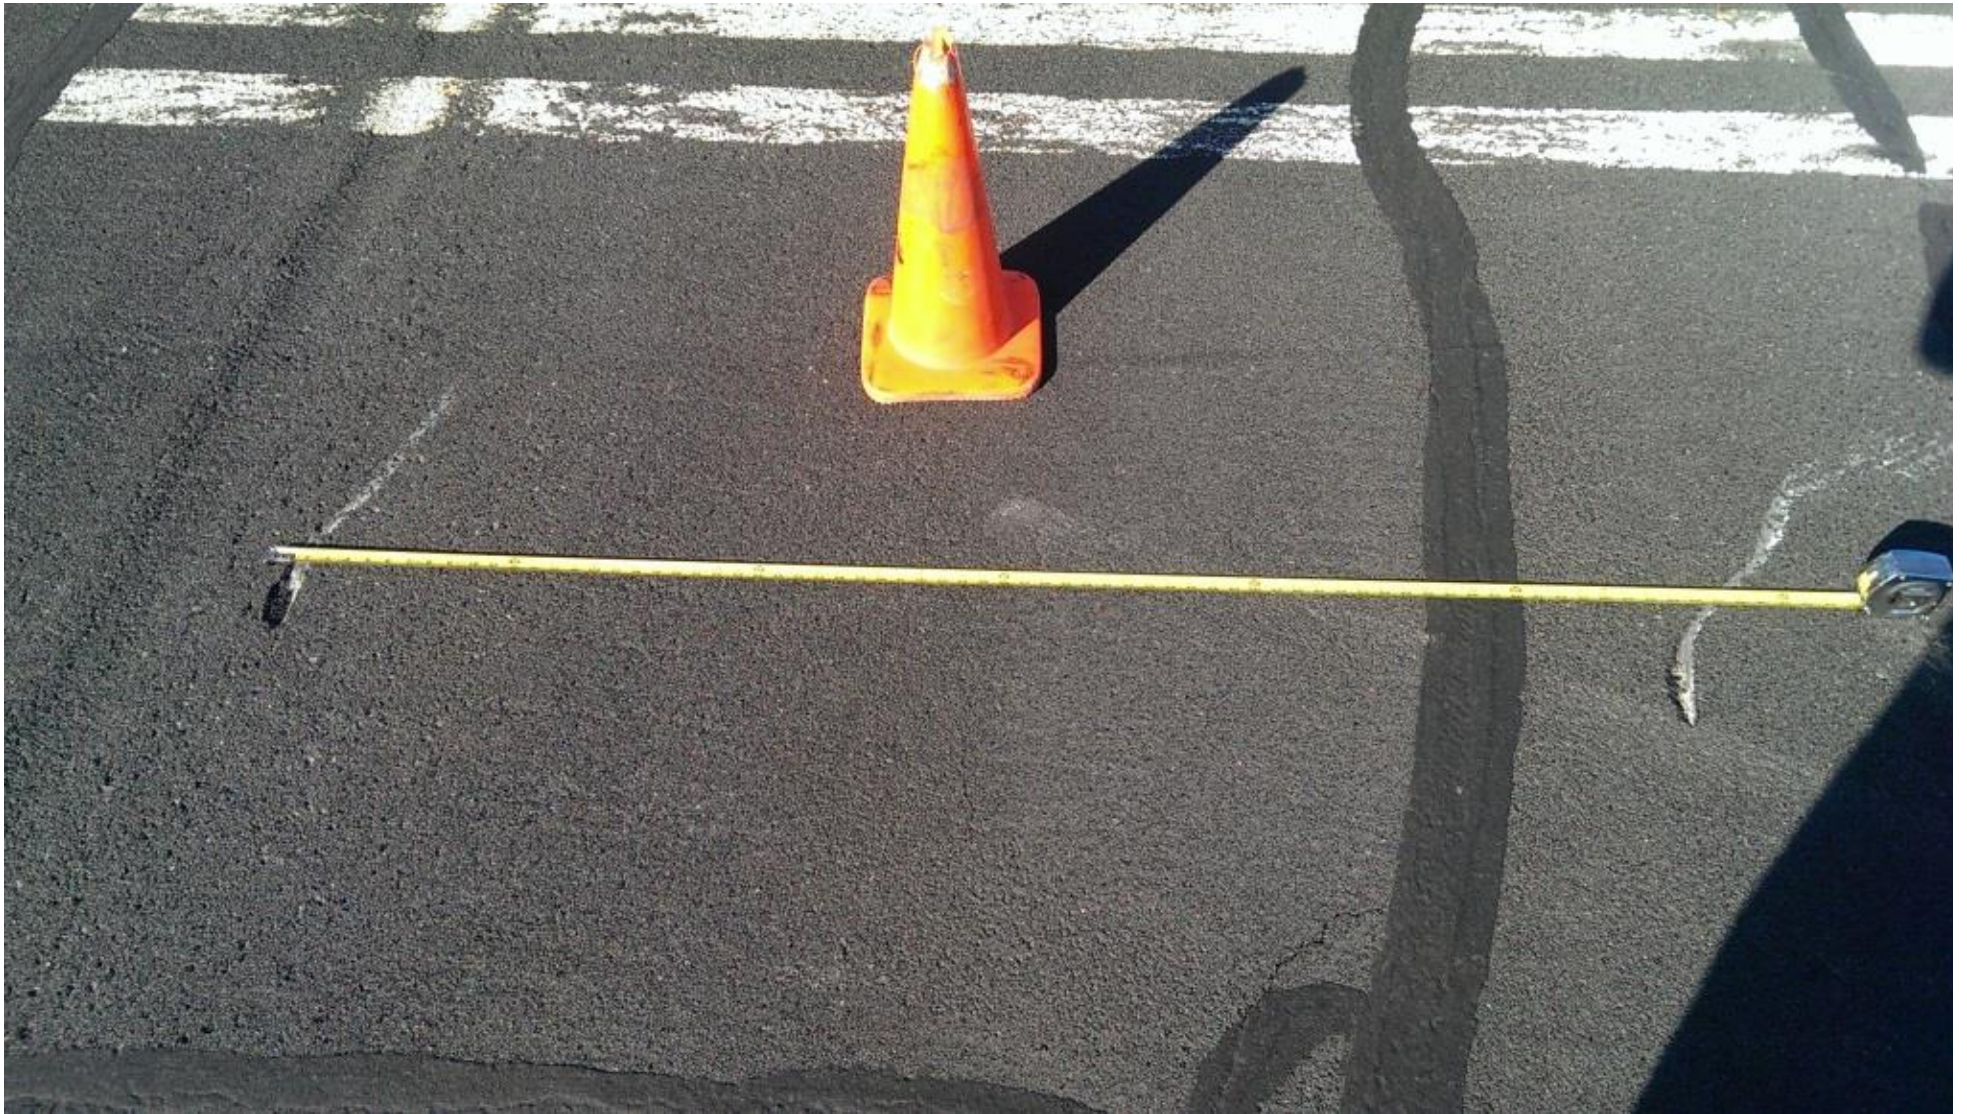
**Photo 17 – View of distance between the propeller strikes**

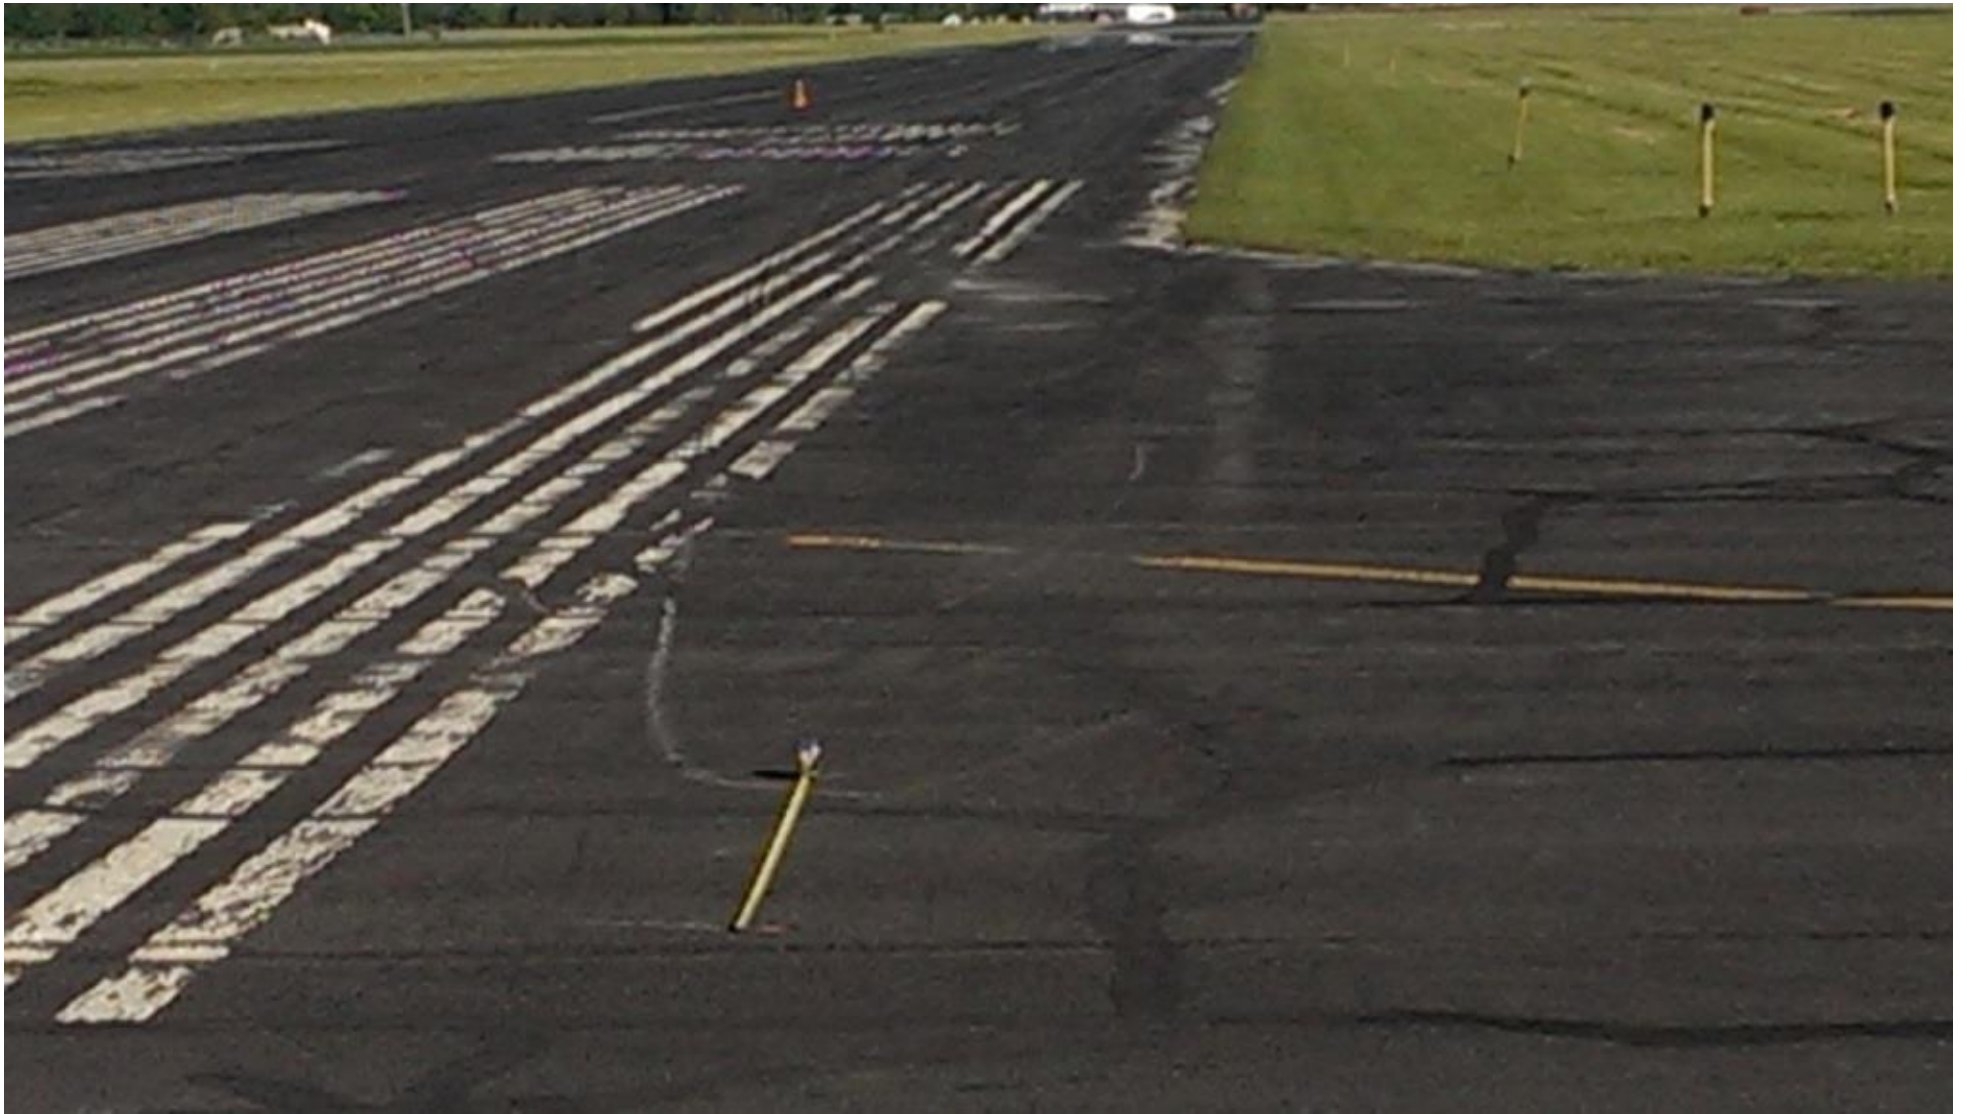
**Photo 18 – View of runway scraping from the propeller strikes to the middle of the runway**

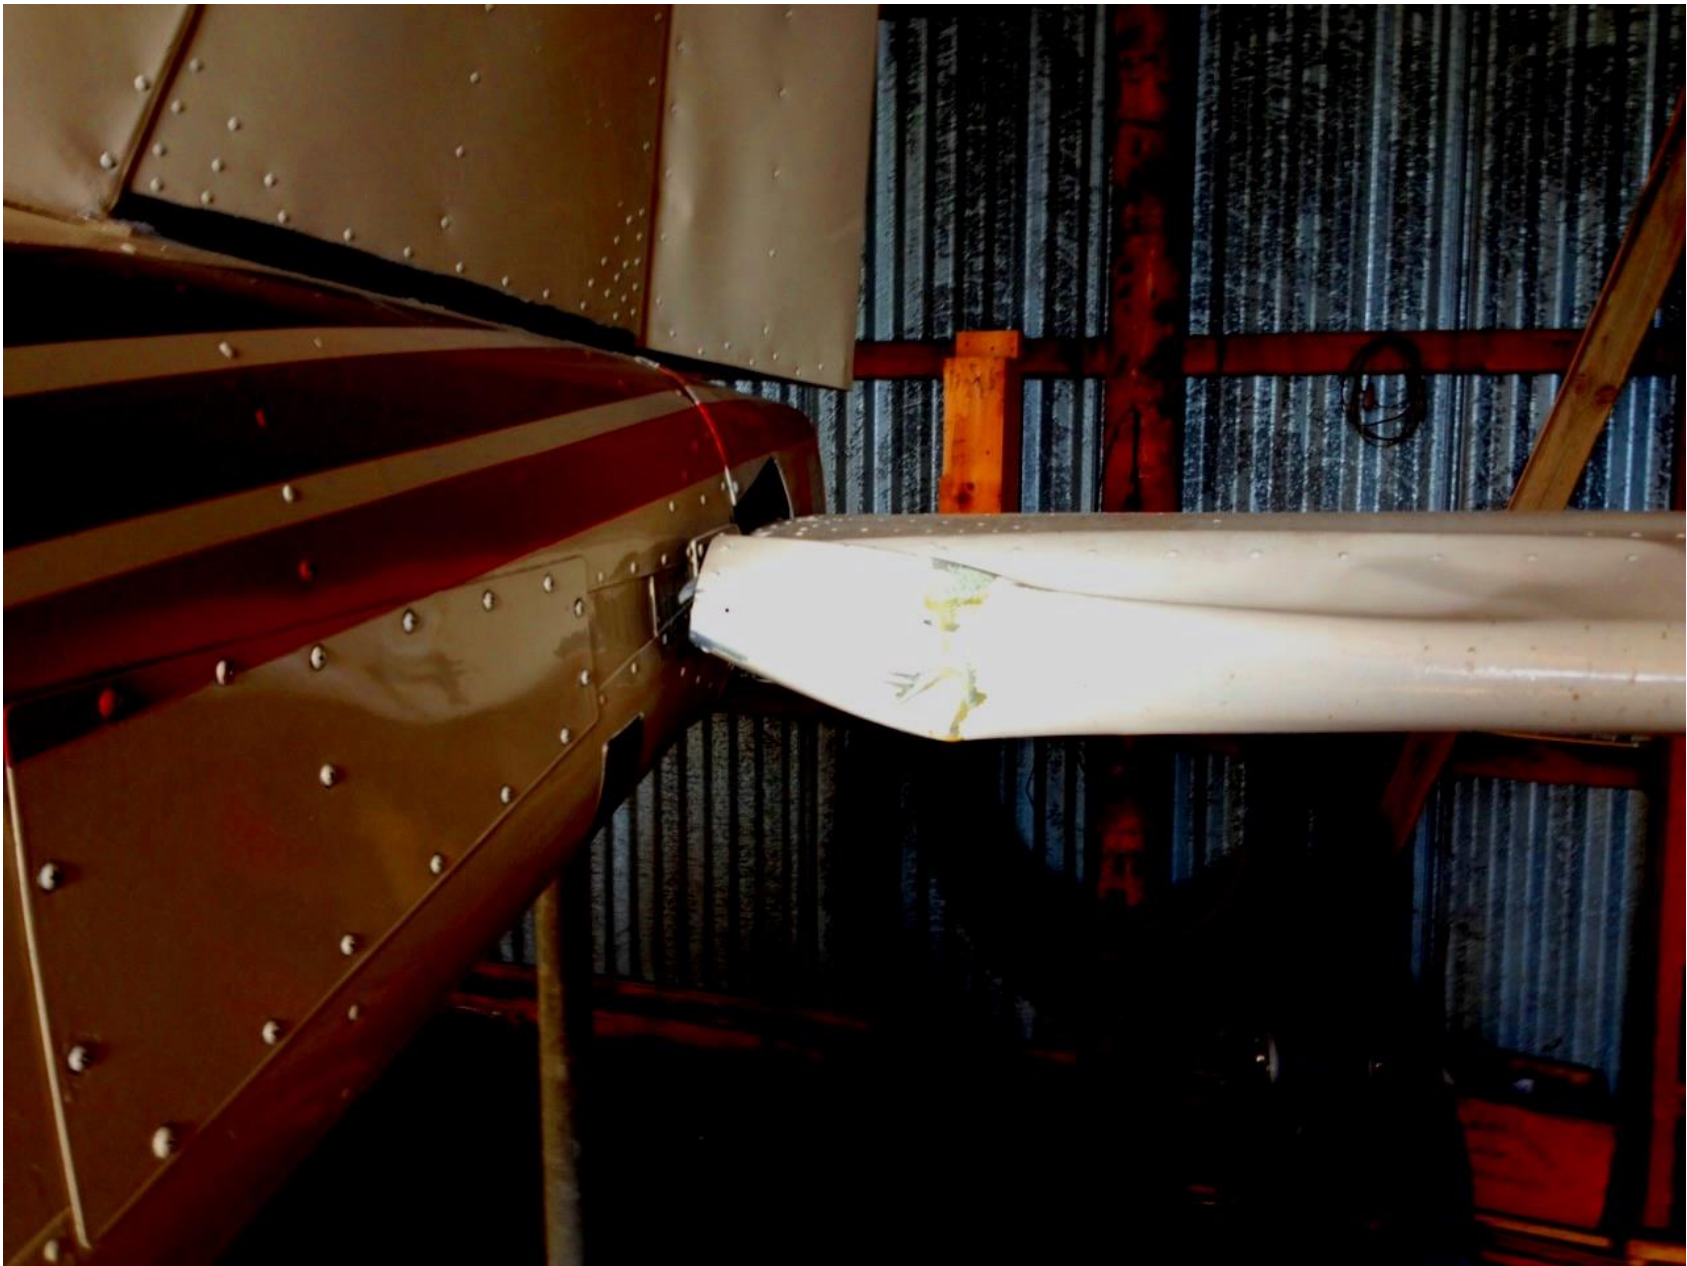
**Photo 19 – View of damage to the left horizontal stabilizer**

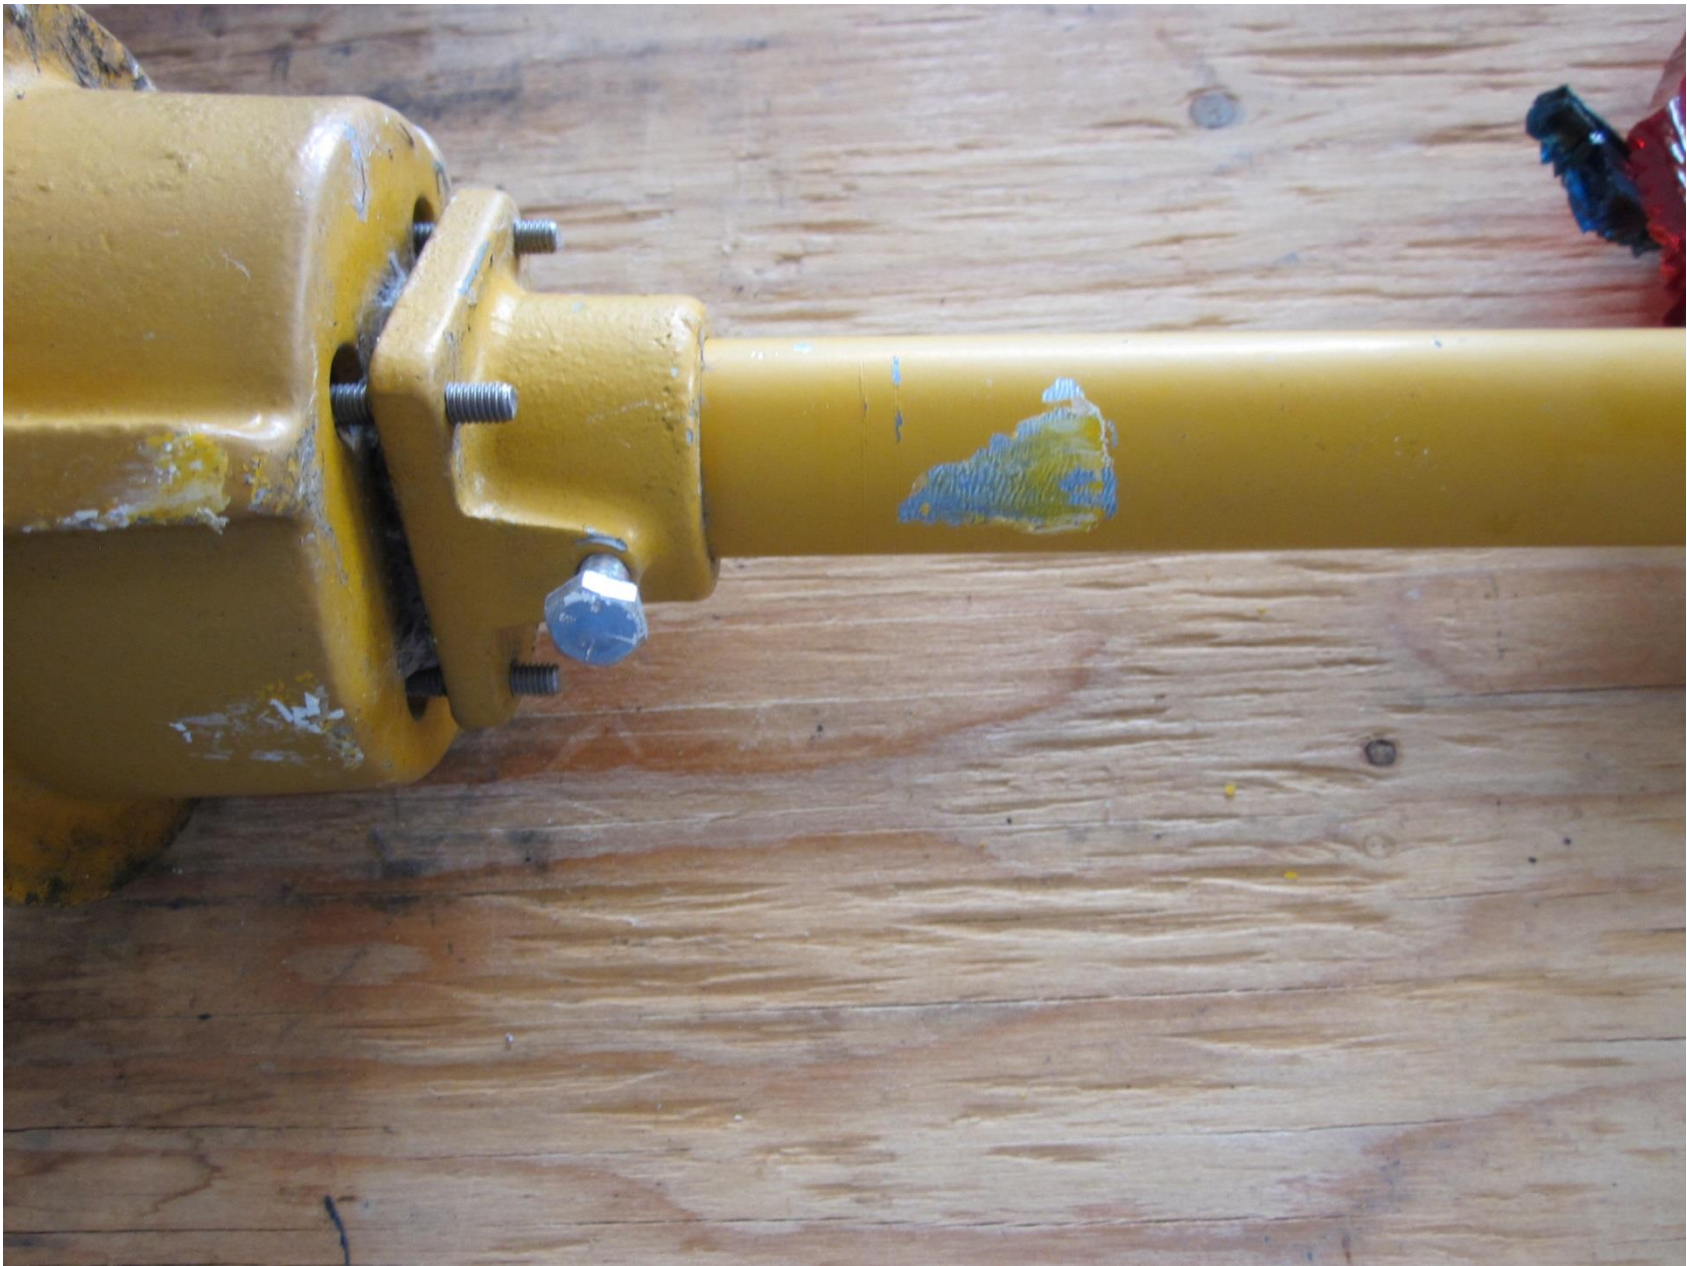
**Photo 20 – View of damaged runway threshold light**
