# NATIONAL TRANSPORTATION SAFETY BOARD

## MATERIALS LABORATORY FACTUAL REPORT

Report No. 16-095

Place : East St. Louis, Illinois  
Date : June 6, 2016  
Vehicle : Aeronca 7AC, N82694  
NTSB No. : CEN16LA218  
Investigator : Courtney Liedler, AS-CEN

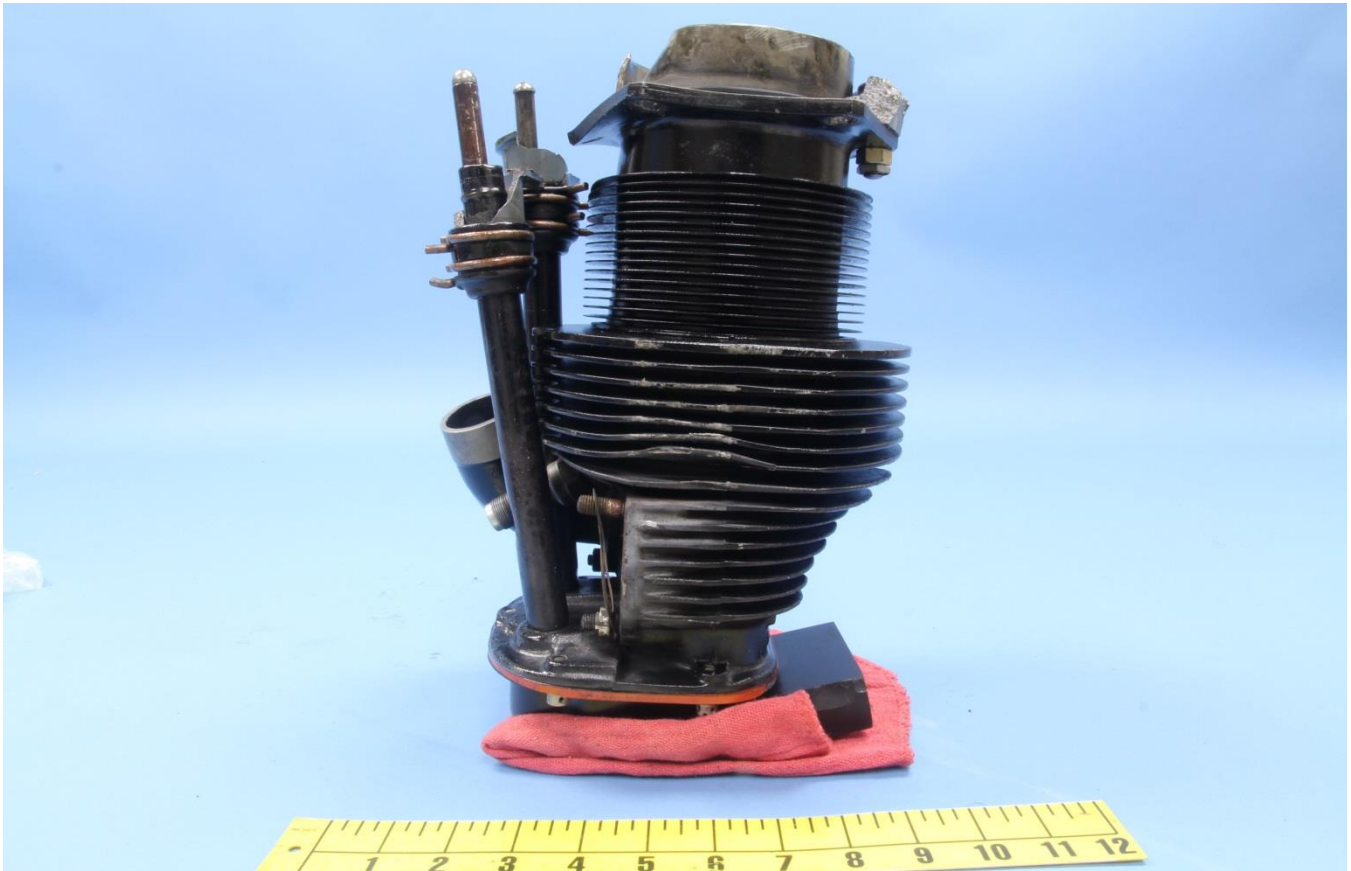
Figure 1 shows the number 2 cylinder assembly, as received. The flange about the opening of the cylinder had been torn and bent. Figure 2 shows the interior of the cylinder, showing the bent flange on the left side of the figure. The piston crown was still present inside the cylinder with a fragment of the connecting rod still attached by the piston pin. The piston crown could be moved up and down slightly, but due to the deformation of the cylinder walls, was trapped inside the cylinder. The sides of the cylinder were sectioned and bent outward so as to remove the piston crown, rod fragment, and the piston pin.

Figure 1 – The #2 cylinder, as received. The upper flange was torn and bent on the top of the figure.

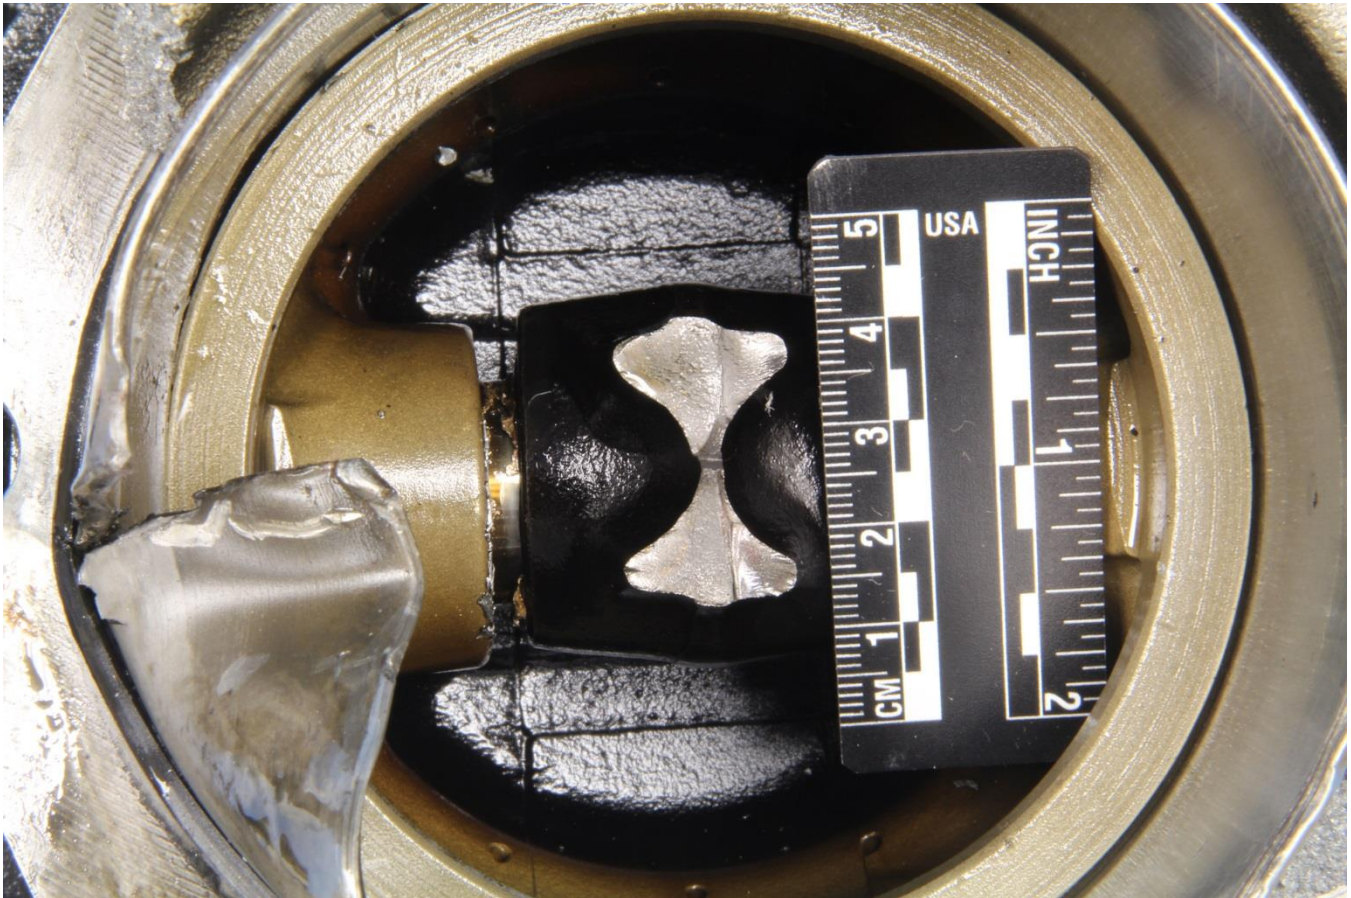
Figure 2 – A closer view of the inside of the cylinder, as-received, showing the fractured fragment of the connecting rod.

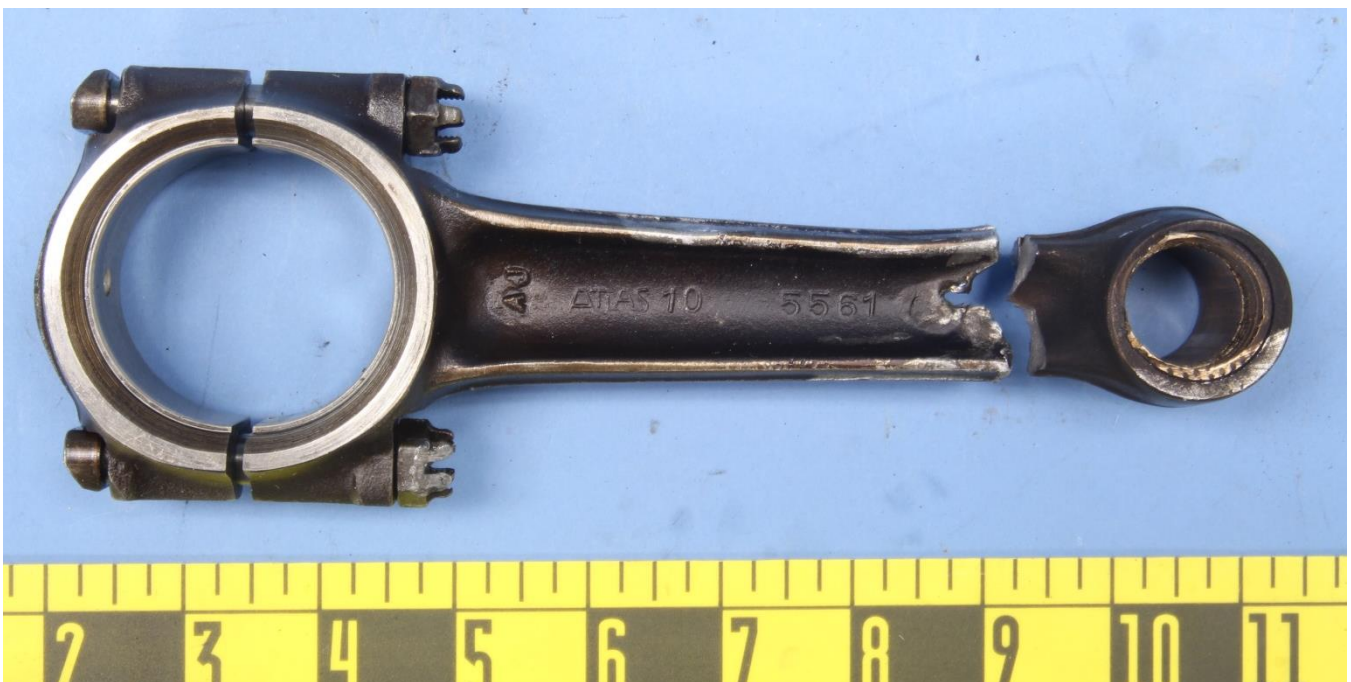
Figure 3 shows the connecting rod fragment removed from the cylinder positioned next to the mating connecting rod. The markings on the connecting rod stated, "ATLAS 10 5561". The rod had fractured approximately 0.58 to 0.79 inches from the piston pin bore. Figure 4 illustrates the condition of the pin bore of the connecting rod. The bore exhibited a small step, as well as material deformation outward with longitudinal wear and chatter marks.

Figure 3 – The fractured halves of the connecting rod, shown after removal of the fragment from the cylinder (right).

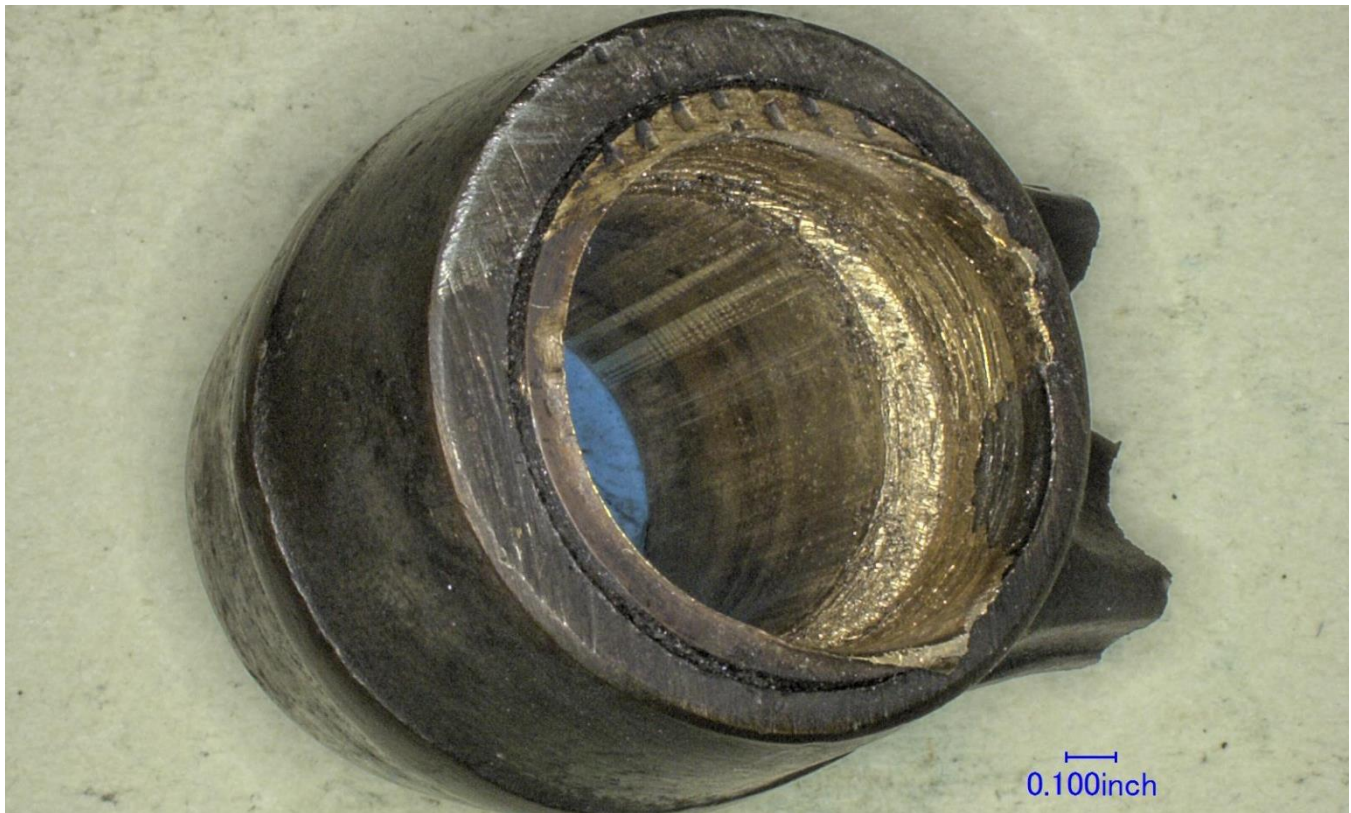
Figure 4 – Side view of the bearing of the fractured connecting rod, where the fractured pin was located.

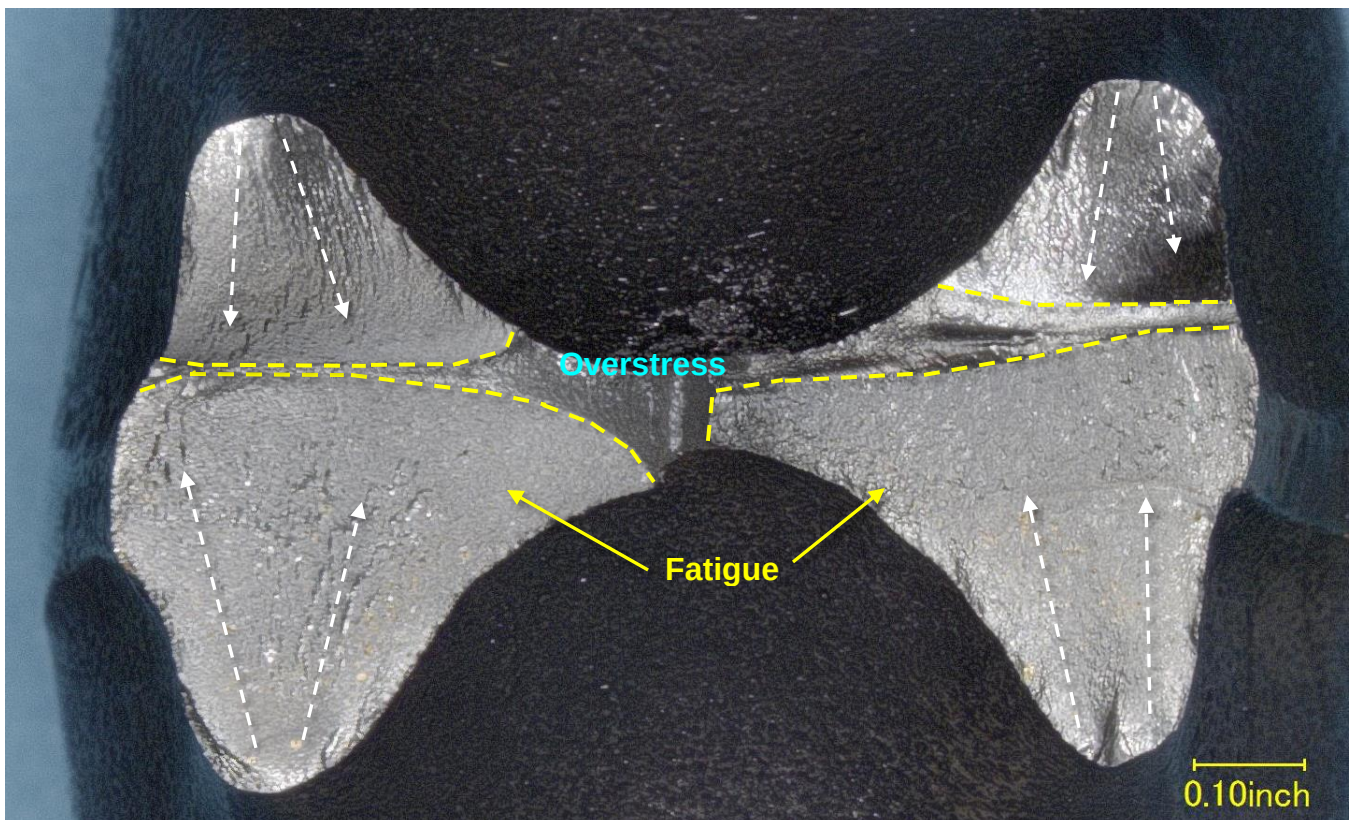
The fracture surface on the arm side of the rod had been mostly obliterated, consistent with post-fracture impact damage. However, the piston crown side of the connecting rod had not been similarly damaged, as shown in Figure 5. This fracture surface of the rod exhibited features, such as crack arrest and ratchet marks, consistent with progressive cracking, later determined to be consistent with fatigue.

The nature of the fatigue cracking features was consistent with stresses from reverse bending, originating in four distinct initiation sites at the rod flanges (annotated in Figure 5, and as typified in Figure 6). These cracks grew inward until the remaining rod cross section succumbed to overstress. The relatively large percentage of fatigue features on the fracture surface was suggestive of low-load or high-cycle fatigue.

Figure 5 – Closer view of the rod fracture surface (piston side), after removal from the cylinder and cleaning. The different fracture regions are annotated, and the crack growth directions are depicted with white arrows.

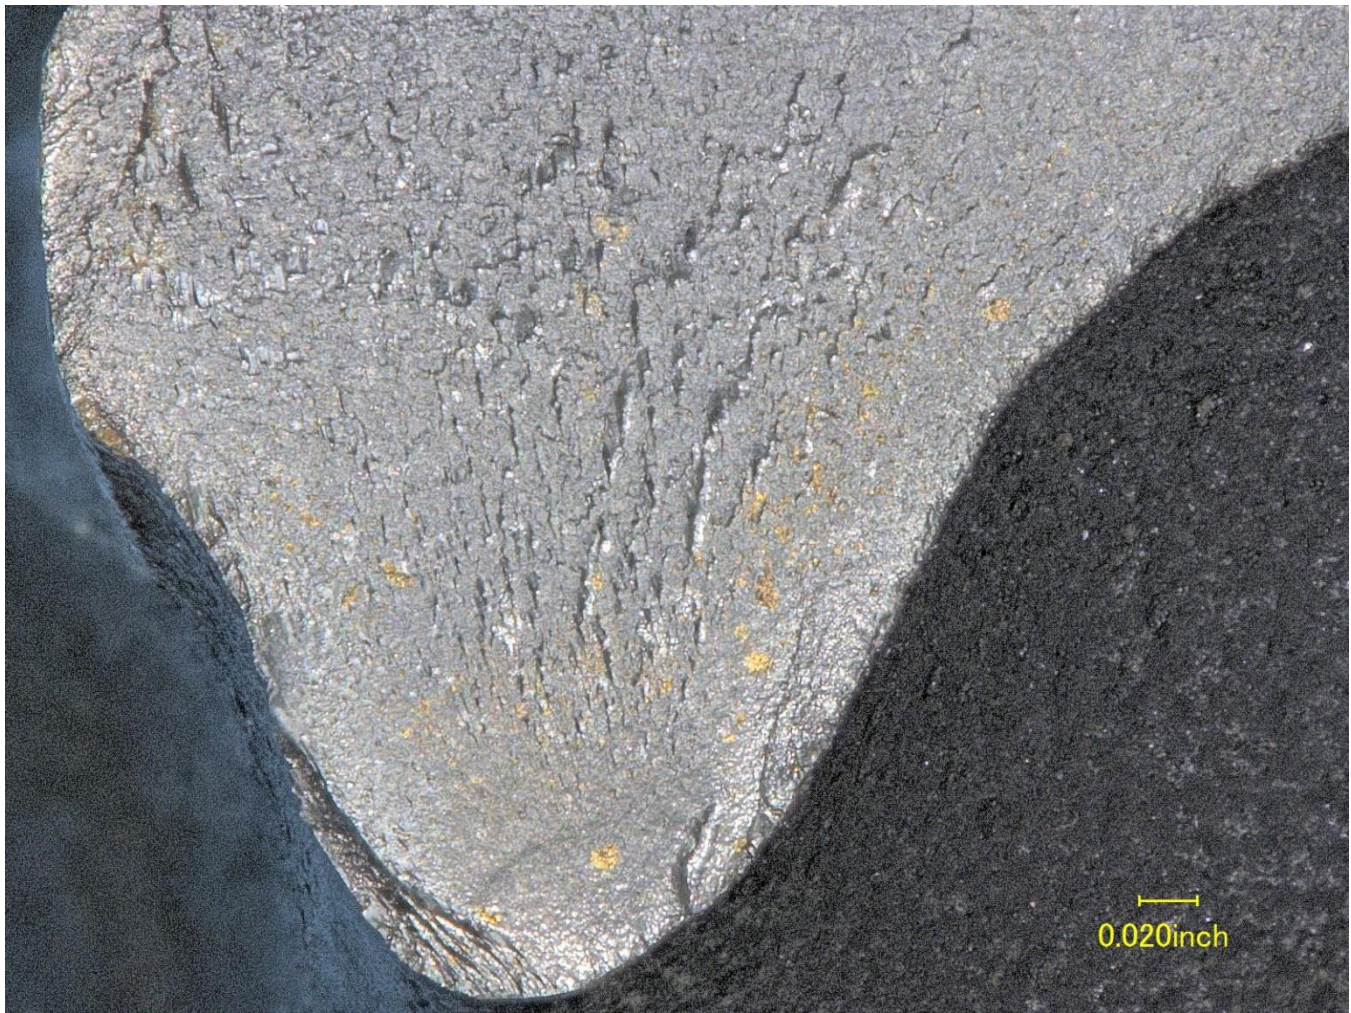
Two of the crack initiation sites of the rod fracture surface are illustrated in Figures 6 and 7. These initiation sites showed ratchet marks of varying sizes, consistent with smaller fatigue cracks that coalesced as they propagated inward. The crack arrest marks were consistent with the cracks propagating away from these corner initiation sites.

Figure 6 – Closer view of the crack initiation site of the lower left side from Figure 5.

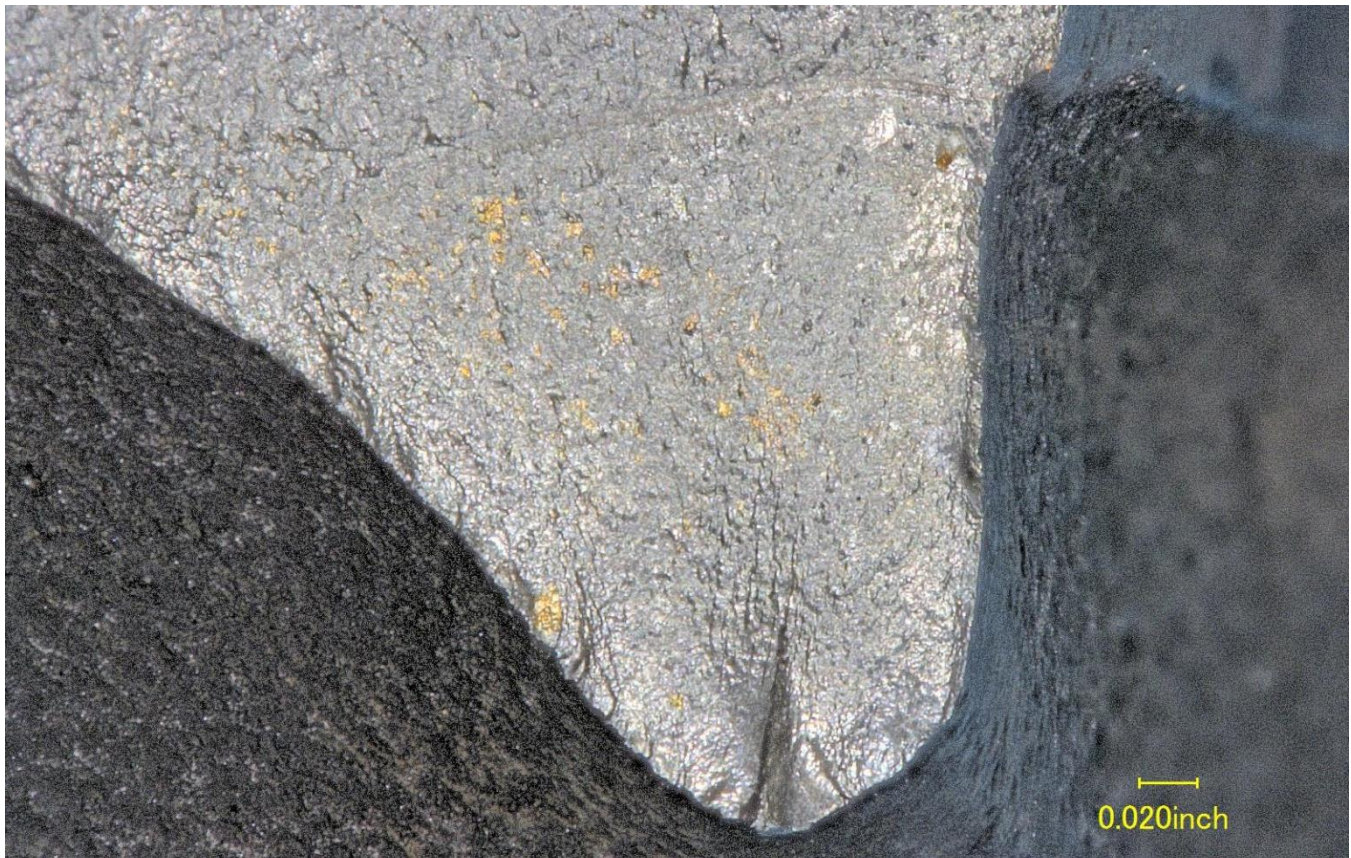
Figure 7 – Closer view of the crack initiation site on the lower right side of Figure 5. A ratchet mark was present in the figure.

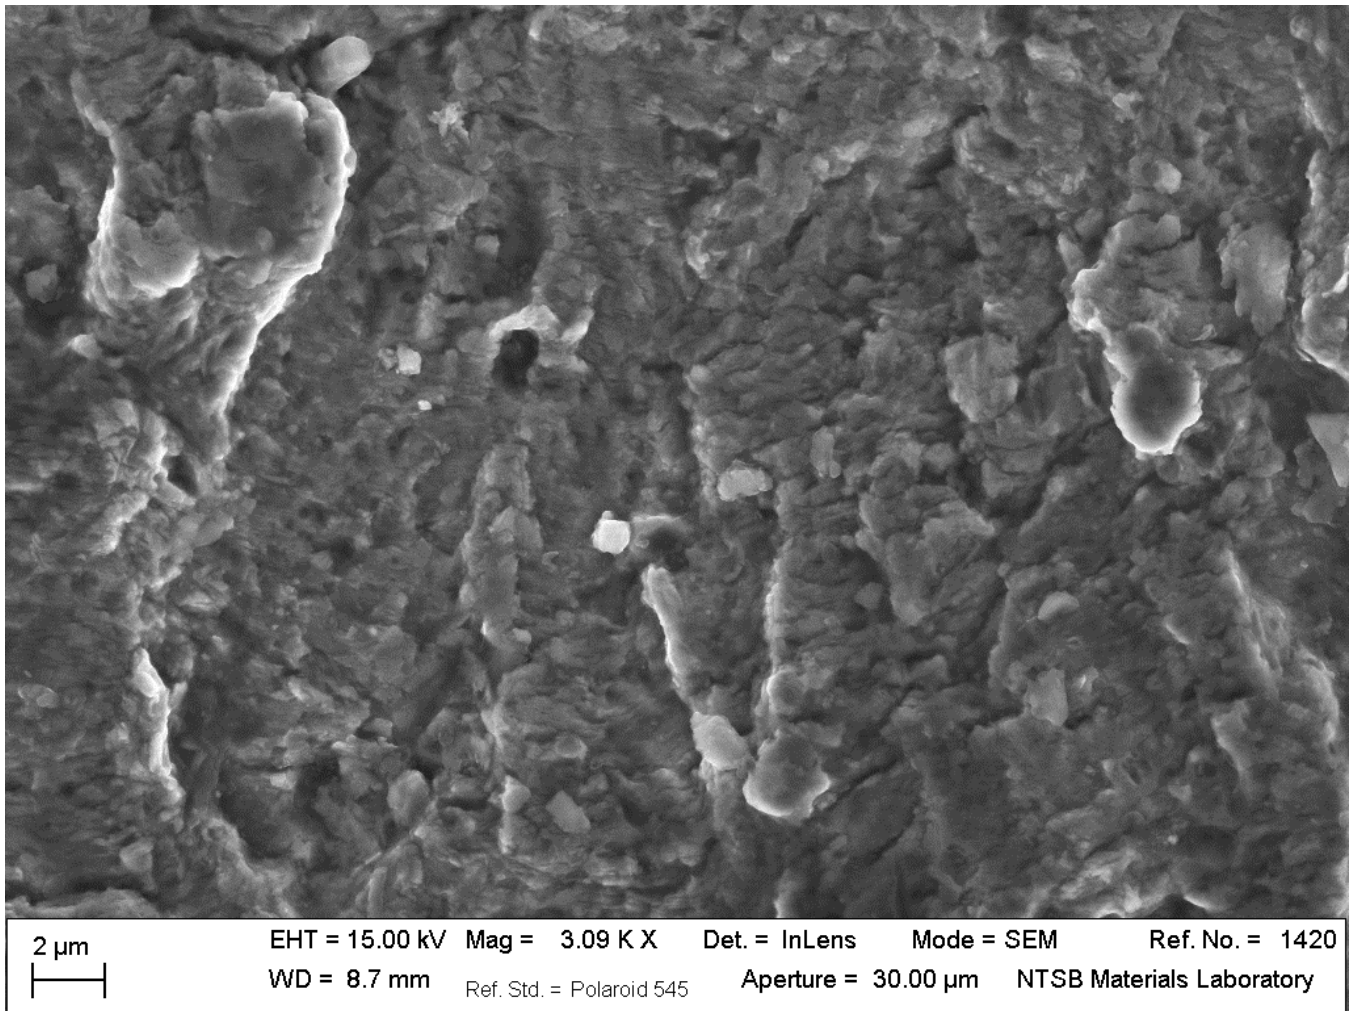
The fracture surface was examined using a scanning electron microscope (SEM). Figure 8 shows a typical area of one of the fatigue cracks, containing fatigue striations. The thin region between the opposing fatigue cracks (as annotated in Figure 5) is highlighted in Figure 9. This region exhibited dimple rupture, consistent with overstress failure.

Figure 8 – Secondary electron (SE) micrograph of fatigue striations on the connecting rod fracture surface.

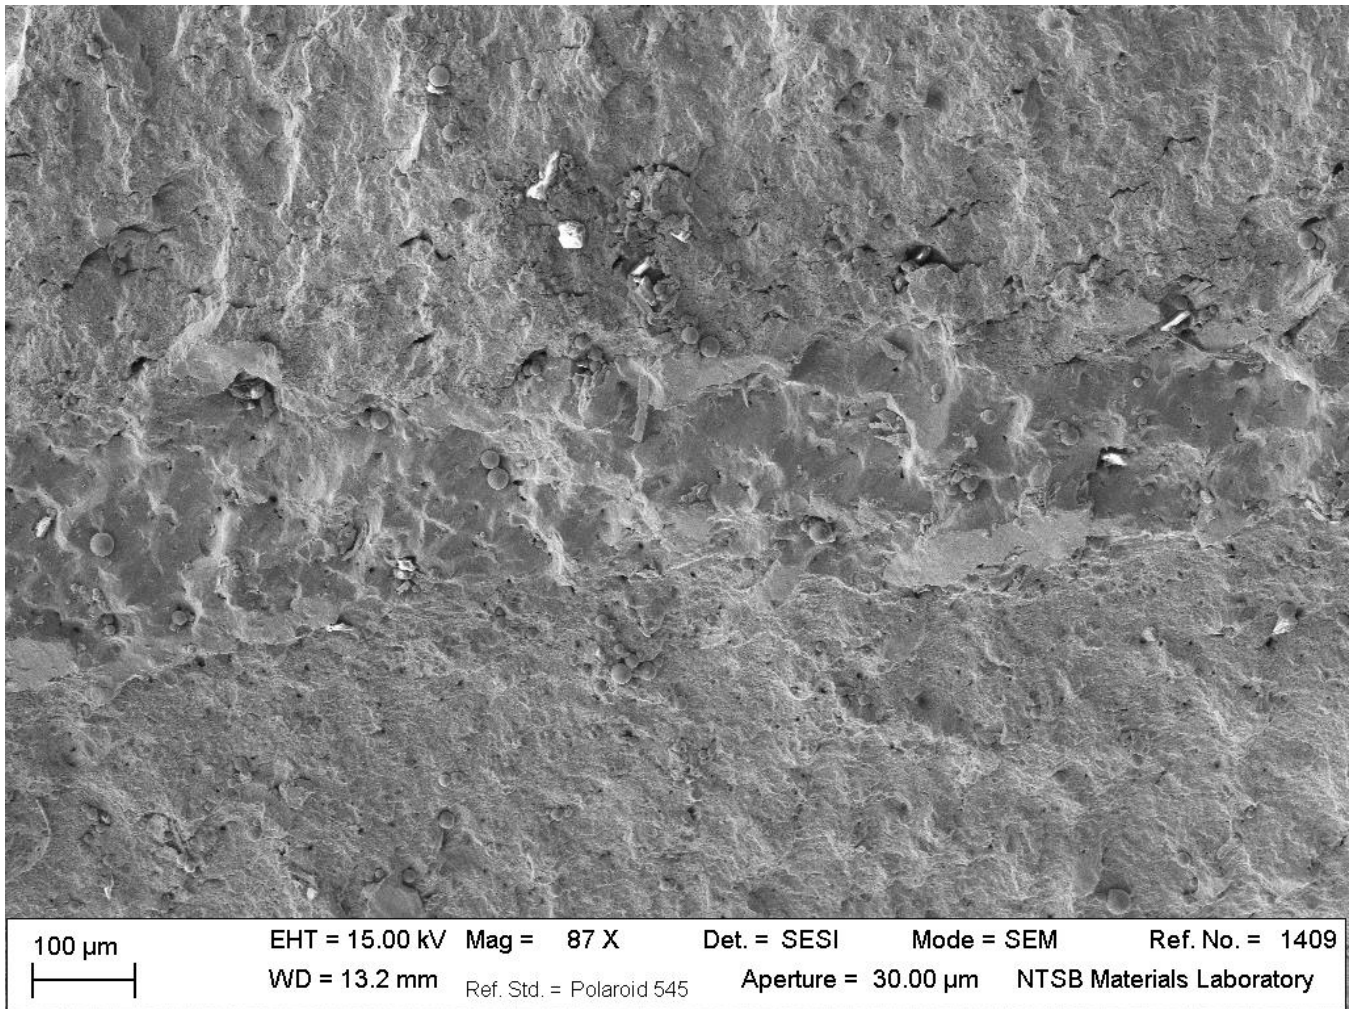
Figure 9 – SE micrograph of the middle of the rod fracture surface, showing the middle overstress fracture between two fatigue crack regions.

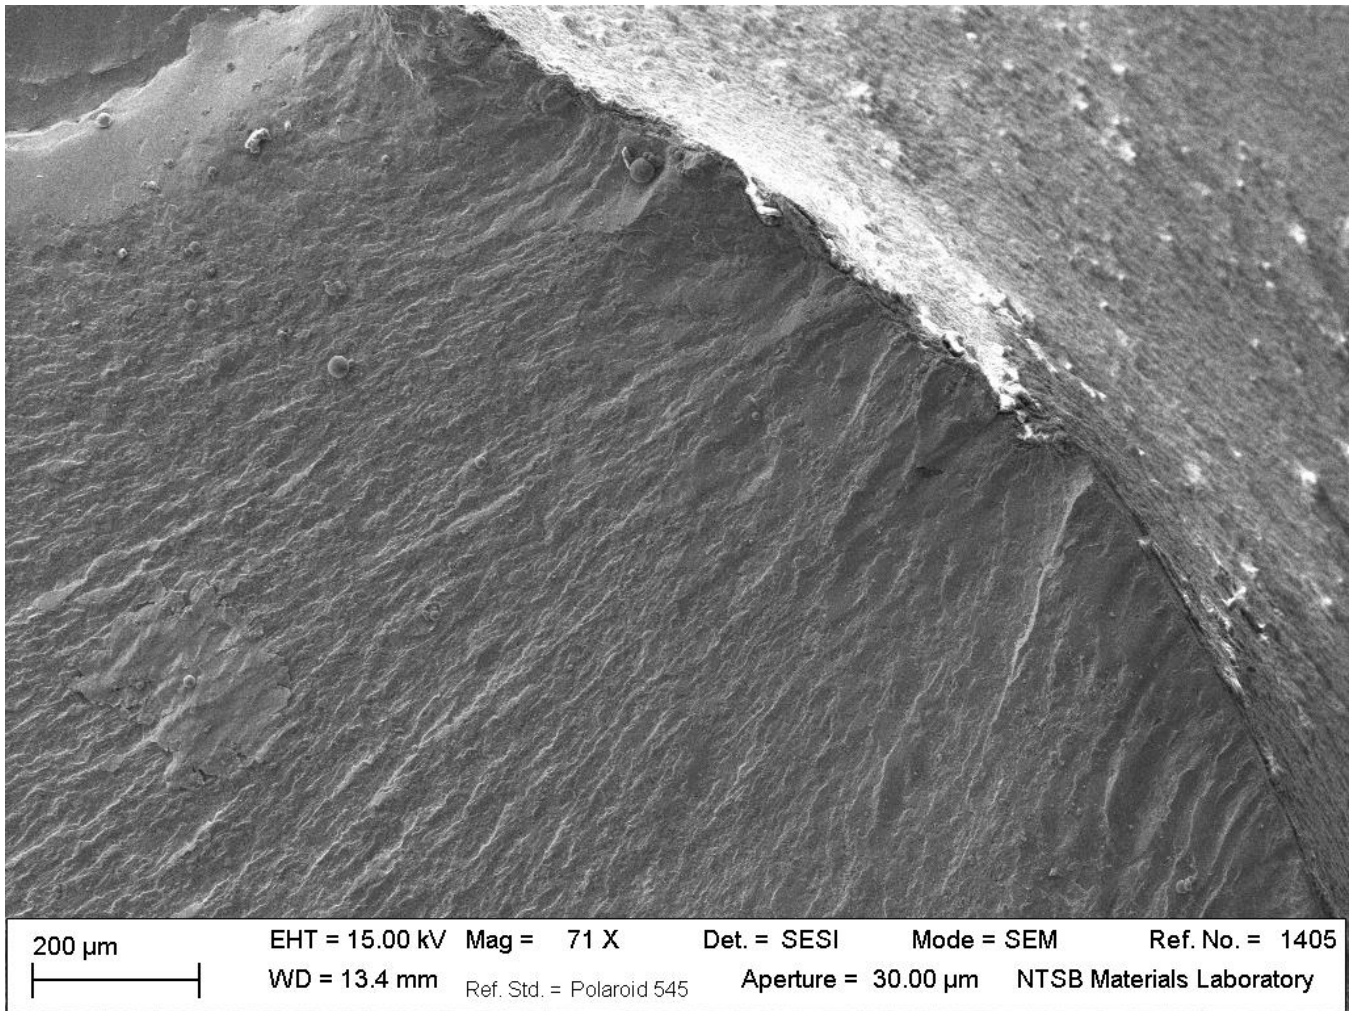
As observed visually, the crack initiation sites exhibited features consistent with multiple crack initiation sites. One such site is highlighted in Figure 10. For the most part, the crack initiation sites did not exhibit any mechanical or material defects, such as inclusions, pores, or voids, that would lead to premature failure. However, the crack initiation site in Figure 10 did exhibit a pit-like feature with non-conductive material present (see Figure 11). Examination of the non-conductive material using energy dispersive x-ray spectroscopy (EDS) did not reveal any elements typically associated with iron-based corrosion products. The composition of the connecting rod was consistent with a plain carbon steel.

Figure 10 – SE micrograph of one of the fatigue crack initiation sites on the connecting rod.

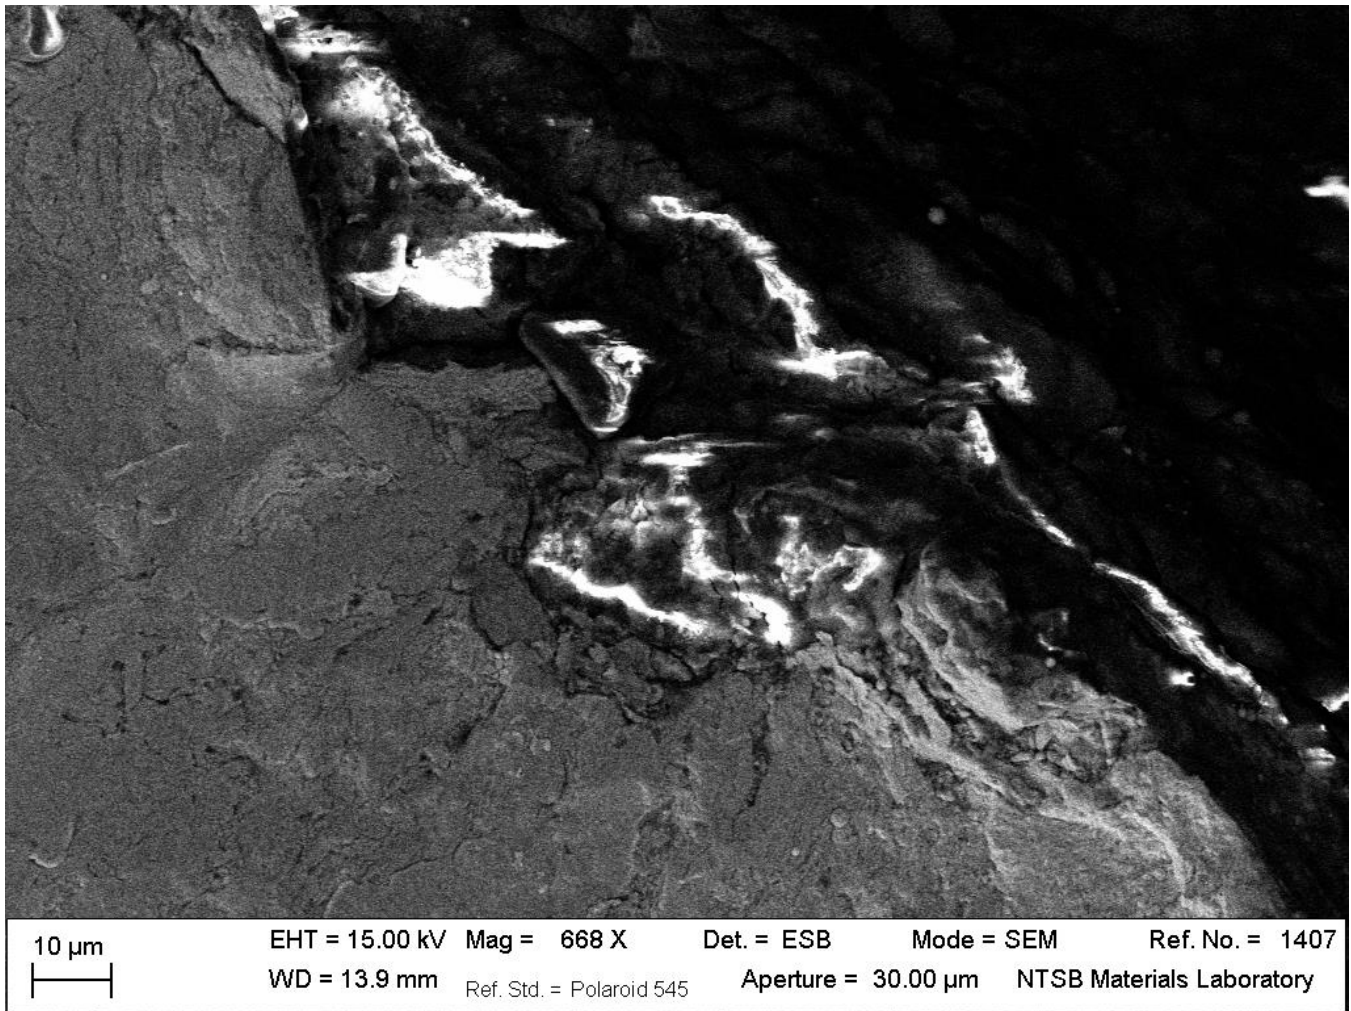
Figure 11 – Backscattered electron (BE) micrograph of one of the initiation sites in Figure 10. The figure shows non-conductive material present at pit-like features at this initiation site.

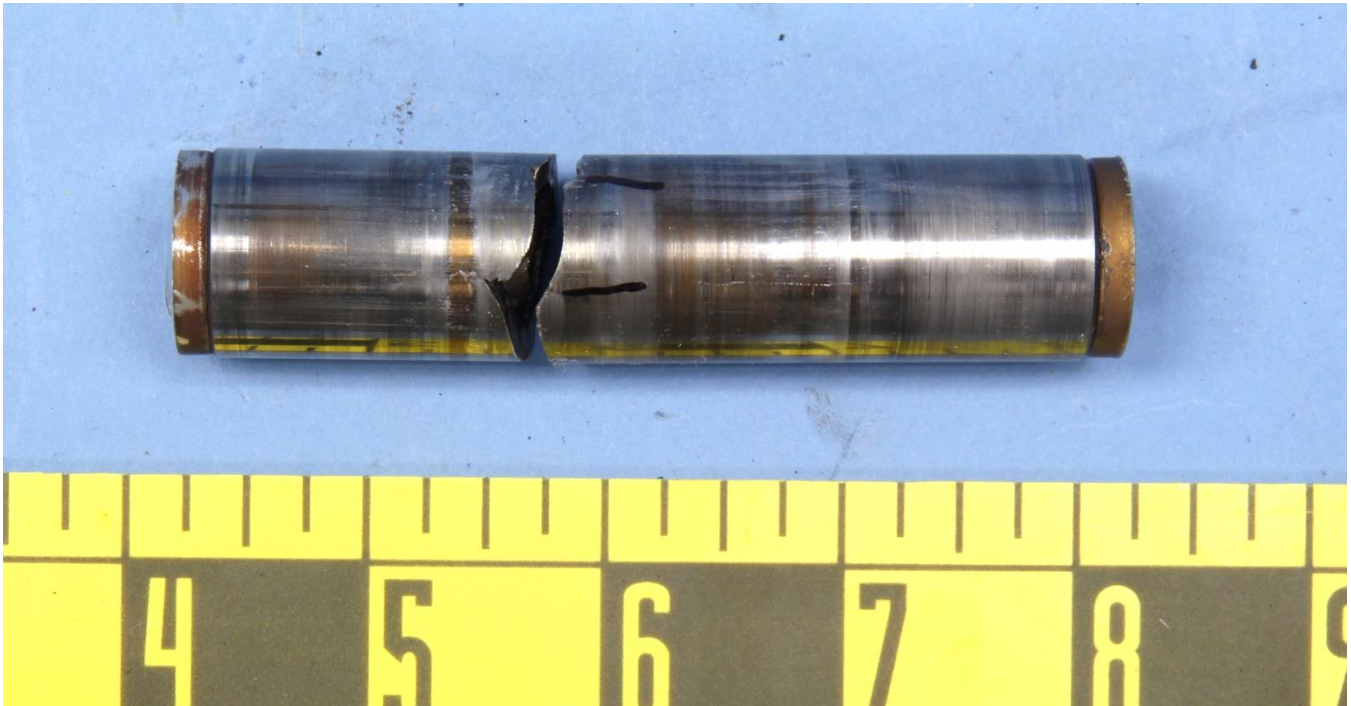
Figure 12 shows the piston pin after removal from the piston crown and cleaning. The pin had fractured inside the connecting rod bore (shown in Figure 4) and was only discovered upon disassembly. The pin fracture location was between 1.37 and 1.59 inches from the shorter stub side. Most of the mating fracture surfaces exhibited smearing damage, consistent with continual rubbing while in contact inside the connecting rod bore. Figure 13 shows the less damaged of the two pin mating fracture surfaces. The fracture surfaces consisted of steps, generally oriented perpendicular to the pin forging direction. The surfaces were relatively flat, particularly around the outer regions (see Figure 14).

Figure 12 – The fractured piston pin after removal of the connecting rod fragment from the cylinder.

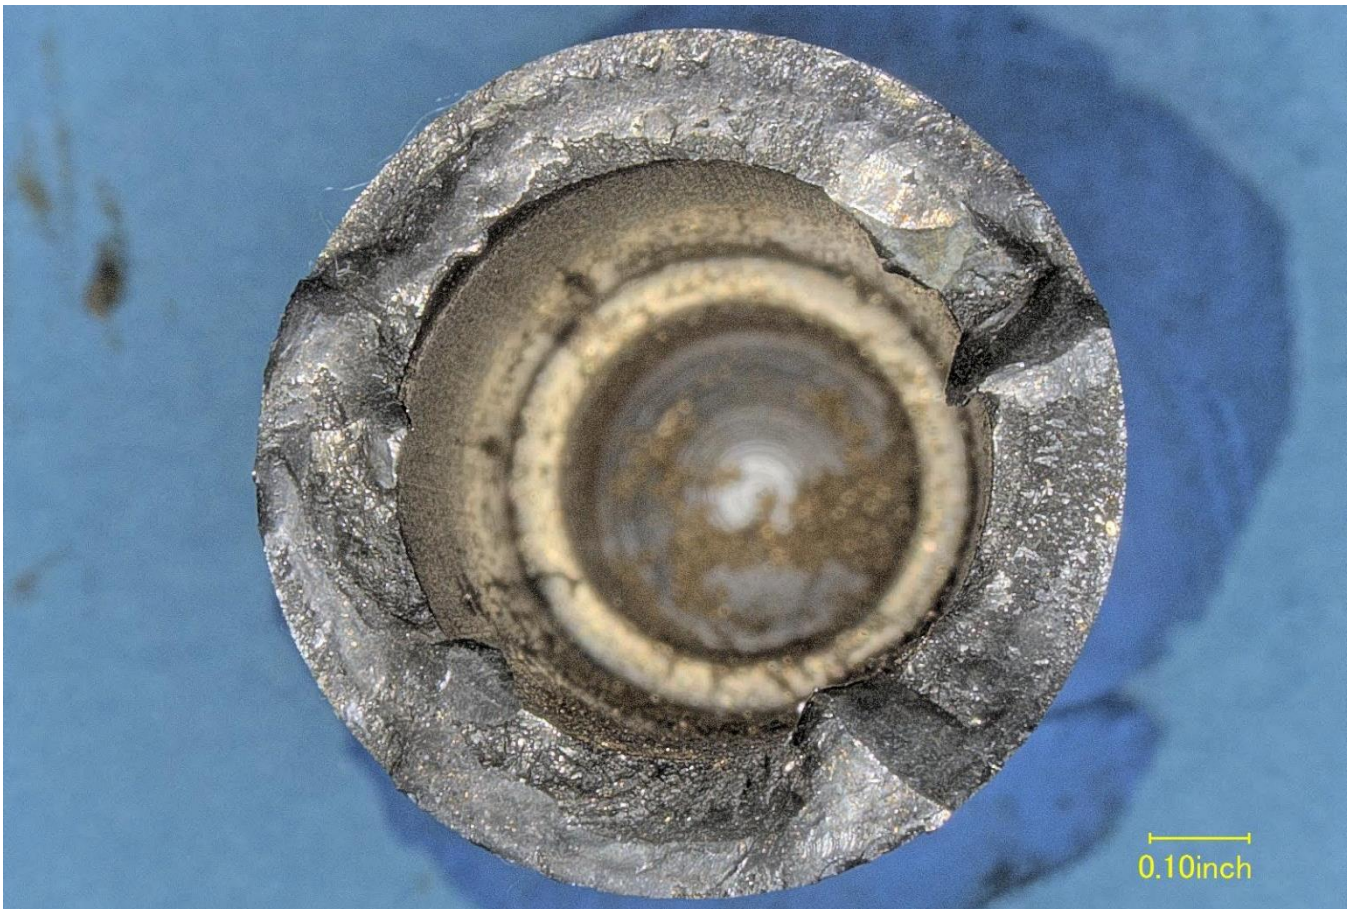
Figure 13 – The less damaged fracture surface of the pin from the connecting rod.

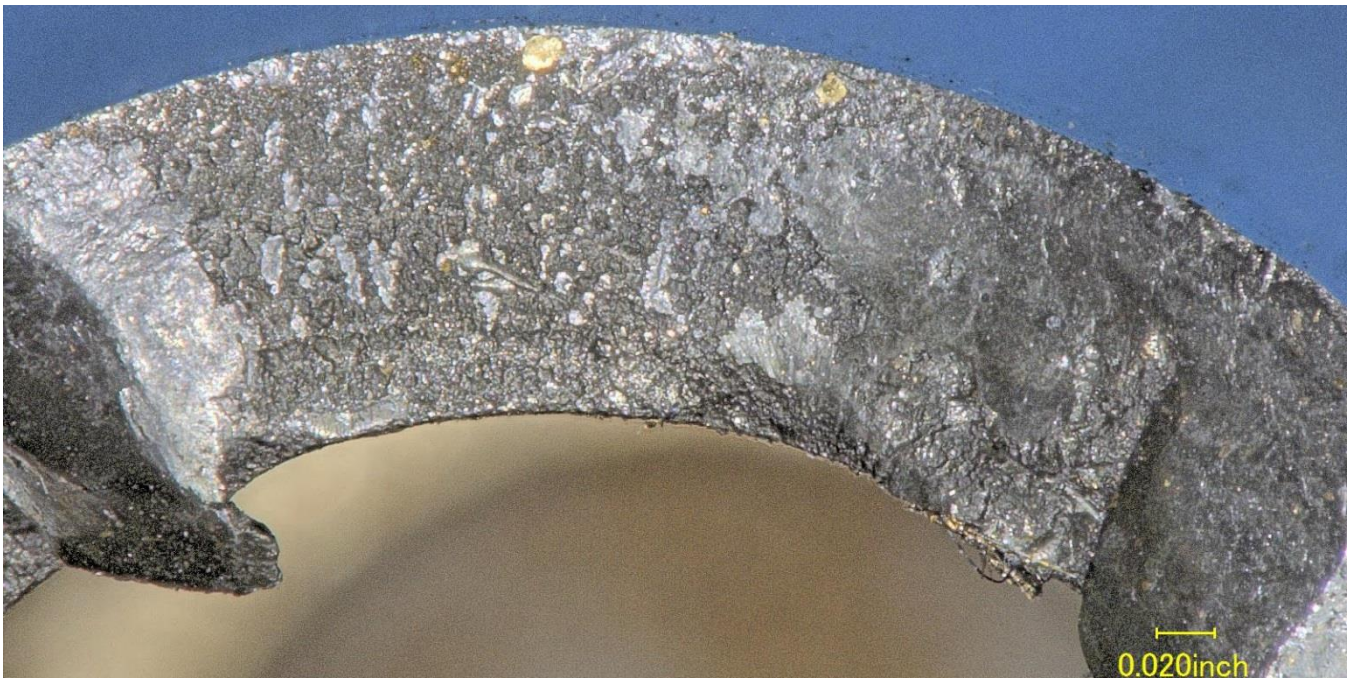
Figure 14 – Closer view of the pin fracture surface, showing relatively flat surface, with rubbing damage present.

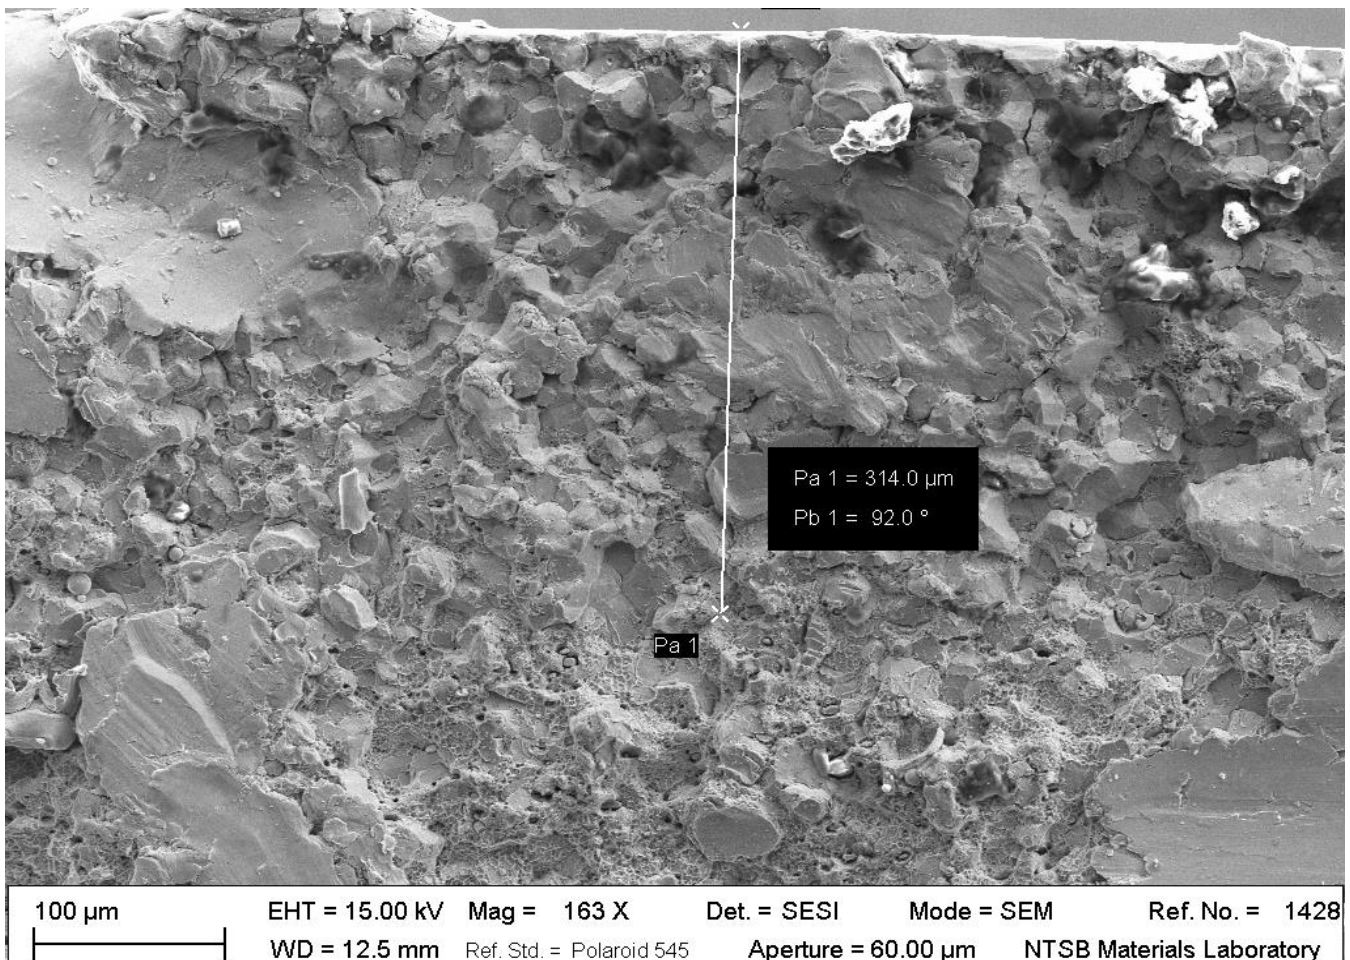
Examination of the fracture surface using a SEM found two distinct regions of features on the fracture surface (see Figure 15). The outer region, which extended to a depth of approximately 314  $\mu\text{m}$  (0.012 inch), exhibited intergranular fracture (see Figure 16). The inner regions of the pin fracture surface exhibited dimple rupture, consistent with tensile overstress (see Figure 17).

Figure 15 – SE micrograph, showing an outer region of intergranular features, and an inner region of dimple rupture. The depth of the outer intergranular region is annotated on the figure.

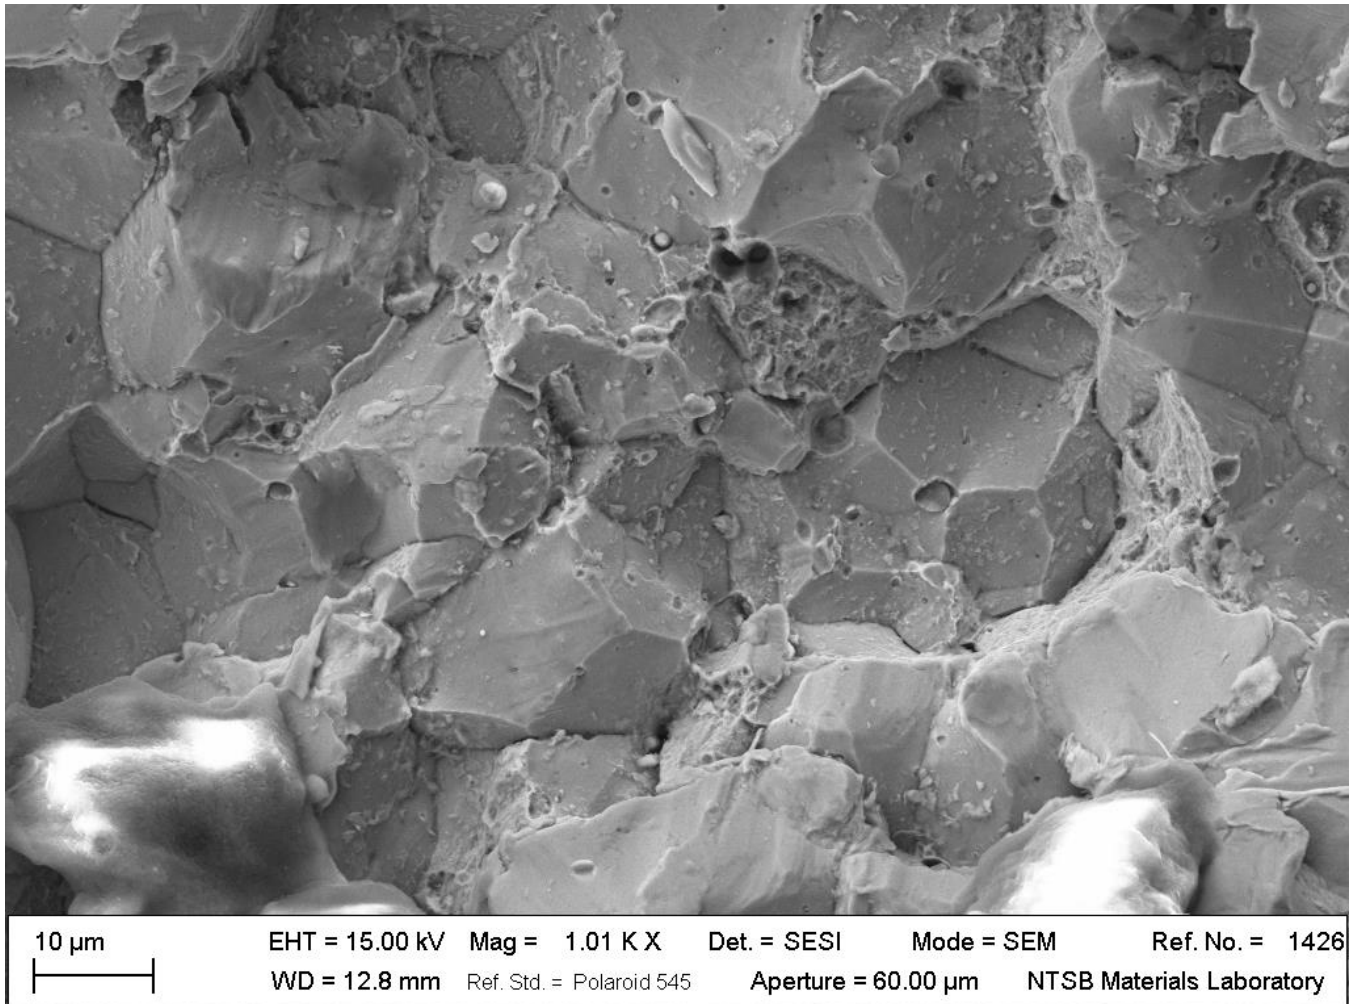
Figure 16 – SE micrograph showing a closer view of the intergranular fracture region of the pin from Figure 15.

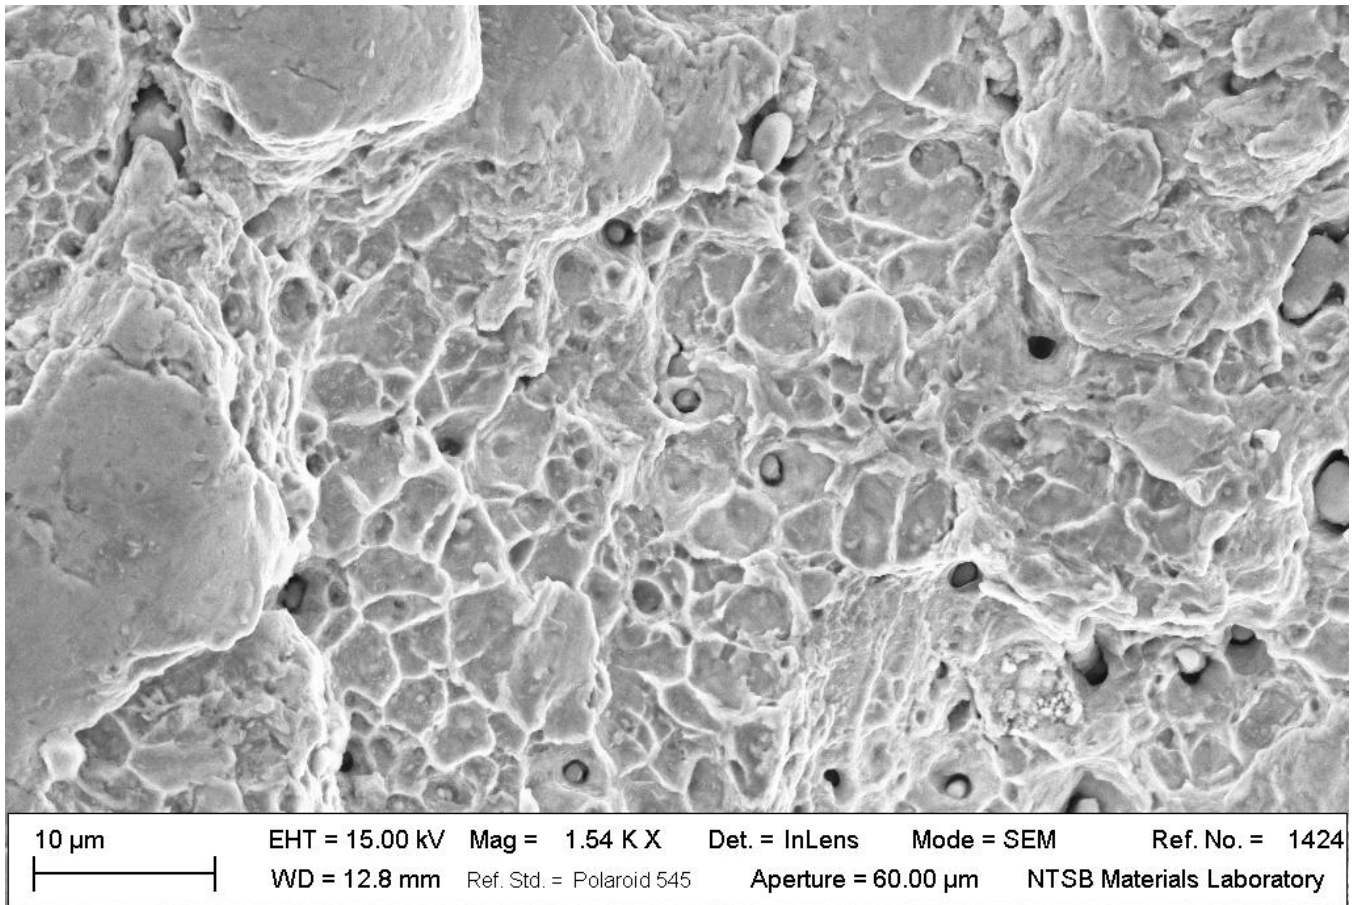
Figure 17 – SE micrograph of the inner dimple rupture features of the pin fracture surface.
