# NATIONAL TRANSPORTATION SAFETY BOARD

## MATERIALS LABORATORY FACTUAL REPORT

Report No. 16-095

Place : East St. Louis, Illinois  
Date : June 6, 2016  
Vehicle : Aeronca 7AC, N82694  
NTSB No. : CEN16LA218  
Investigator : Courtney Liedler, AS-CEN

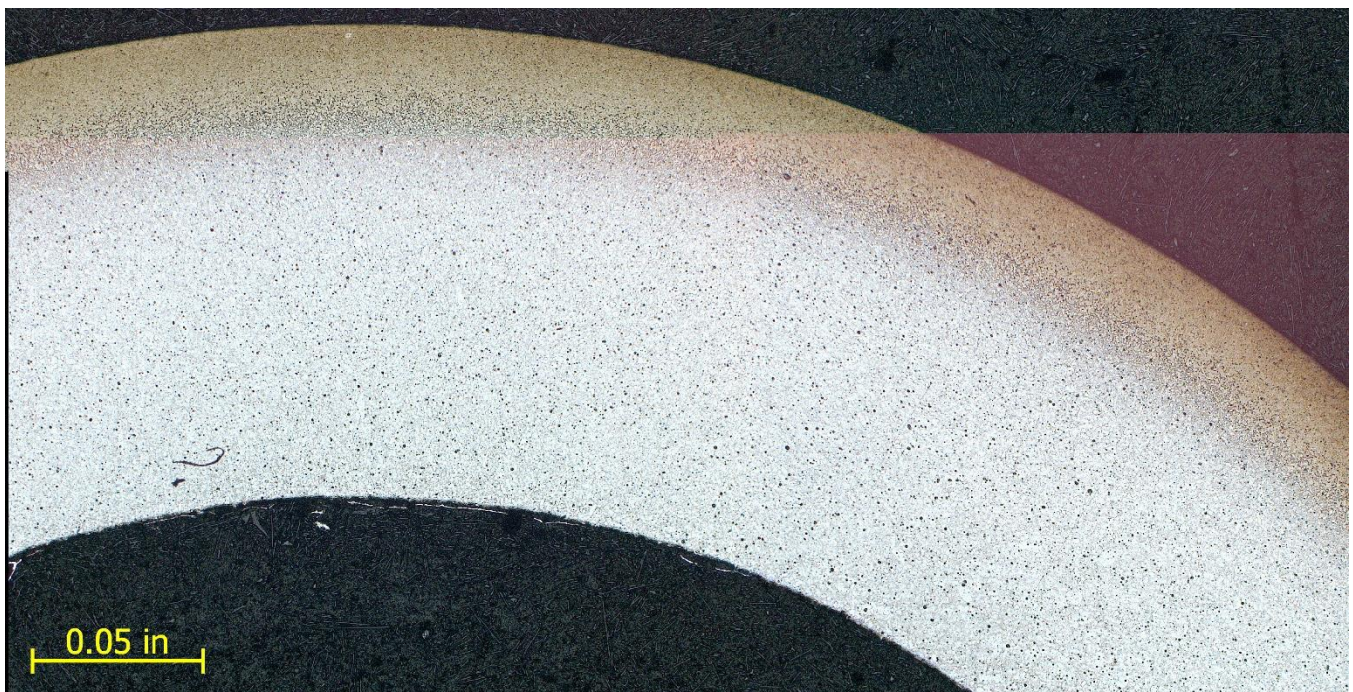
The pin and the rod were cross sectioned near one of the fracture surfaces, mounted, polished, and etched. Figure 18 and Figure 19 show a cross section of the pin. The pin exhibited visual contrast between the core of the material and the outer layer. This outer layer exhibited a depth of approximately 0.02 inch. The inner core microstructure of the pin exhibited a mostly ferrite structure with darker-colored fine pearlite and manganese sulfide particles (see Figure 20). However, the outer layer was that of tempered martensite and some carbides on the prior austenite grain boundaries (Figure 21). This microstructure was consistent with a resulfurized carbon steel that had been surface hardened, such by carburizing or carbonitriding.<sup>2</sup> Examination of the surface hardened region on the pin using EDS, found relatively higher amounts of carbon, but did not measure any detectable amounts of nitrogen.

Figure 18 – Montage of micrographs showing a cross section of the pin, with contrast between outer and inner layers (bright field, ~25X, etched 2% Nital).

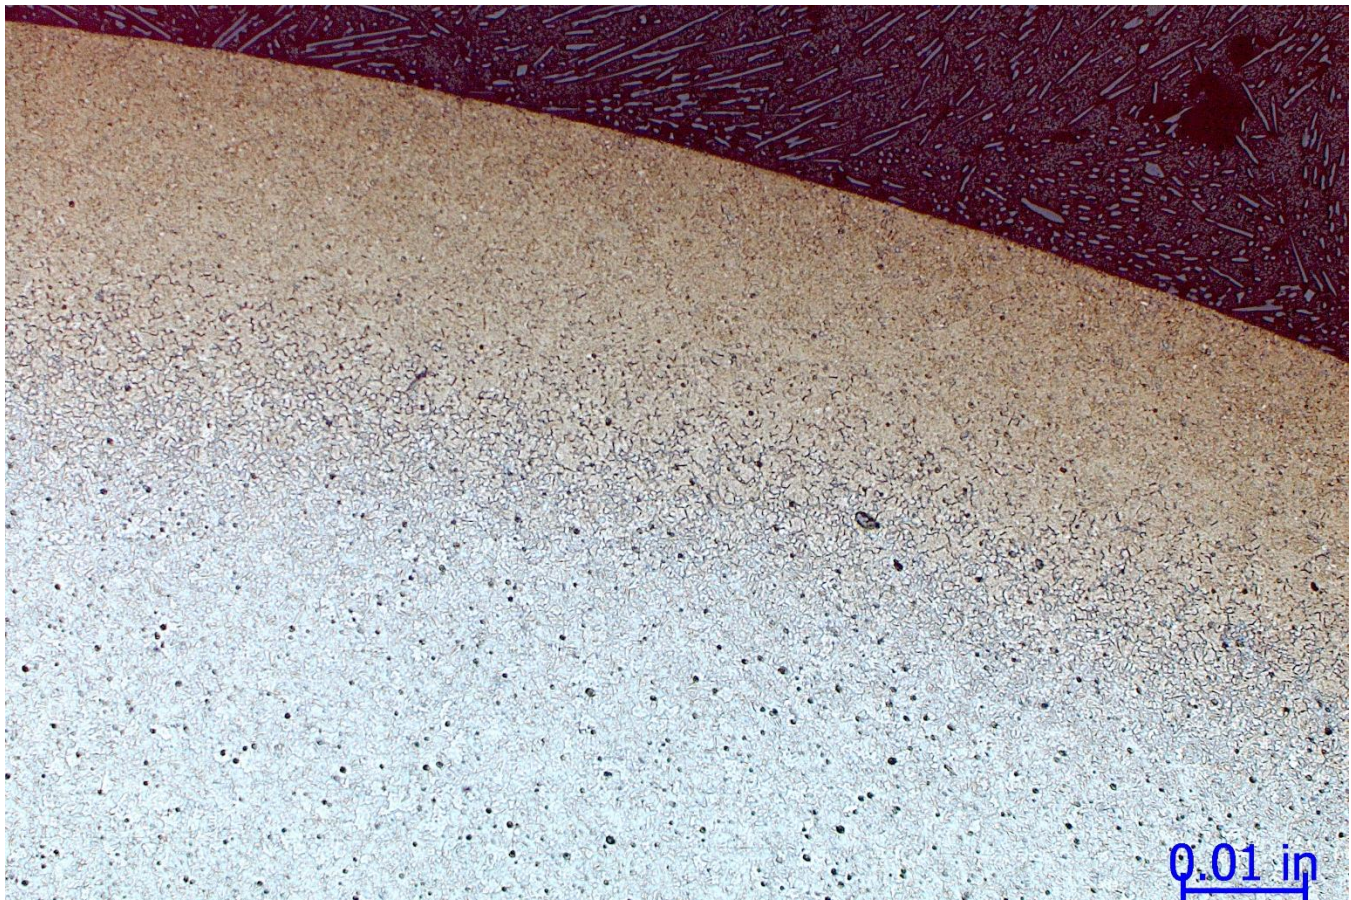
Figure 19 – Bright field (BF) micrograph showing the transition of the outer layer of the pin (~50X, 2% Nital).

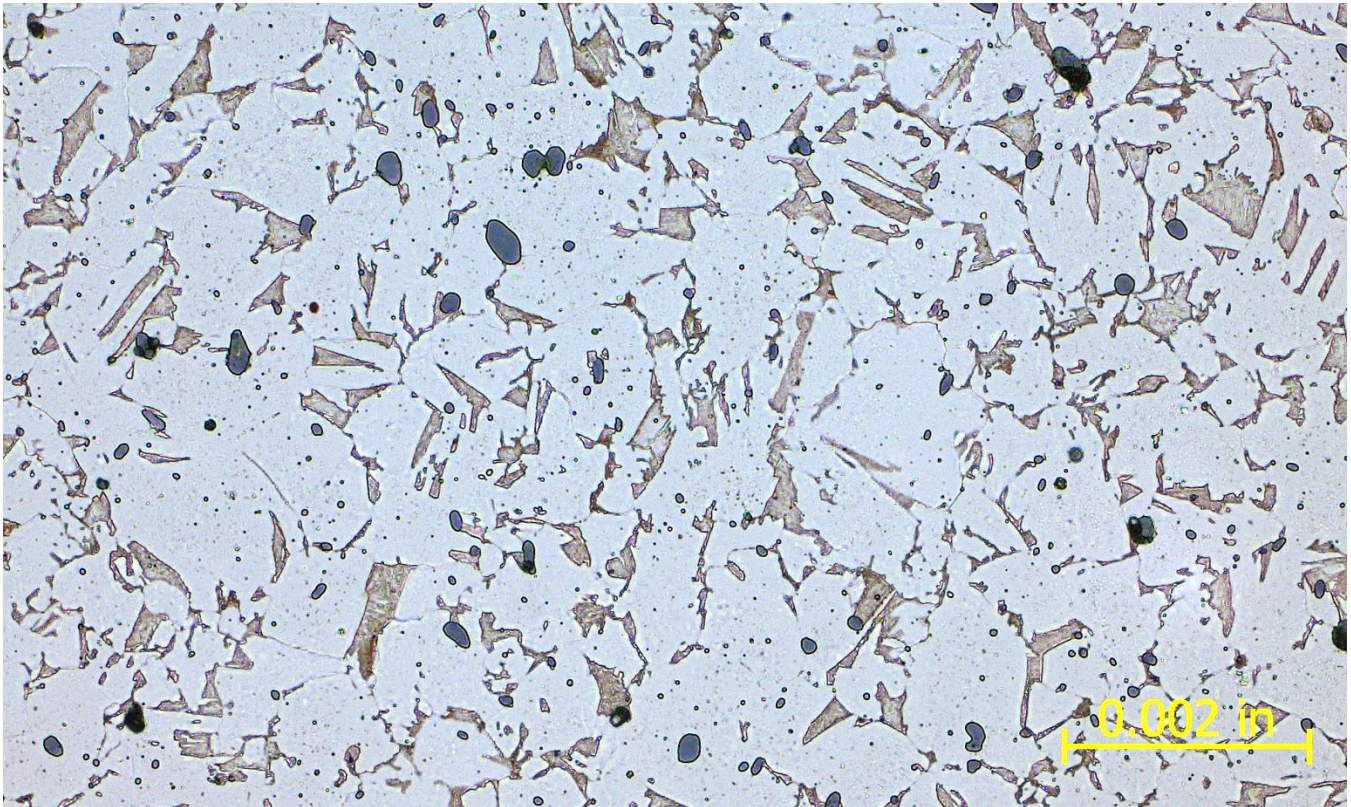
Figure 20 – BF micrograph showing the inner core of the pin cross-section, with a ferrite (lighter phase) and pearlite (darker phase) mixture and dark blue rounded MnS particles (~500X, etched 2% Nital).

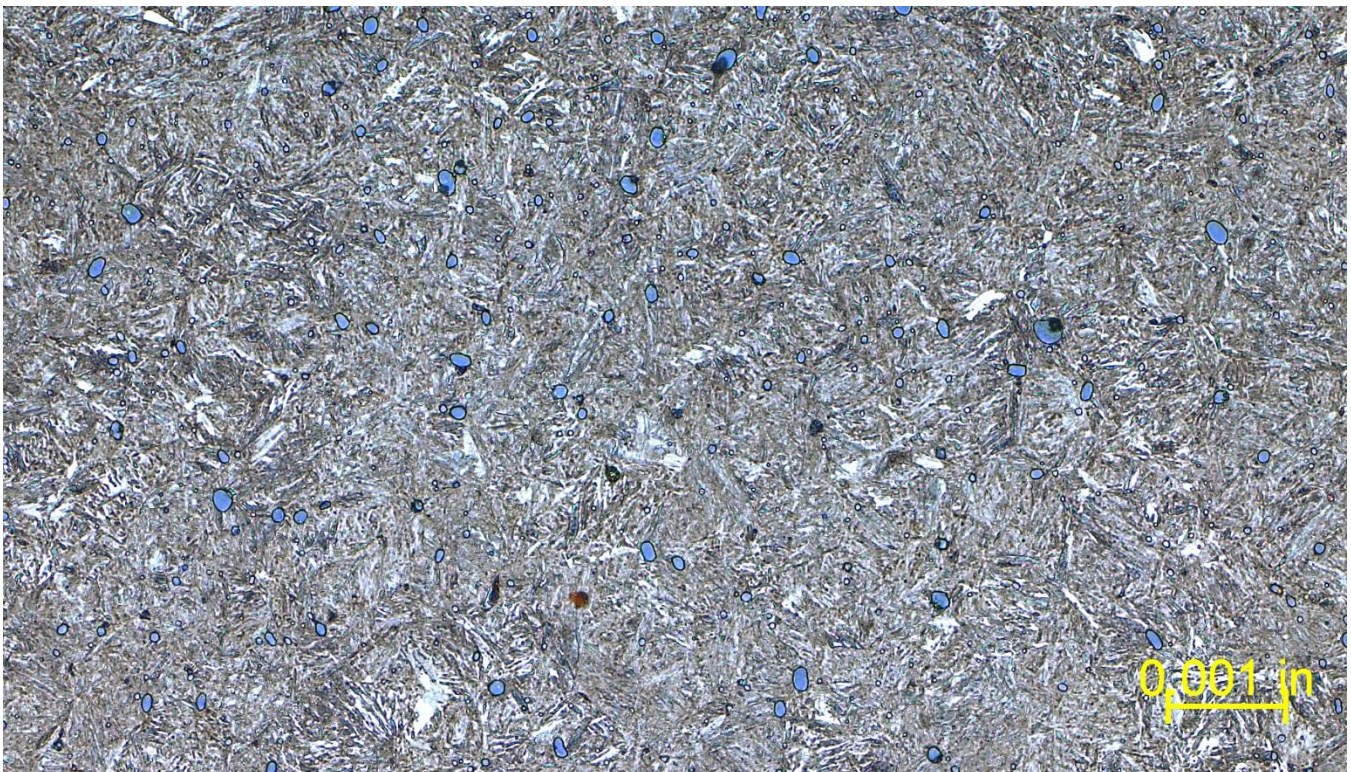
Figure 21 – BF micrograph of the outer case hardened layer, containing tempered martensite not present in Figure 20 (~500X, etched 2% Nital).

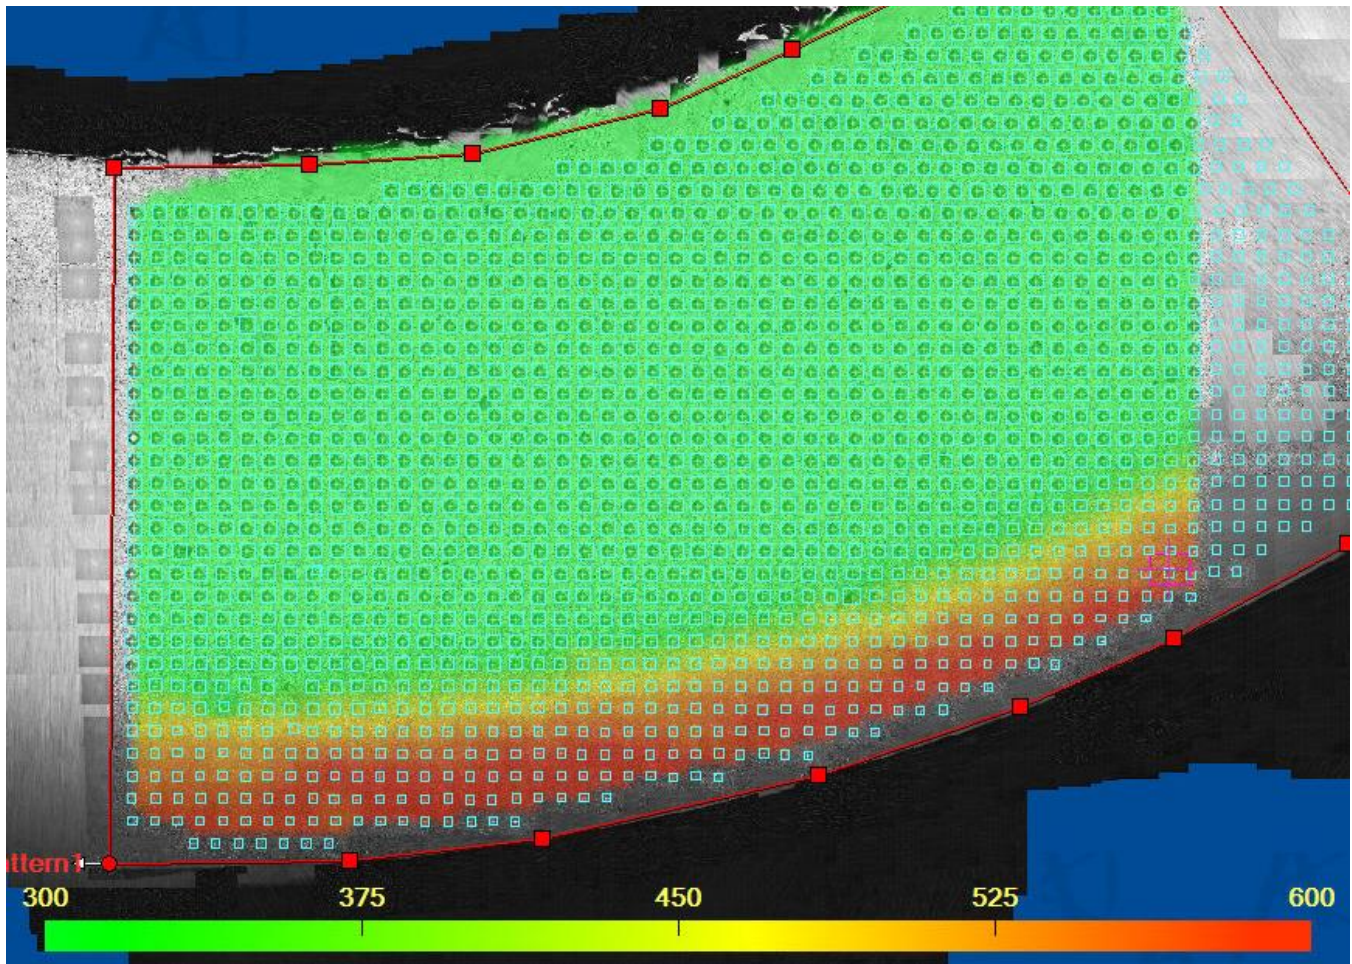
The hardness of the parts was inspected using microindentation hardness per ASTM E384.<sup>3</sup> The hardness was plotted using a false color overlay, as depicted in Figure 22. While the hardness in the core regions averaged 93 HRB (195 HV<sub>500</sub>), the hardness in the case hardened region averaged 55 HRC (594 HV<sub>500</sub>). The effective case depth of the case hardened layer was approximately 0.013 inches, consistent with that observed in the metallographic cross section (Figure 19).

Figure 22 – False color map of microindentation hardness results (in HV500), showing a softer inner core (green, ~300 HV500) and an outer case hardened layer (red, up to 600 HV500). The image is flipped vertically from the Figure 19 orientation.
