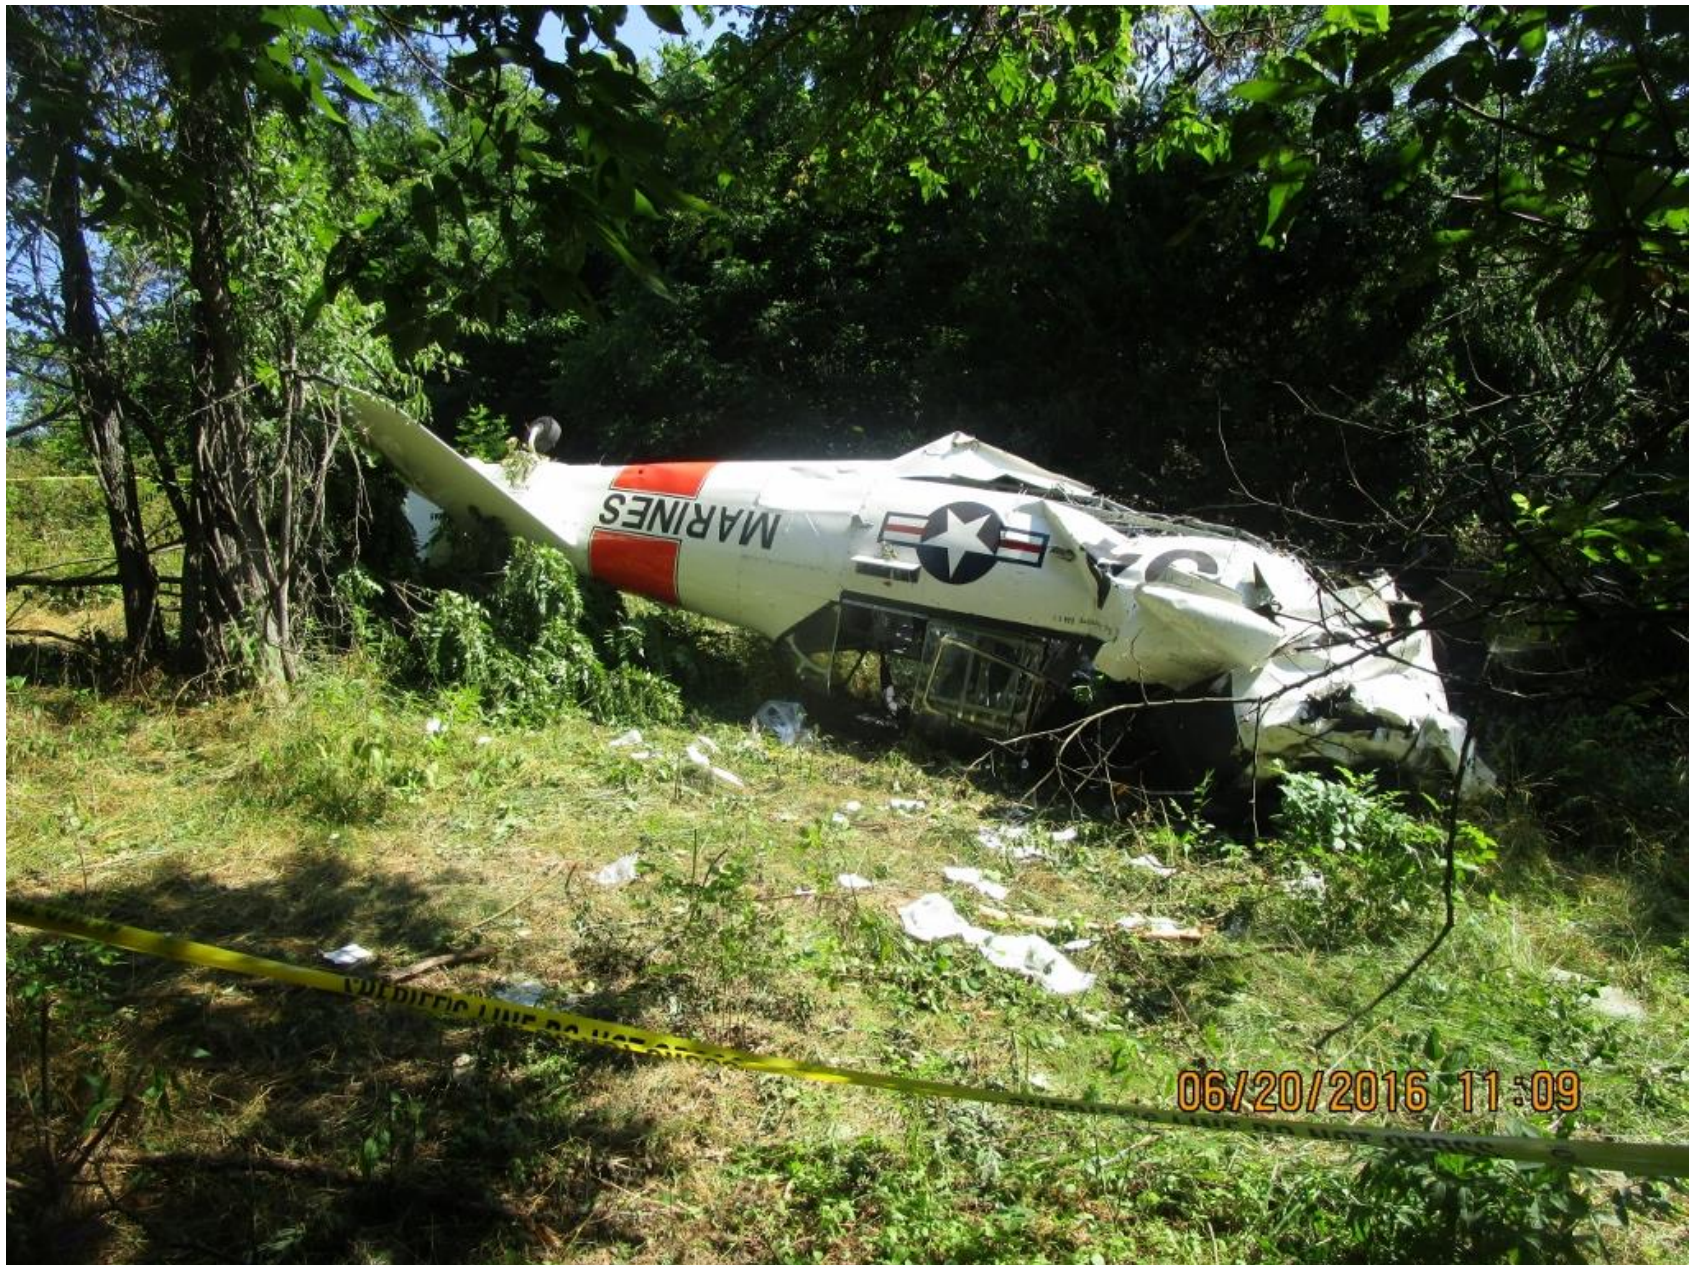
Photo 1 – View of wreckage laying inverted in the woods

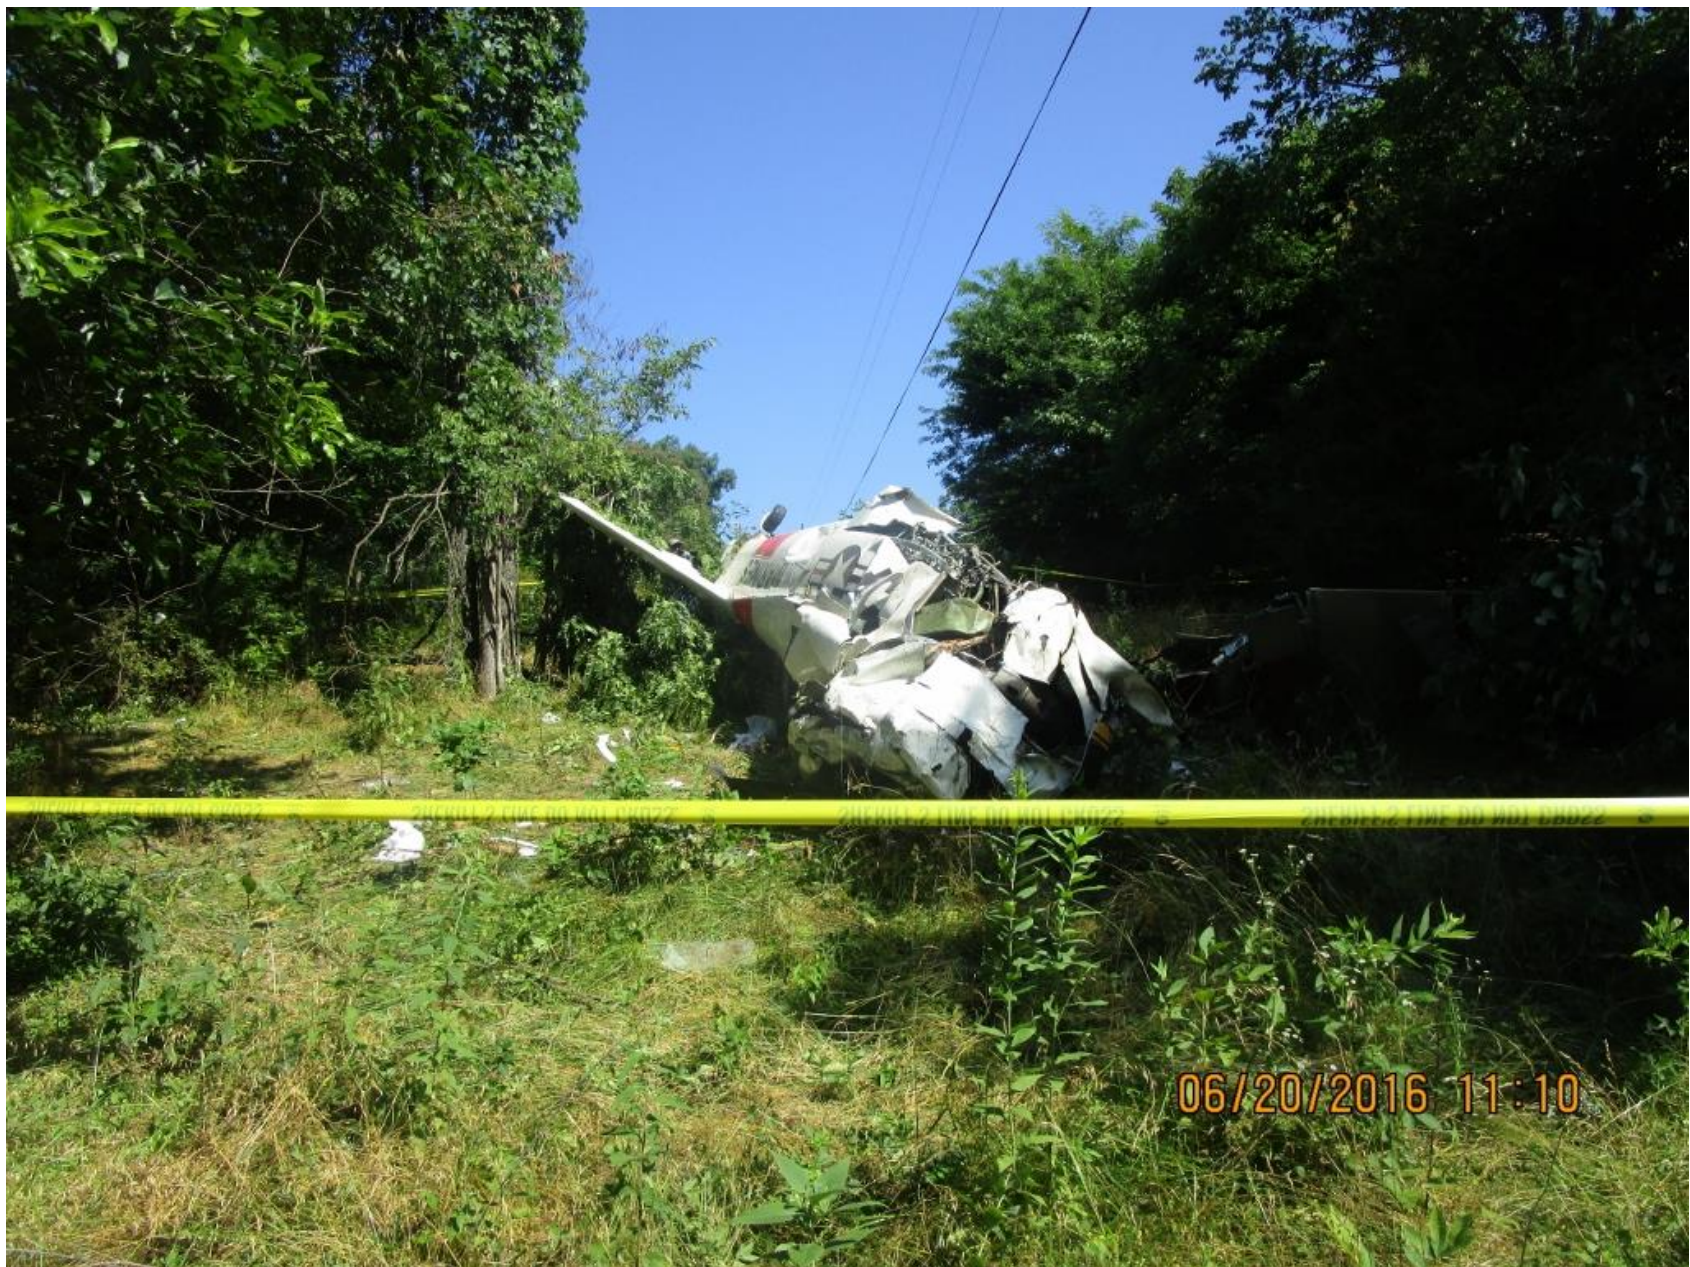
**Photo 2 – View from the front of the inverted wreckage**

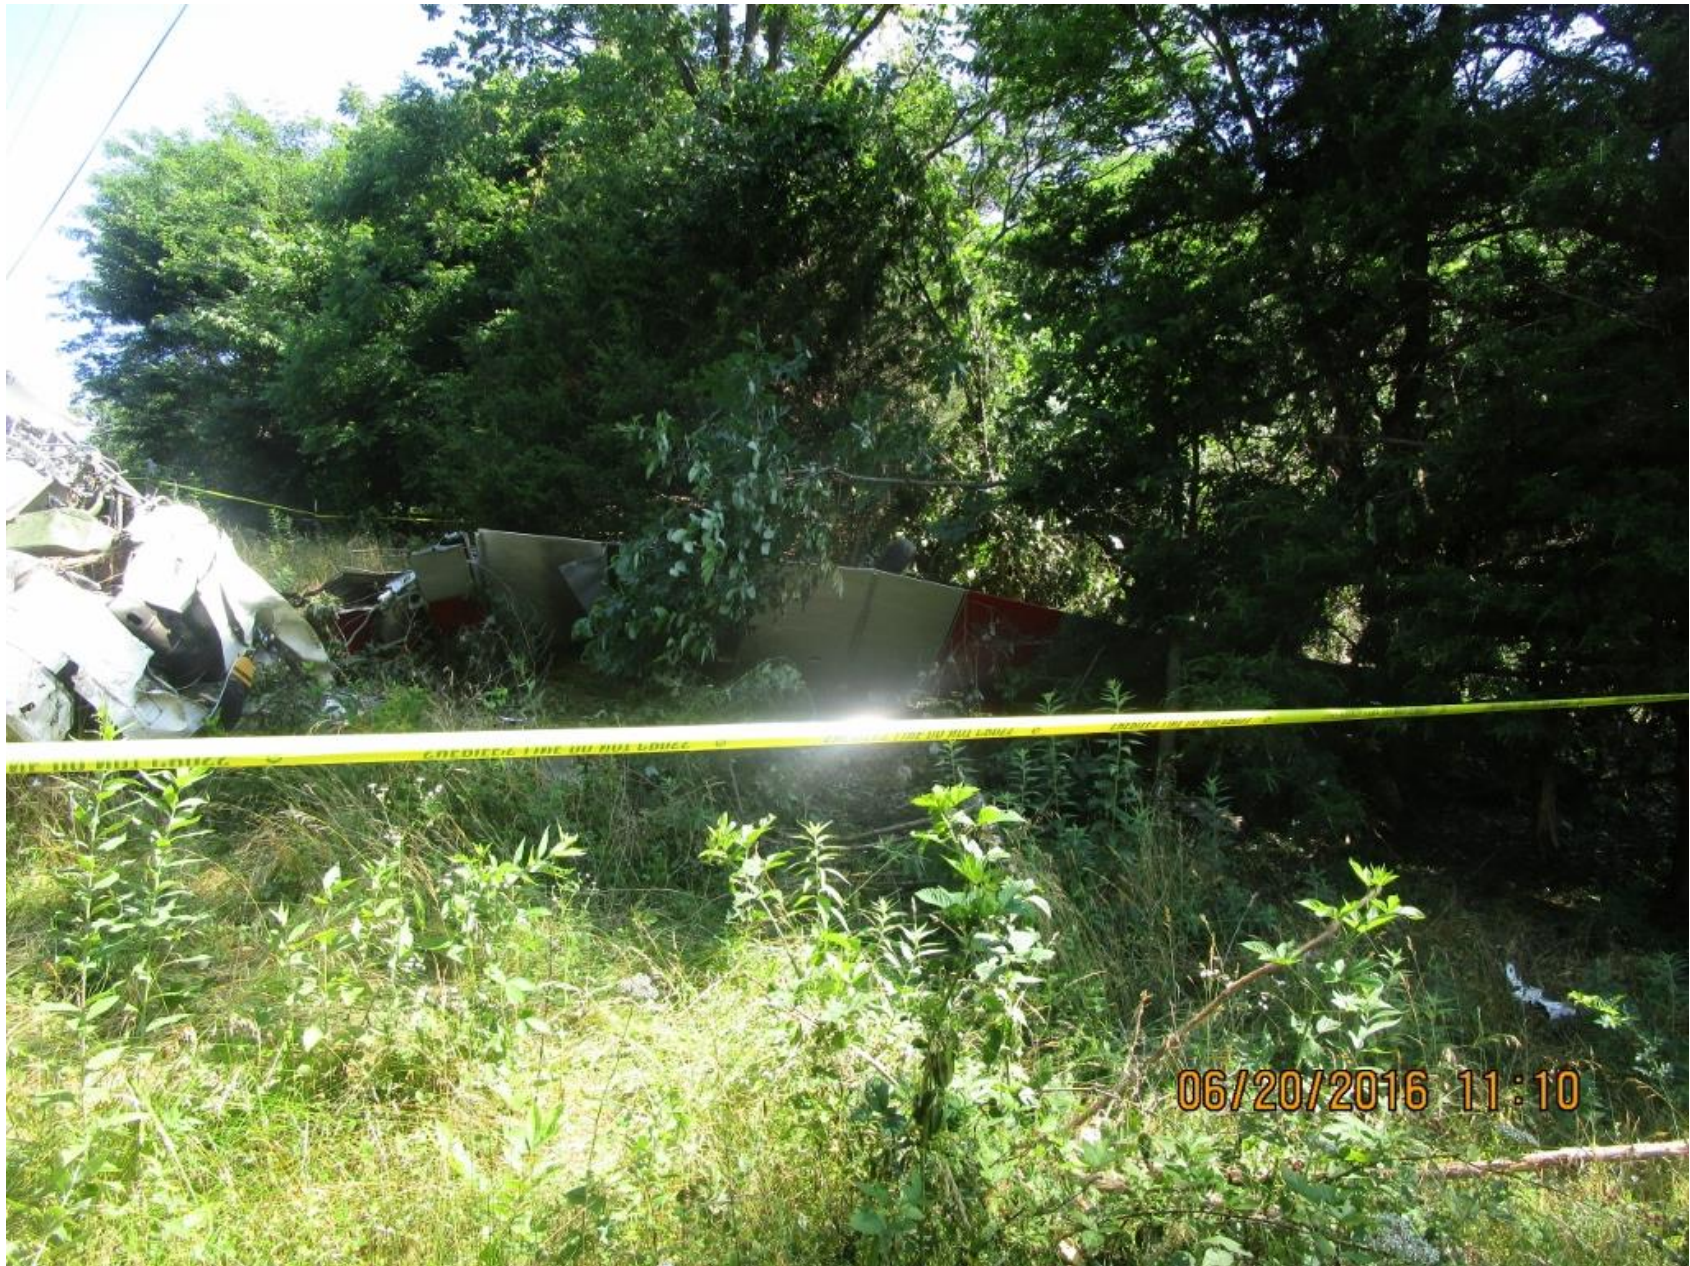
**Photo 3 – View of right wing separated and lying next to the fuselage**

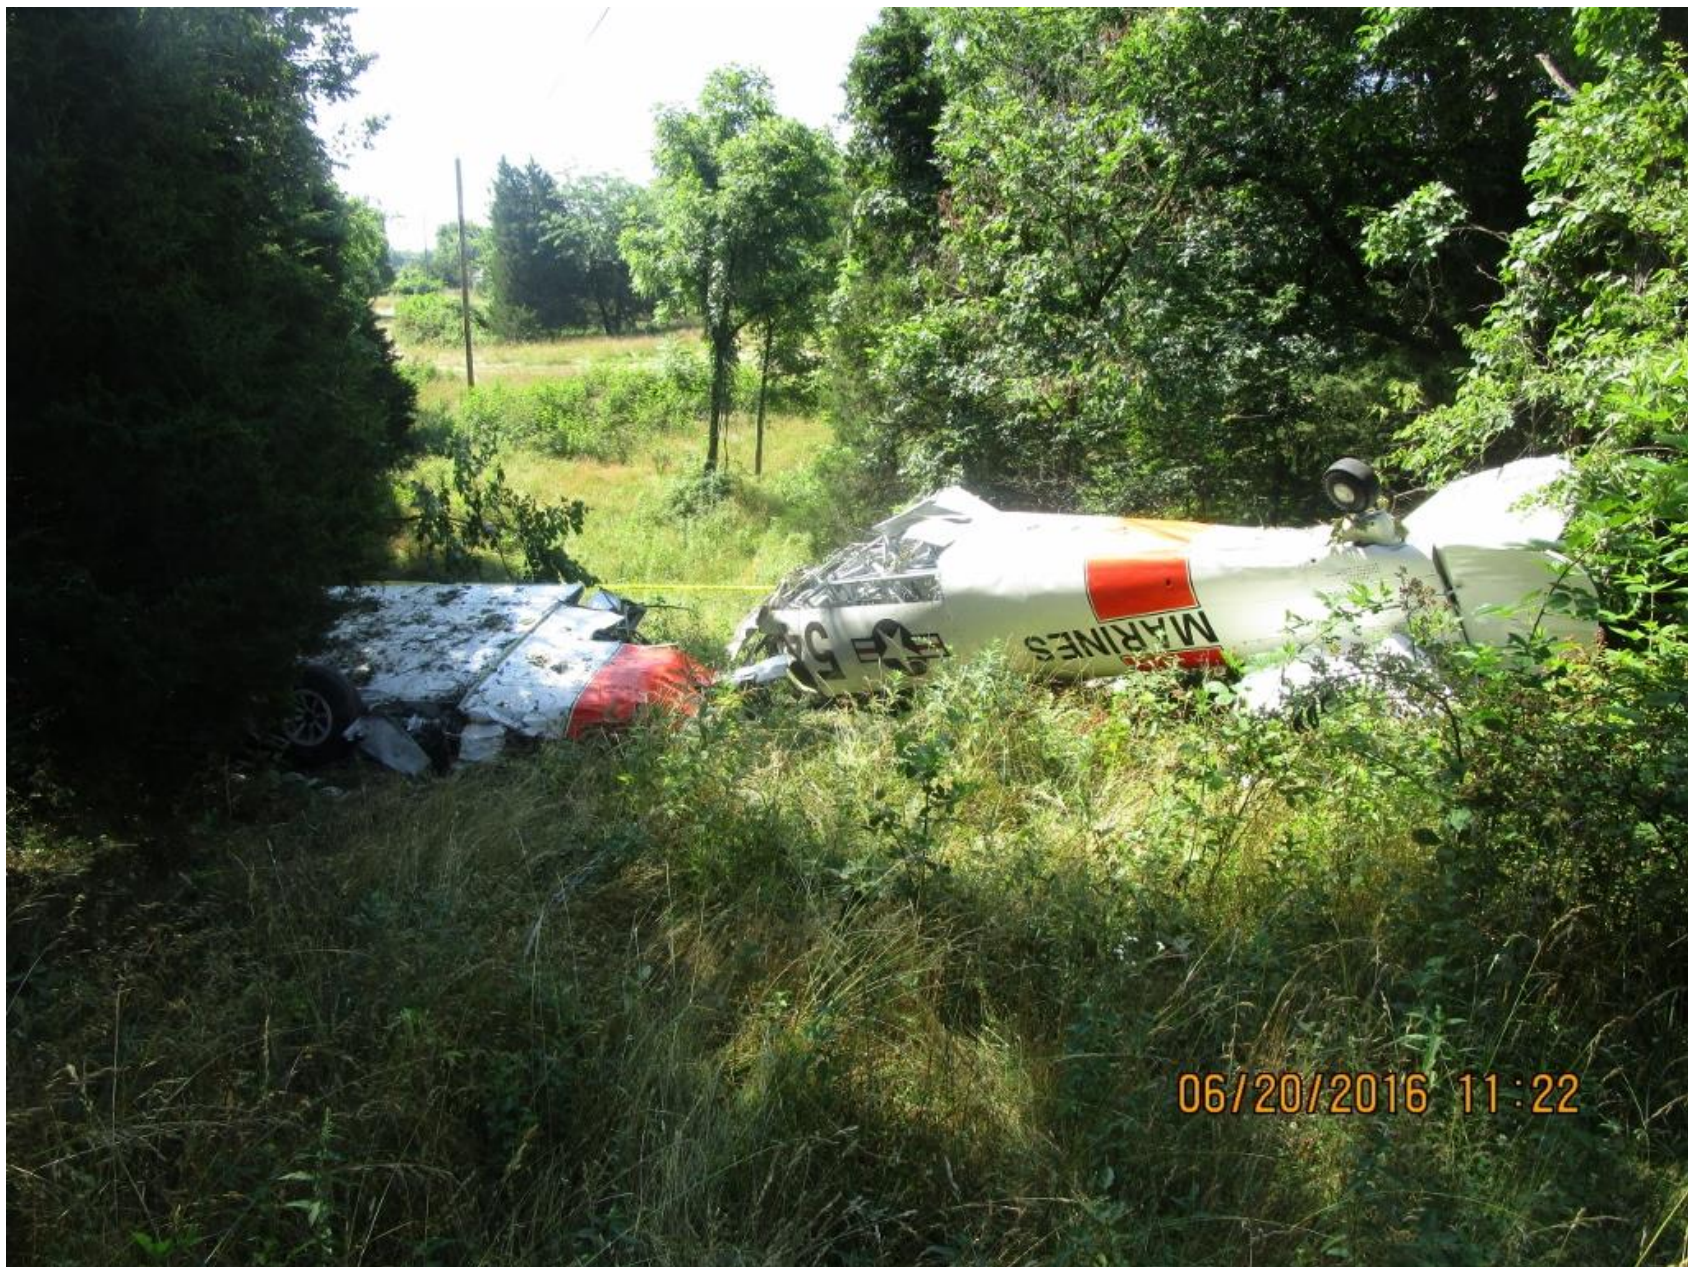
**Photo 4 – View of the separated right wing and fuselage from the left rear of the aircraft**

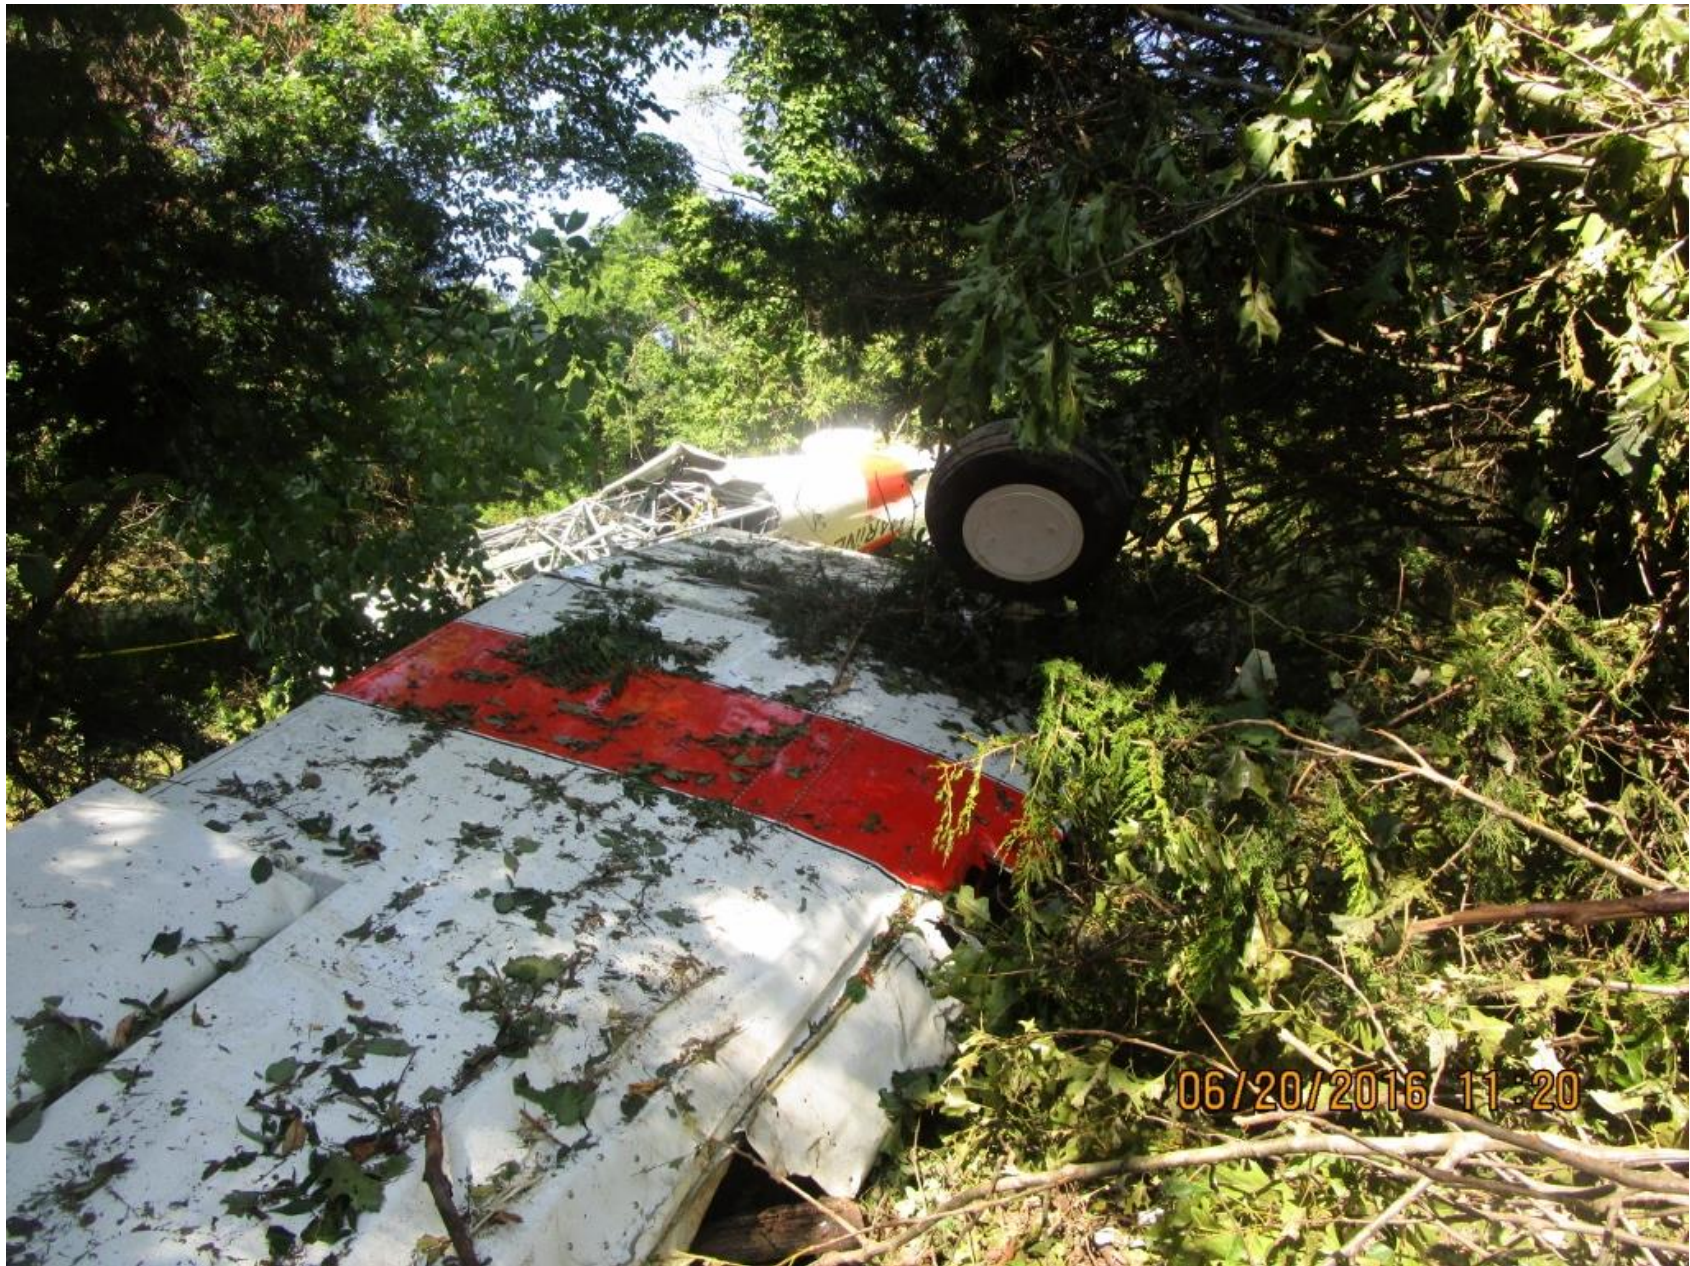
**Photo 5 – View of the inverted right wing and landing gear**

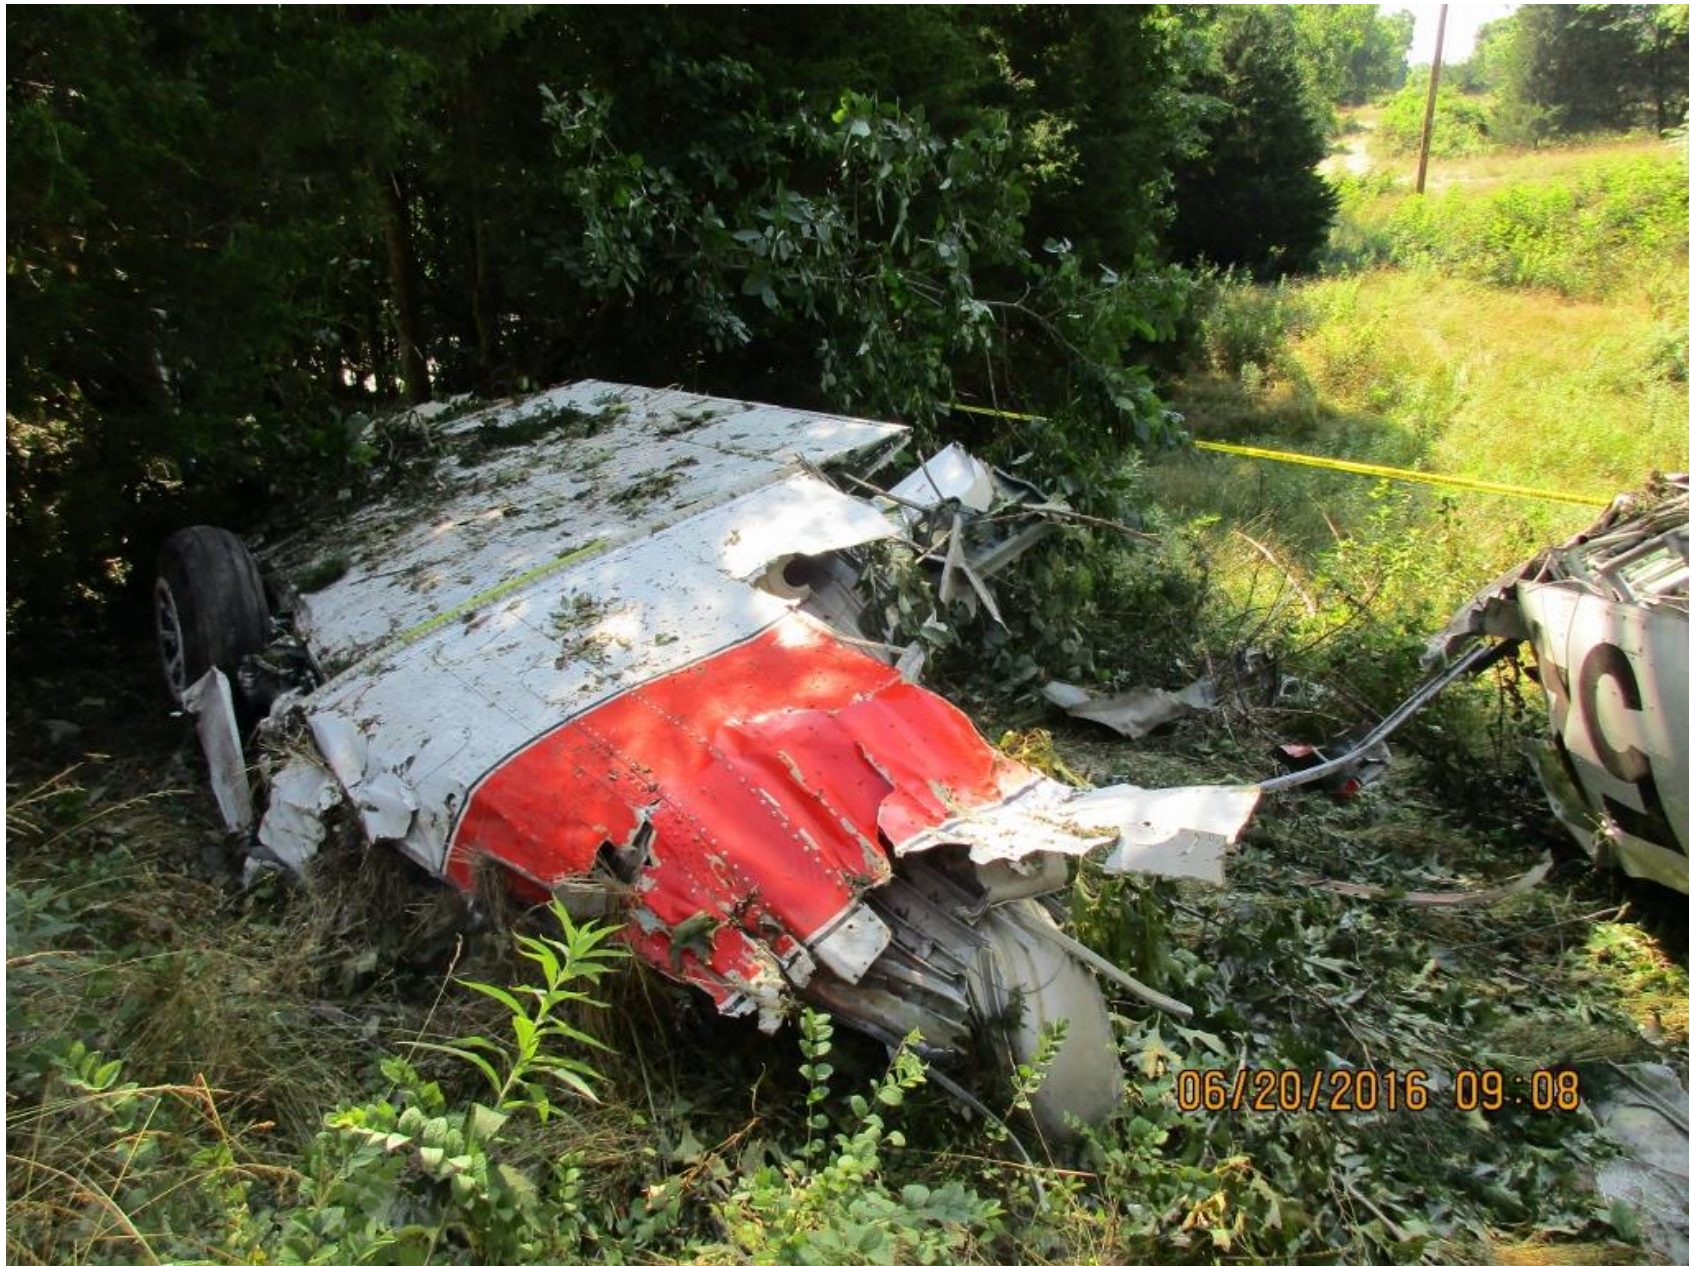
**Photo 6 – View of right wing and center section wing spar**

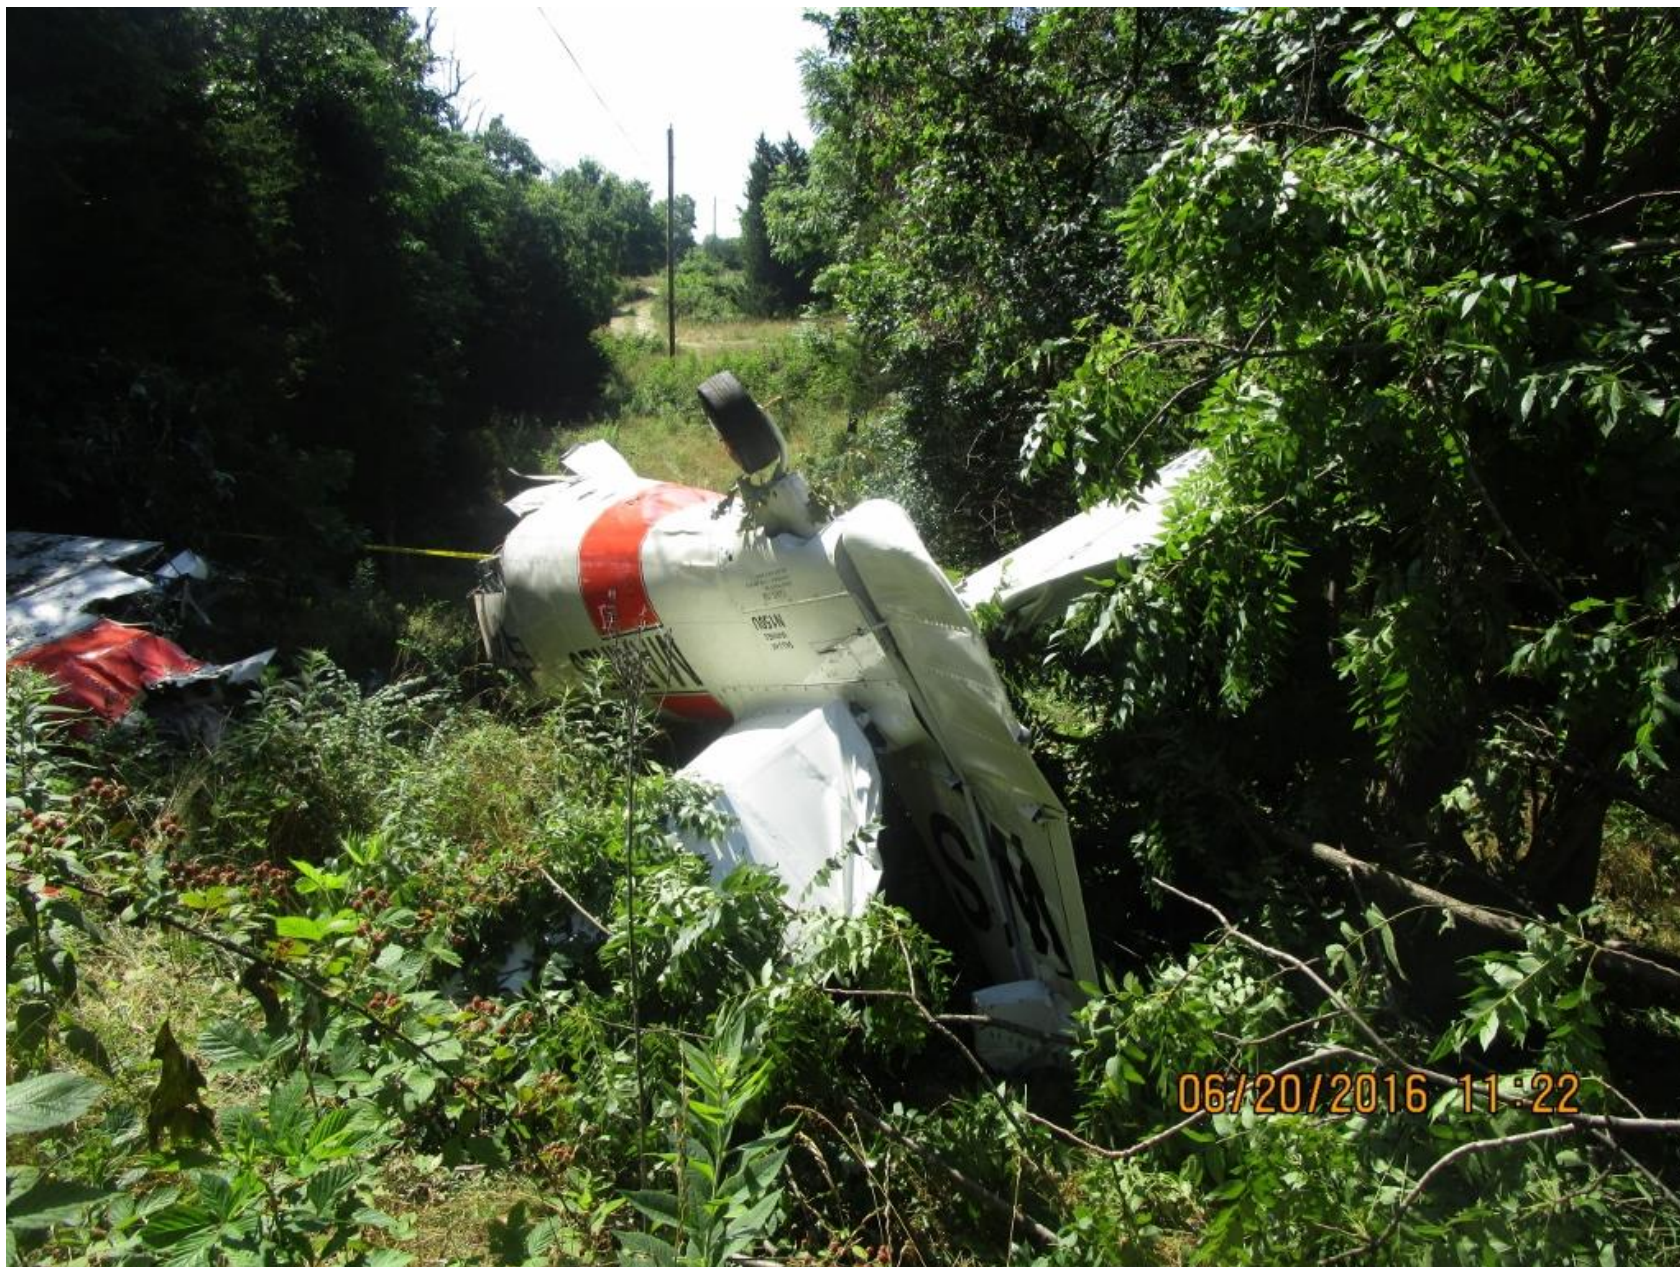
**Photo 7 – View of the empennage and tailwheel**

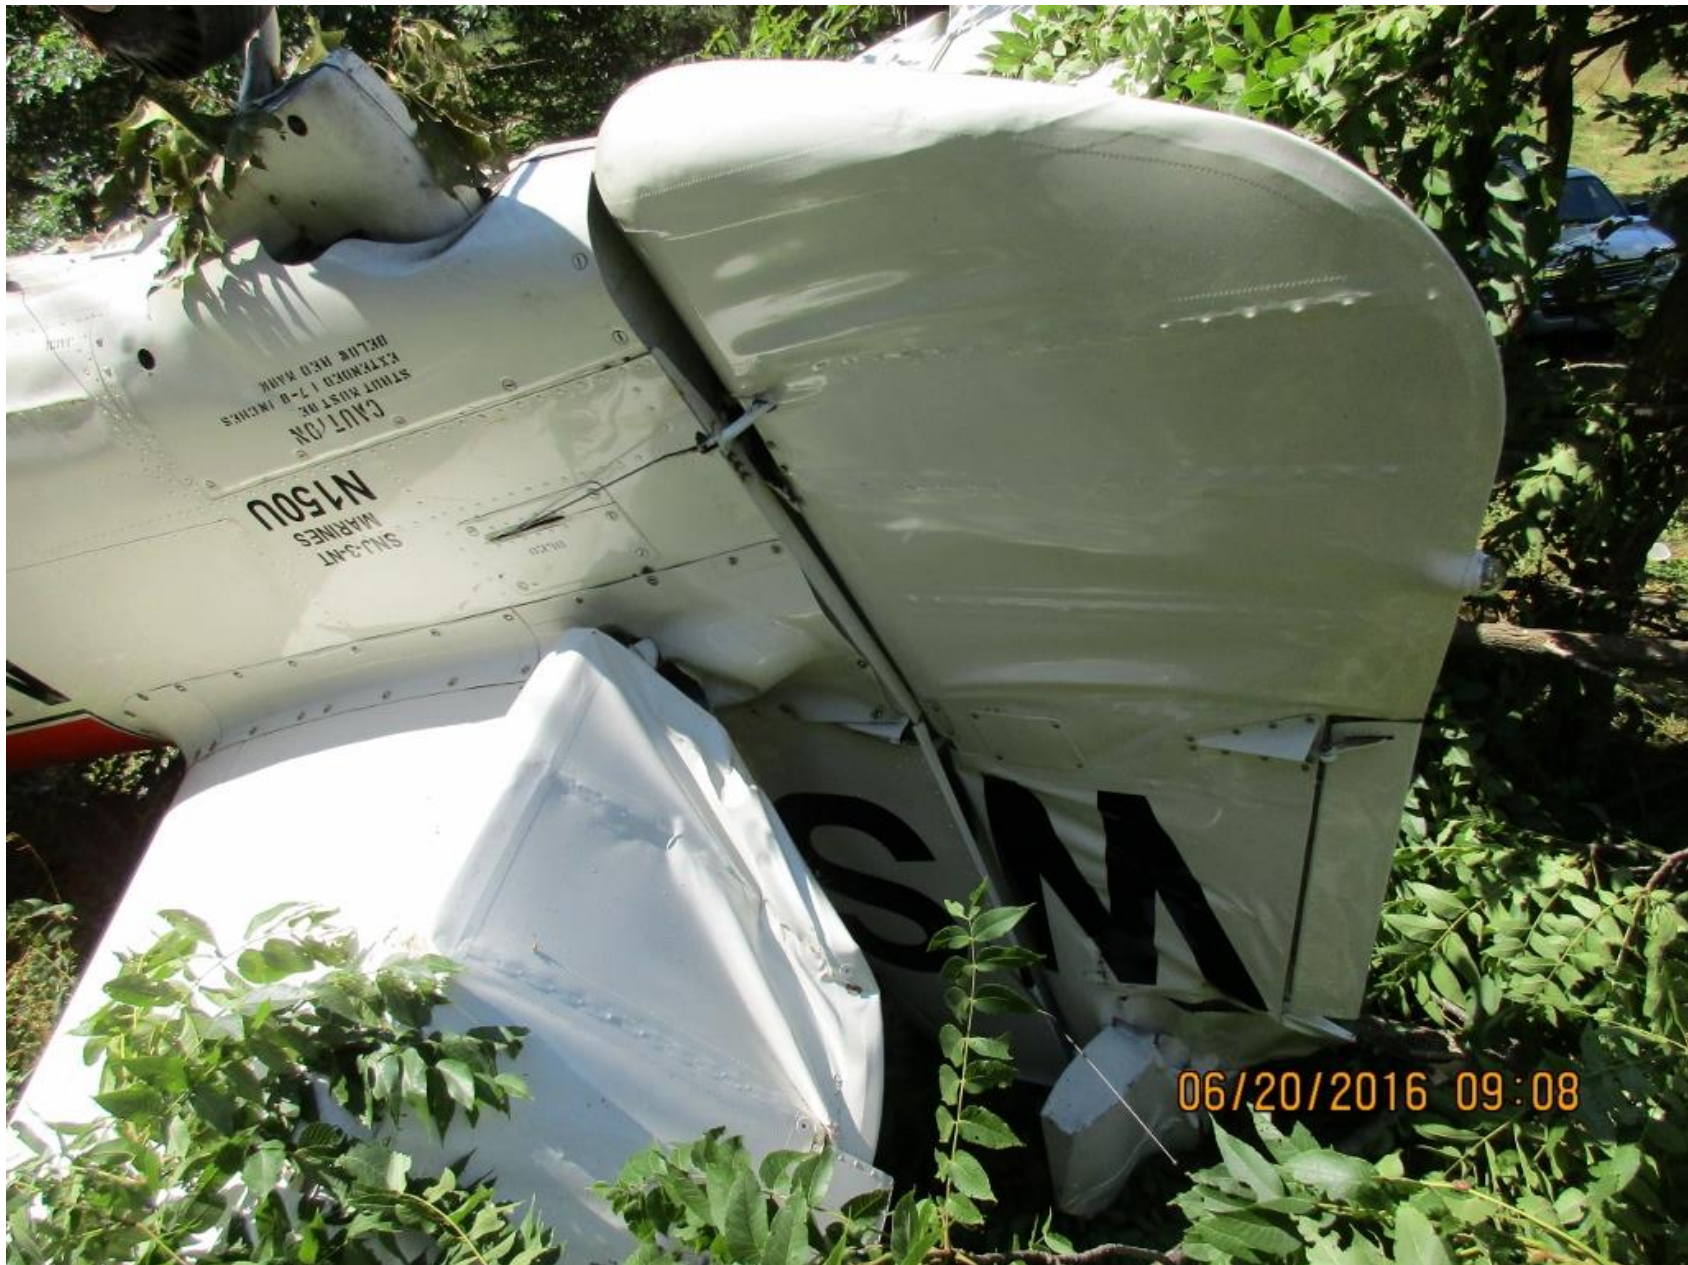
**Photo 8 – Close-up view of rudder and right elevator**

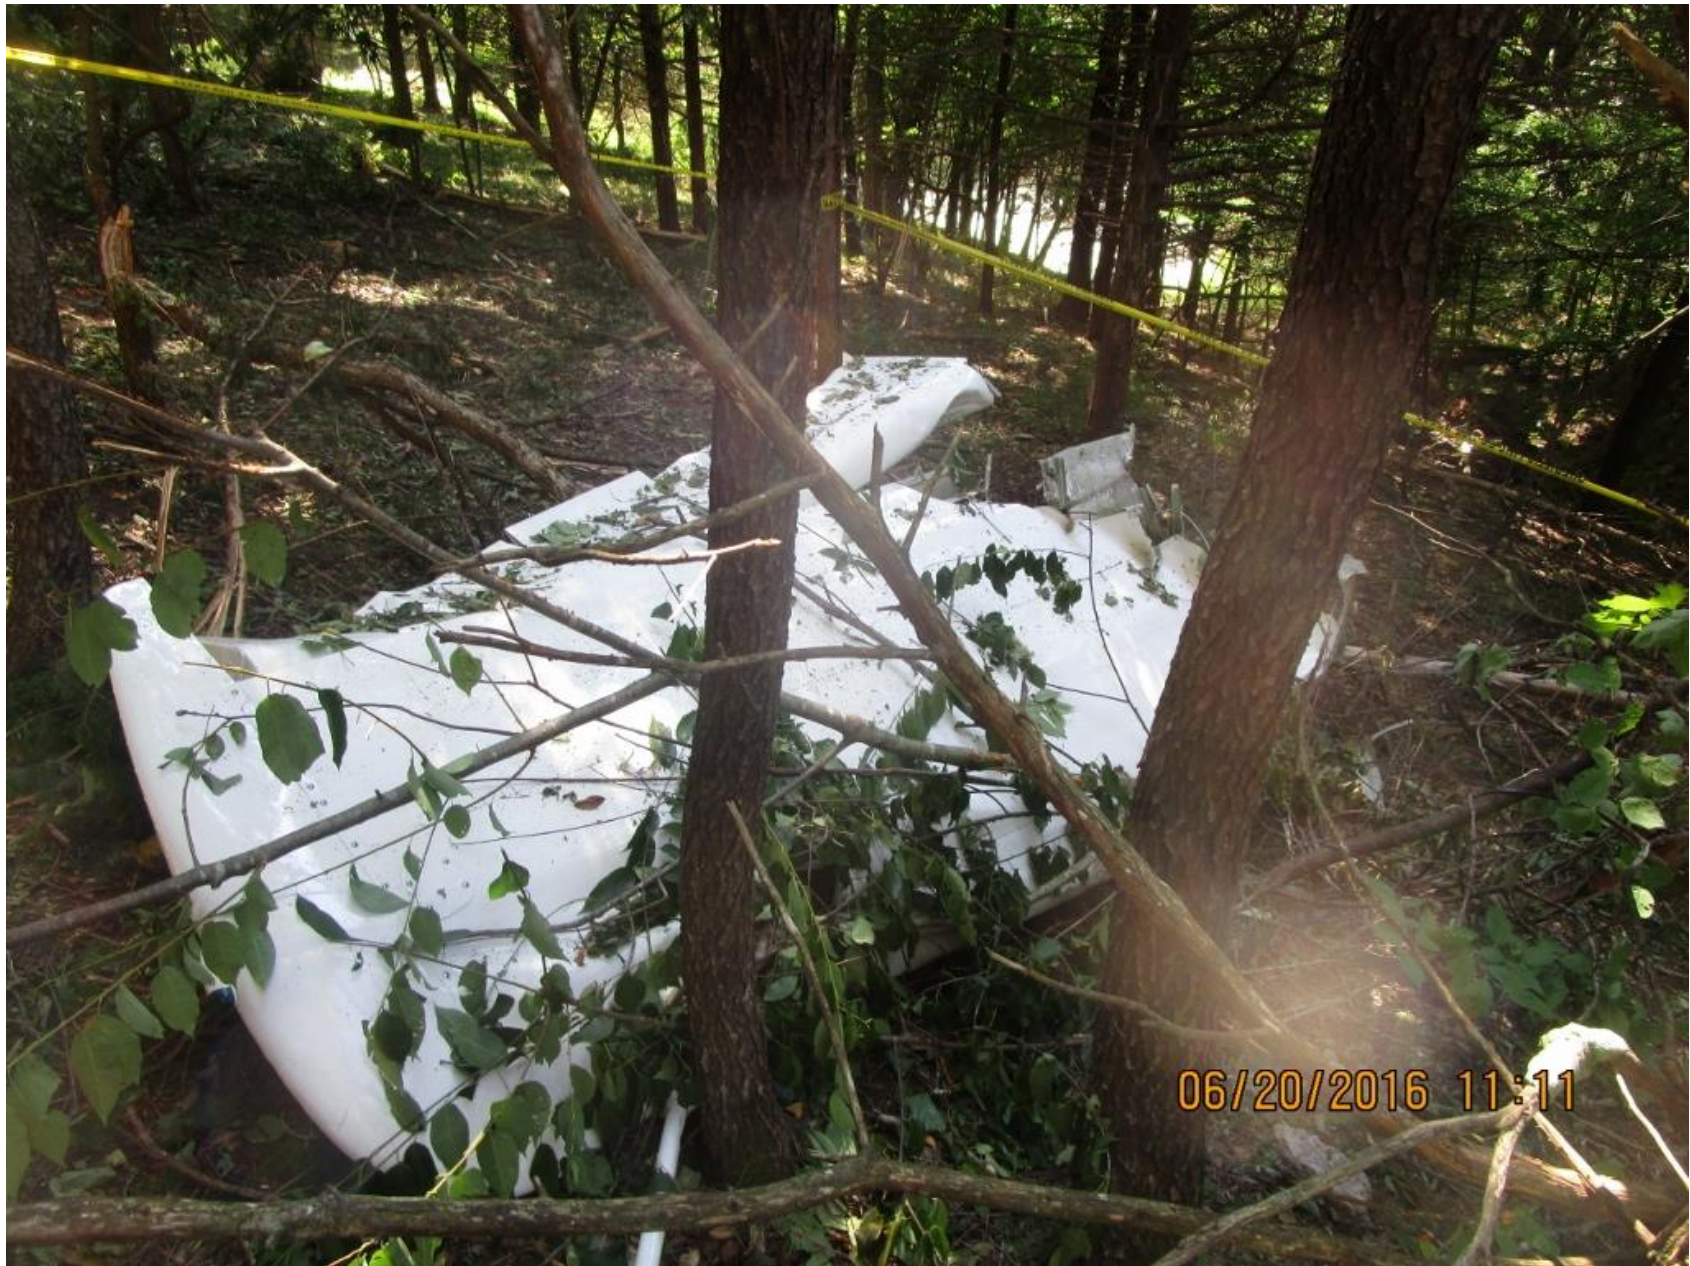
**Photo 9 – View of the separated left wing in the woods**

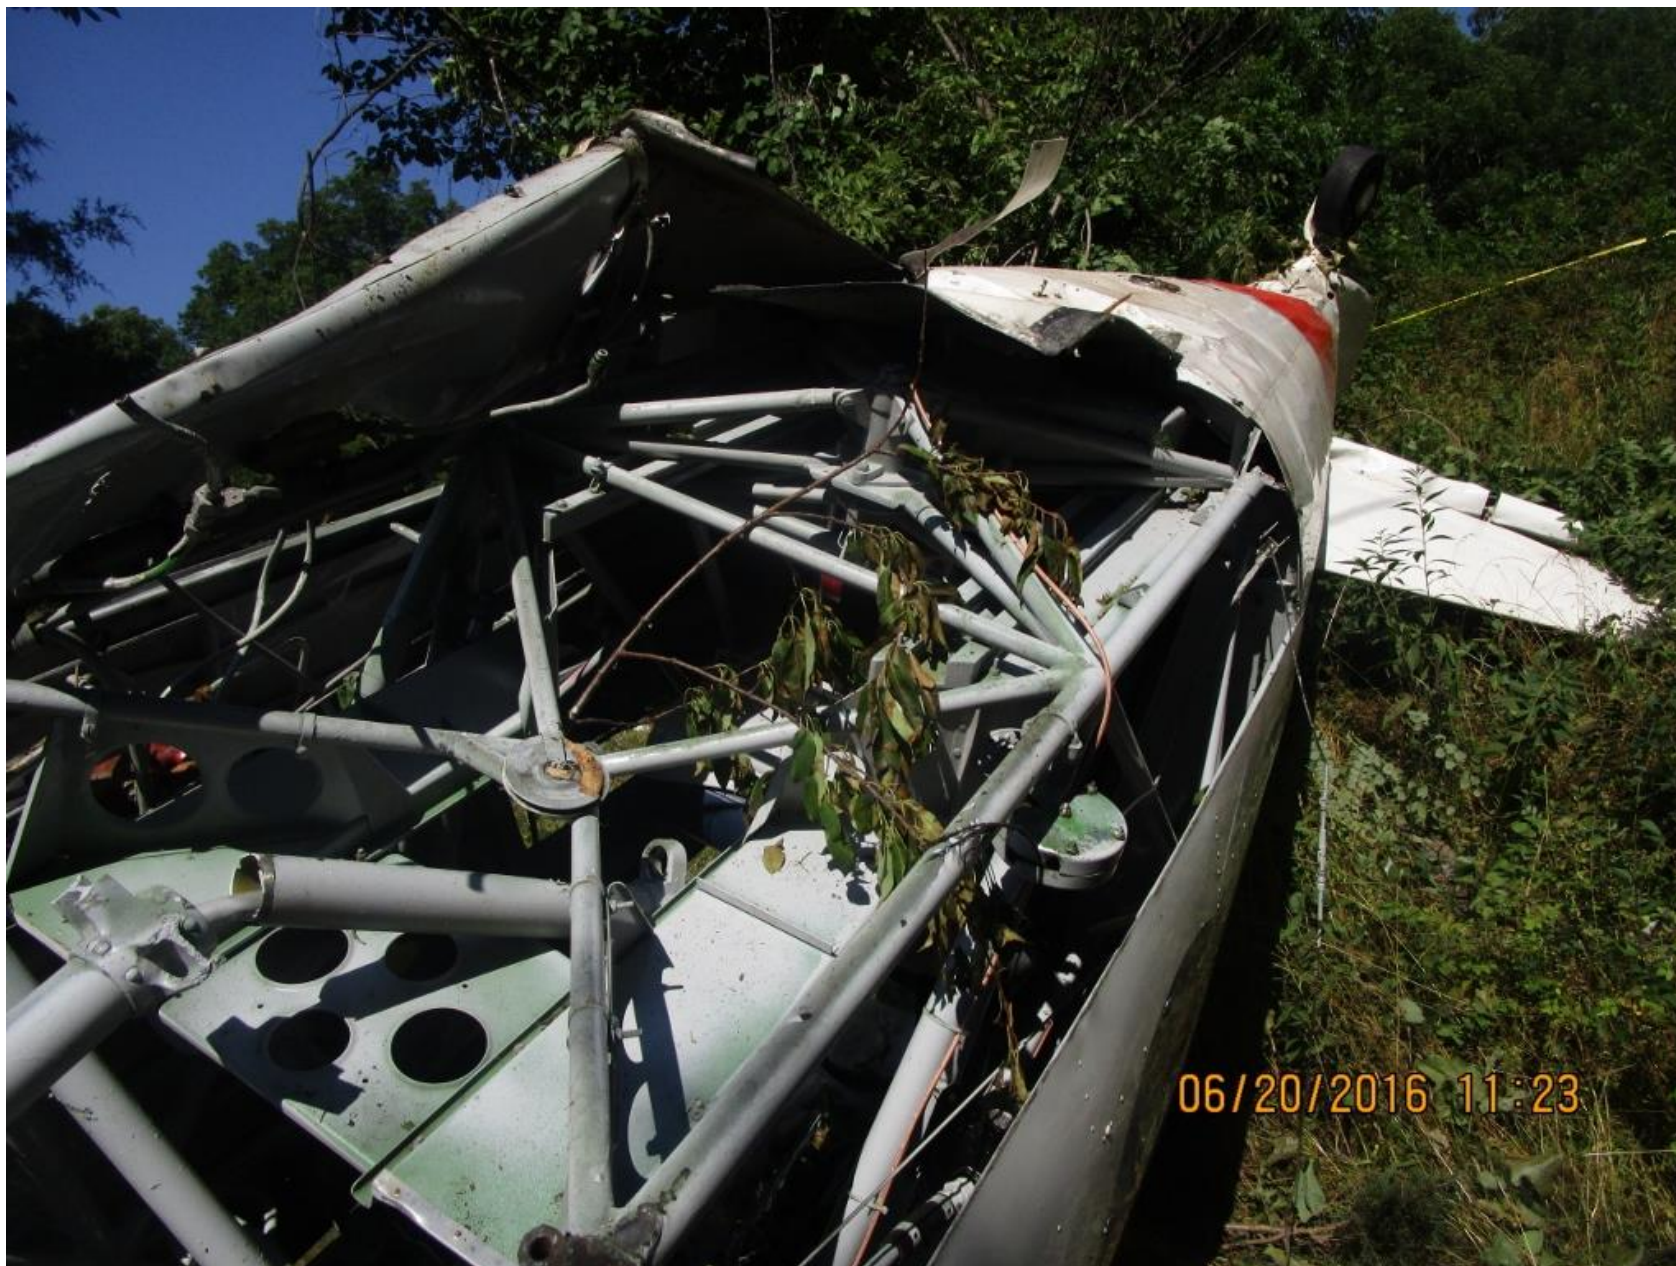
**Photo 10 – View of the bottom of the fuselage’s center section**
