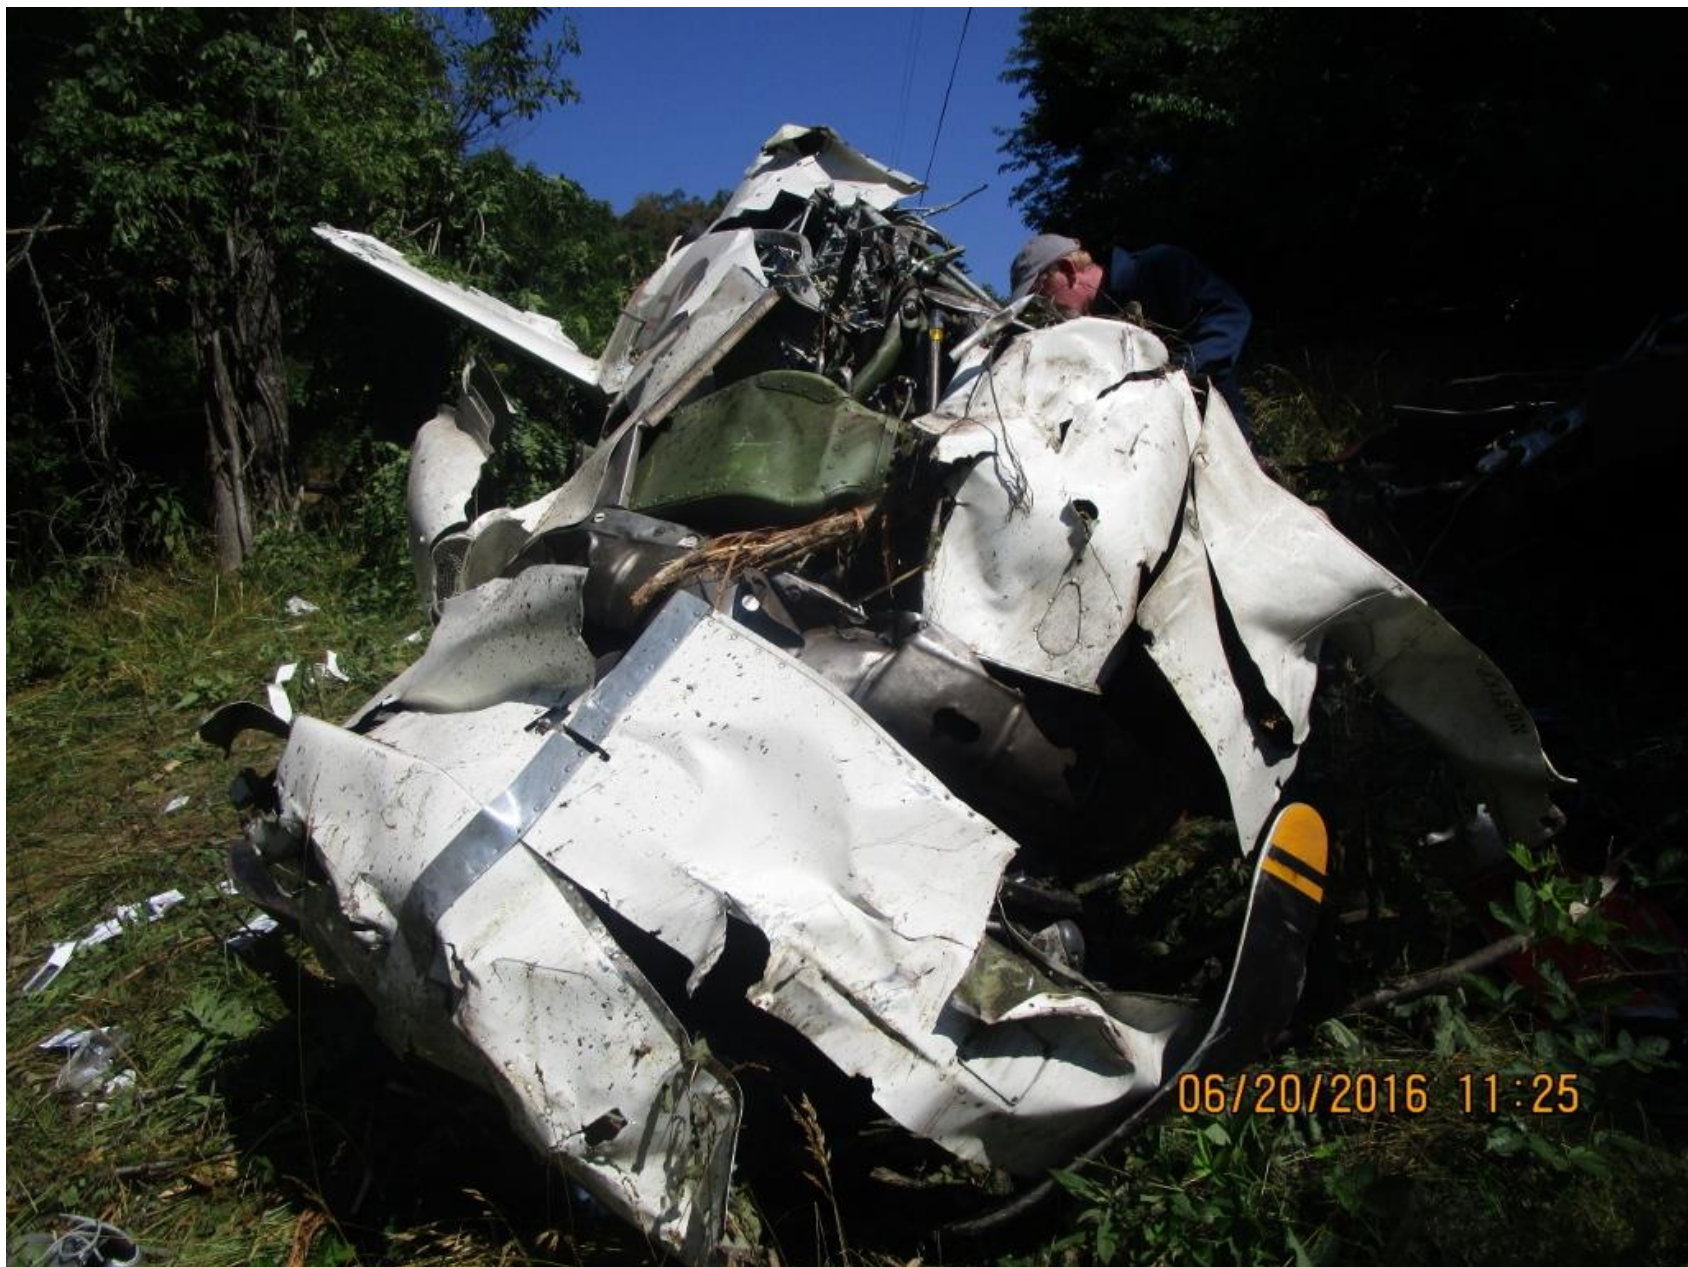
**Photo 11 – View of the aircraft’s propeller and the crushed engine cowling**

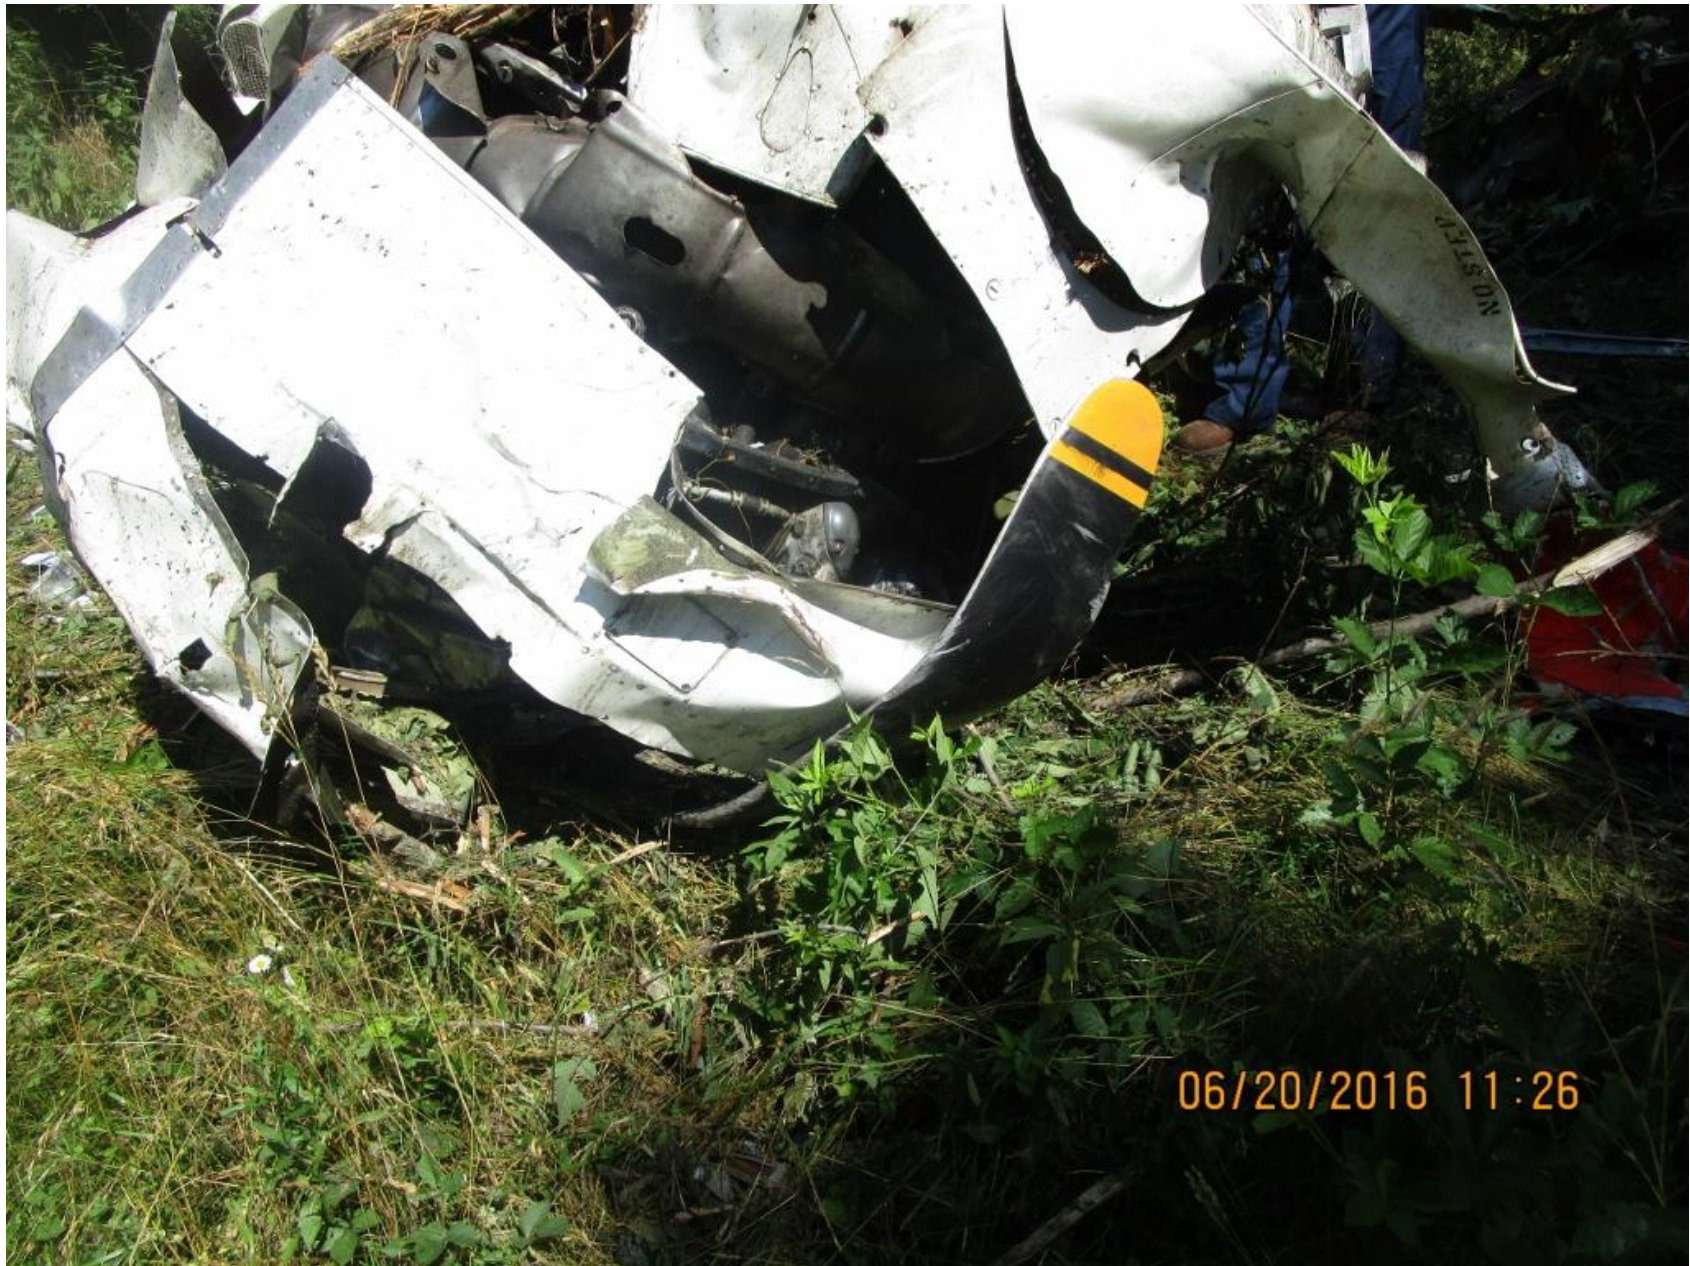
**Photo 12 – View of propeller blade**

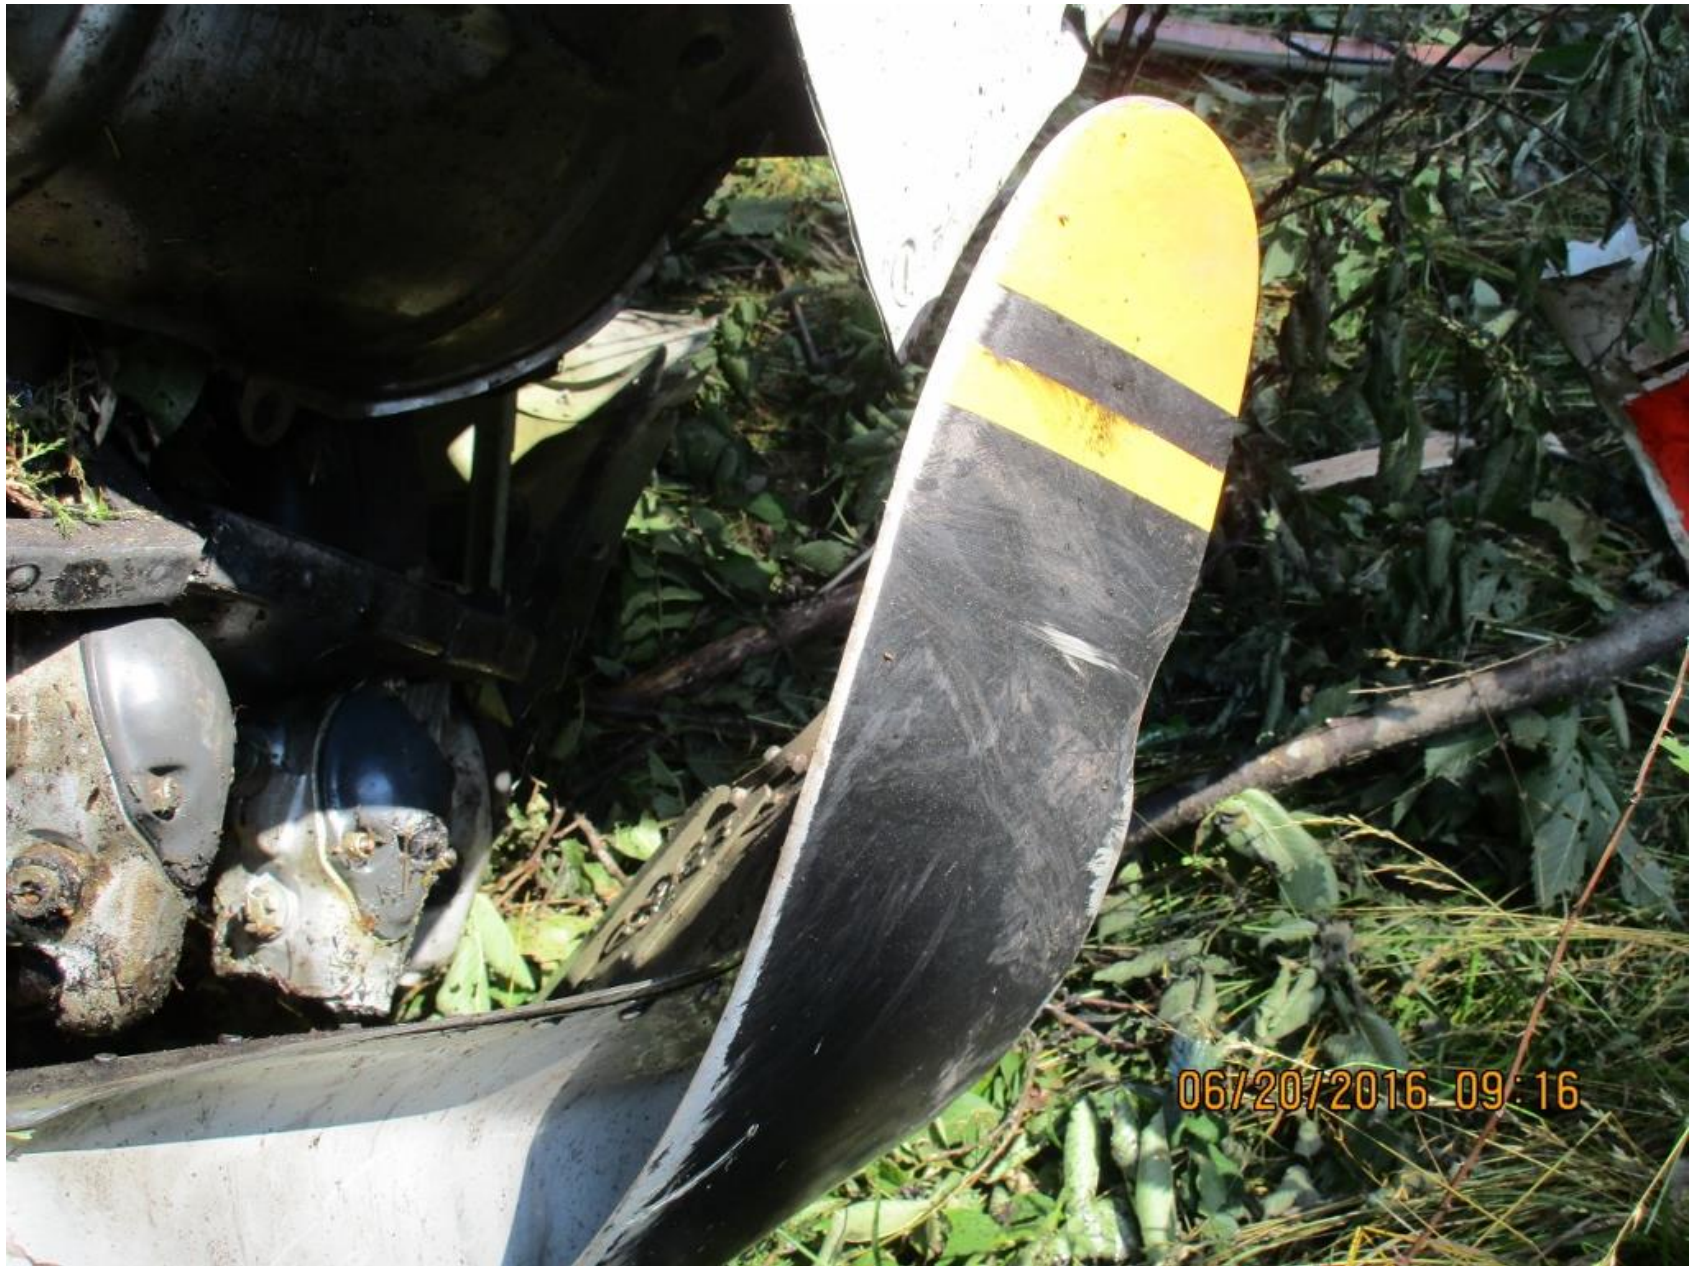
**Photo 13 – Close-up view of the propeller blade**

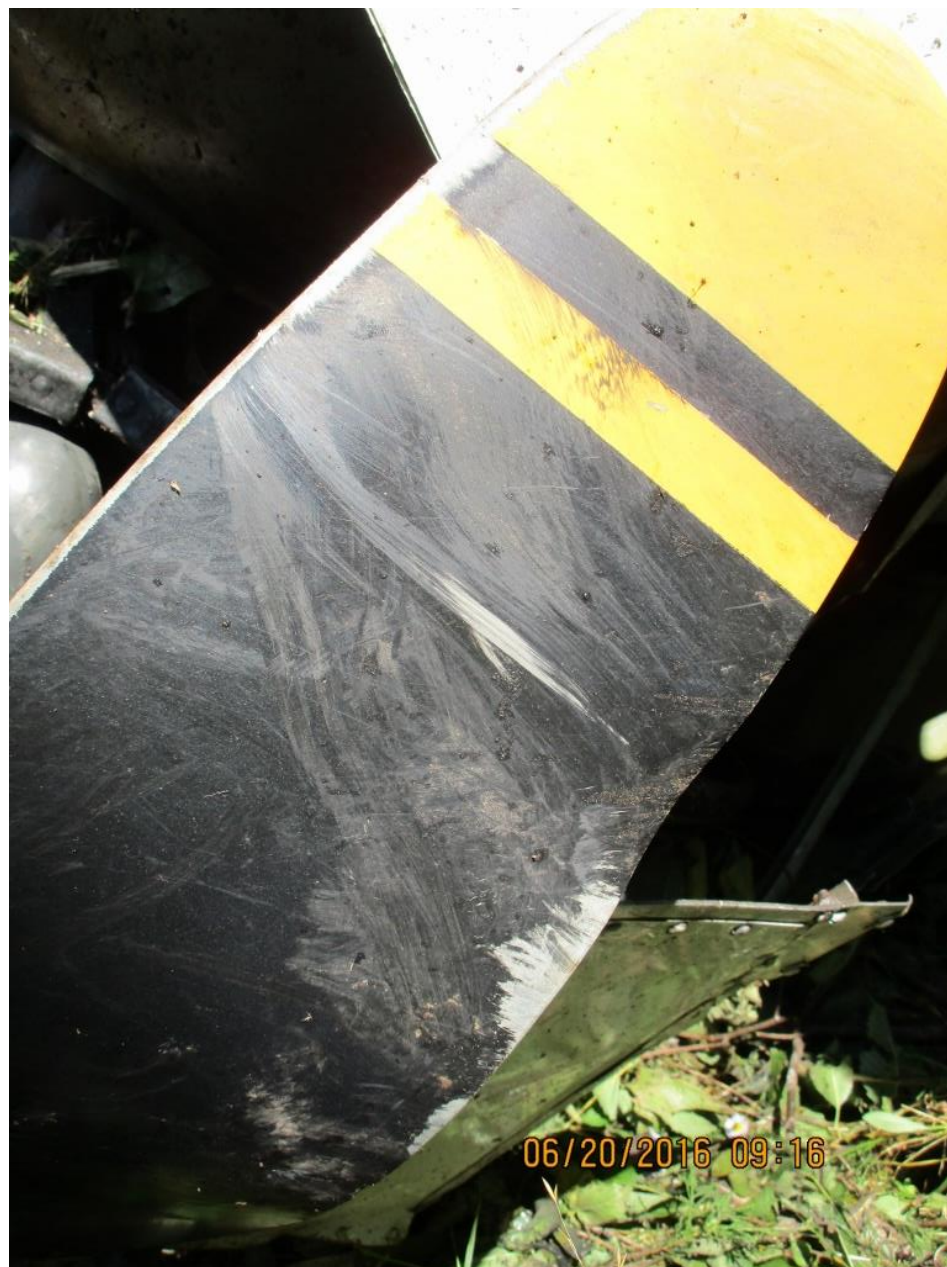
**Photo 14 – View of damage to the blade tip**

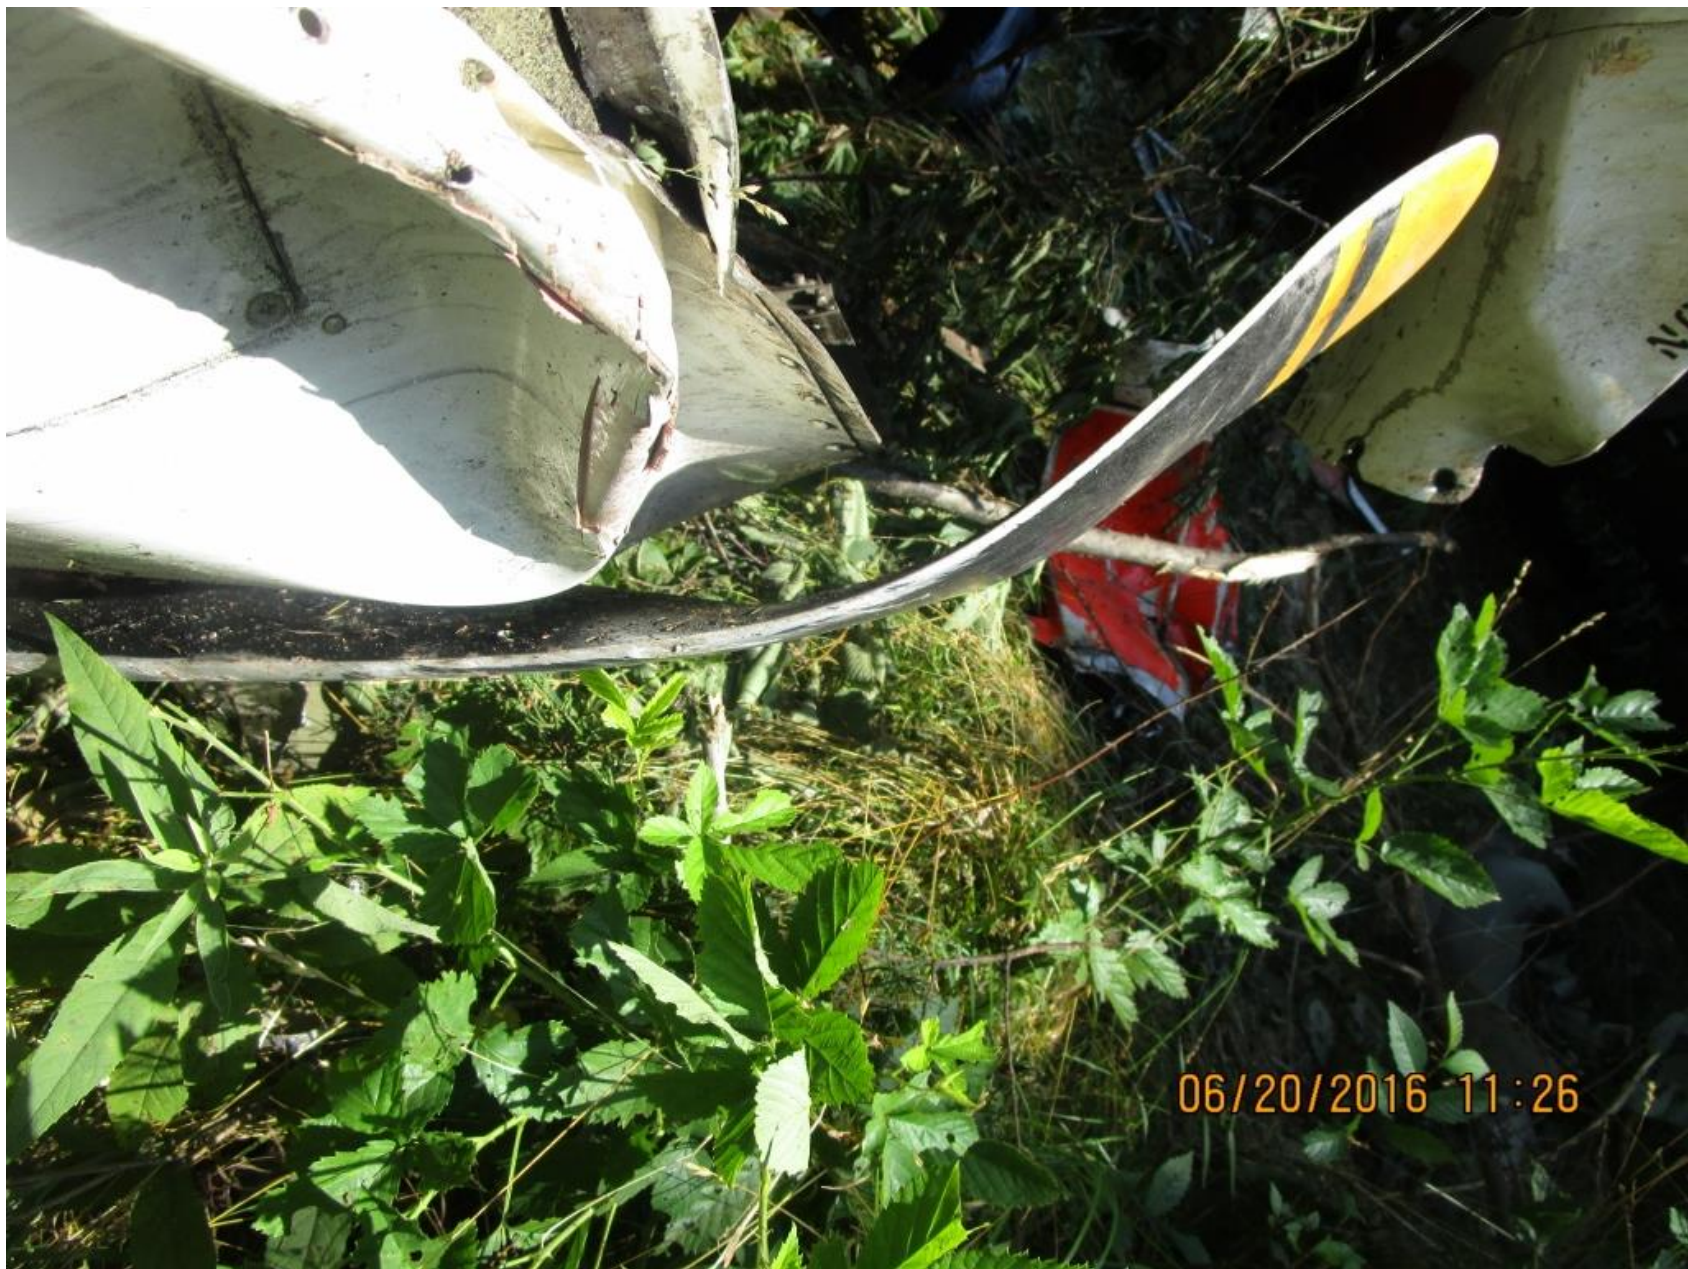
**Photo 15 – View of the leading edge of the propeller blade**

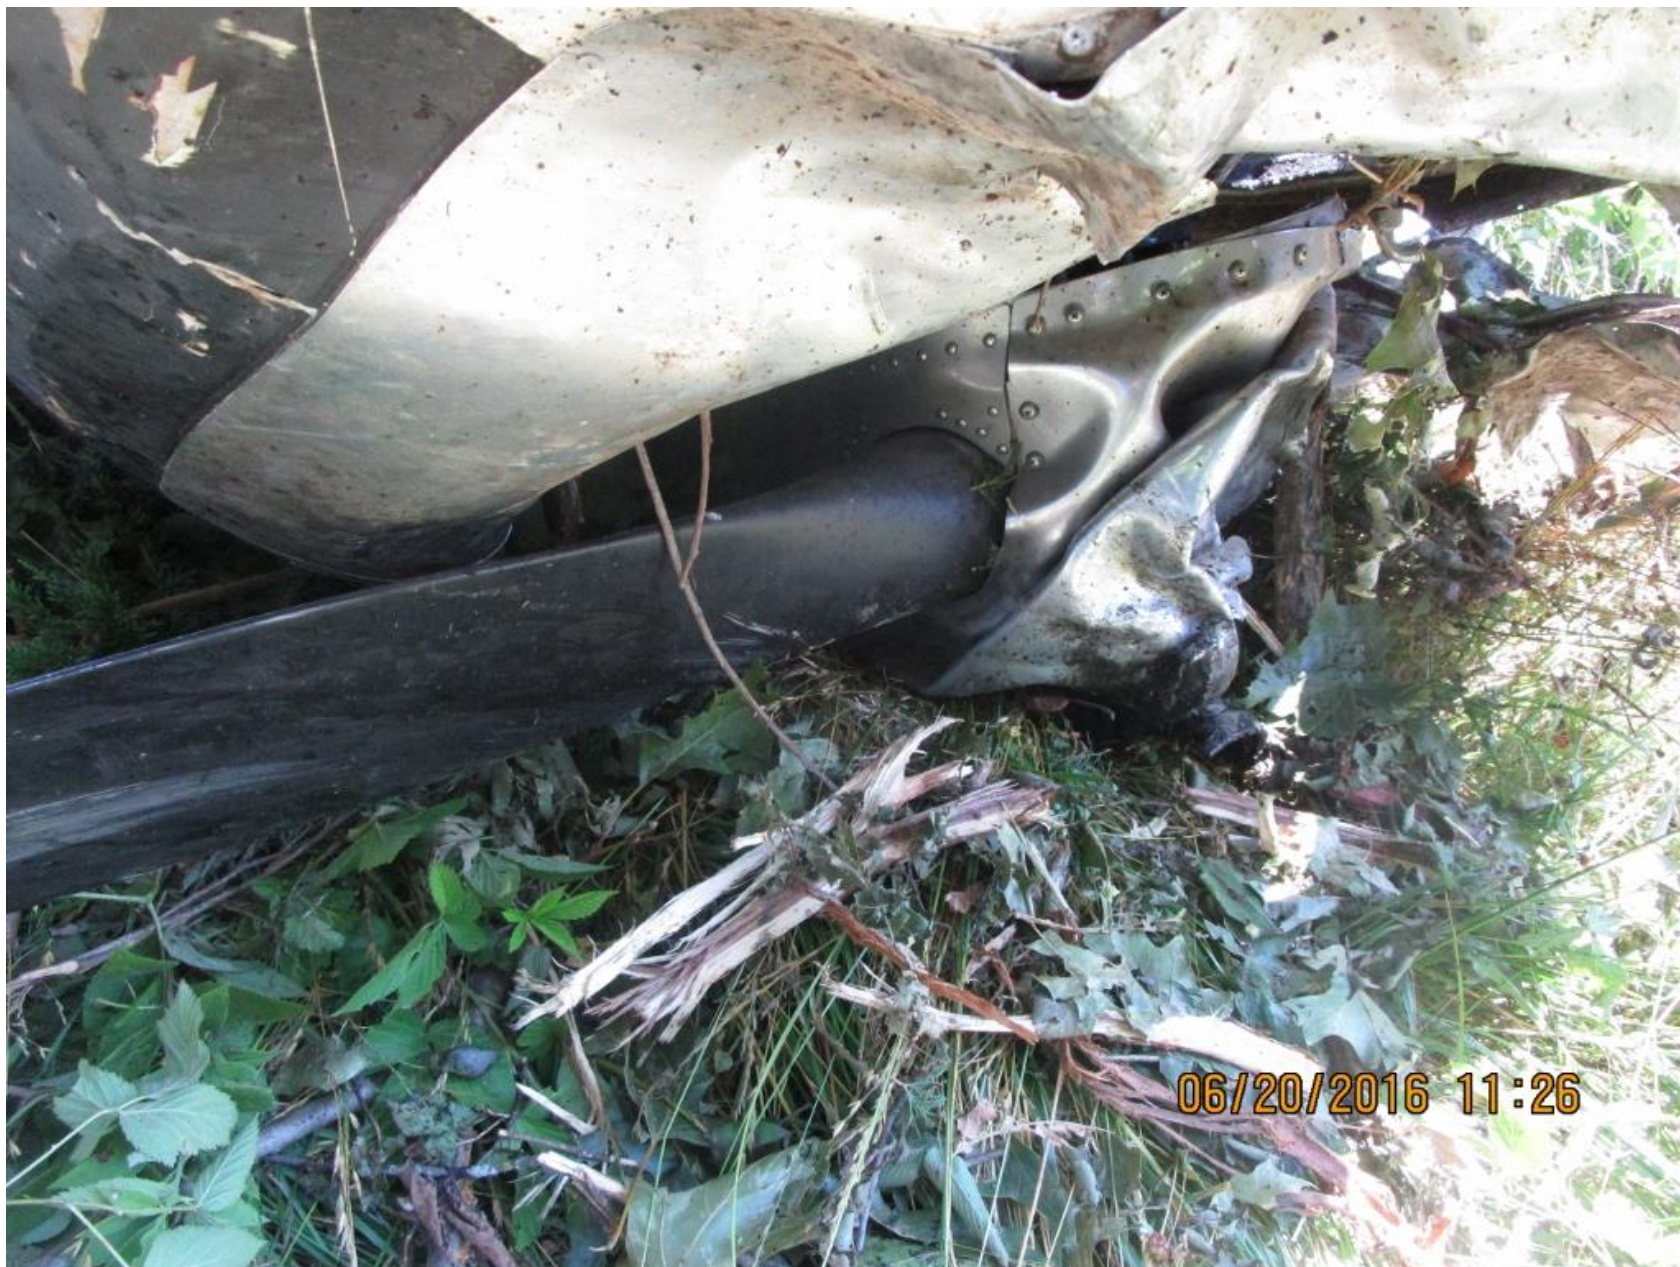
**Photo 16 – View of the crushed propeller spinner and other propeller blade**

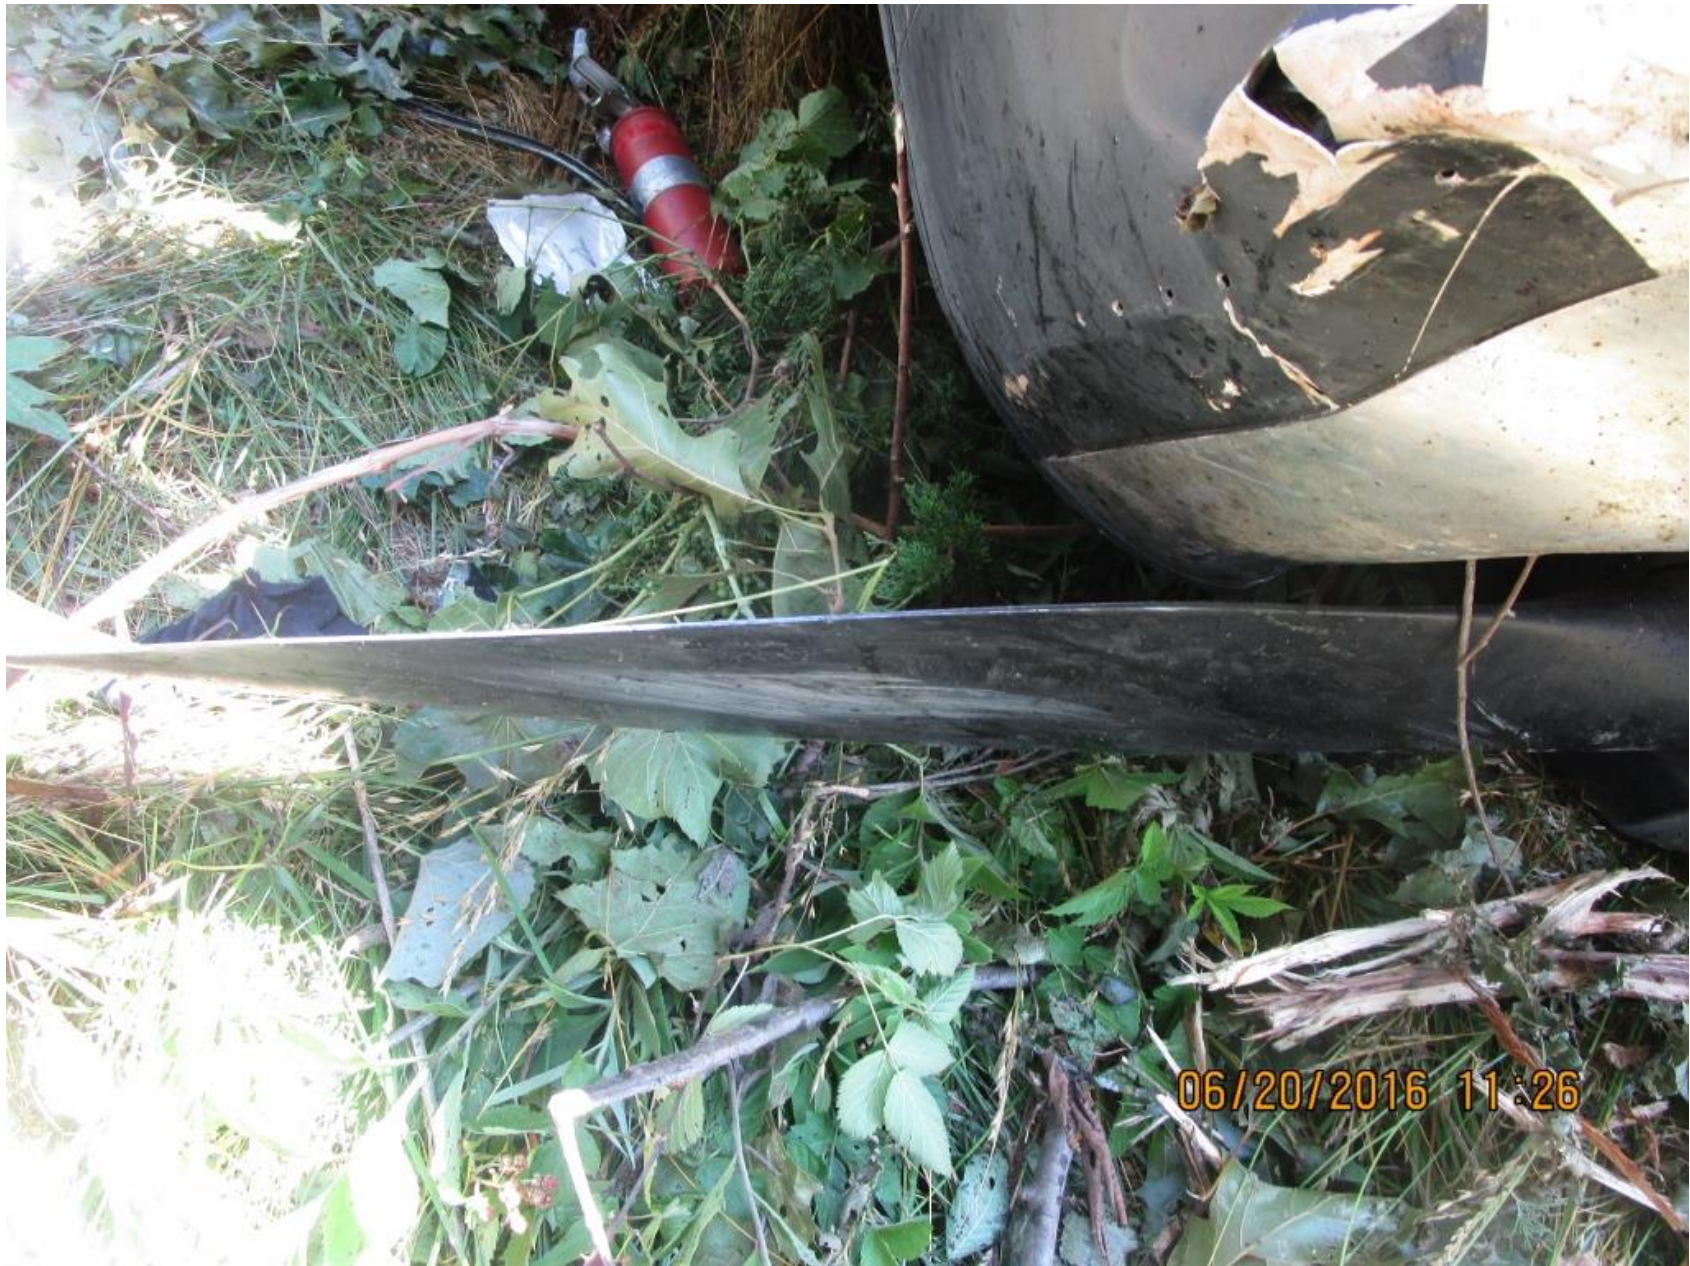
**Photo 17 – View of the other propeller blade**

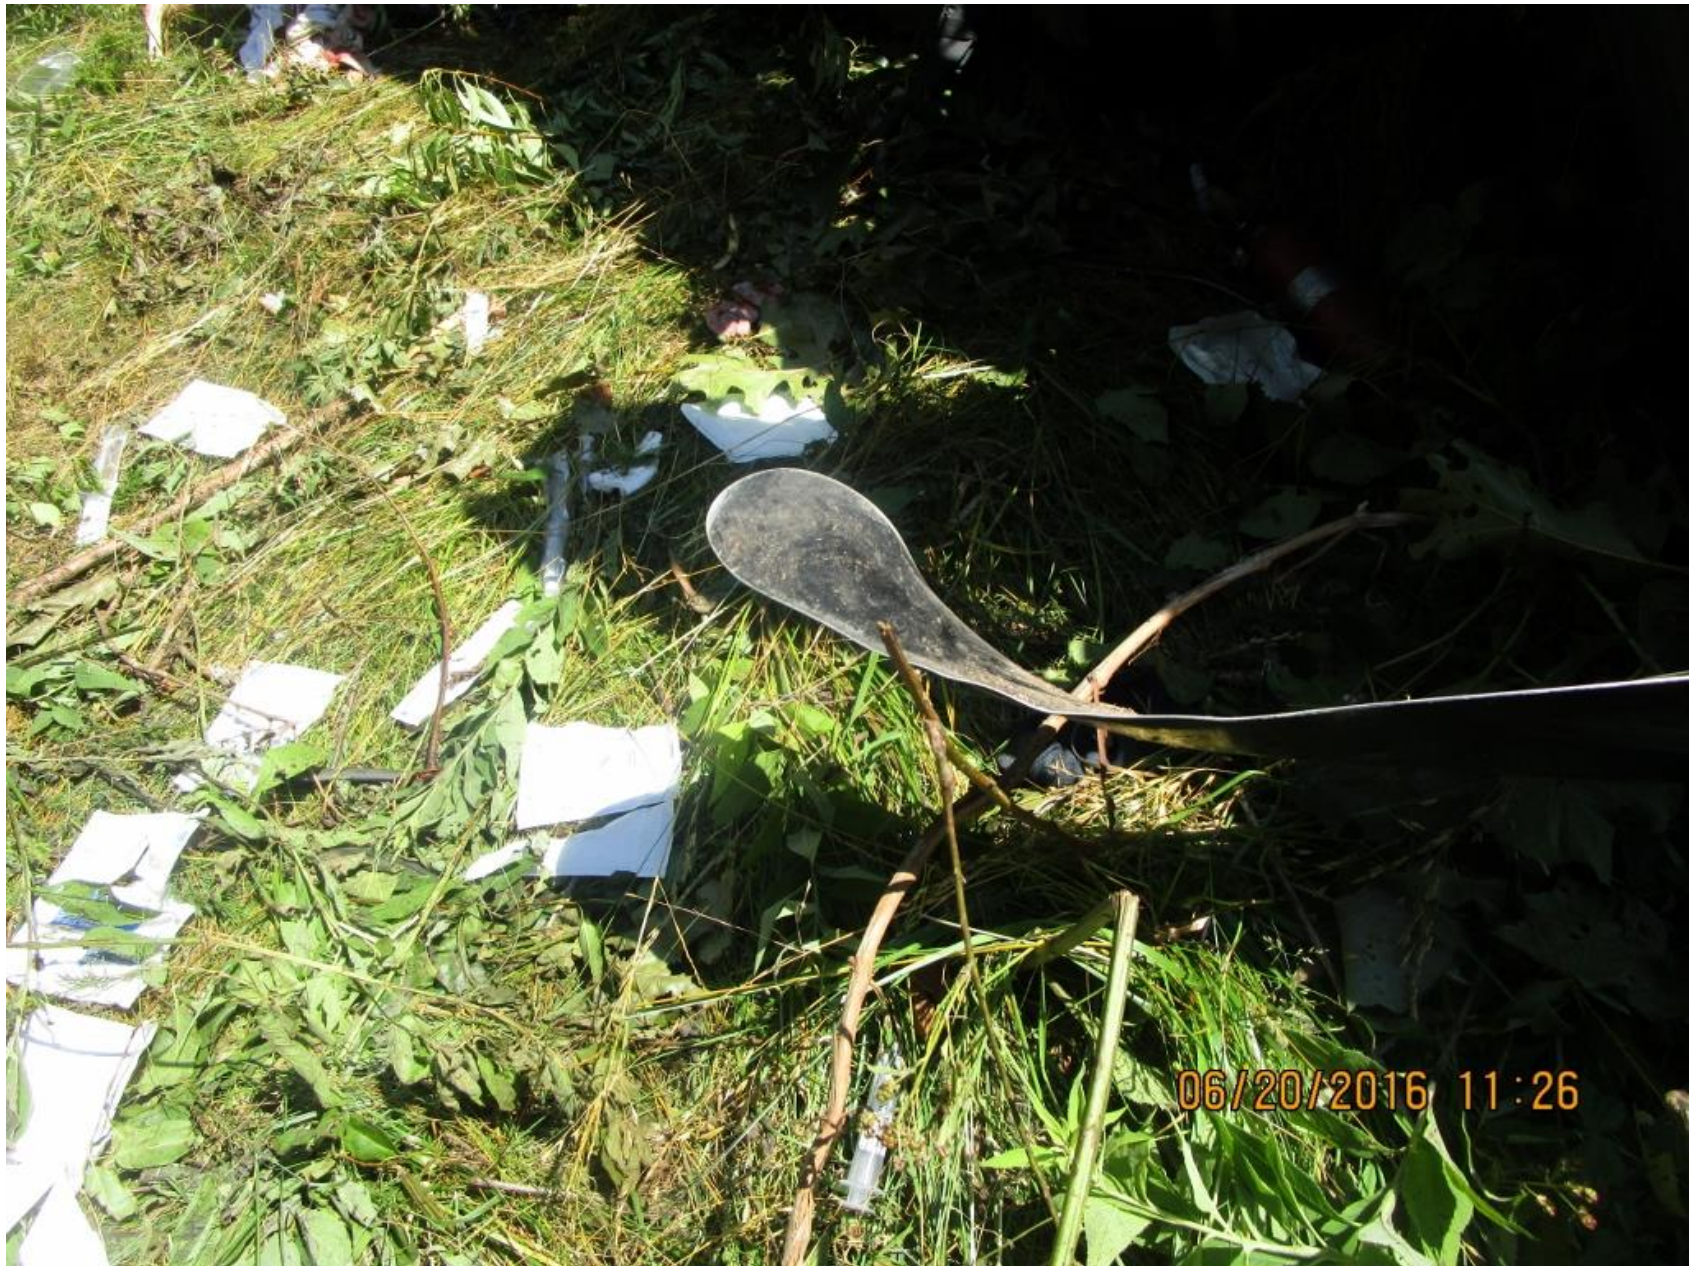
**Photo 18 – View of the other propeller blade tip**

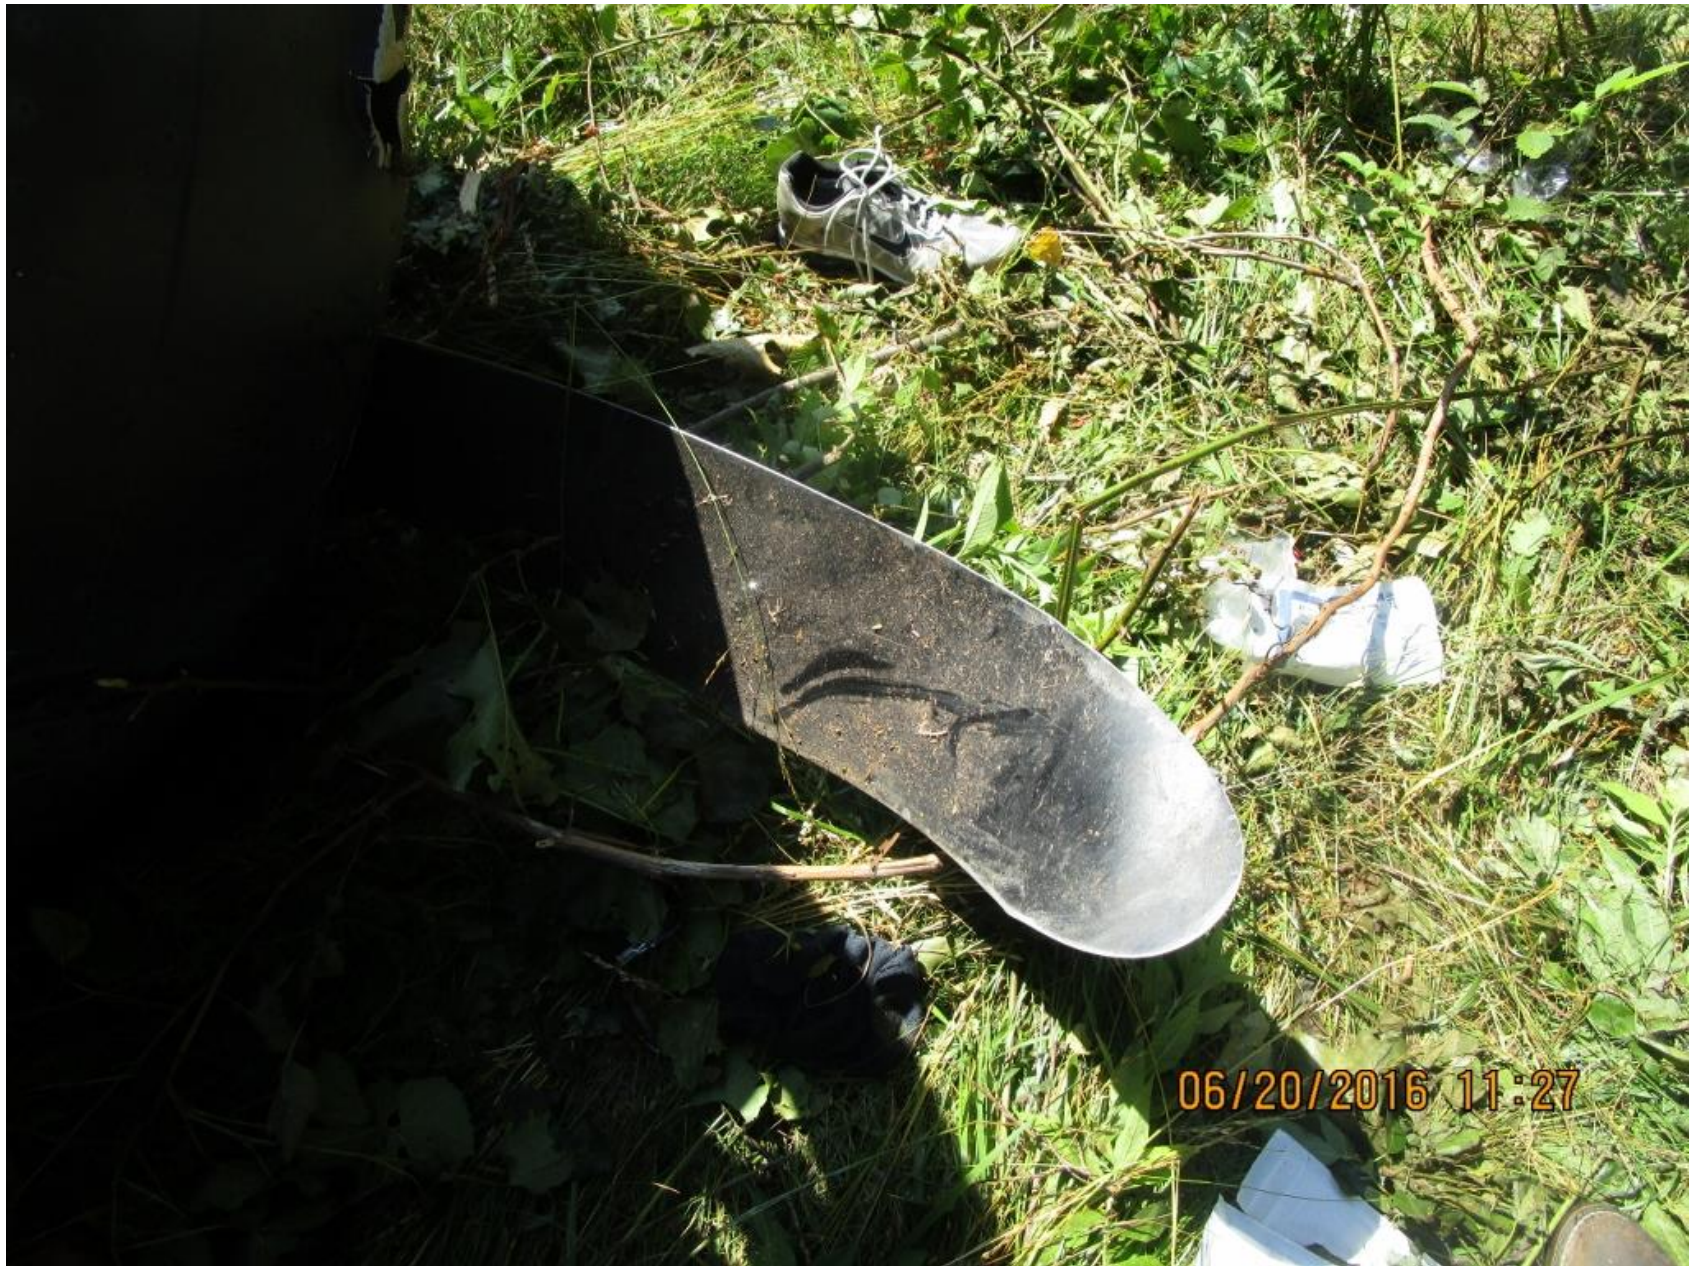
**Photo 19 – View of the blade face of the other propeller**

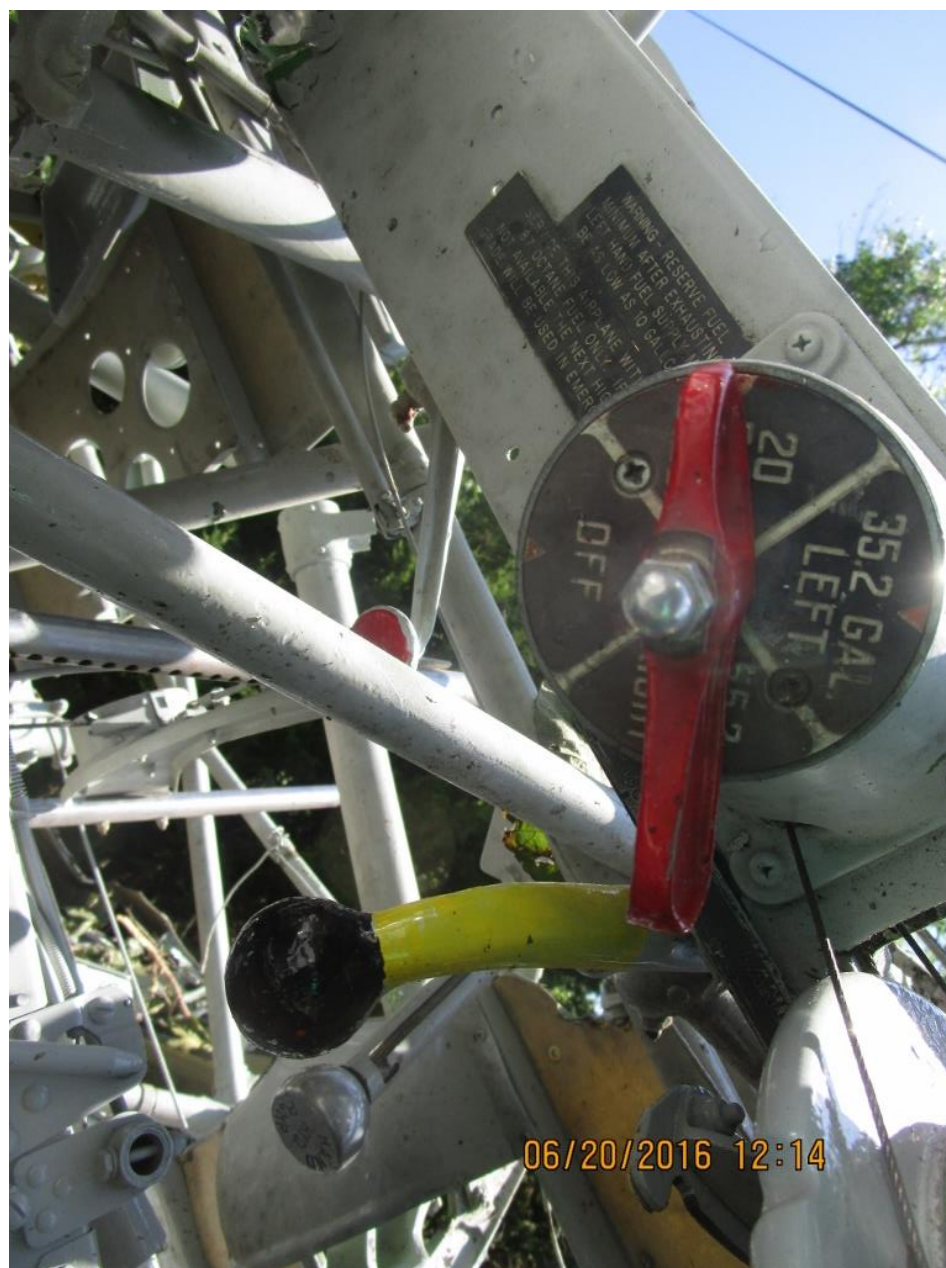
**Photo 20 – View of fuel selector**
