# SERVICE LETTER

No. 747

Piper Aircraft Corporation

Inspection of Throttle and Mixture Control Attachments.

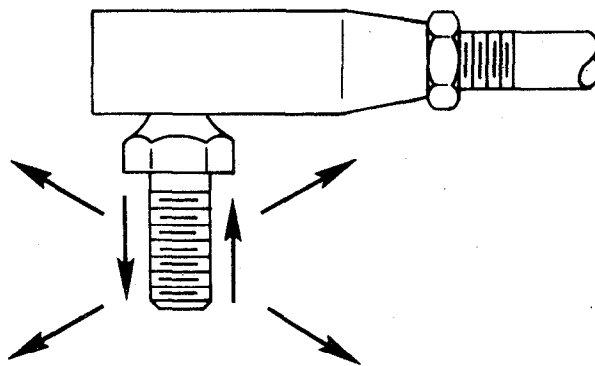
#### INSPECTION INSTRUCTIONS

1. Inspect the Throttle and Mixture Control Attachment Joint Assembly, Piper Part No. 31747-00, for evidence of wear per the sketch below.

Firmly grasp the unit and pull, twist and rotate the ball end. If excessive wear exists, replace the unit with new ball joint (P/N 31747-00) or applicable kit.
