# Continental Motors

## ENGINE FIELD INSPECTION REPORT

| ENGINE MODEL | IO520B (6B) |
| CMI FILE NUMBER | 15-676 |

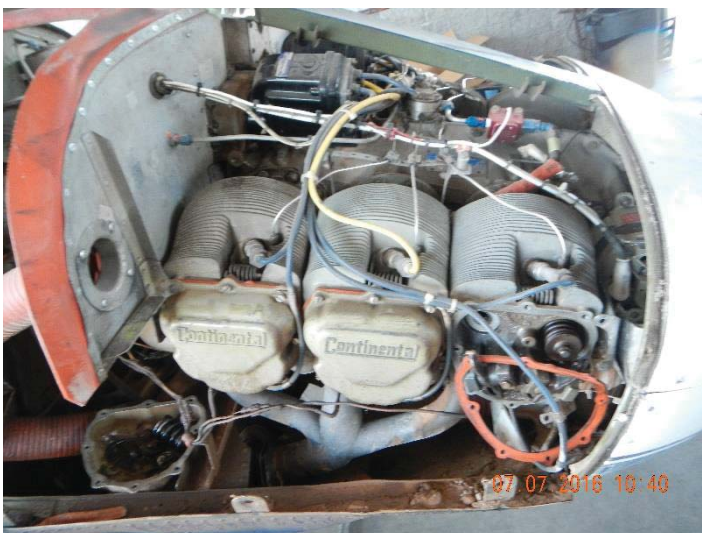
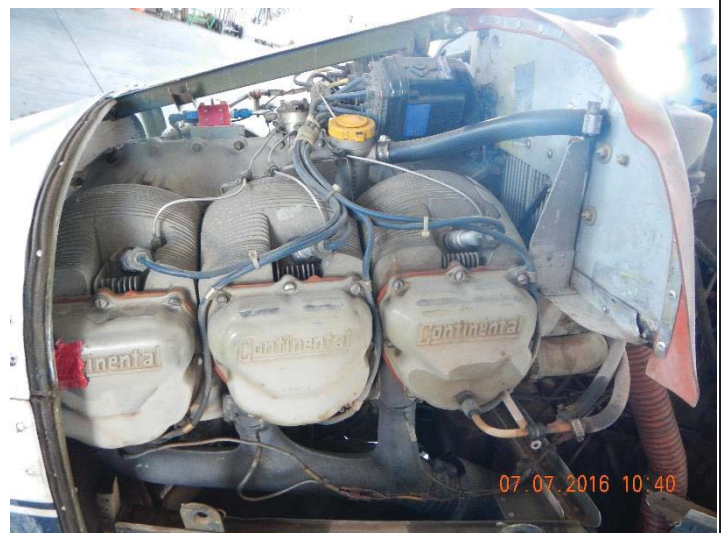
The engine remained attached to the damaged airframe. The upper engine cowling was removed to gain access to the engine. The rocker cover for cylinder # 5 had been previously removed by unknown persons. This rocker box cover was located in the engine compartment and contained an inner exhaust valve spring, an outer exhaust valve spring, a damaged valve guide, portions of a rotocoil assembly, damaged valve spring keys and six machine screws and lock washers used to secure the rocker cover. The rocker cover exhibited a hole which was located directly outboard of the exhaust valve and spring assembly. The remainder of the engine appeared to be undamaged.

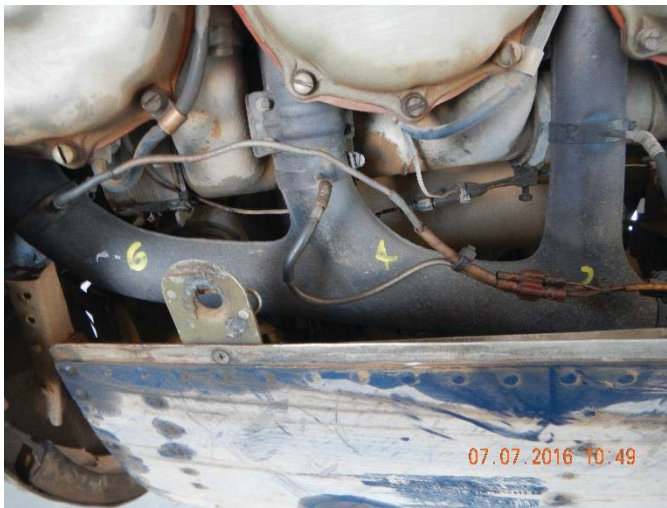
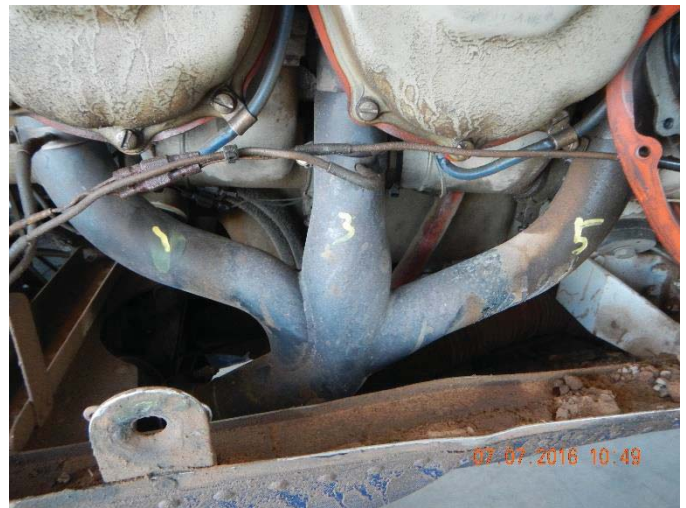
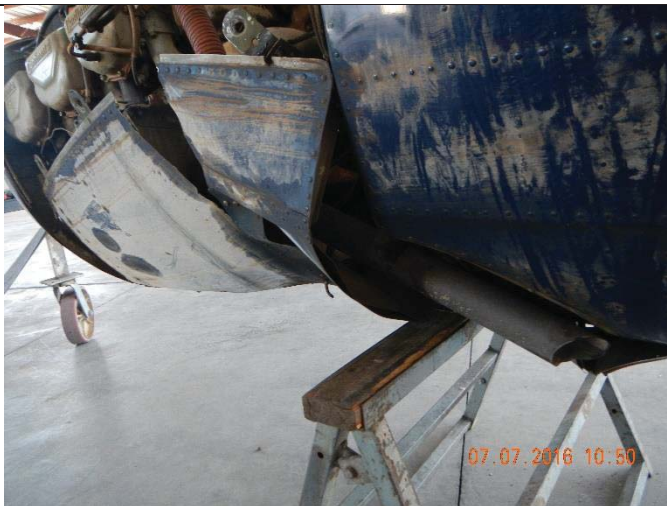
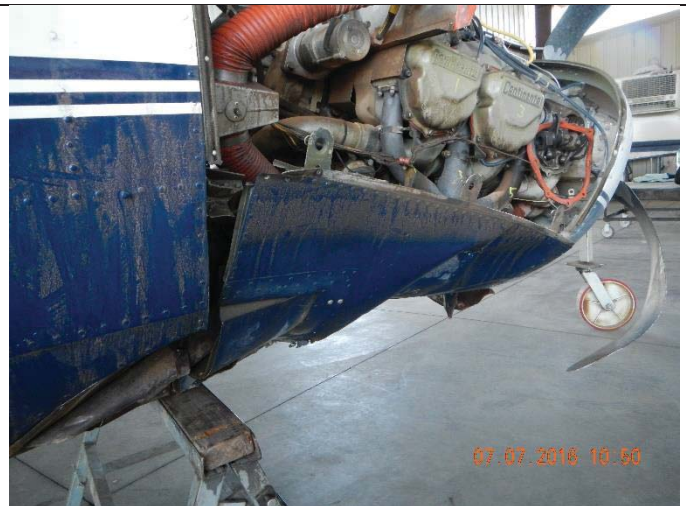
The exhaust collectors were undamaged. The mufflers and tailpipes received minor impact damage where they exit the lower cowling.

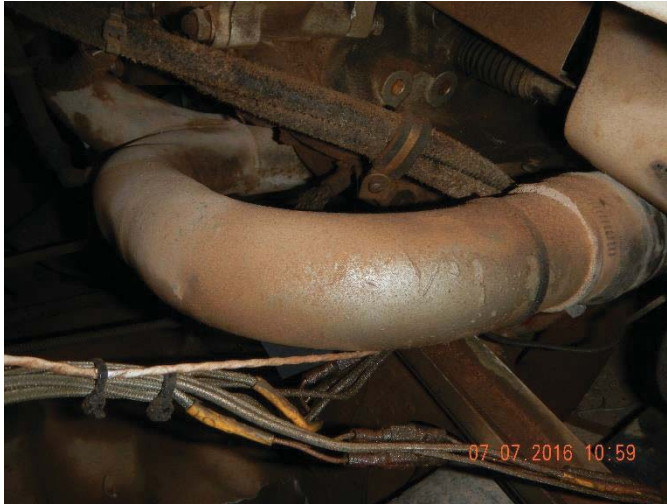
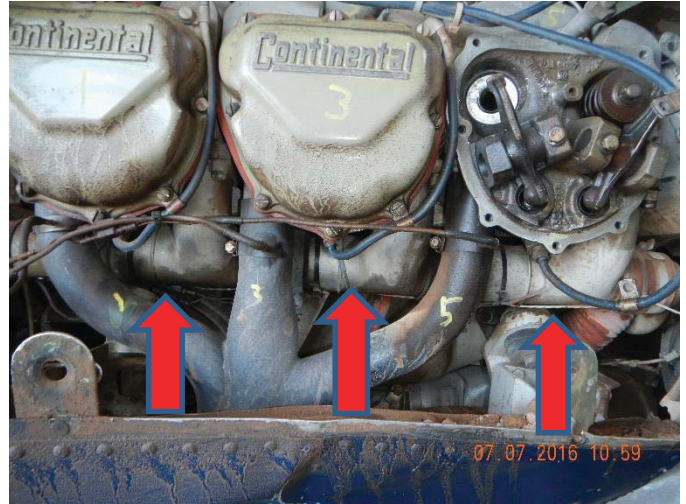
Condition: The induction system did not receive damage. Red arrows point to the right (1-3-5) induction tube elbows.

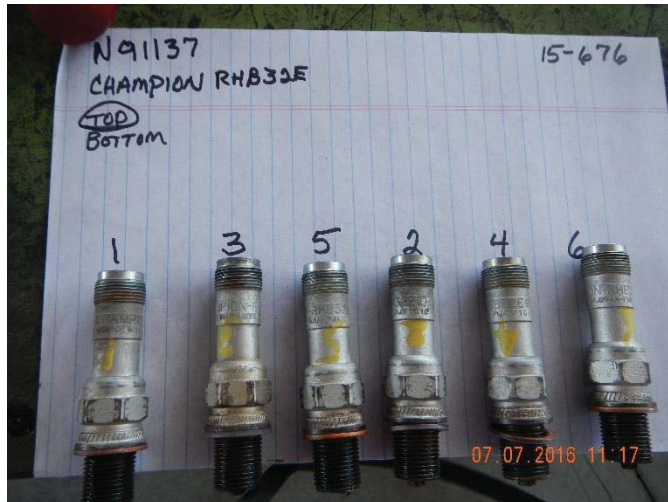
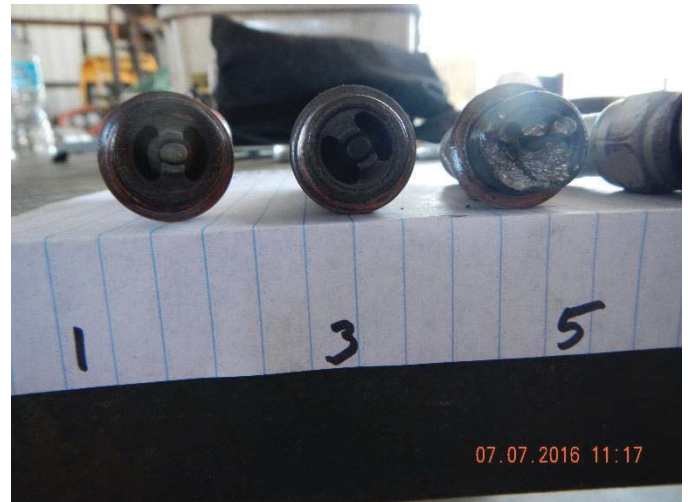
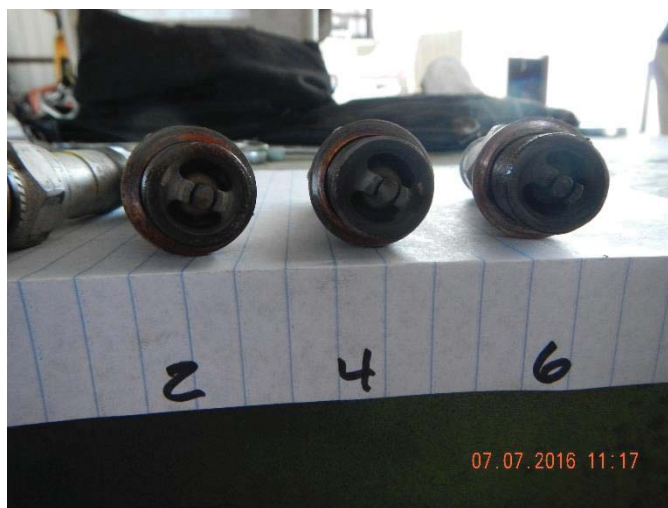
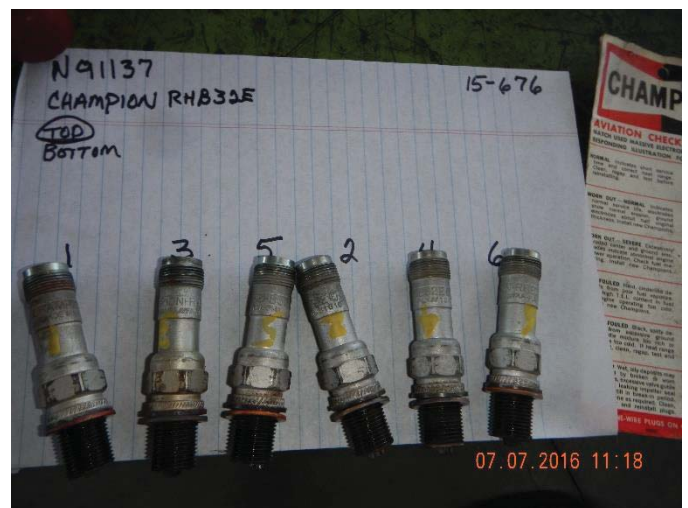
When compared to images on a Champion Check A Plug chart, the wear patterns best match *normal to worn out normal*. The top sparkplug from cylinder # 5 displayed mechanical damage and metal contamination was present.

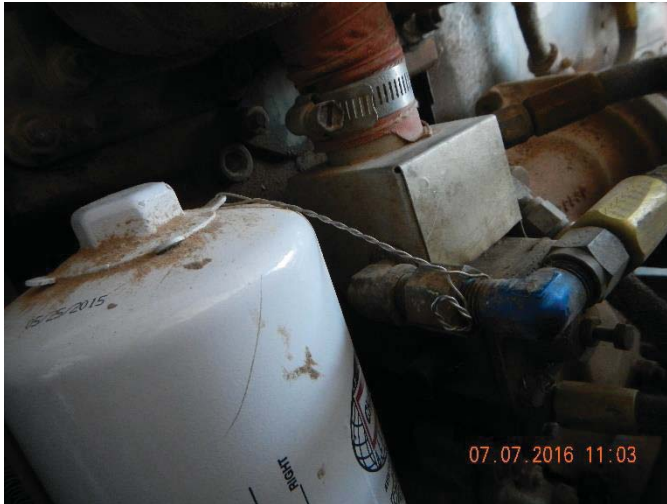
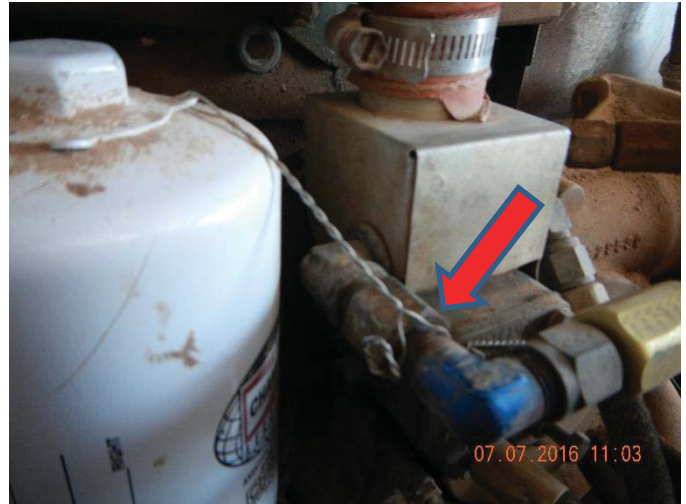
No damage was noted. Note that oil filter security wire is incorrectly attached to the fuel pump hose fitting. See red arrow below.

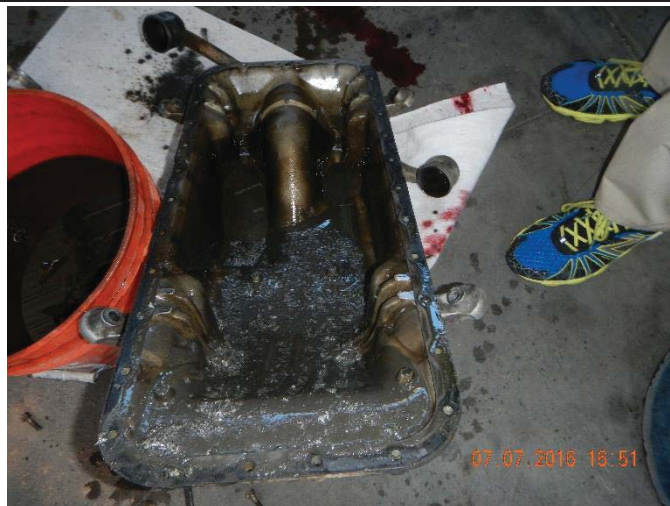
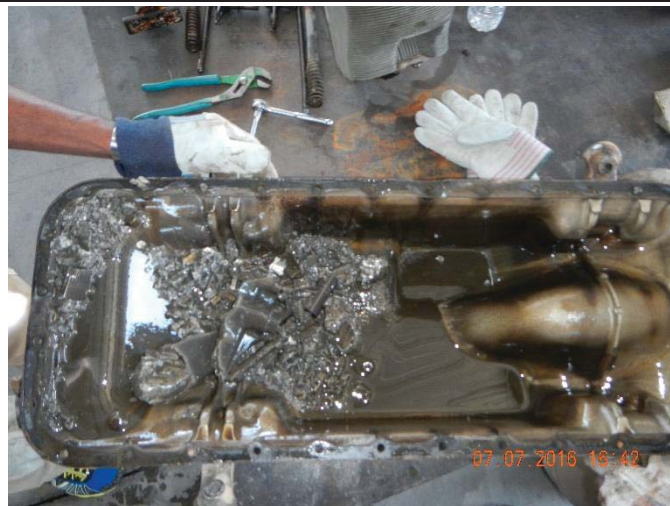
Condition: The exterior of the oil sump did not display any damage. The interior of the sump was contaminated with damaged engine components and metal debris.

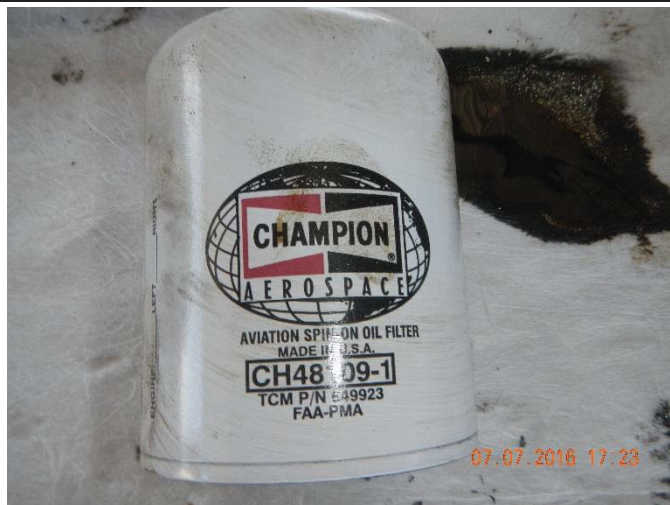
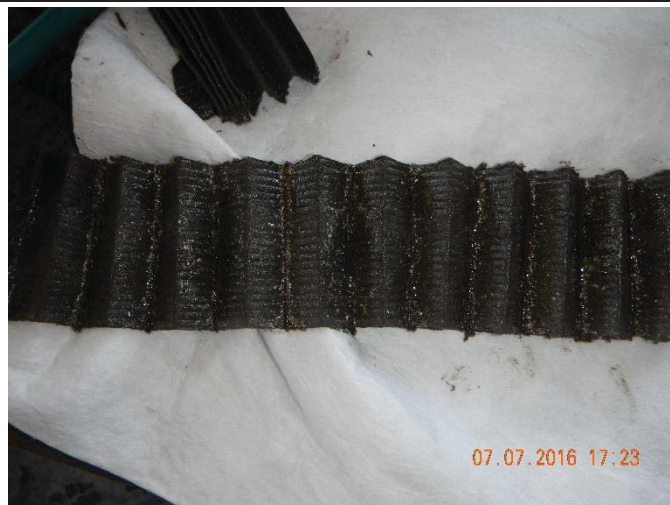
Condition: When opened for inspection, the filter was contaminated with metal.

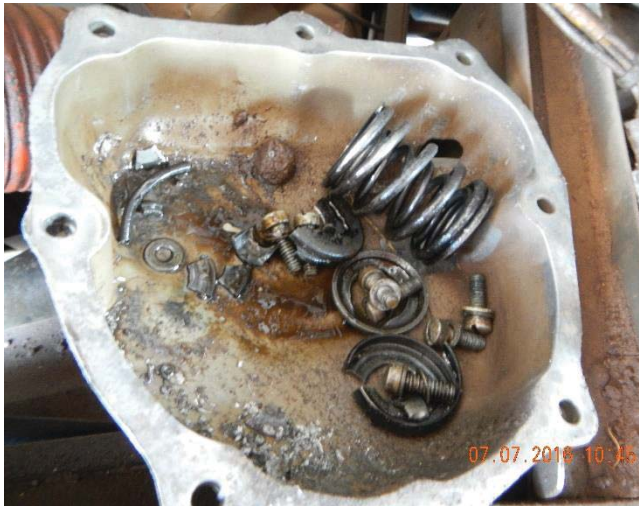
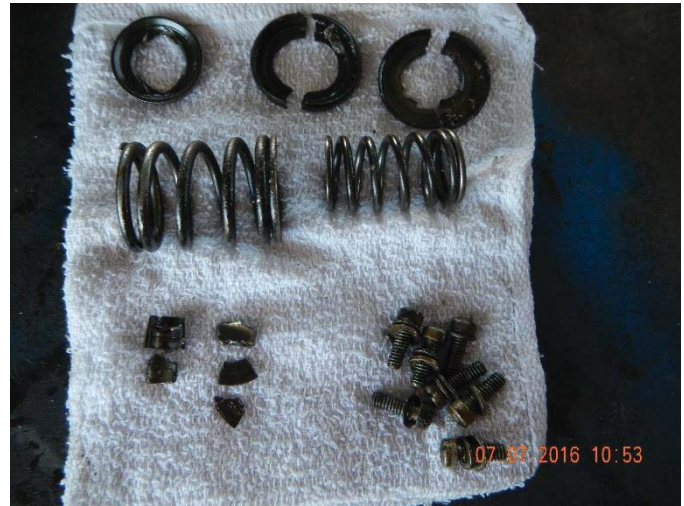
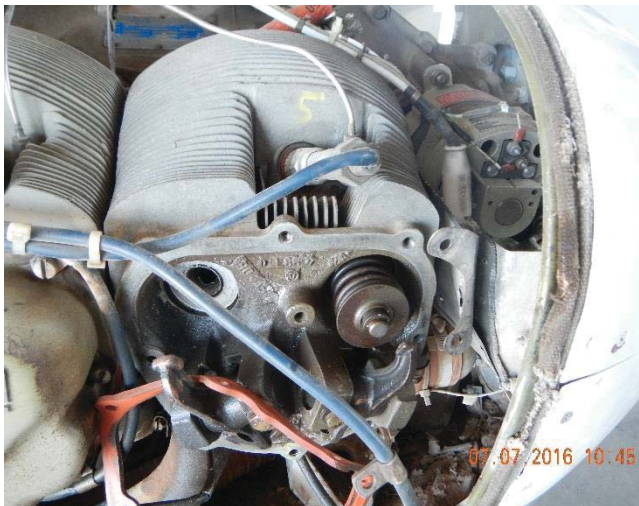
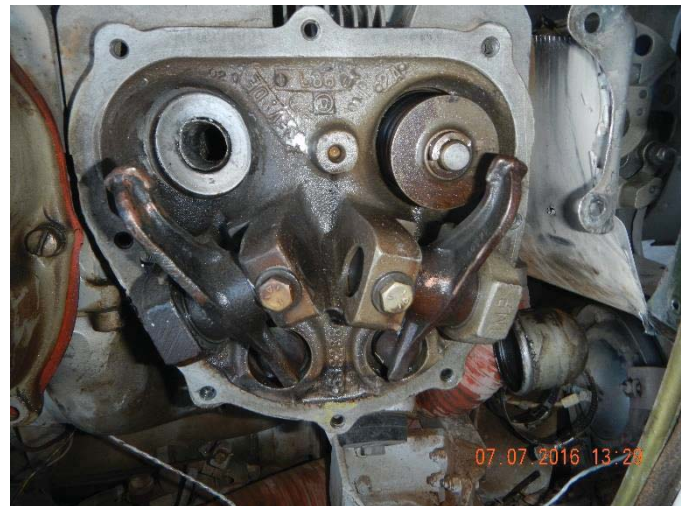
CYLINDER #5

Rocker cover exhibited damage directly over the exhaust valve and valve spring assembly. Exhaust valve separated. Inner and outer valve springs, damaged valve spring keys, exhaust valve guide, valve spring retainers and rocker box screws were found in the previously removed rocker box cover. The intake push rod was bent. The cylinder was removed. The piston separated leaving only the piston pin and damaged connecting rod. The damaged piston and rings were found in the oil sump. The exhaust valve head was located in the oil sump with approximately 1/2" of valve stem protruding.

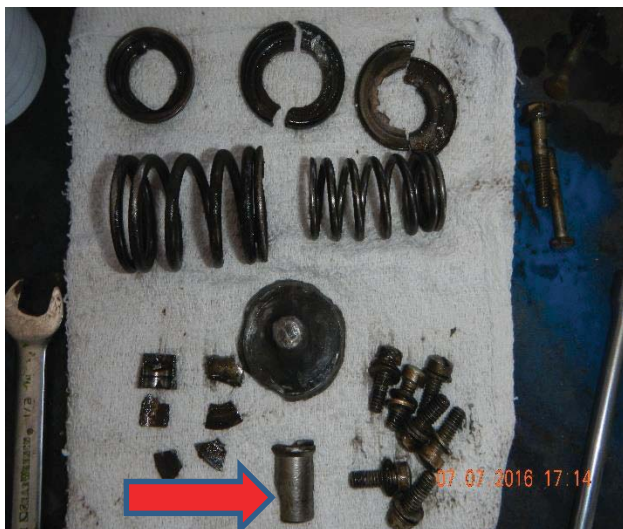
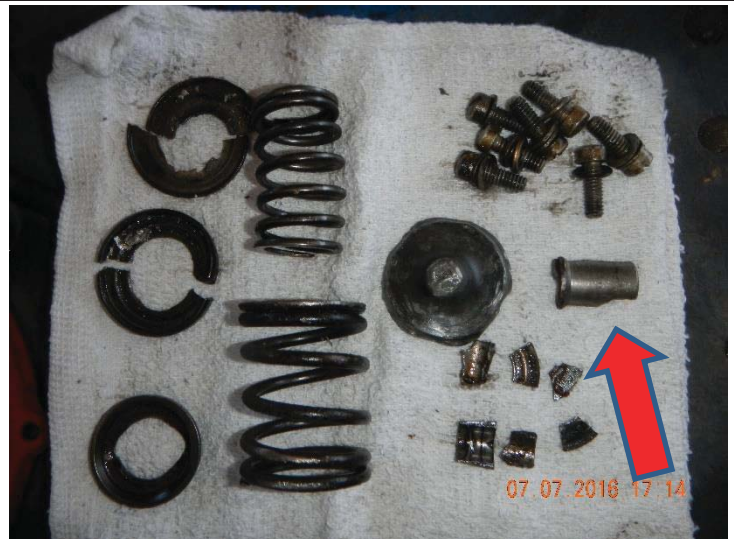
Cylinder # 5 exhaust guide separated and was among the metal debris recovered from the removed oil sump. The red arrows point to the damaged # 5 exhaust guide. All other guides appeared undamaged.

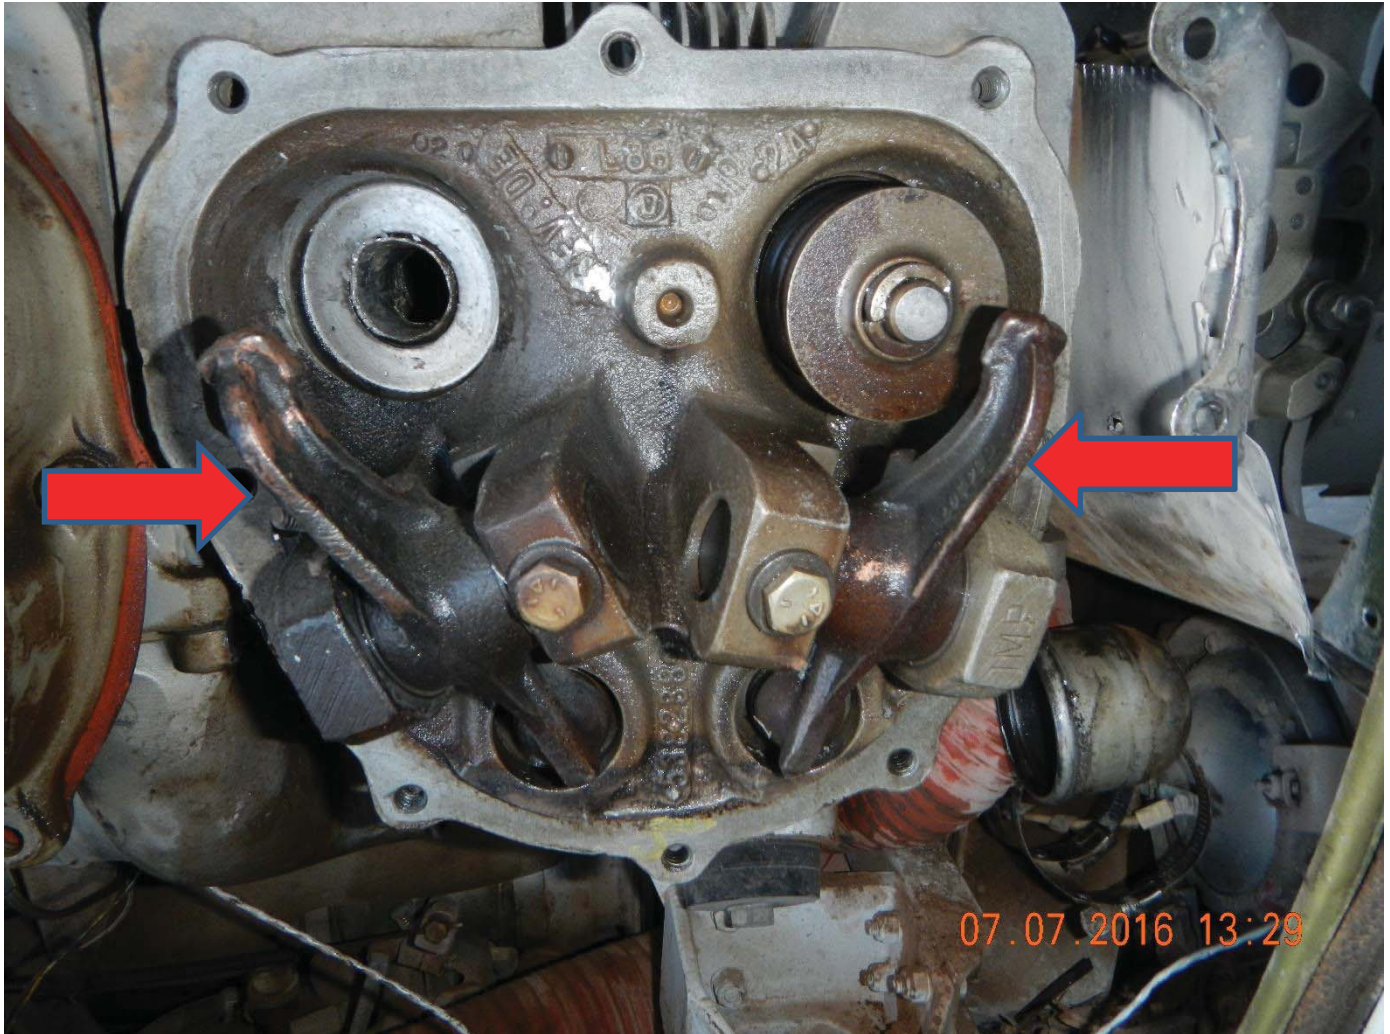
No damage was noted. Red arrows indicate intake and exhaust rocker arms.

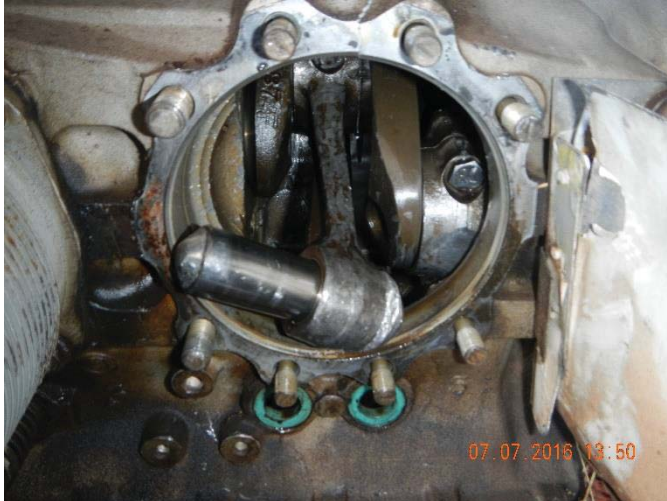
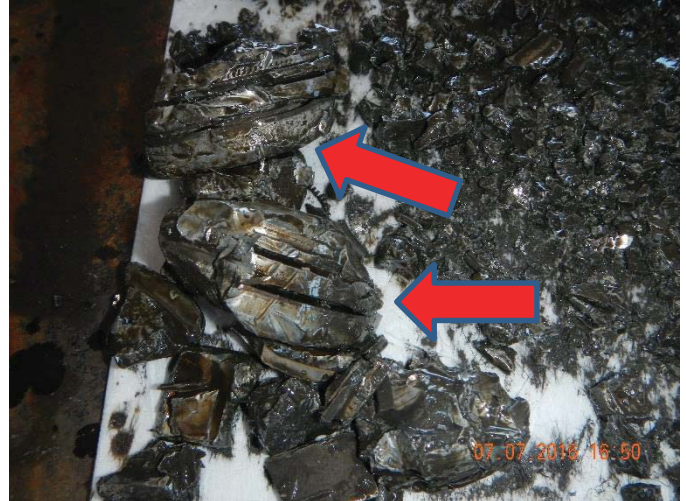
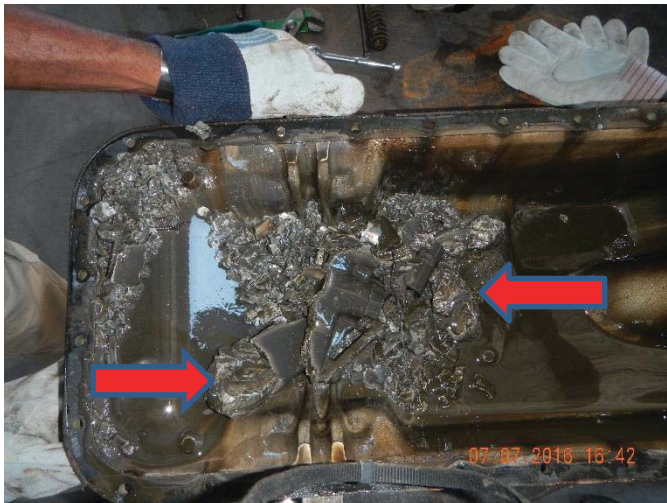
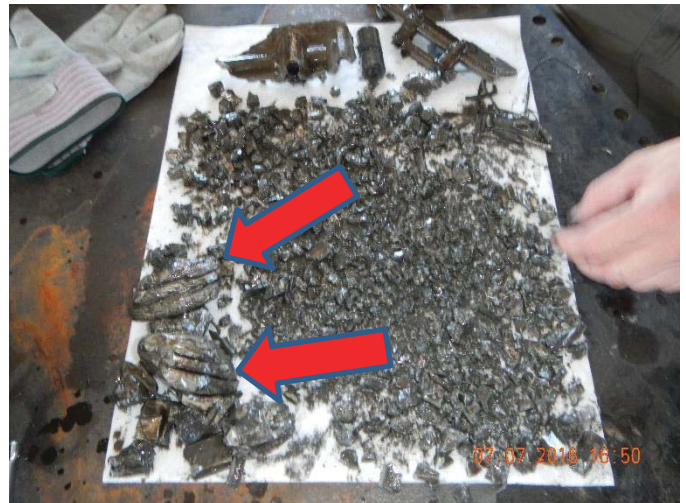
The piston and rings separated and were recovered from the engine oil sump. Red arrows indicate piston material.

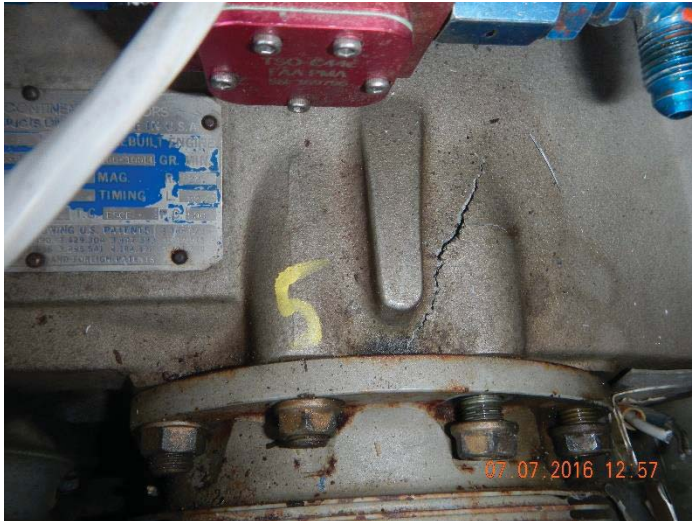
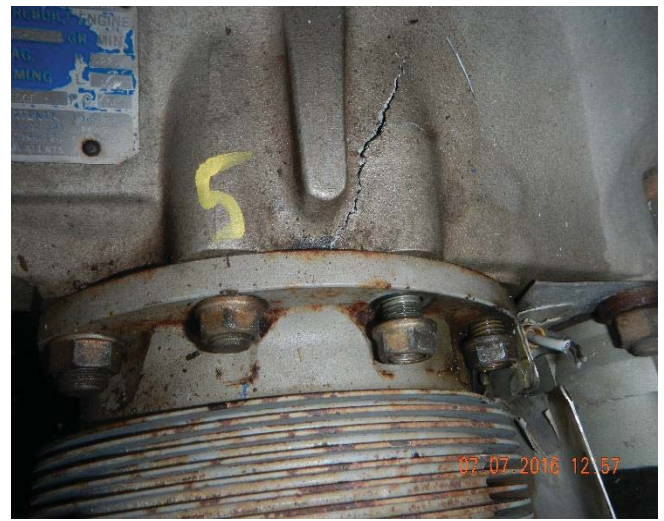
The right (1-3-5) crankcase half was damaged beginning at the base of cylinder # 5 resulting in a crack which extended approximately two inches toward the center parting line.

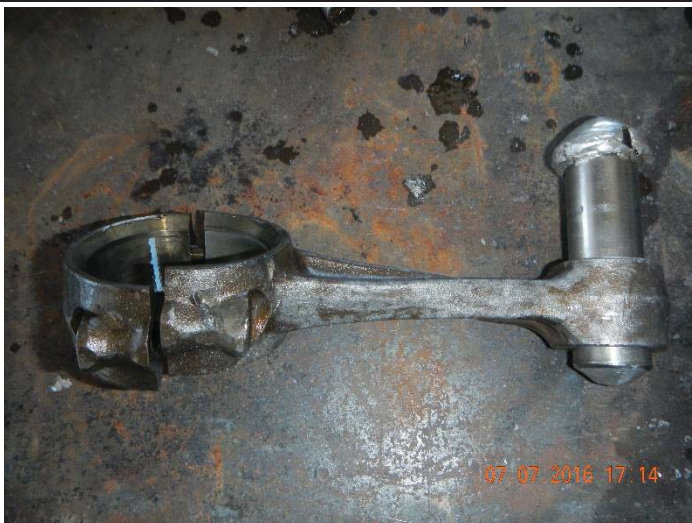
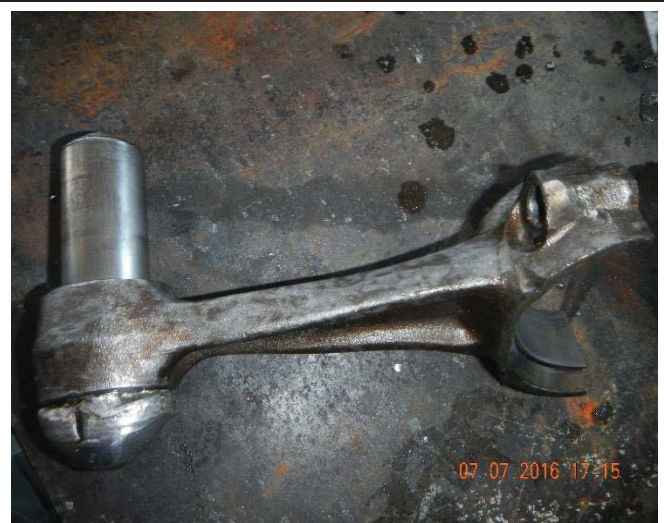
#5 CONNECTING ROD

The connecting rod was twisted and the piston pin was mushroomed on both ends.

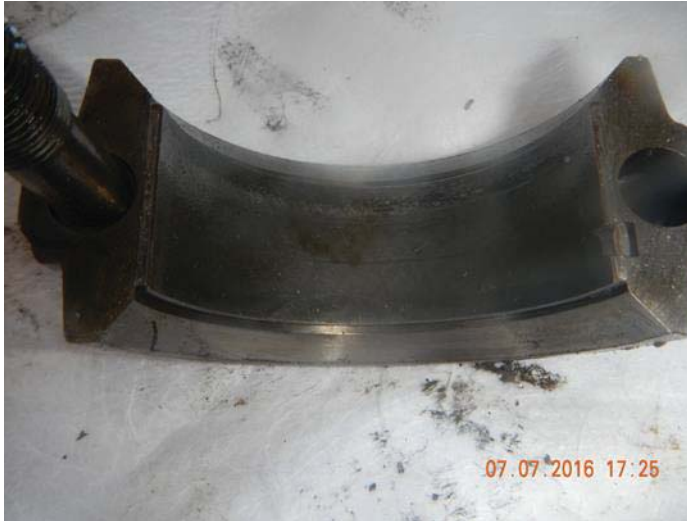
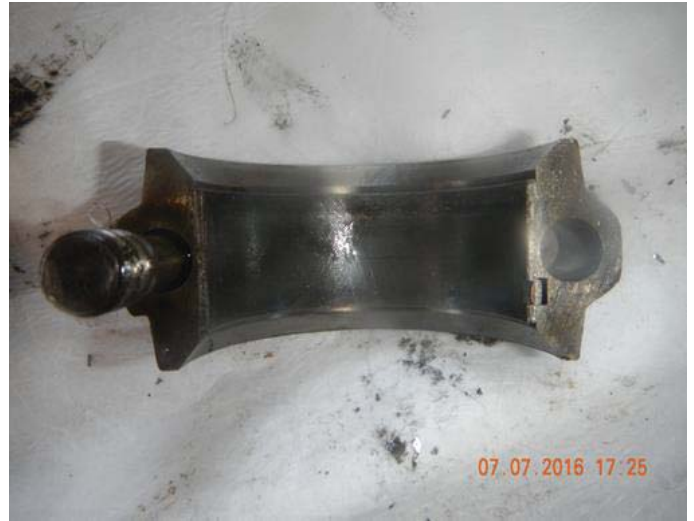
The bearing exhibited normal wear patterns.
