## MEMORANDUM FOR RECORD

**NTSB Accident Number: CEN16LA259**

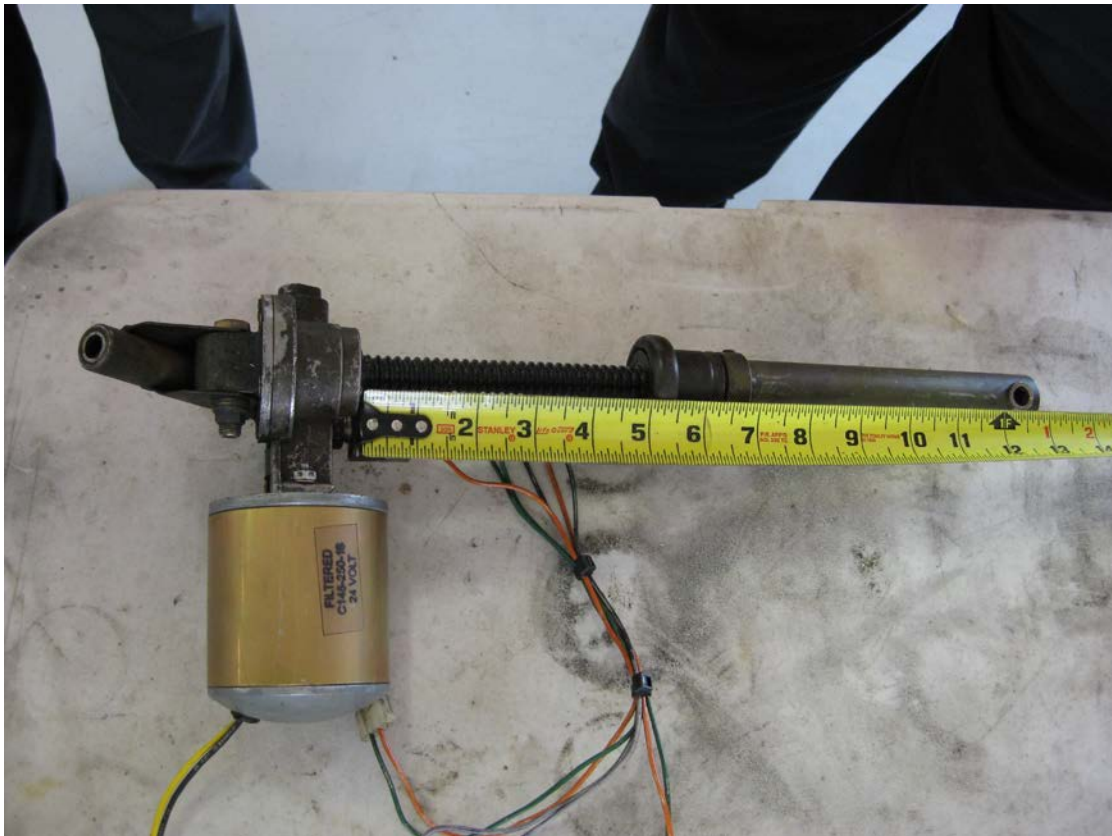
Inspectors from the Federal Aviation Administration examined the airplane and found the flap assembly “seized” or bound at the flaps down position. A review of the maintenance log books found entries concerning the flaps in the preceding six months. The inspectors removed the flap motor assembly and shipped it to the Wichita Aircraft Certification Office until an examination could be scheduled.

Figure 1 – The flap motor assembly as found by inspectors from the FAA FSDO (FAA photo)

The flap actuator motor, jackscrew, and flap tube assembly were sent to APPH Wichita Inc. the vendor of the flap motor assembly for an examination. Under the auspices of inspectors from the Federal Aviation Administration and with assistance from Textron Aviation, the jackscrew was unboxed and examined. The flap tube assembly on the flap actuator motor was found fully extended and bound. The tube assembly was freed from being bound and when examined showed no anomalies. The flap actuator motor was energized, and the assembly operated normally. Further examination did not find a reason for why the tube assembly had become bound. No anomalies were detected with the jackscrew or the flap actuator motor.
