Re: Accident Investigation Number: CEN16LA275

RE: Engine Power Loss Opinion of Meyers Aircraft 200B – N229RS

## FAA Accident Incident Data System Report

**5. NTSB ID** CEN16LA275

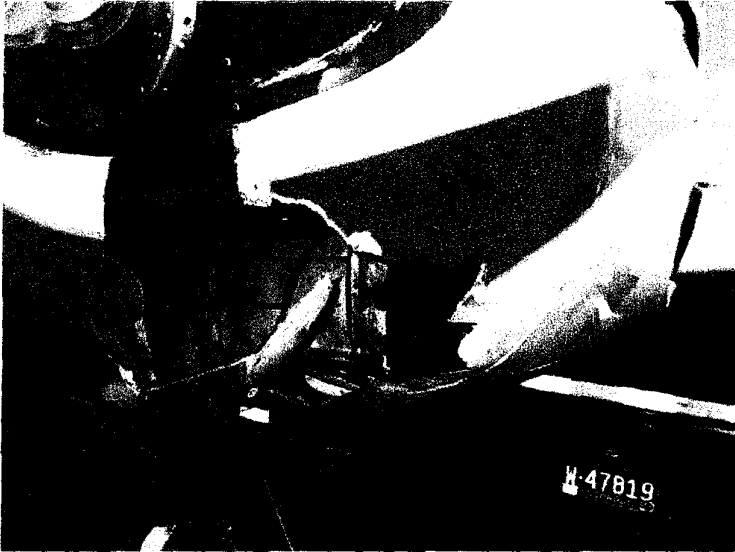
- The missing bolt that secures the throttle cable clamp was discovered in the front left side of the engine compartment under dirt and debris from the off field landing.

Front left engine cowling area

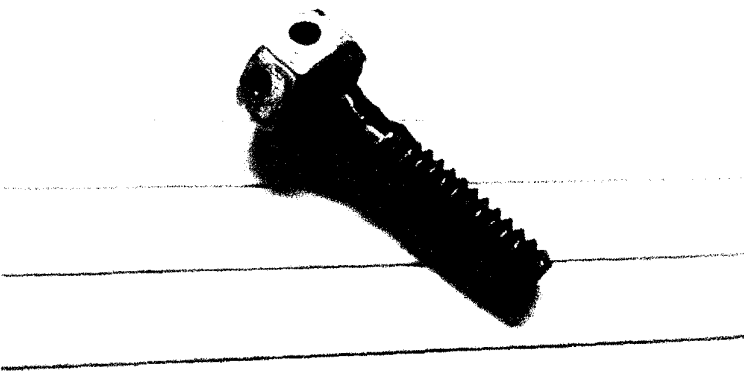
- The grip area on the bolt area shows wear signs consistent with the steel mount bracket still secured on the throttle cable housing confirming this is the missing bolt.

- Common practice when using drilled head bolts like a MS20074-4-04 would be to install lock wire through the bolt head securing it to remain in the torqued position.

Missing Bolt – worn grip area, no evidence of lock wire

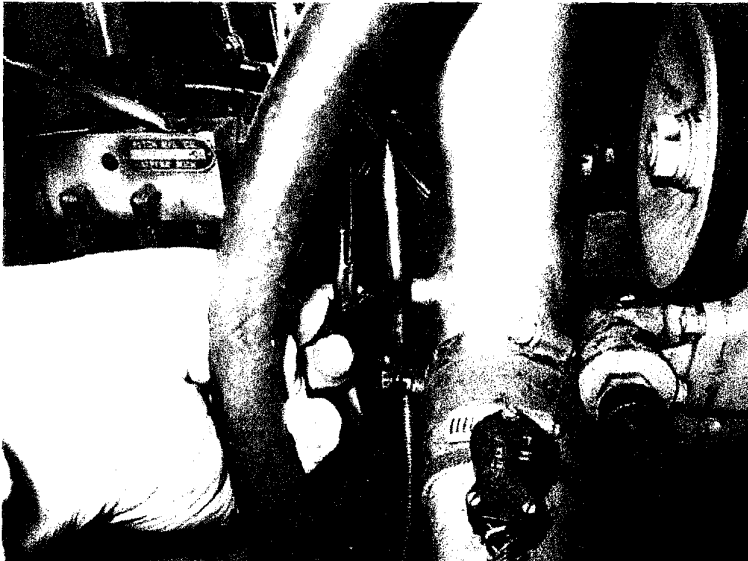
- The throttle body assembly threaded boss to accept the missing bolt was still intact – the female threads are not stripped allowing a bolt to be properly installed per design.

Throttle cable clamp and throttle body attachment boss – missing bolt location

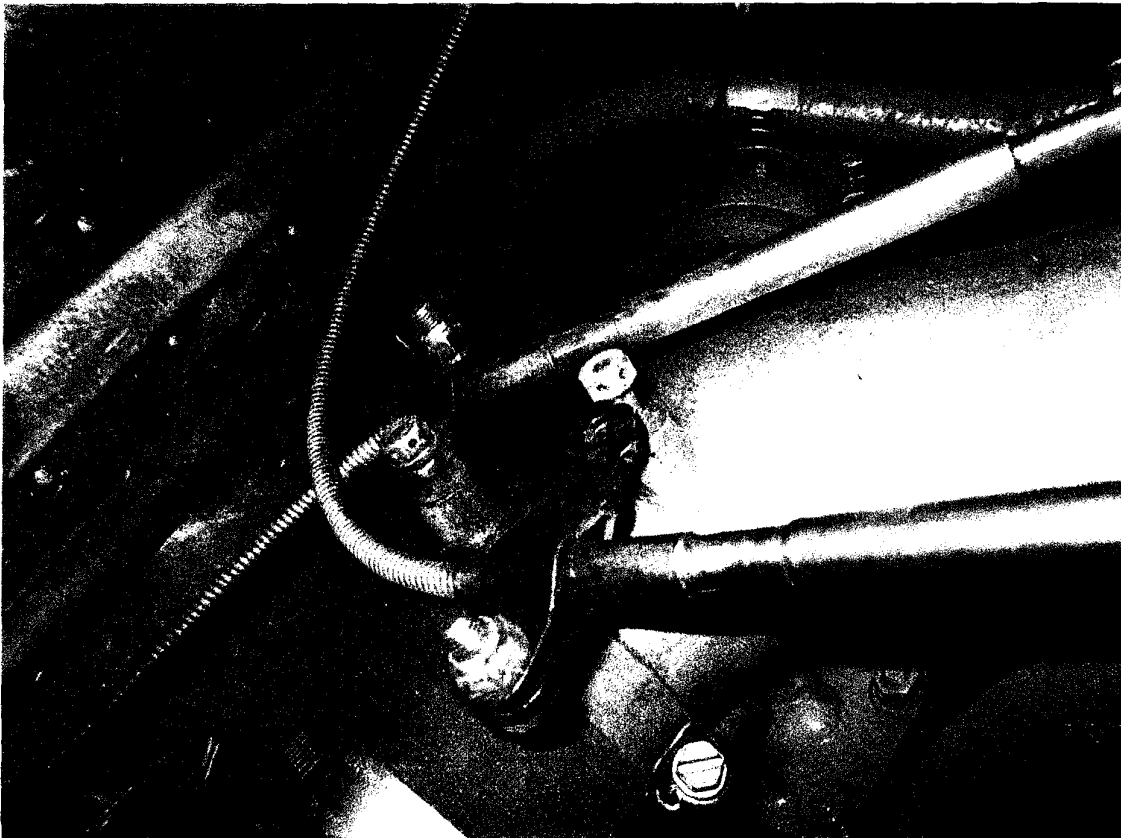
After completing a thorough inspection on the above aircraft on September 13<sup>th</sup>, 2016, it appears hardware attaching the throttle control cable to the engine induction tube was not secured through the use of safety wire allowing the bolt to become loose and vibrate out of the housing. The subsequent loss of the bolt rendered the throttle cable inoperable permitting the engine throttle body to close to an idle condition or subsequent loss of power.

- There is no evidence of lock wire installed between the two bolts on the throttle body preventing either one from backing out of the tube assembly.

Bolt was threaded back into throttle housing temporarily to show orientation of clamp and neighboring drilled head bolt. Common practice would be to lock wire the bolt from the mixture cable clamp to the bolt in the throttle cable clamp. There is no evidence of lock wire through either bolt.
