**November 15, 2016 : Supplemental Evidence/Report Information**

RE: Crosswind Aviation, LLC (7580-XL)  
July 19, 2016 Aircraft Incident of N299RS

**Review of Surveillance Video production from Atlantic Aviation (Crosswinds' Hangar-Landlord)**

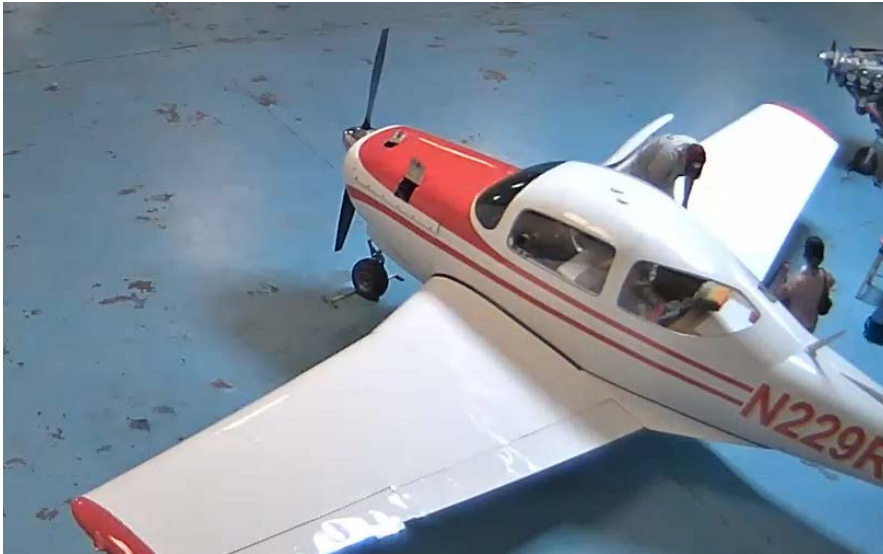
Claimant Mayes and wife unloading aircraft after Atlantic towed it into the hangar on Sunday - for Monday repair.

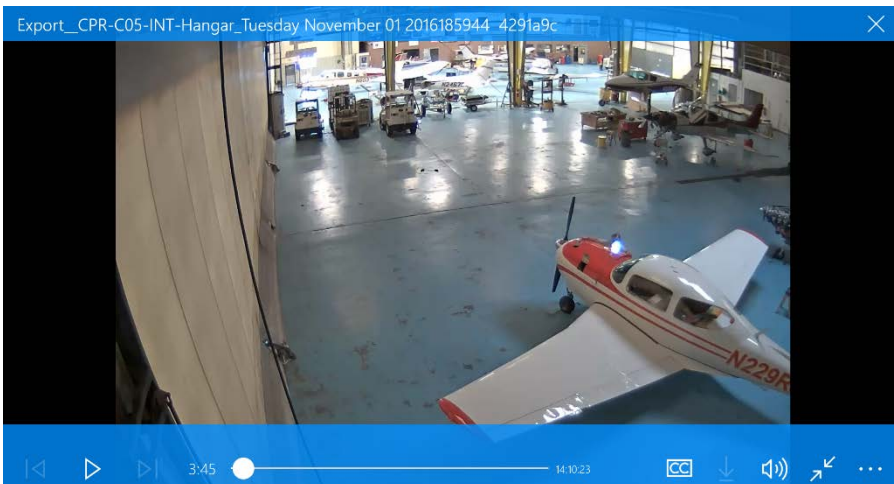
On Monday morning, Mayes removes cowling in less than a minute – before the insured's mechanic, KH (Kevin Haggard) gets there.

Mayes then stays with the aircraft throughout most of the 8 hour repair.

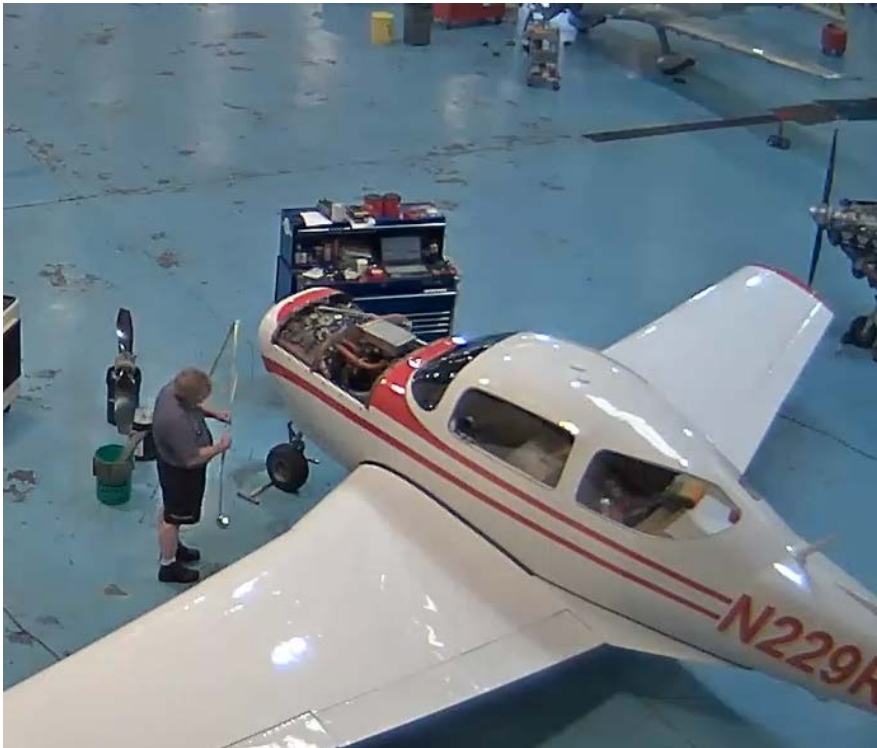
KH working on  
REPAIR 2 -  
replacement of missing  
overboard fuel drain  
line.

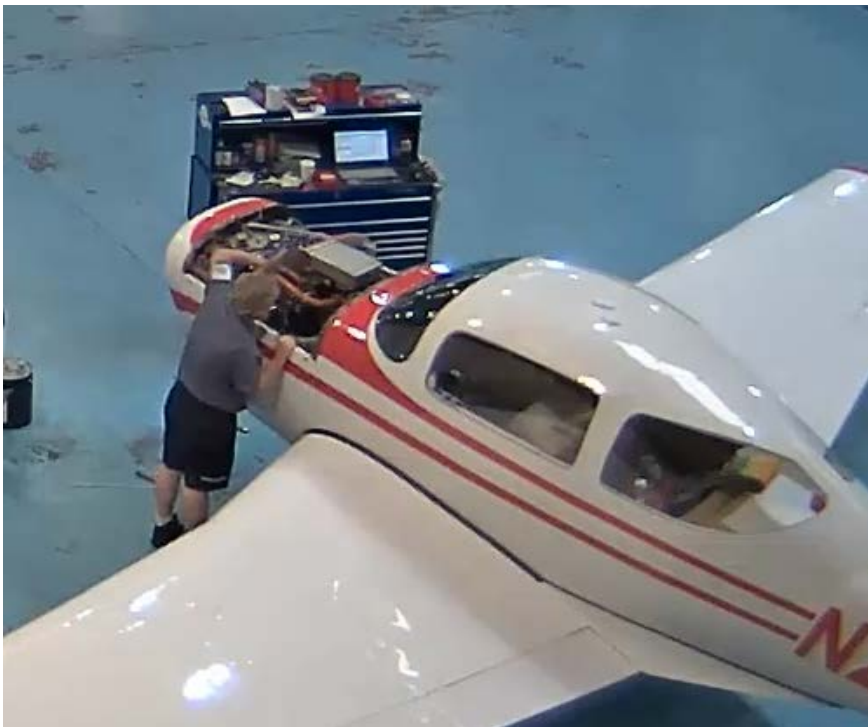
KH still working on  
REPAIR 2 -  
replacement of missing  
overboard fuel drain  
line.

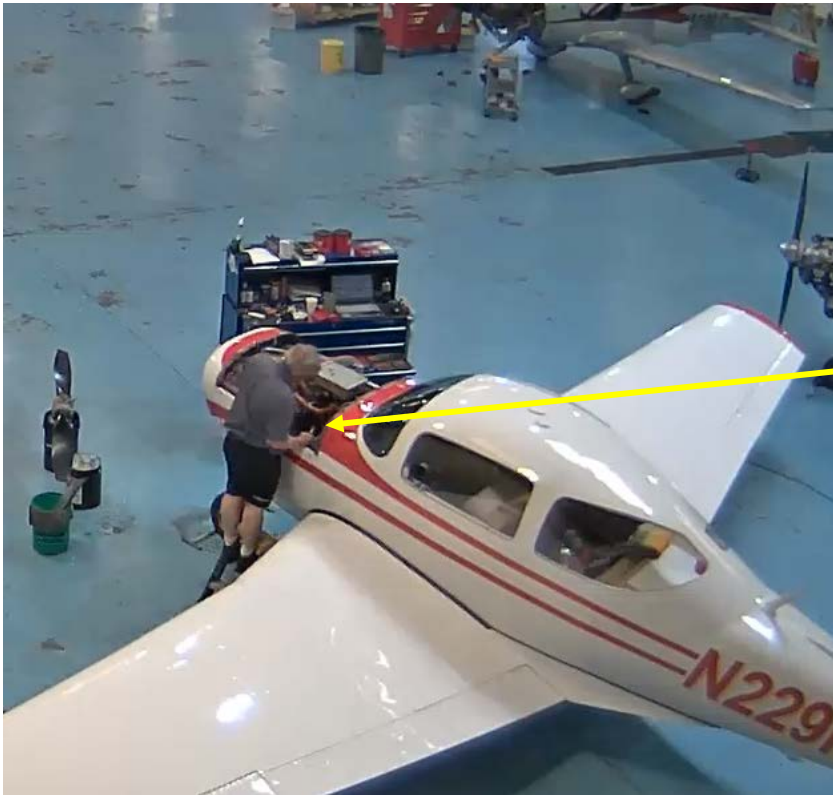
KH with the replacement “bolt” in his right hand for REPAIR 3. KH recalls putting the safety wire on the two bolts and then coming back with the safety wire tool.

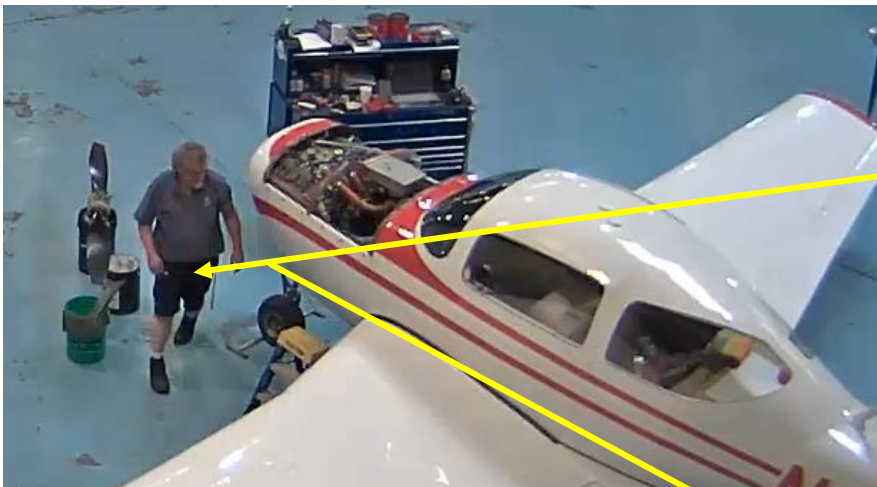
KH next approaching the same area with a safety-wire tool in his right hand (taken from his fourth down right drawer – as seen in video) –

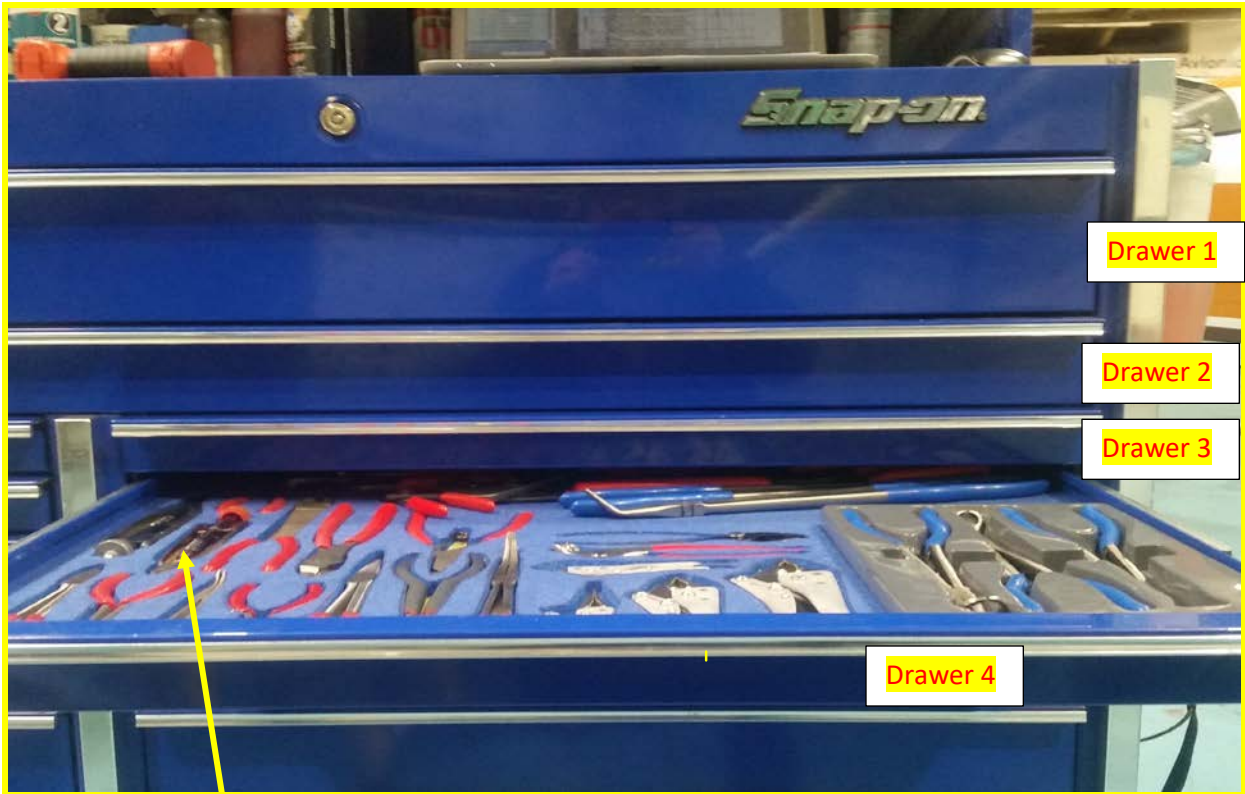
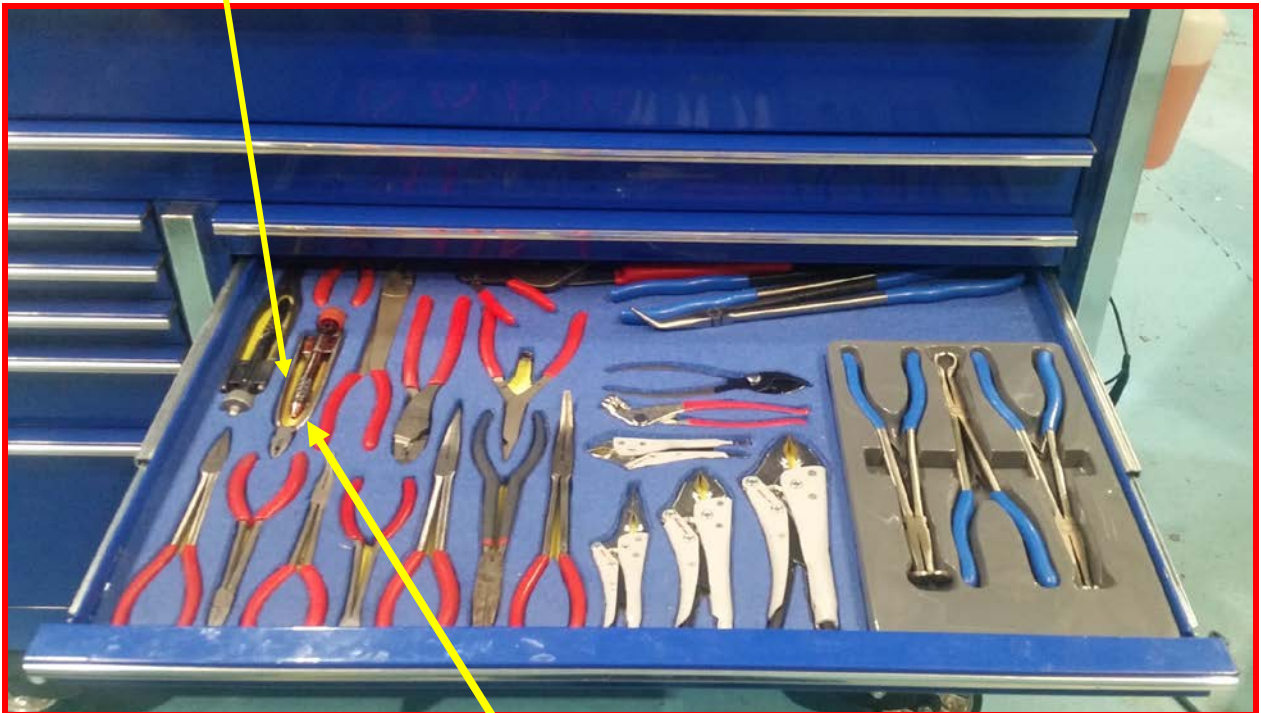
Mechanics photo of his 4<sup>th</sup> drawer with the tool in that drawer – sent to me on 11-15-16:

Following that conference call, PH and KH went out into the shop and took the toolbox photos confirming the location of the video-captured 4<sup>th</sup> drawer safety-wire tool location.

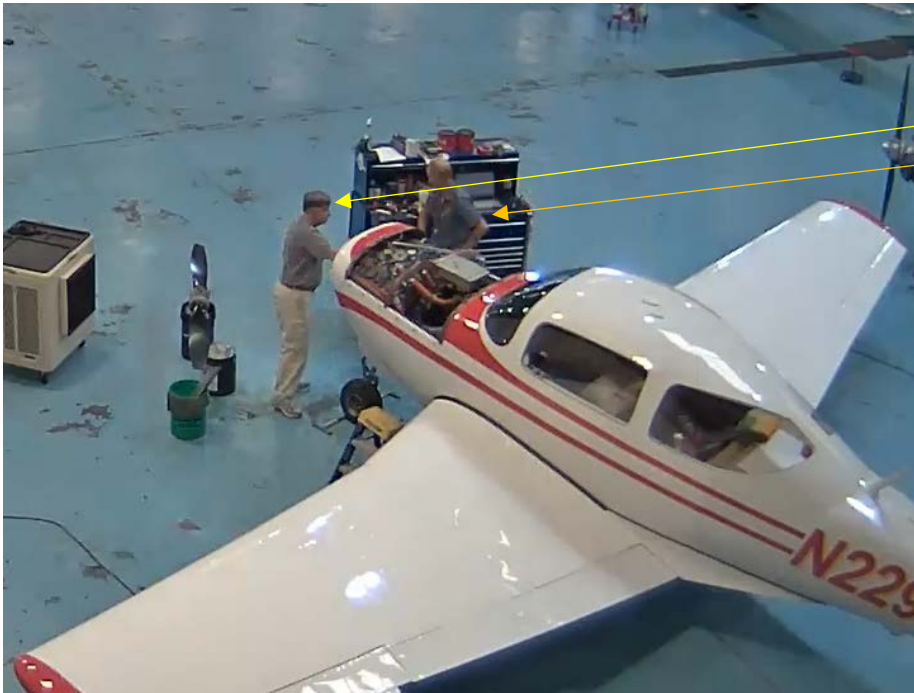
**Mayes and  
DOM PH (Pat  
Harrington) inspect  
prop seal area.**

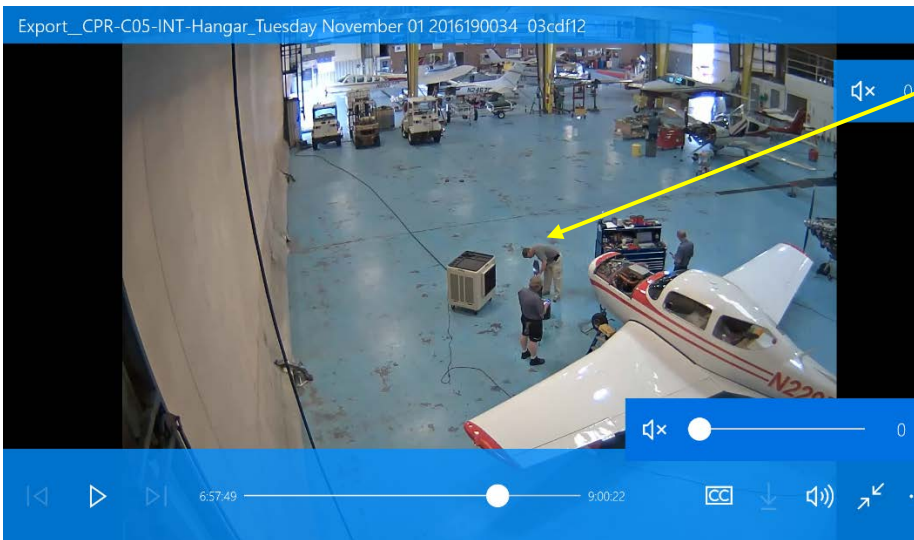
**Mayes inspects prop  
seal area...while  
waiting on seal cure  
time.**

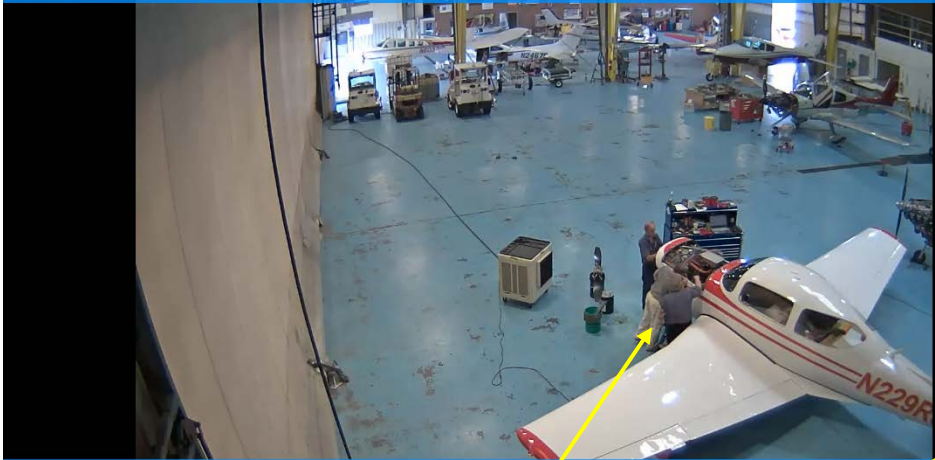
| <p>Export_CPR-C05-INT-Hangar_Tuesday November 01 2016190034_03cdf12</p> <p>6:56:53 9:00:22</p> | <p><b>Mayes looking at safety wired-area from the left side with KH.</b></p> |

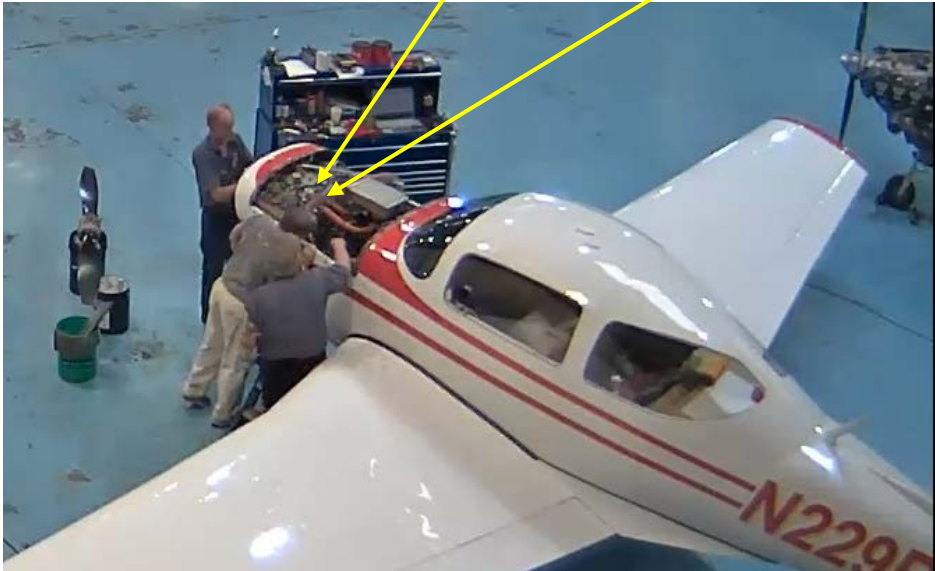
| | <p><b>KH pointing out how he ran the fuel line and showing Mayes the safety-wired bolt and assembly.</b></p> |

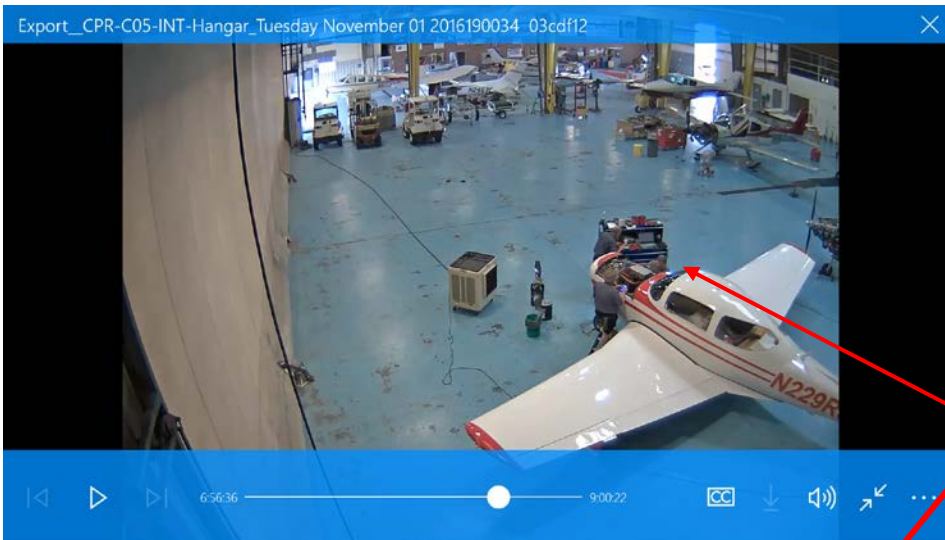
While waiting on prop seal cure time....

**Mayes looking at safety-wire area from right side.**

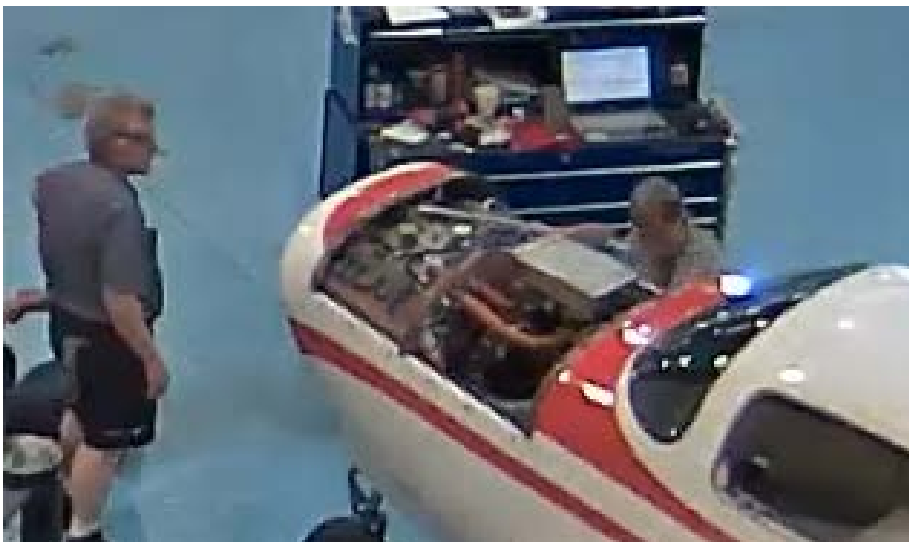
Mayes looks into the area of the safety wire and the drain line more than 5 times – this time he steps onto a step-ladder to get a better look.

And in the frames to the left – Mayes actually reaches inside to feel something in the area of the alleged “missing bolt” / “missing safety-wire”.

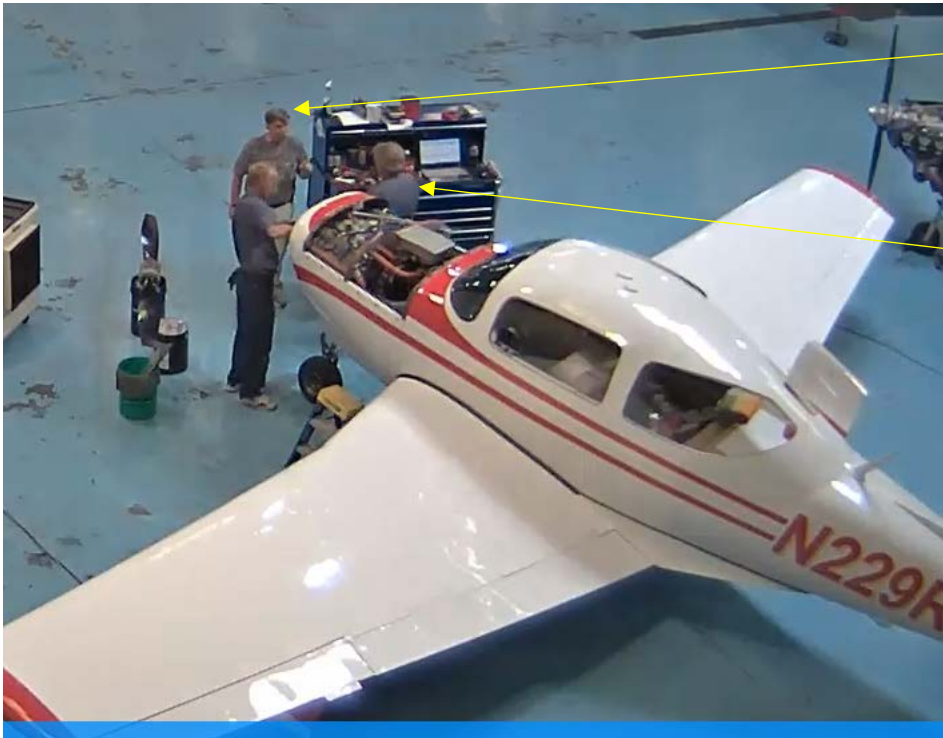
Mayes asks if he can put cowl on to save time as PH and KH install prop ...

– KH advises him to allow KH to take a last safety look at the repair areas first.

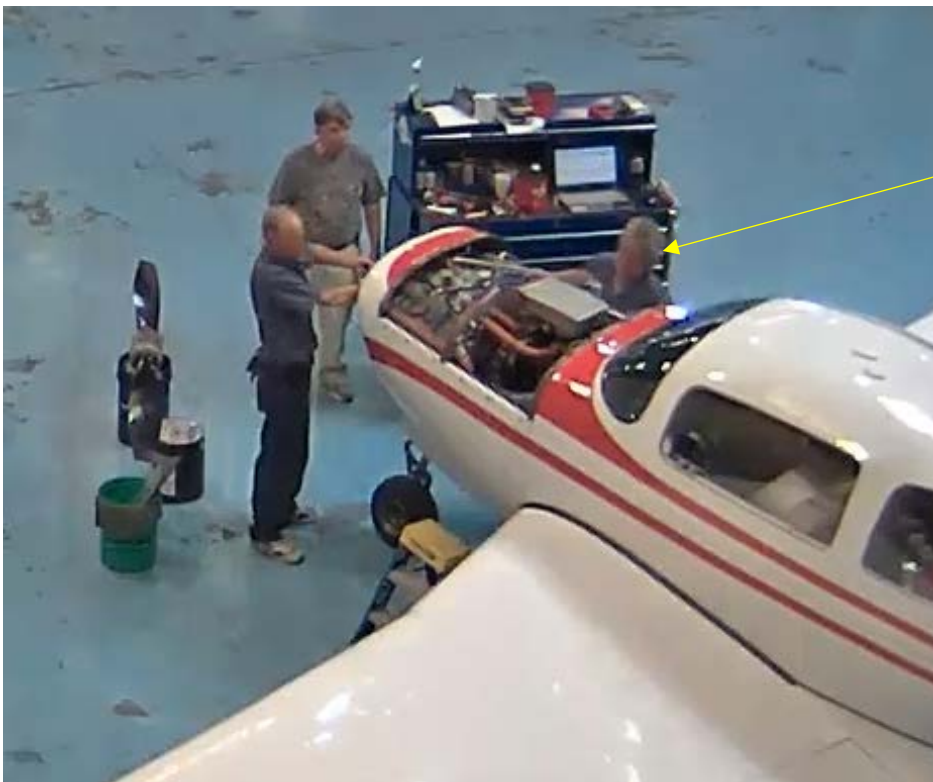
KH then takes final “safety check” look at areas of repair - before allowing Mayes’ to cowl the engine.

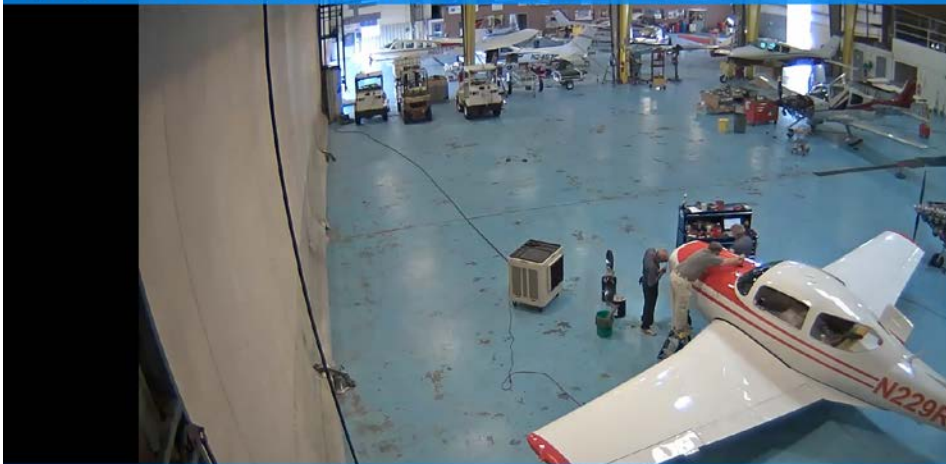
Mayes installs the cowl and tightens the safety screws.

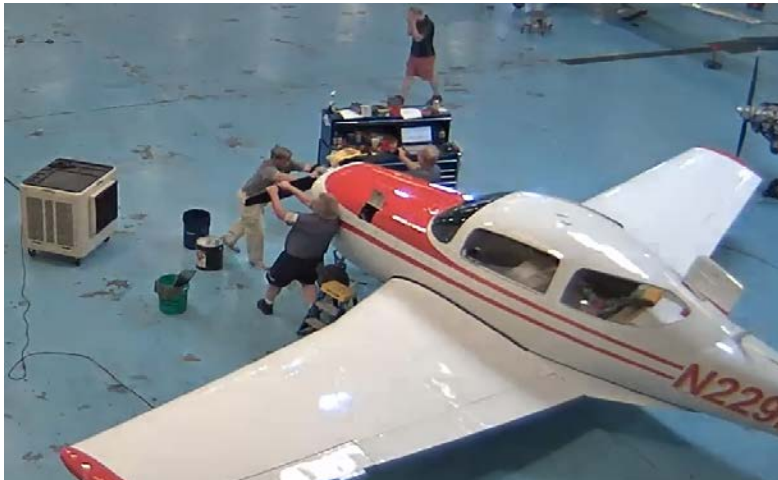
Then Mayes continues to help KH and PH with spinner and prop.

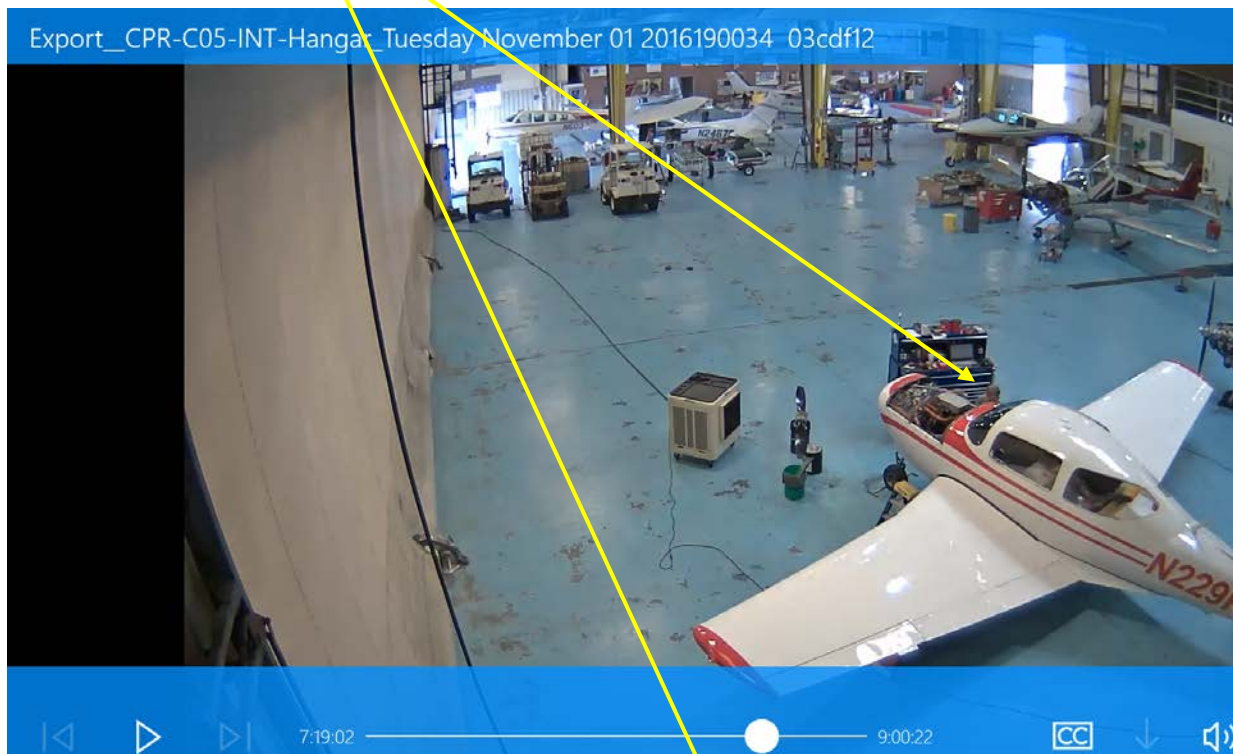
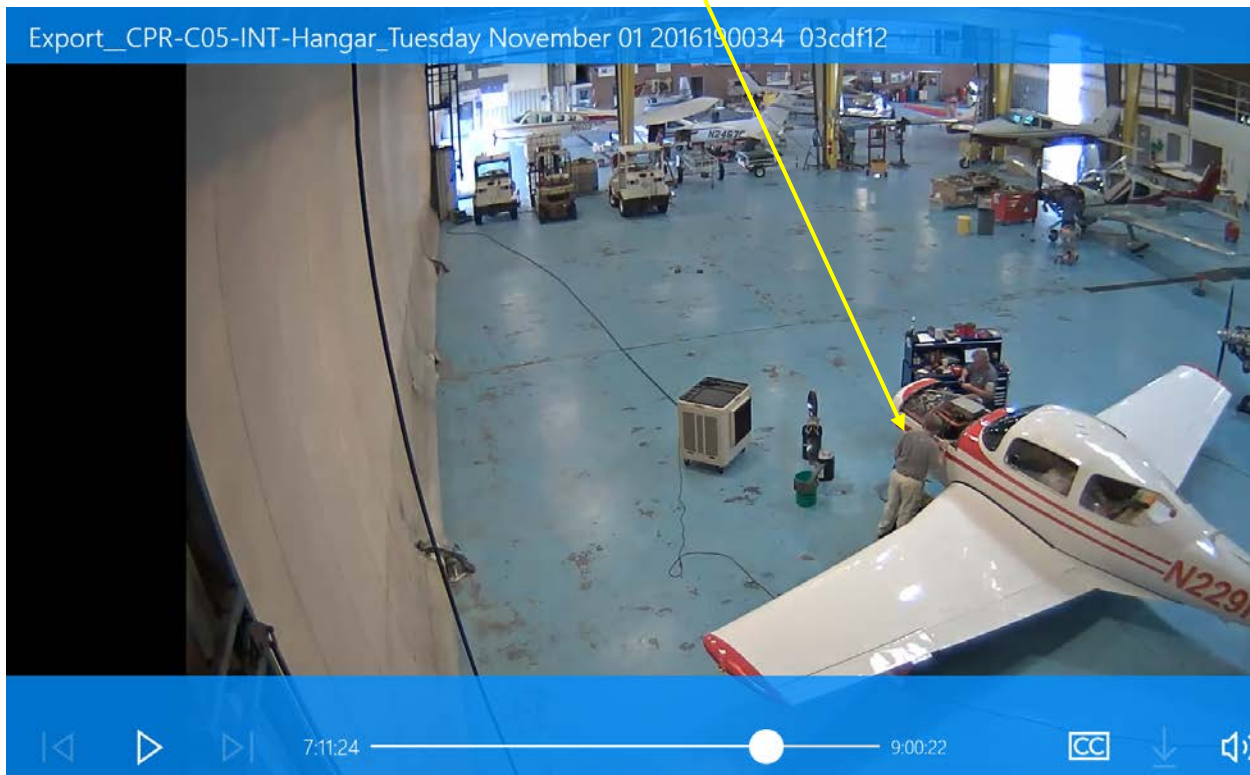
Additional/separate Mayes inspection looks into the **Repair 3** area – where the safety-wired bolt is said to have been readily visible – and easily removable by the claimant if he was so inclined after the accident.  
(Note: no cowling in place or visible in accident photos).
