**Air Tractor, Inc.**  
Accident Investigation

**AIRFRAME ACCIDENT REPORT**

**CEN16LA292**

AT-402 manufactured in 1989  
402-0720  
N1016G

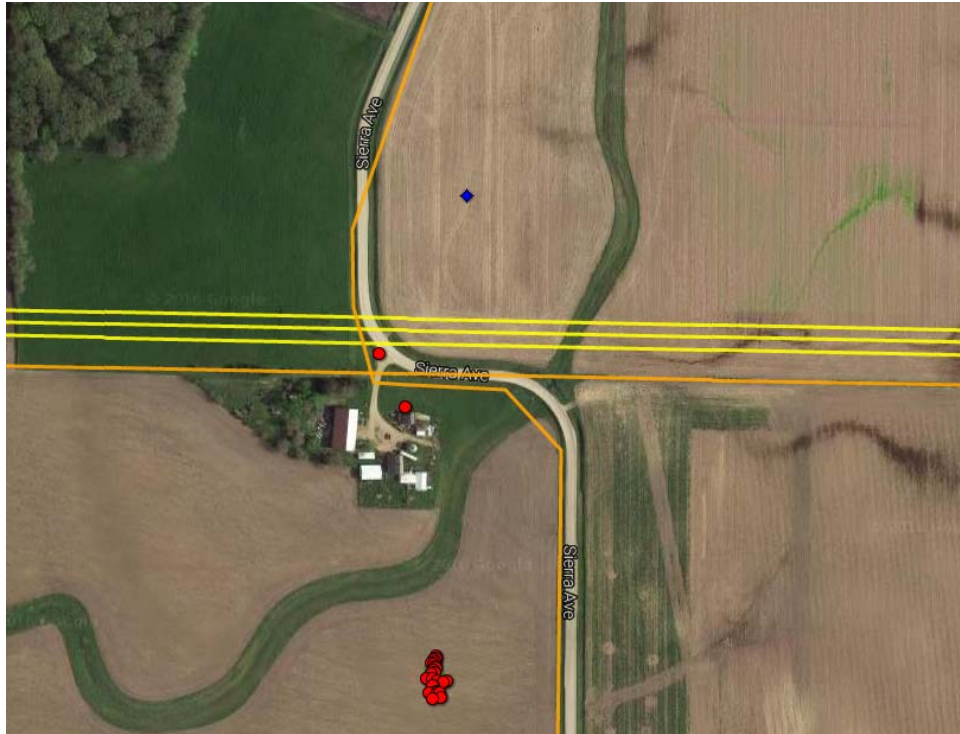
According to the FAA Inspector on scene, the field being treated ("target field") was directly north of the accident site and located on the east side of the Sierra Avenue. There were multiple obstacles in the area between the target field and the accident site.

A large set of cross-country power transmission lines ran through the south edge of the target field. These lines were running east-west approximately 150 feet north of the southern boundary of the field. The lines consisted of common H pole configuration with 3 pairs of current carrying lines underneath two ground or "static" lines at the top of the poles.

**Aerial view of the accident site. The target field is marked with a blue diamond. Aircraft wreckage is marked with red circles. Power lines are marked in yellow and orange.**

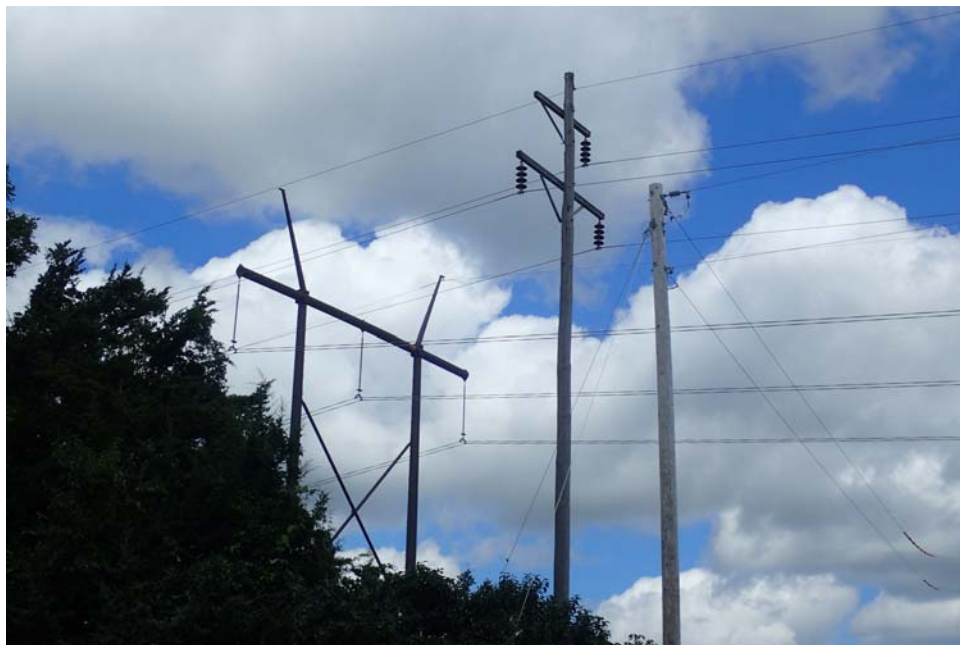
At the southwest corner of the target field, there was a farm with several large barns and some

**View near southwest corner of the target field showing multiple obstacles**

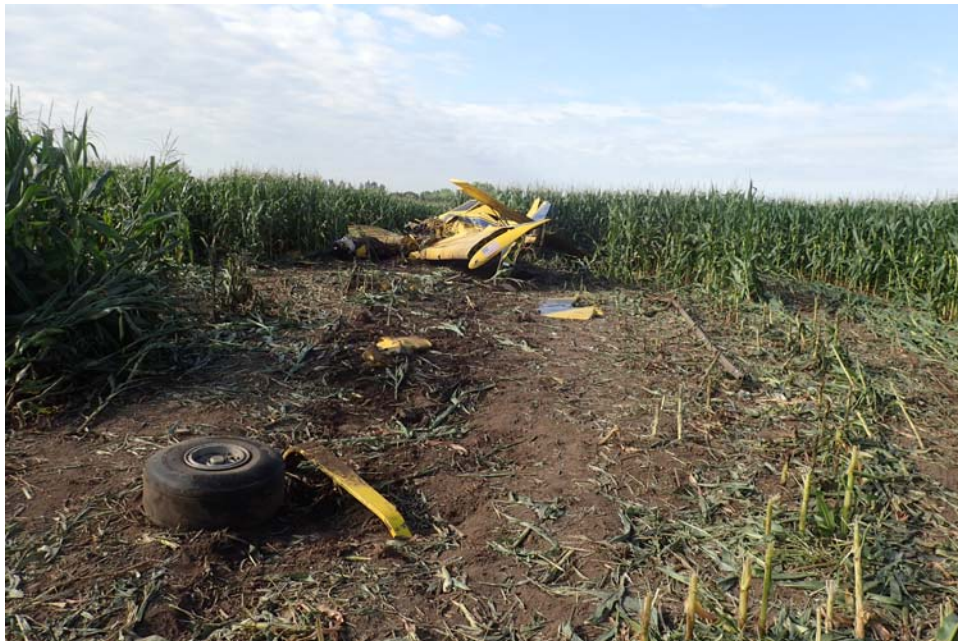
The wreckage was located 750 feet south of Sierra Avenue. The wreckage debris trail was oriented from north to south. The wreckage had cut a swath through the corn upon impact and this area was generally devoid of foliage except for some areas of corn stalks that had been snapped off near the ground.

The center of the wreckage was approximately 75 feet from the initial impact area. The debris trail and position of the wreckage are consistent with a low-angle impact of moderate speed. The evidence suggests that the aircraft impacted in a wings-level upright attitude with a very high yaw angle. It is difficult to determine exactly what the impact yaw angle was, but the following facts were gathered:

**Wreckage viewed from initial impact point**

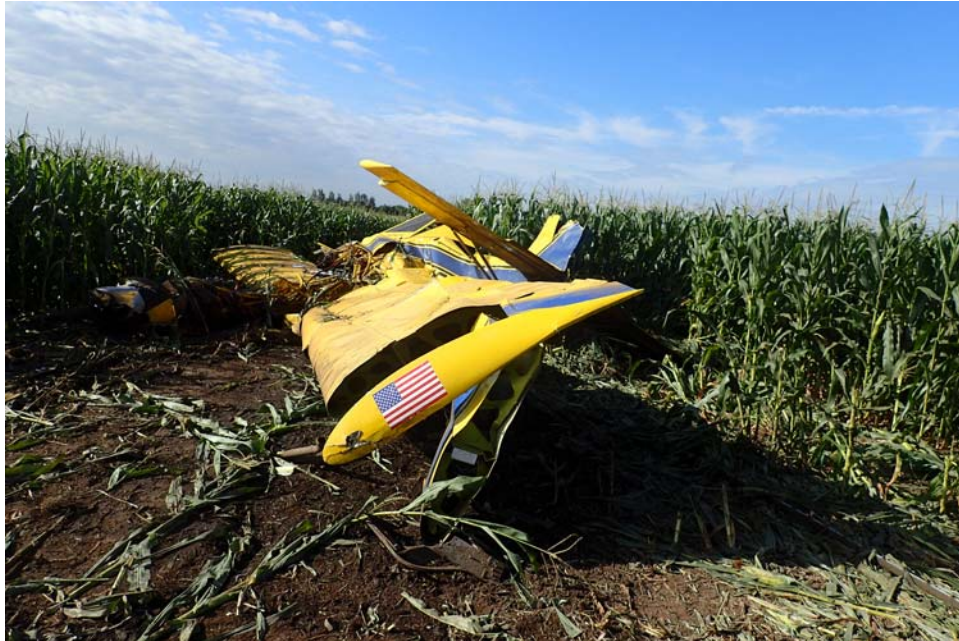
The primary aircraft wreckage was significantly distorted from its pre impact state. The center fuselage between the firewall and the cockpit was destroyed and scattered around the fuselage wreckage. The fuselage was bent so that the aft fuselage nearly touched the trailing edge of the left wing. The engine and engine mount remained connected to the wreckage but were severely damaged.

**Closer view of wreckage**

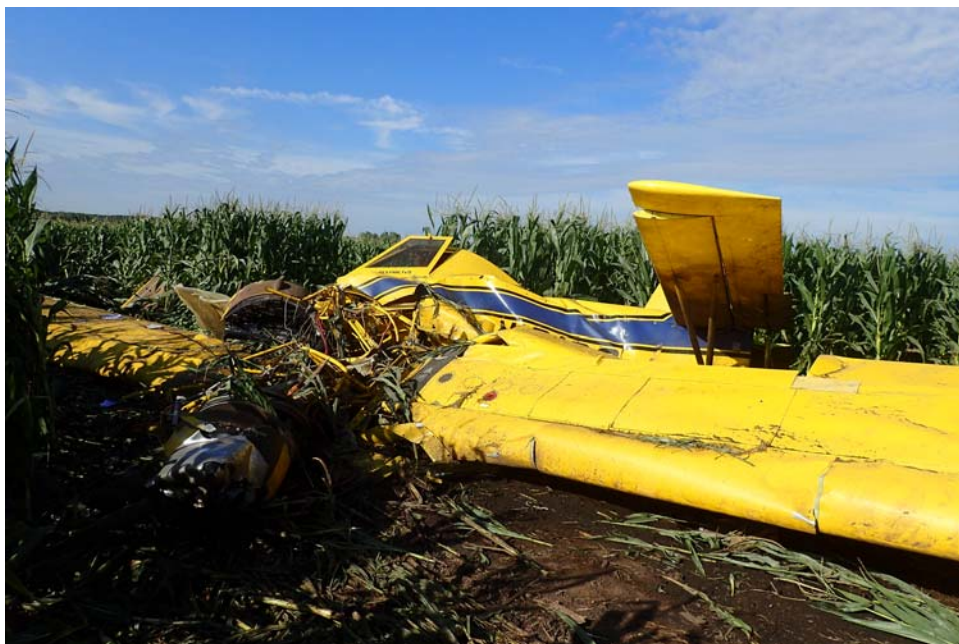
All aspects of the fuselage were damaged by impact forces, with the most severe damage being concentrated in the center of the fuselage between the firewall and the cockpit area. This portion of the fuselage exhibited damage from the torqueing of the fuselage relative to the wing. The chemical hopper is a major component of this area of the aircraft. The hopper extends from the aft side of the firewall to the forward wall of the cockpit and instrument panel. The hopper was split with the hopper top, hopper lid, and various pieces of the hopper walls scattered to the southern end of the wreckage. The aft wall of the hopper remained with the fuselage wreckage with the instrument panel still attached.

**Fuselage Wreckage**

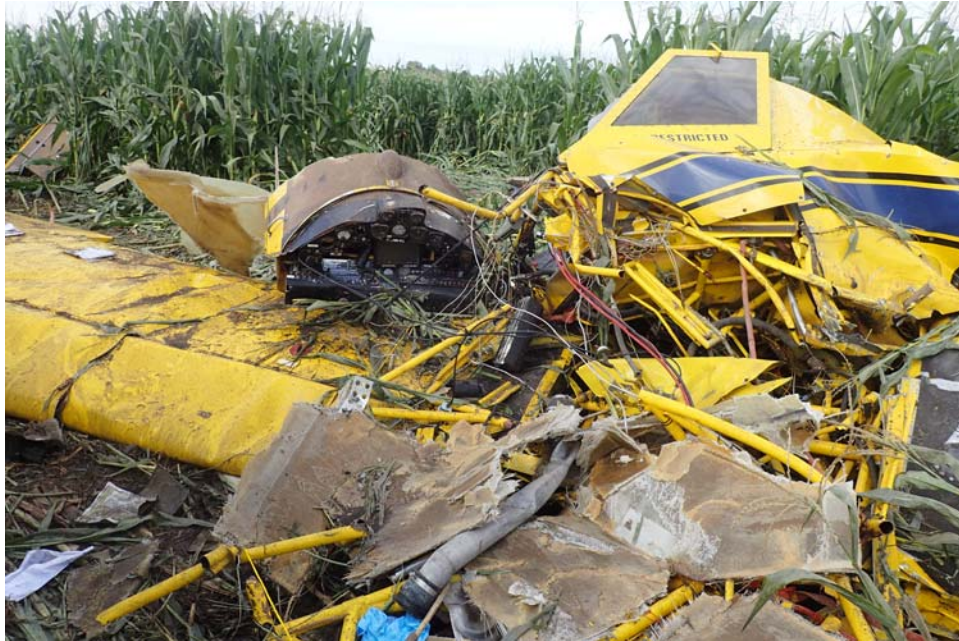
**Detail of Center Fuselage Wreckage**

Aft of the cockpit area, the fuselage was generally in one piece, but with significant deformation. This deformation consisted of torsional and bending deflection of the aft fuselage.

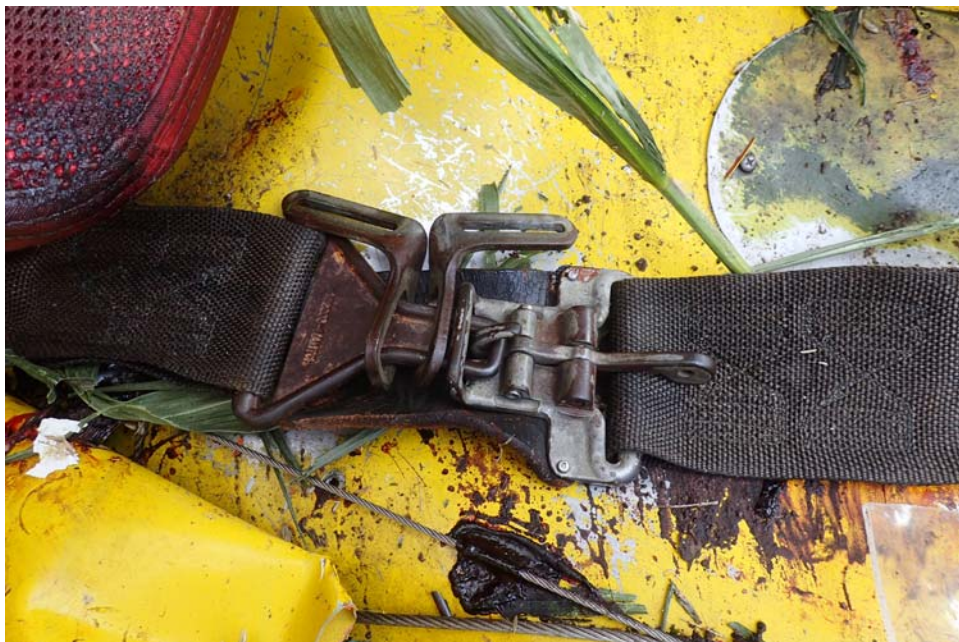
This aircraft was equipped with a four point pilot restraint system. The restraints were found in the aircraft buckled with both shoulder harness attachments engaged. The lap belt had been cut by first responders on the left side of the buckle.

**Lap Belt & Shoulder Harness Buckle**

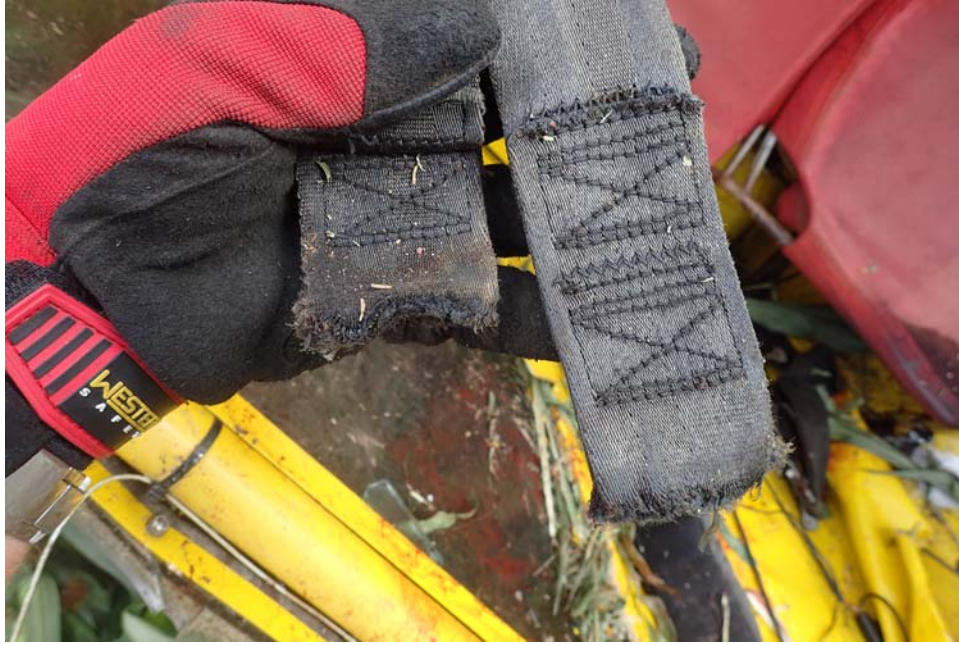
The shoulder harness straps had separated from the attachment points at the lap belt. There was also some fraying of the shoulder harnesses, but no failure, at an area near the top of the seatback. The condition of the shoulder harness webbing material appeared to be damaged

from UV exposure.

**Ends of Shoulder Harness Straps**

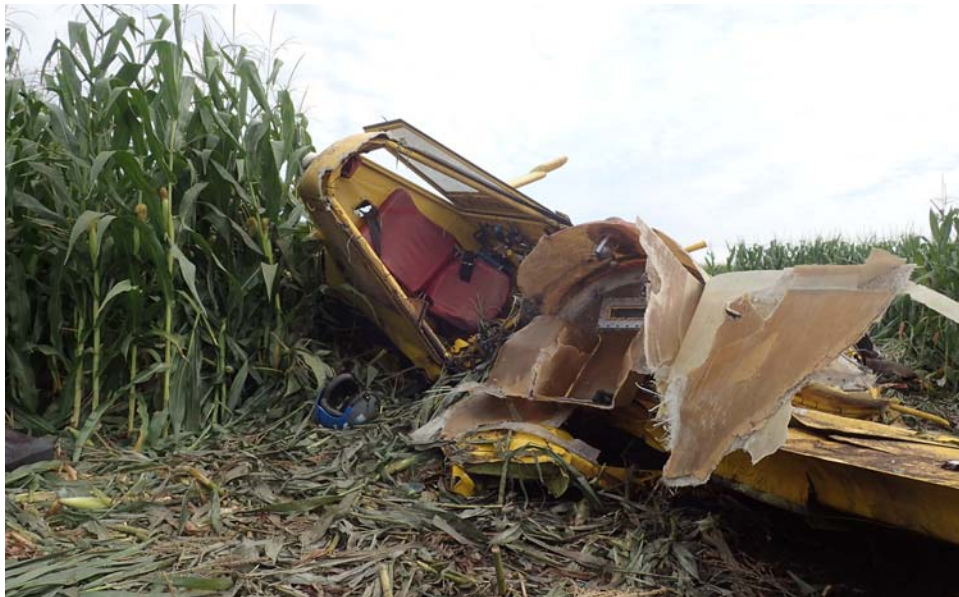
The cockpit area of this aircraft was found with the forward wall and windshield no longer in place. The forward wall of the cockpit is part of the hopper structure and was laying adjacent to the fuselage as described earlier in the Fuselage section of this report. Attached to this section of the hopper is the instrument panel. Despite the separation of the shoulder harnesses that was mentioned earlier, a review of the instrument panel showed no indications of a head impact. There was no significant panel damage and there was no hair or flesh found on the panel.

**Cockpit Wreckage**

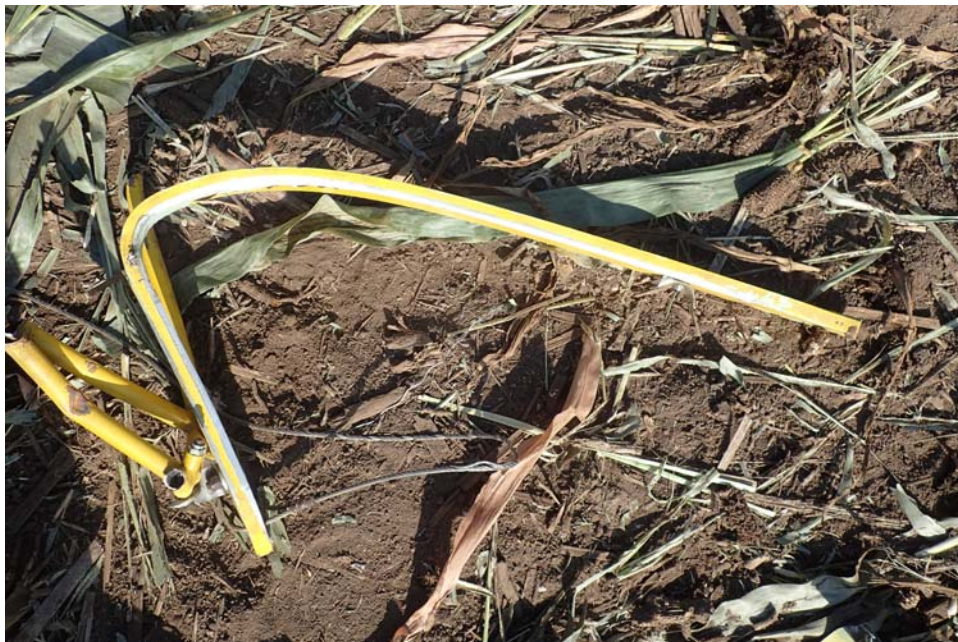
The aluminum bar was found in the debris field, along with the rudder, and was severely damaged. The bar was no longer attached to its lower base. At the upper end, the tubular support structure had separated from the cockpit overturn structure and remained attached to the bar. A piece of the deflector cable, approximately 6 feet long, remained attached to the top of the bar.

**Aluminum bar as found (overturn structure and cable attached)**

The aluminum bar was bent into a rough V-shape with an inside angle of about 45 degrees. This bend was toward the lefthand side of the aircraft. This is consistent with an asymmetric wire strike that was not deflected over the canopy.

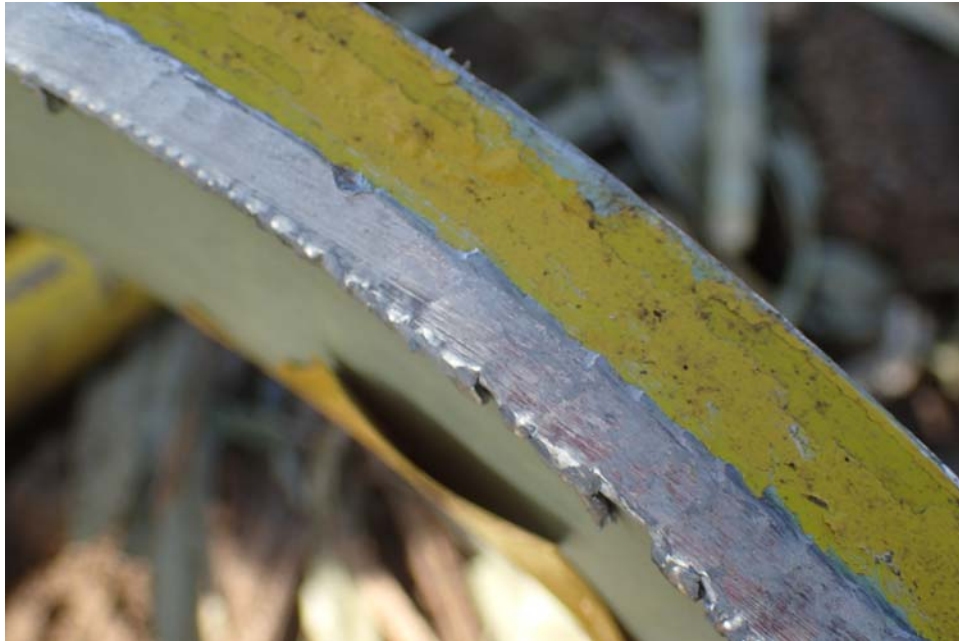
The bar had a deep chamfer on the righthand edge that ran the entire length of the part. The

cable that was attached to the bar exhibited abrasion and damage. This is consistent with a wire impact that was deflected by the bar, over the canopy, and onto the cable. An aftermarket GPS antenna was also missing from the top of the canopy. The markings on the canopy indicated that the antenna was dislodged by a rearward scraping action, possibly from a wire strike.

**Detail of the bar showing chamfered edge**

The markings on the bar indicate that the wire strike was asymmetric. This may have been due to any of several factors such as hitting the wires at an acute angle, hitting the wires with a significant amount of yaw angle (sideslip), or hitting the wire near an anchor point (e.g. utility pole). An asymmetric wire impact is typically the most damaging type of impact because the unbroken wire creates a sawing action as it slides across the airframe. This results in high lateral forces, an increase in airframe damage, and a lessened tendency to break the wire.

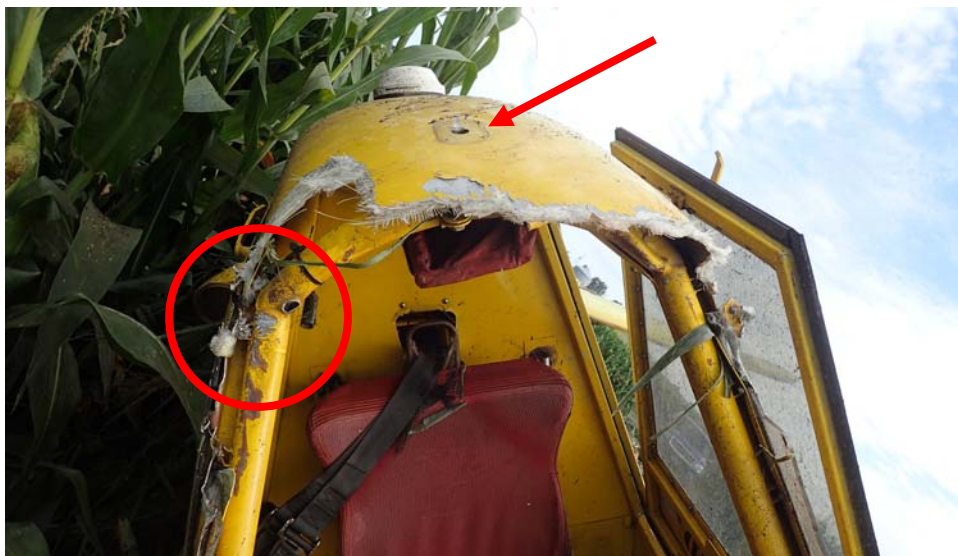
**Detail of canopy damage, wire contact damage (red circle), and missing antenna (red arrow)**

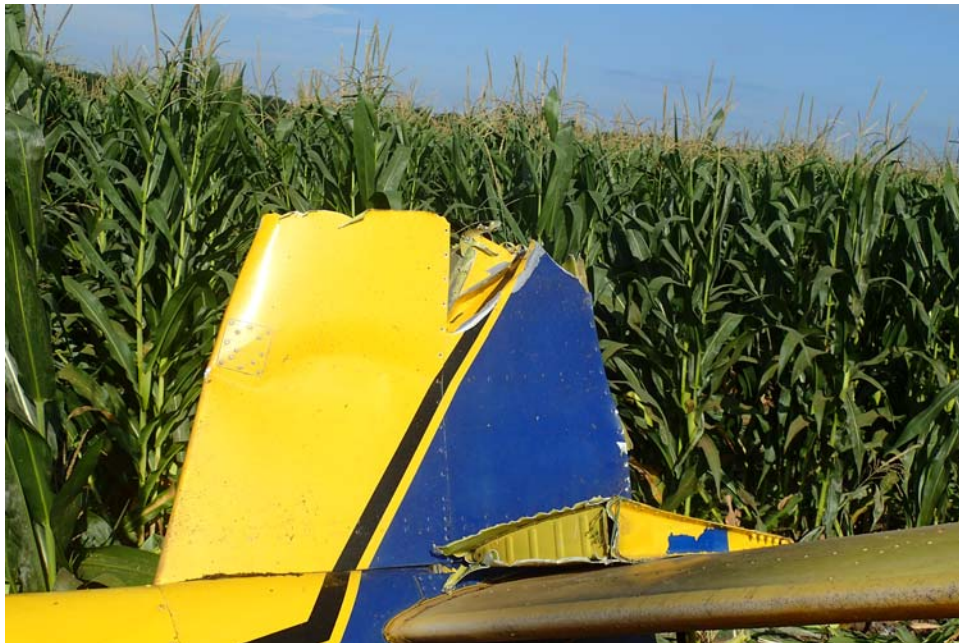
Another strong sign of wire strike was the damage to the vertical fin and rudder. The top 15 inches of the vertical fin was separated from the aircraft. This separation was a clean, slicing cut. The top portion of the vertical fin was found near one of the barns near the power lines. A portion of the deflector cable remained attached to the top of this piece of vertical fin.

**Damage to the vertical fin**

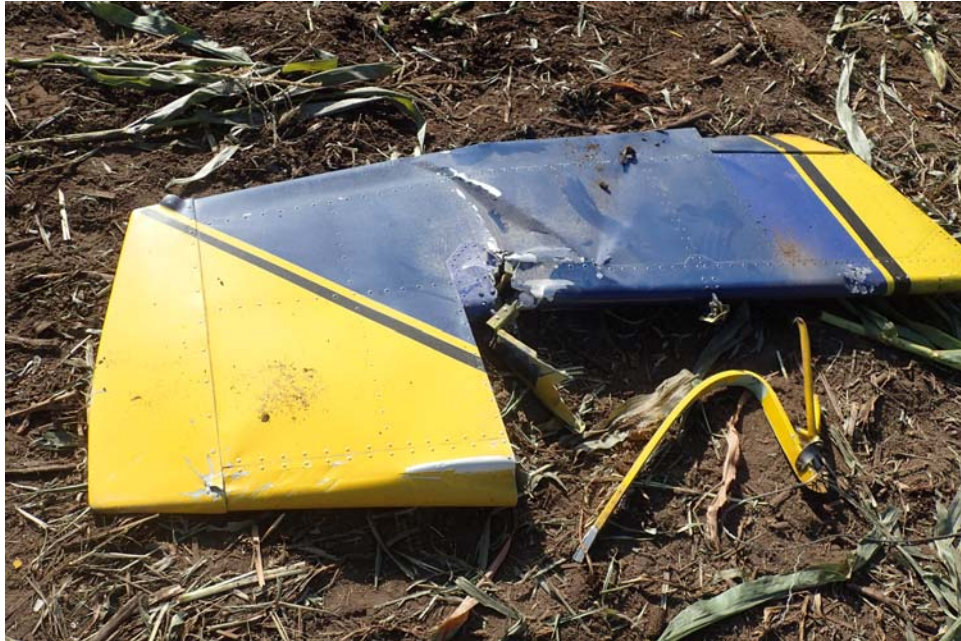
The rudder received a gouge approximately 4 inches deep into the hingeline. The location of this damage is consistent with the separation line of the vertical fin. The rudder separated from the vertical fin at the hingeline and was found beneath the power lines. The aft end of both rudder control cables were attached to the rudder control horn and both sides of the horn were deformed 90 degrees down. This is indicative that the rudder separated from the vertical fin before breaking the rudder cables. Due to the force required to break these cables (~2,400 lbs minimum per side), it is expected that both rudder pedals were pulled aft with significant force and speed before the cables separated.

**Damage to the rudder**

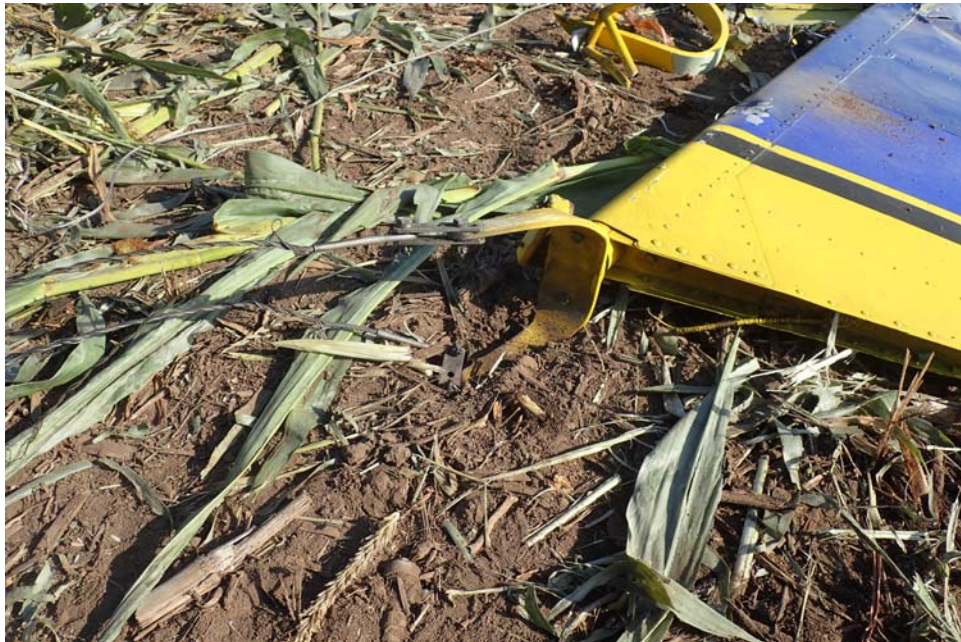
**Deformation of the rudder control horn**

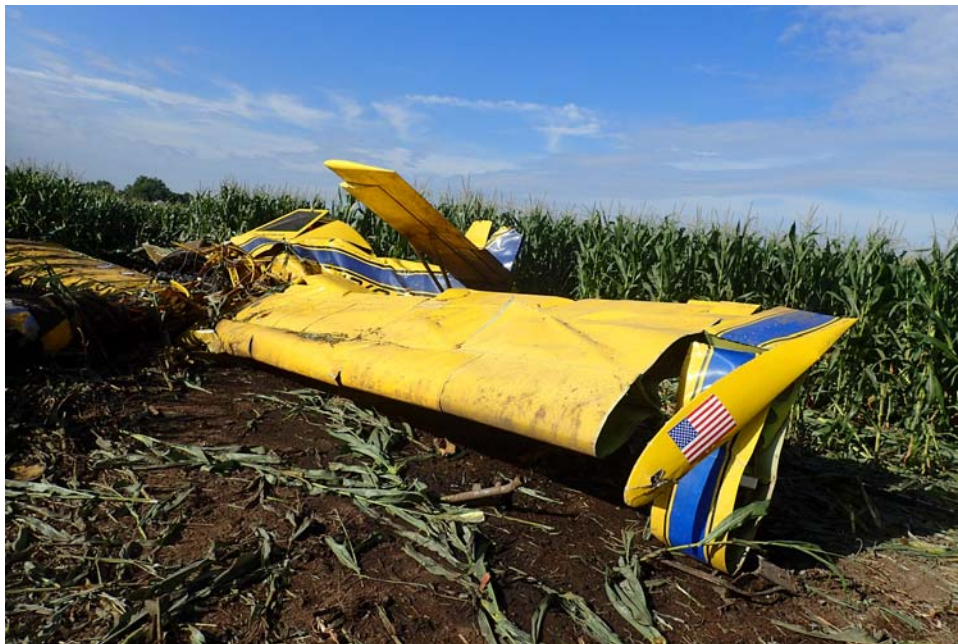
The right and left wings remained connected together at the center splice joint. There were no notable impact marks on the leading edge or upper surface of the wings. The inboard leading edges of both wings were deformed aft and upward slightly. All wing skins had some general damage.

**Right Wing**

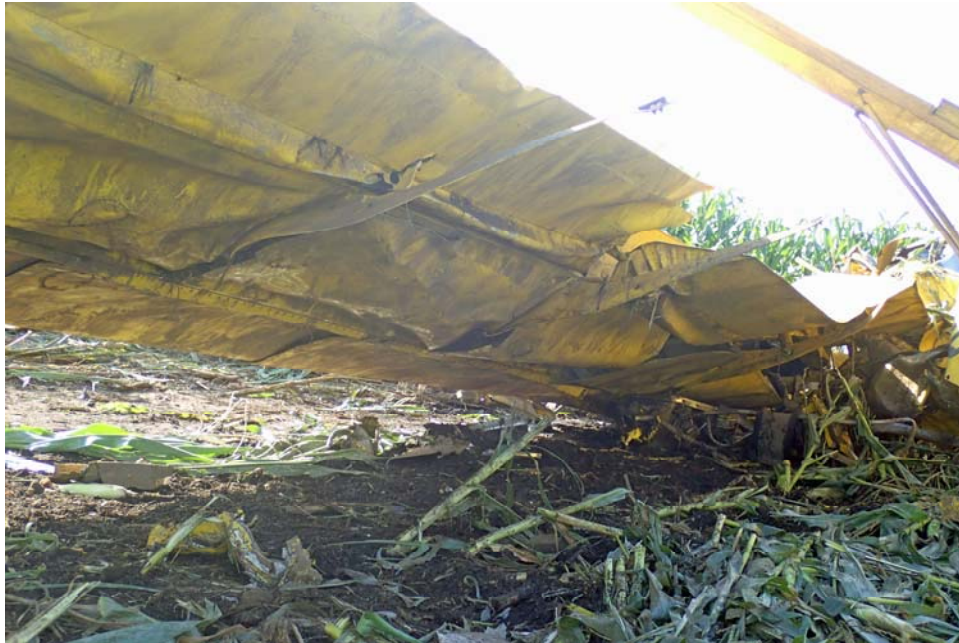
The bottom of the wings displayed heavy crush damage to the skins. All of the aluminum flap and elevator hinges, along with the hangers for the spray booms, were bent toward the lefthand wingtip. The outboard half of the righthand flap had been bent under the inboard half.

All of this evidence strongly supported the conclusion that the aircraft slid along the ground laterally in a right wing forward direction.

**Underside of Right Wing**

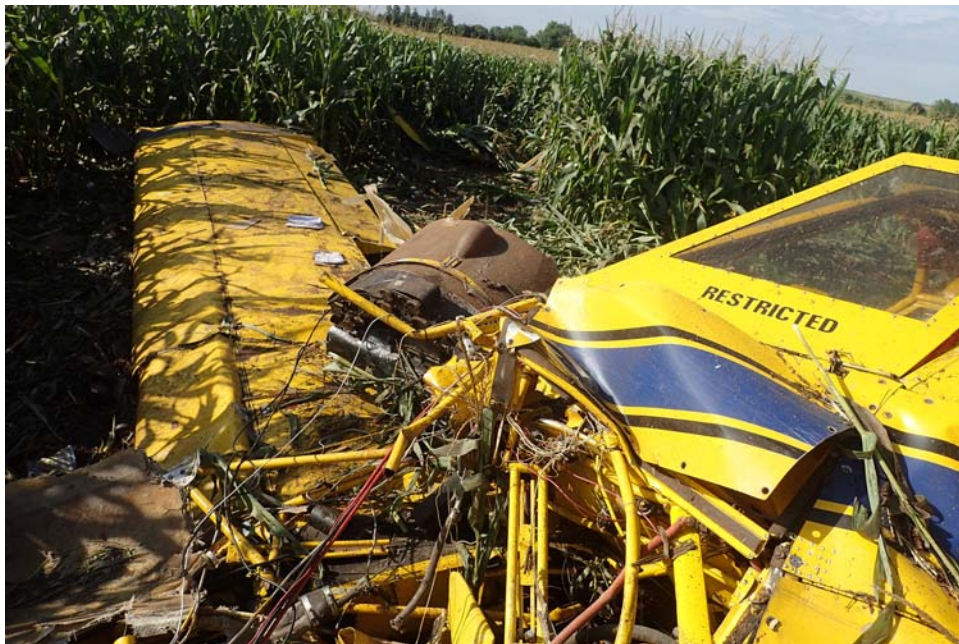
**Left Wing**

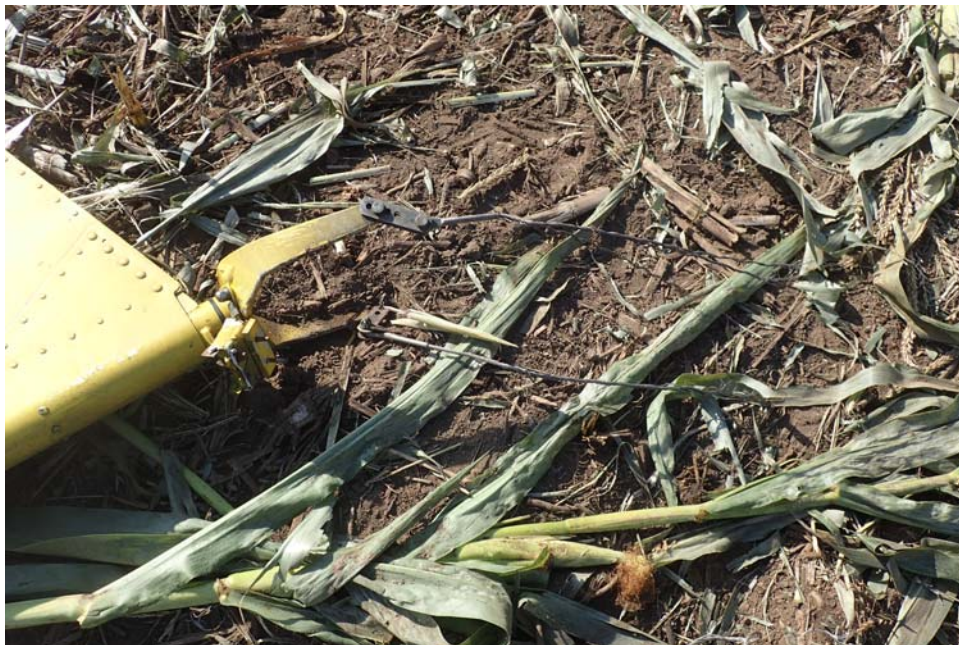
Both rudder pedals remained attached to their pivot points with the rudder cables and adjustment brackets remaining in place. The rudder cables were traced back into the aft fuselage and found to be properly routed to the point that both cables were found to be frayed. This frayed "horse tail" end of the cables is an indicator of tensile overload.

The rudder was located separately at the accident site. The horn plate remained installed on the bottom of the rudder. Instead of in its normally flat layout, the horn was bent into a U-shape. The aft end of the rudder cables were attached properly to the horns. Only about 15 inches of each cable remained attached to the rudder. The ends were frayed, matching the horse-tail pattern of the forward portion of the cable.

**Rudder horn with separated cables**

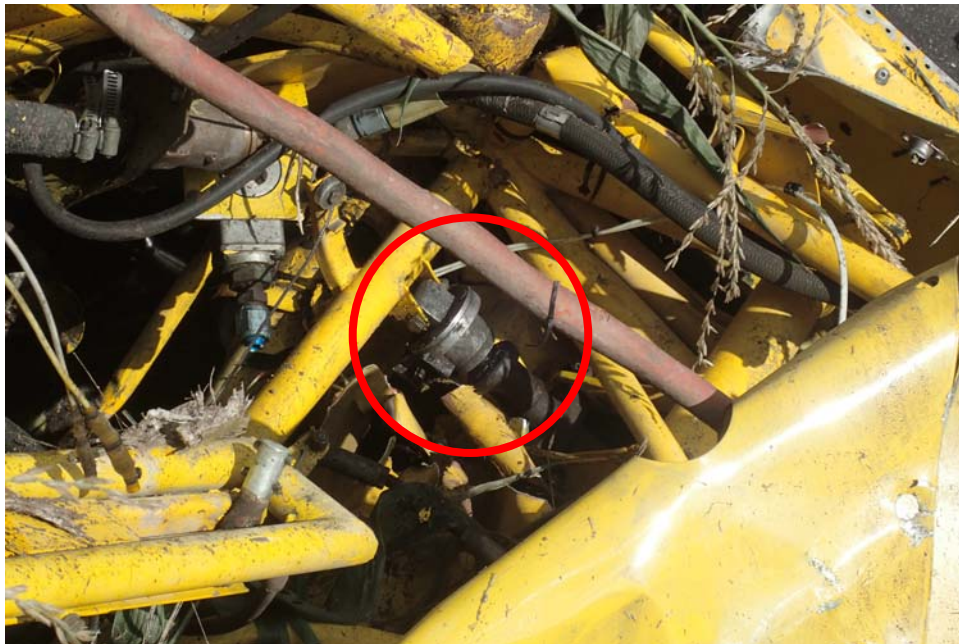
The flap actuator was found in the retracted position, indicating that the flaps were retracted at the time of the impact. The electric flap motor was broken free of the gearbox assembly.

**Retracted Flap Actuator**

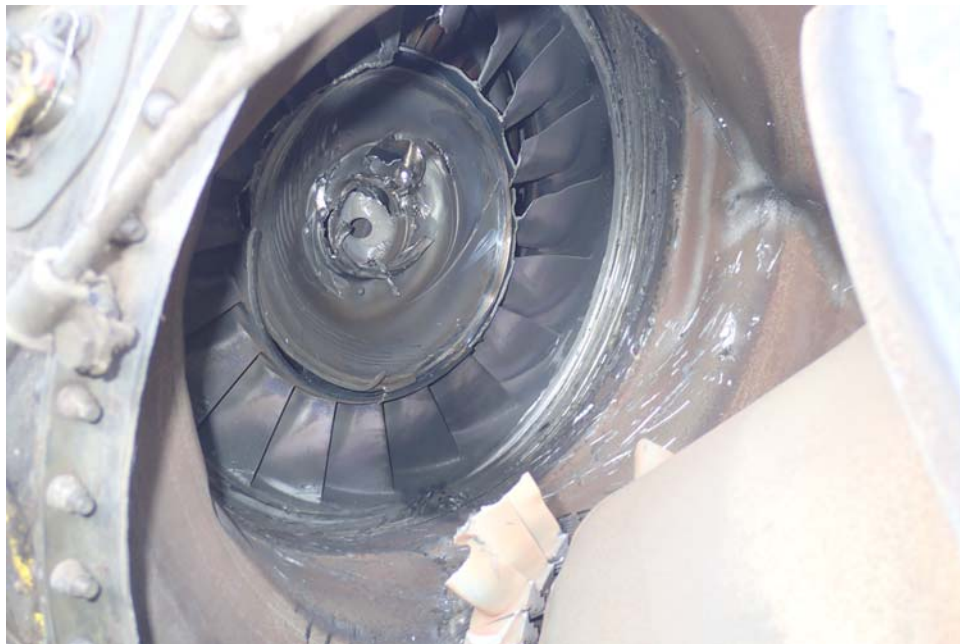
The engine was substantially damaged during the impact, although it remained attached to the engine mounts and the engine plenum bulkheads. There was some crush damage to the engine exhaust case. The engine had separated at the "C" flange, revealing the interstage baffle and the power turbine wheel. The power turbine had damage to all blades and the interior of the engine showed significant rotational signatures.

**Detail of Engine Interior (looking aft through the separation at the "C" flange)**

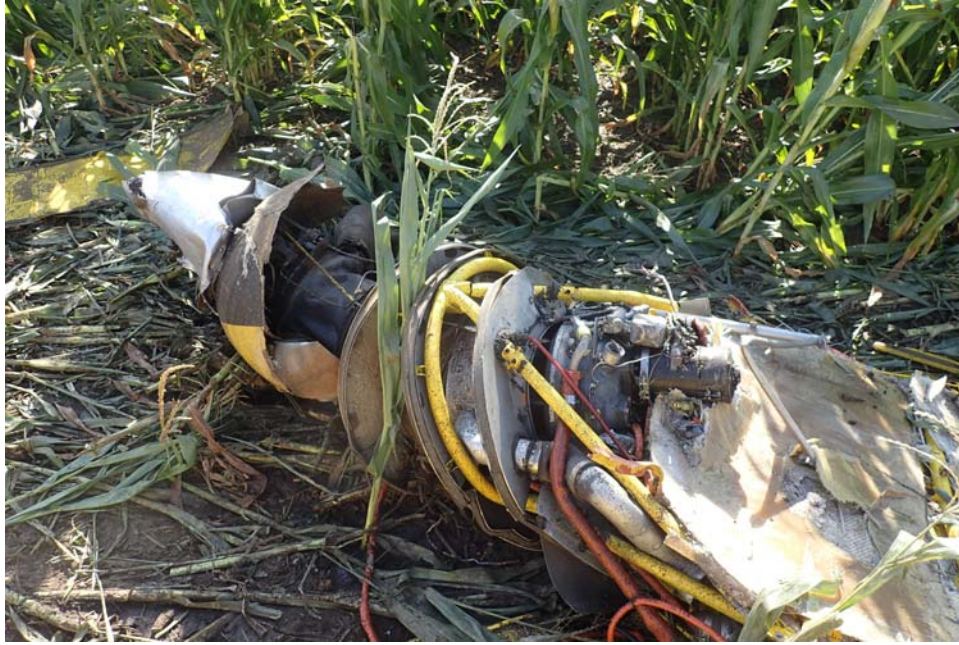
The propeller hub and spinner remained attached to the engine flange. Only one blade remained attached to the hub. The two other blades were not found at the scene. FAA Inspector Rohrer stated that the two blades had been present in the debris field on his previous visit to the scene on the day of the accident. Local law enforcement was called to

**Engine Wreckage as Found**

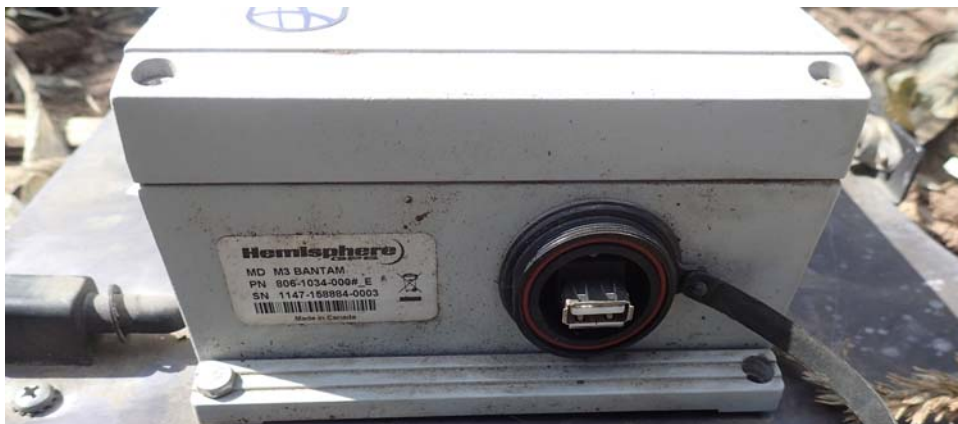
FAA Inspector Josh Rohrer took possession of the CPU component of the Satloc Bantam system GPS system. This unit was removed from the wreckage by separating its mounting plate from the installed vibration isolators. The unit appeared to be undamaged.

**Detail of GPS Unit after removal from wreckage**
