**From:** Gust, Jeffery J [REDACTED]  
**Sent:** Monday, October 17, 2016 4:49 PM  
**To:** Lindberg Joshua  
**Subject:** RE: NTSB Request for Info - Sac City, IA Accident  
**Attachments:** B67 Sac City P&P.PDF

PROJECTS 52451 & 52452  
FACILITY B67 - SECTION 2  
RAUN TO LEHIGH - 345 KV  
STR 168 TO 327

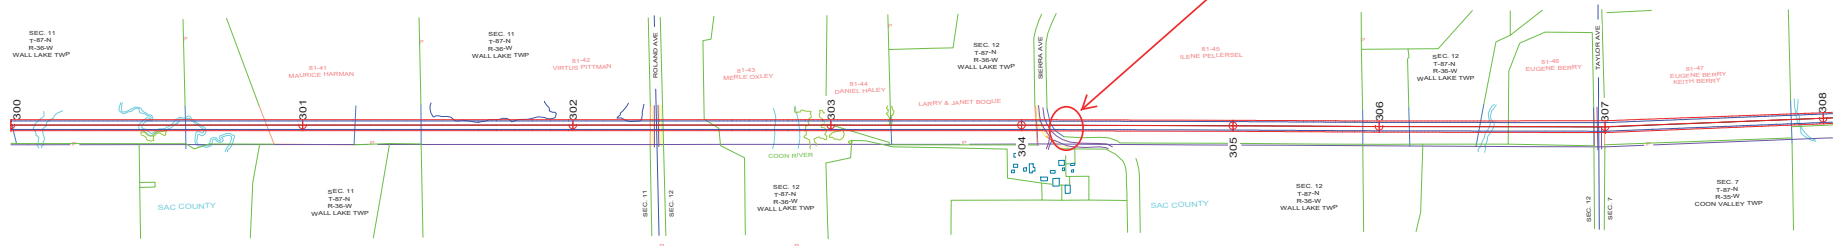
MidAmerican does not know exactly which span of the 345 kV line was struck by the airplane on July 29, but believe it was on one side or the other of Structure 304 based on debris. As shown on the attached, the total height of the steel H-frame structures and difference in height between the conductors and the shield wires at the structures and at maximum locations in the spans from Structure 303 to Structure 305 are:

- Structure 303 Height Above Ground; 106.00 feet
- Structure 303 Wire Elevation Difference; 28.5 feet
- Structure 303-Structure 304 Maximum Wire Elevation Difference; 33.5 feet at maximum sag (not at midspan due to pole and ground elevation differences)
- Structure 304 Height Above Ground; 81.00 feet
- Structure 304 Wire Elevation Difference; 28.5 feet
- Structure 304-Structure 305 Maximum Wire Elevation Difference; 34.5 feet at maximum sag (roughly at midspan)
- Structure 305 Height Above Ground; 87.38 feet
- Structure 305 Wire Elevation Difference; 28.5 feet
