# N211FC

Engine Teardown

August 19, 2016

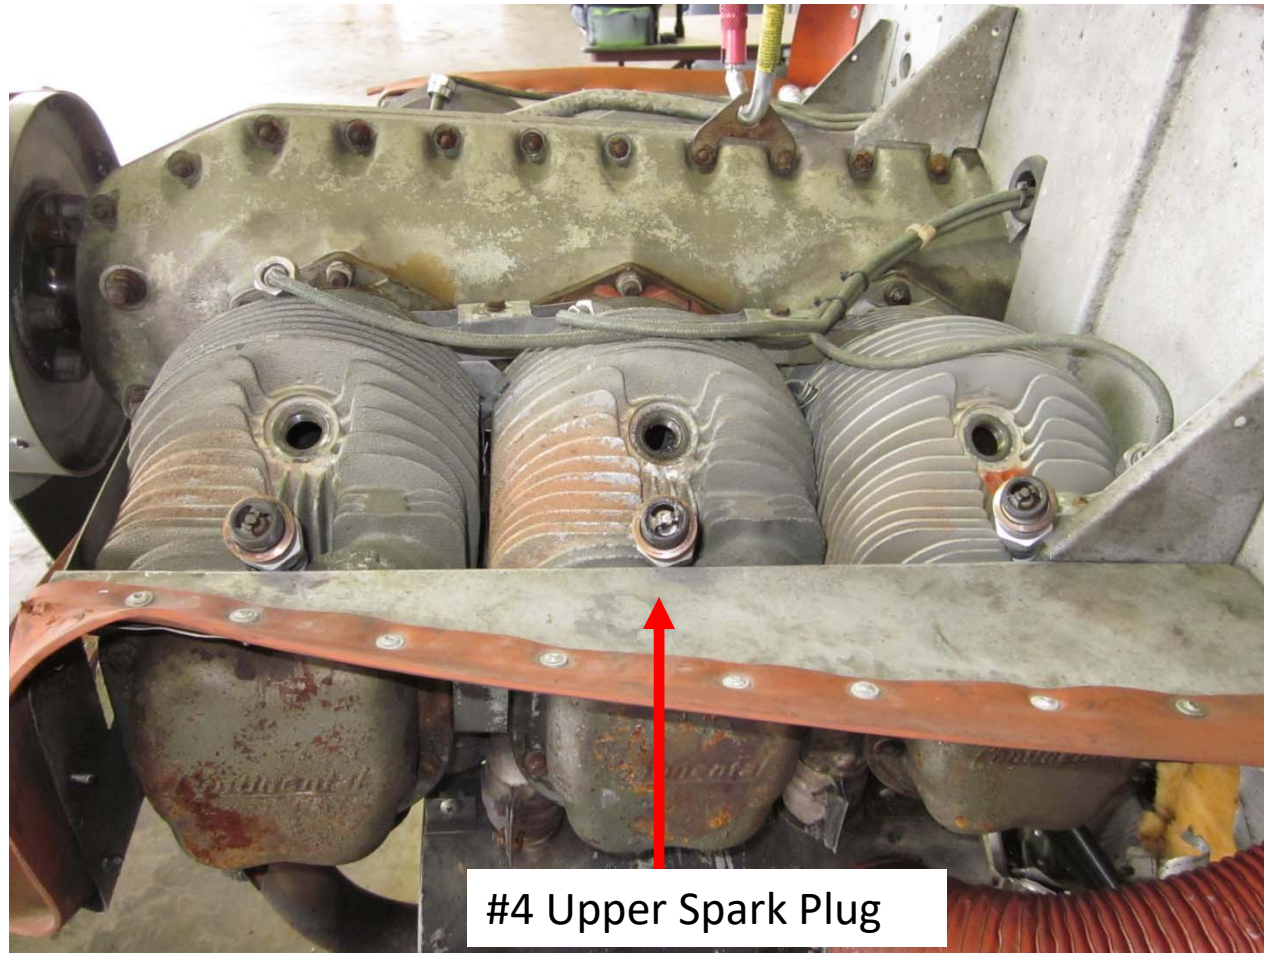
#4 Upper Spark Plug

The engine would not rotate through a complete cycle although the crankshaft had continuity. It was found that the #4 Cylinder spark plug showed damage upon removal

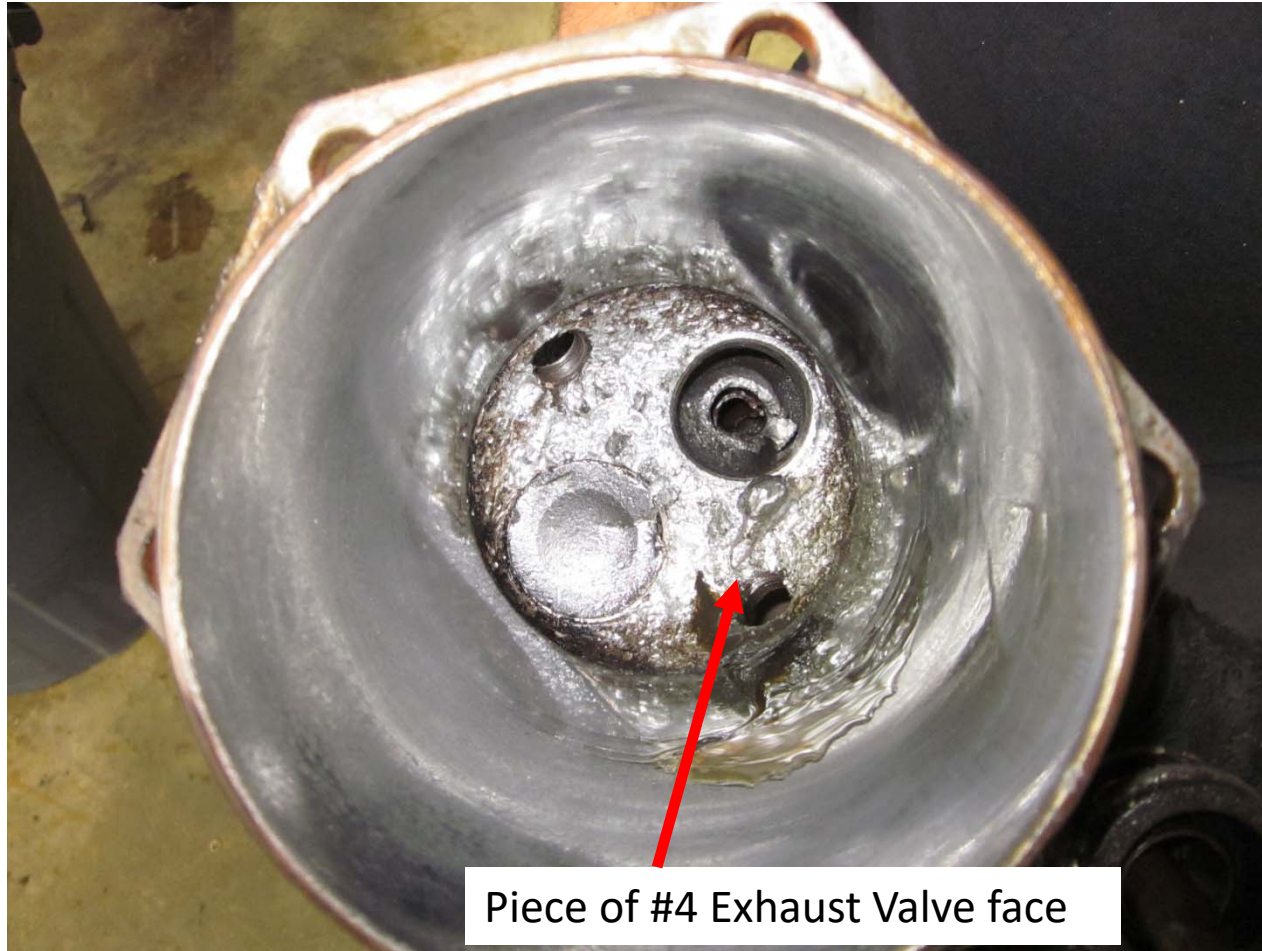
Piece of #4 Exhaust Valve face

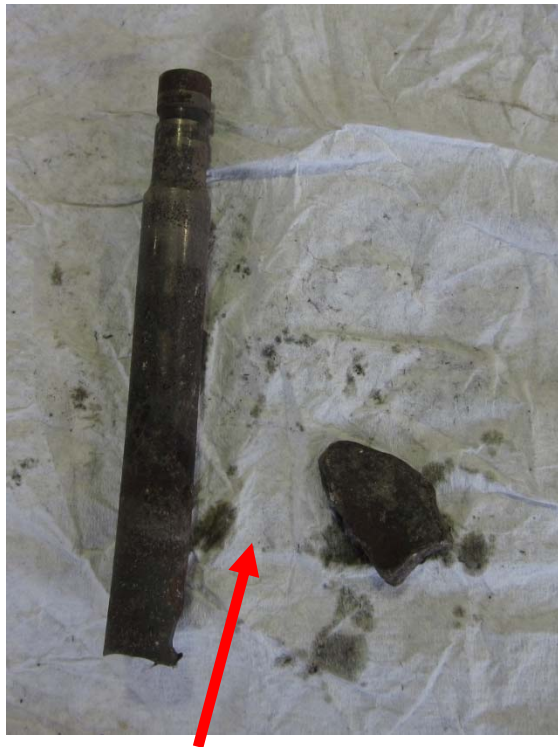
These pieces were found in the left side muffler

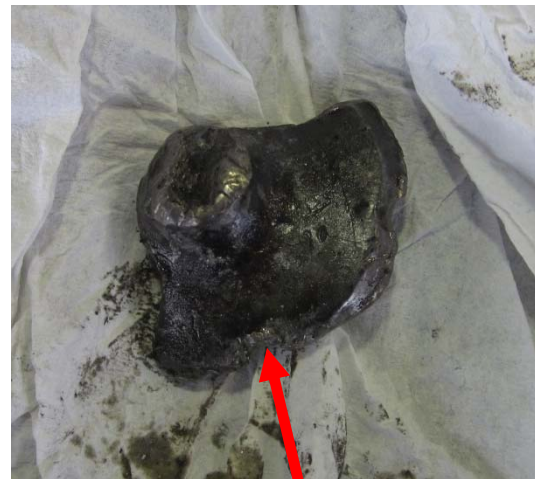
Piece that was in  
the #4 Cylinder

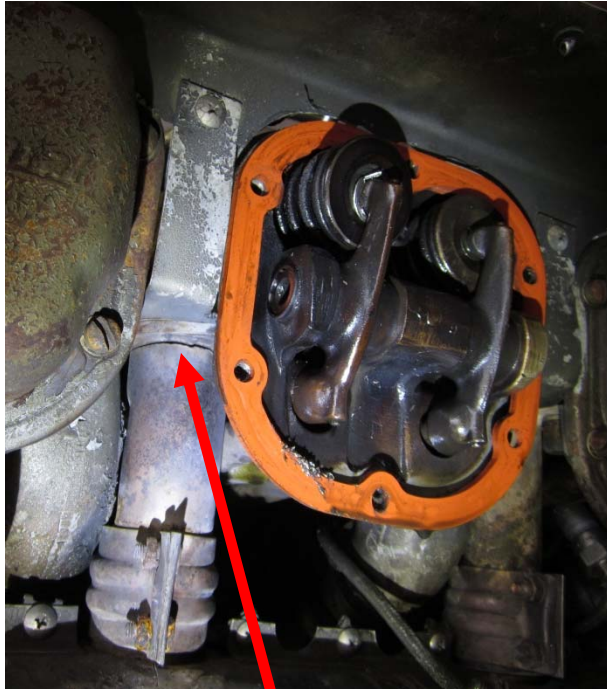
#4 Exhaust found cracked
