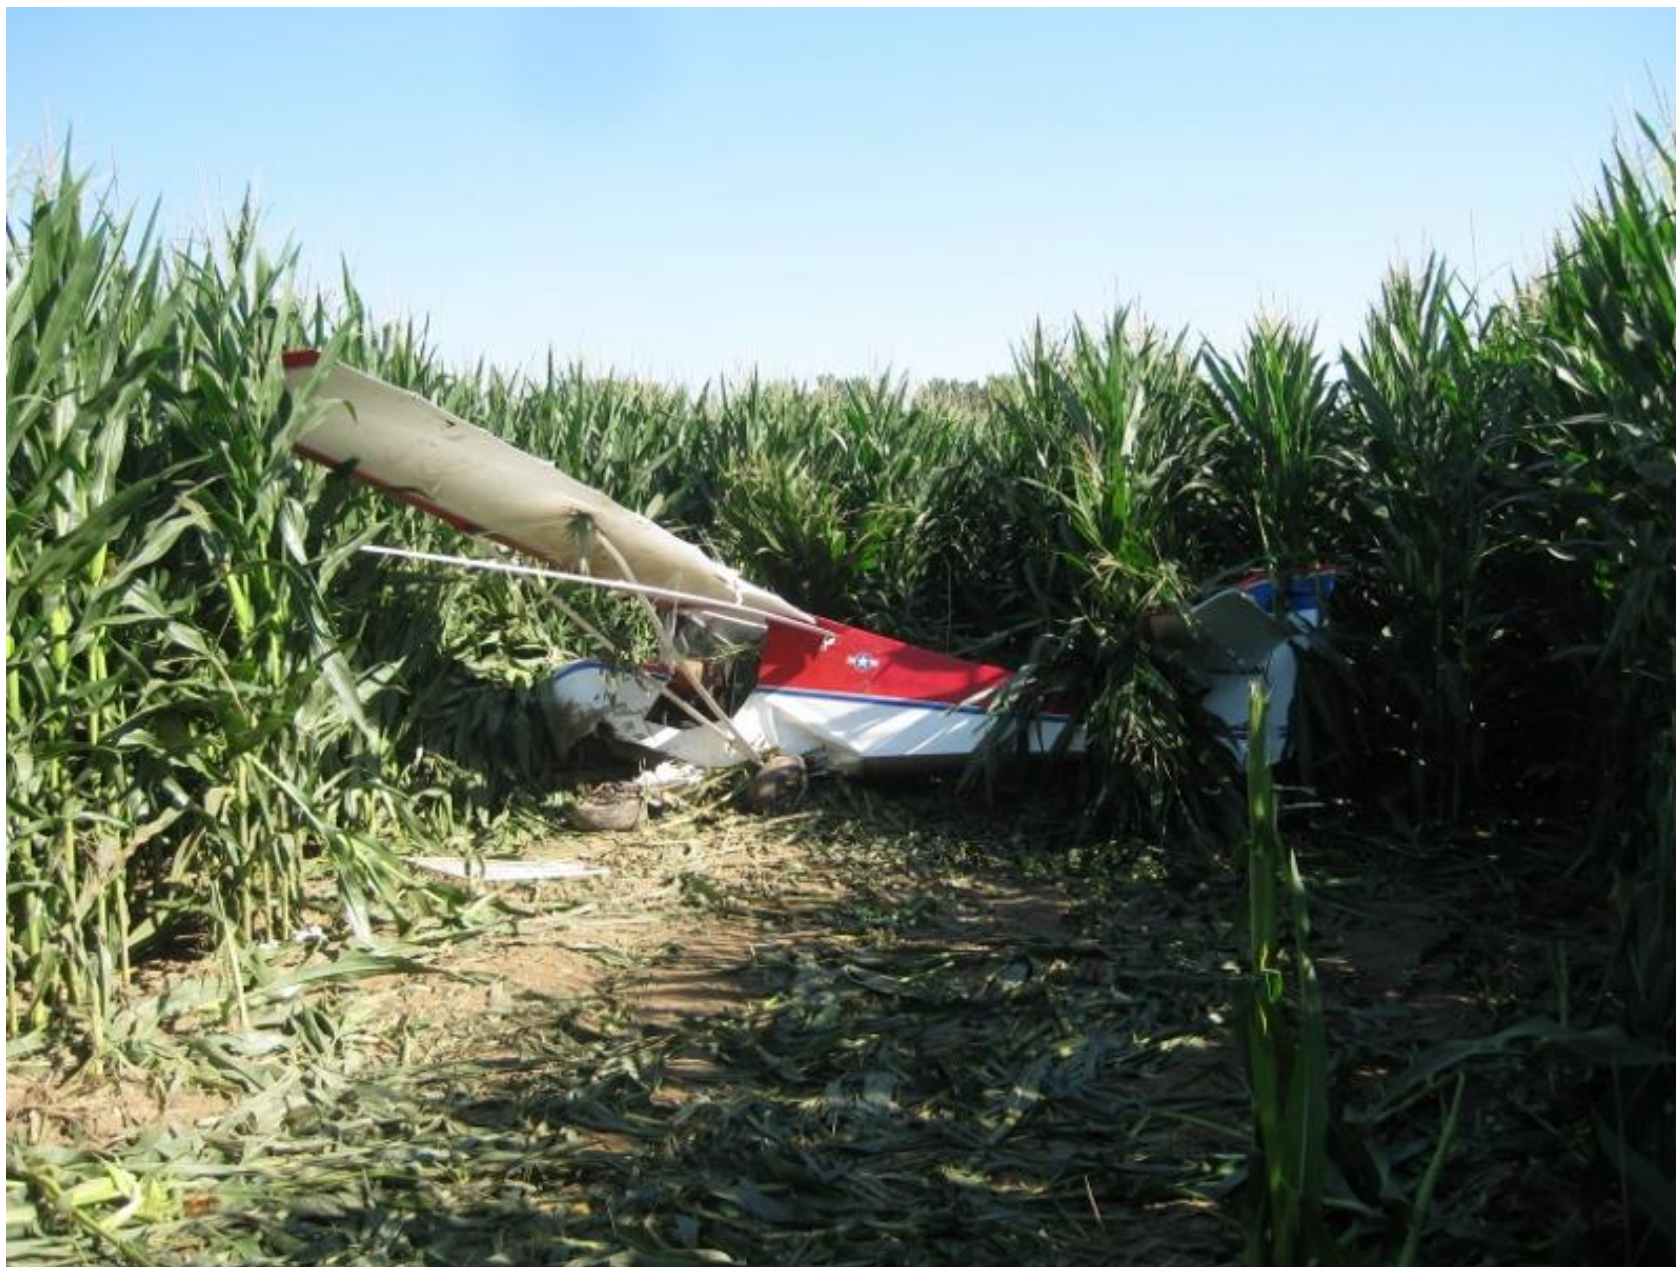
**Photo 1 – View of wreckage in a cornfield**

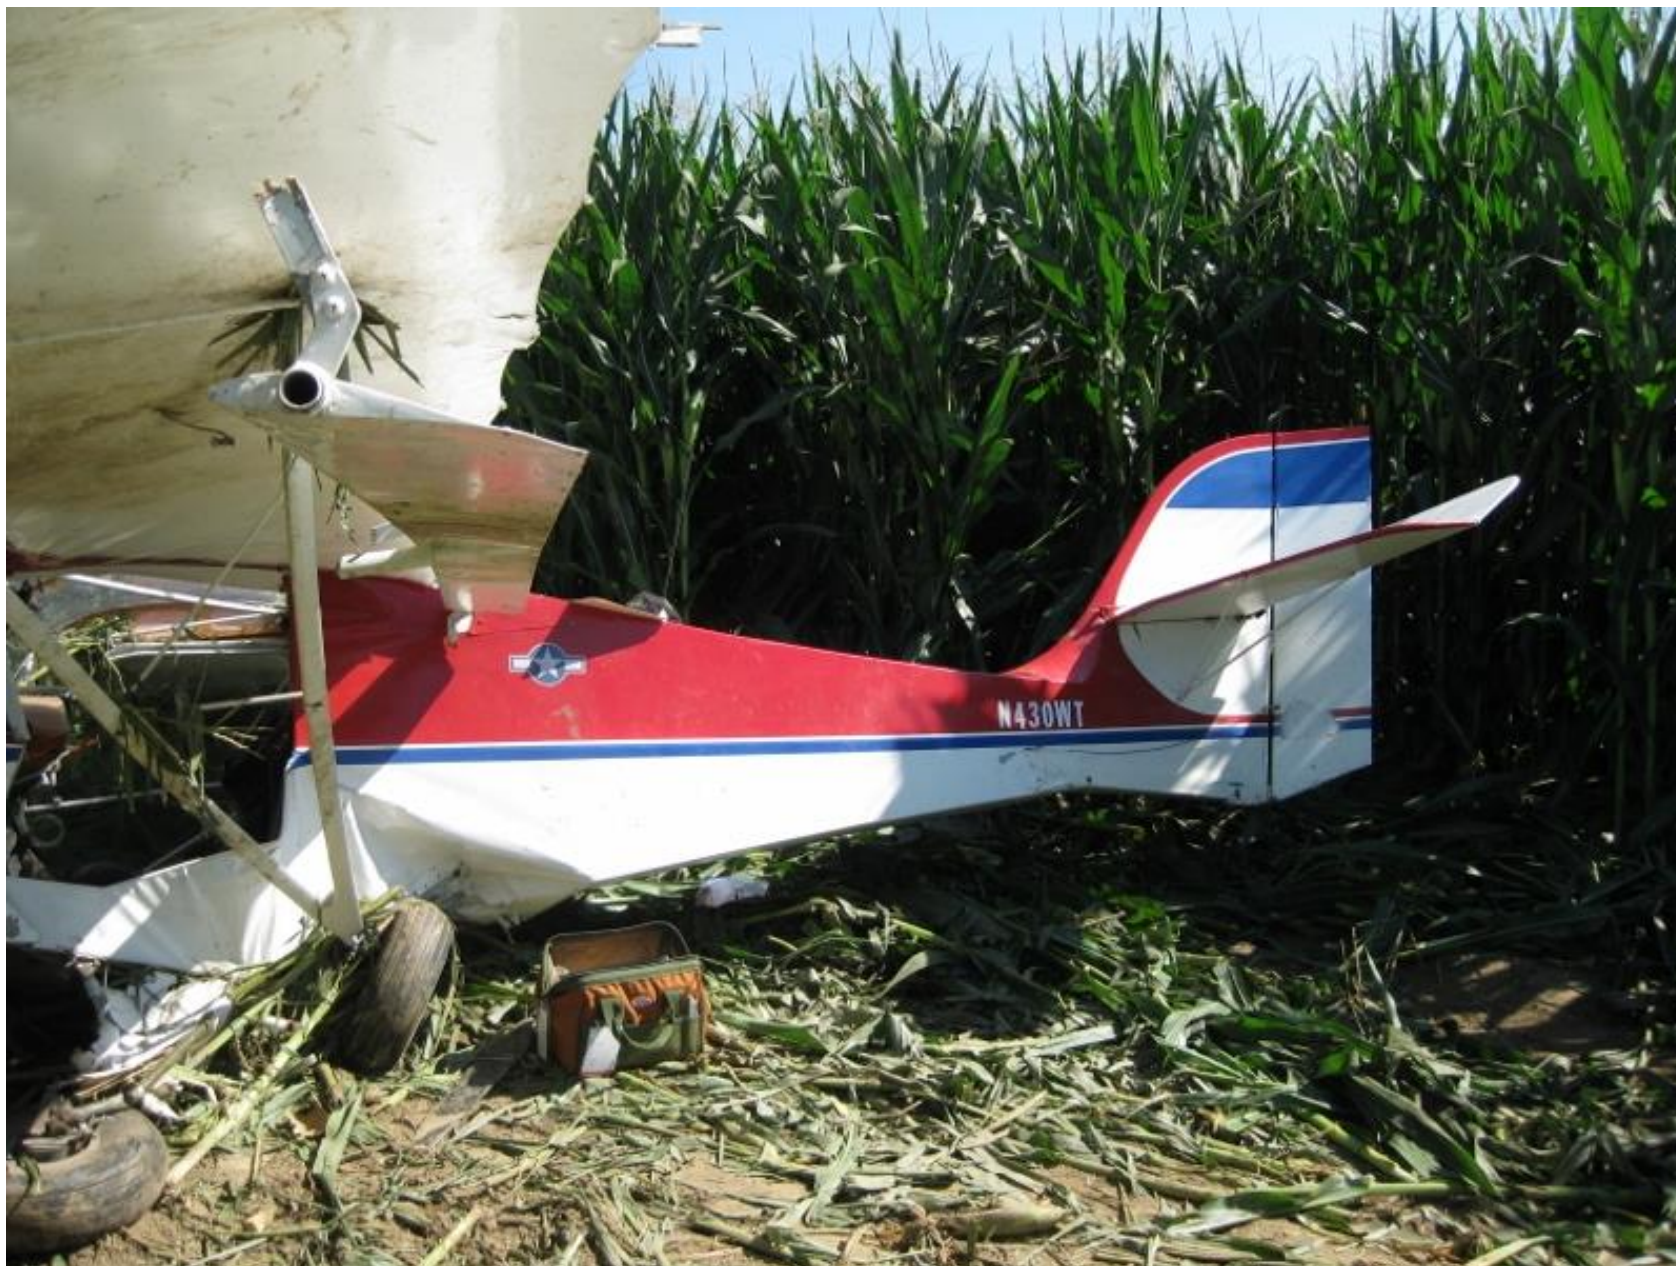
**Photo 2 – View of the left side of the aircraft wreckage in a cornfield**

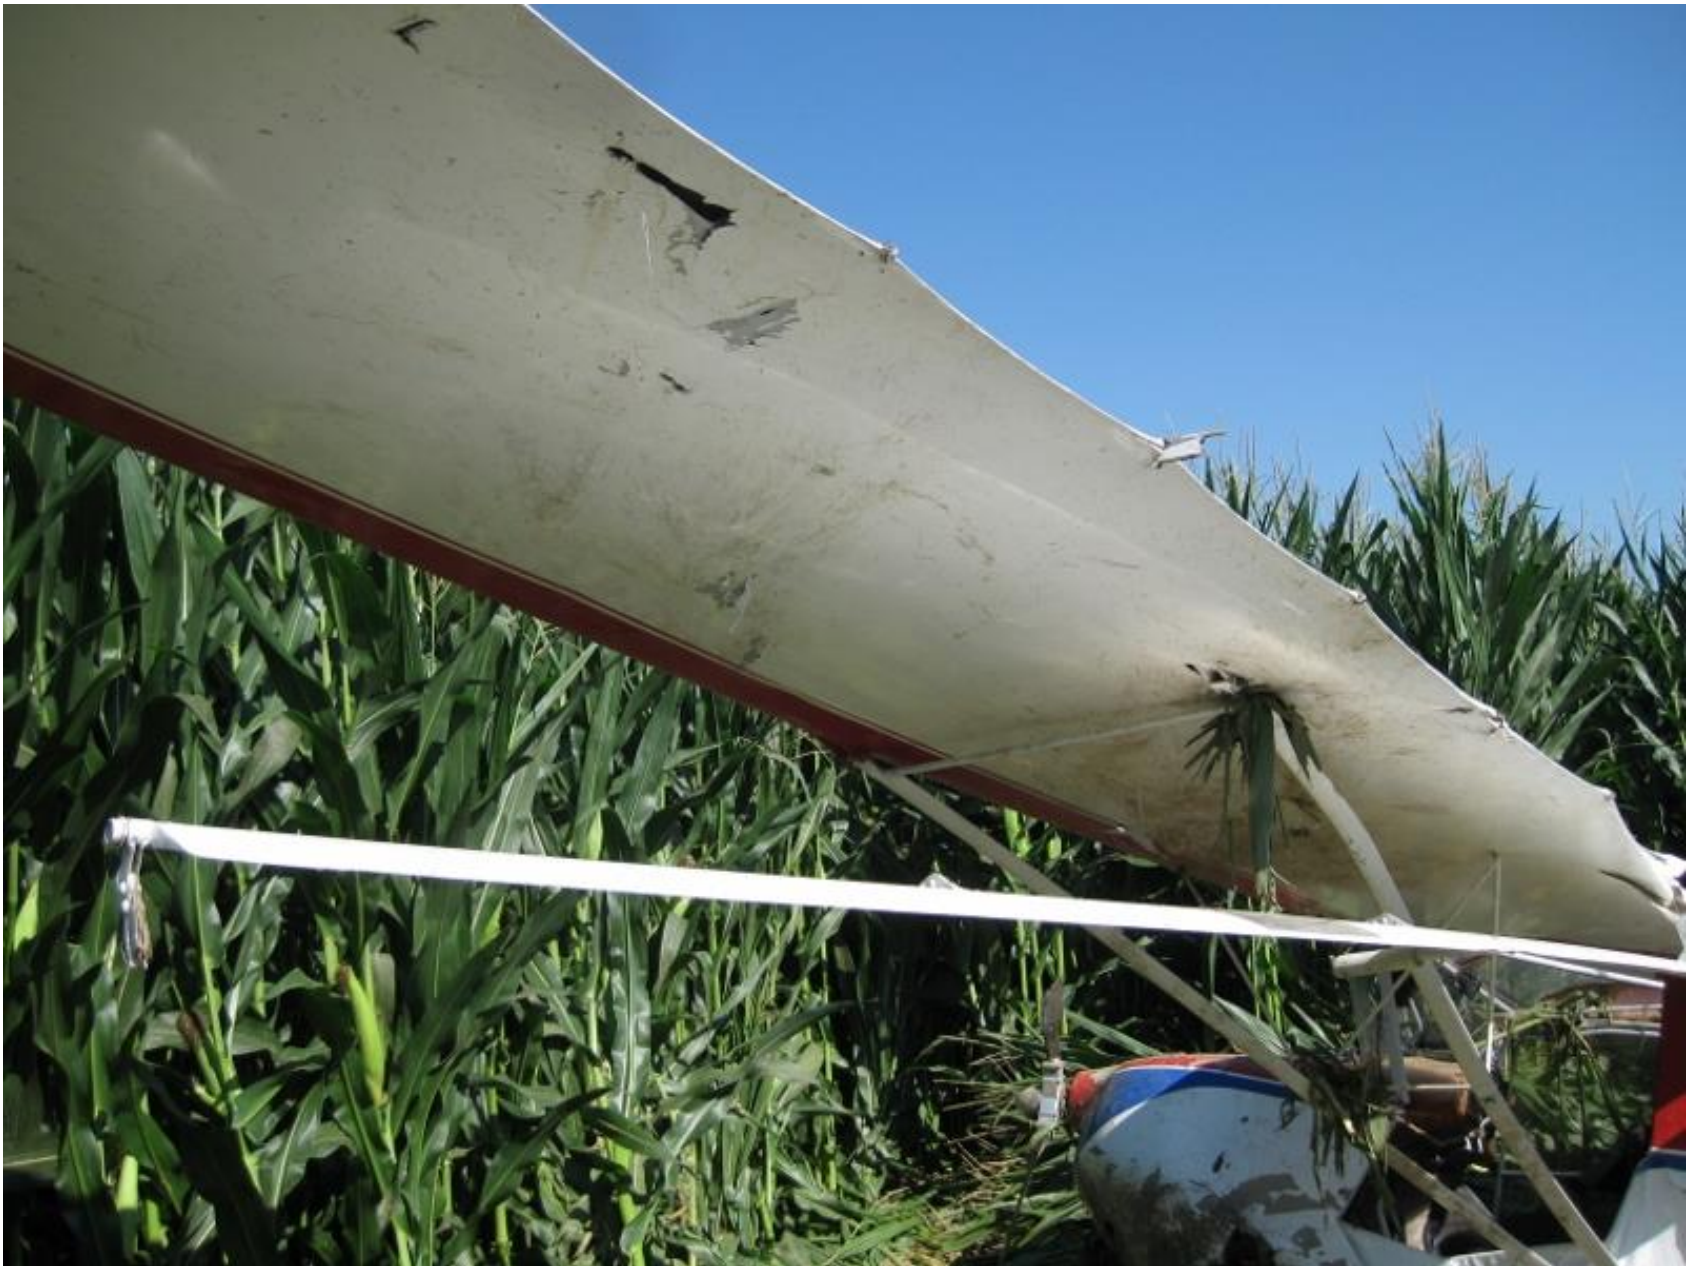
**Photo 4 – View of the left wing and broken flaperon attach points**

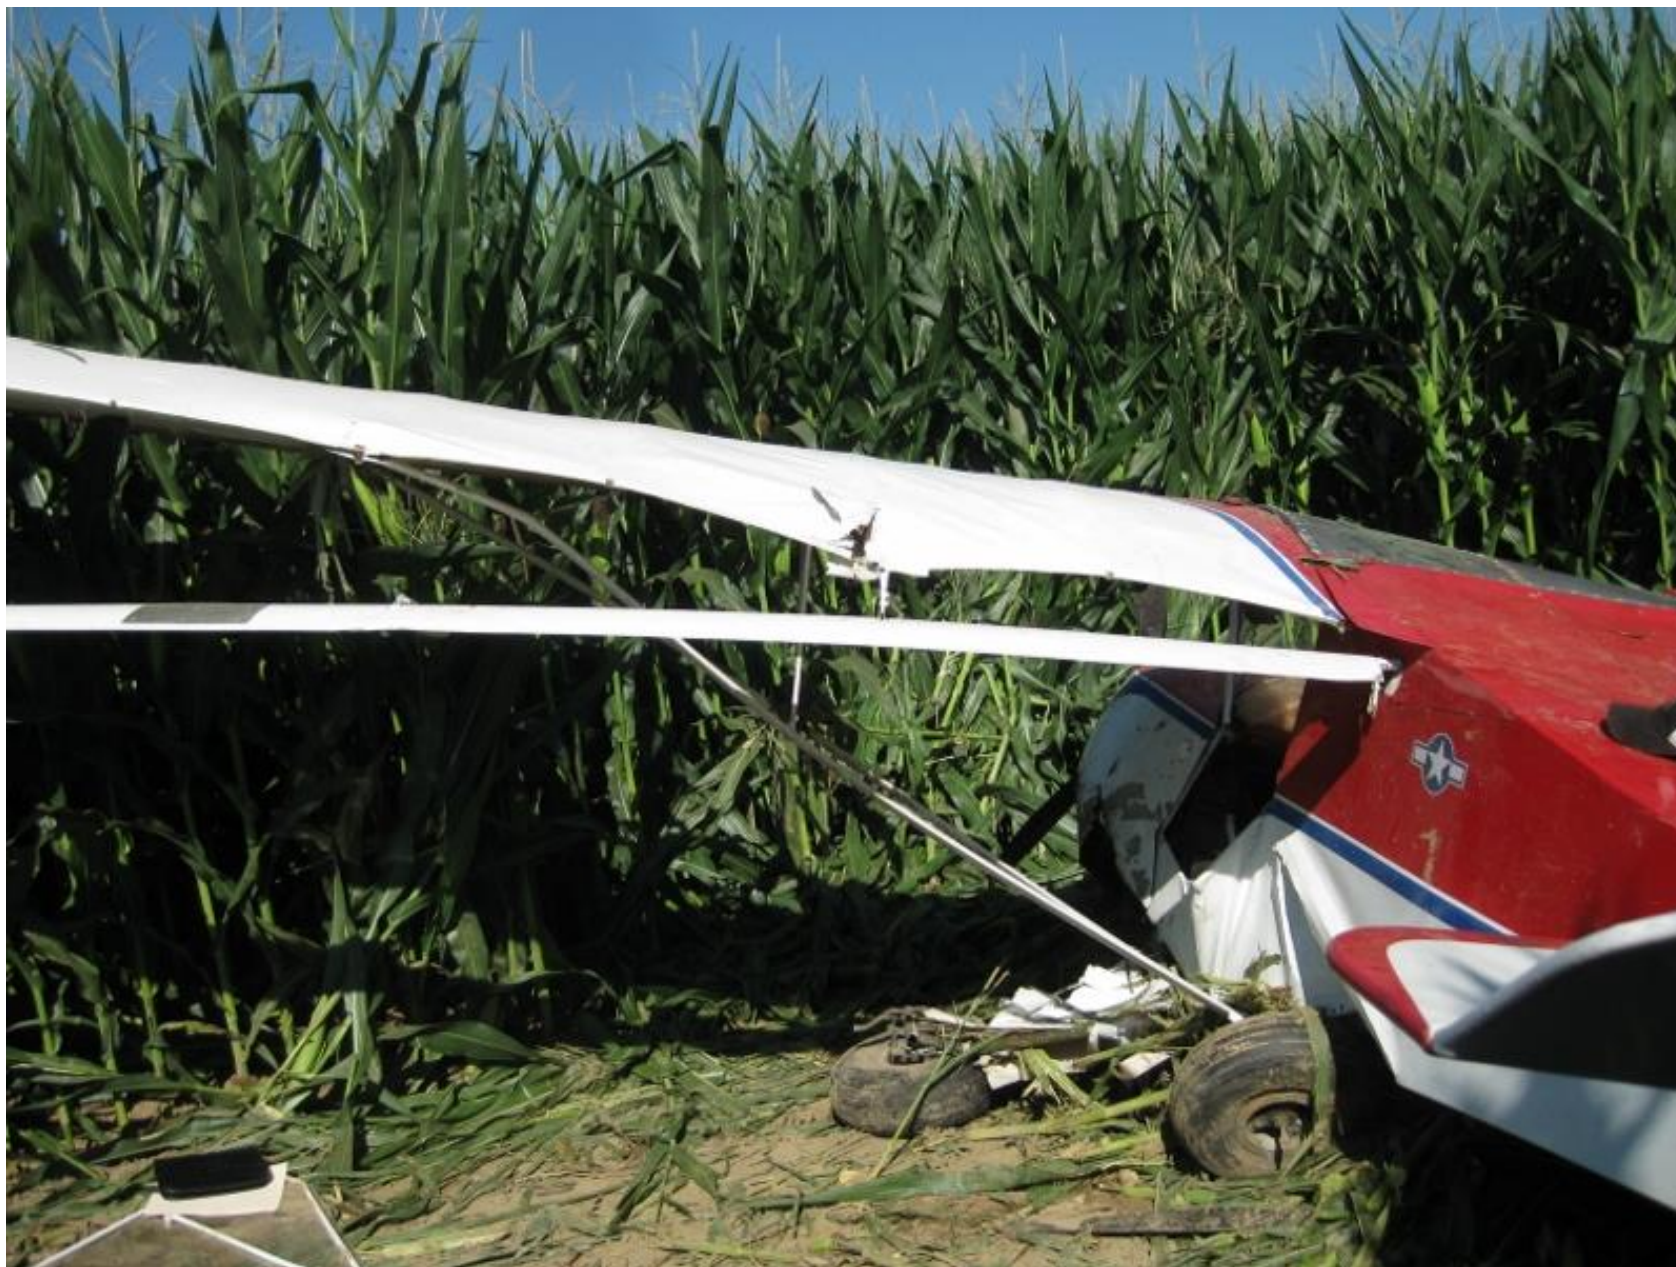
**Photo 5 – View of the left wing and broken flaperon**

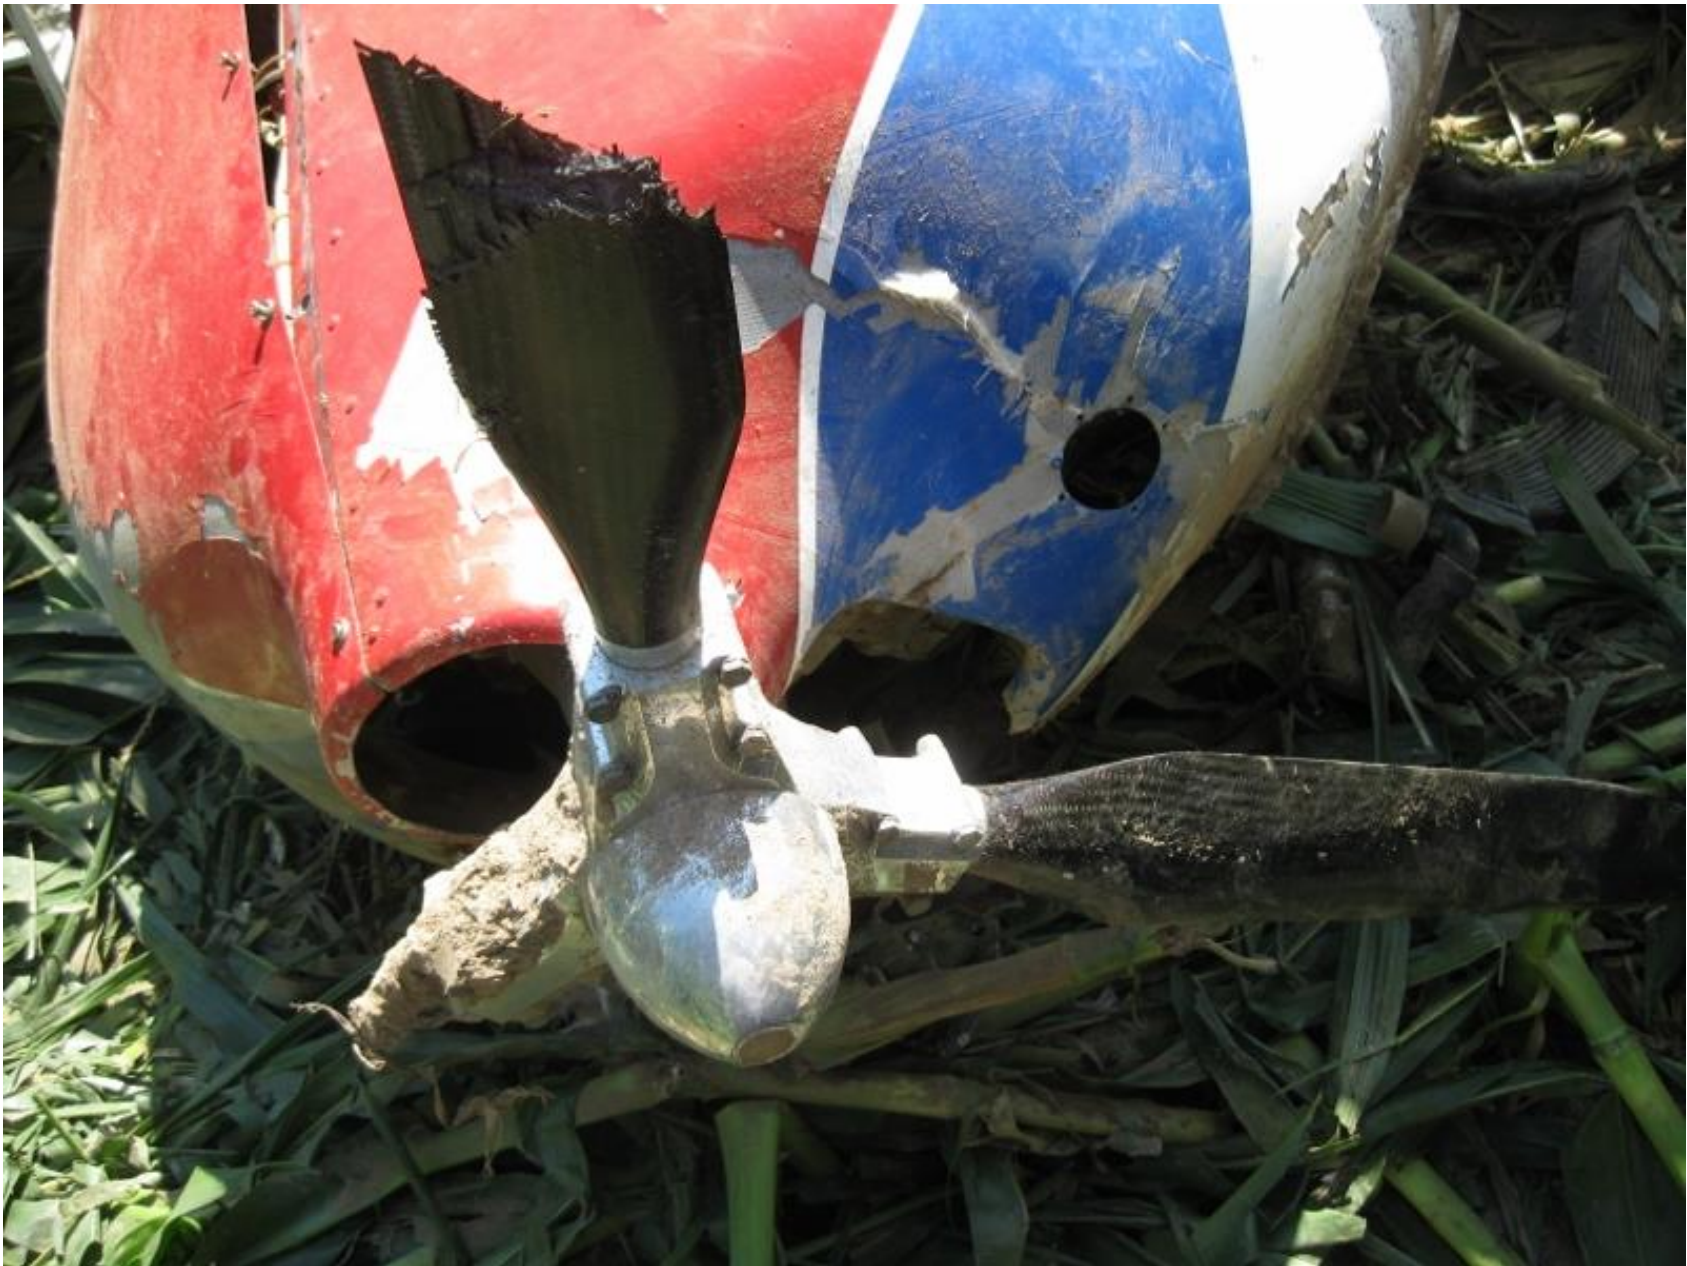
**Photo 9 – View of the broken propeller blades at the accident site**

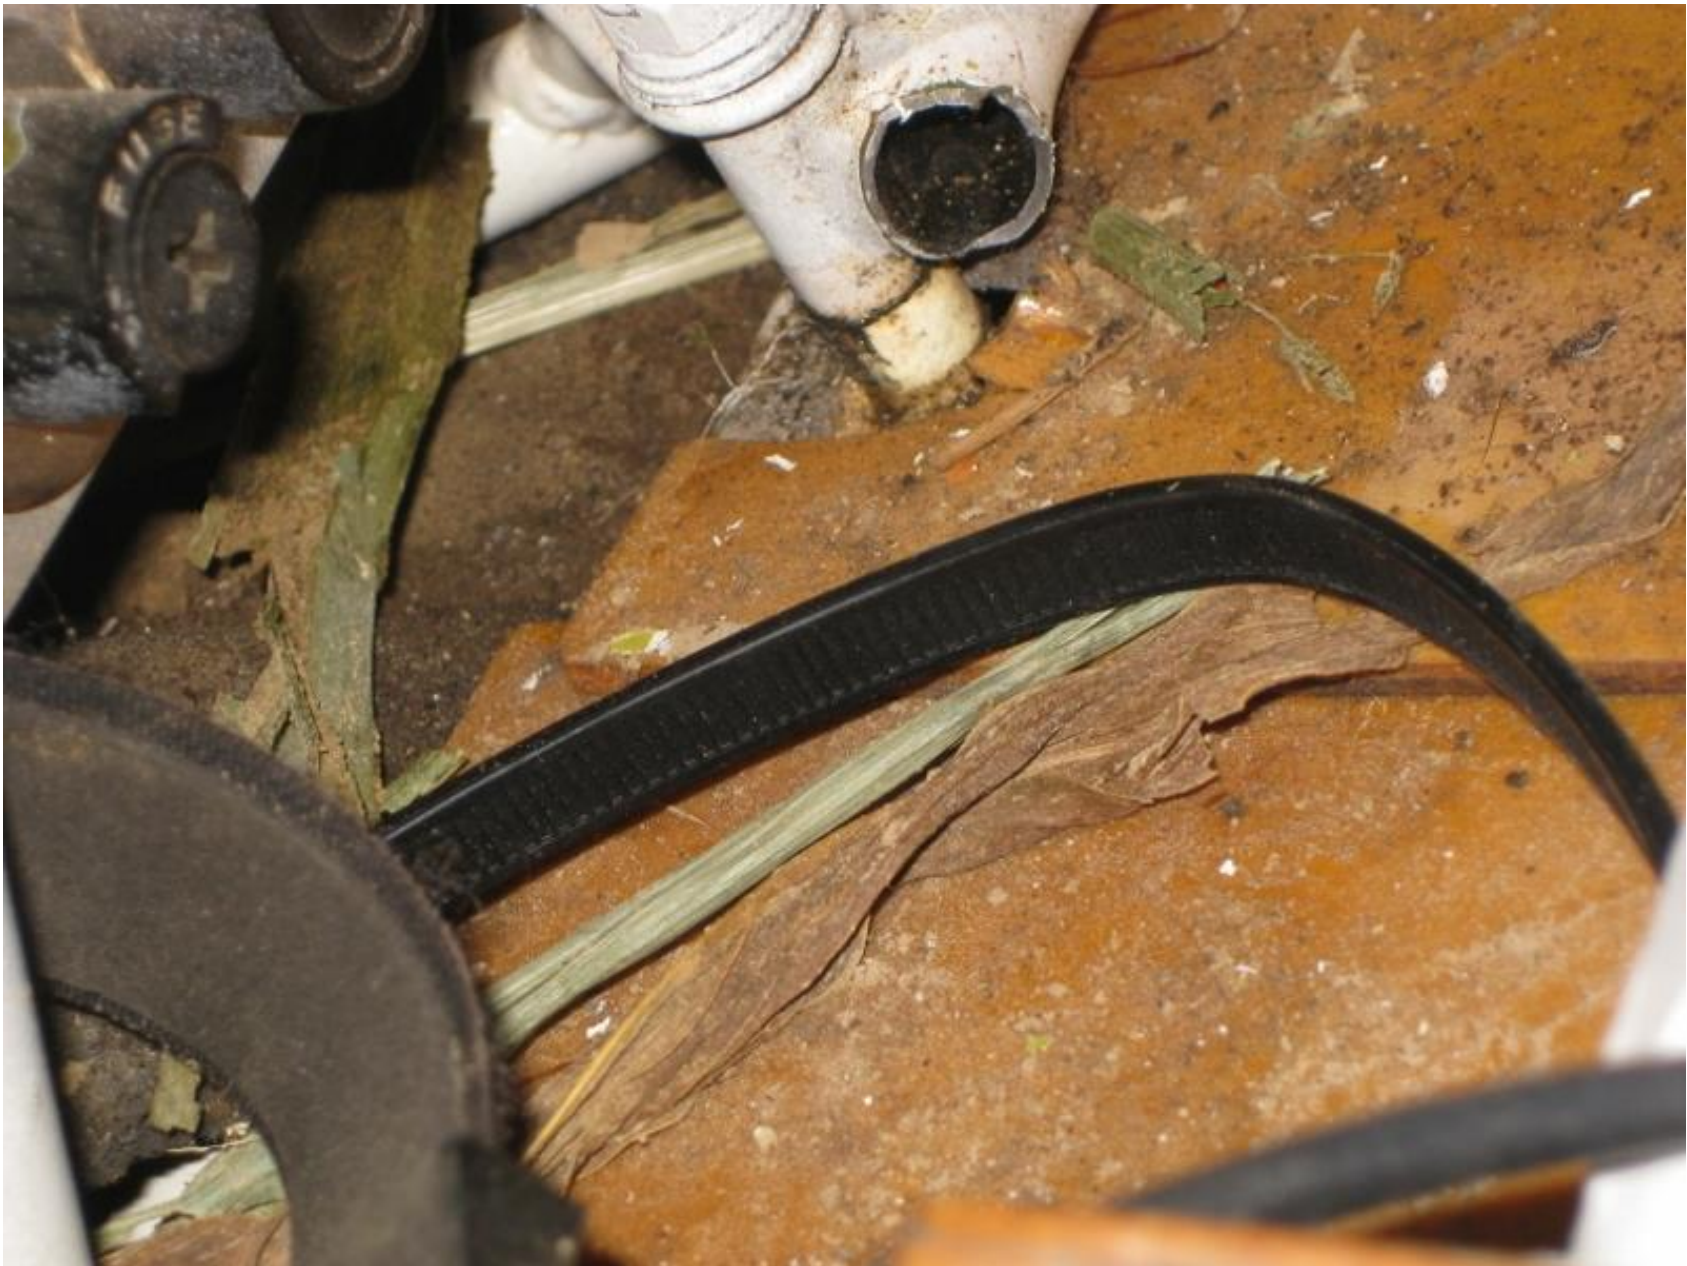
**Photo 14 – View of the fractured flaperon control tube**

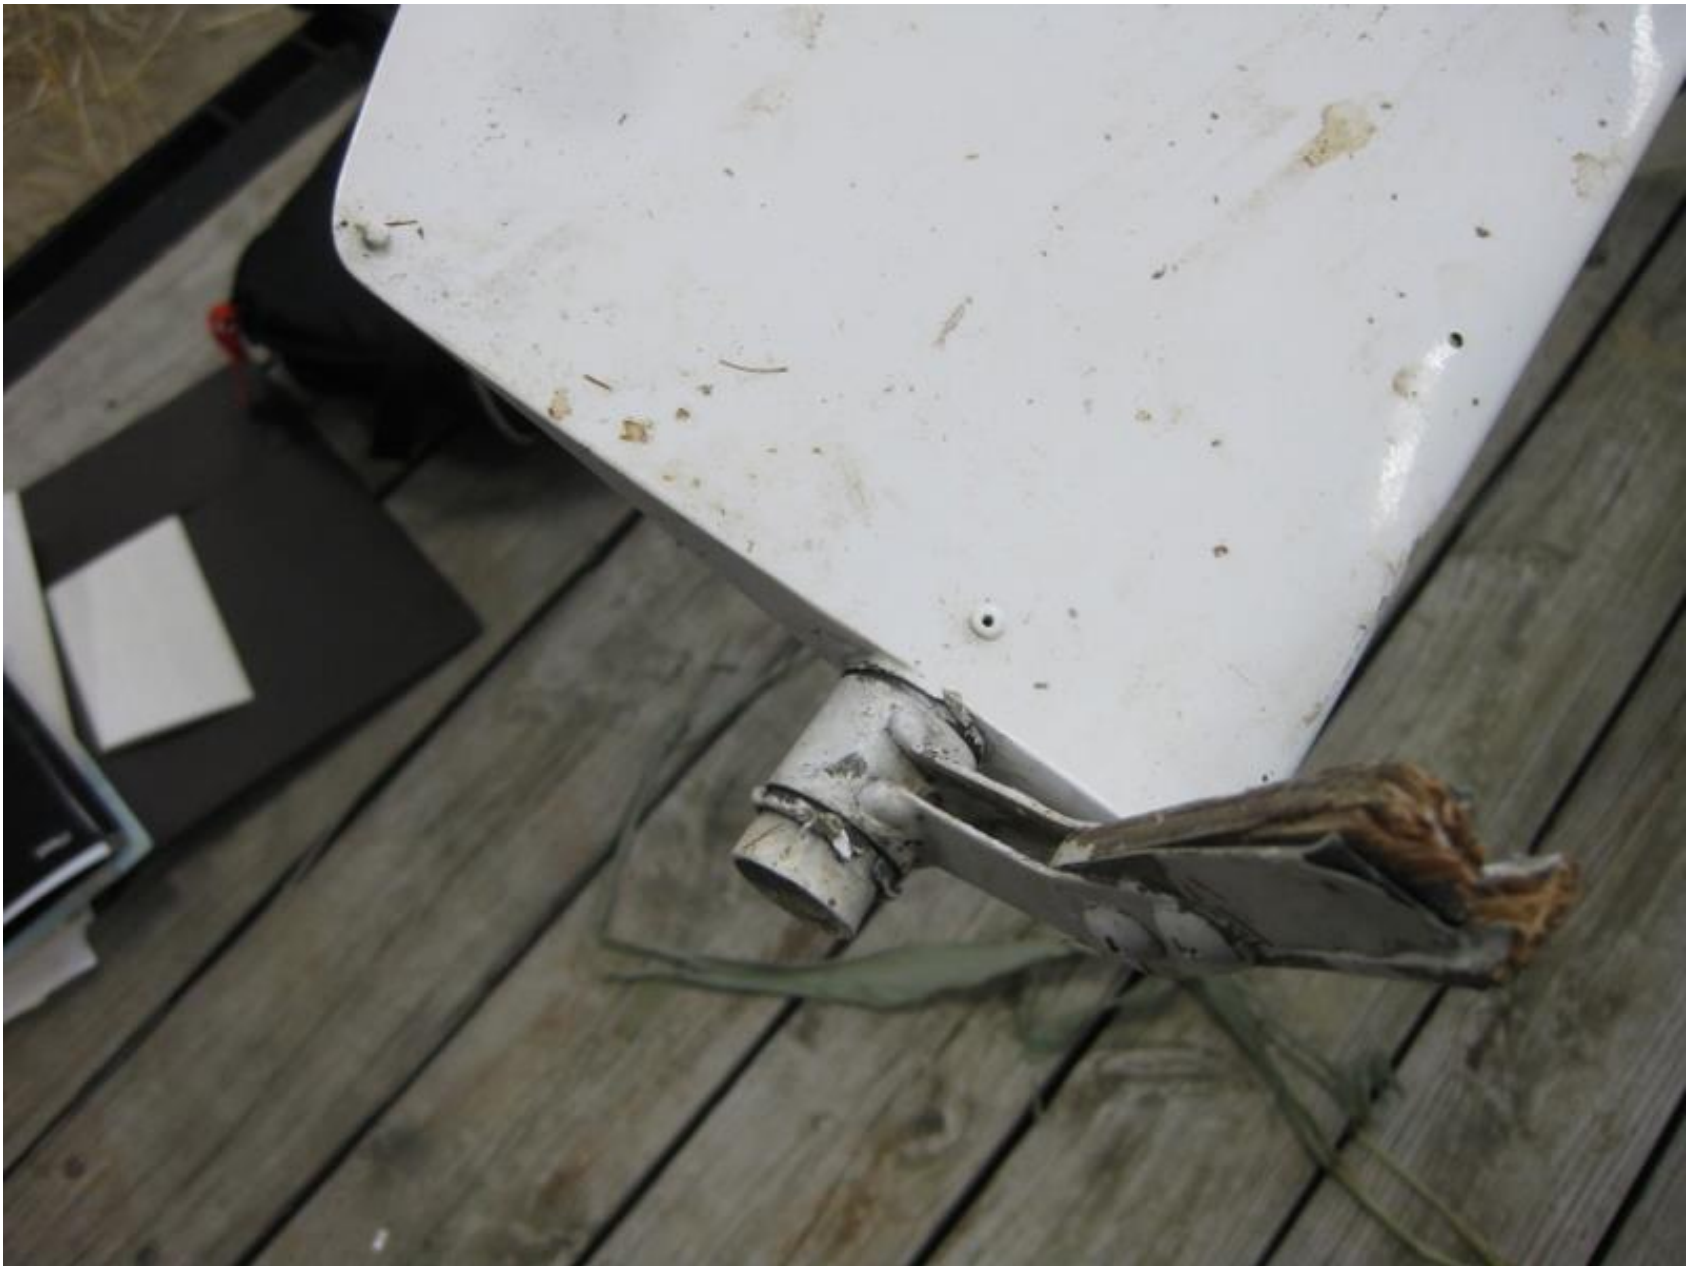
**Photo 18 – View of the broken outboard left wing flaperon attach point**
