# Continental Motors

## ENGINE FIELD INSPECTION REPORT

| ENGINE MODEL | IO-360-ES |
| FILE NUMBER | 13-101 |

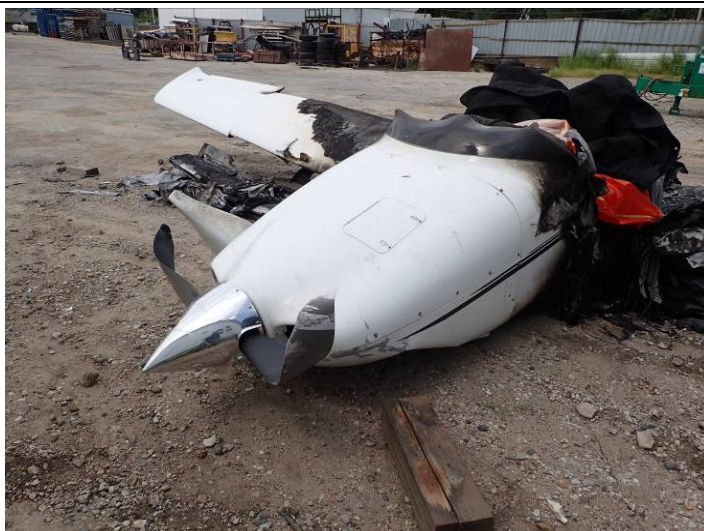
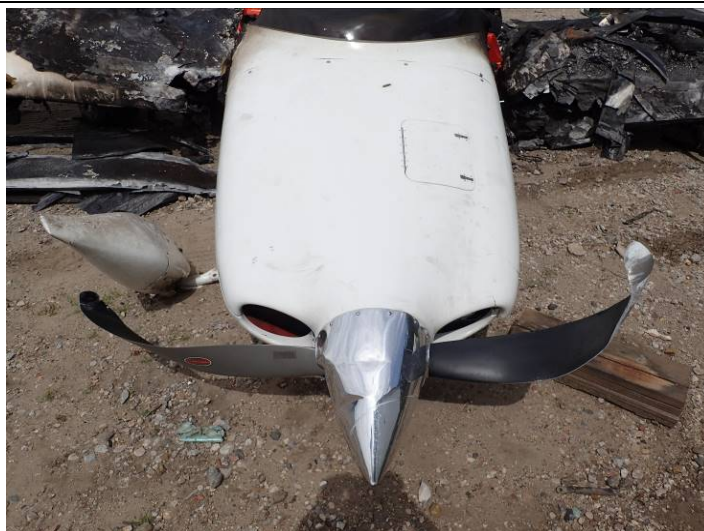
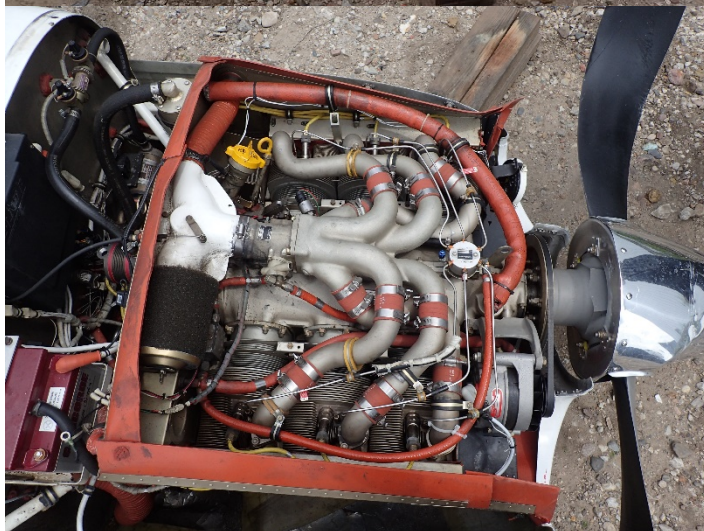
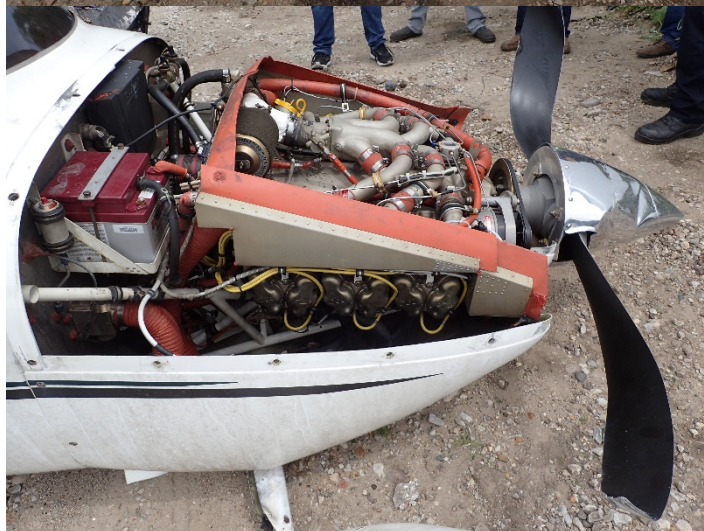
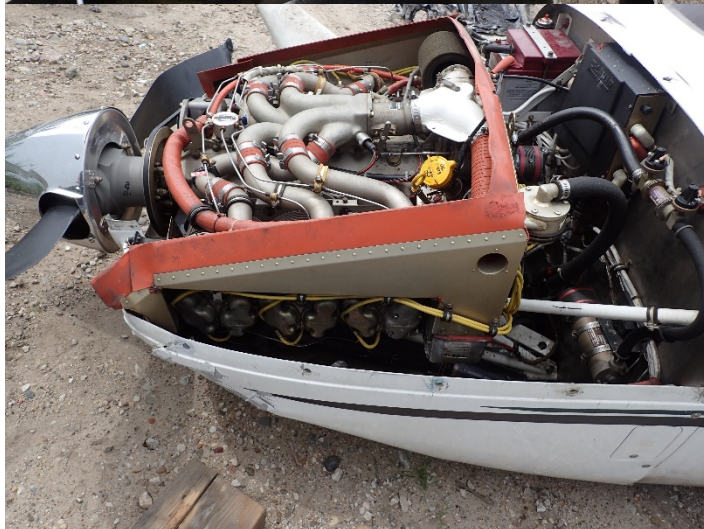
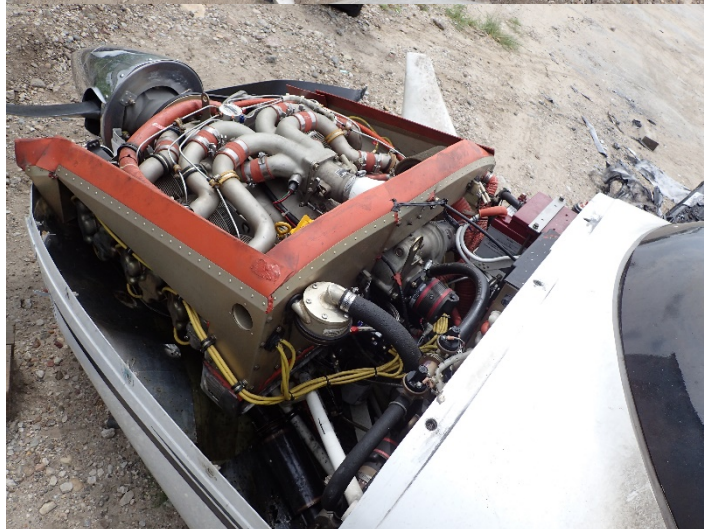
The engine remained attached to the airframe by its engine mounts, wires, cables, and hoses. There were no signs of thermal damage noted to the engine; the engine sustained some impact damage to the bottom of the engine. The two blade, constant speed propeller remained attached to the propeller flange and displayed impact damage signatures. Both of the propeller blades displayed chord wise scratches and gouges, and both of the propeller blades displayed twisting deformation. All six cylinders remained attached to their cylinder bays; the cylinders were undamaged. The crankcase remained intact and was undamaged.

The induction system did not show any signs of impact or thermal damage. It was noted that the #1 cylinder induction tube coupling was only partially attached to the induction tube going into the #1 cylinder. It was also noted that the #3 induction tube going into the #3 cylinder was fractured at the mounting flange. There was a significant amount of soot around the #3 induction tube fracture area as well as the mounting clamp.

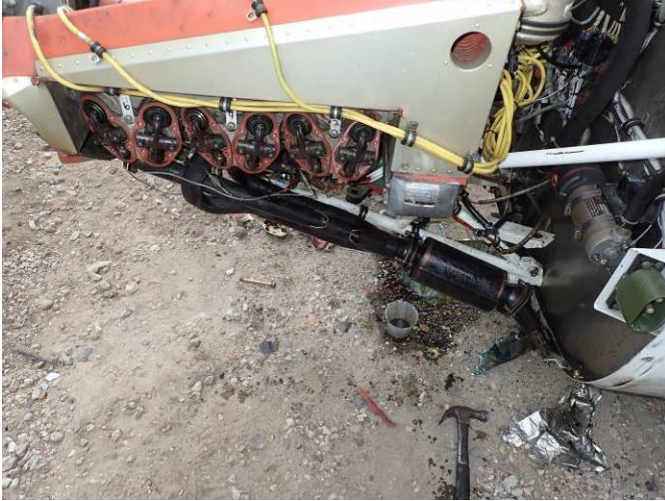
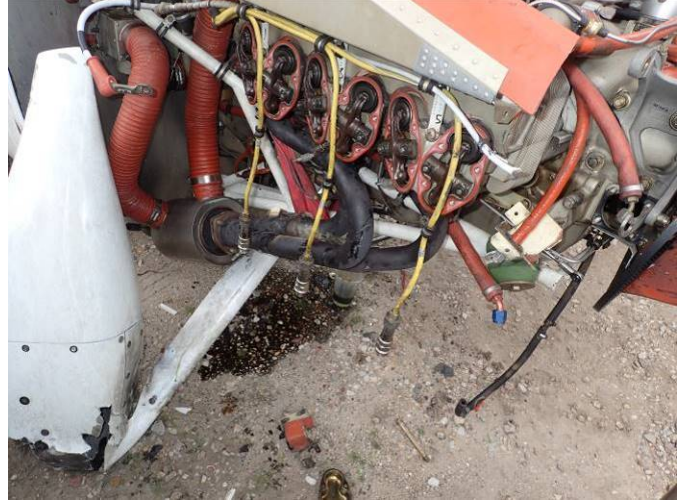
The exhaust system remained attached to the engine and displayed impact damage signatures to the tail pipes. There were no signs of exhaust leaks or other anomalies noted with the exhaust system.

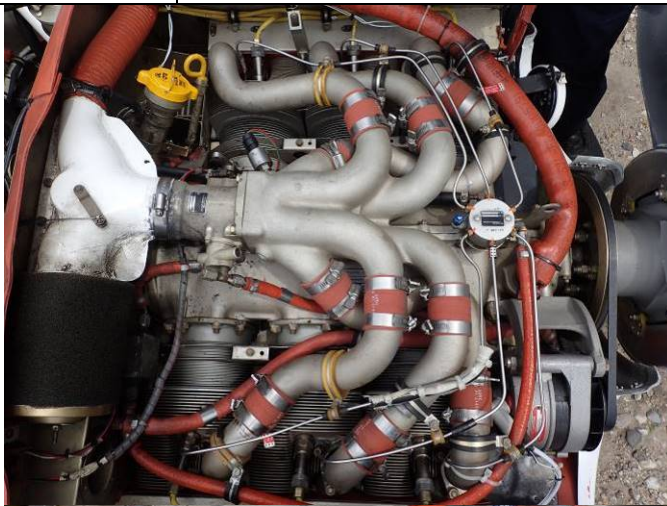
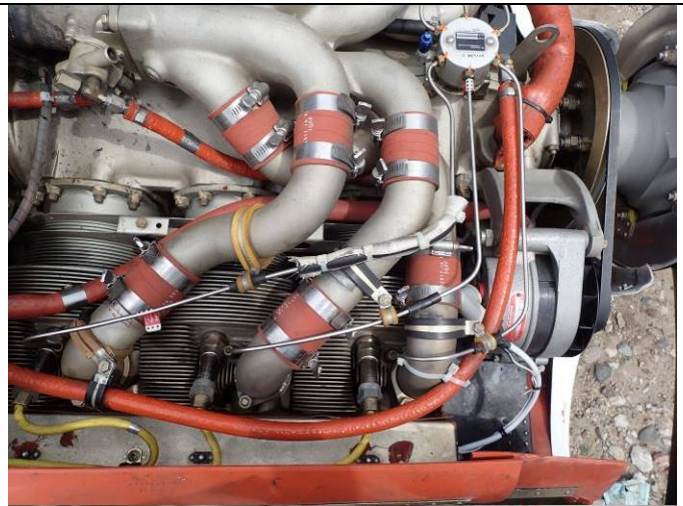
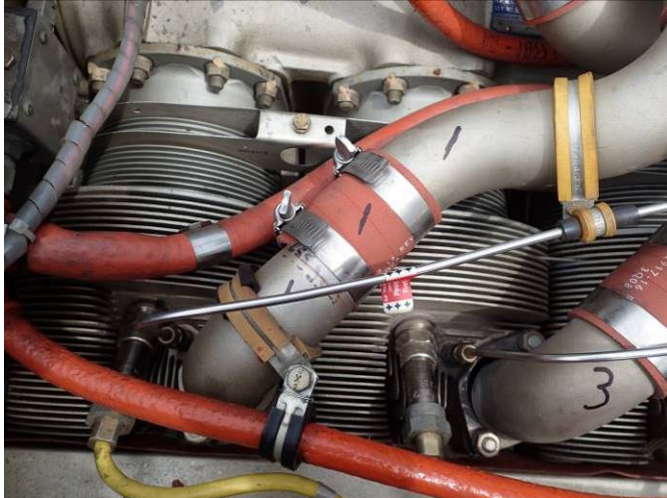
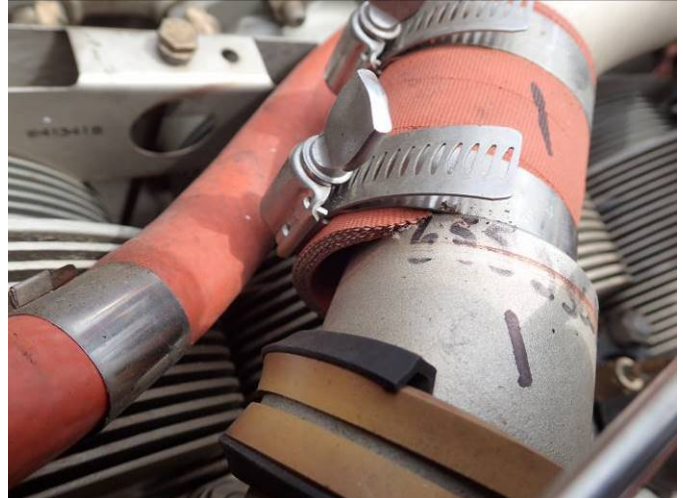
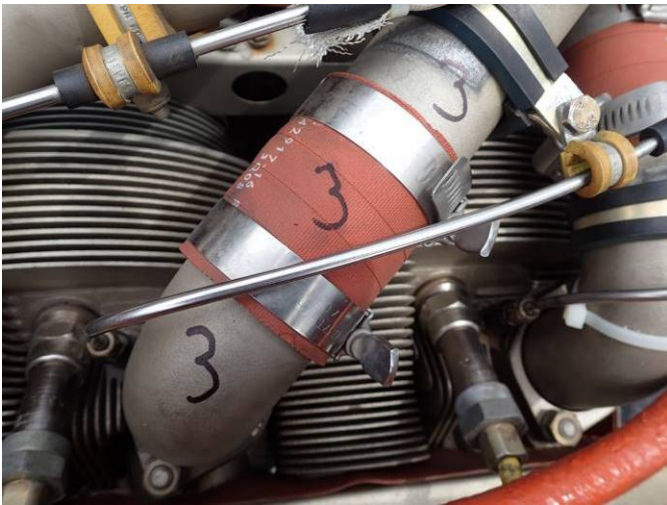
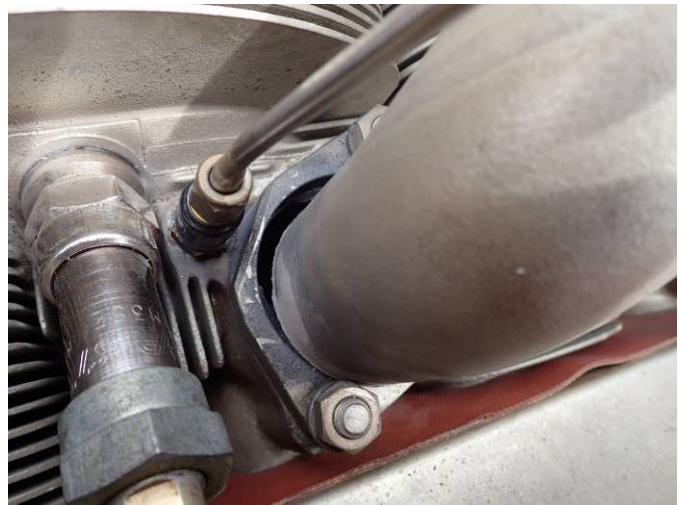
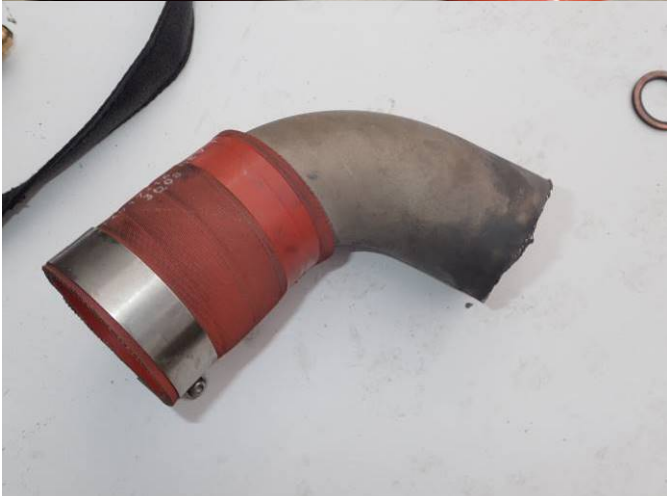
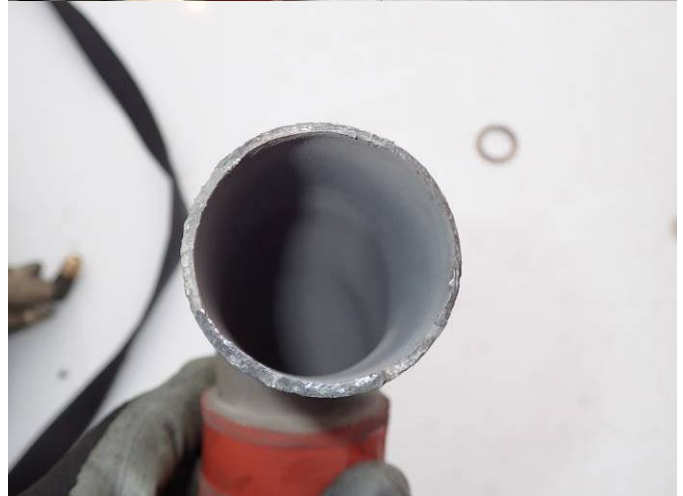
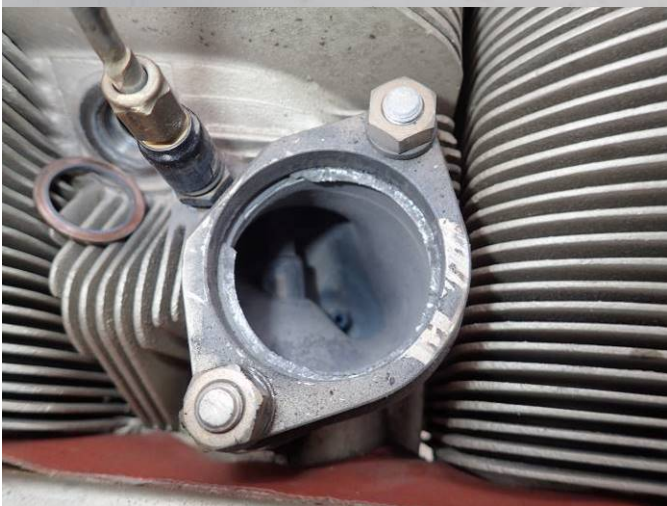
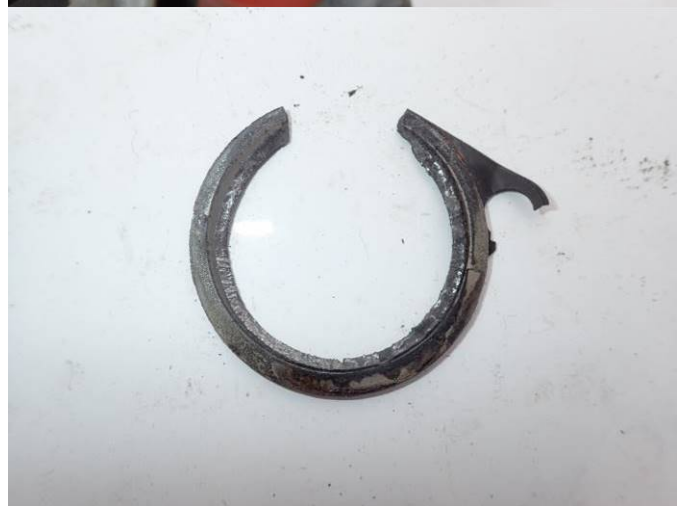
The #3 induction tube was found fractured at the mounting flange and the #1 induction tube coupling was found partially detached from the induction tube going into the #1 cylinder. The #3 induction tube and flange were shipped to the NTSB Materials Laboratory for further testing and examination.

The induction system did not display any signs of impact damage. It was noted that the #1 induction tube coupling was only partially attached to the induction tube going into the cylinder. The worm gear clamp remained secured to the rubber coupling. It was noted there was a wear area on the induction tube going into the cylinder consistent with where the rubber coupling was installed; it was noted that the width of the wear area was shorter than the width of the worm gear clamp. The #3 induction tube was found to be completely fractured at the mounting flange. It was noted that the induction tube and mounting area had a coating of soot. The induction tube and flange were removed from the engine; it was noted that a portion of the induction tube flange had broken free from the rest of the flange and was not located. The #3 induction tube and flange were sent to the NTSB Materials Laboratory for additional examination and testing. The remaining induction tubes displayed normal operating signatures.

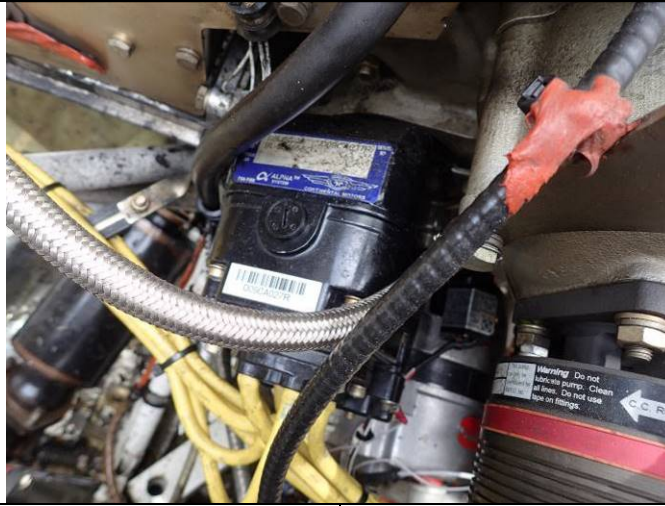
The magneto remained attached to its installation point and was undamaged. The crankshaft was rotated by hand and it was noted that the impulse coupling operated normally. It was noted that during impulse coupling operation the magneto was capable of producing a spark on each of the ignition leads. It was also noted that each ignition lead produced a spark with the approximate same timing as the corresponding ignition lead coming from the right magneto.

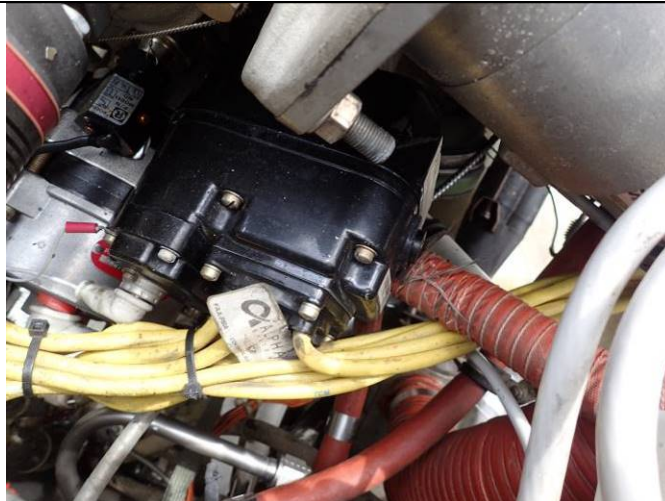
The magneto remained attached to its installation point and was undamaged. The crankshaft was rotated by hand and it was noted that the impulse coupling operated normally. It was noted that during impulse coupling operation the magneto was capable of producing a spark on each of the ignition leads. It was also noted that each ignition lead produced a spark with the approximate same timing as the corresponding ignition lead coming from the left magneto.

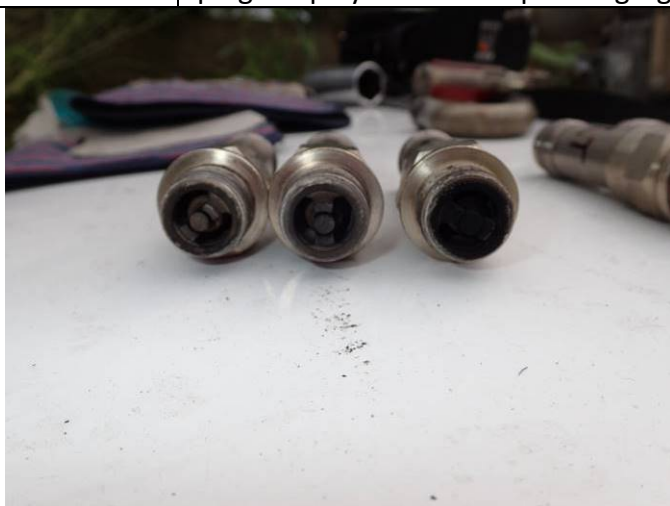
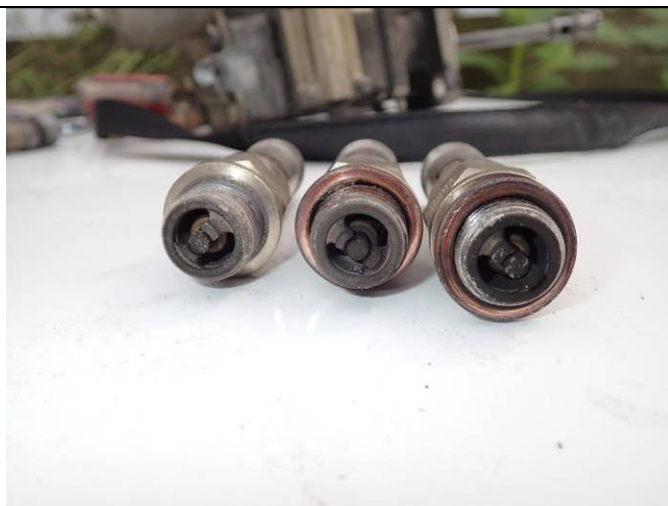
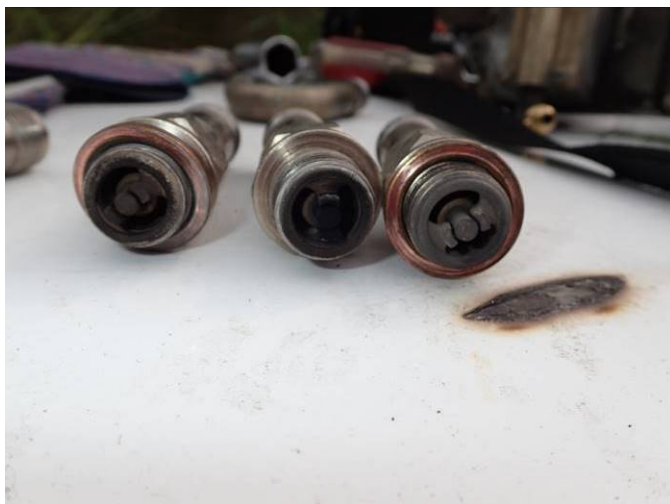
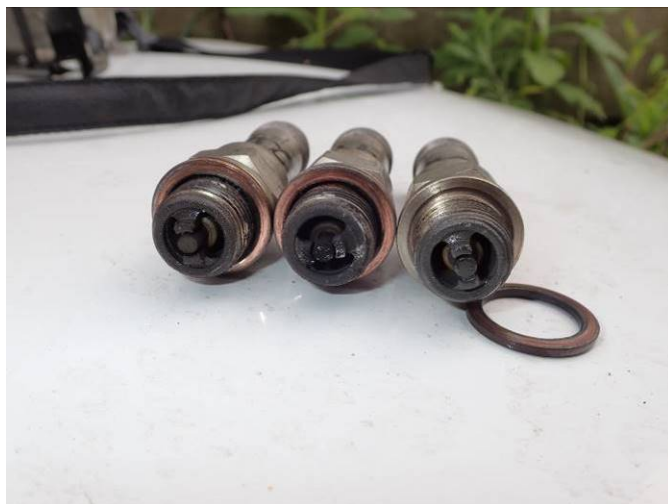
All of the spark plugs remained installed in their cylinders and were undamaged. All of the spark plugs were removed and it was noted that all of the spark plugs displayed normal wear signatures. It was noted that the #5 and the #4 cylinder spark plugs displayed a significant amount of soot consistent with an overly rich mixture. The remaining spark plugs displayed normal operating signatures.

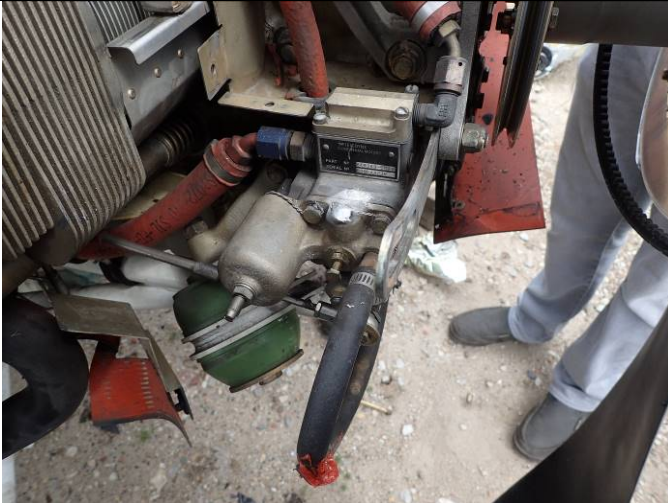
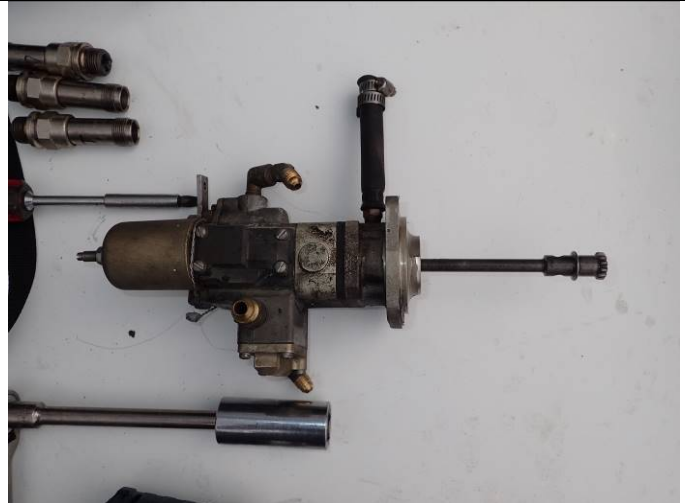
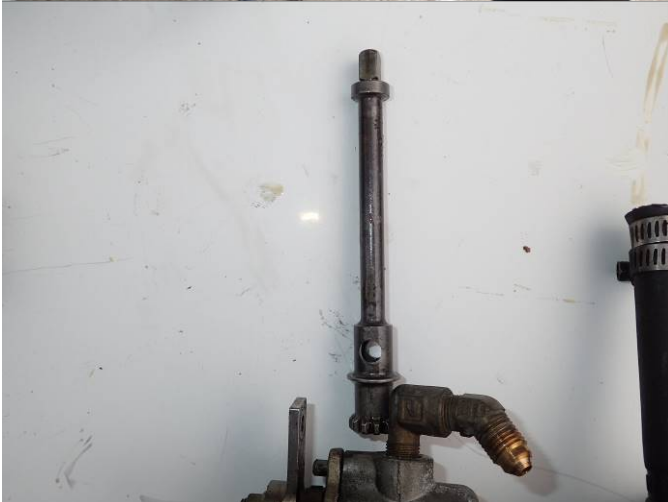
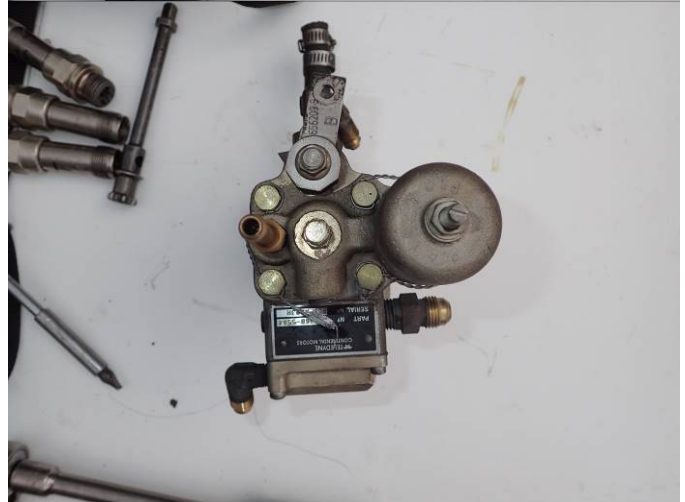
The fuel pump remained attached to its installation point and was undamaged. All of the fuel lines that attach to the fuel pump were secure and there were no signs of fuel leaks. The fuel pump was removed and it was noted that the fuel pump coupling remained intact. The fuel pump was rotated by hand and it was noted that a residual amount of fuel was pumped out of the fuel pump. There were no anomalies noted with the fuel pump.

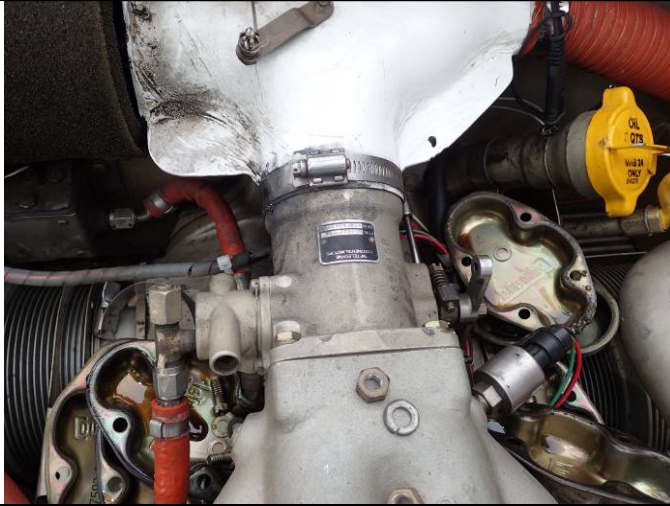
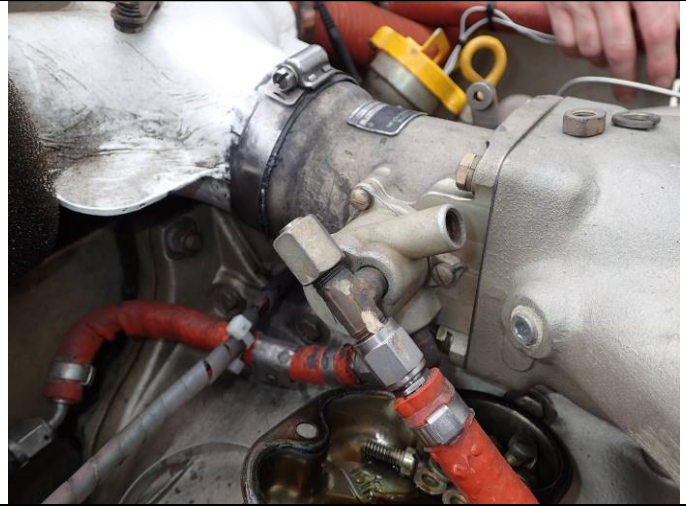
The throttle and fuel metering assembly remained attached to its installation point and was undamaged. The throttle arm was secure on the throttle shaft. It was noted that the air box was slightly loose at the attachment to the throttle body. There were no further anomalies noted.

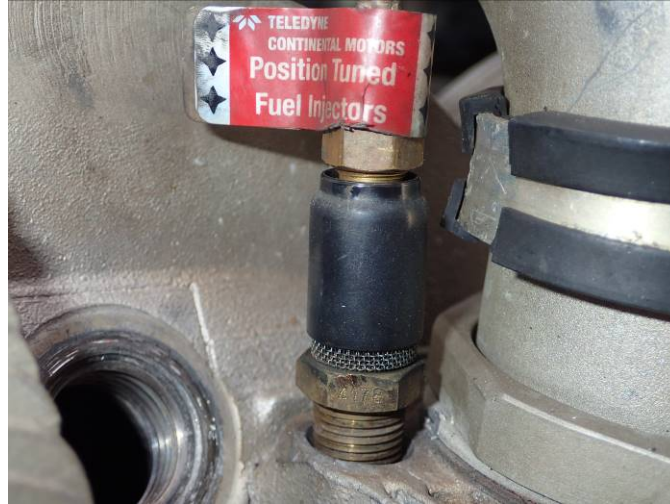
#4 Fuel Nozzle

| Position | #1 | #3 | #5 | #2 | #4 | #6 |
|---|---|---|---|---|---|---|
| Condition: | All of the fuel nozzles remained installed in their cylinders and there were no signs of fuel leaks around the nozzles. It was noted that the #4 fuel nozzle was cross threaded in the cylinder and was not installed in the cylinder as far as the other nozzles. All of the nozzles were removed and it was noted that all of the nozzles were clear of obstructions. | | | | | |

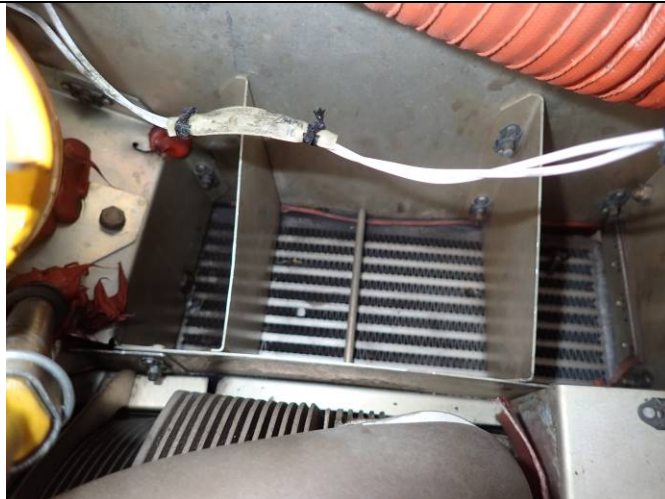
Condition: The oil cooler remained attached to its installation point and was undamaged. There were no anomalies noted with the oil cooler.

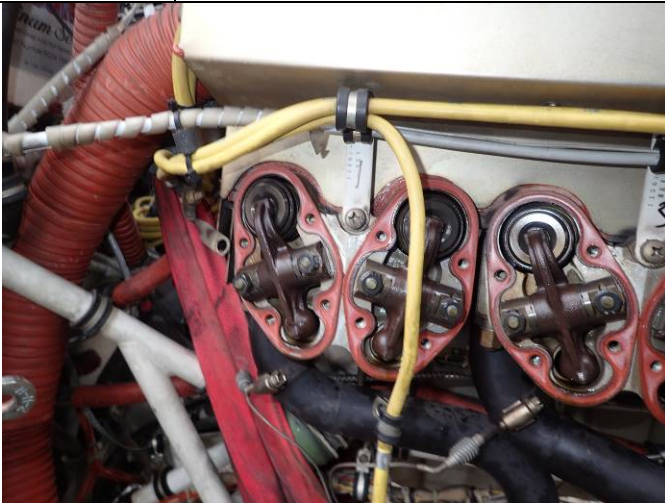
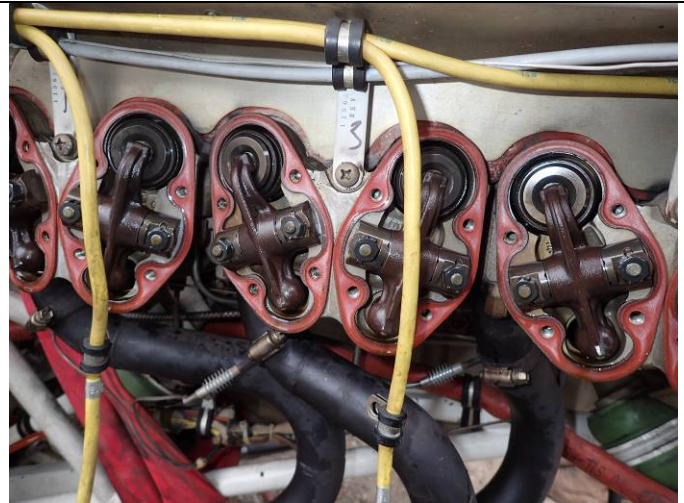
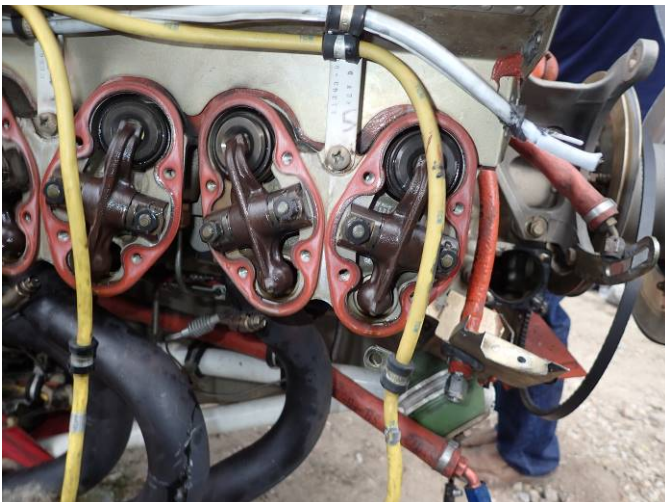
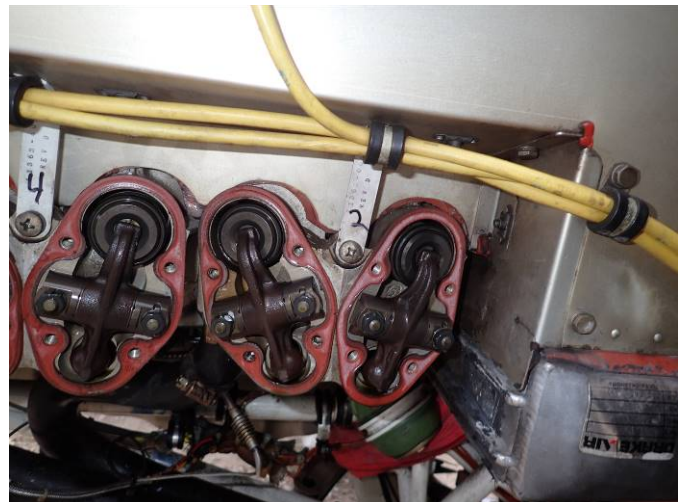
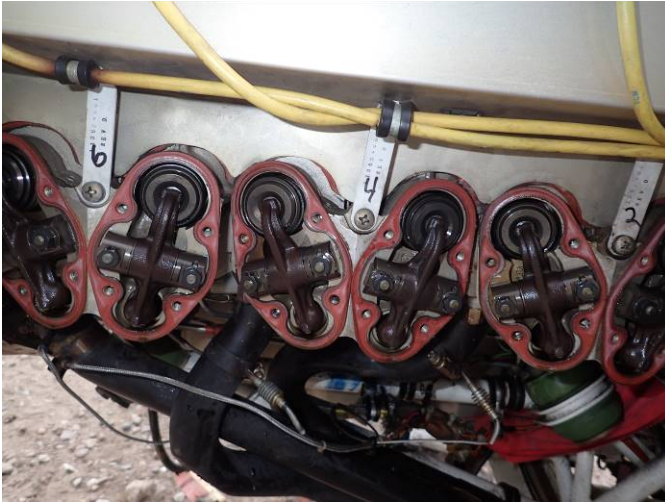
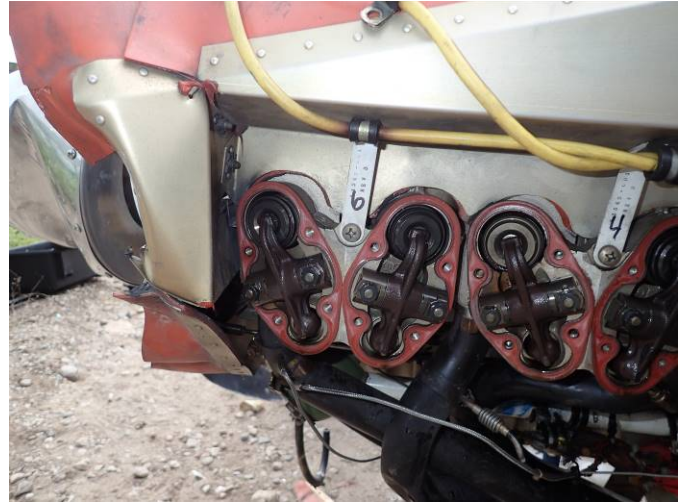
Condition: All of the cylinders remained attached to their cylinder bays and were undamaged. It was noted that there was a significant fuel leak coming from the even numbered cylinder drains; there were no further external anomalies noted. All of the cylinders were inspected using a lighted borescope; the cylinder bores, piston faces, and valve heads displayed normal operating and combustion signatures. The crankshaft was rotated by hand and it was noted that all of the cylinders displayed good thumb compression and suction; it was also noted that all of the cylinder overhead components (valves, springs, rocker arms) operated normally during crankshaft rotation.

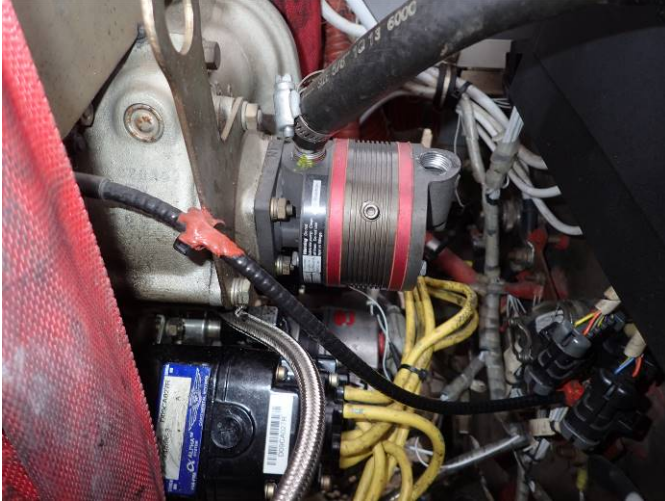
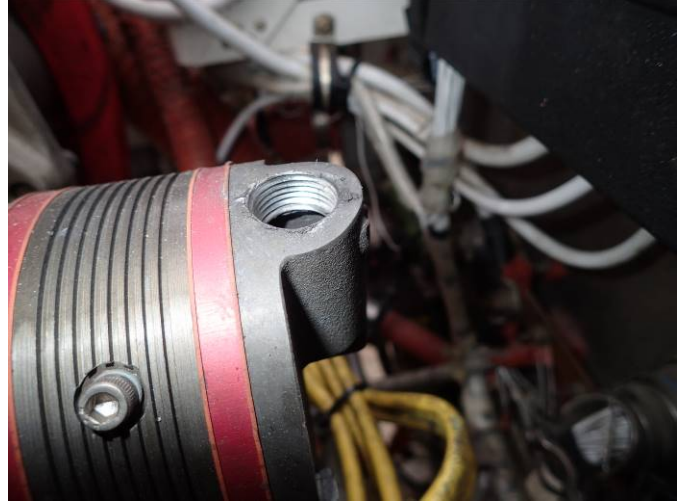
The vacuum pump remained attached to its installation point and was undamaged. It was noted that the vacuum pump outlet pipe was not installed on the vacuum pump; the outlet pipe was located at the bottom of the cowling. All of the threads in the vacuum pump and the outlet pipe remained intact.

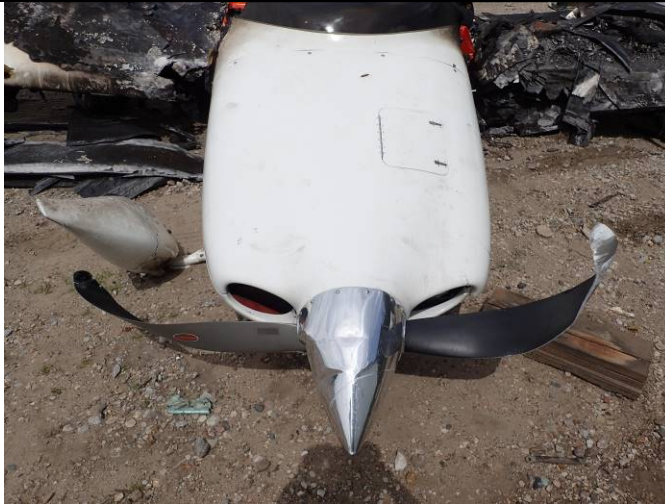
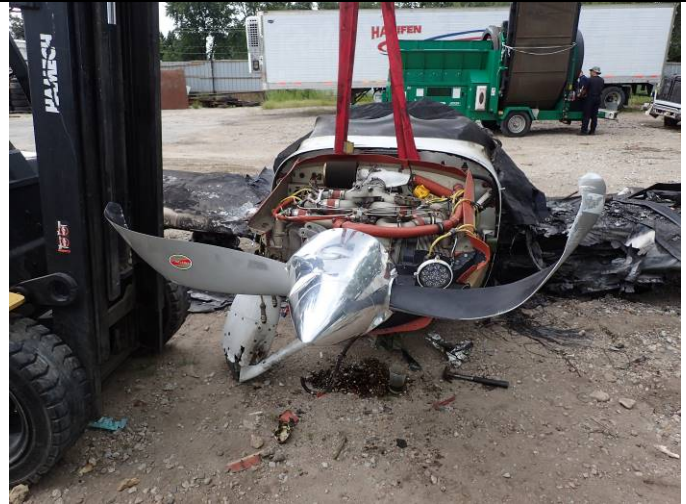
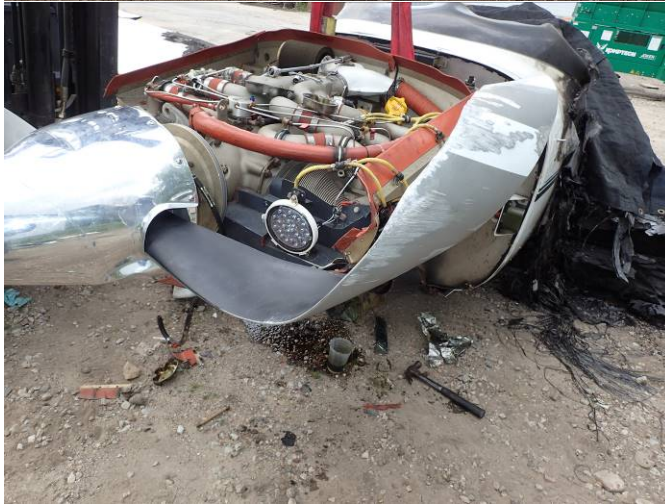
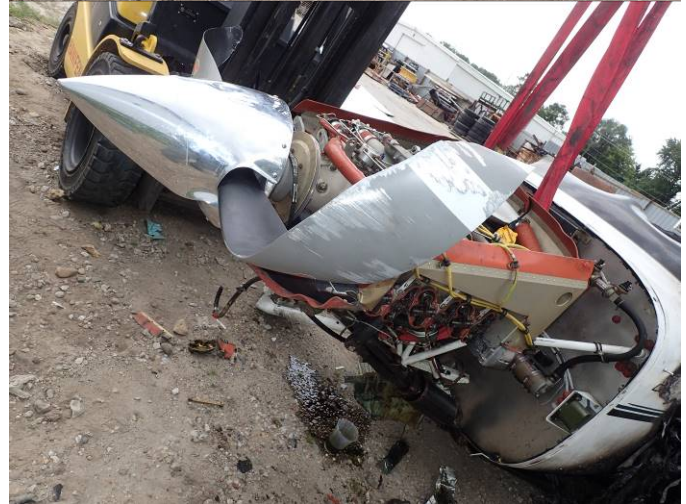
The two blade, constant speed propeller remained attached to the propeller flange and displayed impact damage signatures. Both of the propeller blades displayed chord wise scratches and gouges, and both of the propeller blades displayed twisting deformation.
