# NATIONAL TRANSPORTATION SAFETY BOARD

## MATERIALS LABORATORY FACTUAL REPORT

Report No. 18-092

Place : Des Moines, Iowa  
Date : August 13, 2016  
Vehicle : Cirrus SR20, N314BF  
NTSB No. : CEN16LA320  
Investigator : Andrew Todd Fox, AS-CEN

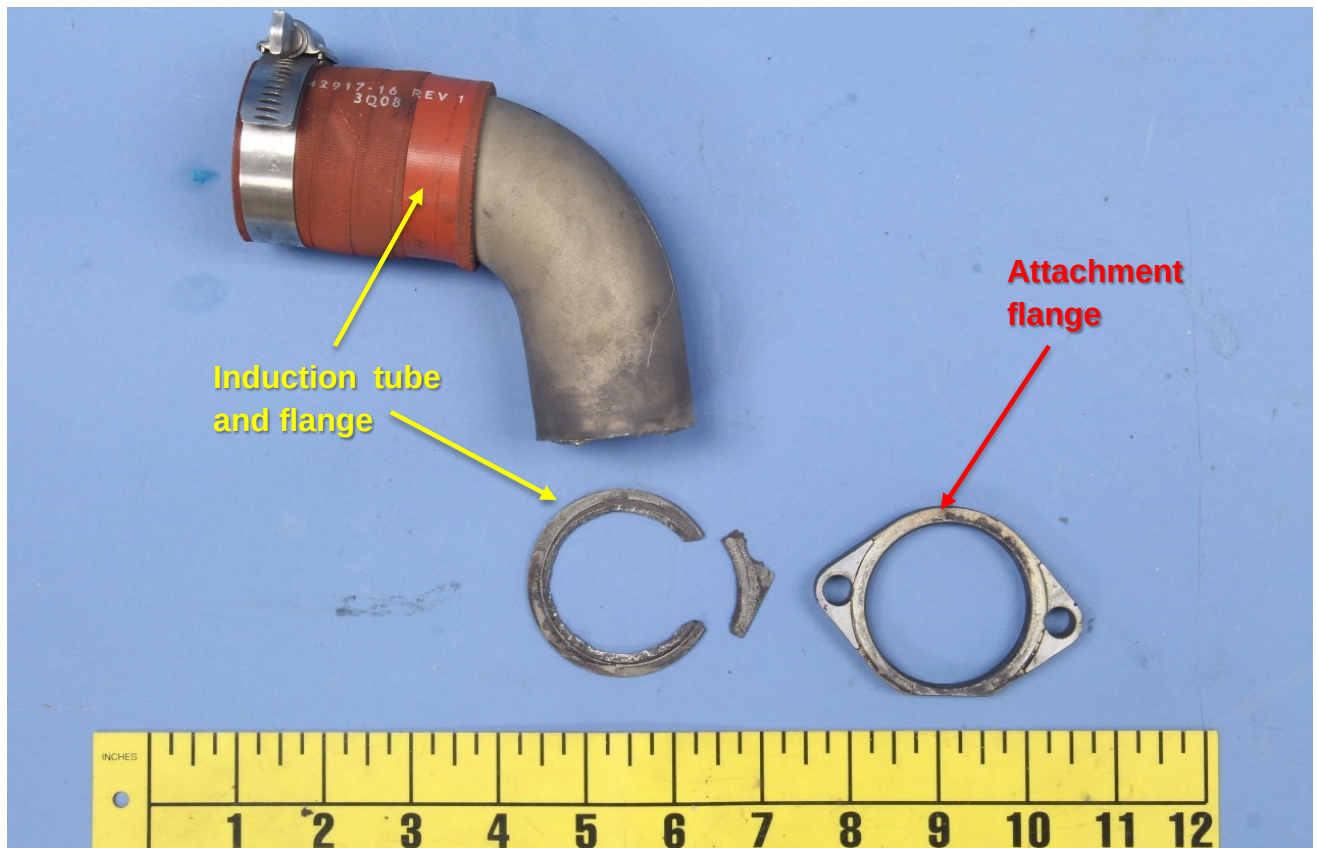
Figure 1 shows the #3-cylinder intake tube components, as received. The induction tube consisted of a metal alloy tube that was curved, affixed to an orange-colored rubber boot. The boot was stamped with the following markings: "642917-16 REV 1" and "3Q08" (see Figure 2). As shown in Figure 1, the mounting flange of the tube had fractured from the main body of the tube. An additional attachment flange, also shown in Figure 1, did not exhibit any discernible damage.

Figure 1 – The pieces of the fractured #3 induction tube and attachment flange, as received.

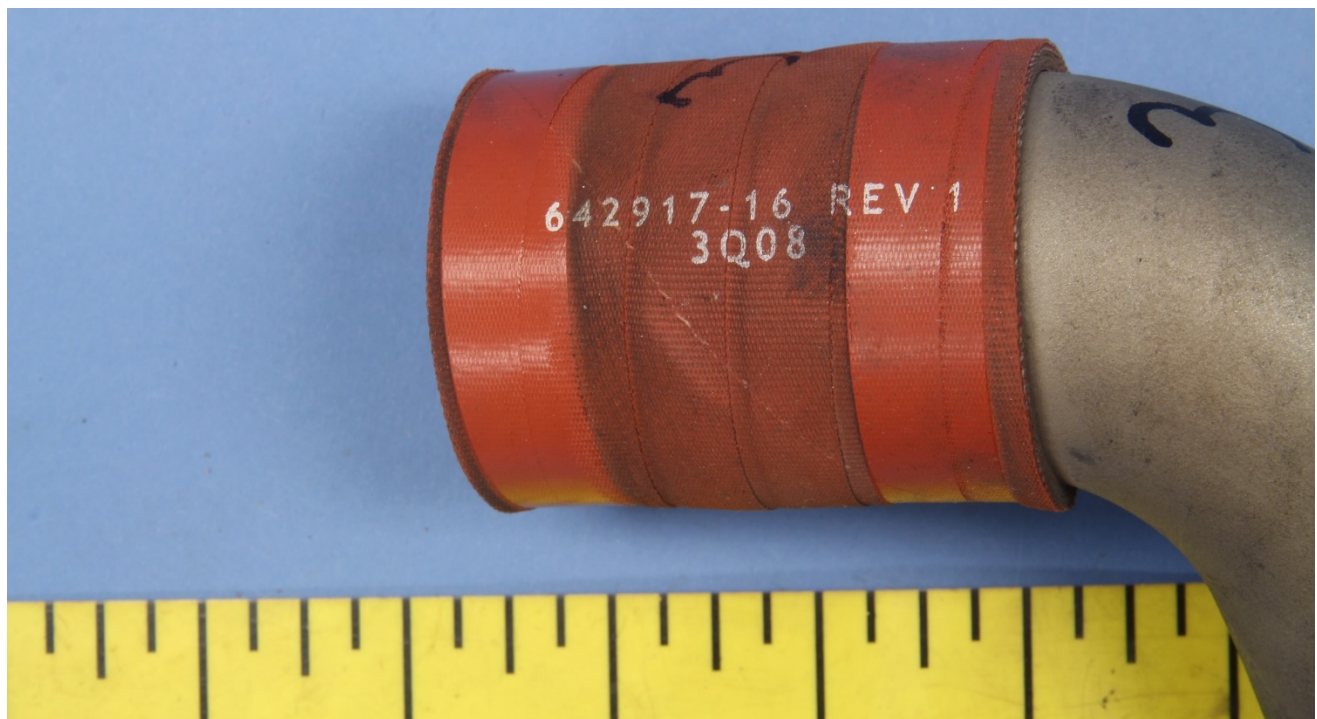
Figure 2 – Markings on the orange rubber connector on the opposite side of the induction tube.

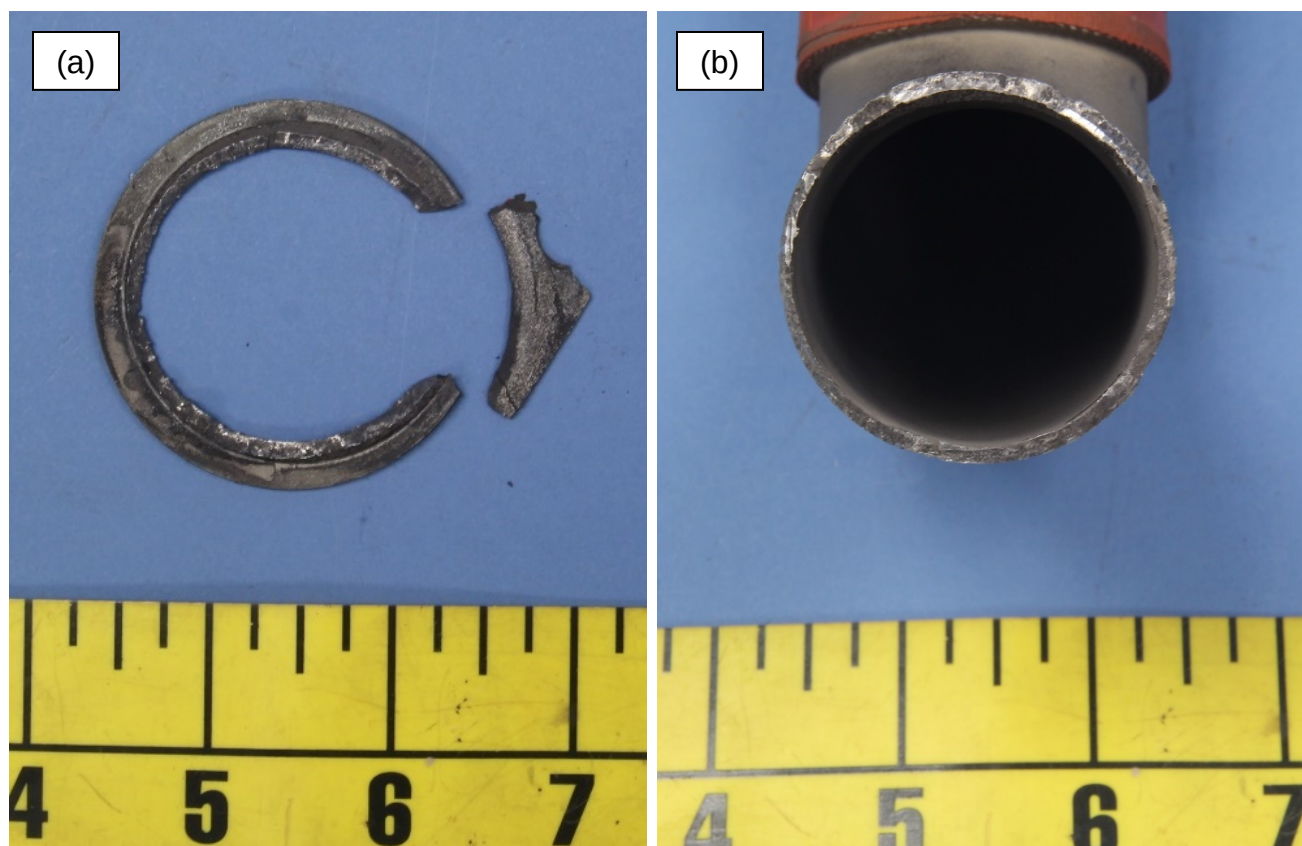
Figure 3 shows the mating sides of the induction tube fracture surface from the mounting flange (3a) and the tube (3b) sides. The fracture was circumferential in orientation and was perpendicular to the tube direction. The flange had also fractured in two additional locations longitudinally, creating two flange fragments.

Figure 3 – The fracture surfaces of the induction tube from (a) the fractured flange and (b) the tube.

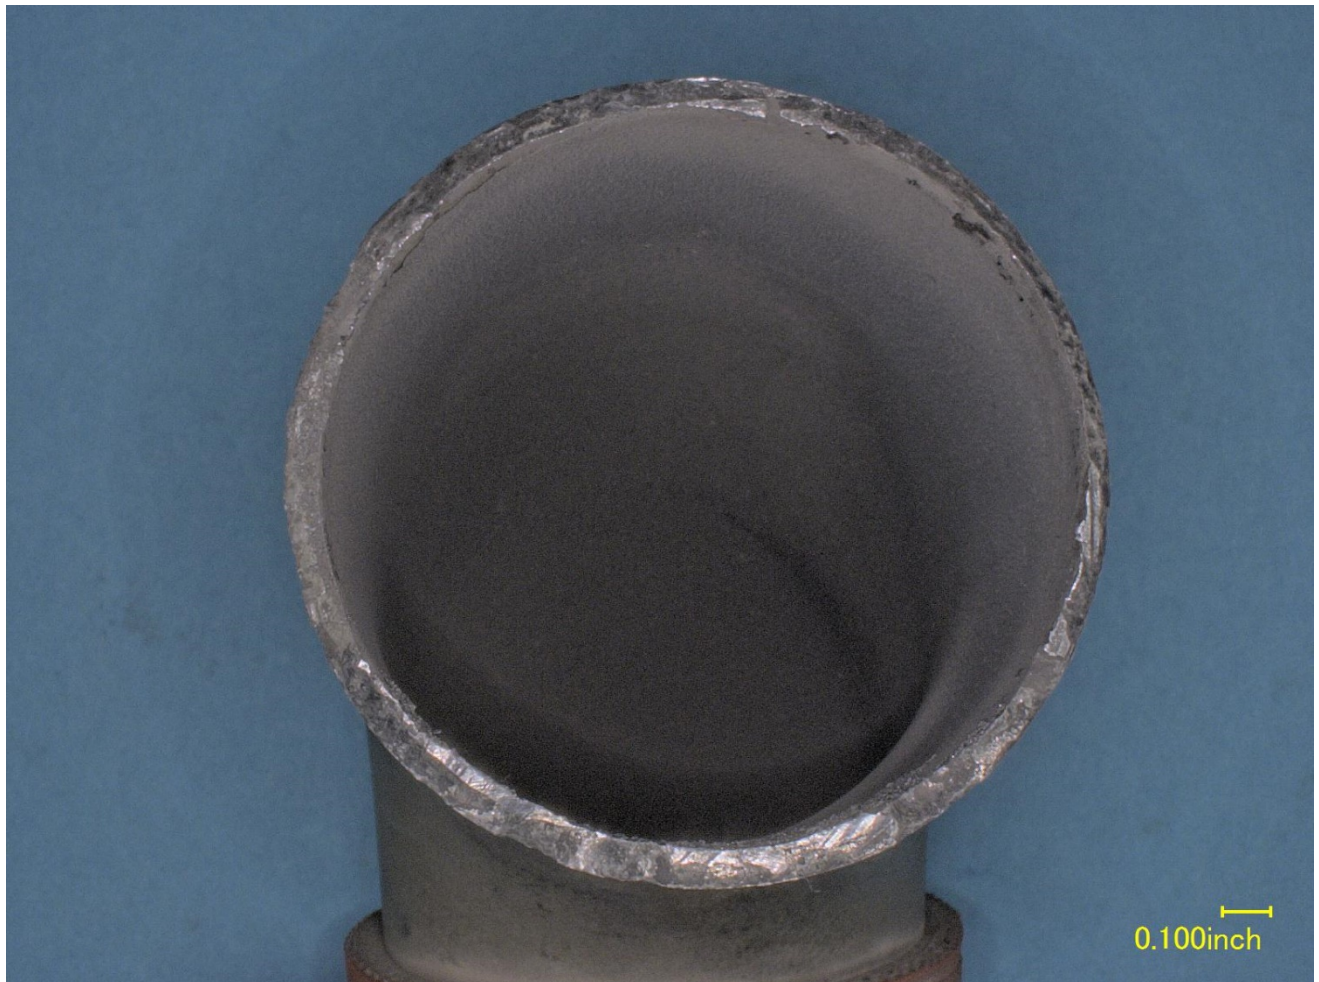
Figures 4 through 7 show closer views of the mating fracture surfaces. In general, the fracture surfaces exhibited a flat orientation, with some areas exhibiting an approximately 45° orientation. As shown in Figures 5 and 7, most of the fracture surfaces exhibited smearing and rub marks, consistent with post-fracture damage. These damaged regions appeared shiny in contrast to the surrounding less damaged or undamaged portions of the fracture surface. These undamaged areas exhibited a dull luster and rougher surface texture.

Figure 4 – Closer view of the tube side fracture surface.

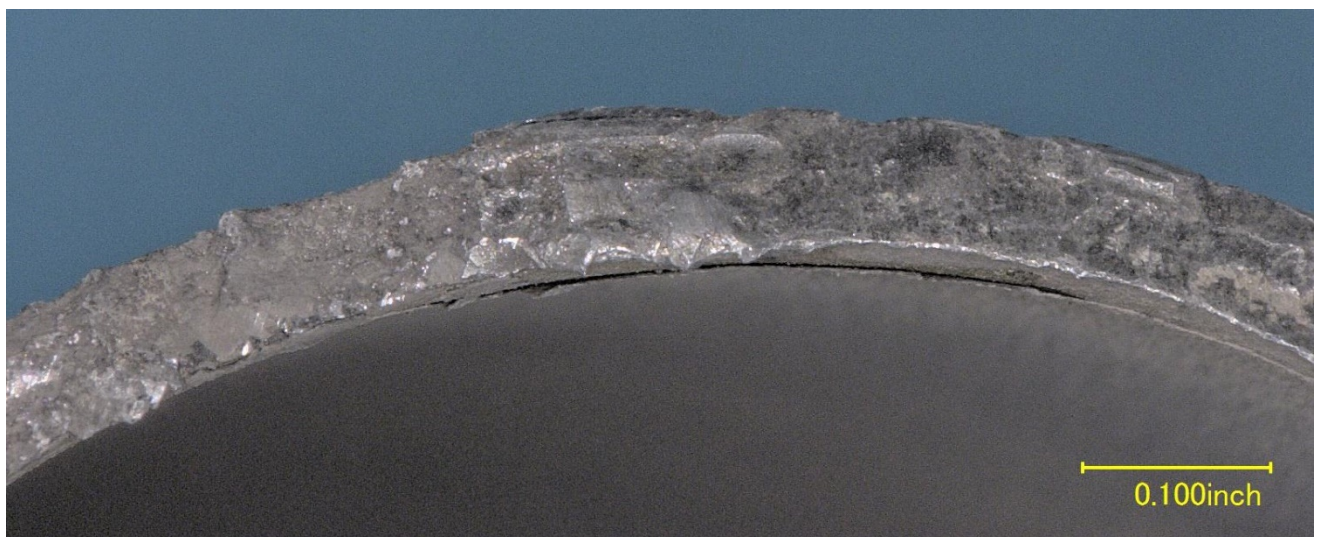
Figure 5 – View of the upper portion of the tube fracture surface, showing post-fracture damage.

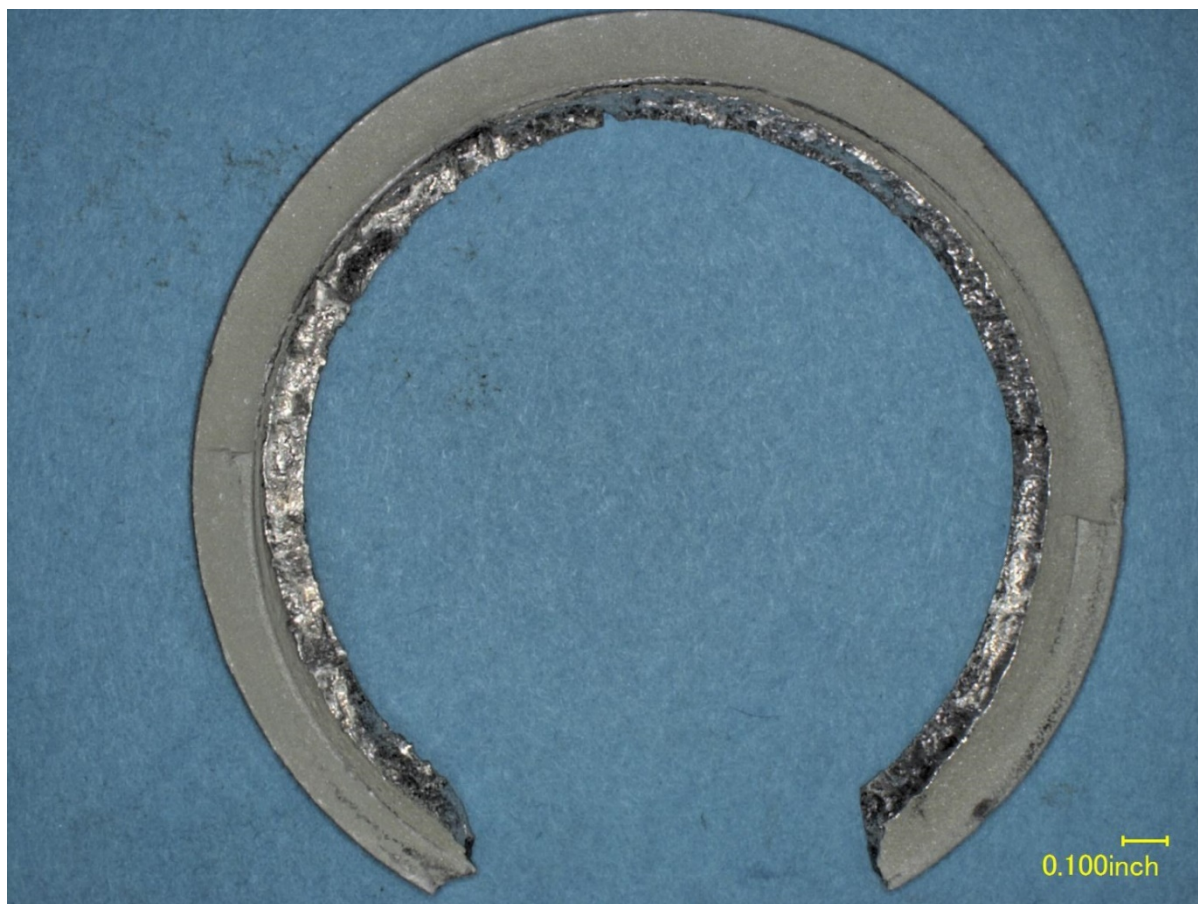
Figure 6 – The fracture surface of the fractured tube flange.

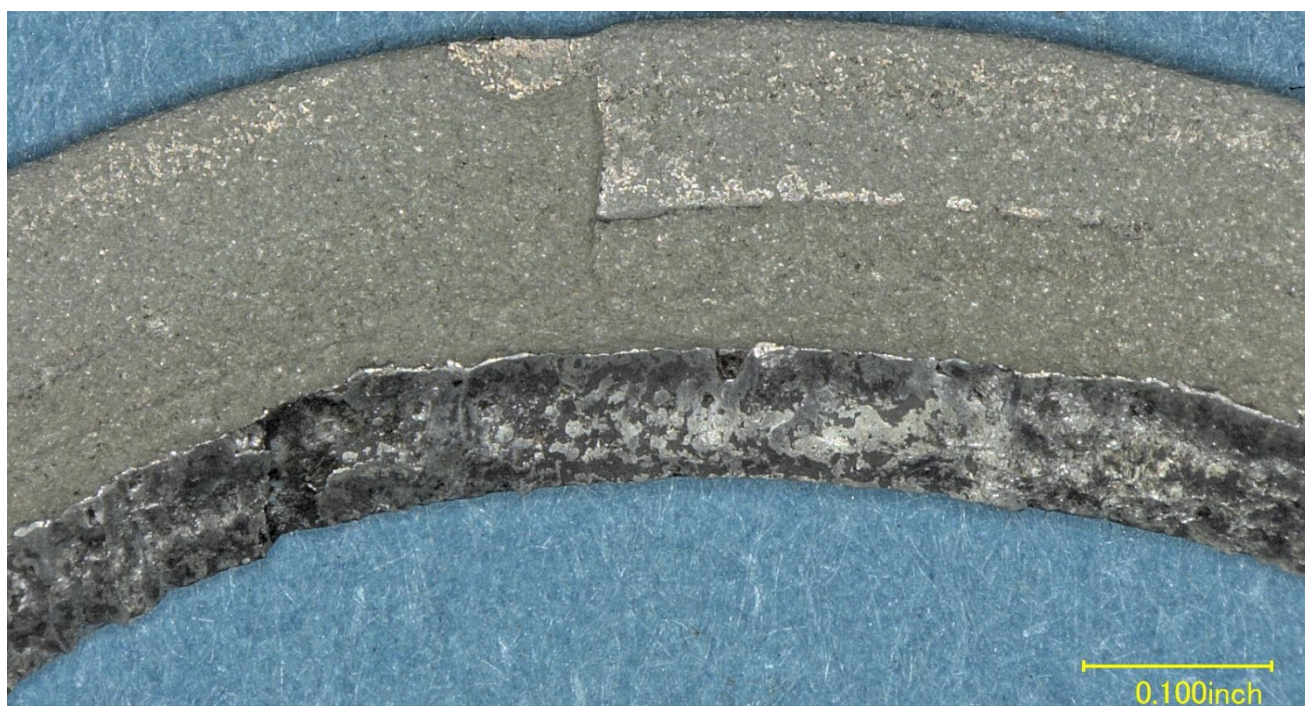
Figure 7 – Closer view of part of the flange fracture surface.

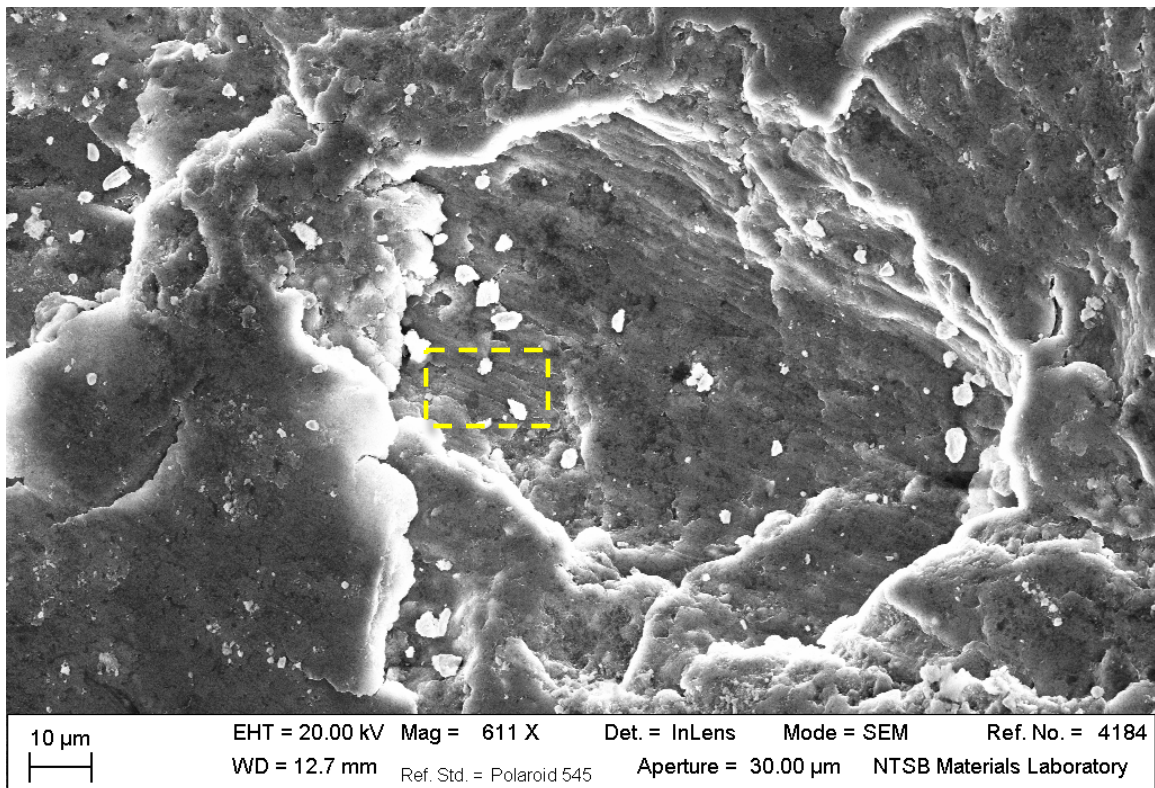
The flange side fracture surface was examined using a scanning electron microscope (SEM). As described previously, much of the fracture surface had been damaged to the extent that typical fracture features had been obliterated. However, in isolated areas, some fracture features could be discerned, as shown in Figures 8 and 9. As illustrated in these figures, the undamaged portions of the fracture surface showed striations, consistent with fatigue crack propagation. The character and spacing of the striations were consistent with high-cycle fatigue.

Figure 8 – Secondary electron (SE) micrograph showing an undamaged part of the flange fracture surface. The boxed area is shown in Figure 9.

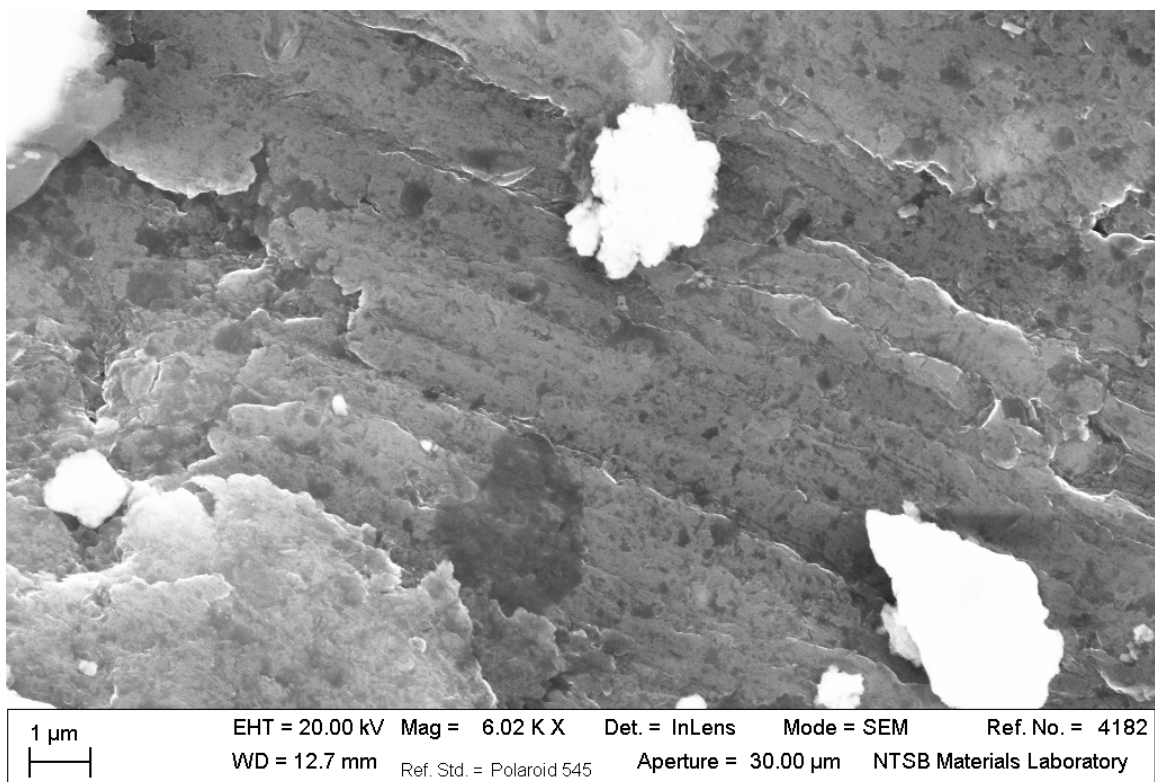
Figure 9 – SE micrograph showing fatigue striations from the boxed area in Figure 8.

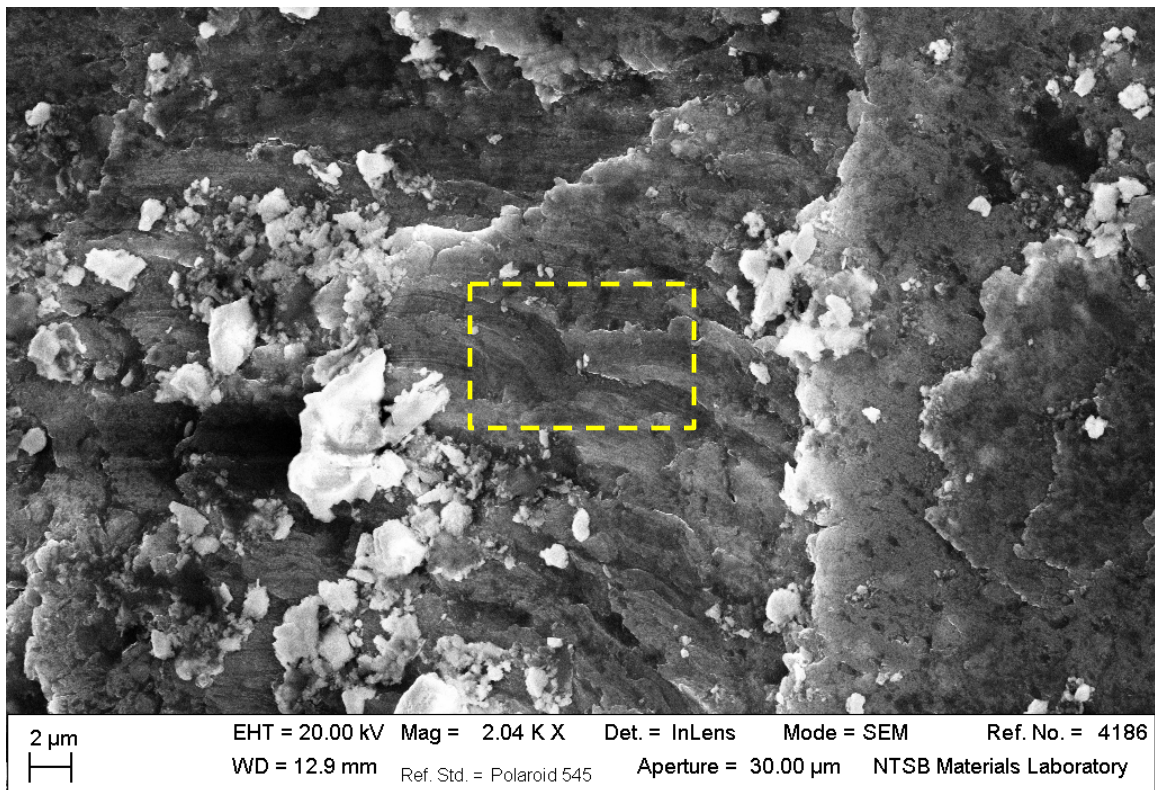
An additional area near the edge of the fracture surface is shown in Figures 10 and 11. This undamaged portion of the fracture surface also exhibited fine fatigue striations. However, the likely initiation sites of the fatigue cracking had been destroyed by post-fracture smearing. In addition, no features consistent with other fracture modes were observed on the undamaged areas of the fracture surface.

Figure 10 – SE micrograph of fatigue striations near the fracture surface edge.

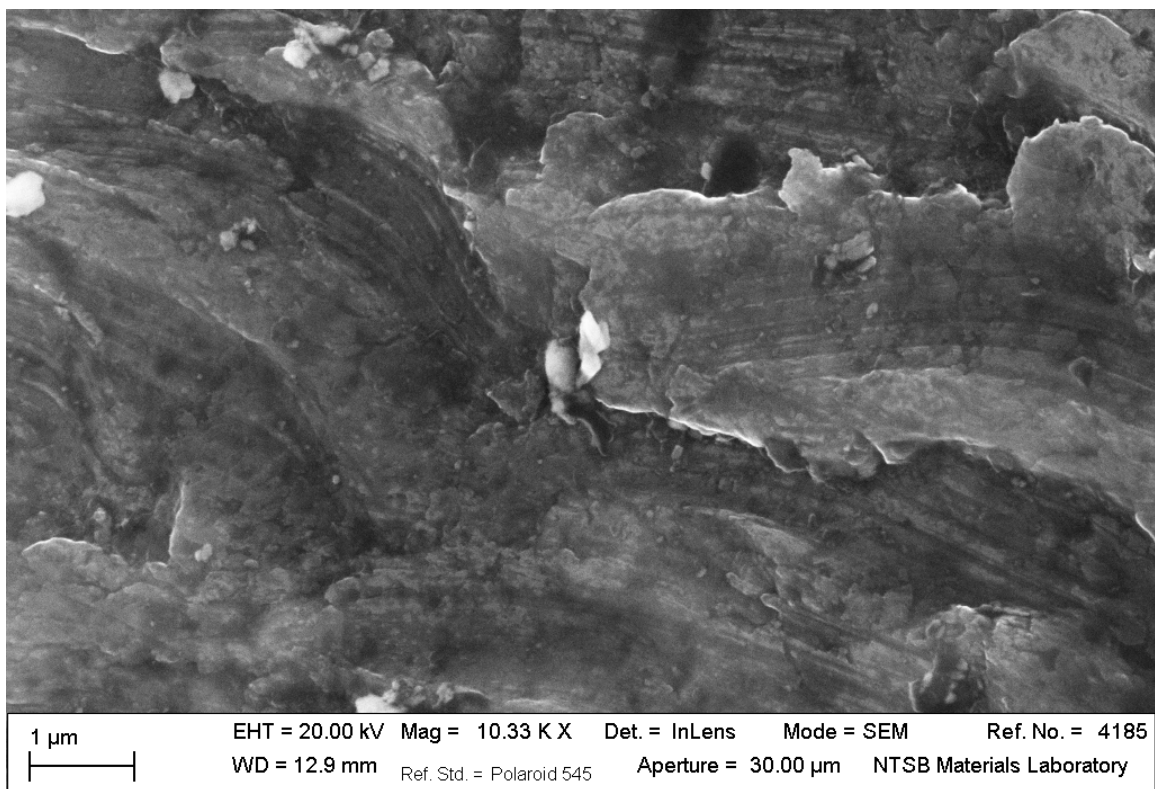
Figure 11 – SE micrograph of the yellow boxed area in Figure 10, showing fine fatigue striations.

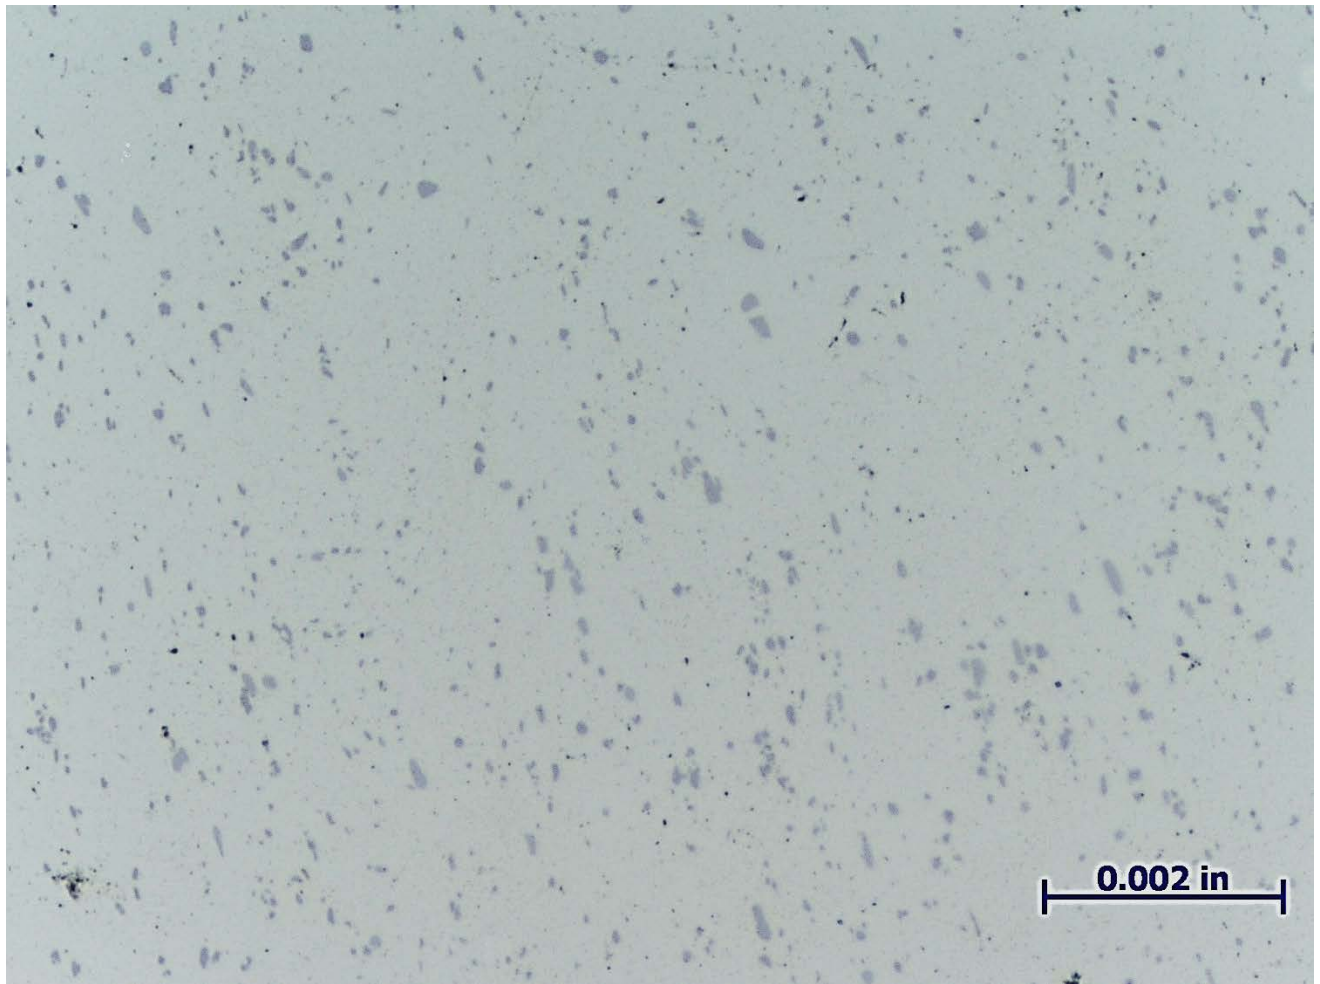
A section of the fractured flange through the fracture surface was mounted and polished. Figure 12 shows a typical area of the flange microstructure, which exhibited a two-phase structure consistent with wrought materials. The chemical composition of the tab was inspected using energy dispersive x-ray spectroscopy (EDS). The composition

was consistent with an AA 6061-series aluminum alloy. The electrical conductivity and hardness were inspected per ASTM E1004 and ASTM E384, respectively.<sup>2,3</sup> The conductivity averaged 42.5% IACS, and the hardness averaged 46 HV<sub>500</sub>. These data were consistent with those typical of this alloy in the annealed condition.

Figure 12 – Bright-field (BF) optical metallograph of the flange microstructure (~500X, as polished).
