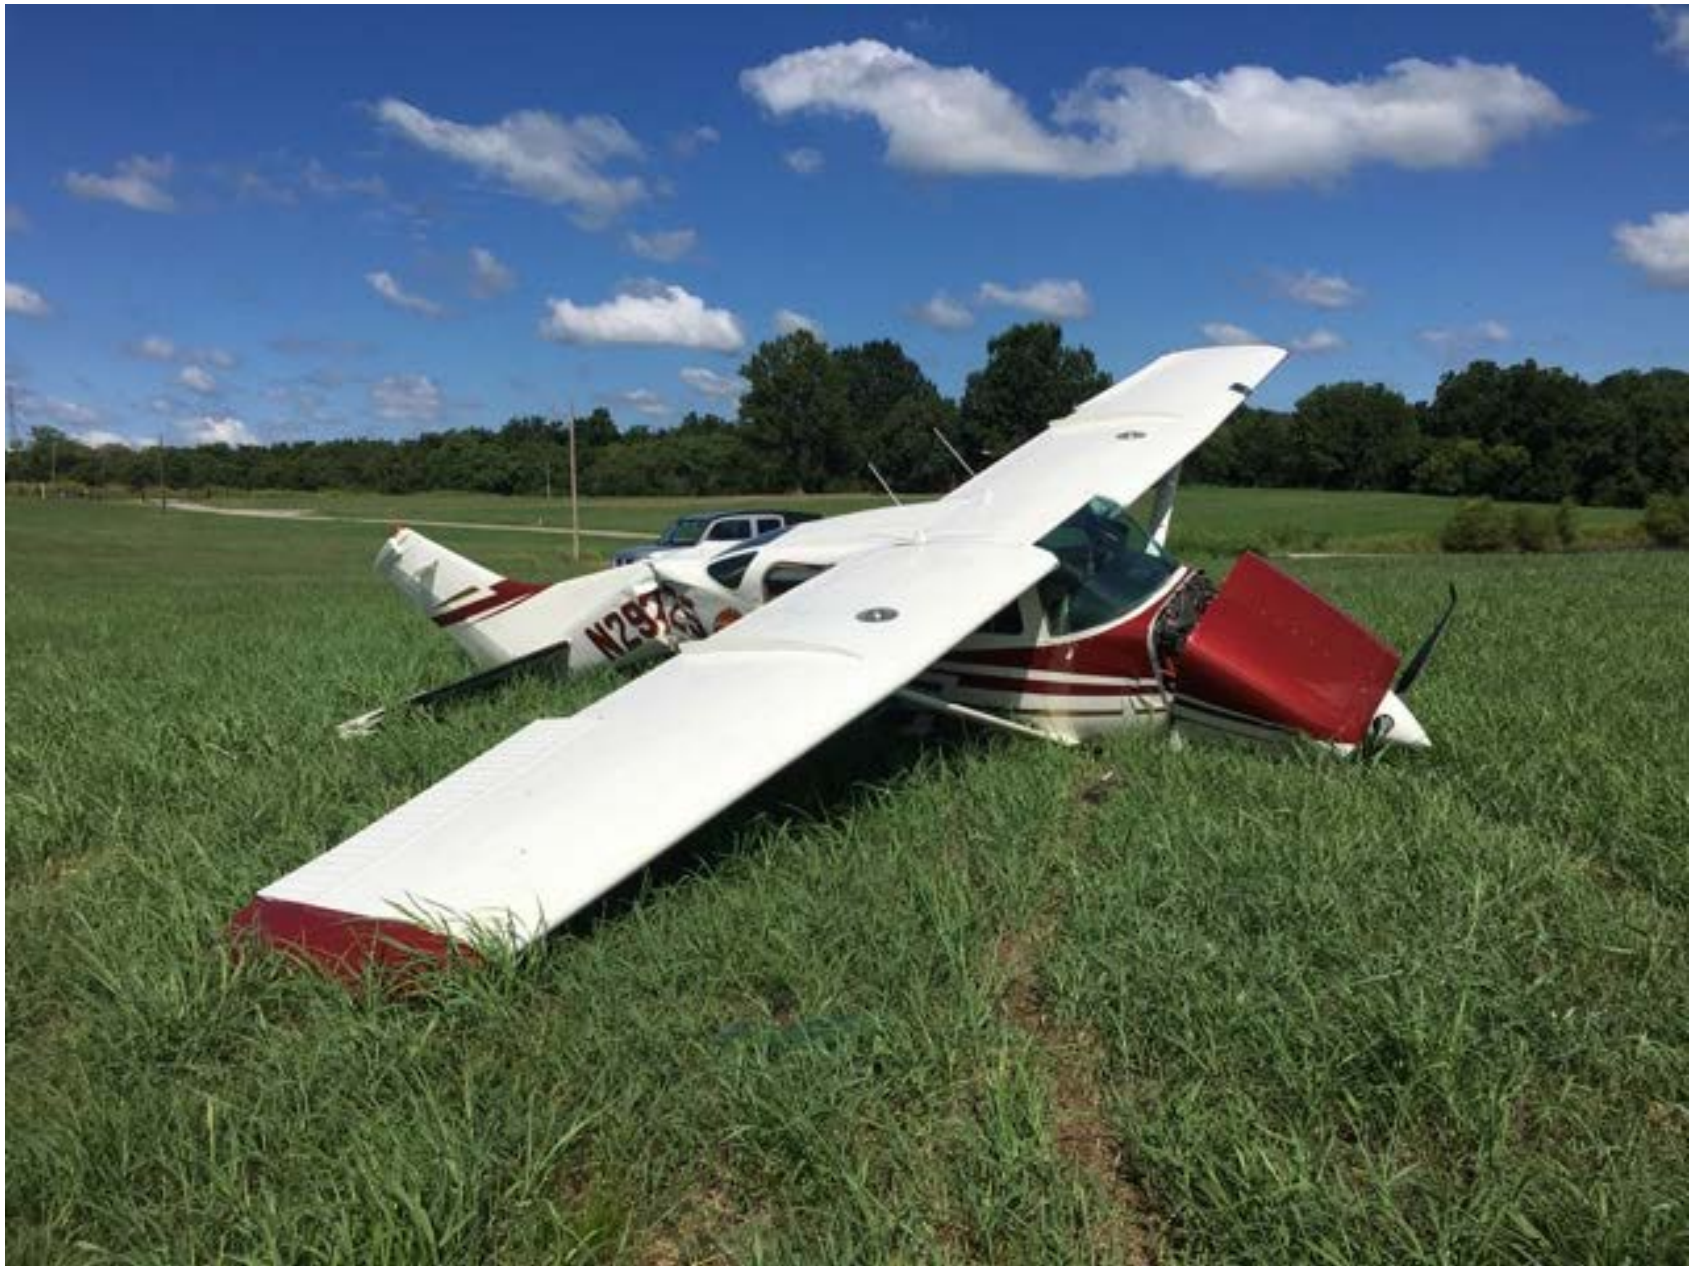
**Photo 1 – Airplane Wreckage at Accident Site Right Side**

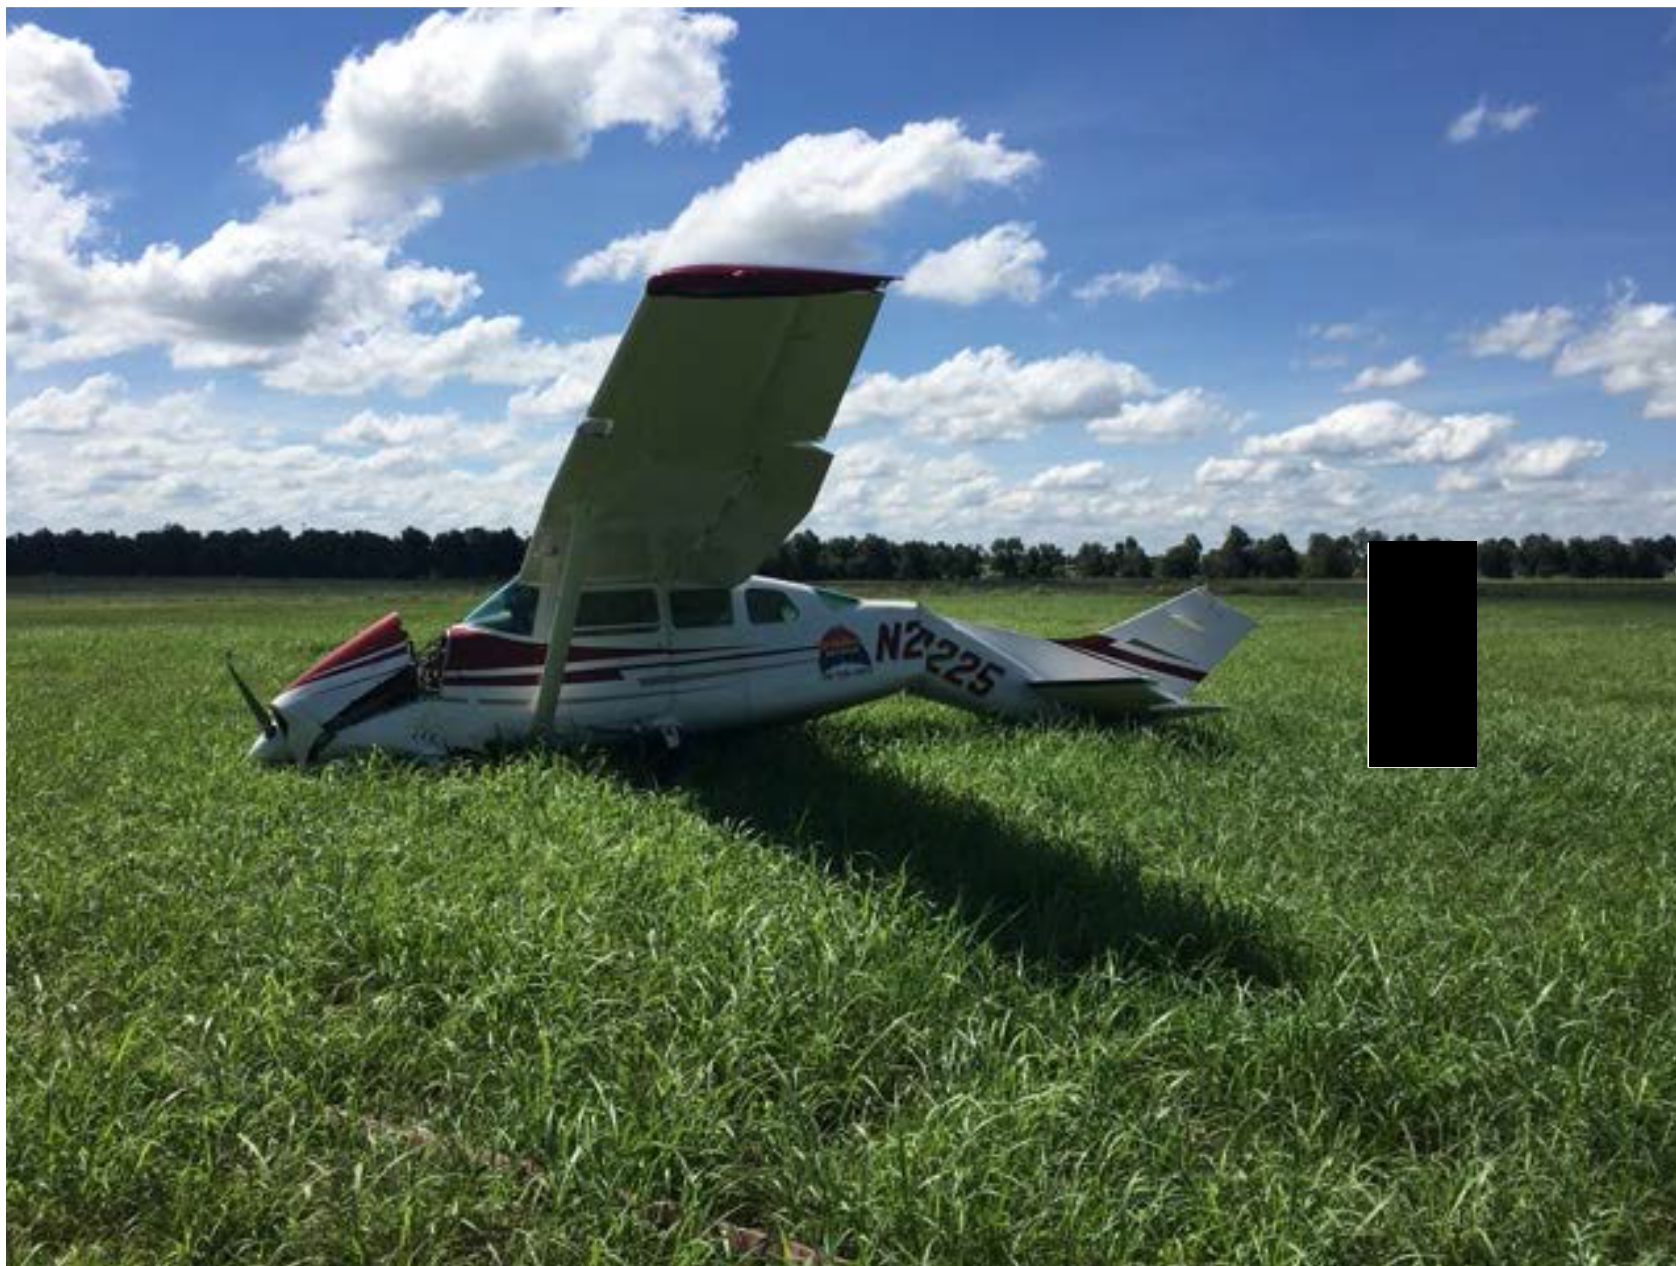
**Photo 2 – Airplane Wreckage at Accident Site Left Side**

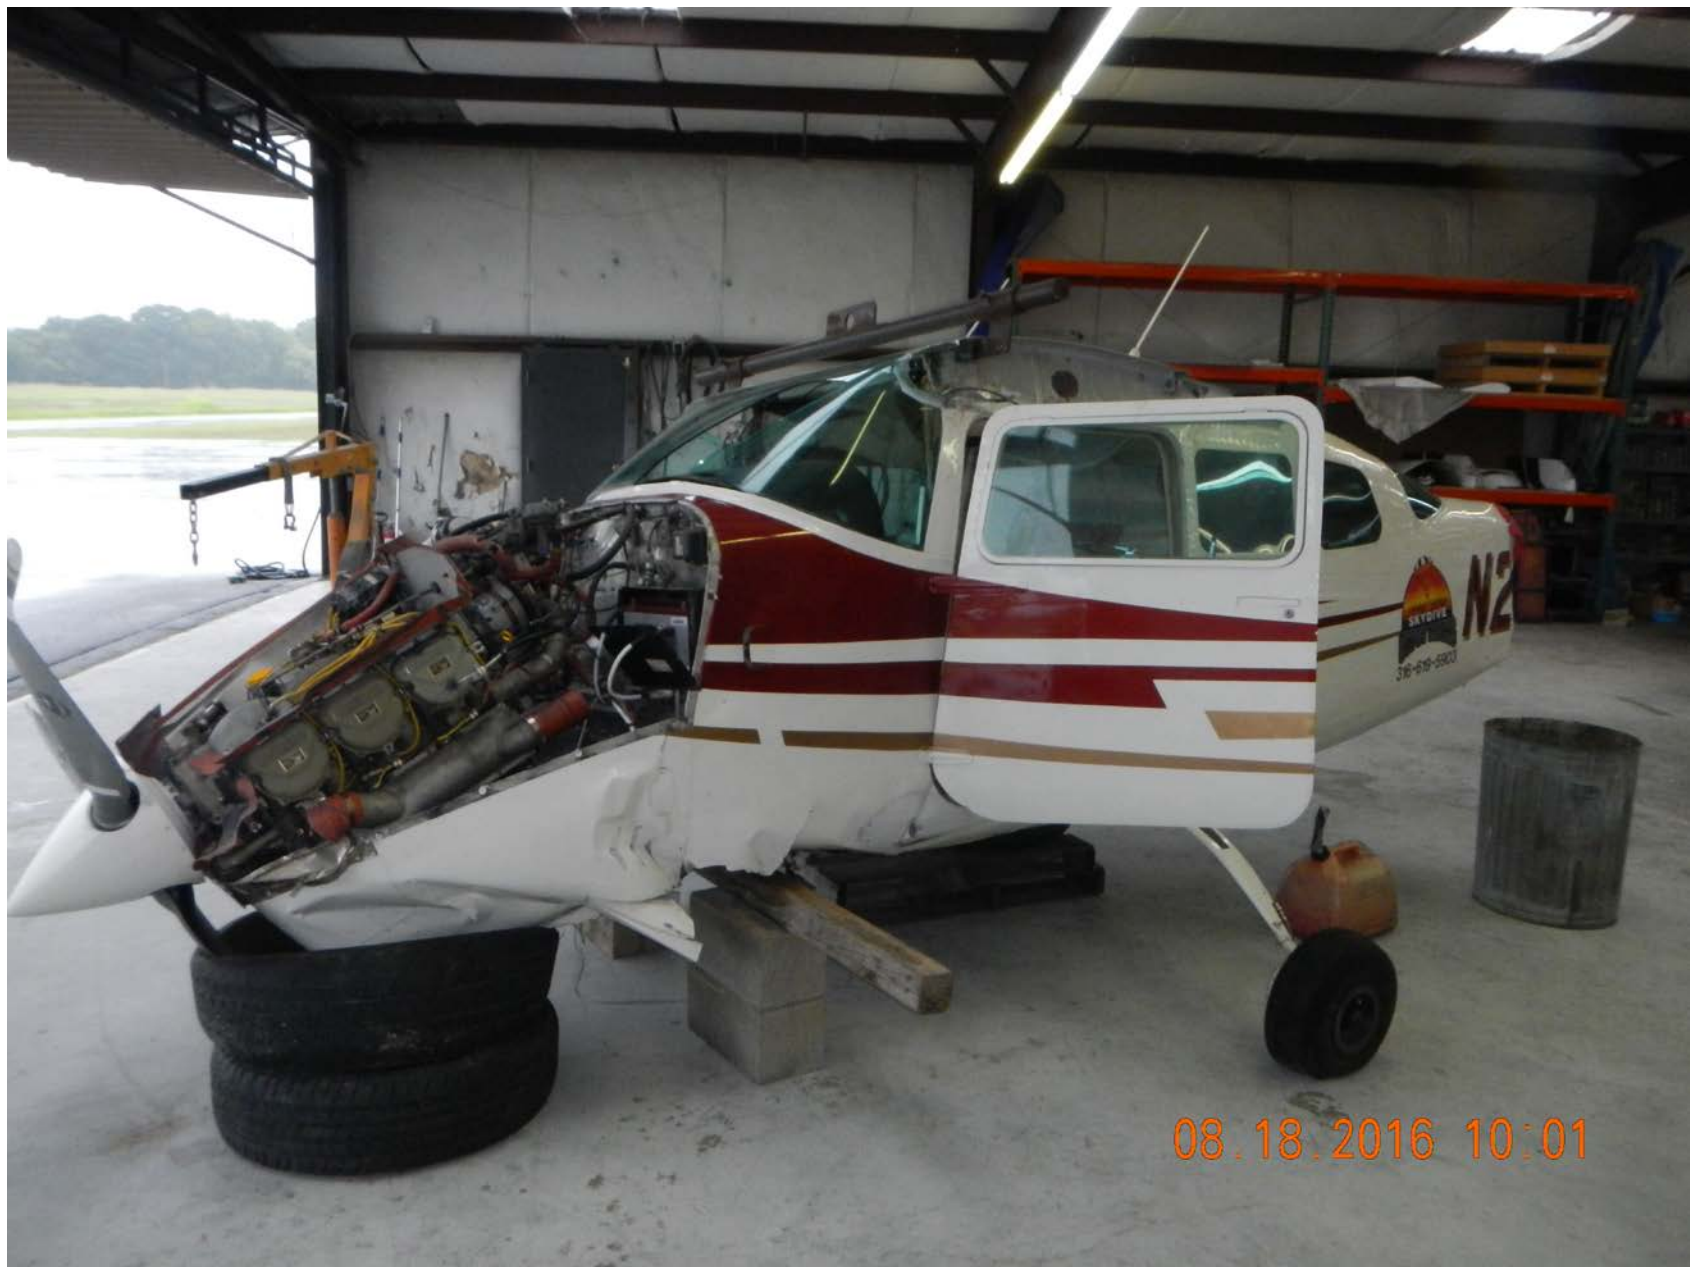
**Photo 3 - Airplane Wreckage in Hangar after Recovery**

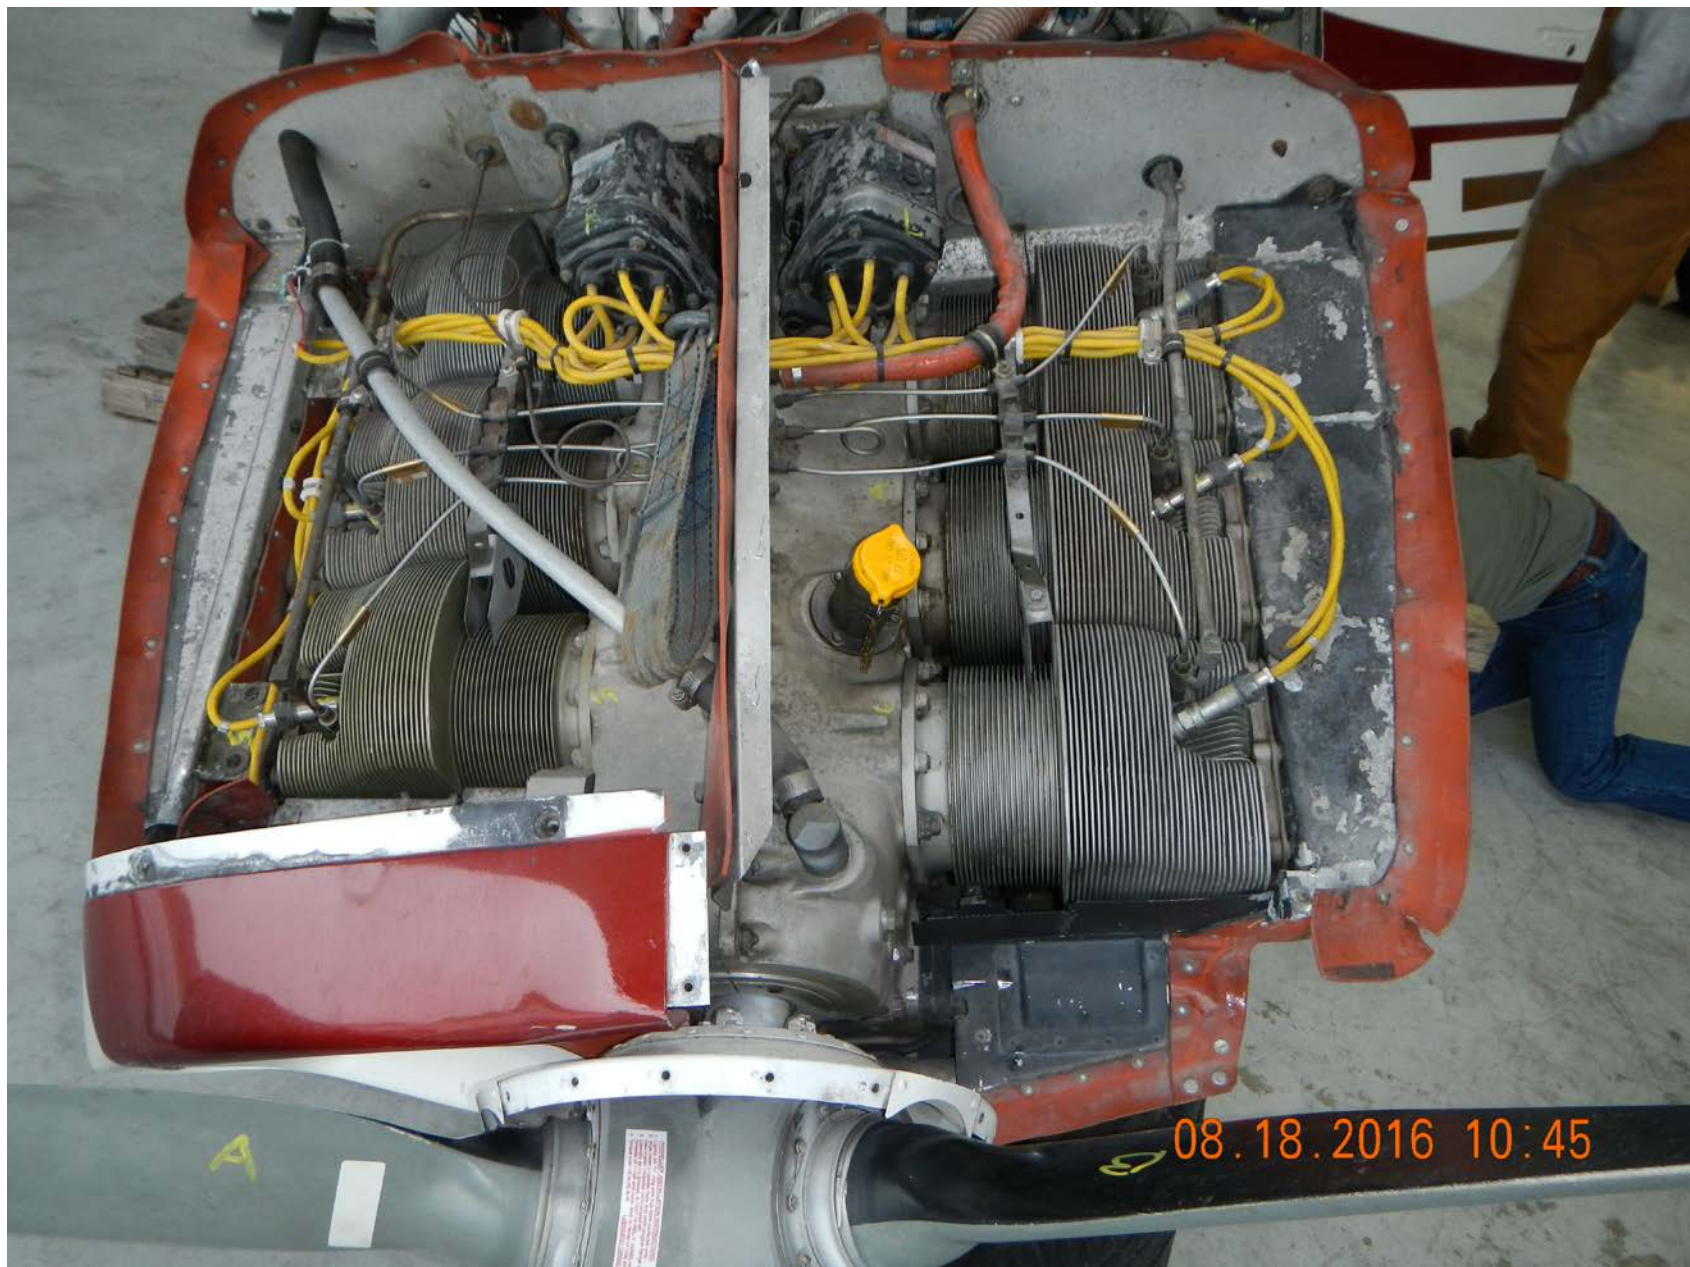
**Photo 4 - Closeup of Engine After Recovery**

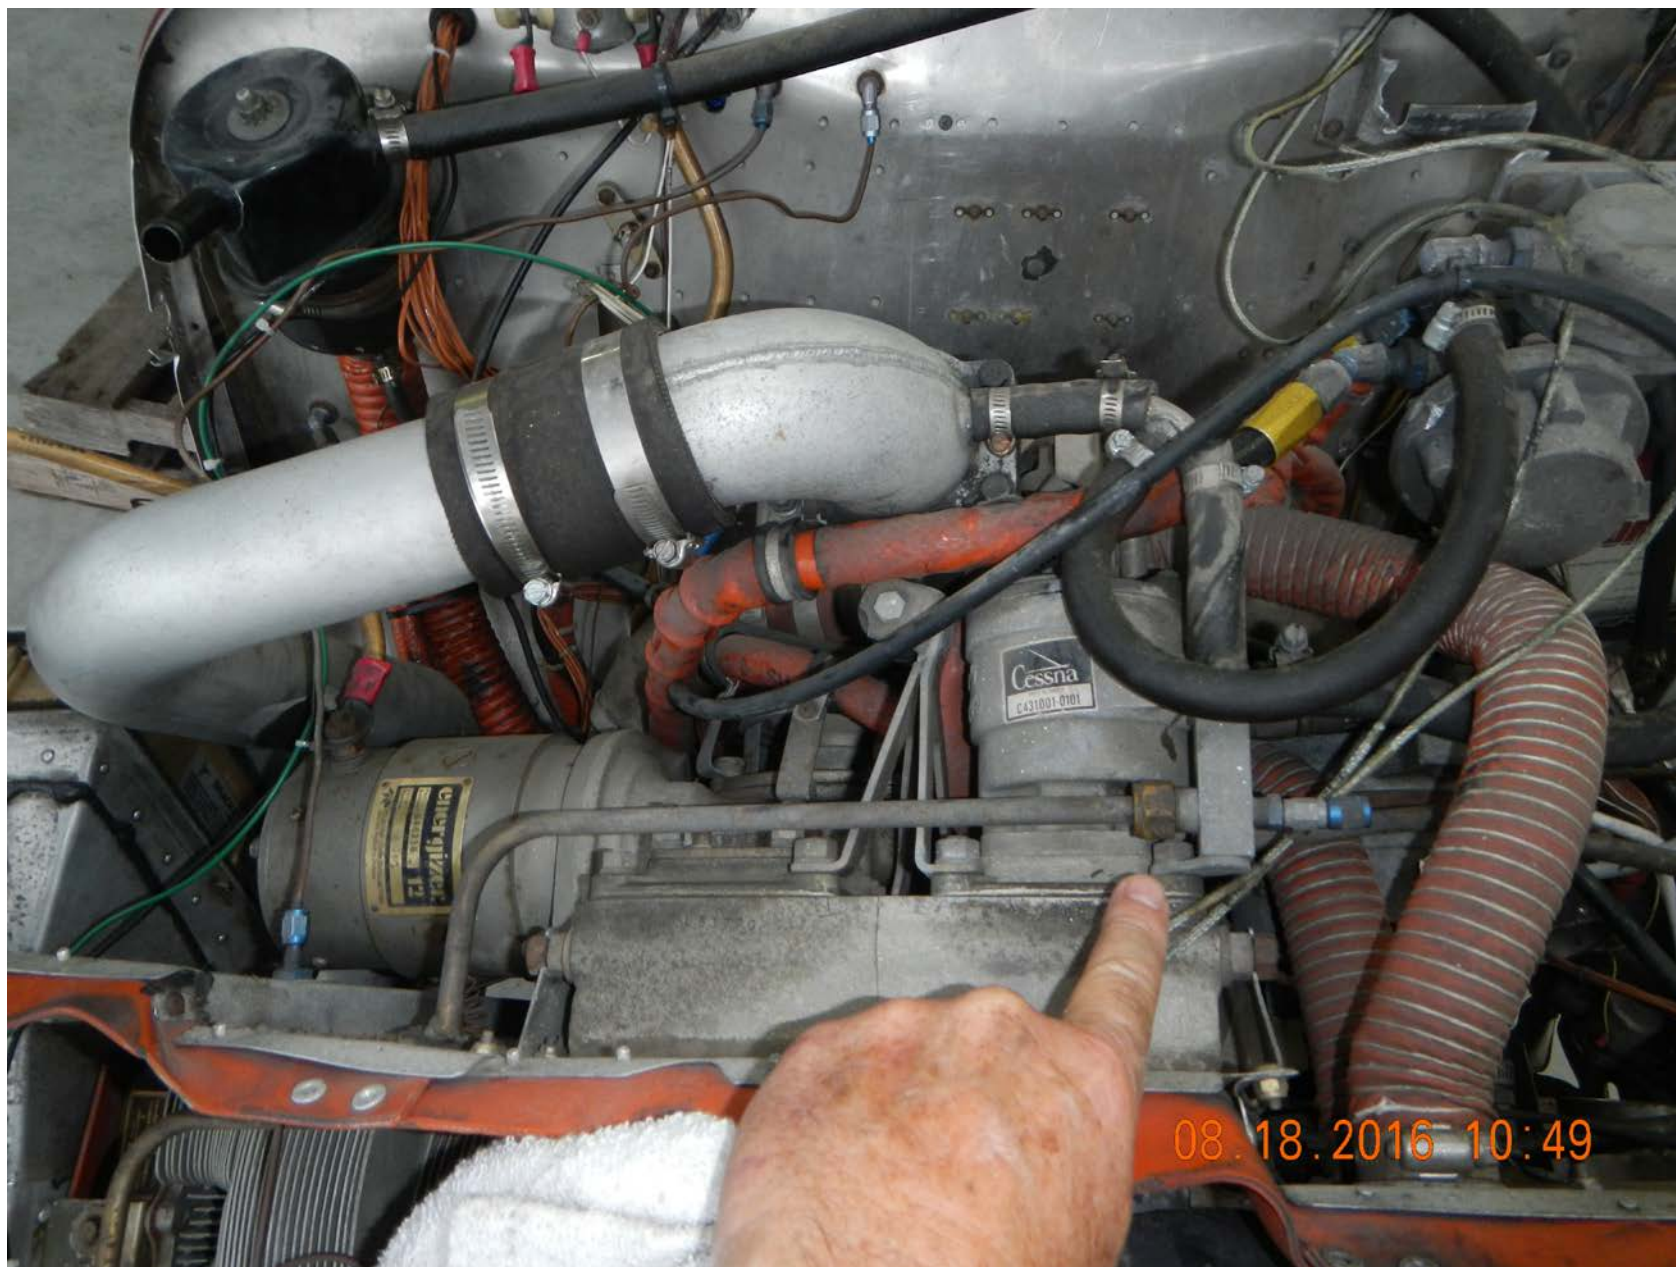
**Photo 5 - Loose B-Nut Fitting Observed During Engine Examination**

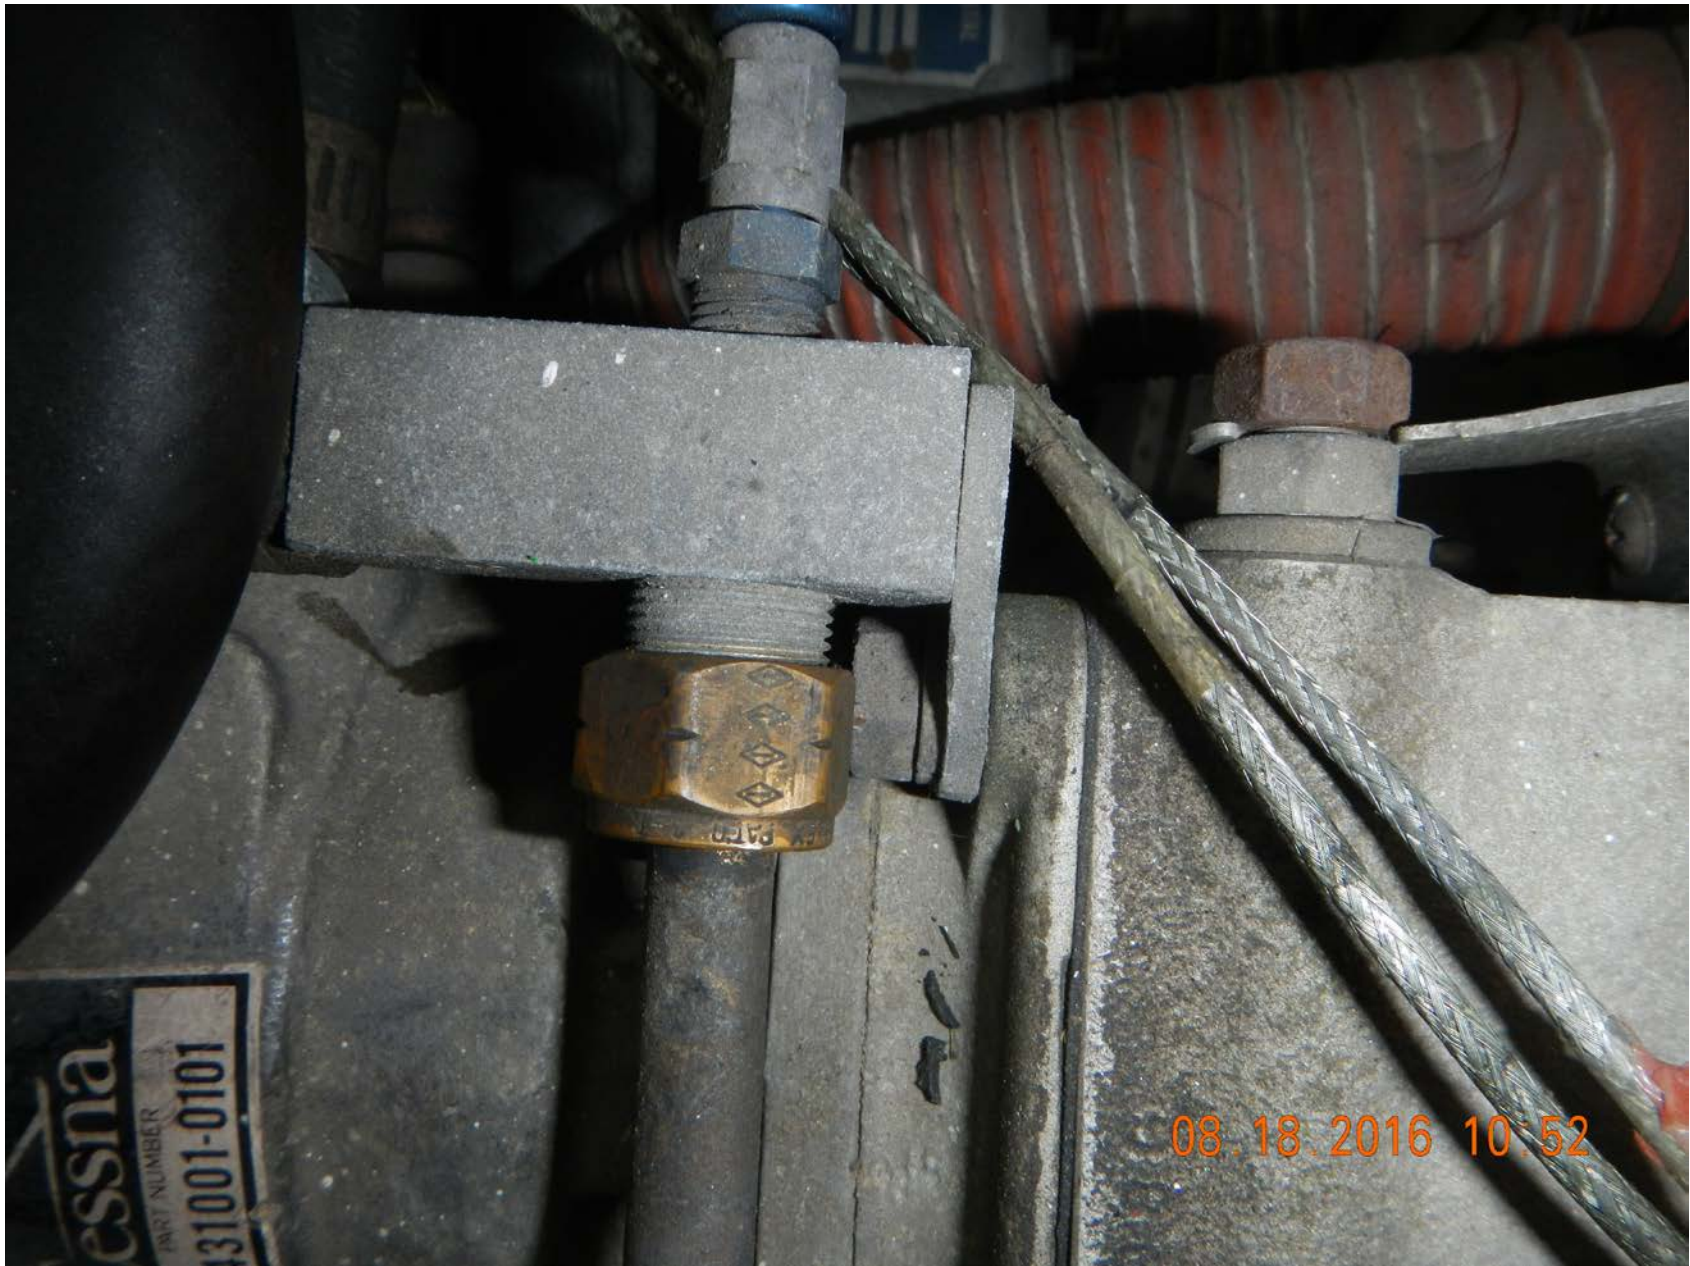
**Photo 6 - Closeup of Loose B-Nut Fitting**

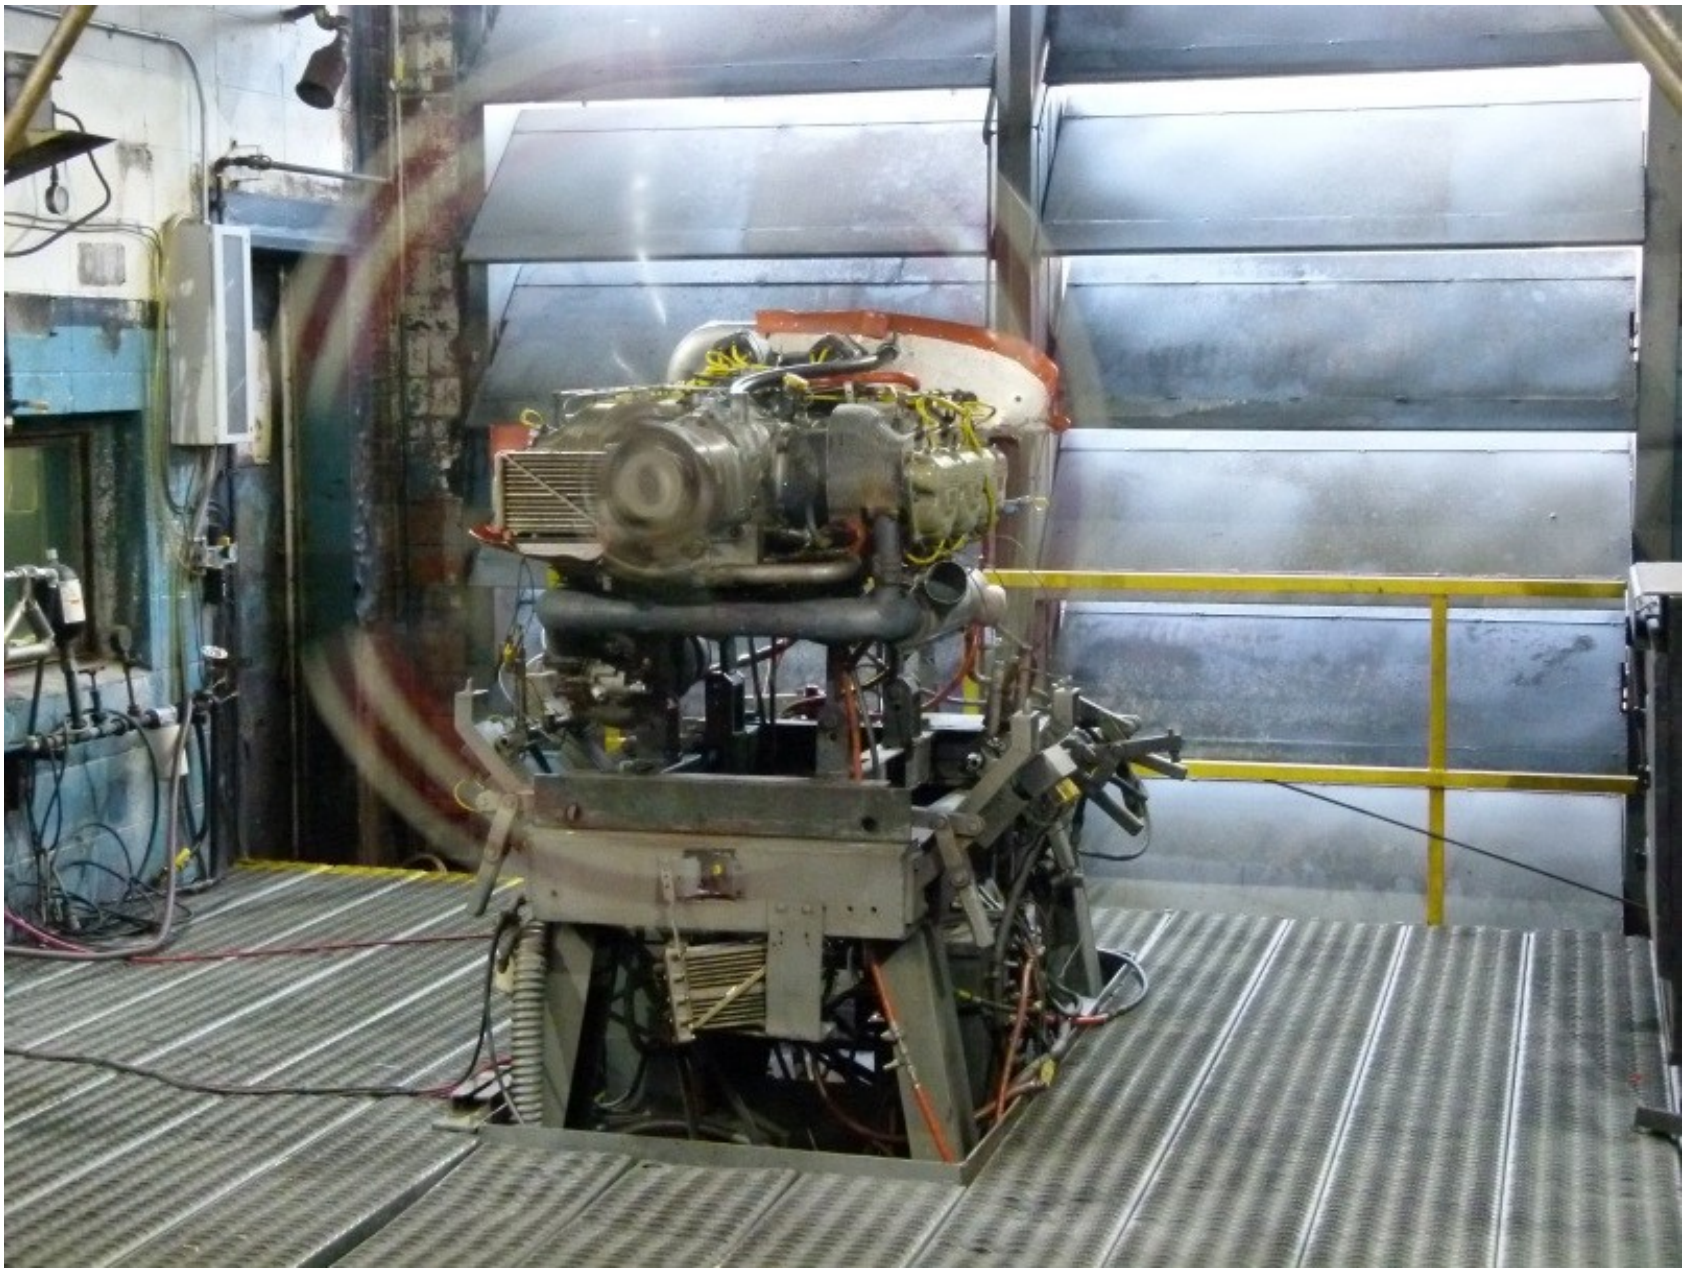
**Photo 7 - Engine Running in Test Cell**
