# NATIONAL TRANSPORTATION SAFETY BOARD

## MATERIALS LABORATORY FACTUAL REPORT

Report No. 17-048

Place : Cokeville, Wyoming  
Date : August 23, 2016  
Vehicle : Hiller UH-12D, N97TH  
NTSB No. : CEN16LA330  
Investigator : Craig Hatch, AS-CEN

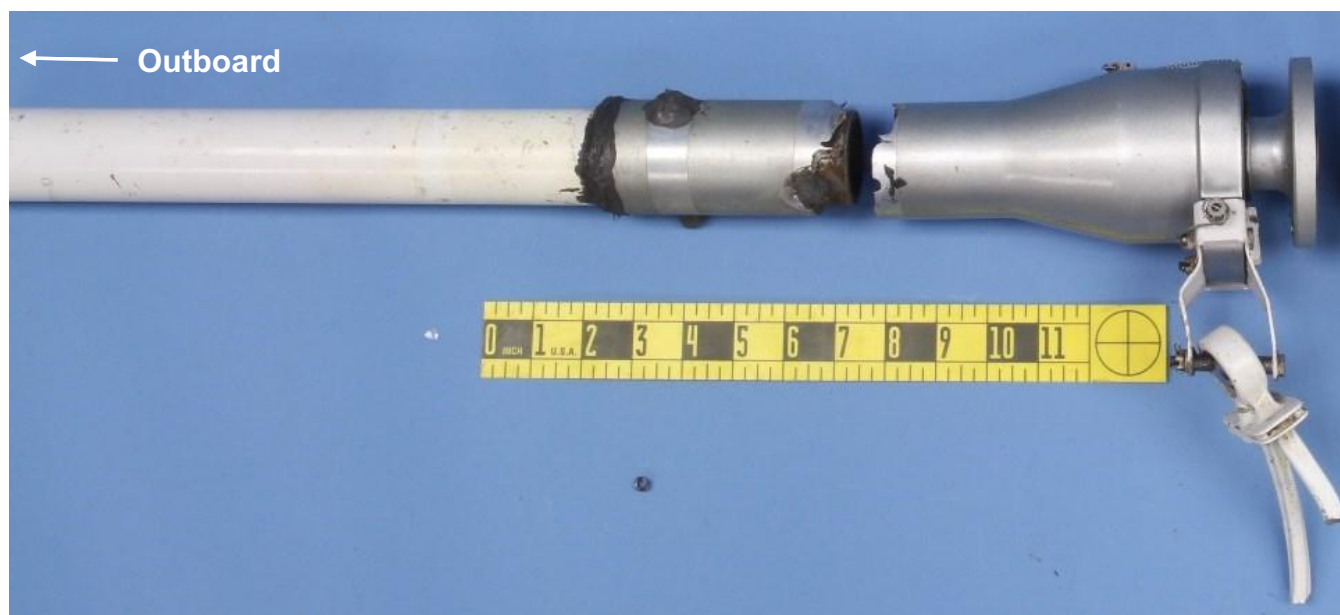
The mating fractured control rotor cuff sections of the cuff (P/N 36124) are shown in Figure 1, and a second sectioned intact control rotor cuff, which was opposite the fractured cuff, is shown in Figure 2. The cuff fragments in Figure 1 had fractured about the circumference of the outer shaft on the inboard bolt holes. This fracture surface exhibited a flat portion that was oriented perpendicular to the shaft direction, as shown in Figure 3. This flat portion was measured as 2.813 inches in circumferential length. The remaining portions of the fracture surface were more random in orientation, with a generally rougher texture.

Figure 1 – The fractured portions of the control rotor cuff, as received. The fractured region is shown in Figures 3 through 5.

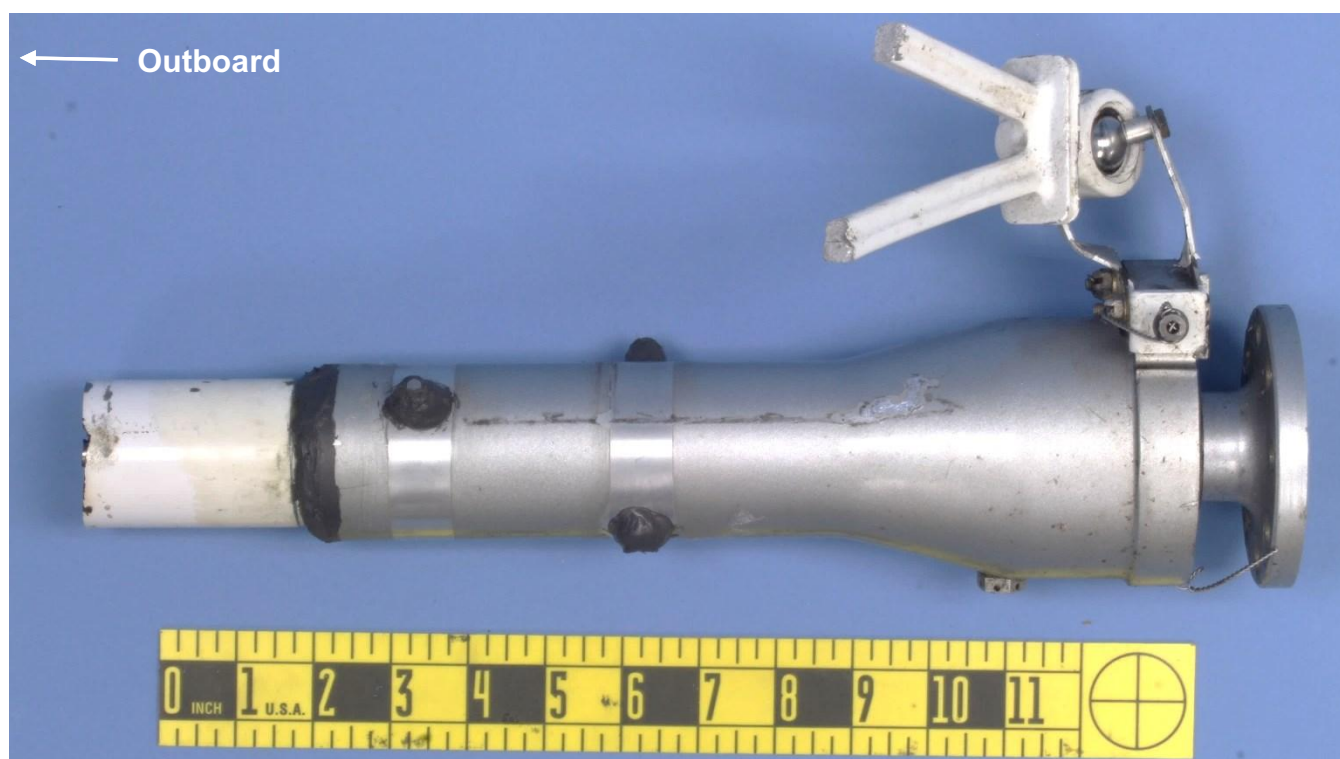
Figure 2 – The section of the intact control rotor cuff, opposite the fractured one in Figure 1, as received.

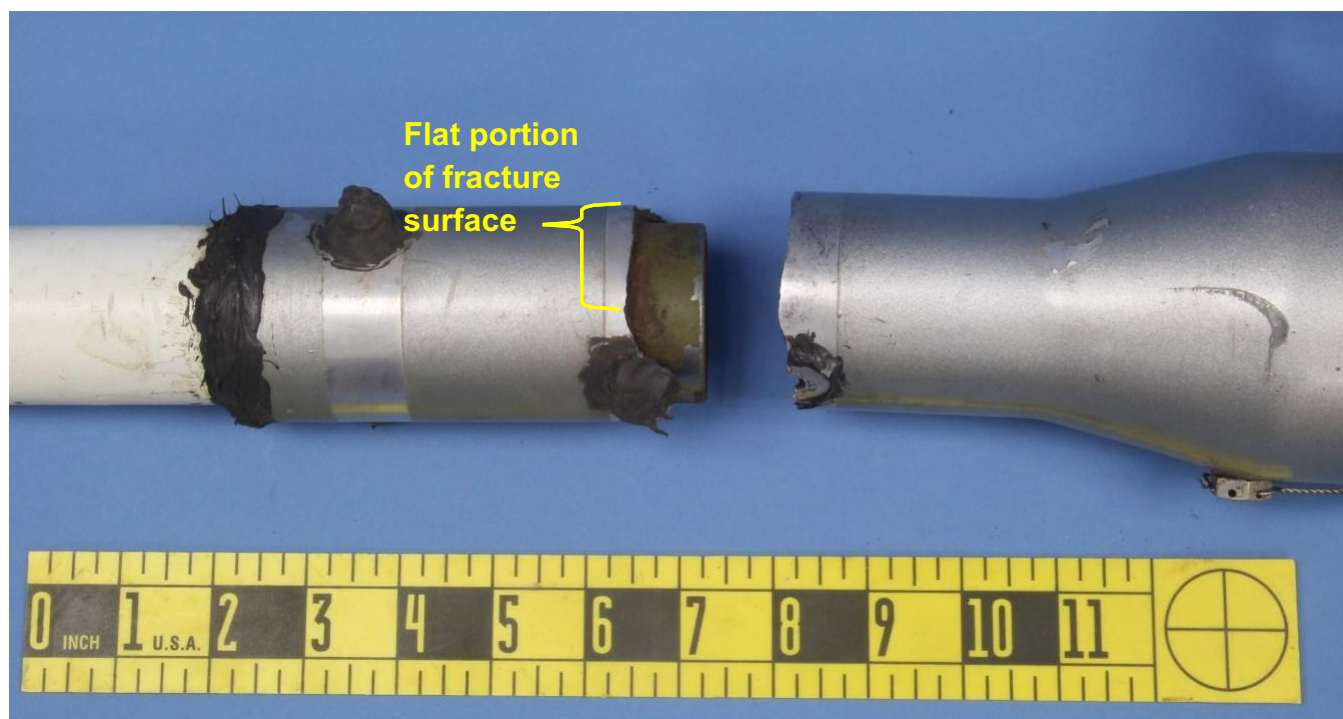
Figure 3 – Closer view of the control rotor cuff fracture, showing portion of the fracture surface oriented 90° to the shaft direction, with a relatively flat surface.

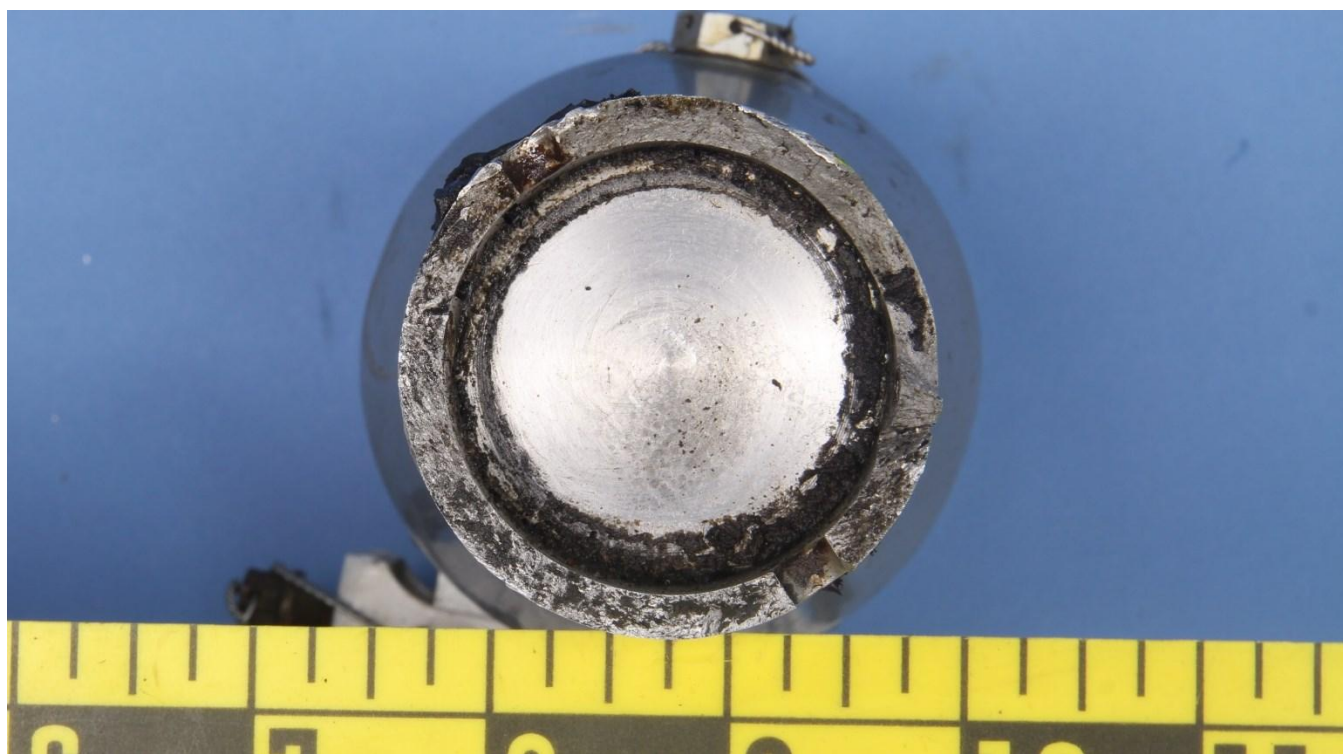
The mating faces of the cuff fracture are shown from the inboard and outboard sides in Figures 4 and 5, respectively. The outboard fracture surface of the cuff shaft was separated from the remaining assembly and cleaned. Figure 6 illustrates the flat portions of this fracture surface. The flatter portion of the fracture surface exhibited crack arrest marks consistent with progressive crack propagation, later determined to be fatigue.

Figure 4 – The cuff fracture surface on the inboard side (looking inboard), as received.

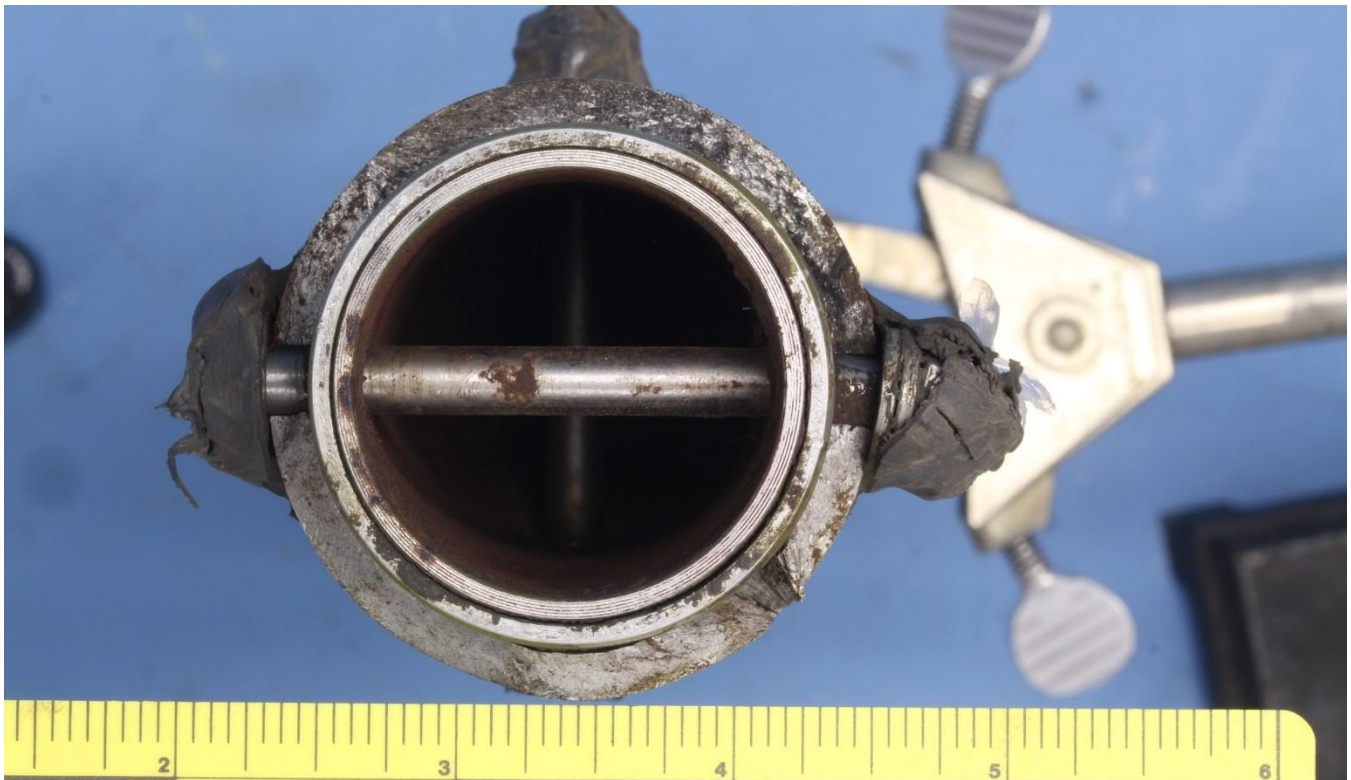
Figure 5 – The outboard side cuff fracture surface (mating that in Figure 4), as received.

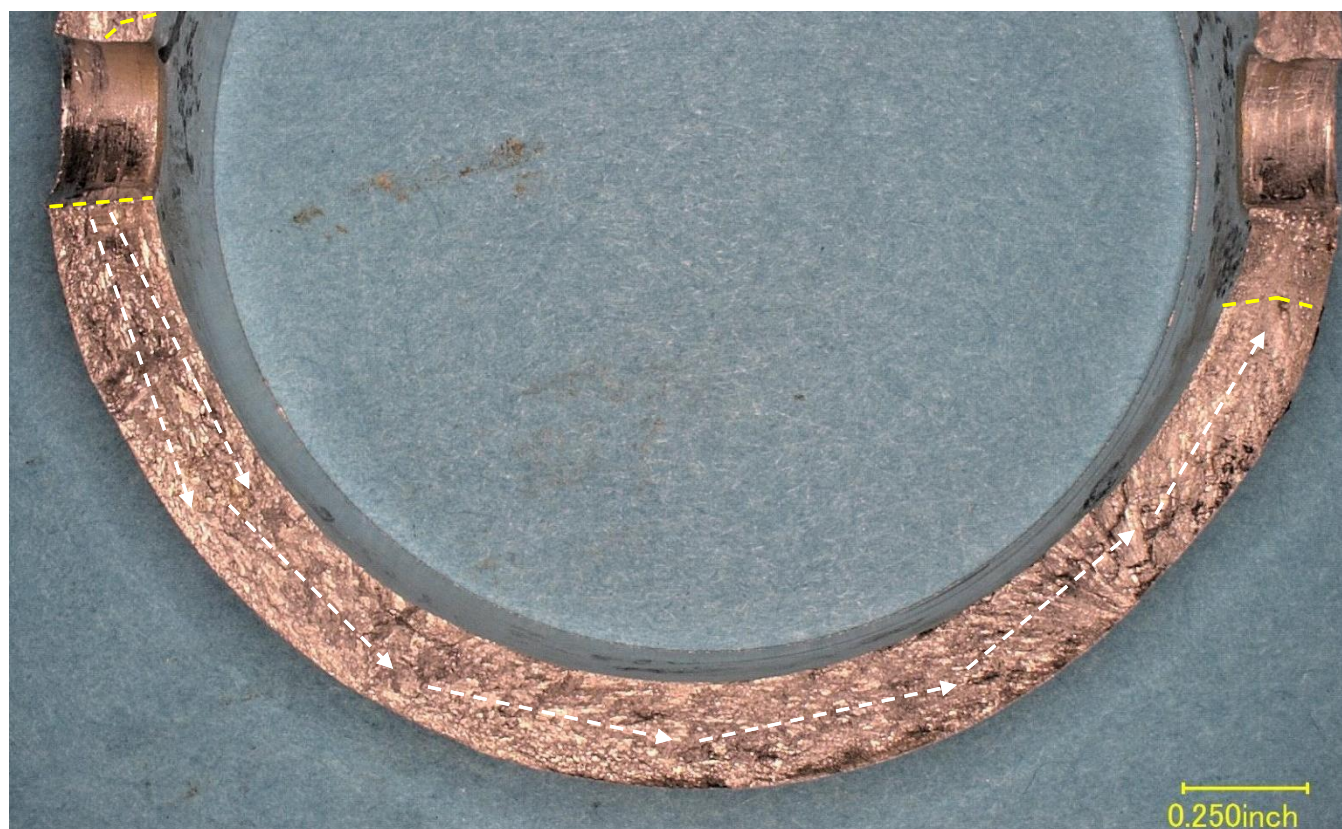
There were two fatigue cracks present on the cuff fracture surface: a larger one previously measured as 2.813 inches in length, and a smaller one located in the inside corner of the cuff bolt hole (upper left in Figure 6). The boundaries of the larger and smaller cracks are outlined in Figure 6, along with the crack growth direction (white dashed lines).

Figure 6 – Closer view of the flat portion of the outboard fracture surface of the cuff (from Figure 5), after disassembly and cleaning. The progressive portions of the fracture surface are outlined and the crack direction is annotated.

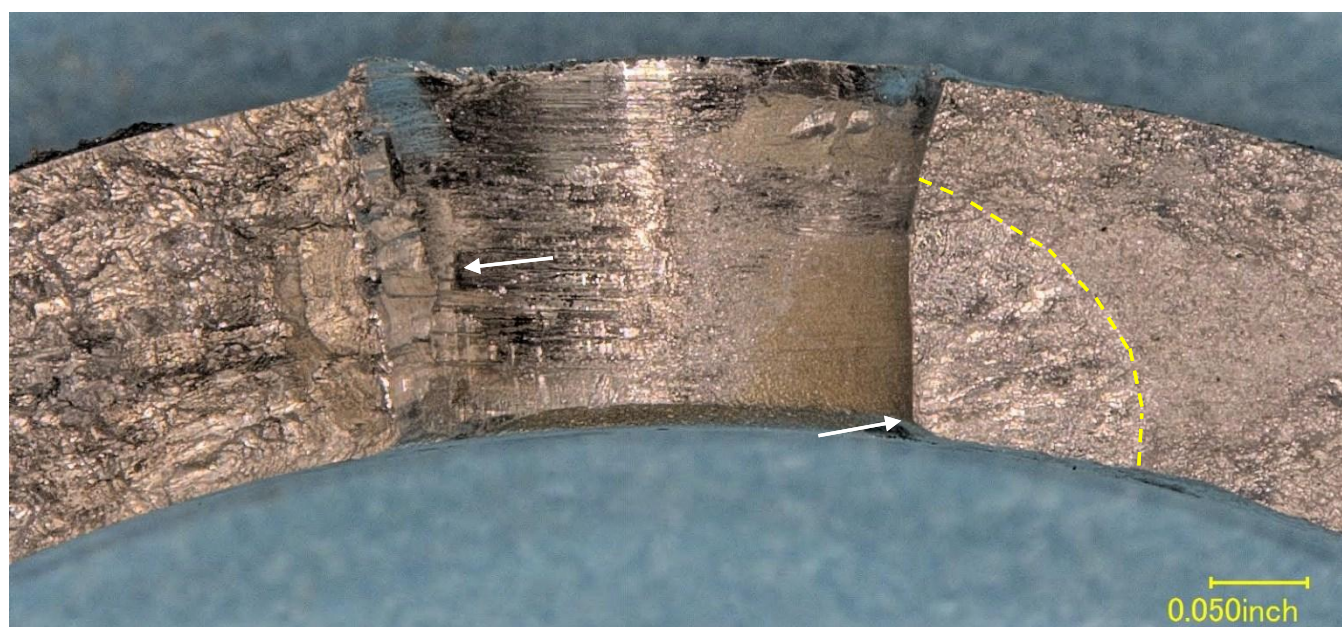
Figure 7 shows a closer view of the bolt hole, where both fatigue cracks initiated. The initiation site of the larger fatigue crack exhibited substantial smearing at the bolt hole edge. The undamaged features of the fatigue crack adjacent the smeared section were consistent with initiation at the middle of the bolt hole bore (Figure 8). In contrast, the smaller fatigue crack initiated at the surface corner of the inner shaft surface and the bolt hole.

Figure 7 – Closer view of the fatigue crack initiation sites (denoted by arrows) about the bolt hole of the cuff. The smaller fatigue crack is outlined on the right.

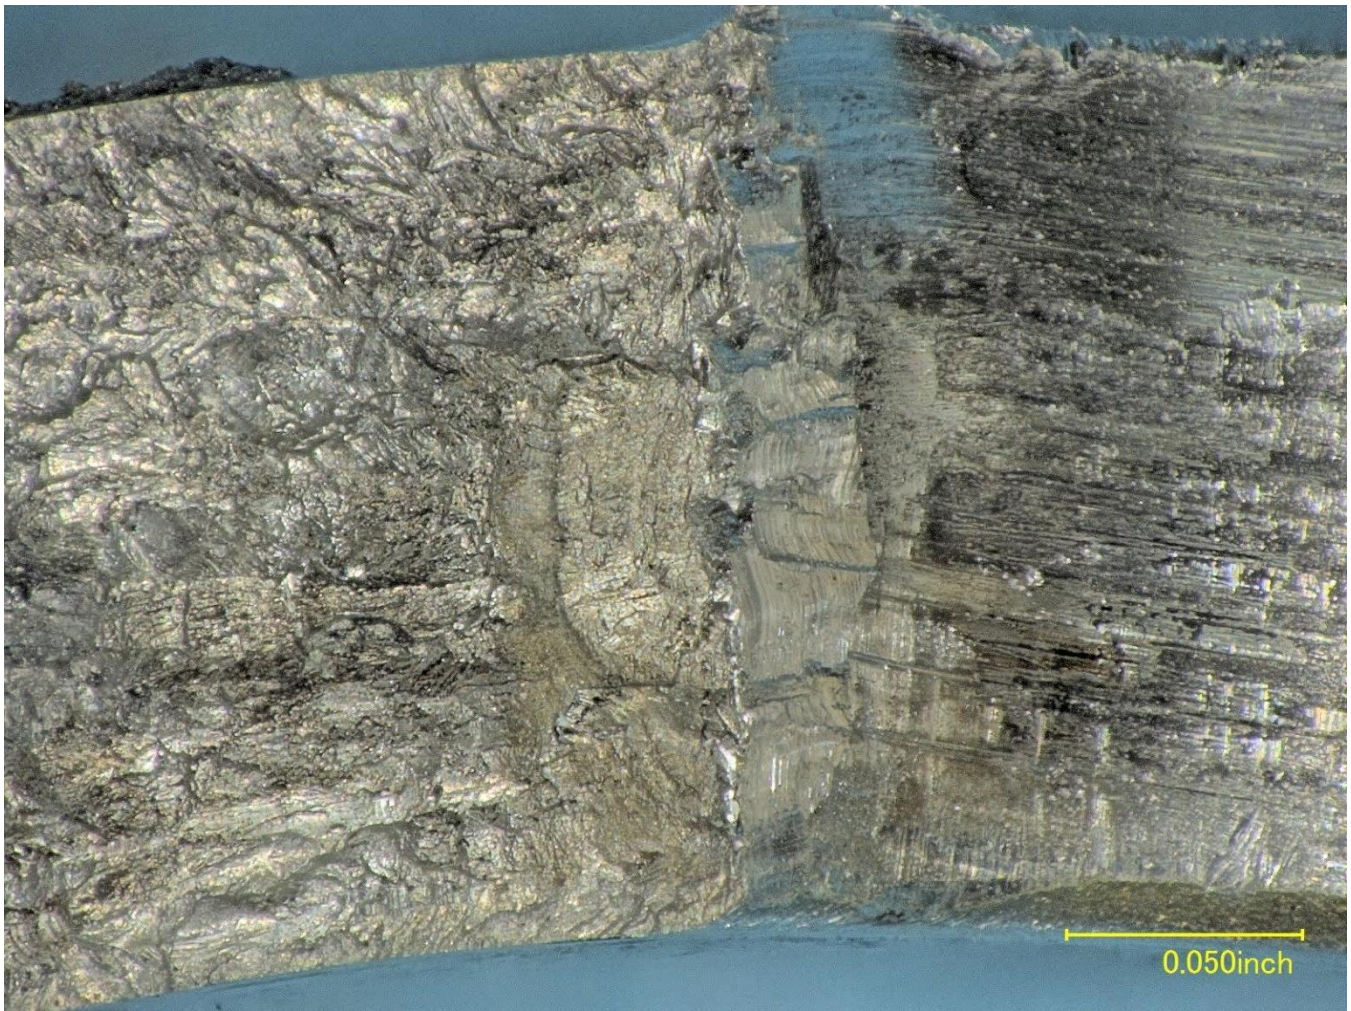
The outboard fracture surface was examined using a scanning electron microscope (SEM). As typified in Figure 9, the larger fatigue crack exhibited fatigue striations. These striations were fine in size and erratically spaced, consistent with high cycle fatigue under spectrum loading. As previously observed in Figure 8, the initiation site of the larger fatigue crack had been obliterated by smearing (Figure 10).

Figure 8 – Closer view of the major fatigue crack initiation site on the cuff fracture surface.

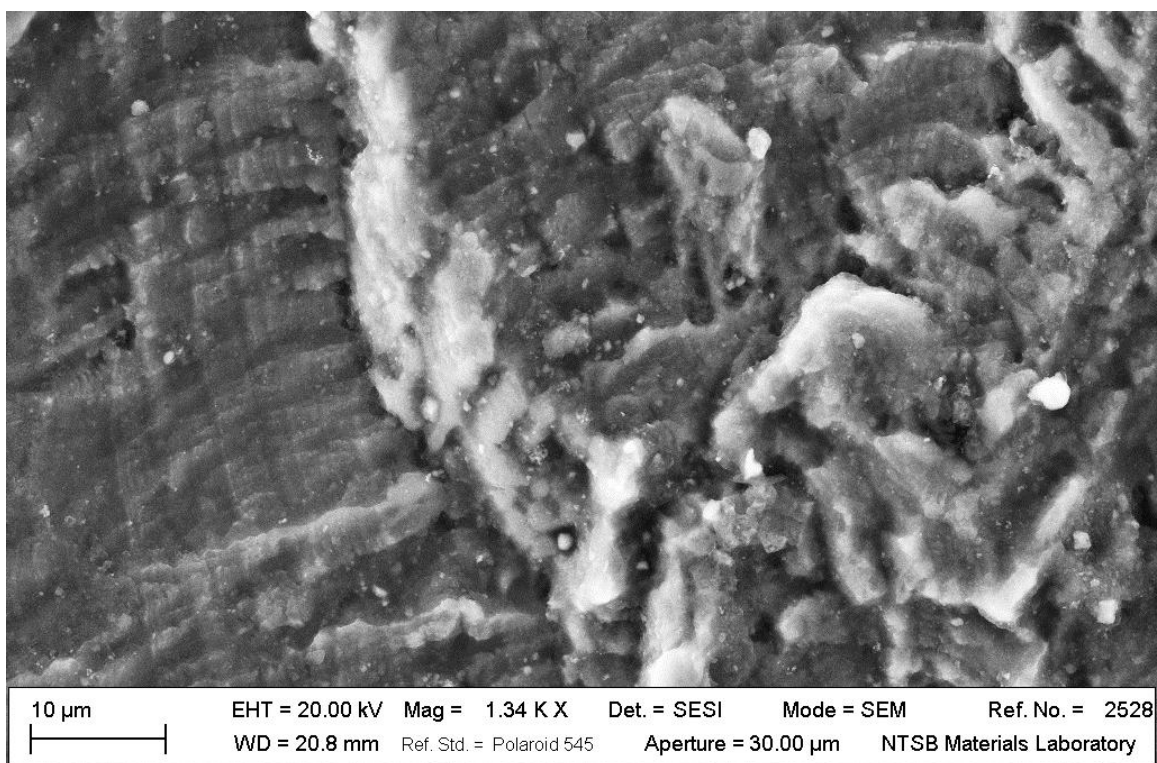
Figure 9 – Secondary electron (SE) micrograph of major fatigue crack, showing striations propagating from right to left.

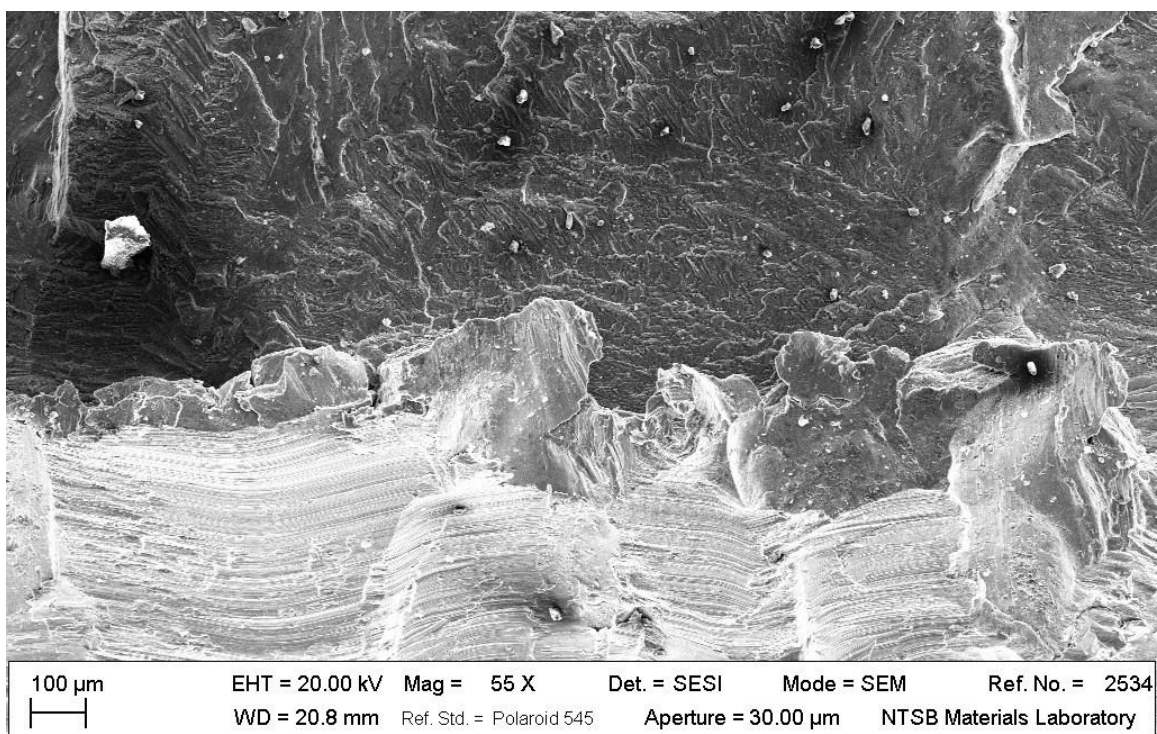
Figure 10 – SE micrograph of the major fatigue crack initiation site, showing smearing along the corner with the bolt hole.

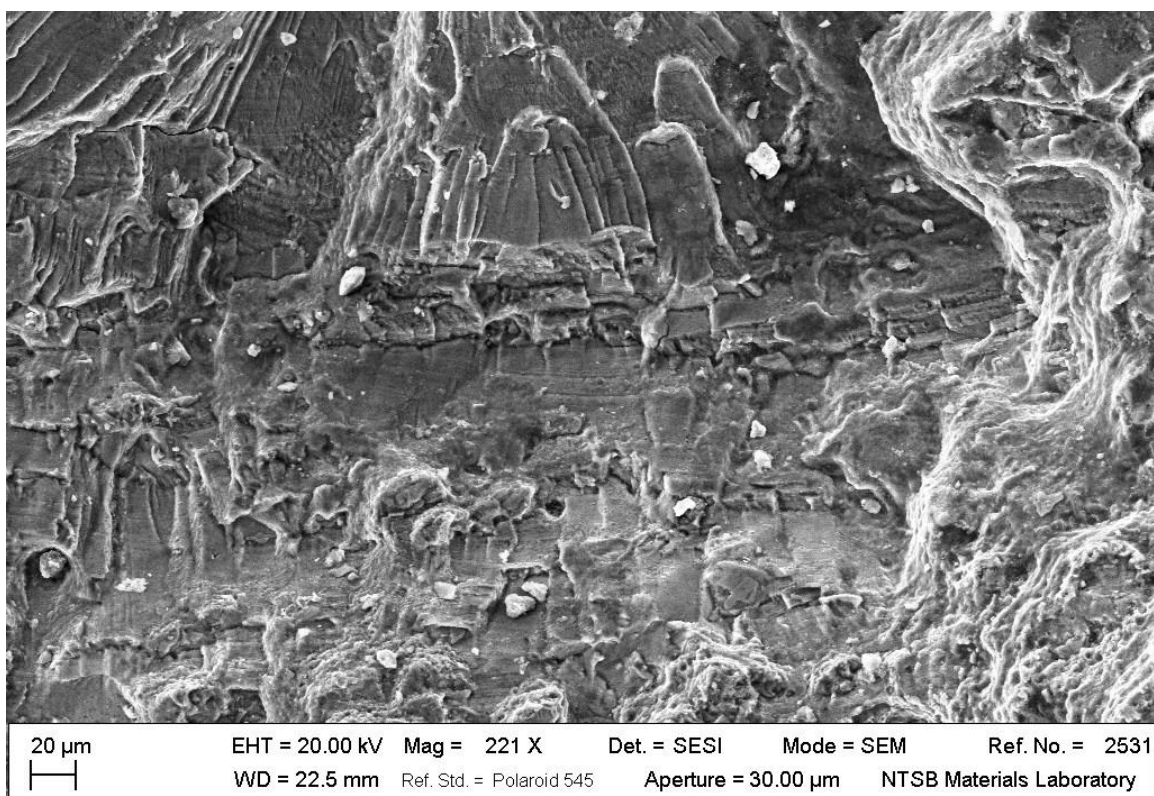
The striations and other features of the fatigue crack were consistently present until the end of the crack, near the opposite bolt hole (See Figure 11). Outside the fatigue cracks, dimple rupture, consistent with overstress was observed (Figure 12).

Figure 11 – SE micrograph showing the end of the major fatigue crack on the cuff fracture surface.

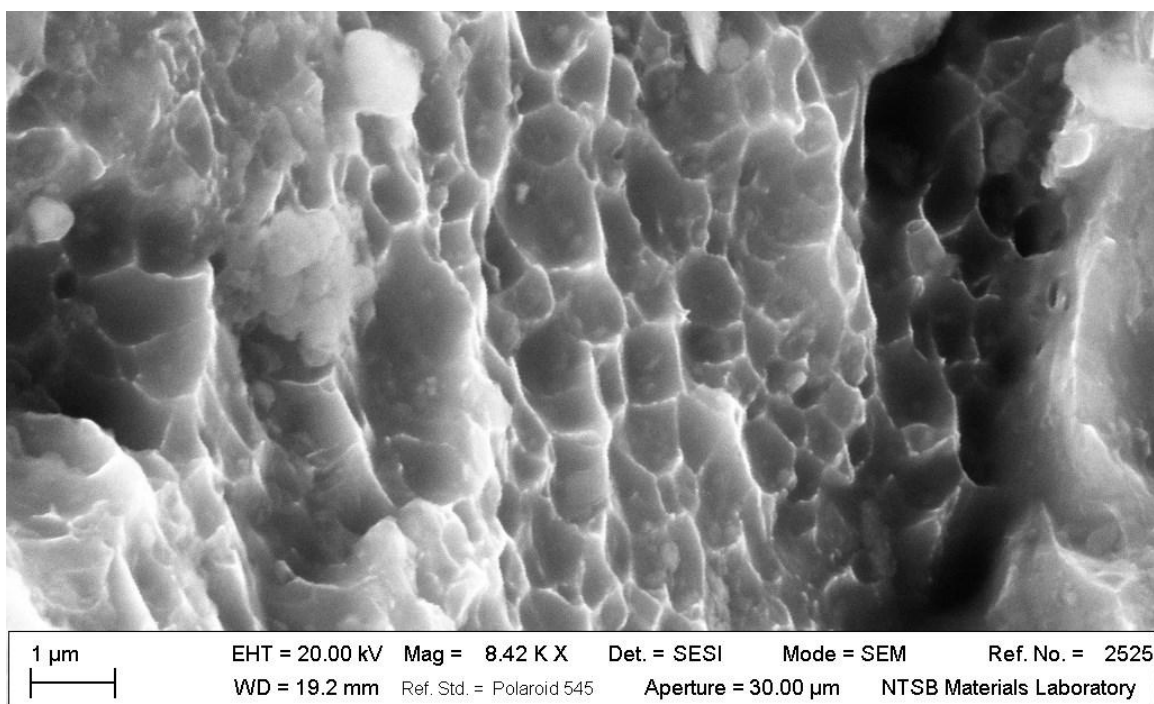
Figure 12 – SE micrograph showing dimple rupture on the portions of the fracture surface outside the fatigue features.

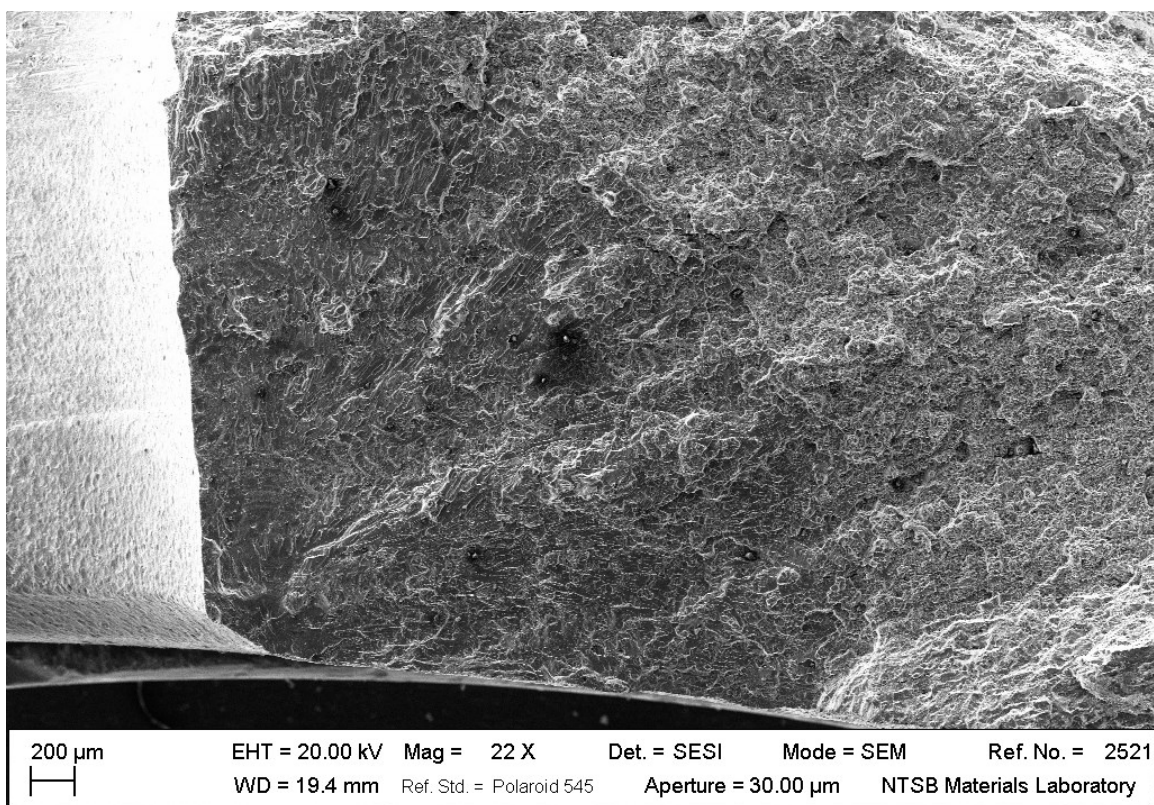
The smaller fatigue crack is illustrated in Figure 13. This crack measured 0.105 inches (2.66 mm) on the bolt bore surface and 0.0932 inches (2.37 mm) on the shaft inner surface. The corner of the bolt hole and the inner shaft surface had been beveled. This smaller fatigue crack also exhibited fatigue striations, as typified in Figure 14. The crack initiation site of the smaller crack was located interior to the bolt hole bore or shaft surfaces (see Figure 15). A closer view of this crack initiation site is shown in Figure 16. This region exhibited an irregular jagged appearance, inconsistent with the surrounding fatigue striations. Examination of the site using energy dispersive x-ray spectroscopy (EDS) found it to have elevated levels of oxygen relative to the surrounding material.

Figure 13 – SE micrograph showing the smaller fatigue crack, adjacent the bolt hole.

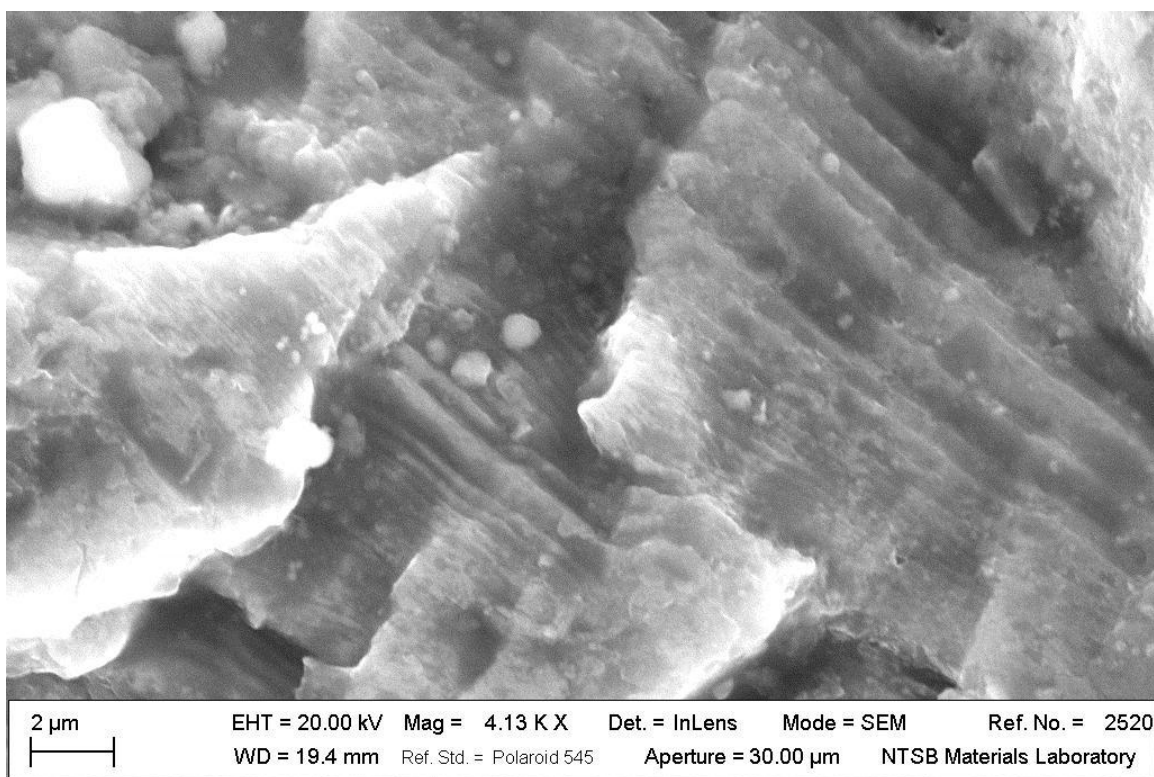
Figure 14 – SE micrograph of an area on the small fatigue crack striations.

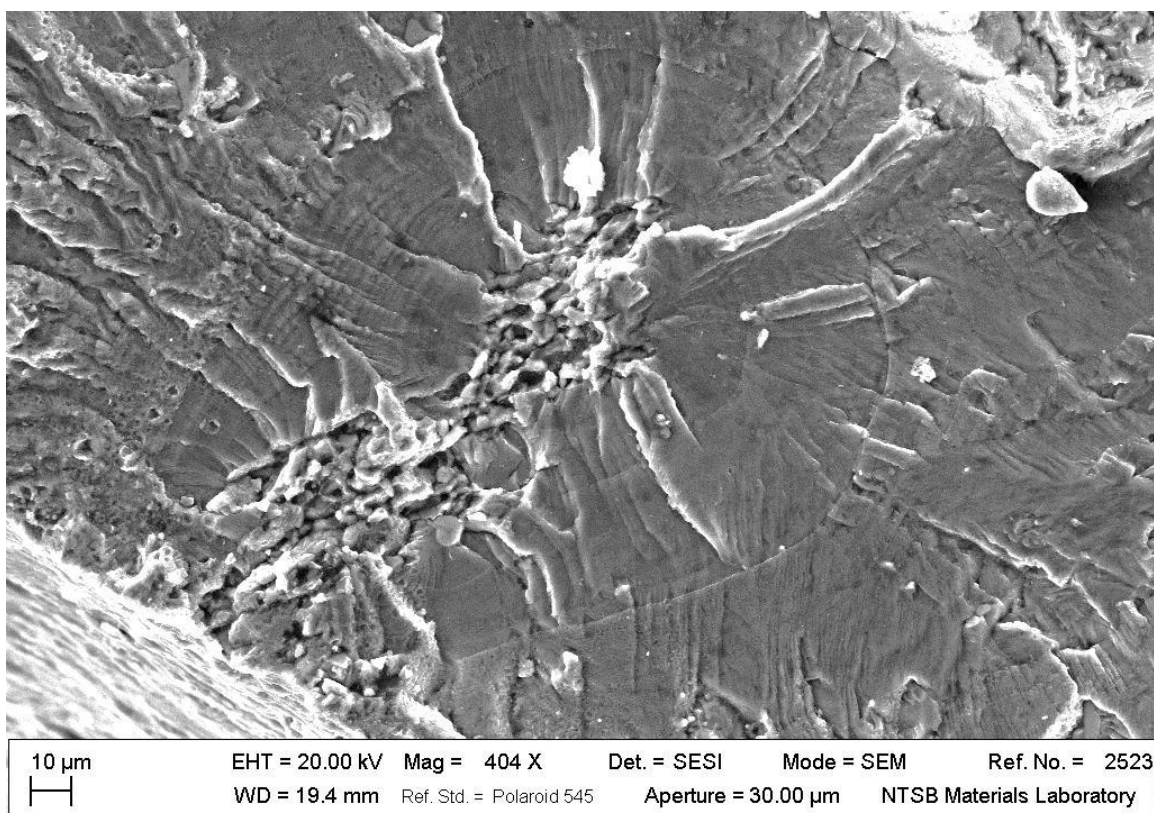
Figure 15 – SE micrograph showing the crack initiation site of the small fatigue crack.

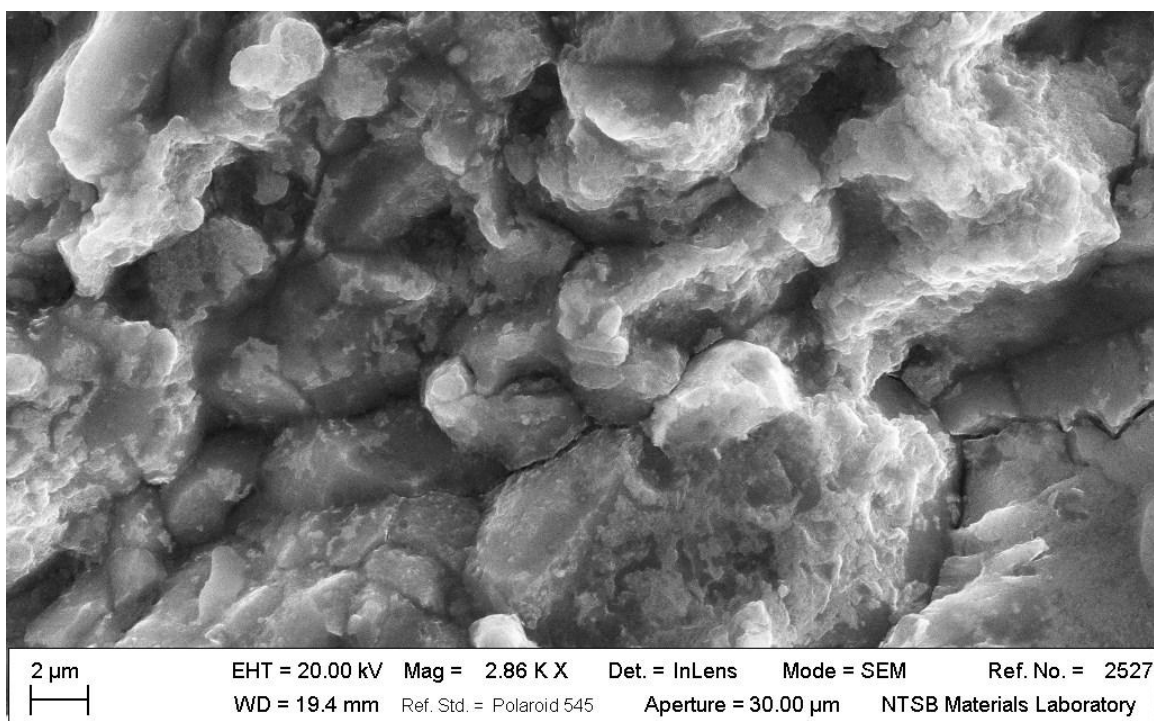
Figure 16 – SE micrograph closeup of the interior of the small fatigue crack initiation site.

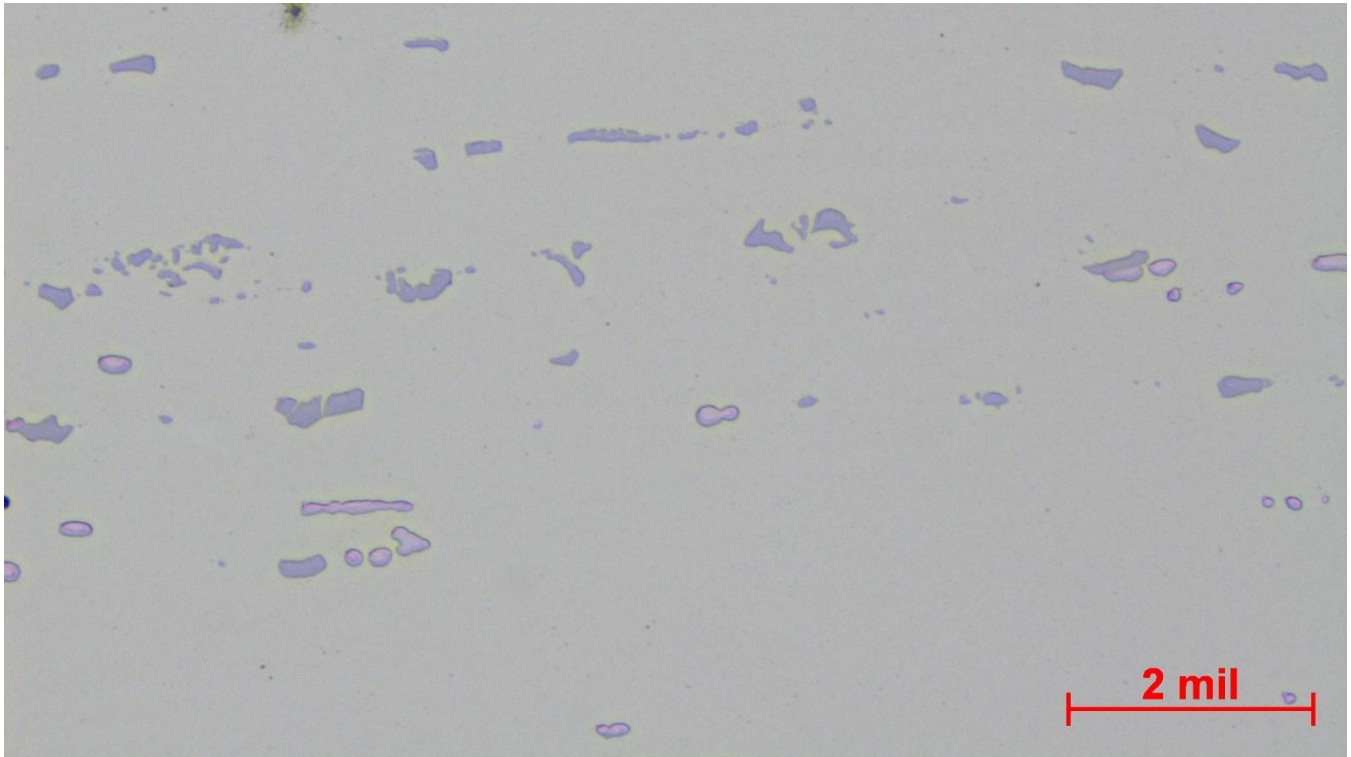
The chemical composition of the control cuff was inspected using EDS and x-ray fluorescence. The cuff material was consistent with an AA 2024 aluminum alloy. The cuff was sectioned, mounted and polished. A typical area of the cuff microstructure is shown in Figure 17. The microstructure consisted of an aluminum-rich matrix, with aluminum-copper second phase precipitates dispersed throughout. No voids or non-metallic inclusions were observed in the microstructure.

Figure 17 – Bright-field micrograph showing a typical area of the cuff microstructure, showing Al/Cu-based precipitates in the Al-primary matrix (~500X, as polished).
