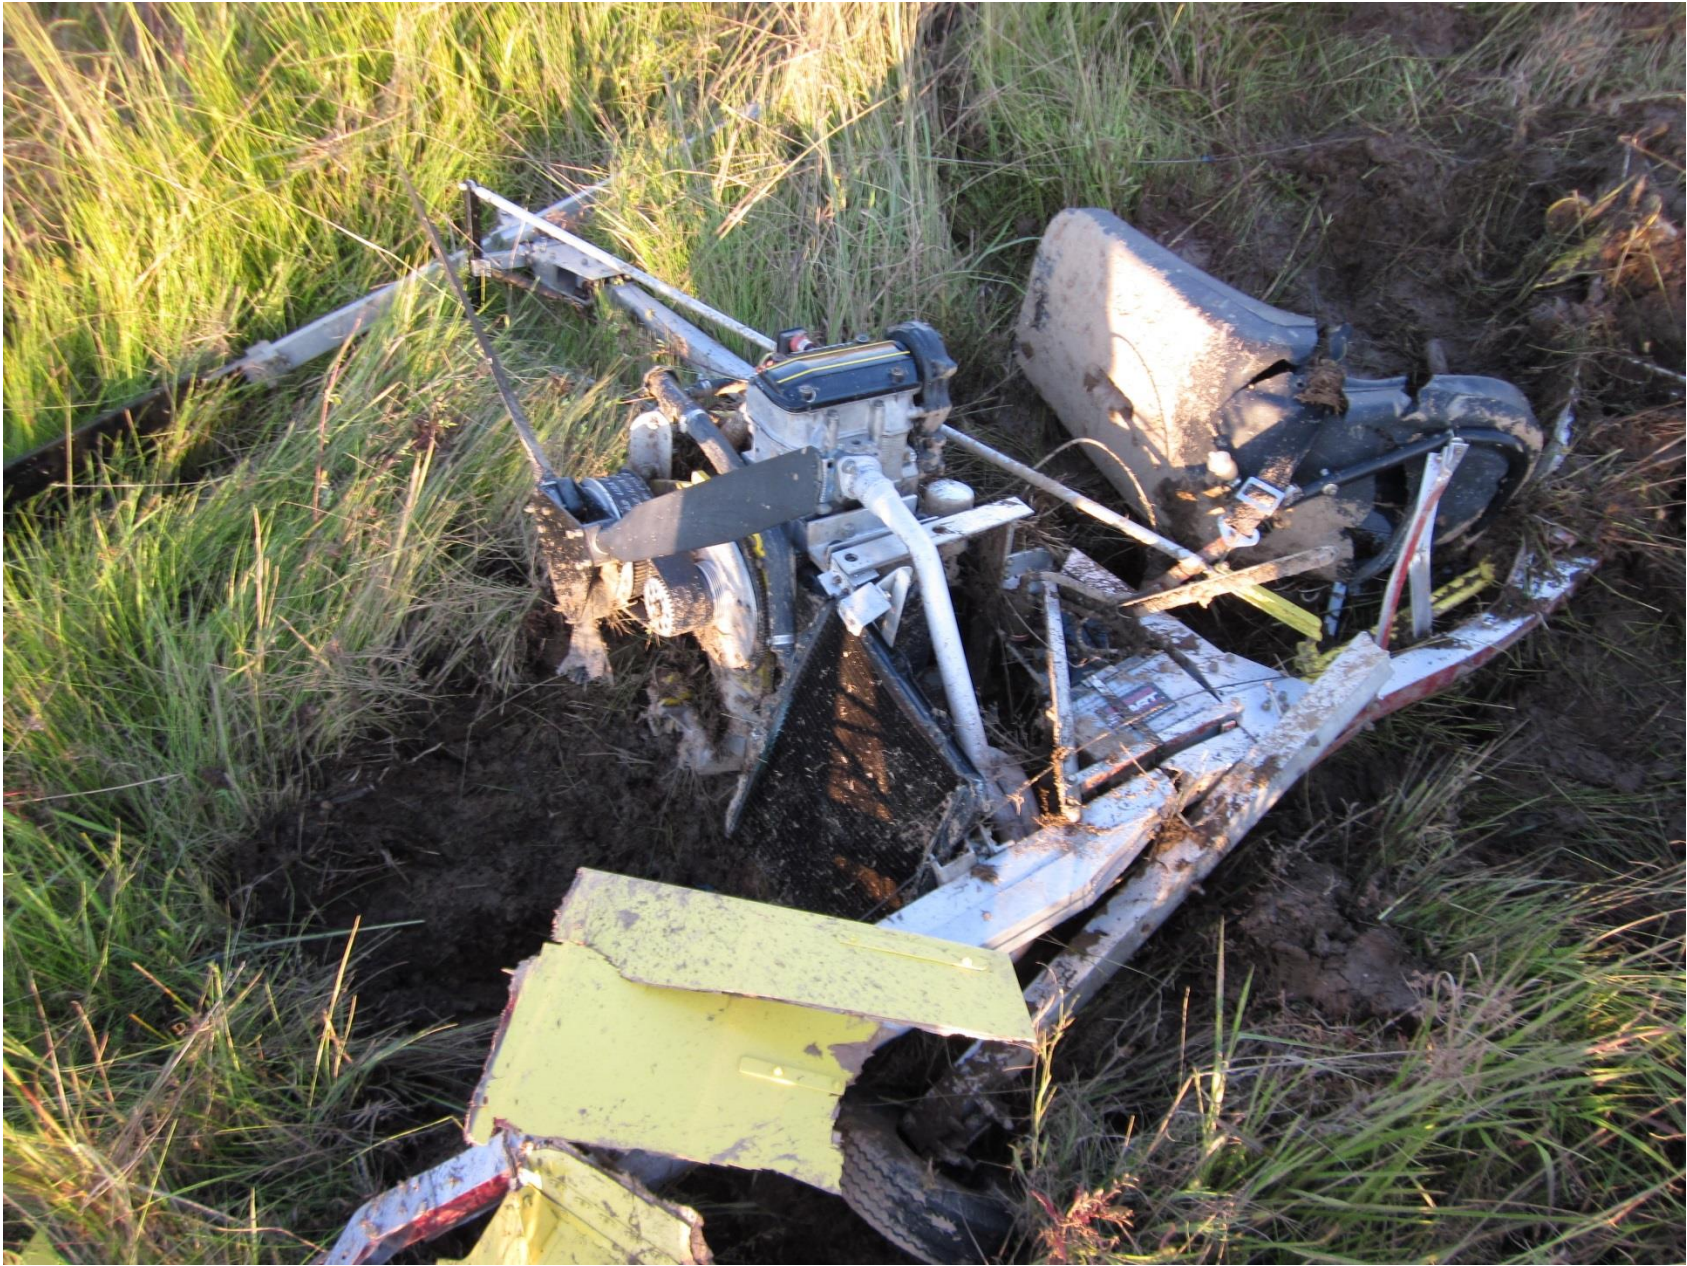
**Photo 1 – The unregistered gyroplane. Note absence of ground scars, only impact crater, consistent with no forward velocity**

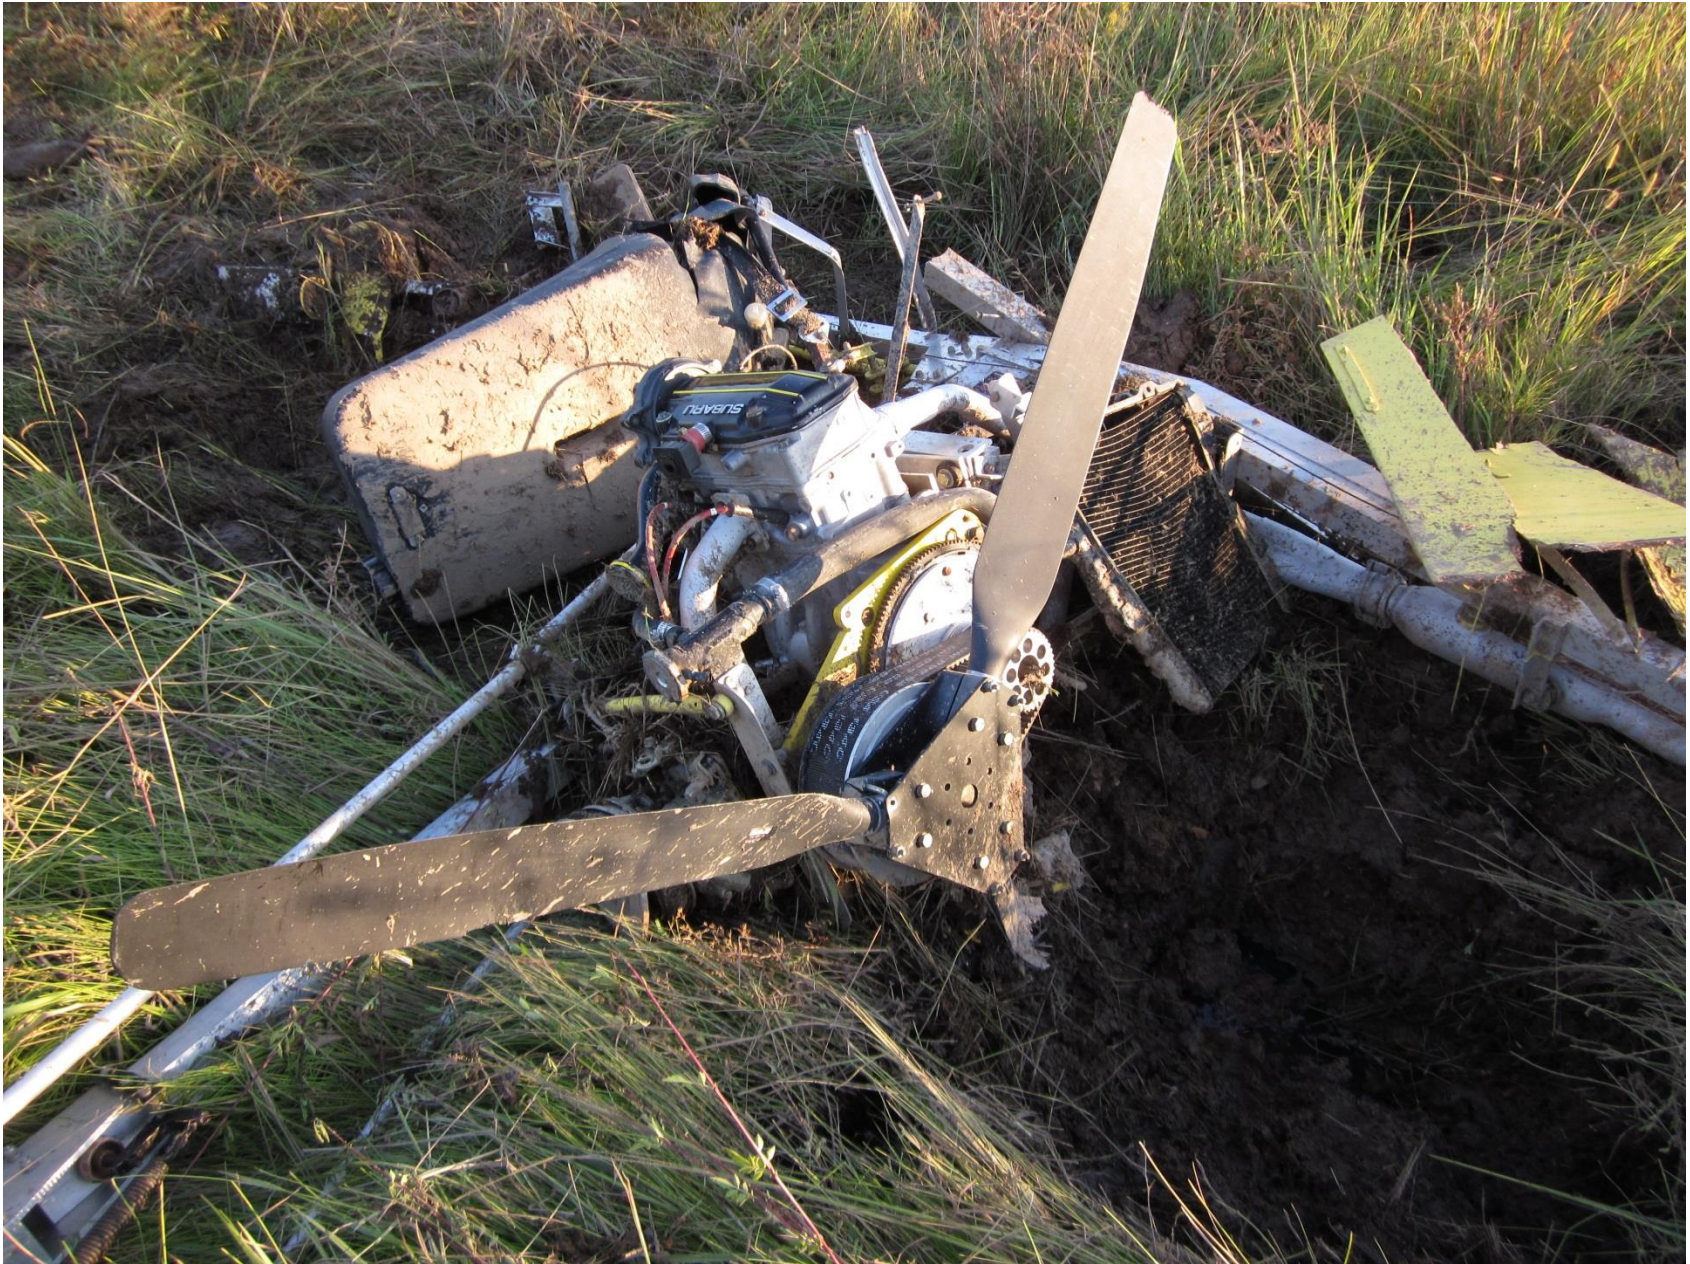
**Photo 2 - Rear view of gyroplane, showing Subaru engine and pusher-type propeller.**

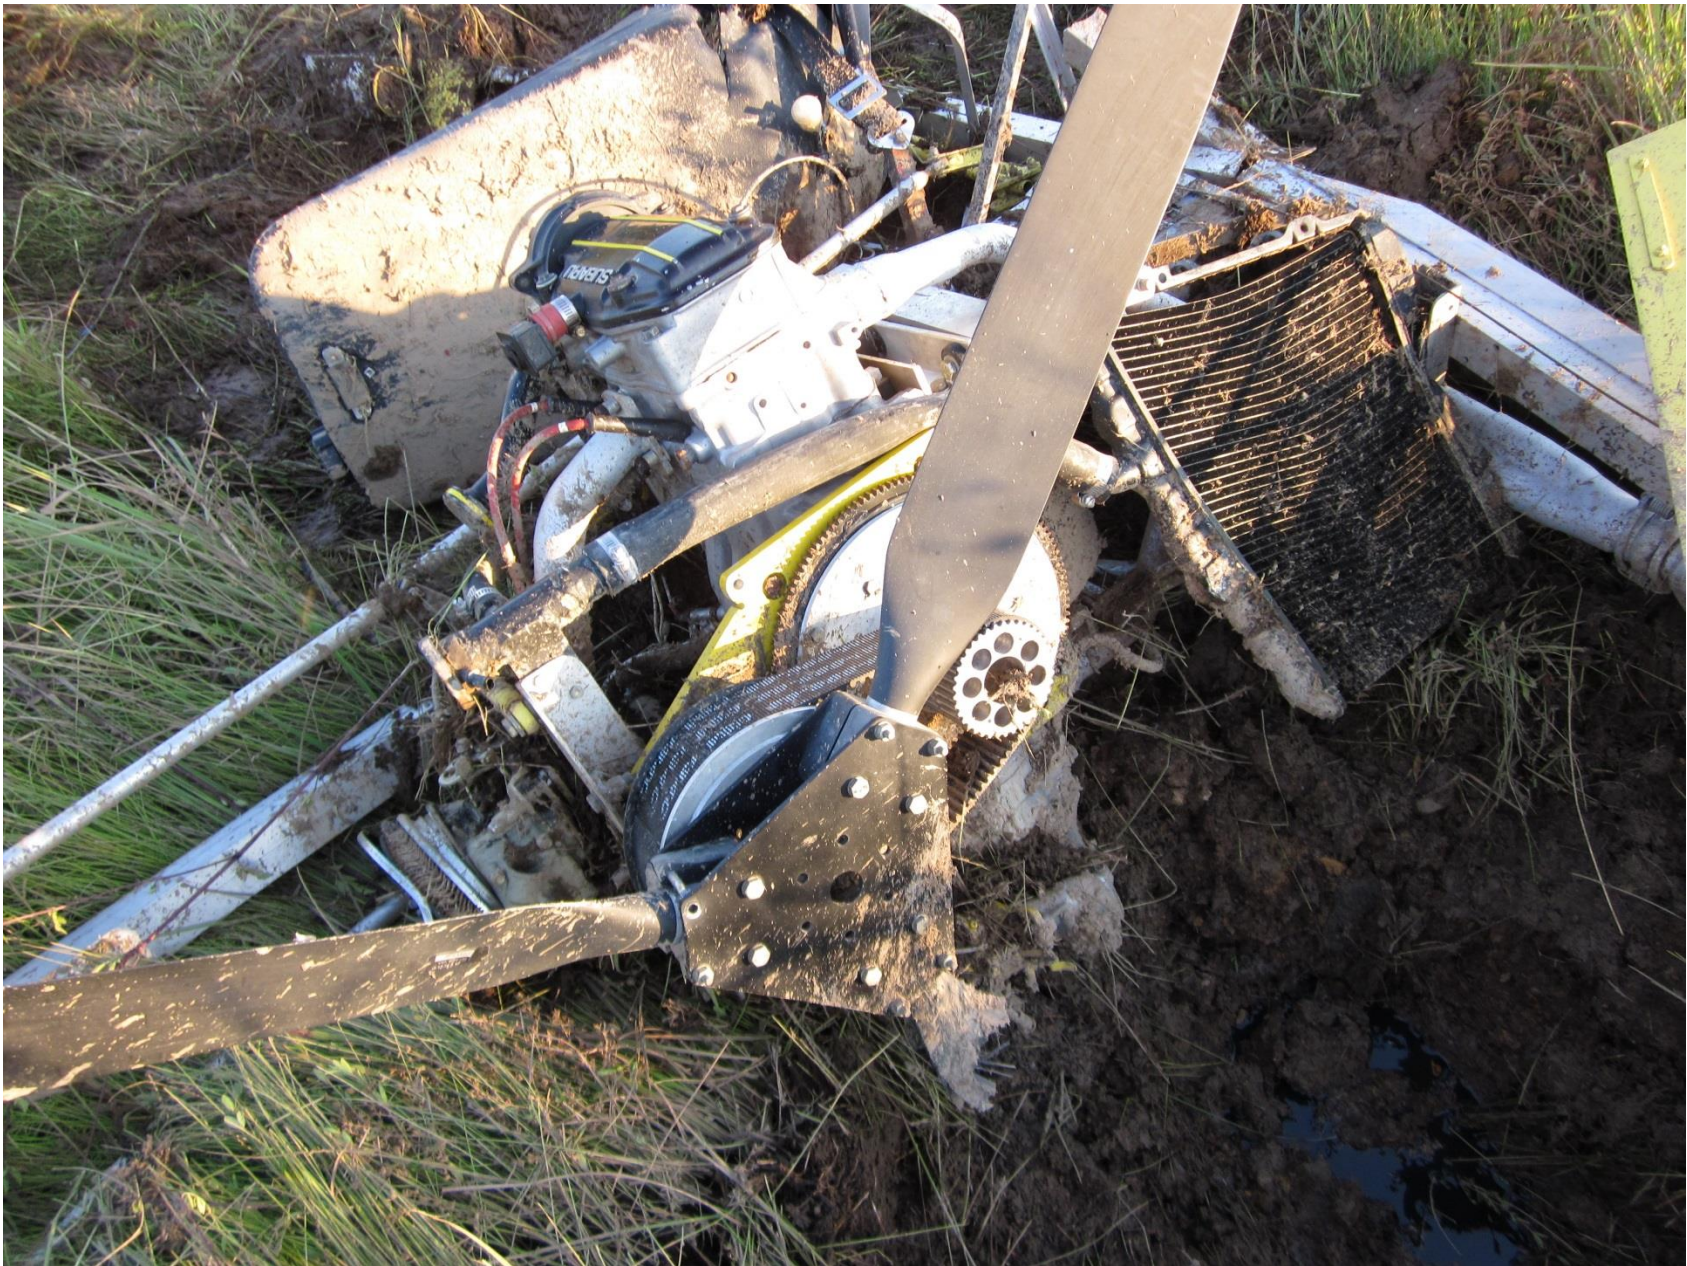
**Photo 3 - Close-up of the engine and propeller.**
