Bell 407  
N361SF  
Lawton, Ok.  
28 September 2016

Site Diagram and Field Note Summary  
Mr. D Smith, Senior Air Safety Investigator  
Mr. Kevin Zemetis, Senior Air safety Investigator  
US DOT, Transportation Safety Institute  
[REDACTED]

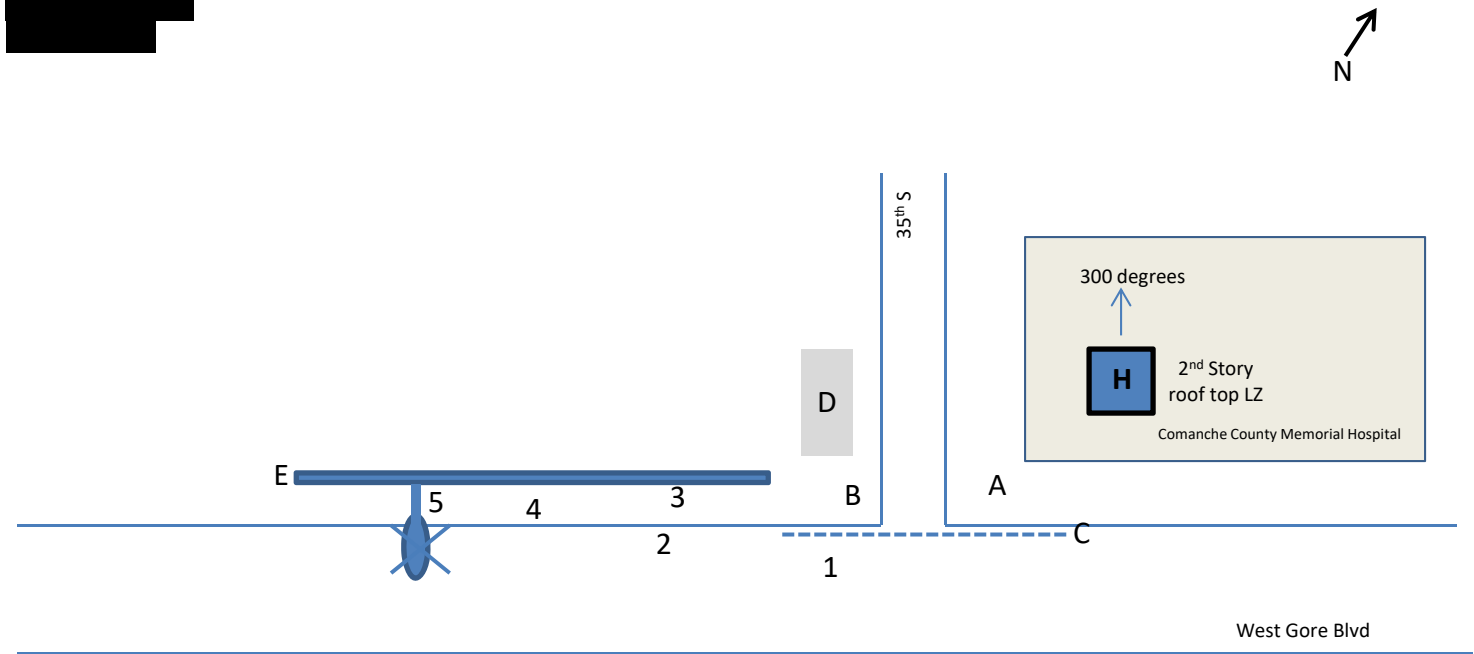
- 1- Ground Scars, Initial impact with asphalt road, approx. 159 feet from landing pad. Ground scars appear to be from right skid. From LZ approx.. 180 Degrees
- 2 - 2<sup>nd</sup> point of impact w/paint transfer from the right skid, sliding along curb, approx. 30 feet from initial impact .
- 3 - Main rotor blade strike on brick wall, adjacent impact point #2
- 4 – Landing light separated and impaled in ground with nose strike, approx. 69 feet from initial impact.
- 5 – Tail rotor 90 degree gear box, shaft, and both blades ripped from A/C when tail rotor impact the brick wall, approx. 99 feet from initial impact.
- 6 – A/C came to rest with tail boom in contact w/the brick wall approx. 103 feet from initial impact. Nose pointing aprox. 170 degrees.

- A – Tree, approx. 40 feet Tall  
B – Stop Sign  
C – Electric wires, approx. 30 feet tall  
D – House  
E – Brick Fence, approx. 4 feet tall

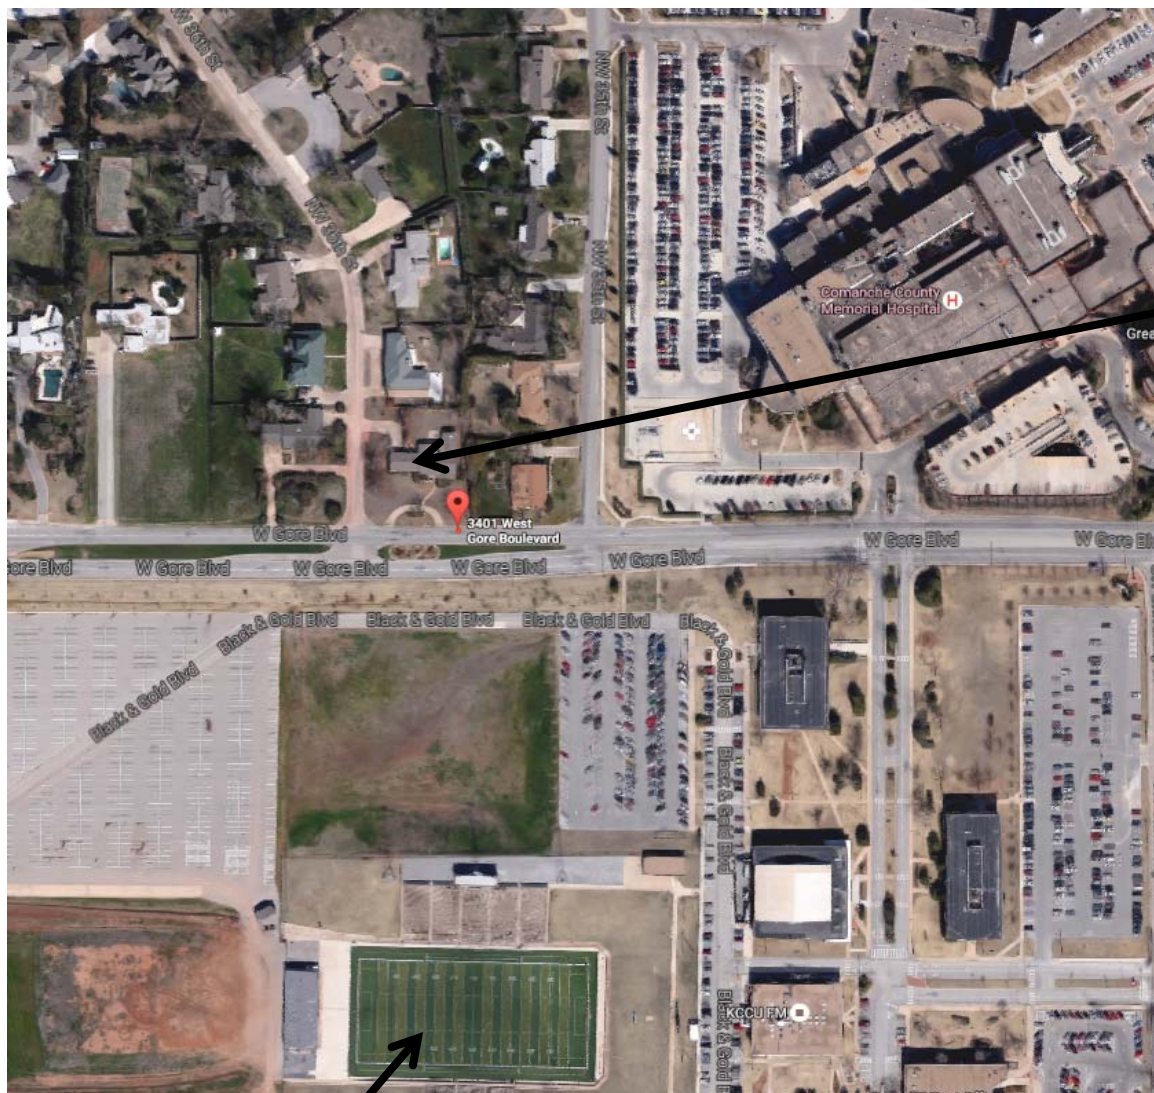
Hospital landing pad.

Sport complex with high light poles,  
south of the landing pad.
