## RECORD OF CONVERSATION

**Date: November 3, 2016**  
**Person: Nicholas Shepler (Rolls-Royce)**  
**NTSB Accident Number: CEN16LA386**

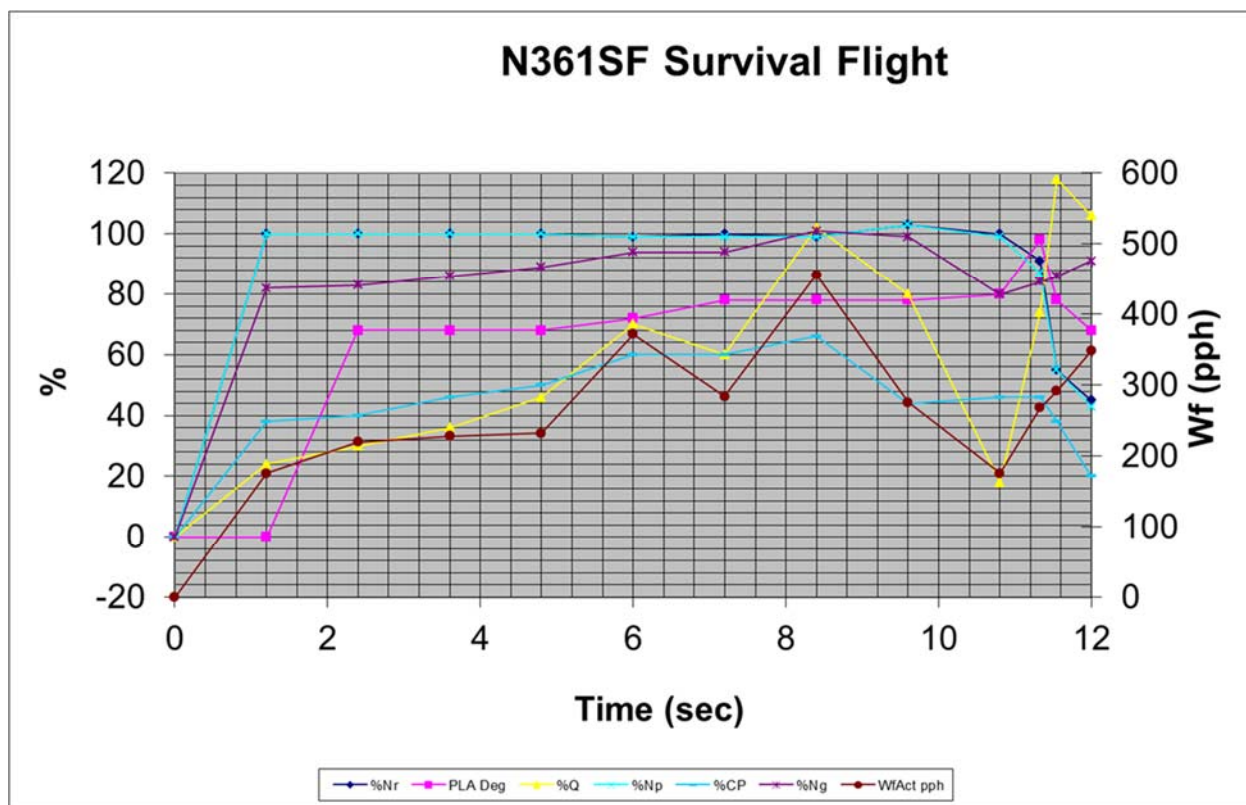
In the graph below the following parameters are listed:

- %NR = Main Rotor Speed (in %)
- PLA Deg = Power Lever Angle (throttle - in degrees)
- %Q = Torque (in %)
- %Np = Power Turbine Speed (in %)
- %CP = Collective Pitch (in %)
- %Ng = Gas Generator Speed (in %)
- WfACT pph = Fuel Flow (in pound/hr)

The pre-snapshot data shows the engine at 100% NR, and other engine parameters (NG, Torque, collective) slowly increasing. At time = 6 seconds, there is a spike up in torque and fuel flow, and the throttle begins to increase as well. The throttle is already at 68 degrees, which is above the “fly” setting of 62 degrees. Therefore, the throttle increase does nothing to available power from the engine as long as the control is in auto mode (which it is). Another spike occurs at time = 8.4 seconds. These spikes are large relative to the collective inputs, which may be indicative of other aircraft control inputs adding to the demand on the engine. Immediately following this second spike, the collective is lowered, and the engine responds accordingly. Snapshot #1 for rotor droop occurs at time 11.3 seconds. This is likely when rotor blades began impacting hard objects. The torque goes up dramatically at this point as well. Snapshot #2 for this torque exceedance follows 0.2 seconds later. Rotor speed further decays, as shown in the last recorded data point at 12 seconds. Electrical power is then lost due to an interruption in aircraft 28 volt supply and the PMA being below 85% NP speed.
