## Get a Grip Adventures

### Zip Line Tour – Quick Response Inspection Report

**Location:** Ozone Zipline Adventures

**Inspection Date:** October 18, 2016

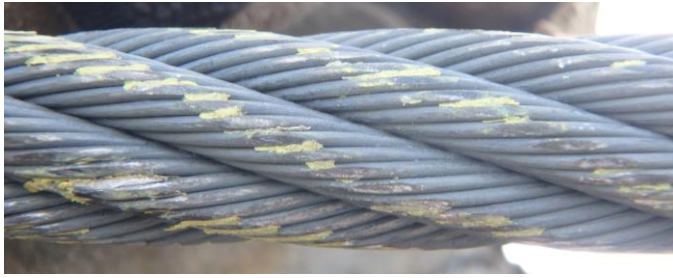
Photo #1 River zip #1

| <u>Zip Line River 1</u> | <u>Pass/Fail</u> | <u>Comments / Recommendations</u> |
|---|---|---|
| ½" zip cable | Fail | The cable was struck by some part of the aircraft. Materials from the aircraft were found imbedded in the cable, see photos #1 and #2. The cable effected only appeared to be 12-18 inches, roughly 486 feet from the sending platform. At the point of impact, the zip line is 170 feet above ground level with a 205-pound load (accounting for the weight of the inspector and gear). The cable also had a large amount of tree fibers imbedded in the cable roughly 85 feet from the sending platform, see photo #3. The tree it appears to have struck is roughly 25-27 feet to the right of the zip line (while facing down line). |

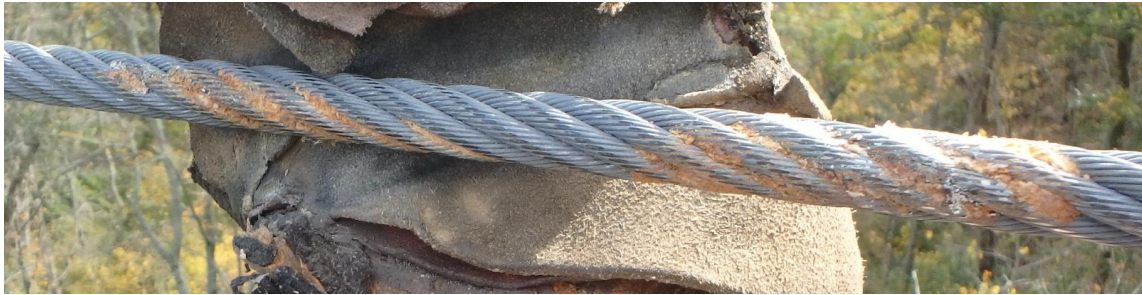
Photo #3 River zip #1 wood fibers
