# NATIONAL TRANSPORTATION SAFETY BOARD

MATERIALS LABORATORY FACTUAL REPORT

Report No. 17-005

Place : Fargo, ND  
Date : 12/1/2016  
Vehicle : Cessna 340, N123KK  
NTSB No. : CEN17FA045  
Investigator : Arnold Scott

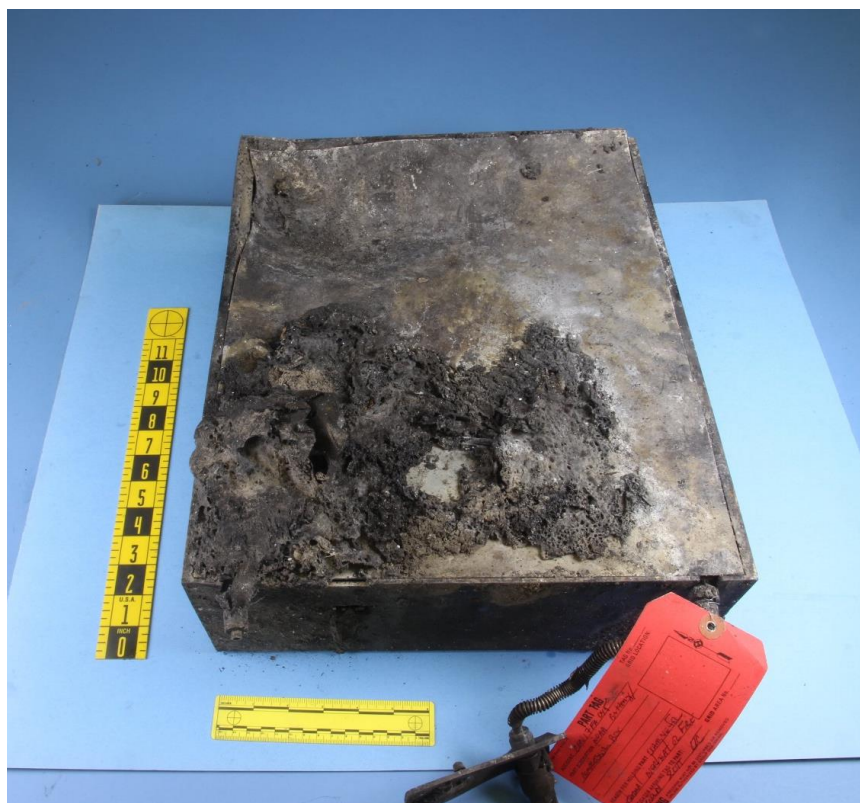
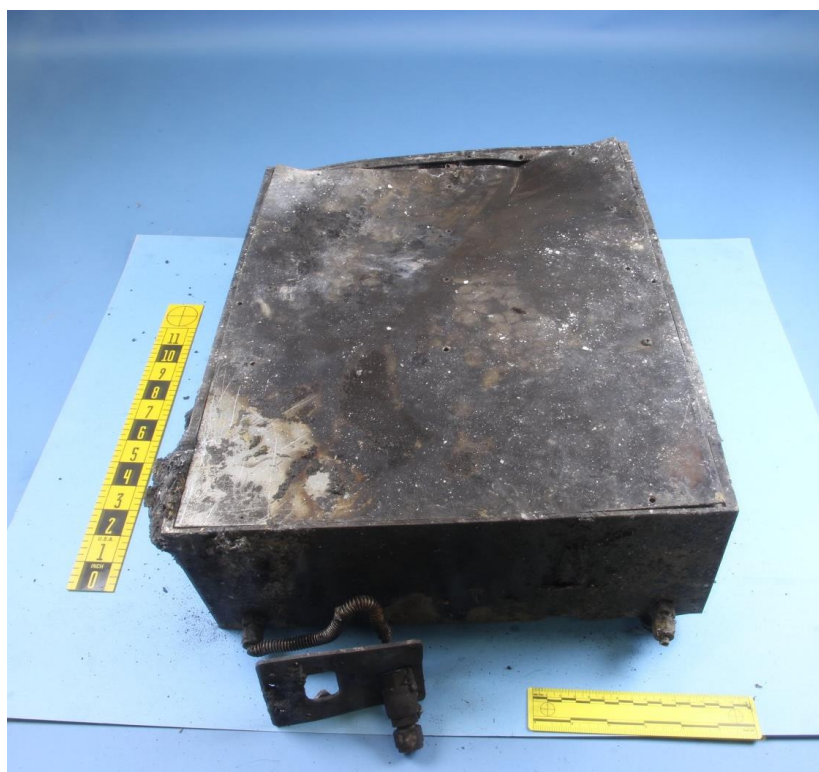
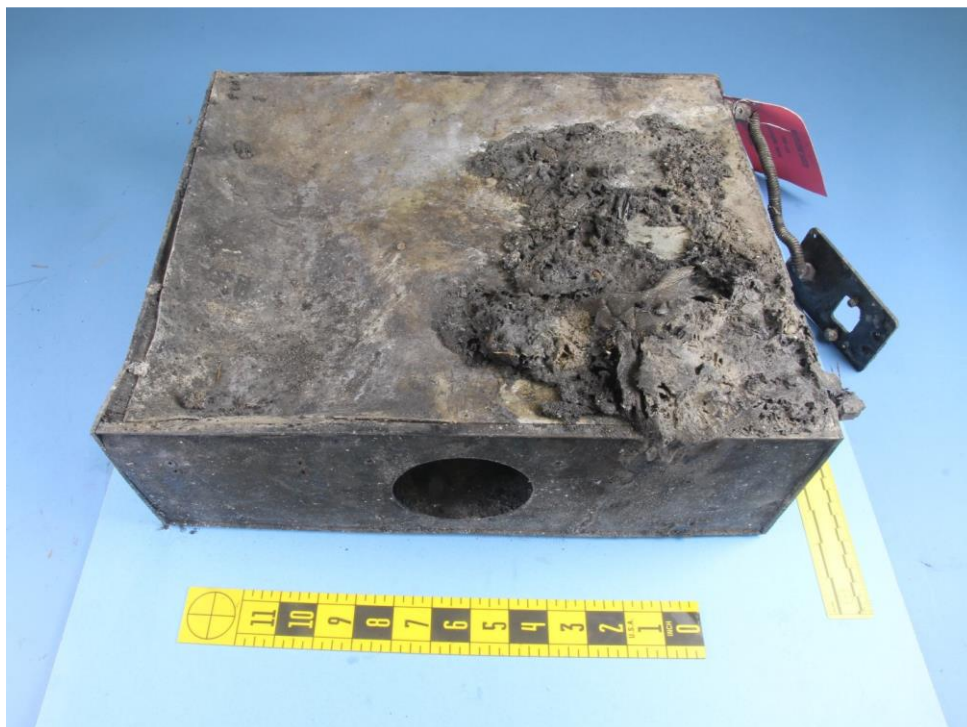
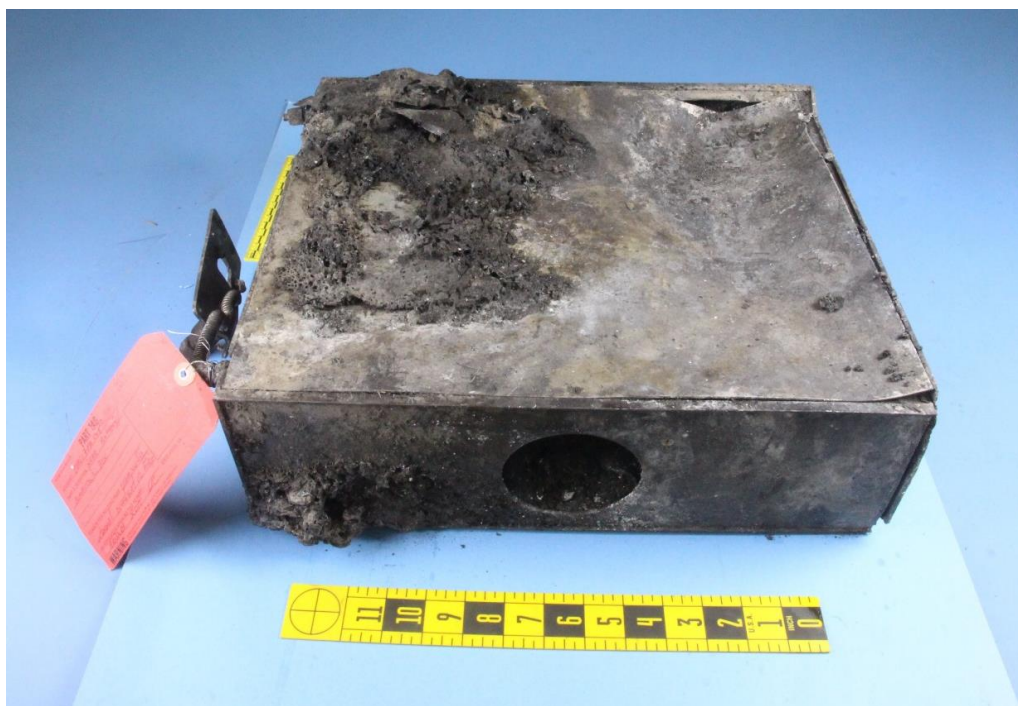
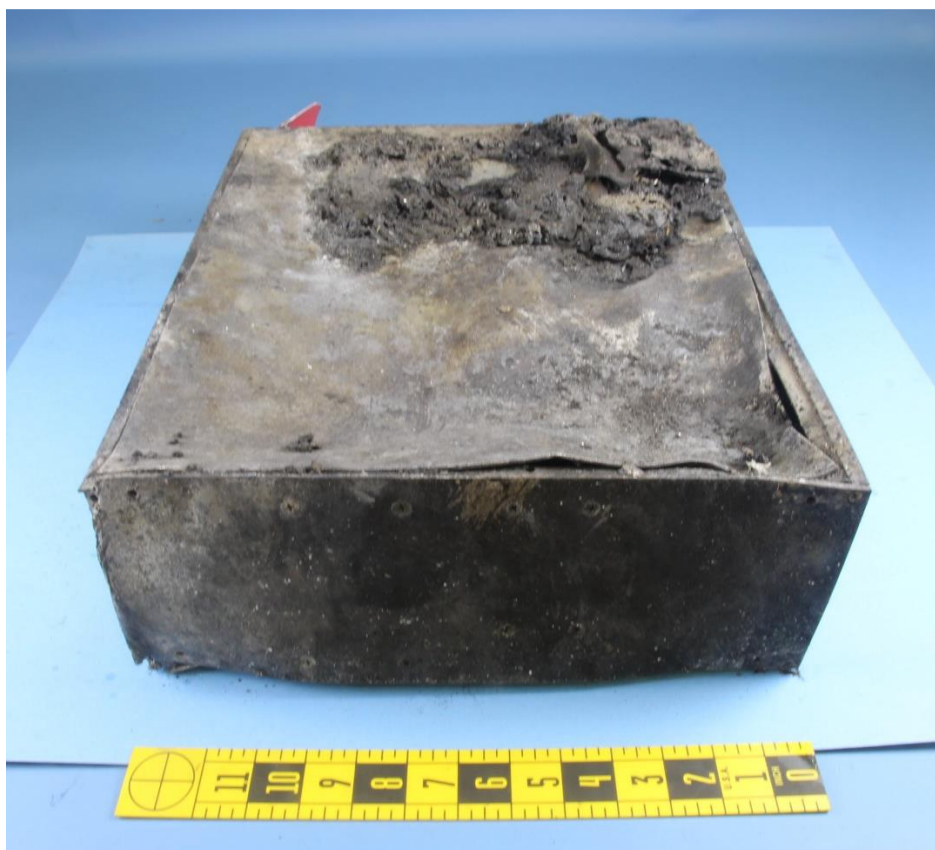
The components of the compressor package were enclosed within an aluminum case (figures 1-5). This aluminum case had two tube fittings and portions of tubes protruding from it. These tubes were for drawing the air sample in and for delivering the air sample to a separate flask package. There were also electrical connections for charging the battery internal to the compressor package and for controlling the activation of the compressor package. The battery pack inside the compressor package was a 24 Volt 14.8 Ampere-hour nickel metal hydride (NiMH) rechargeable battery pack. Overall, the exterior of the compressor package was sooted and exhibited areas where charred

debris had adhered. The compressor package case exhibited mechanical damage and inward deformation in some areas.

Figure 1: Top side of compressor case.

Figure 2: Bottom side of compressor case.

Figure 3: Side of compressor case.

Figure 4: Side of compressor case.

Figure 5: Back side of compressor case.

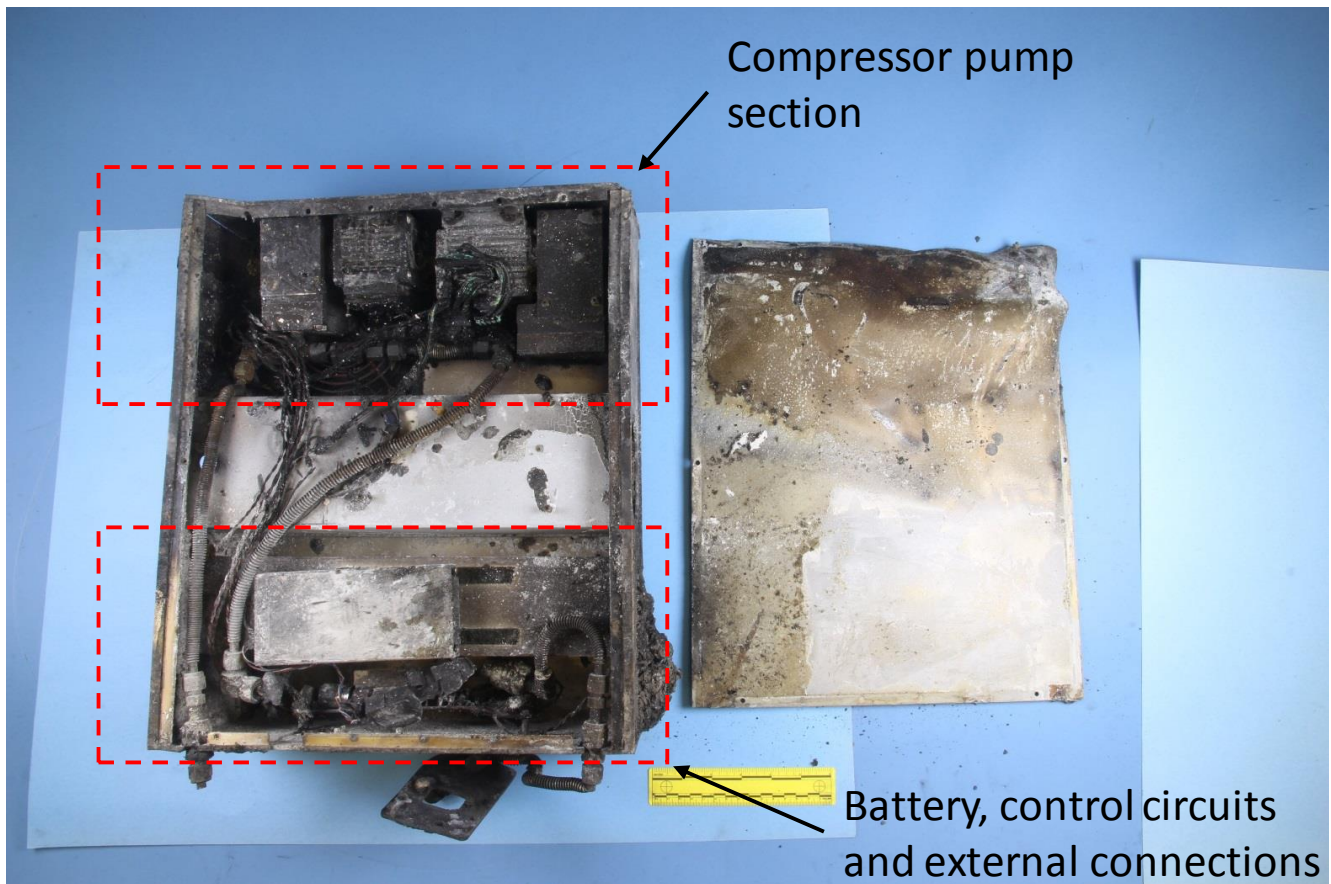
The compressor package was opened to reveal the internal components (figure 6). The case was separated into three distinct sections. There was a section where the two compressor pumps were mounted (figure 7) and a section where the battery pack was housed along with the circuit boards and external connections (figure 8). These two sections were separated by a hollow section in the middle of the case. This hollow section formed a pass through open to the exterior of the compressor case but closed to its interior. Overall, the compressor pump section exhibited the most blackened & charred appearance within the case. Based on the flow path of the re-solidified pump head material the compressor package was oriented with the top cover facing upward when the pump head melted. Wire bundles traversing from the pump section to the battery & control circuit sections exhibited a gradient of thermal damage that lessened towards the battery and circuit board section. A side panel was removed from the compressor case to gain access to the battery (figure 9). The battery was contained within an aluminum extrusion fastened to both side panels of the compressor case. Removal of the side panel again revealed a thermal damage gradient that lessened towards the battery section. There was more wire insulation and thermally sensitive material surviving undamaged in the battery section of the compressor case than in the compressor section.

Figure 6: Compressor case internal components looking in from the top side.

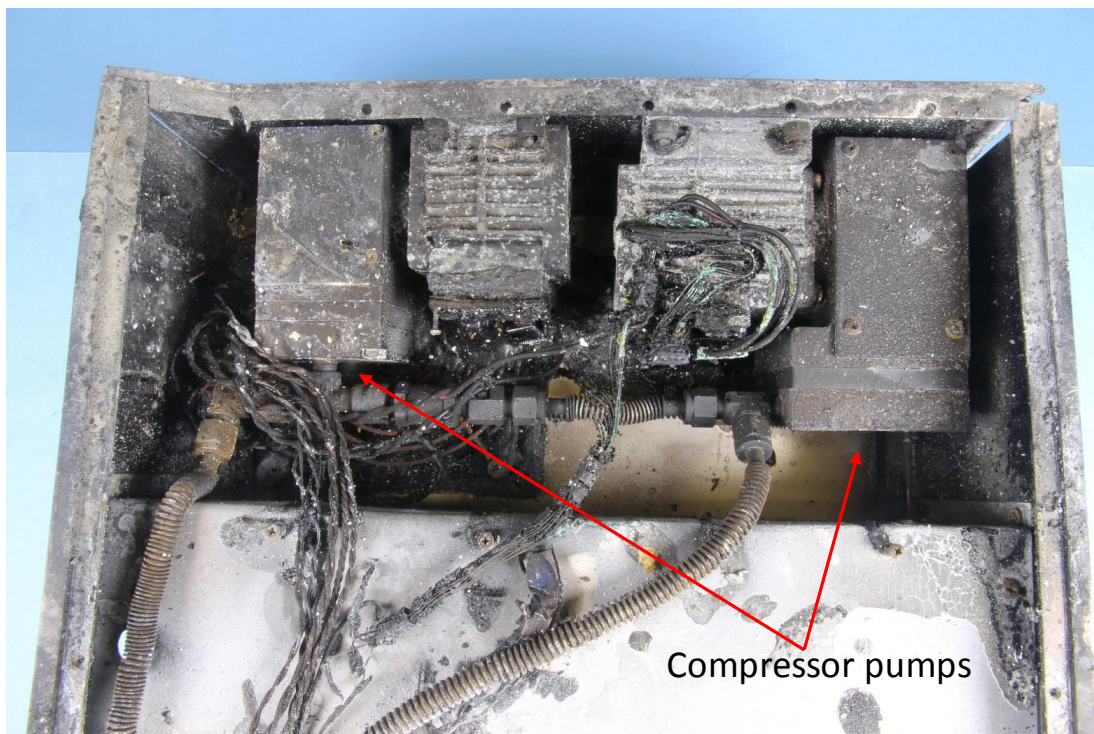
Figure 7: Compressor section of case.

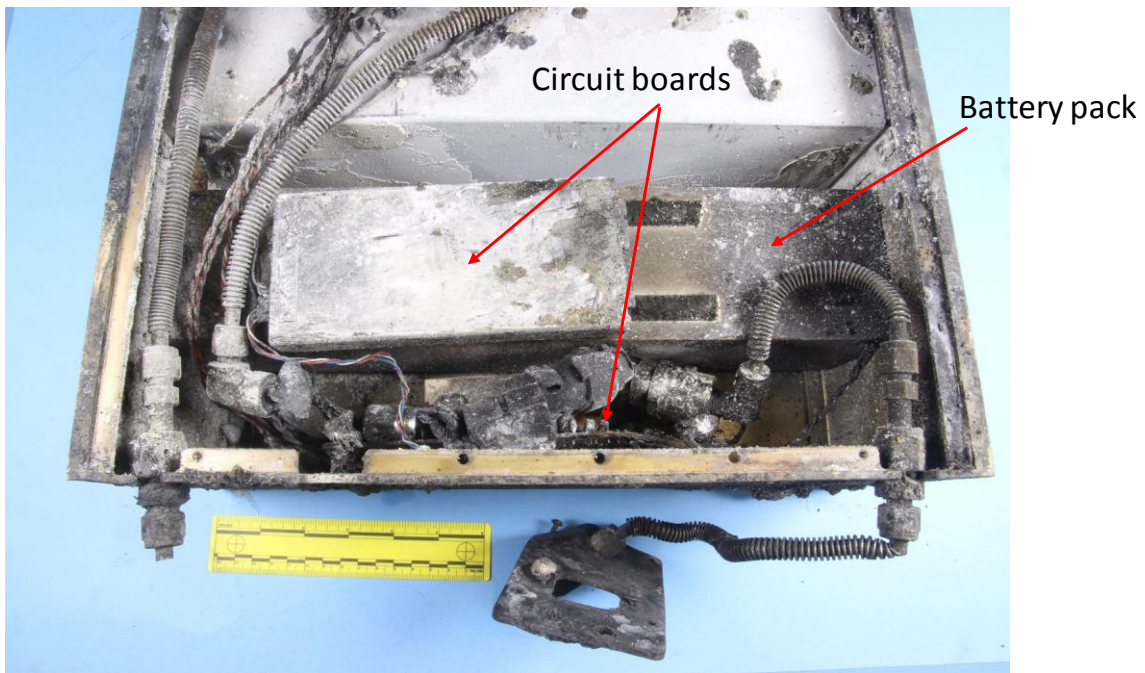
Figure 8: Battery section of case.

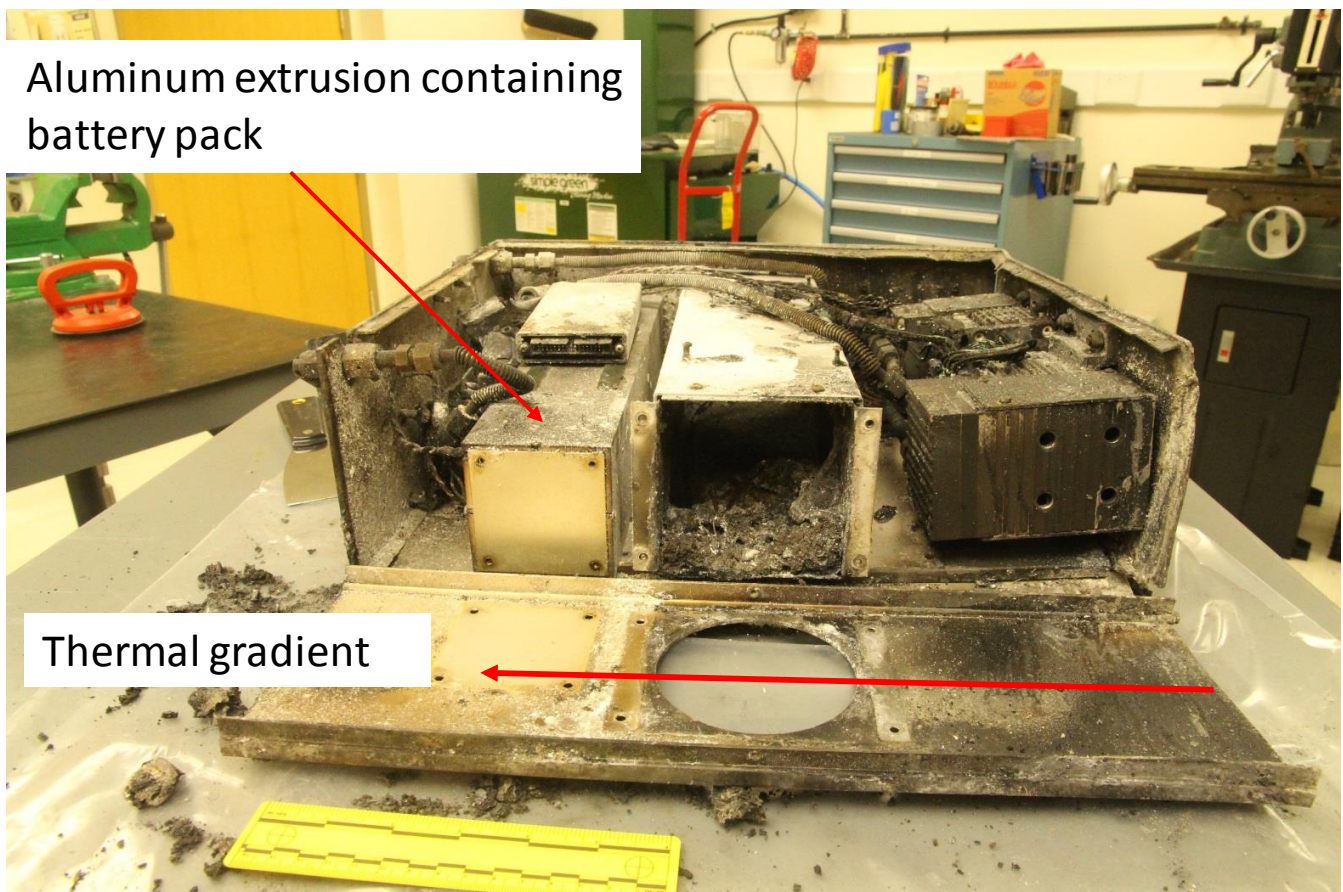
Figure 9: Side panel removed from compressor case.

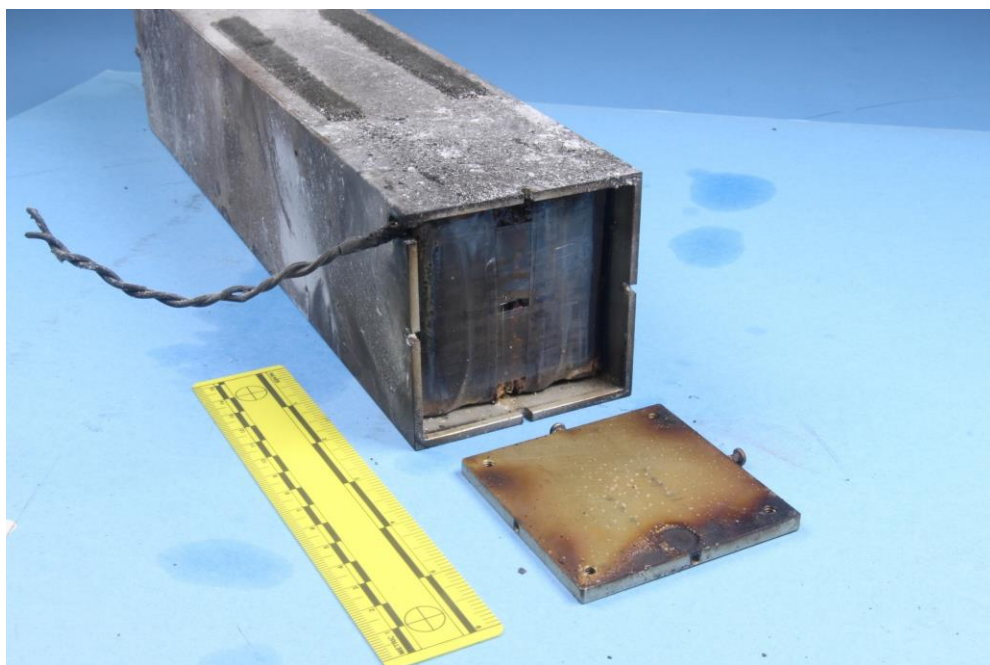
The aluminum extrusion containing the battery was removed and examined. No evidence of bulging or other deformation was observed. The end plates closing the ends of the aluminum extrusion were removed to gain access to the battery inside (figure 10). The battery pack had an insulating paper overwrap (figure 11). This overwrap material was thermally decomposed and darkened in color. Although it had become brittle, it mostly remained intact. A portion of the overwrap had separated exposing some of the cells inside the battery pack. The cells were still wrapped within a clear insulating material and did not exhibit signs of deformation (figure 12). Electrolyte appeared to have leaked from the cells within the battery pack, which is consistent with exposure to a high temperature environment.

Figure 10: Battery pack inside extrusion.

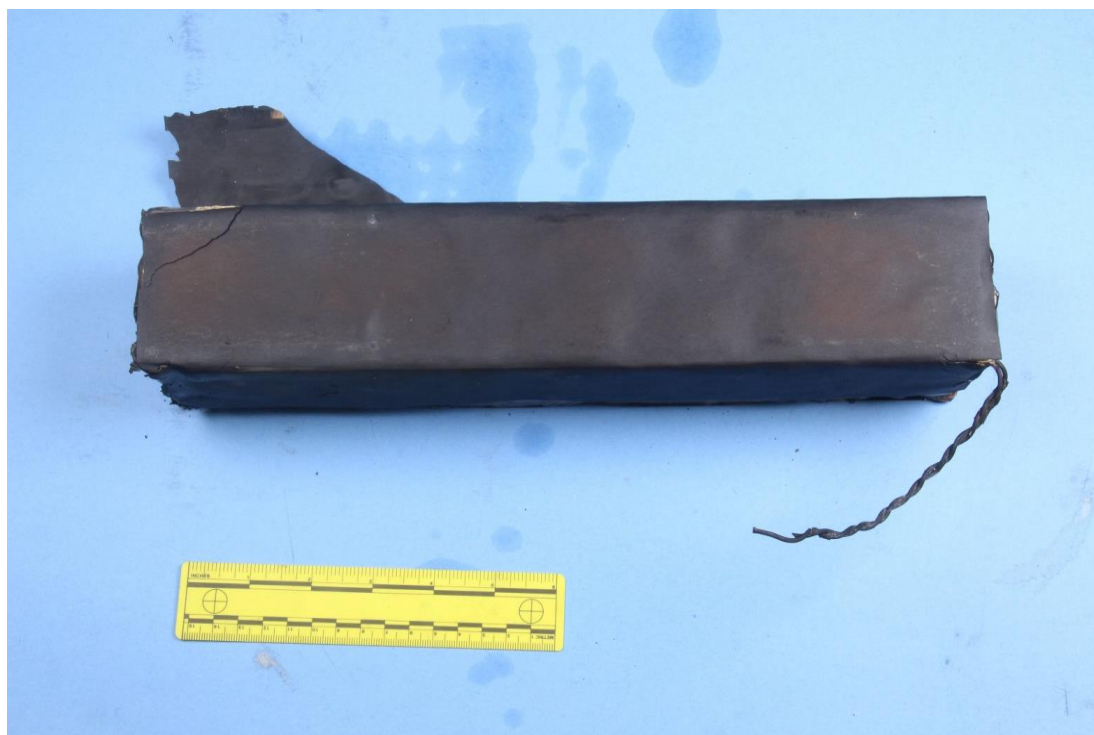
Figure 11: Battery pack with insulating paper.

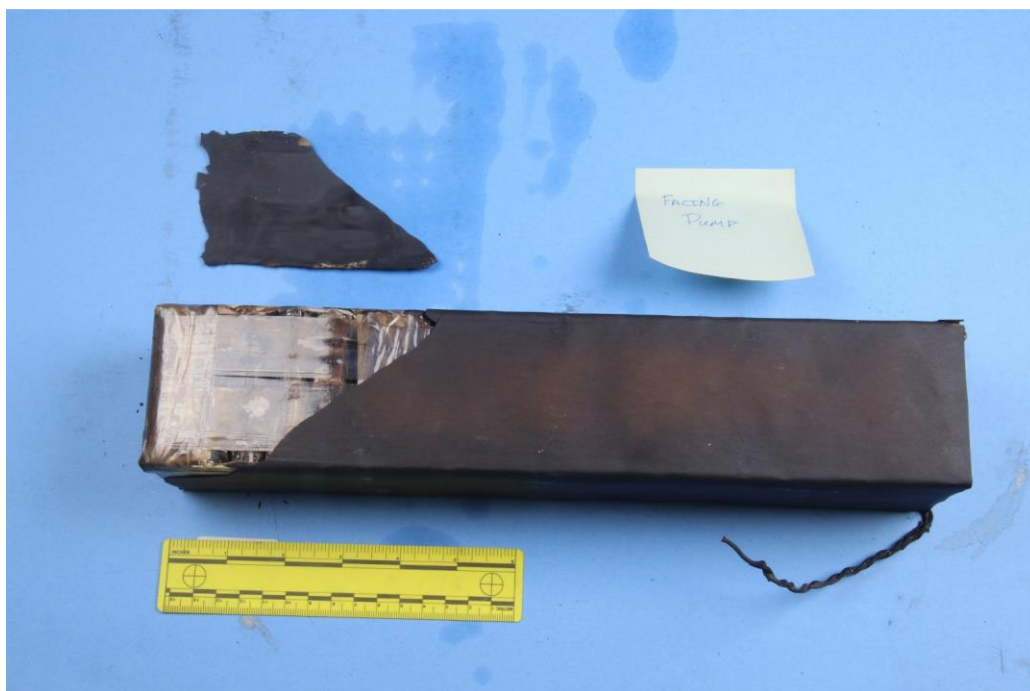
Figure 12: Cells visible within battery pack.
