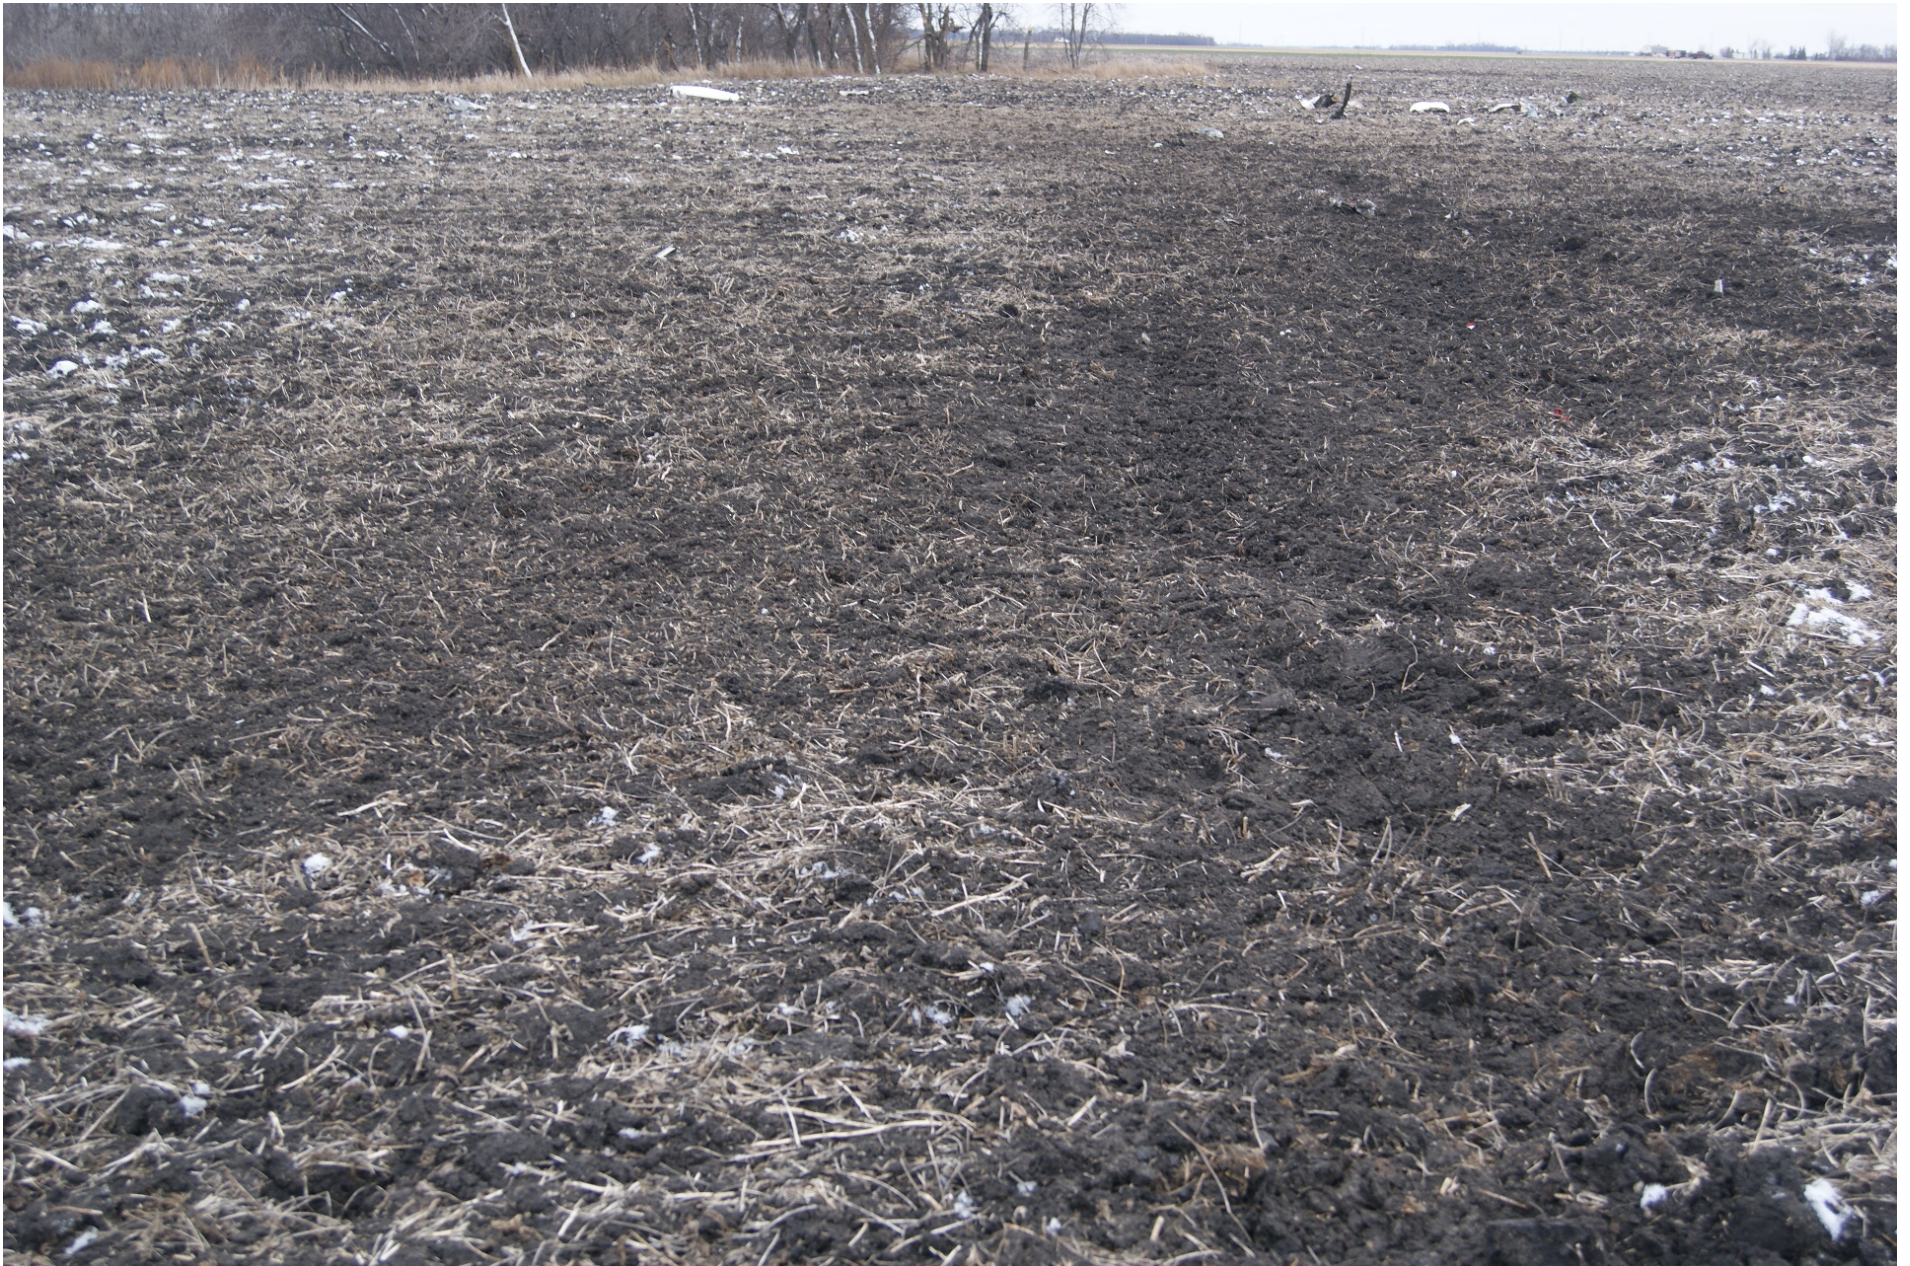
**Photo 1 – The ground scar aligned on magnetic course of 197°.**

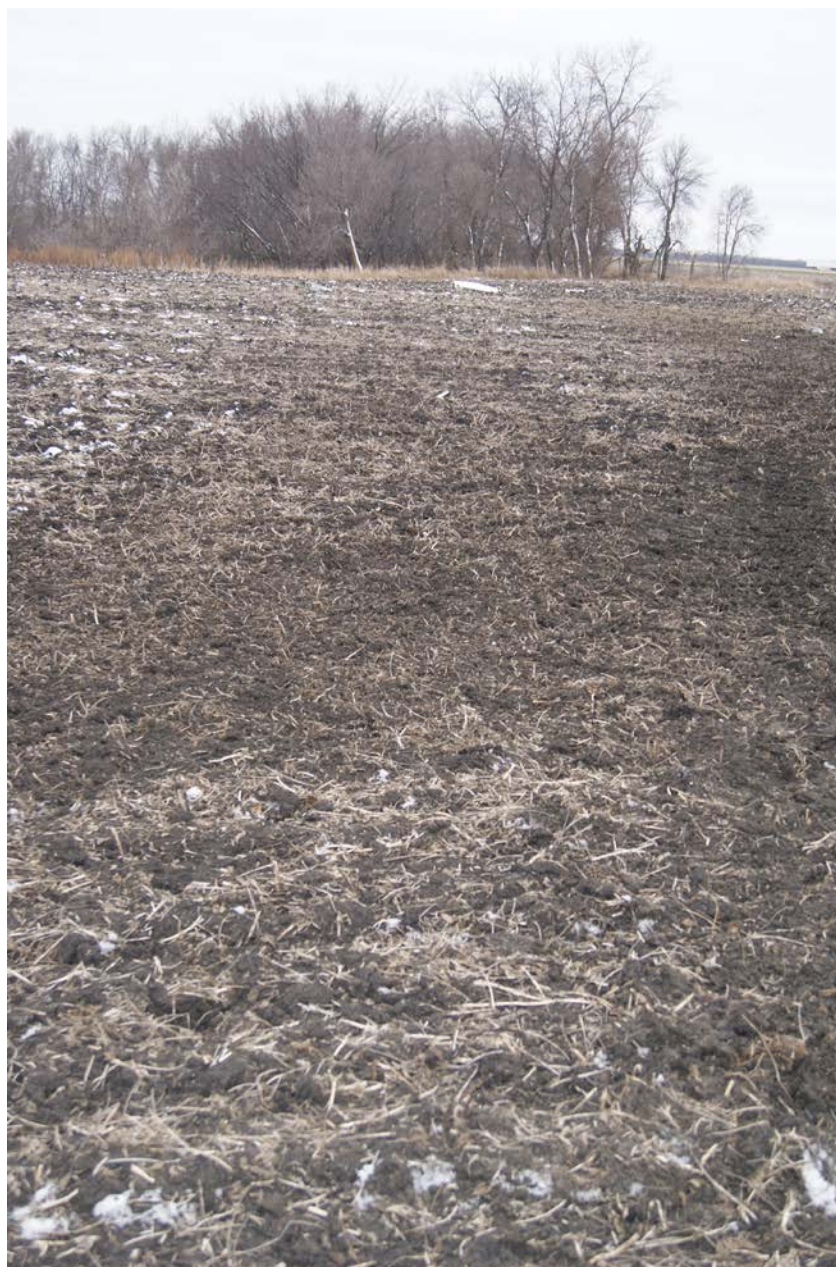
**Photo 2 - Debris field extends towards treeline.**

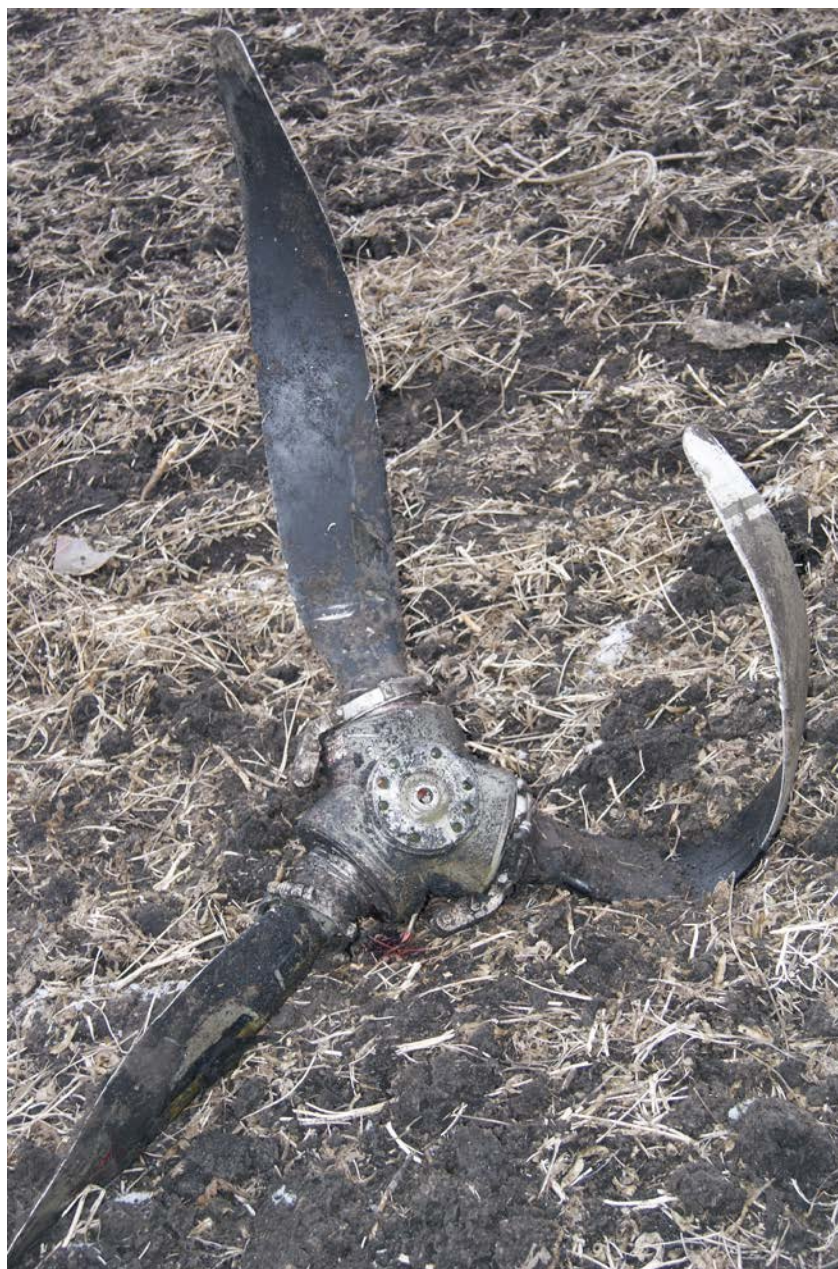
**Photo 3 - Propeller blade assembly.**

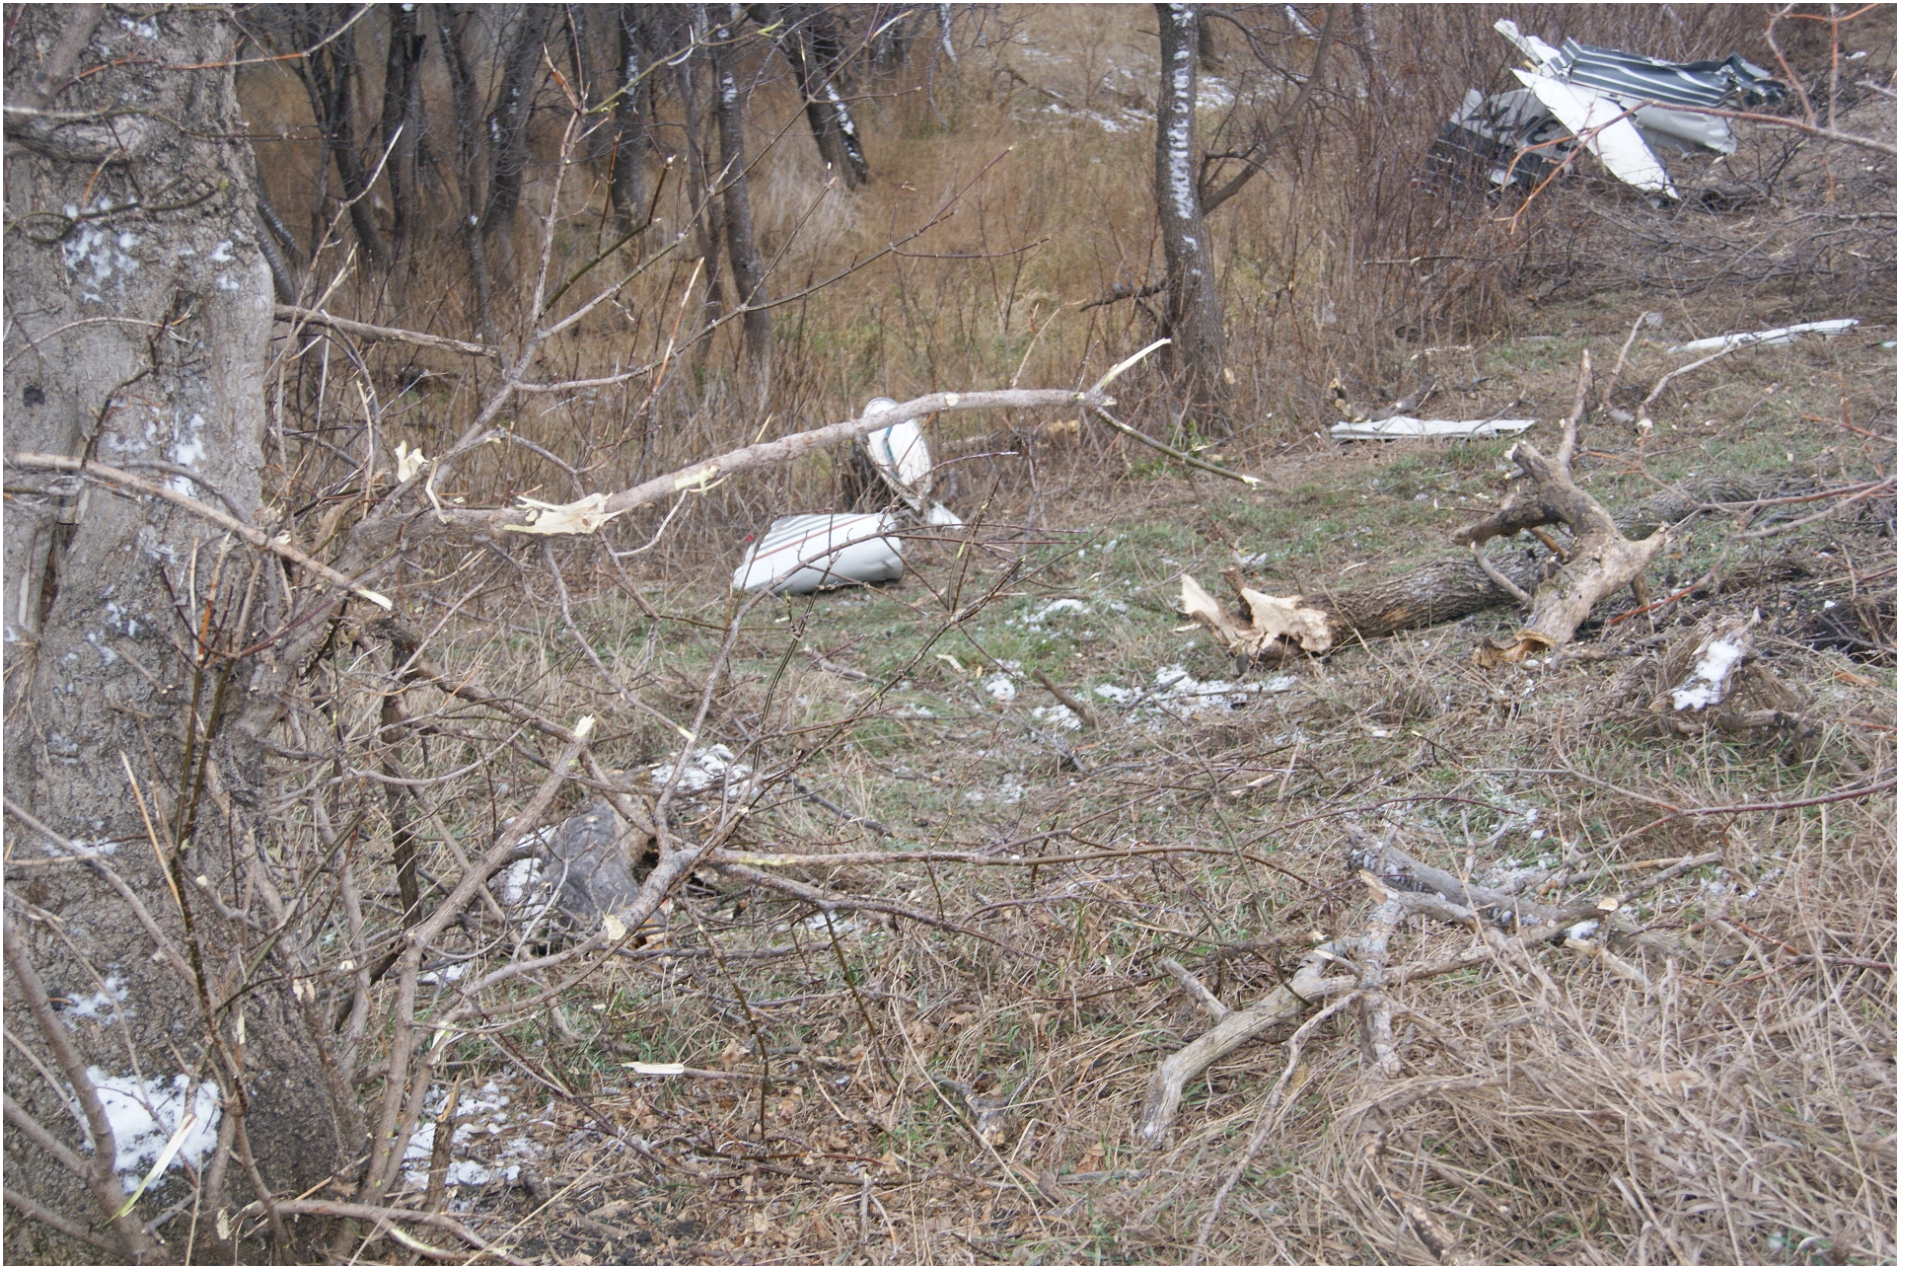
**Photo 4 - Debris field continues down hill into creek bed.**

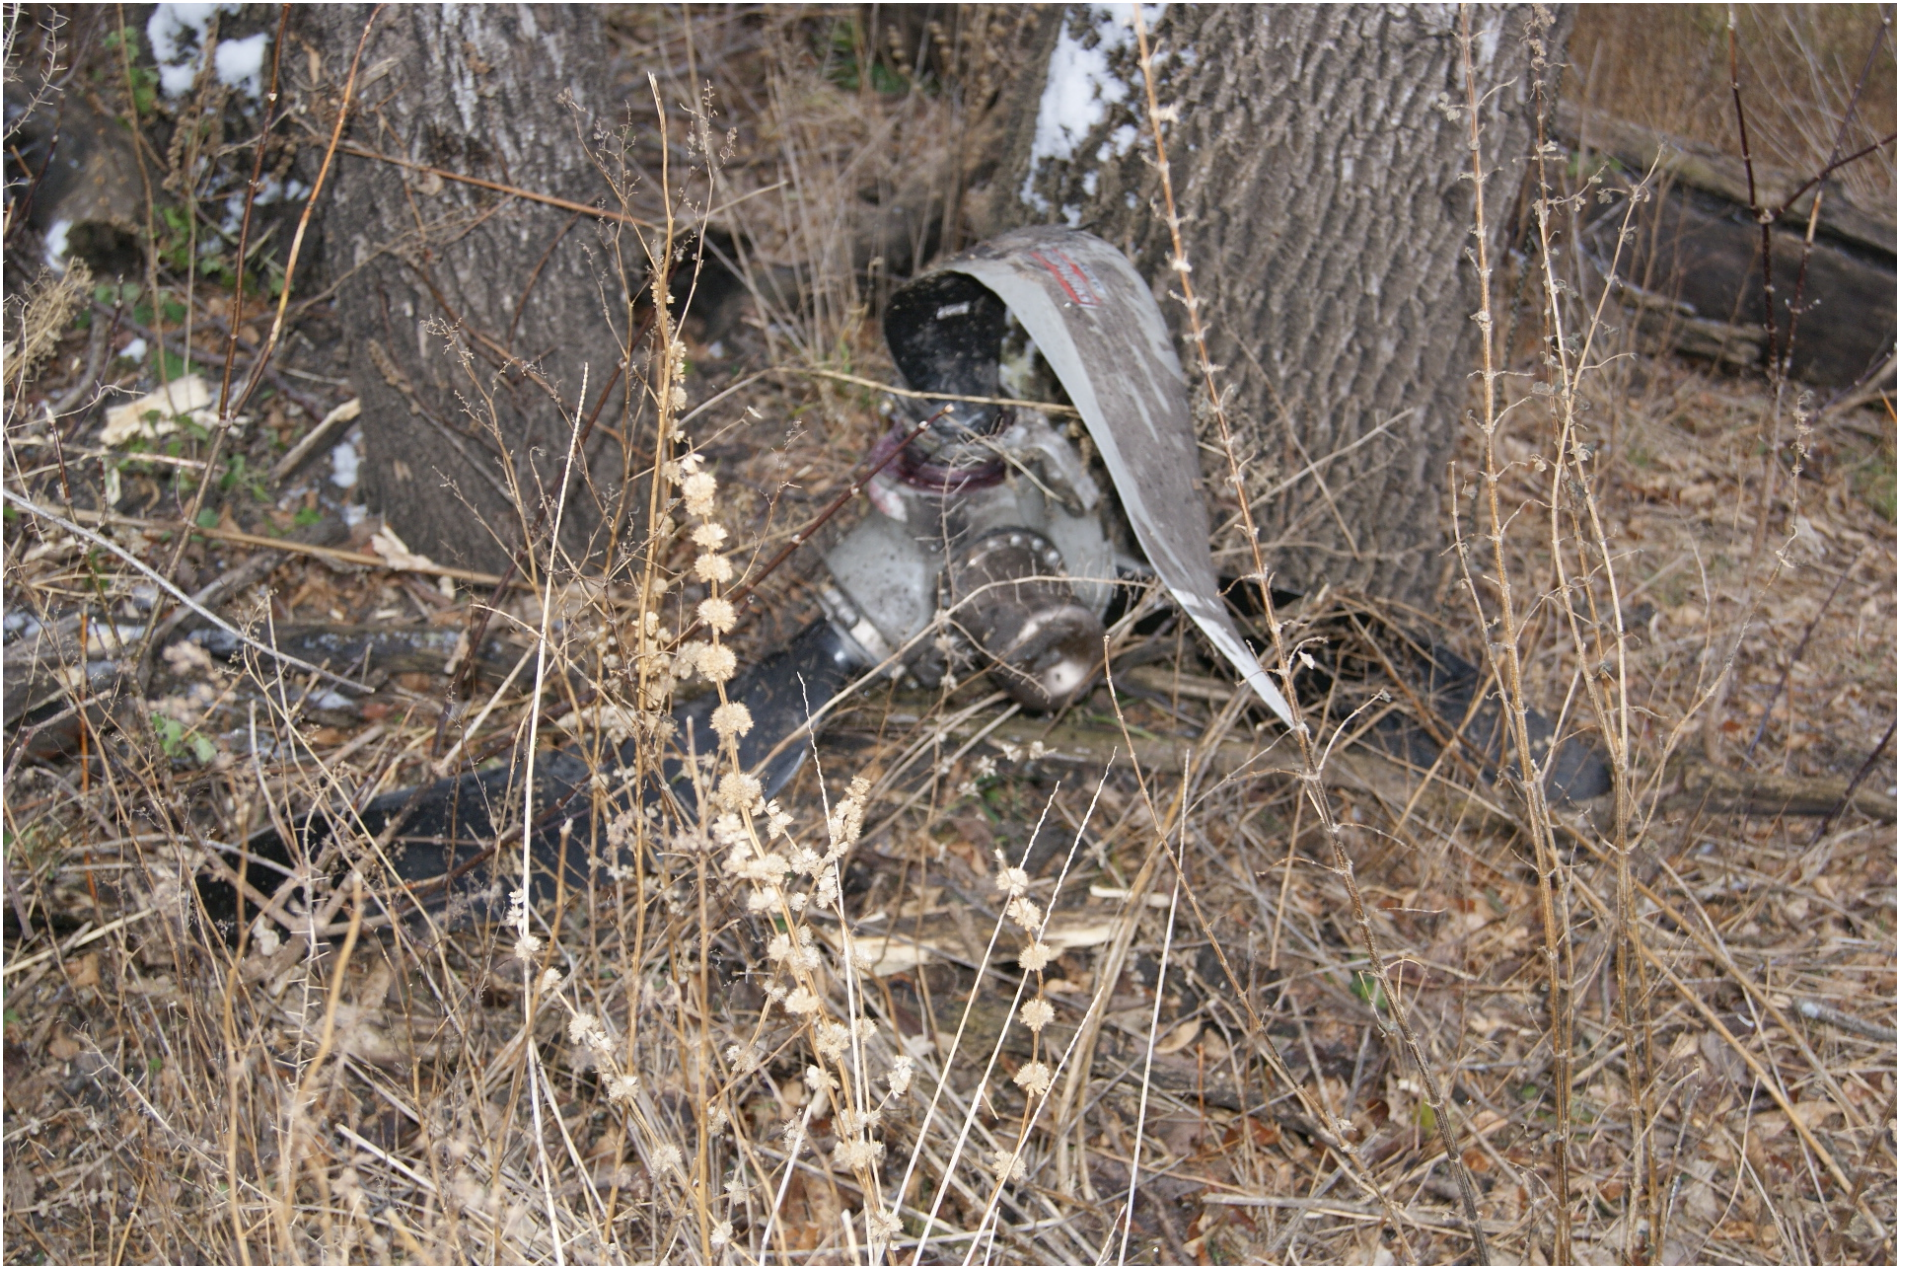
**Photo 5 – Second propeller assembly.**

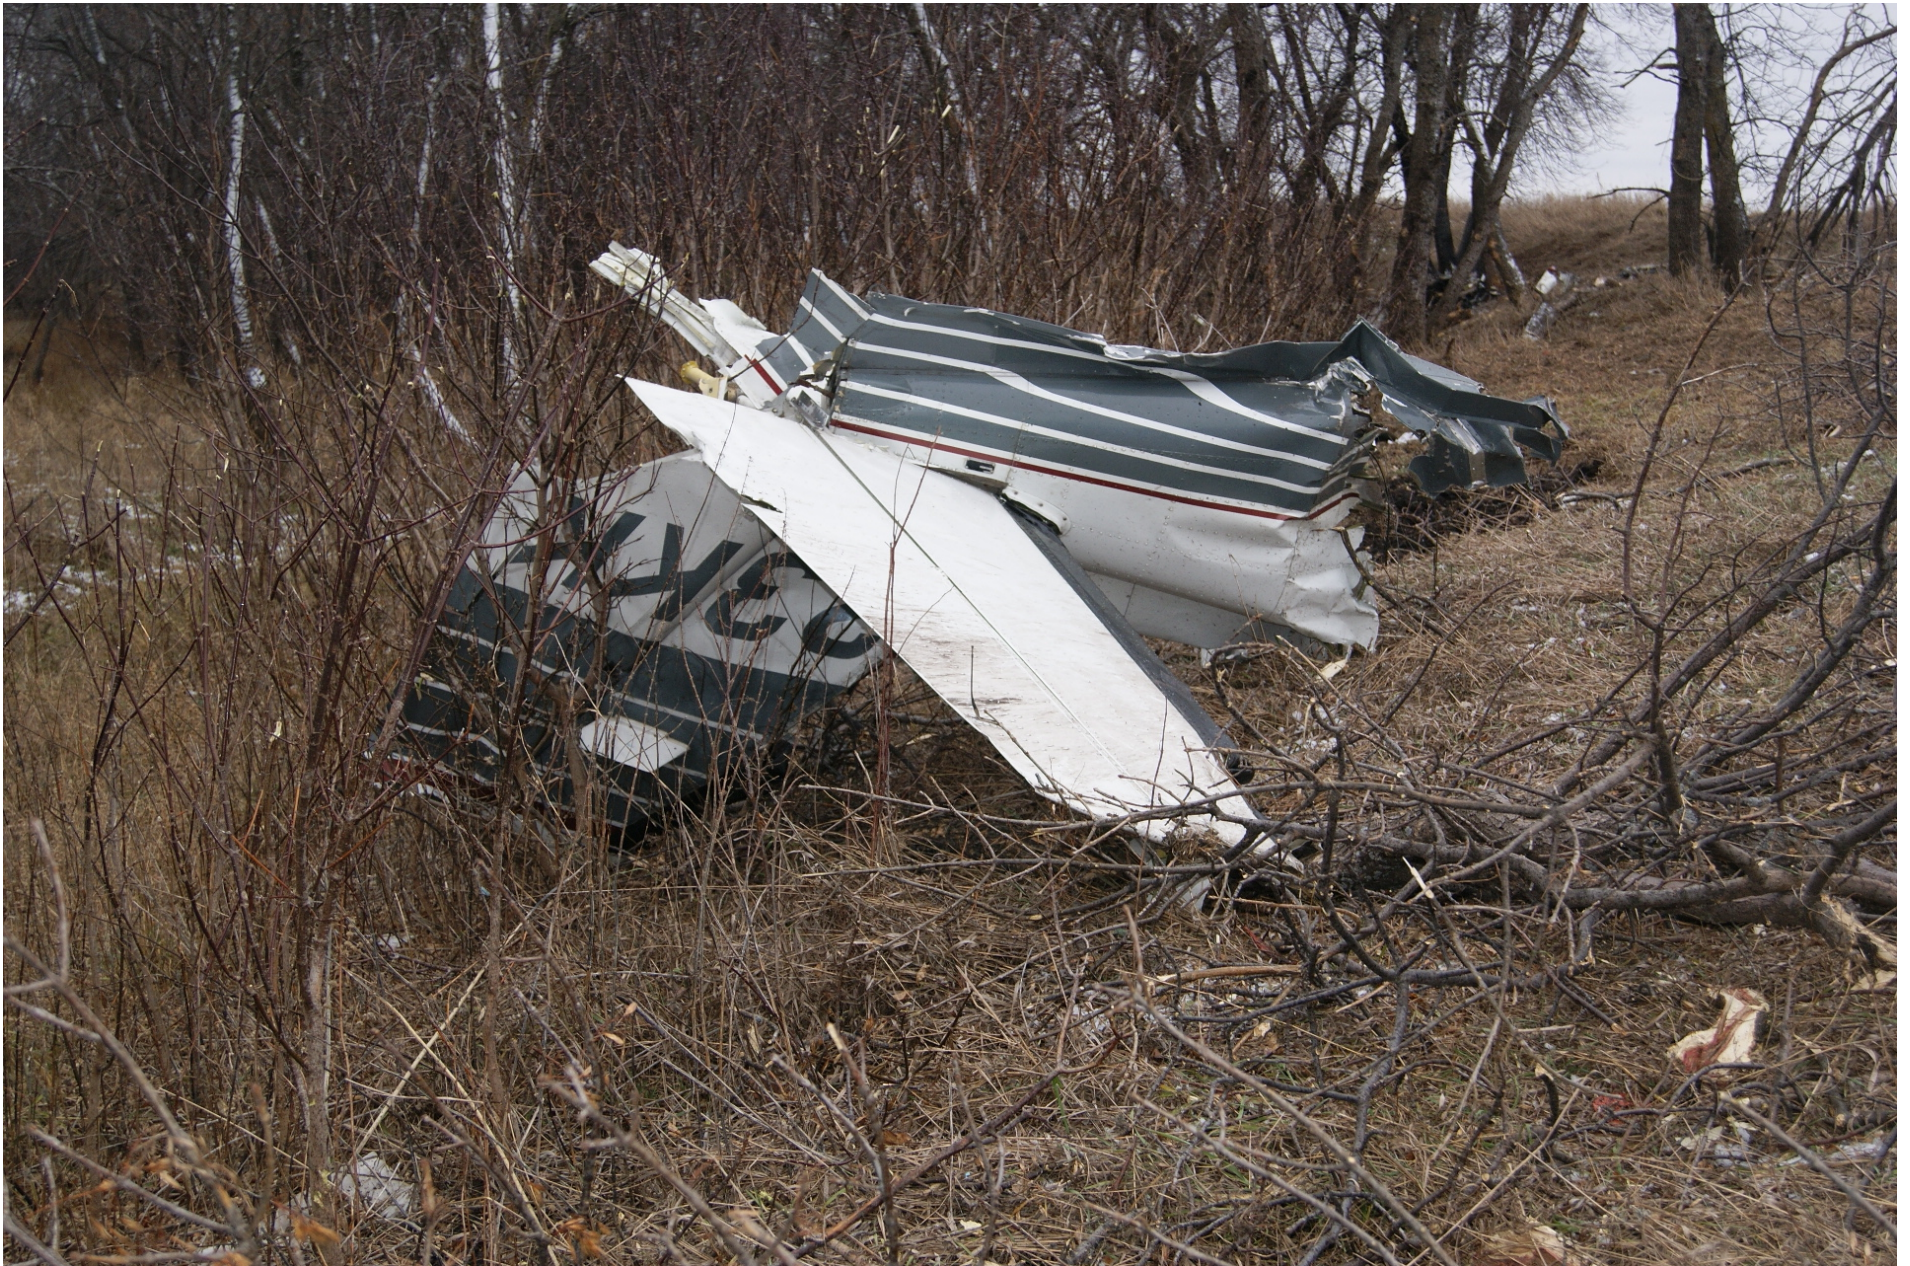
**Photo 6 – The empennage.**

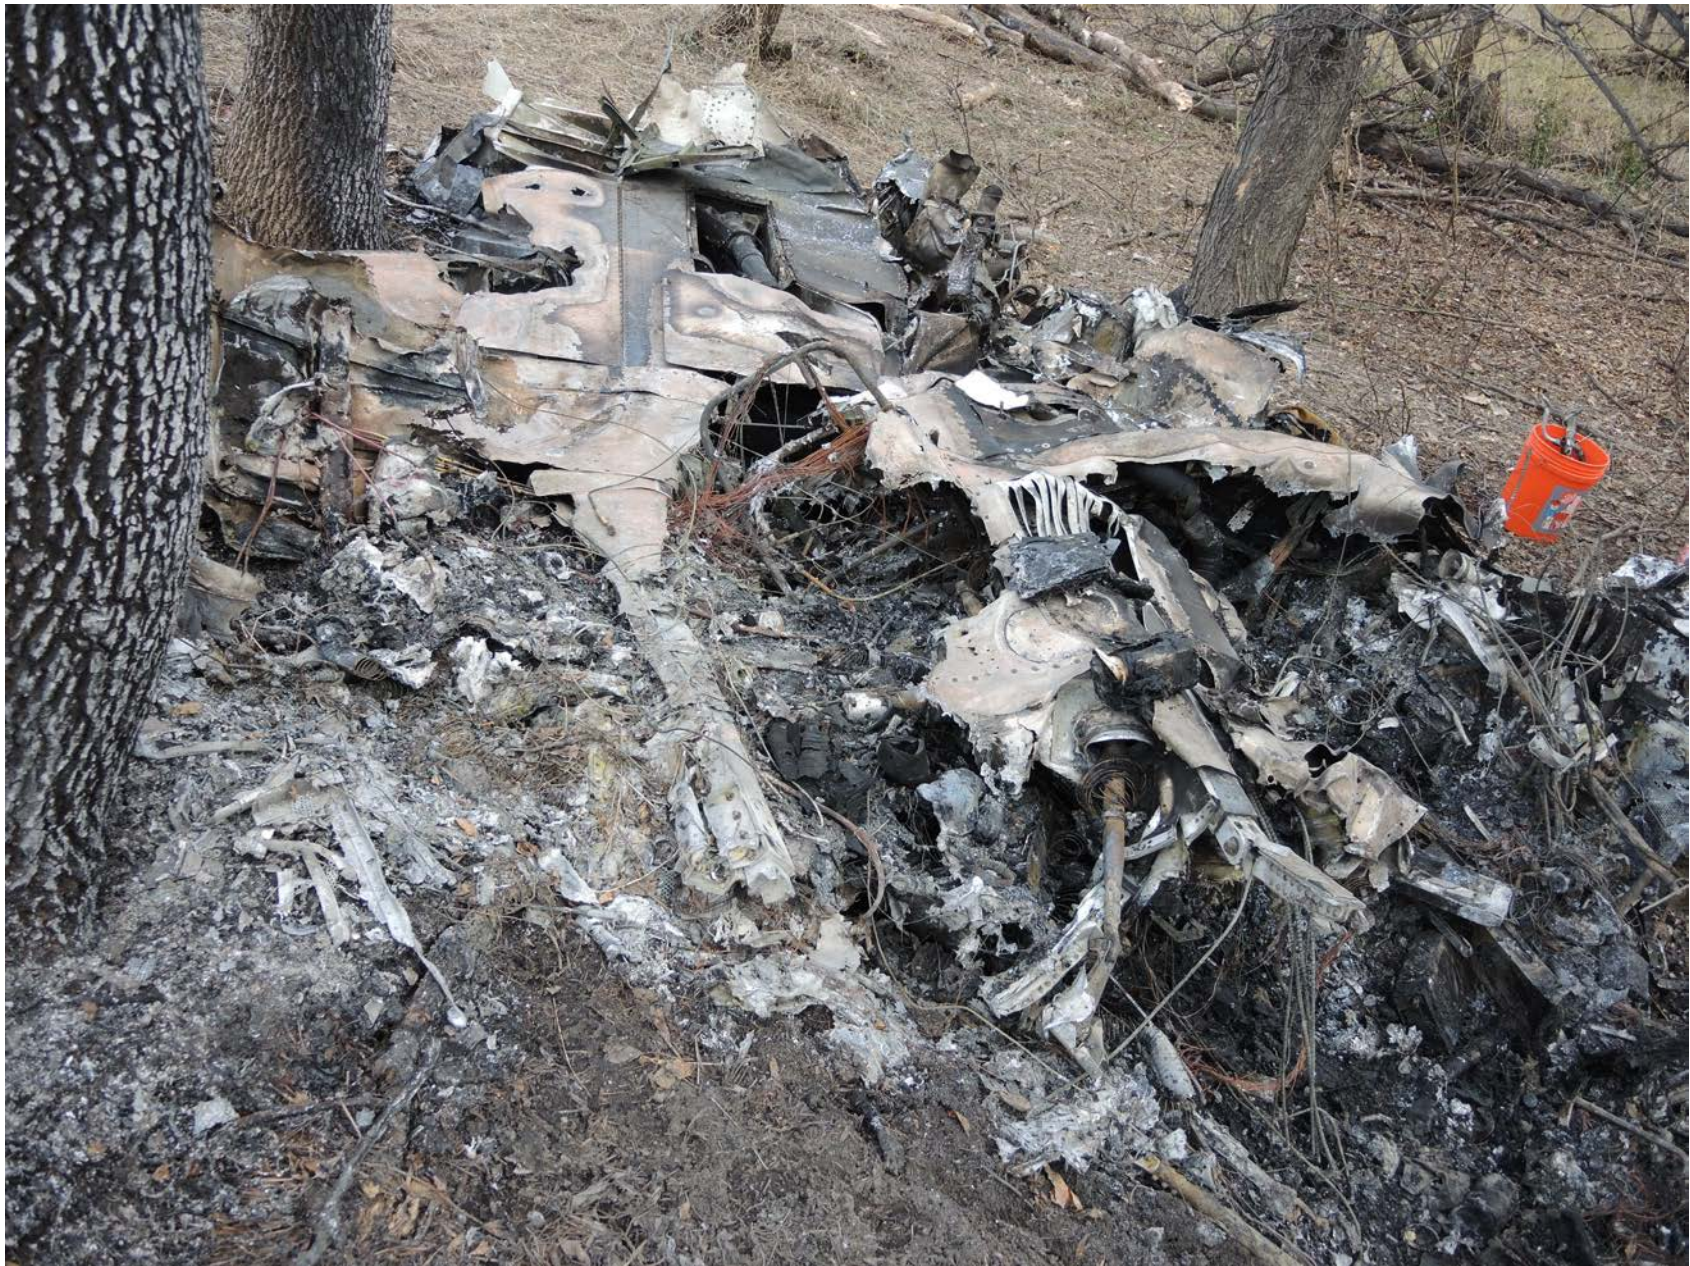
**Photo 7 – Cockpit and cabin area.**

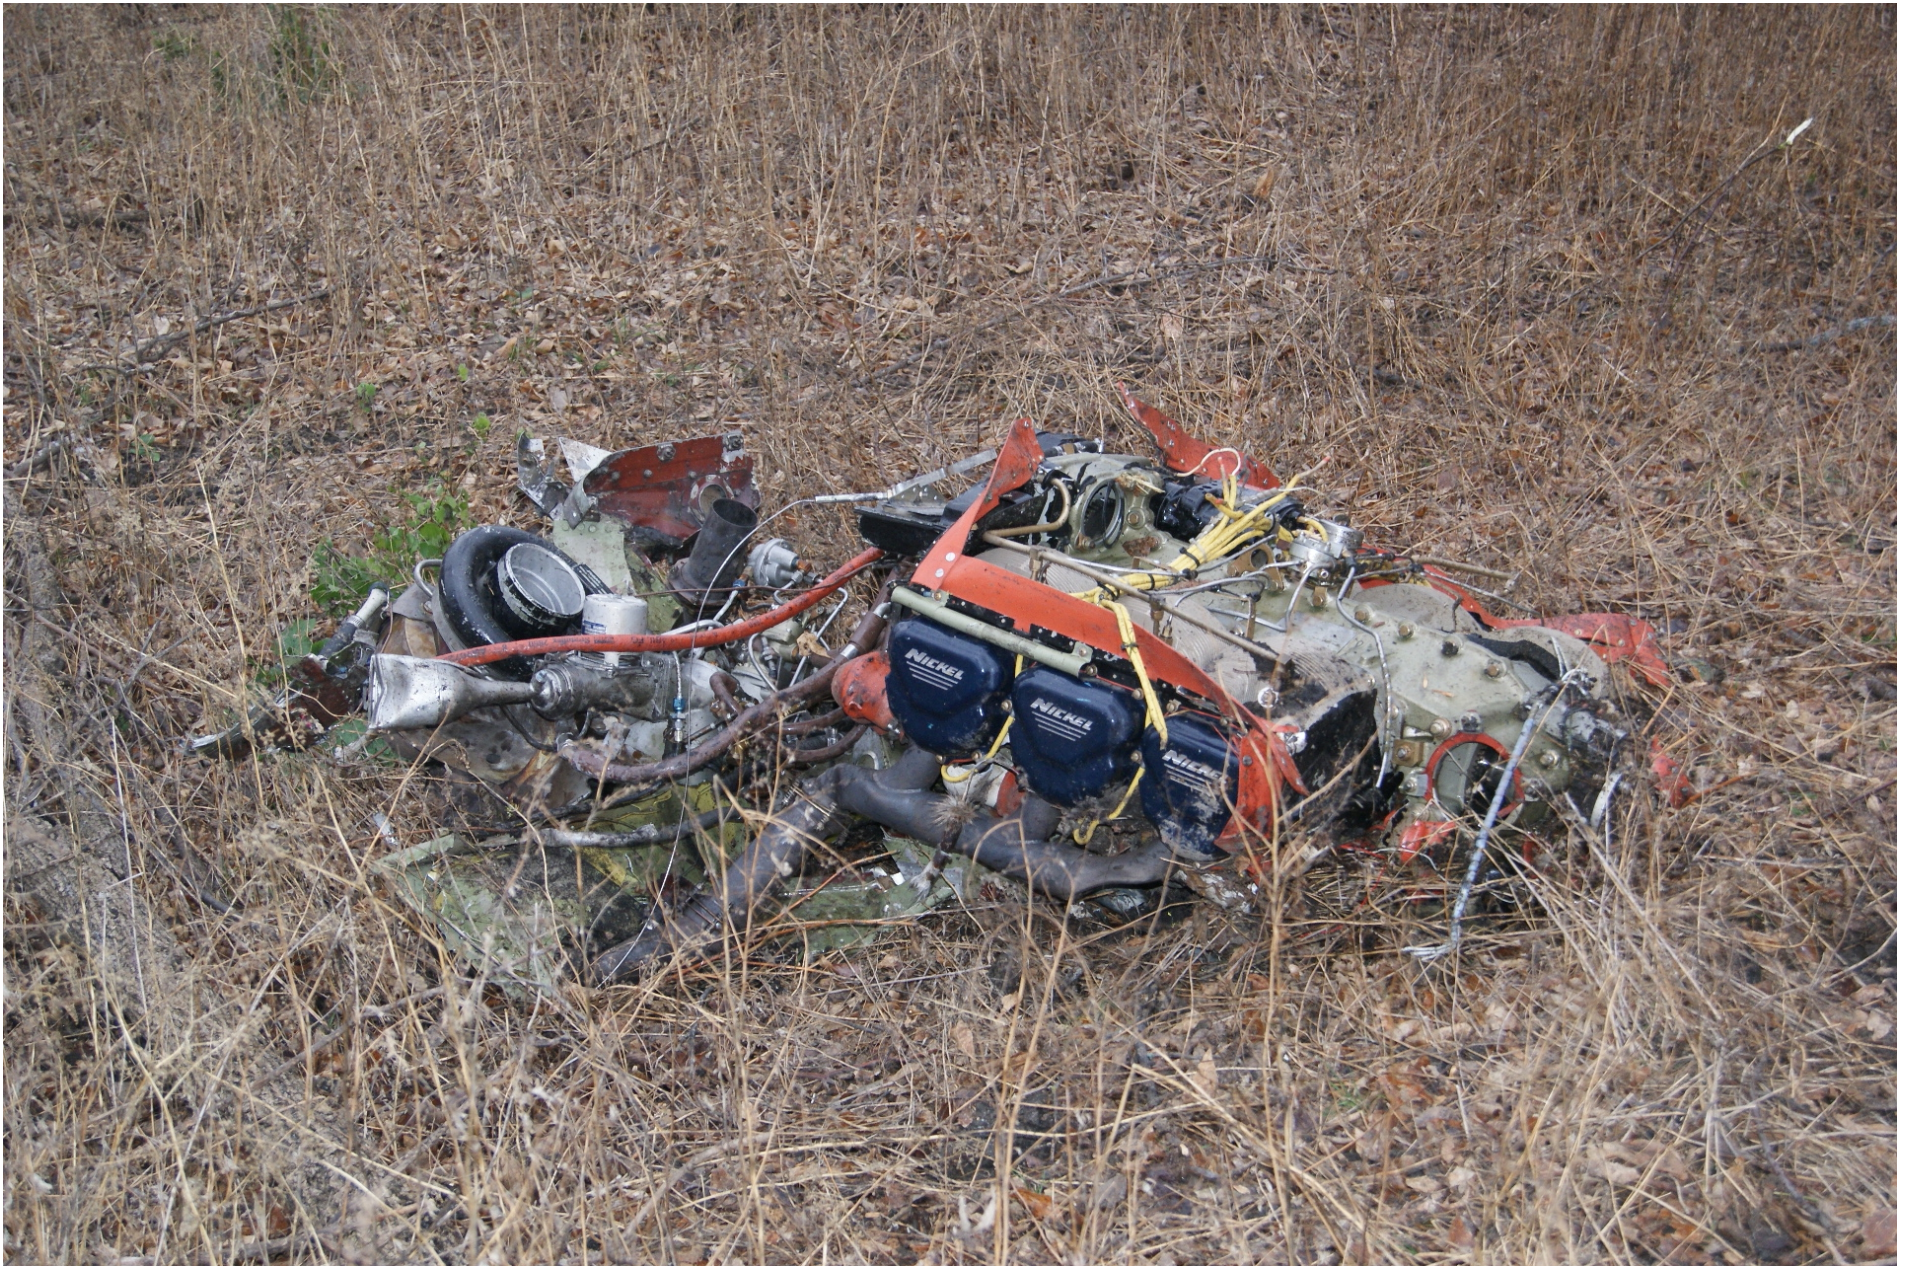
**Photo 8 – Left engine.**

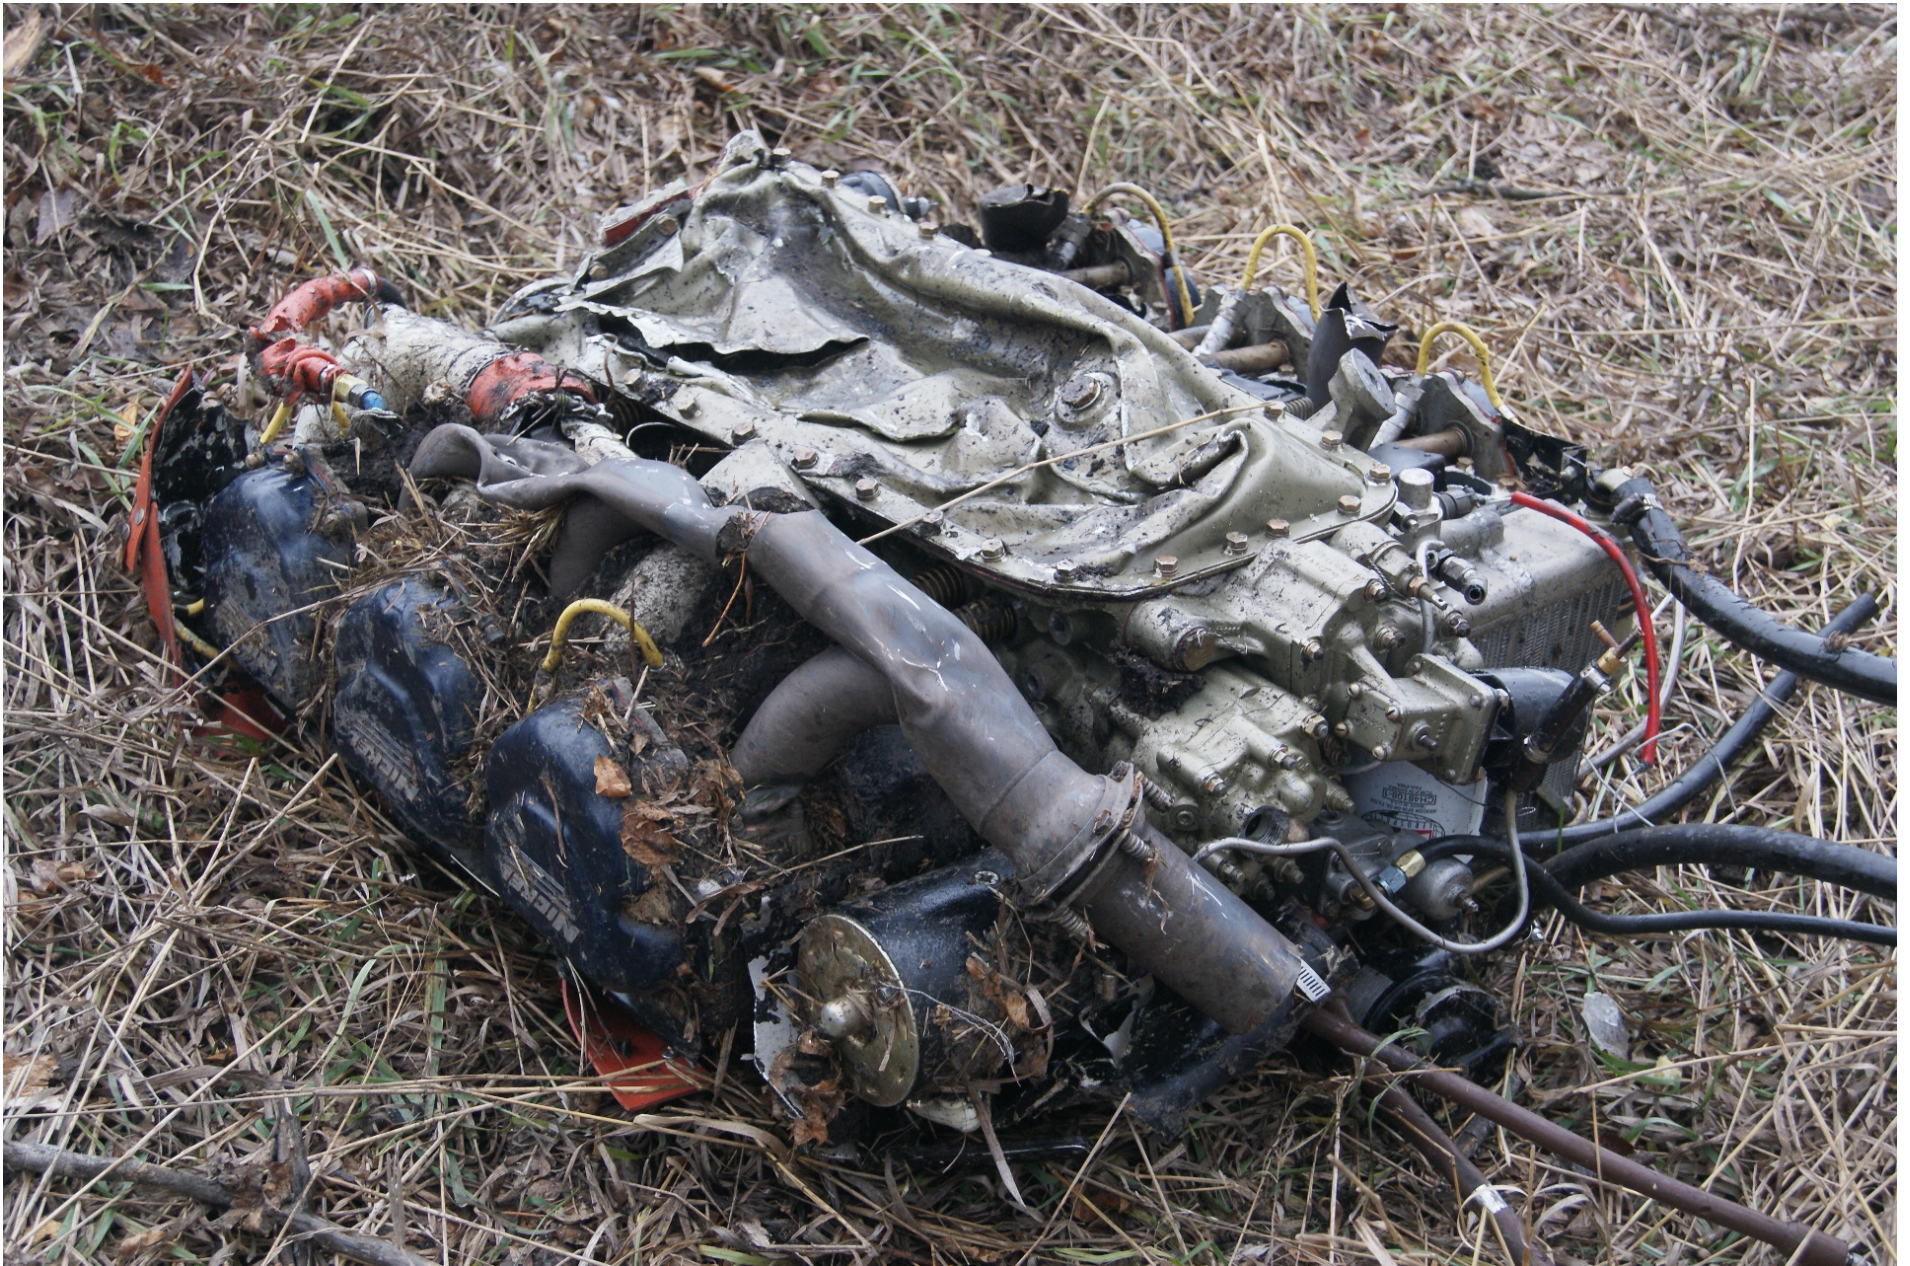
**Photo 9 – Right engine.**

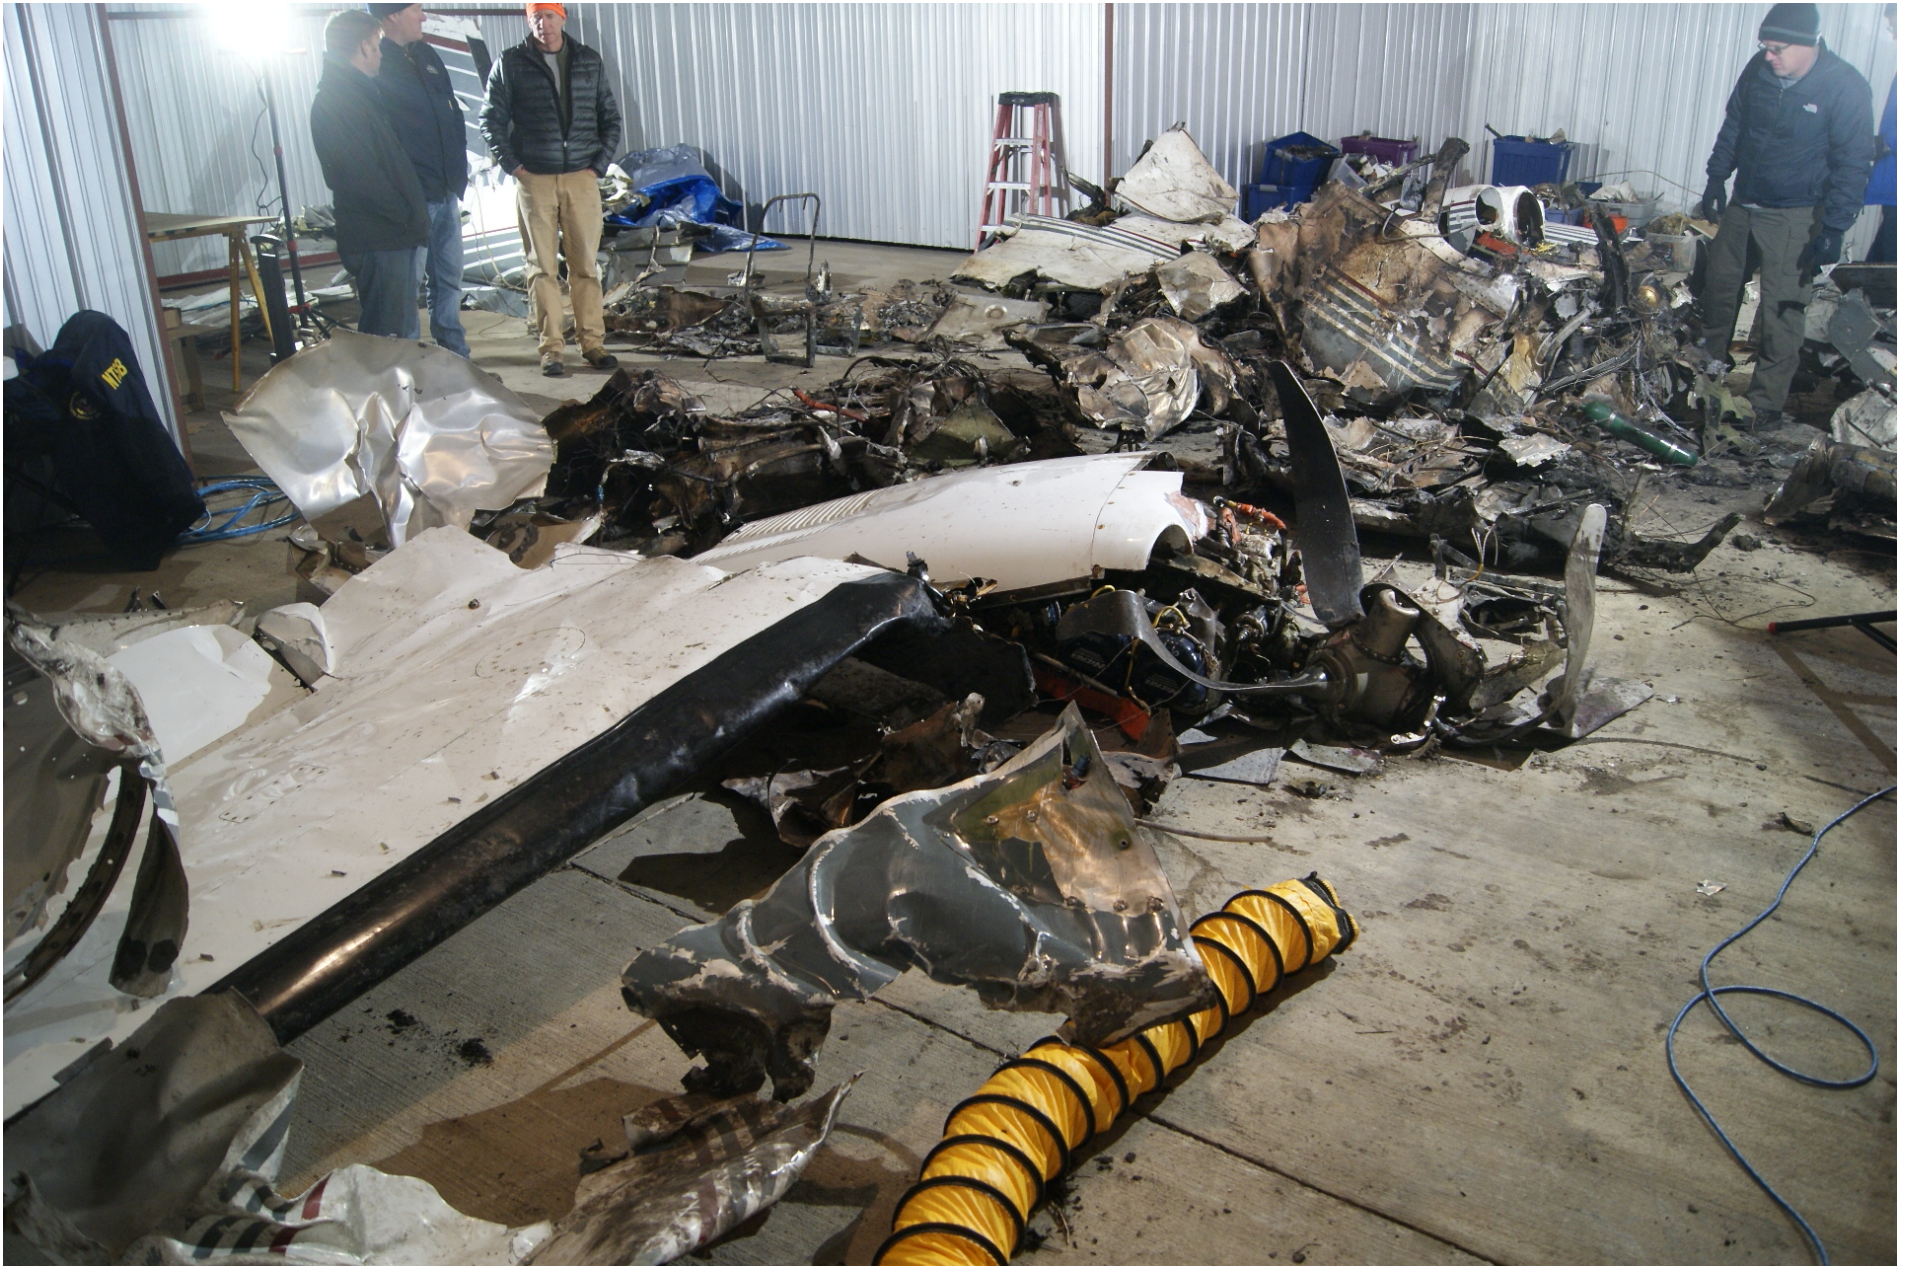
**Photo 10 – Wreckage layout, right front.**
