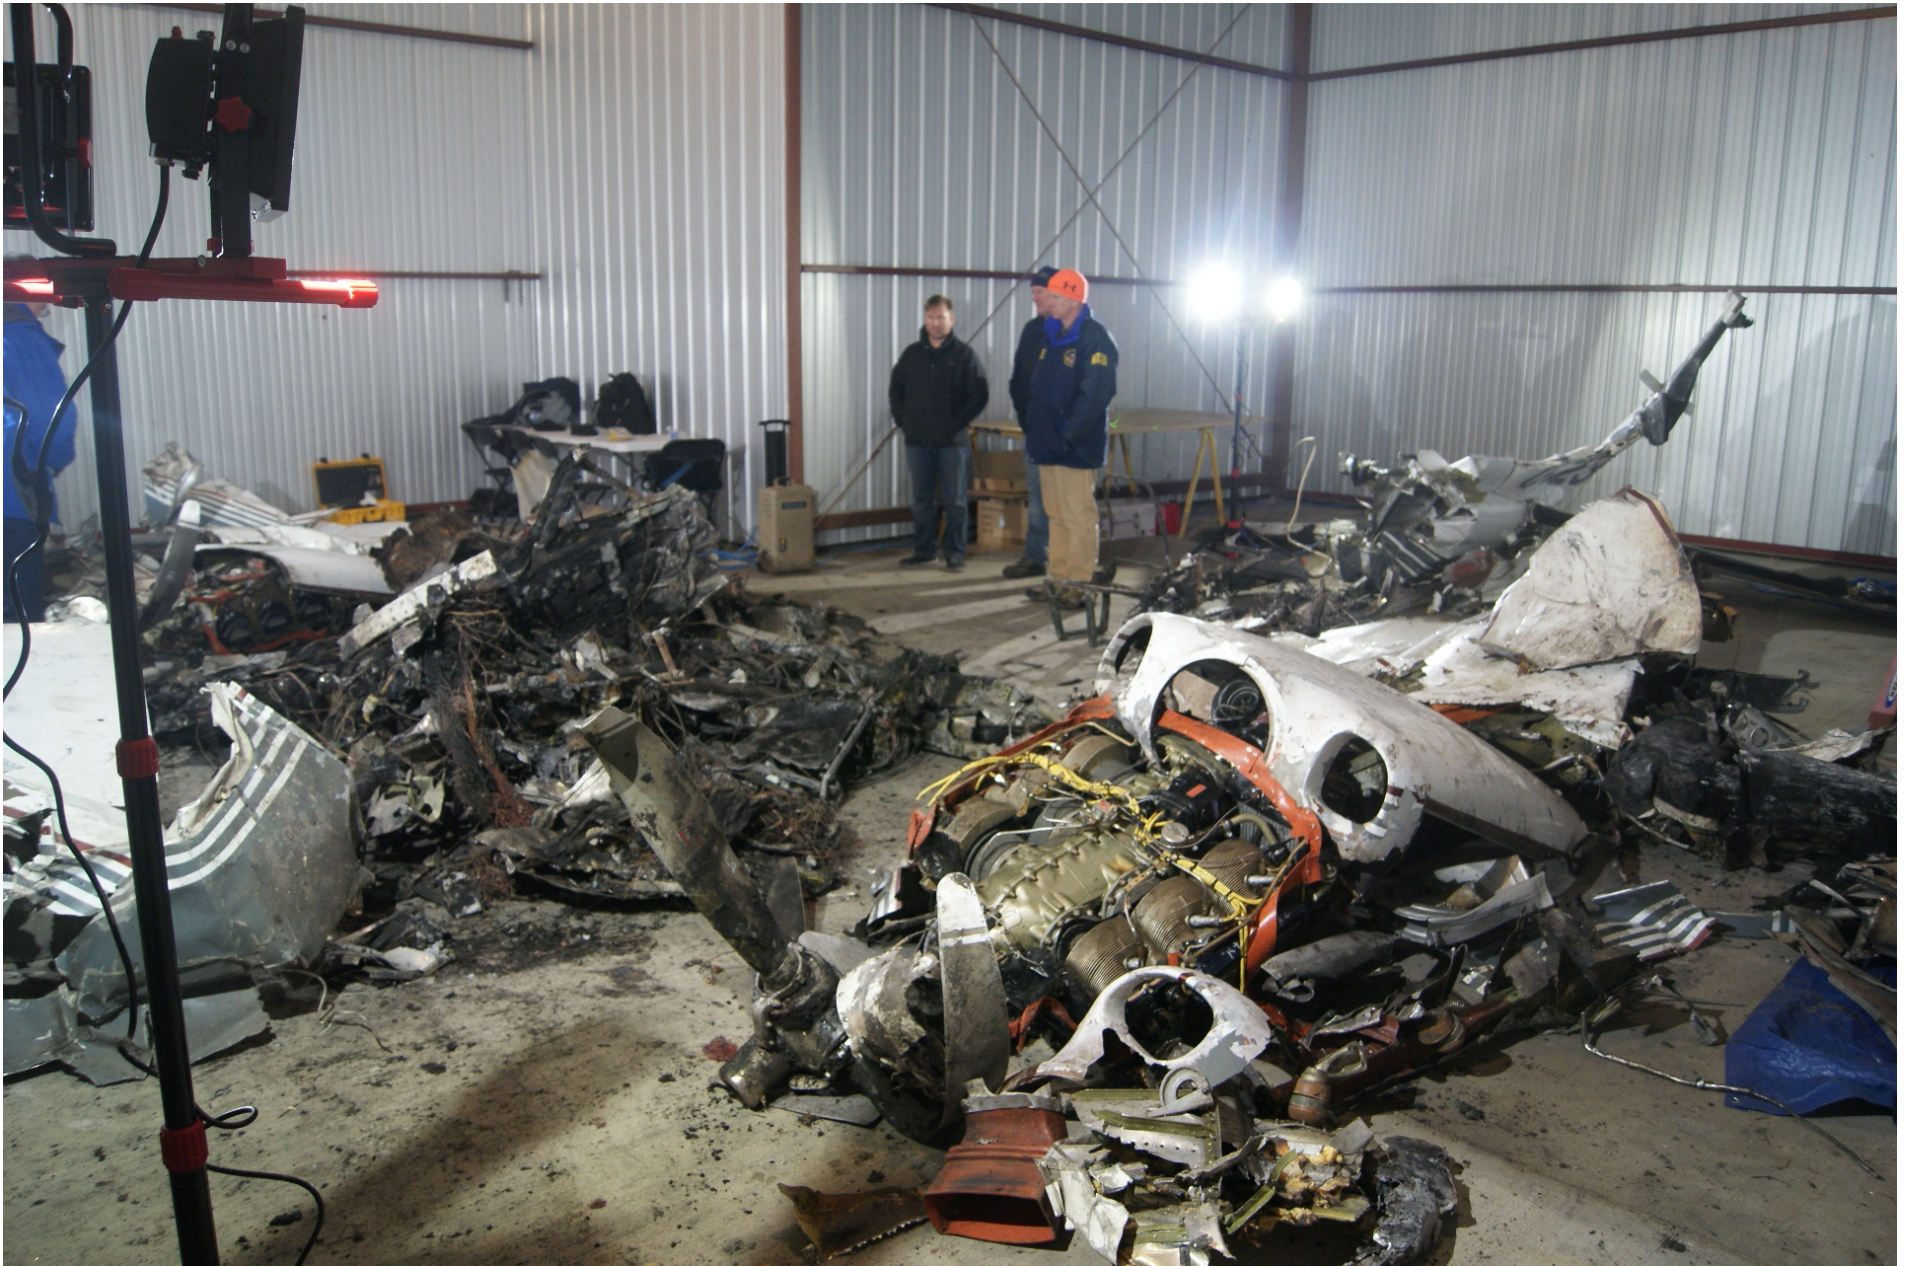
**Photo 11 – Wreckage layout, left front.**

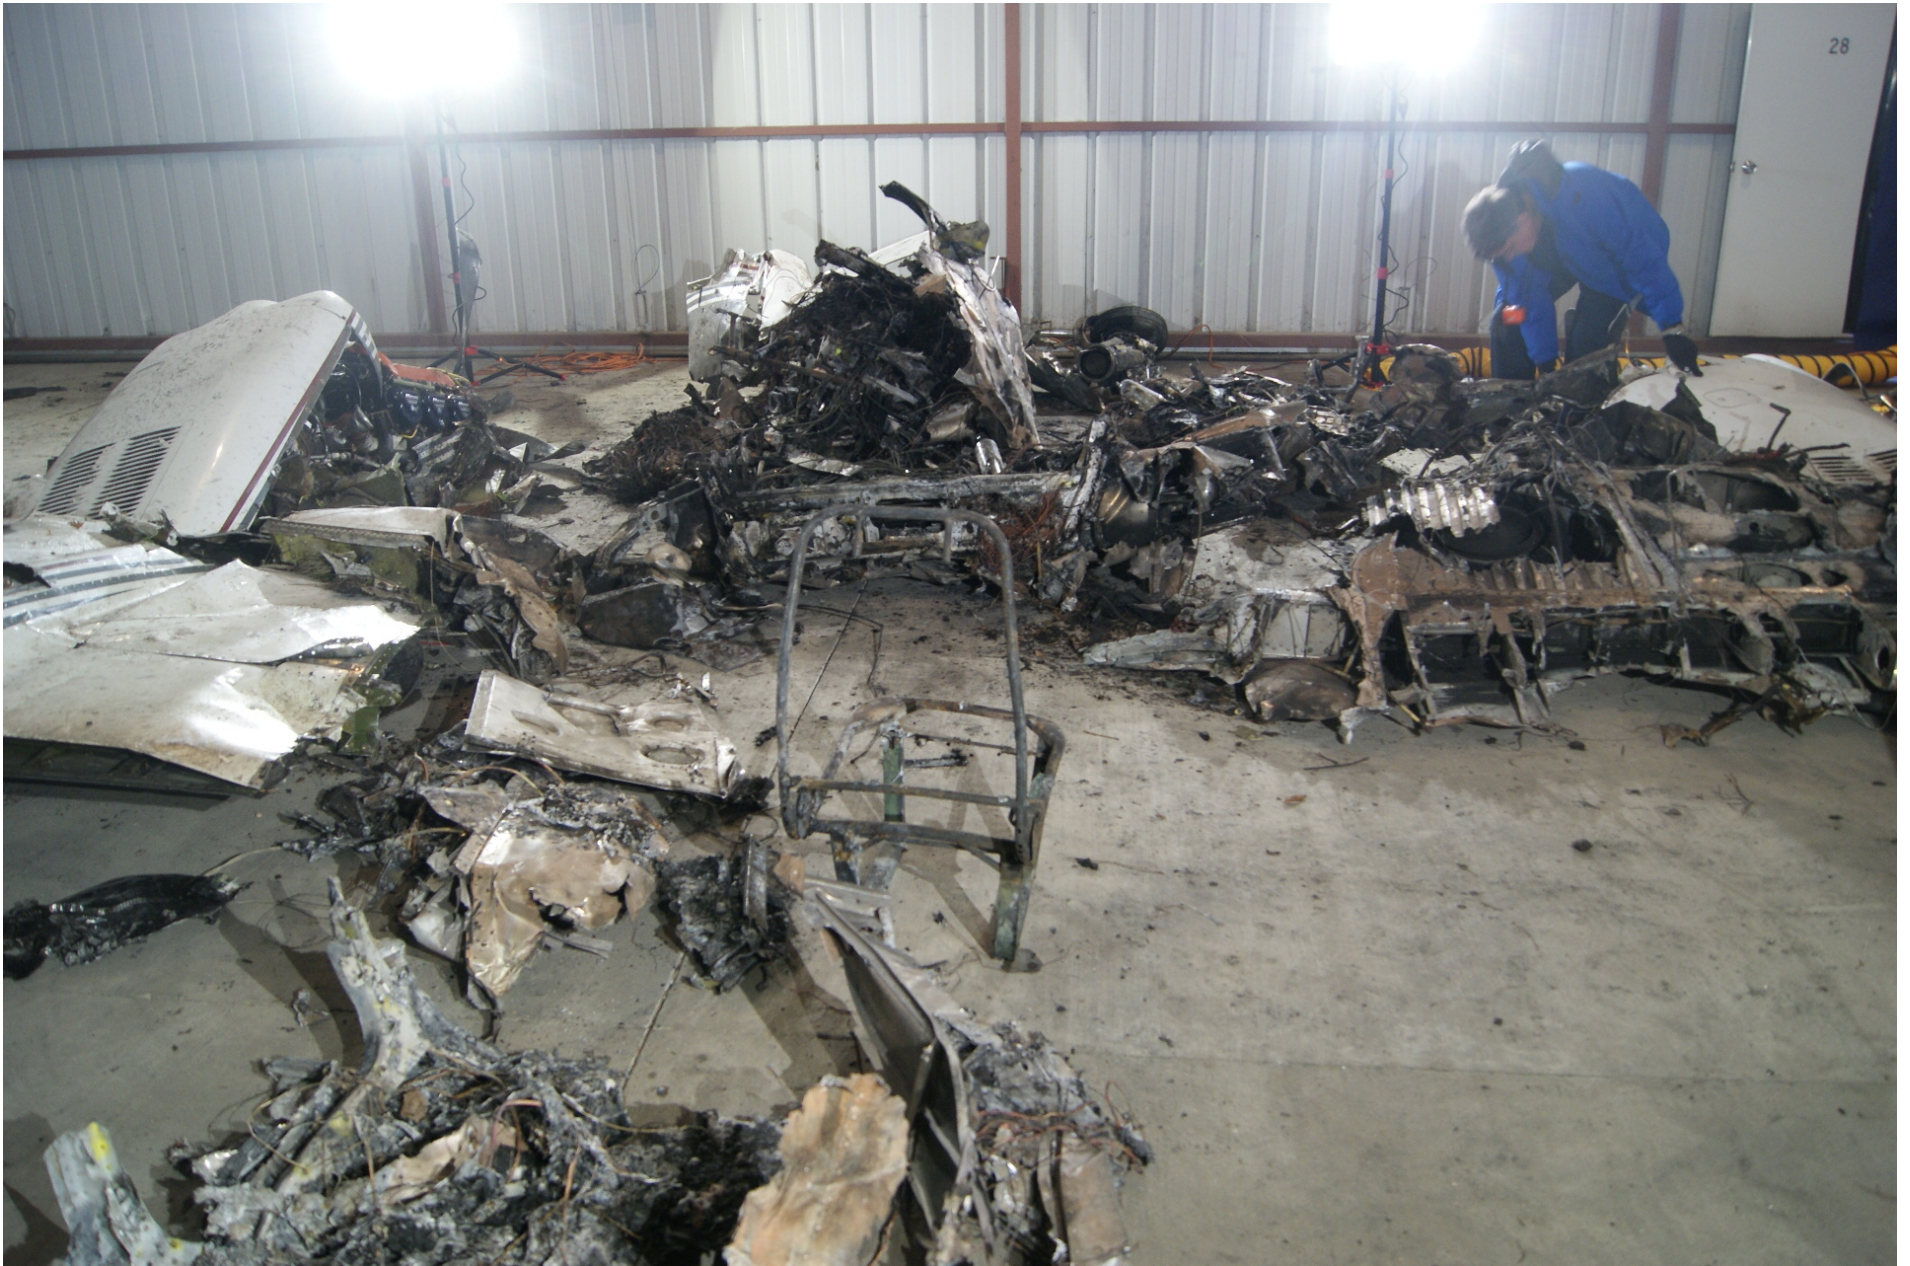
**Photo 12 – Wreckage layout, rear view.**
