## **Hartzell Propeller / Hartzell Engine Technologies** **Air Safety Investigator Examination Report**

NTSB File No. CEN17FA071

Aircraft: Cessna TTx (LC41-550FG), Registration N972JK

### **Propeller Examination**

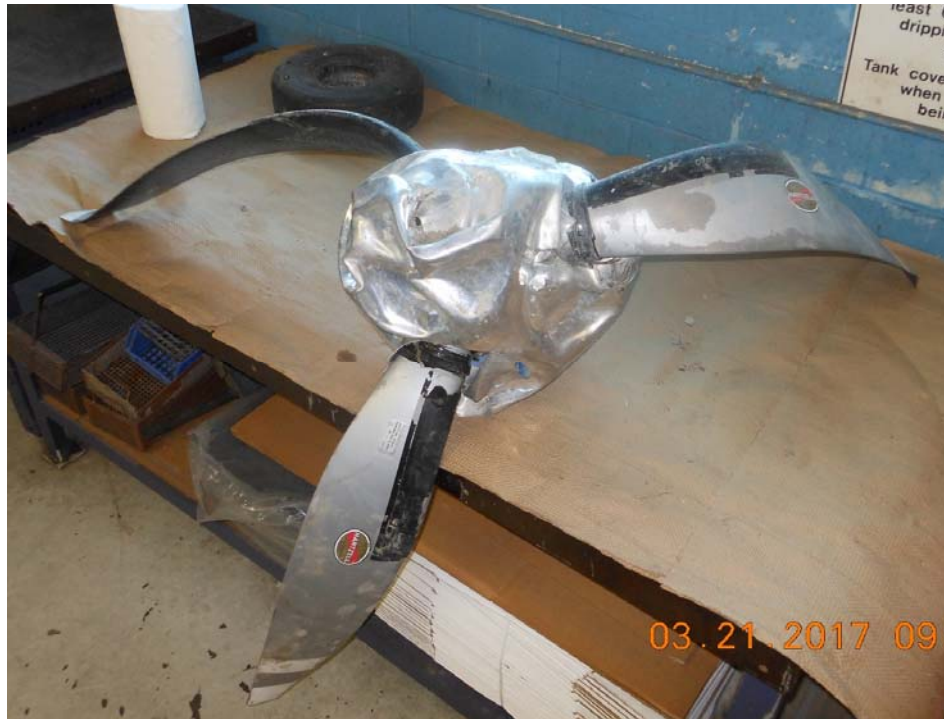
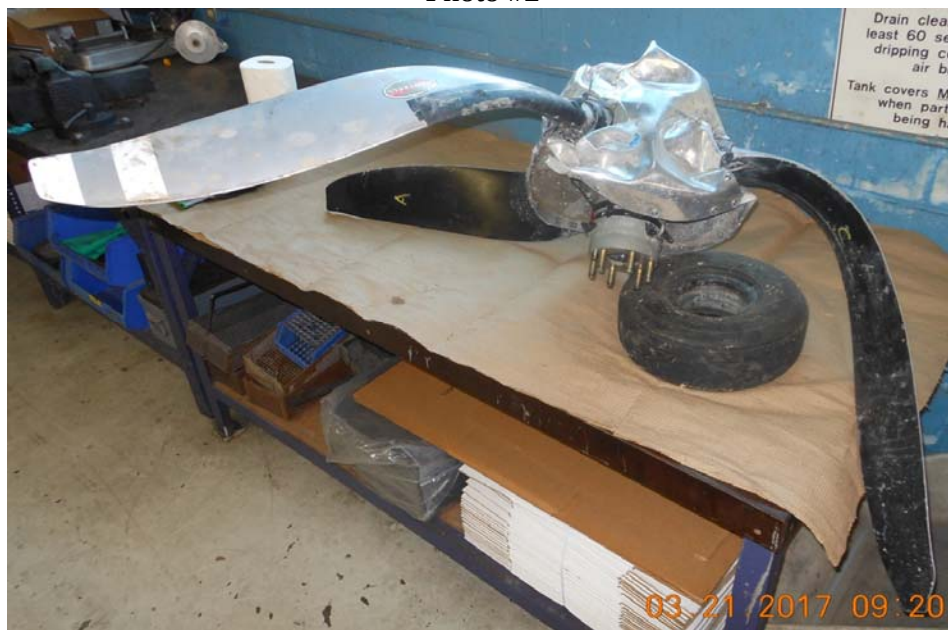
The propeller remained attached to the engine throughout the impact sequence and was removed prior to shipment to Continental Motors in Mobile, AL in the condition shown in Photos #1 and #2. Three blades were bent aft in varying degrees. The spinner dome was deformed around the propeller cylinder area and displayed rotational deformation characteristics. Two blades could be rotated by hand and one blade felt locked in position. The mounting flange and mounting hardware appeared undamaged.

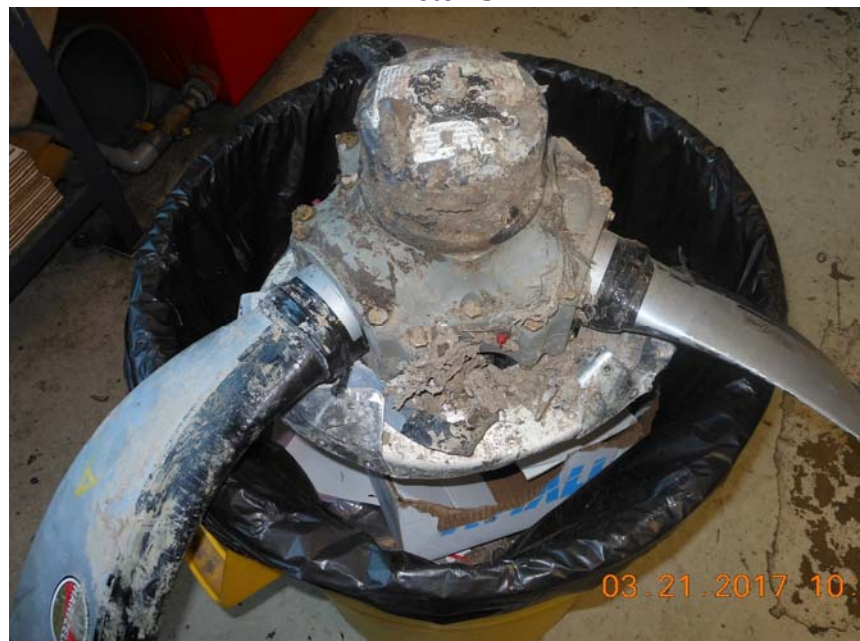
Photo #3

Upon separation of the hub halves it was evident that all three pitch change knobs fractured from their blade butts. There was also water in the hub cavity, again, presumably from pressure washing of the propeller during the recovery process. The #2 hub-side bearing race was fractured in the aft/trailing edge area. The propeller had been over-serviced with grease; there was grease in the area surrounding the fork.

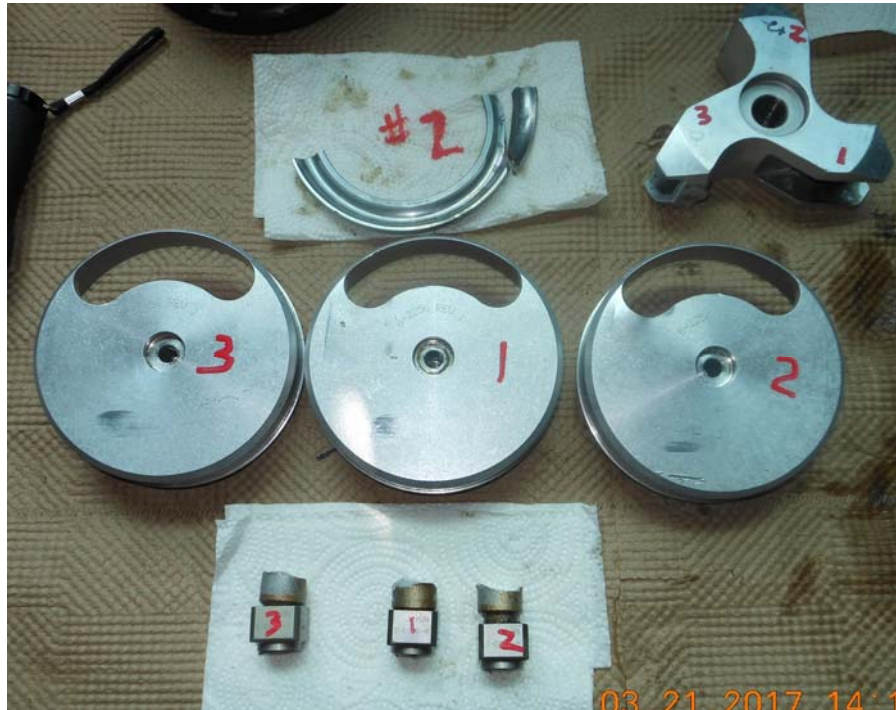
Photo #4

All three preload plates had damage at the forward/low pitch end of the knob slot and also rubbing damage on the internal surface consistent with pitch change knob fractures during impact. All three pitch change knob fracture surfaces appeared to be overload (see Photo #4).

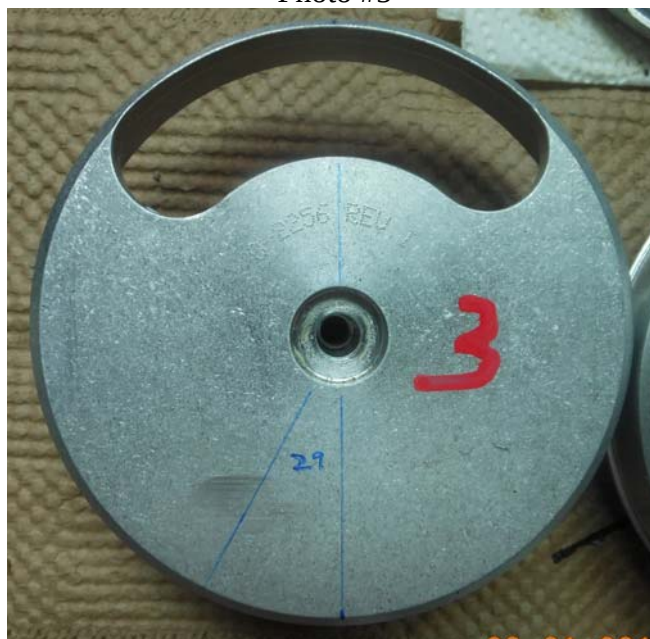
Photo #5

Preload plate #3 had a fork bumper rub area approximately 29 degrees forward of the hub parting line (see Photo #5). Preload plate #2 had a bumper rub mark at approximately 24 degrees (or 30 degrees if interpreting the hub parting line marks differently), (see Photo #6). Preload plate #3 had a noticeable fork bumper impression and fork scrape marks at approximately 16.5 degrees forward of the parting line (Photo #7). All the preload plate markings were in the normal range of operation.

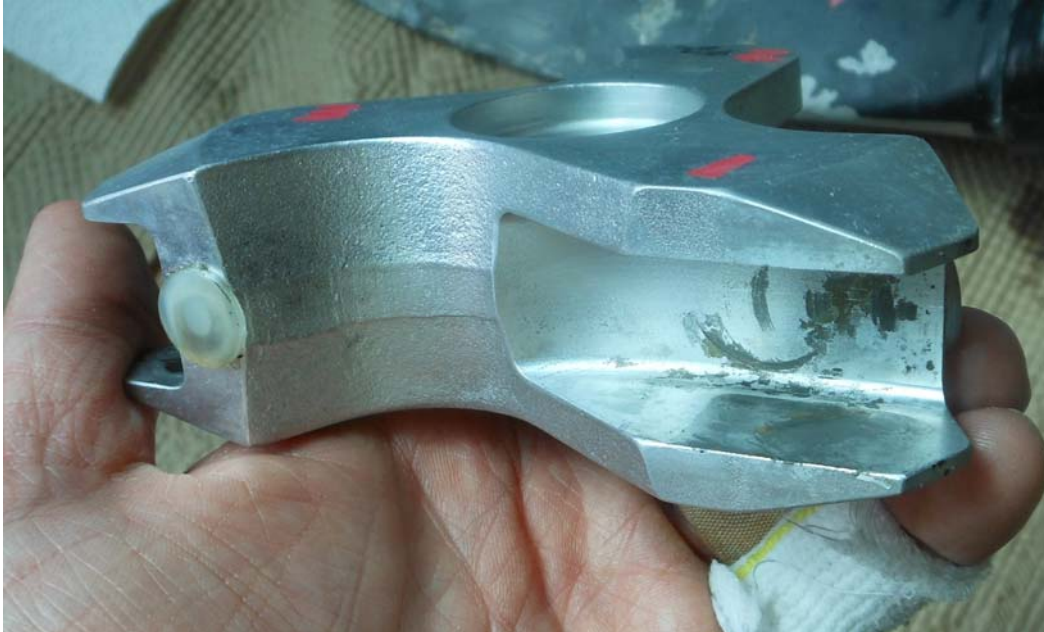
Photo #8

The pitch change fork had knob block skirt impact marks in all three slots (see Photo #8).

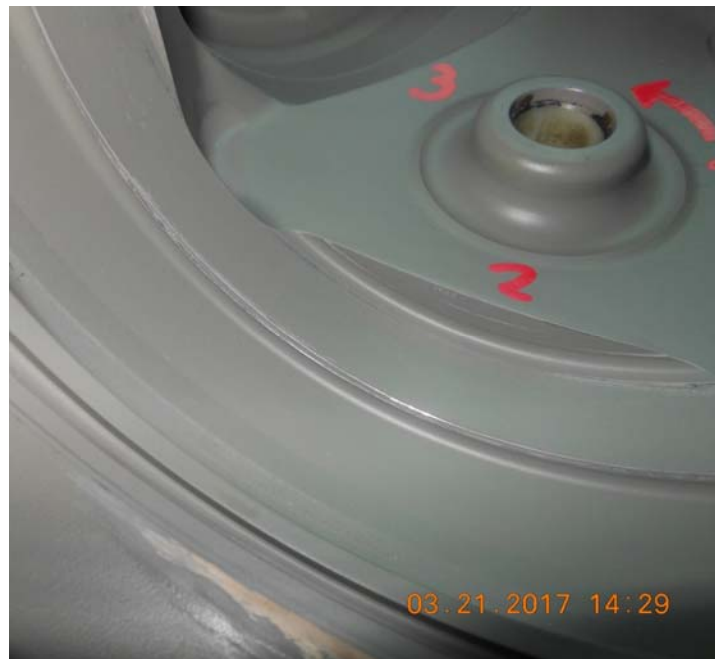
Photo #9

On the aft hub half there was preload plate area damage in blade pockets #2 and #3 (see Photo #9). All three blade pockets had blade contact marks at the aperture that with corresponding damage to the seal rub strip on the blade shanks.

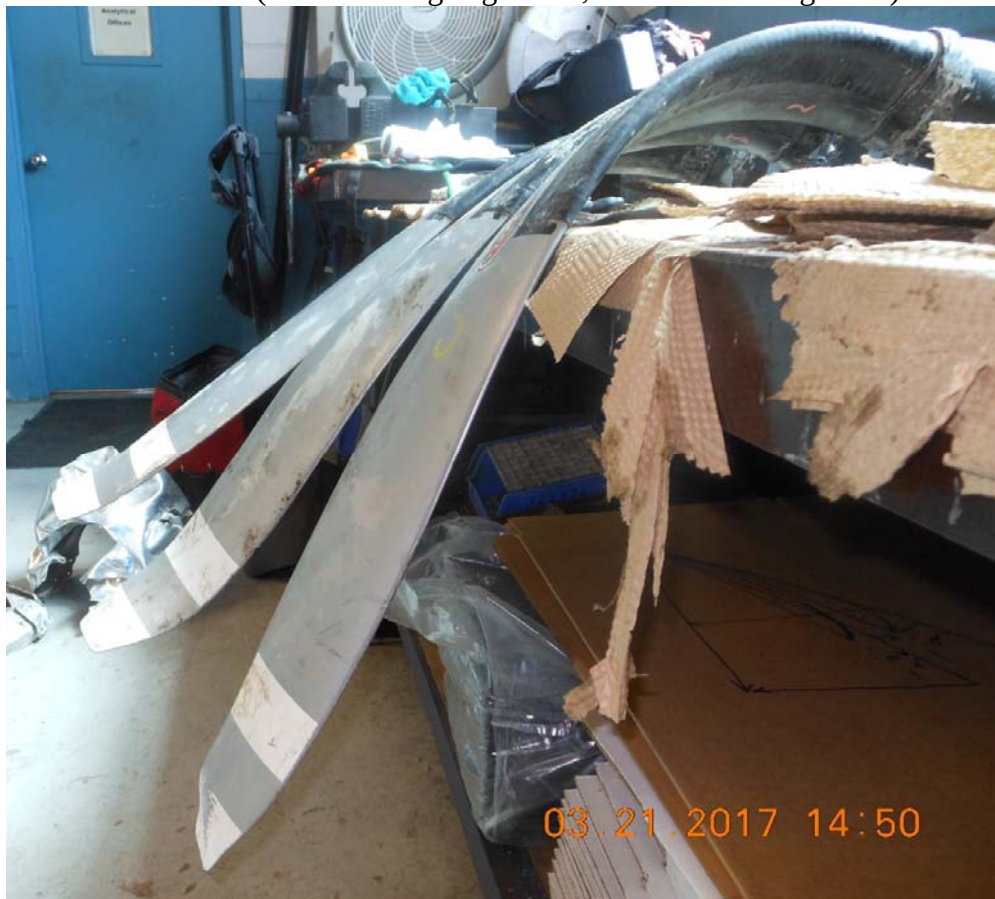
All three blades displayed bending in the aft direction. Blades #1 and #2 showed twisting in the leading edge down/low pitch direction. The blades were positioned in rotation sequence 3-1-2 which demonstrated the progressive aft bending (Photo #10). The tip on blade #1 was bent forward and the tip on blade #2 was bent aft. There were nicks and dents 8-10" from the tips of blades #1 and #2. The blade leading edge and tip areas showed some accelerated abrasion on the camber side near the tip consistent with rotation through rock free water, mud and/or dirt. Photos #10 through #12 shows the blades in 3-1-2 sequence from left to right.

Photo #10 (Blade leading edge view, blade #2 in foreground)

Preload plate impact marks indicated the propeller was operating in the normal blade angle range at time of impact. Blade bending and twisting was suggested a low power and/or windmilling at high airspeed condition at time of impact. There were no discrepancies noted that would prevent or degrade normal propeller operation prior to impact. All damage was consistent with high impact forces.

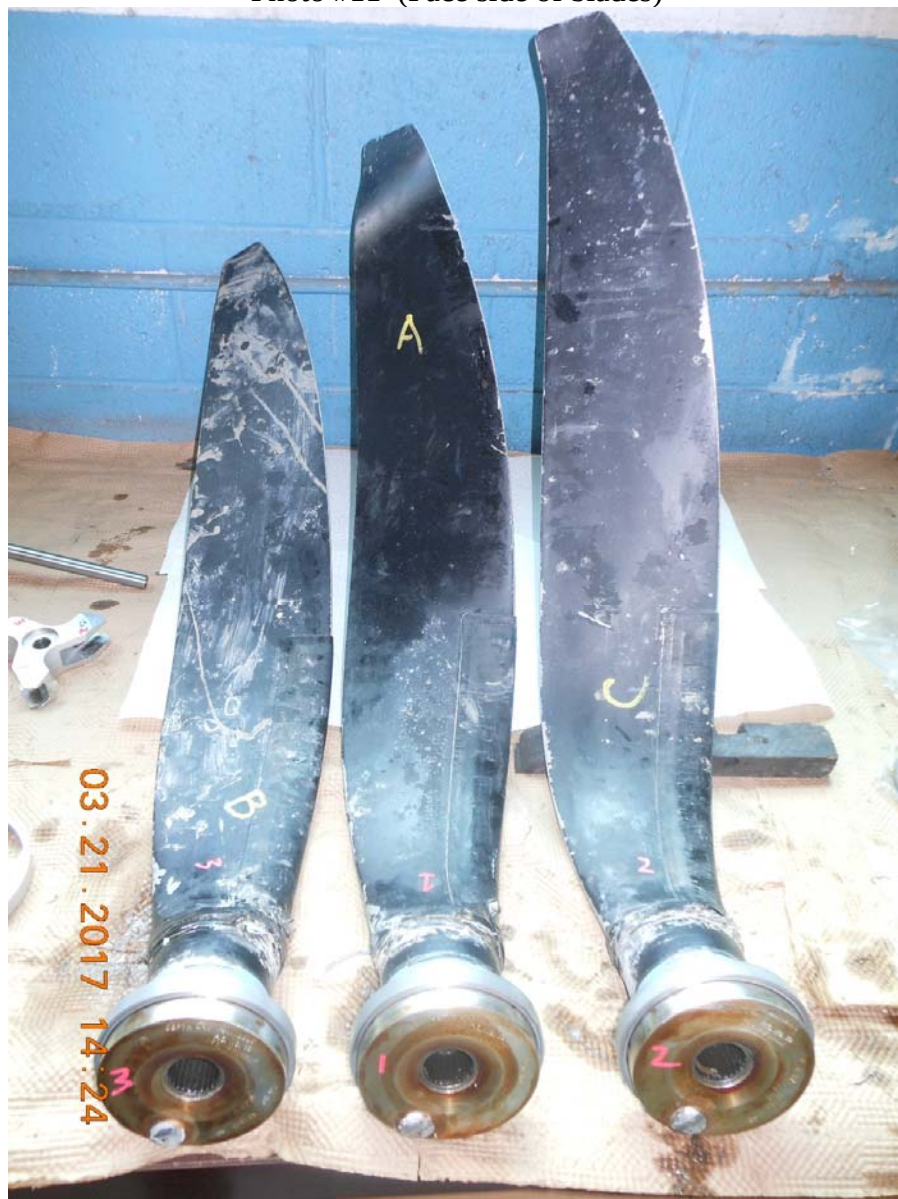
Photo #11 (Face side of blades)

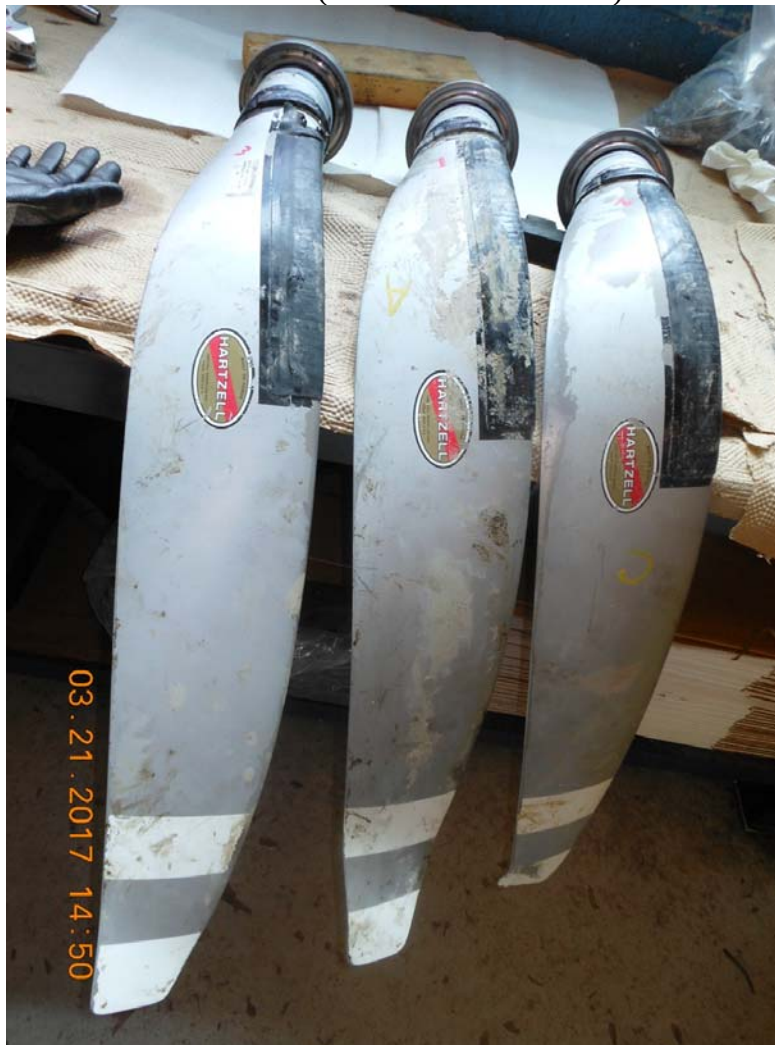
Photo #12 (Camber side of blades)

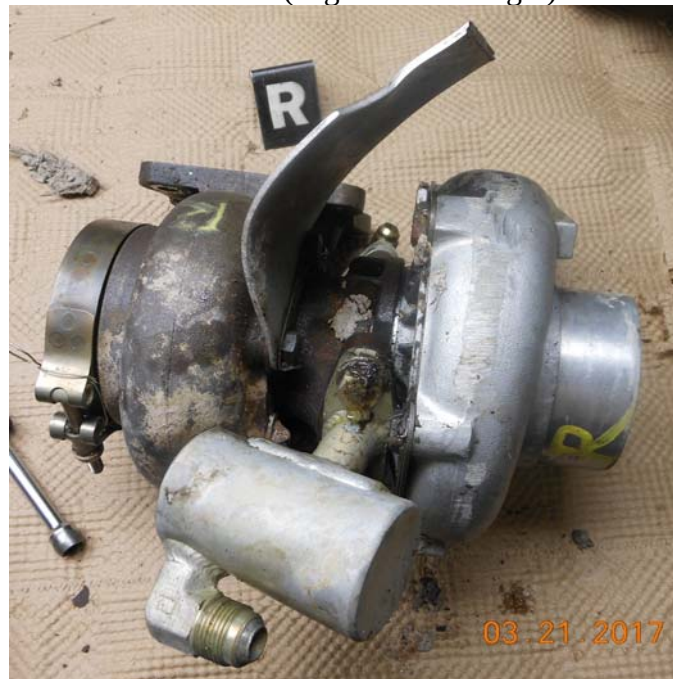
Photo #13 (Right Turbocharger)

1. The turbocharger was found fractured from its mounts at the crash site, was packed full of mud and cleaned with a pressure washer according to on-scene investigators. The exhaust pipe and intake tube were removed prior to this examination. A portion of the mounting bracket remained attached to the turbocharger (see Photo #13). The compressor housing was bent and impinging on the compressor wheel. The compressor housing inlet had a dent on the outermost lip/edge.

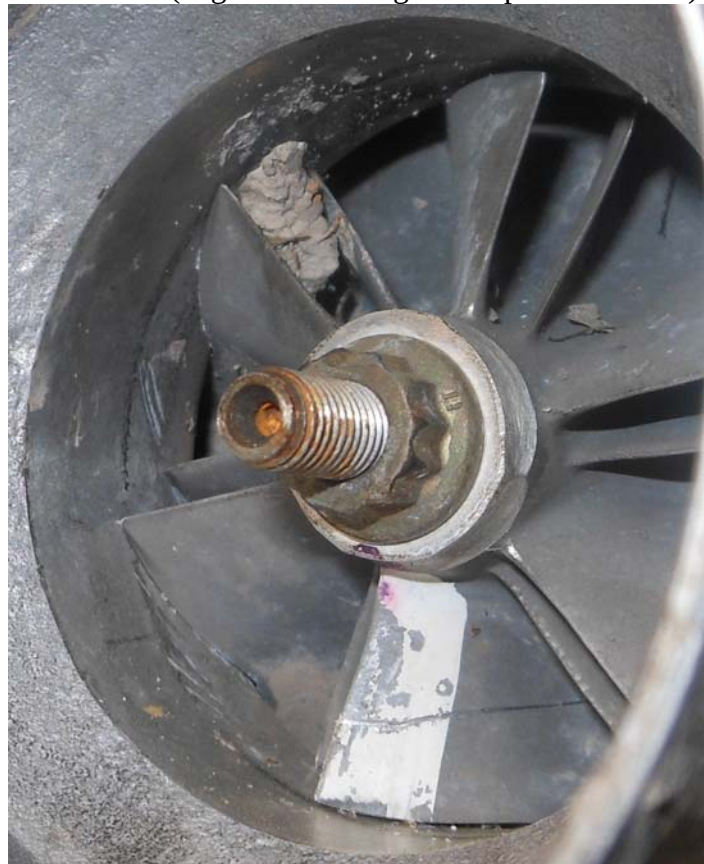
4. There was evidence of compressor wheel rub/contact/chatter on the compressor housing (see Photo #14). There was no evidence of rub or contact of the turbine wheel/housing.

Photo #14 (Right Turbocharger Compressor Wheel)

The right turbocharger compressor housing was bent during impact and impinging on the compressor wheel preventing rotation. There were contact/chatter/rub marks in the compressor housing suggesting rotation at low speed prior to impact, suggesting a low power condition at time of impact.

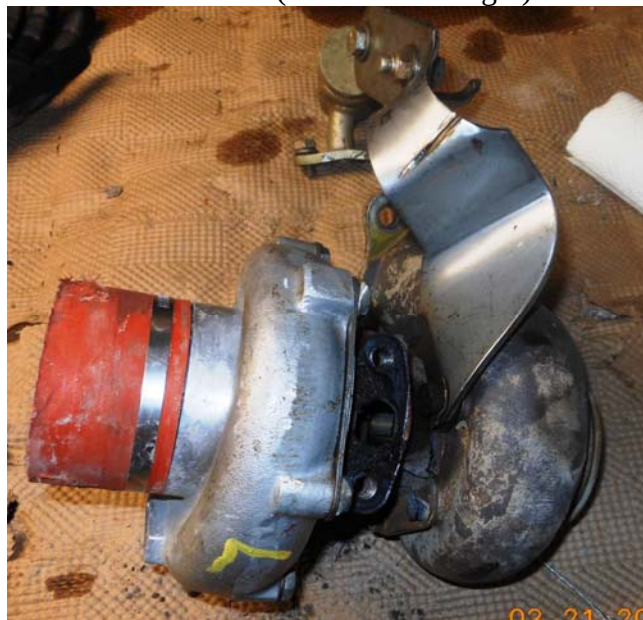
1. The turbocharger was found fractured from its mounts at the crash site, was packed full of mud and cleaned with a pressure washer according to on-scene investigators. The exhaust pipe and most of the intake tube were removed prior to this examination; a small segment of the intake tube remained attached. The mounting bracket remained attached to the turbocharger but had a cut mark partially through it, presumably made during the recovery process (see Photo #15). The compressor housing inlet had a portion of the outermost lip/edge fractured and missing.

Photo #15 (Left Turbocharger)

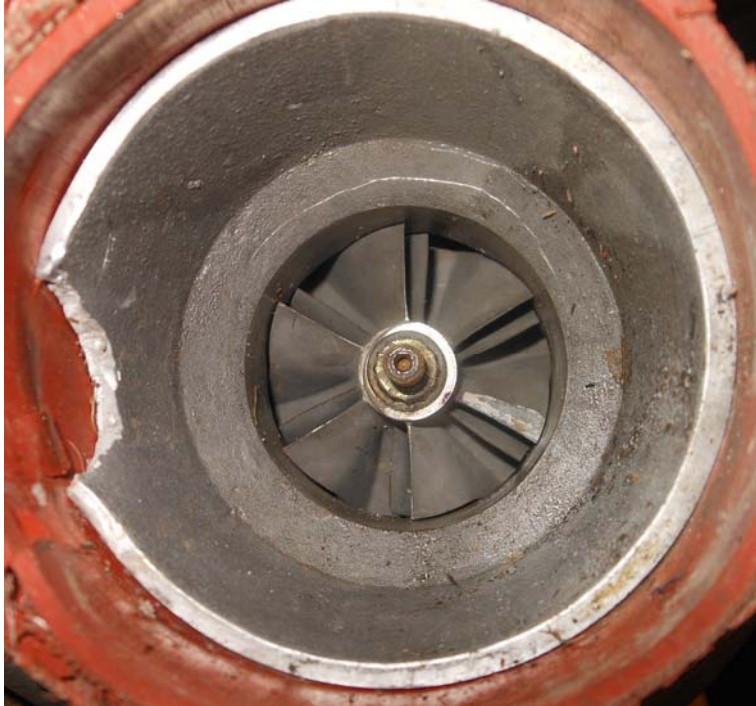
2. The rotor group was intact and turned freely by finger force only.
3. There were balance cuts observed on the turbine wheel/hub.
4. There was no evidence of compressor wheel rub/contact on the compressor housing (see Photo #16). There was no evidence of rub or contact of the turbine wheel/housing.

Photo #16 (Left Turbocharger Compressor Inlet)

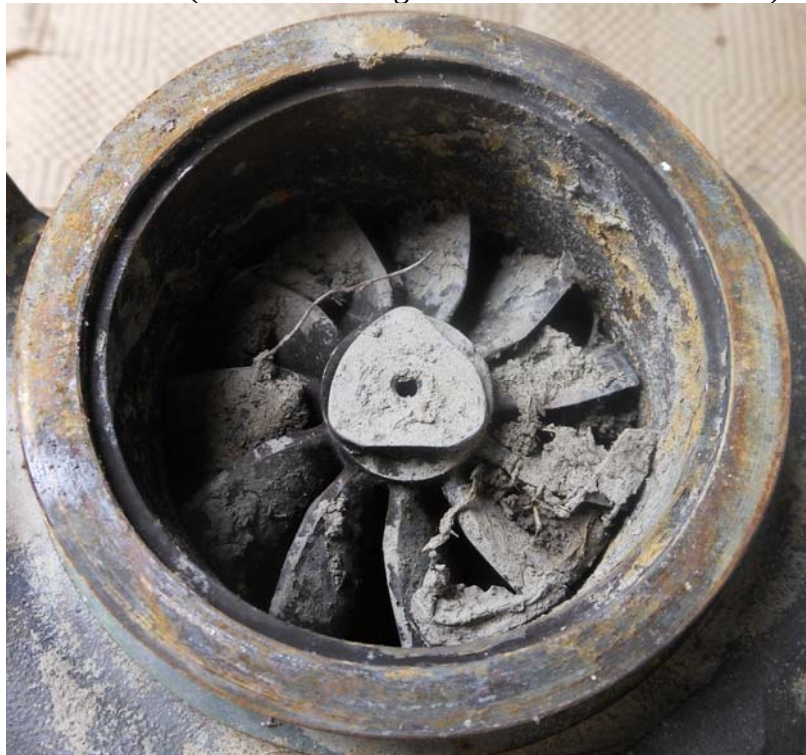
5. There was no remarkable FOD damage observed on either the compressor or turbine side.
6. The turbine housing outlet still had considerable dried mud on and around the turbine wheel.

Photo #17 (Left Turbocharger Turbine Wheel and outlet)
