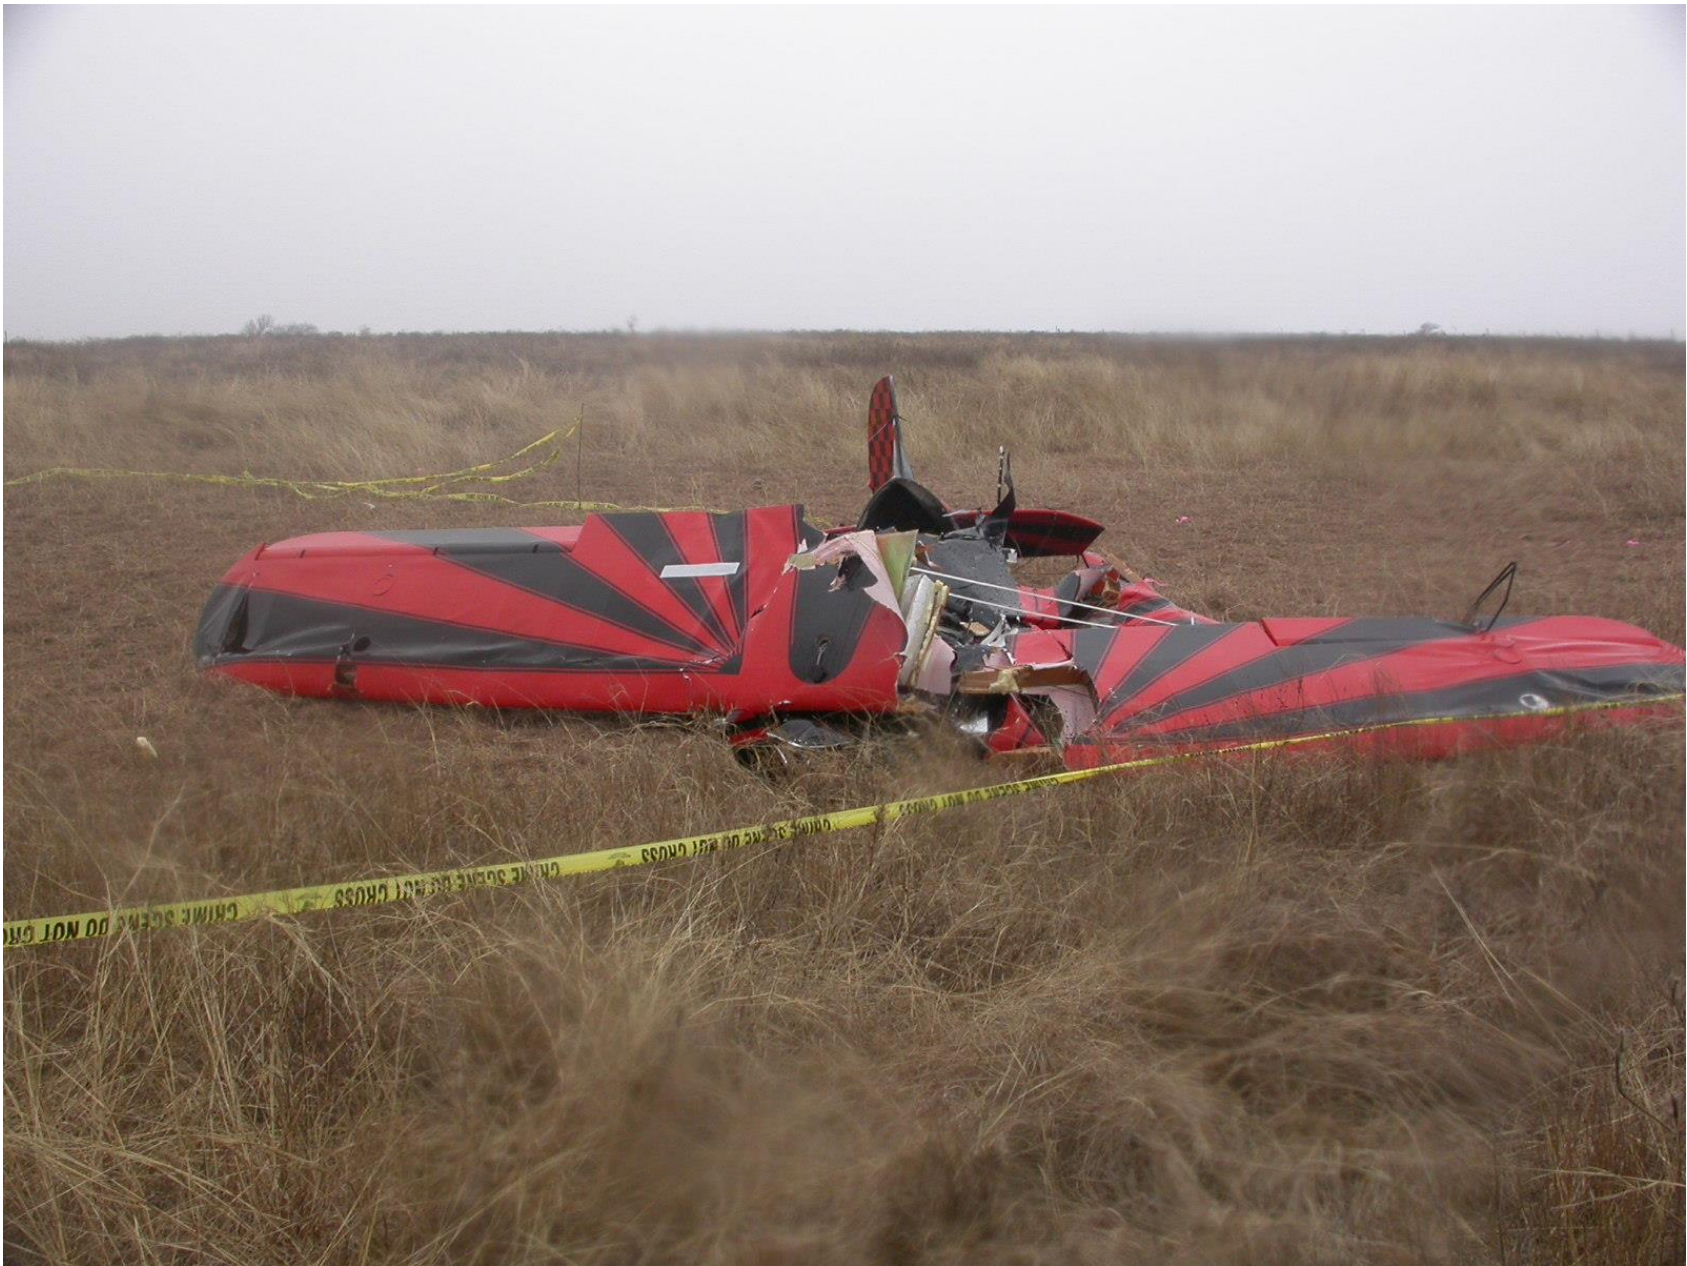
**Photo 1 – View of the wreckage from the front of the aircraft**

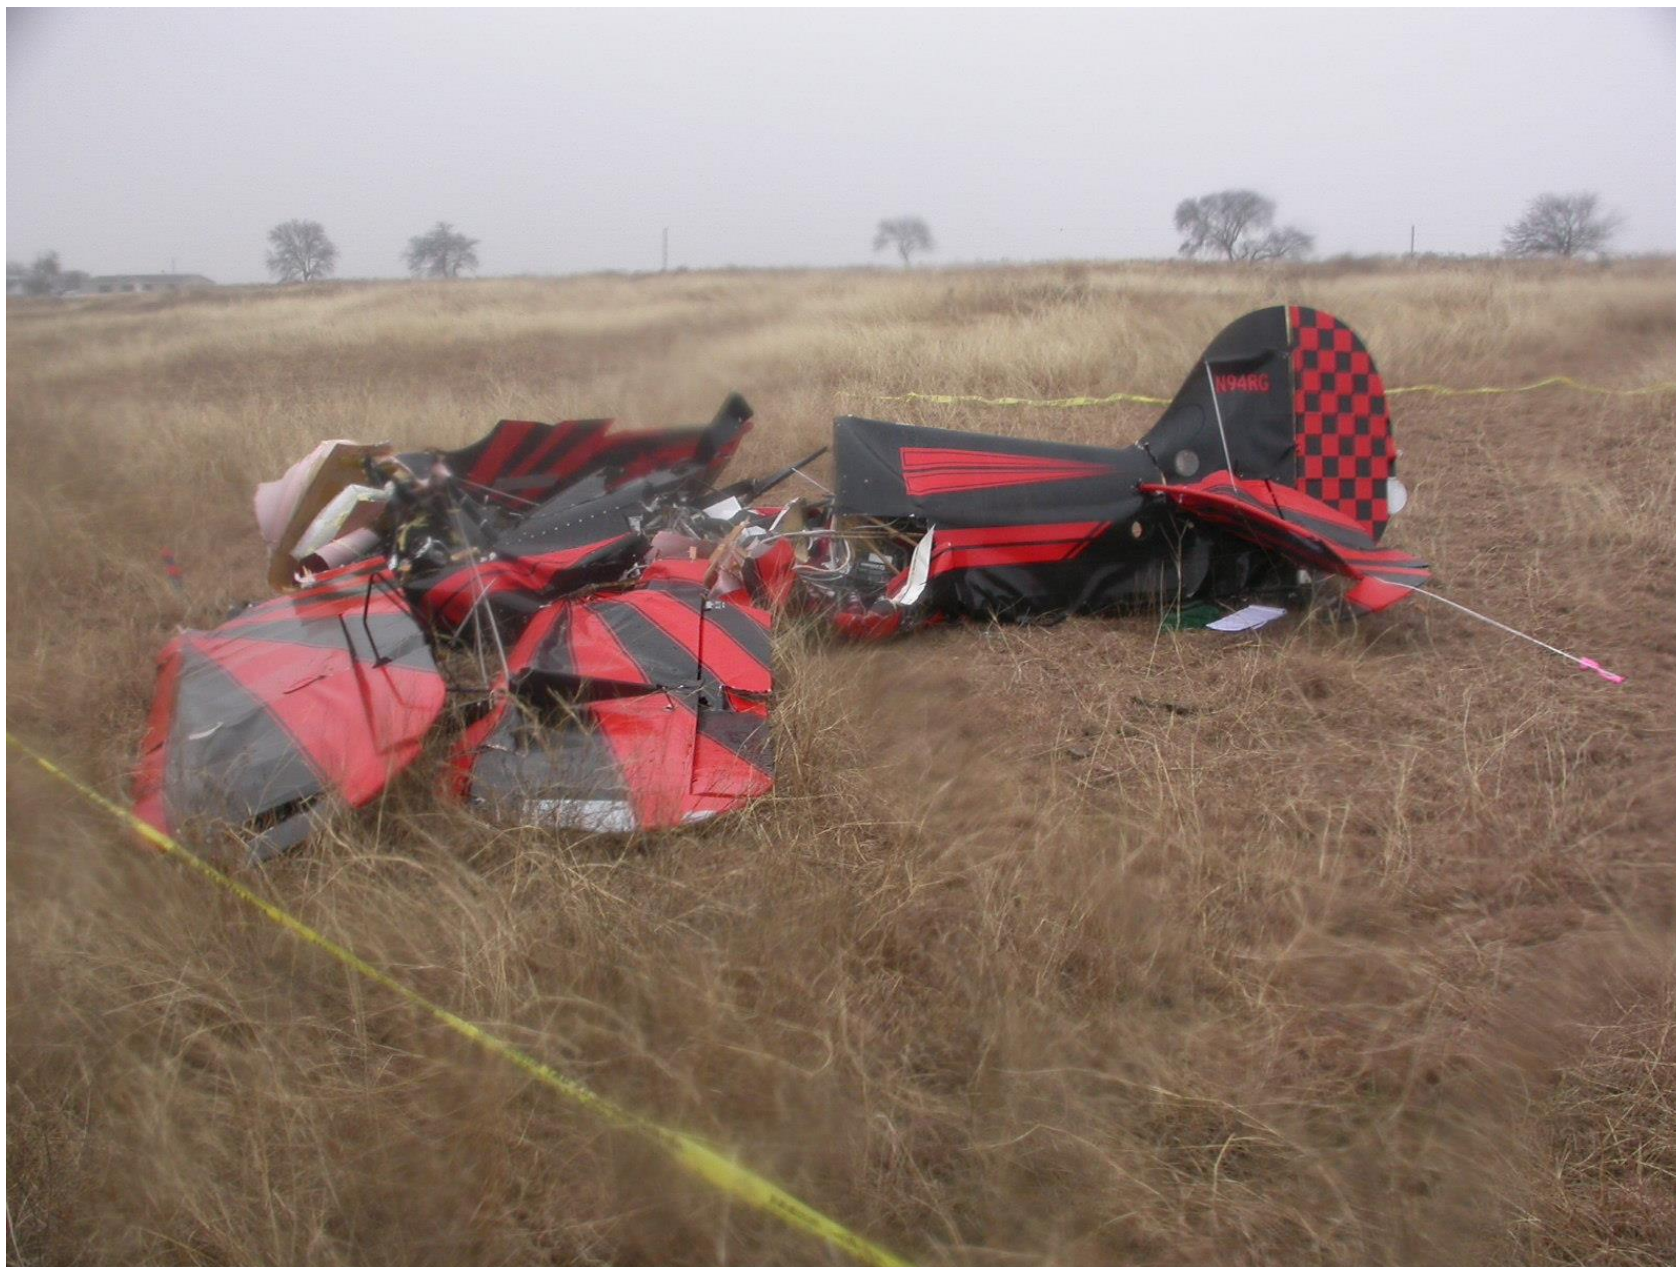
**Photo 2 – View of the left side of the aircraft**

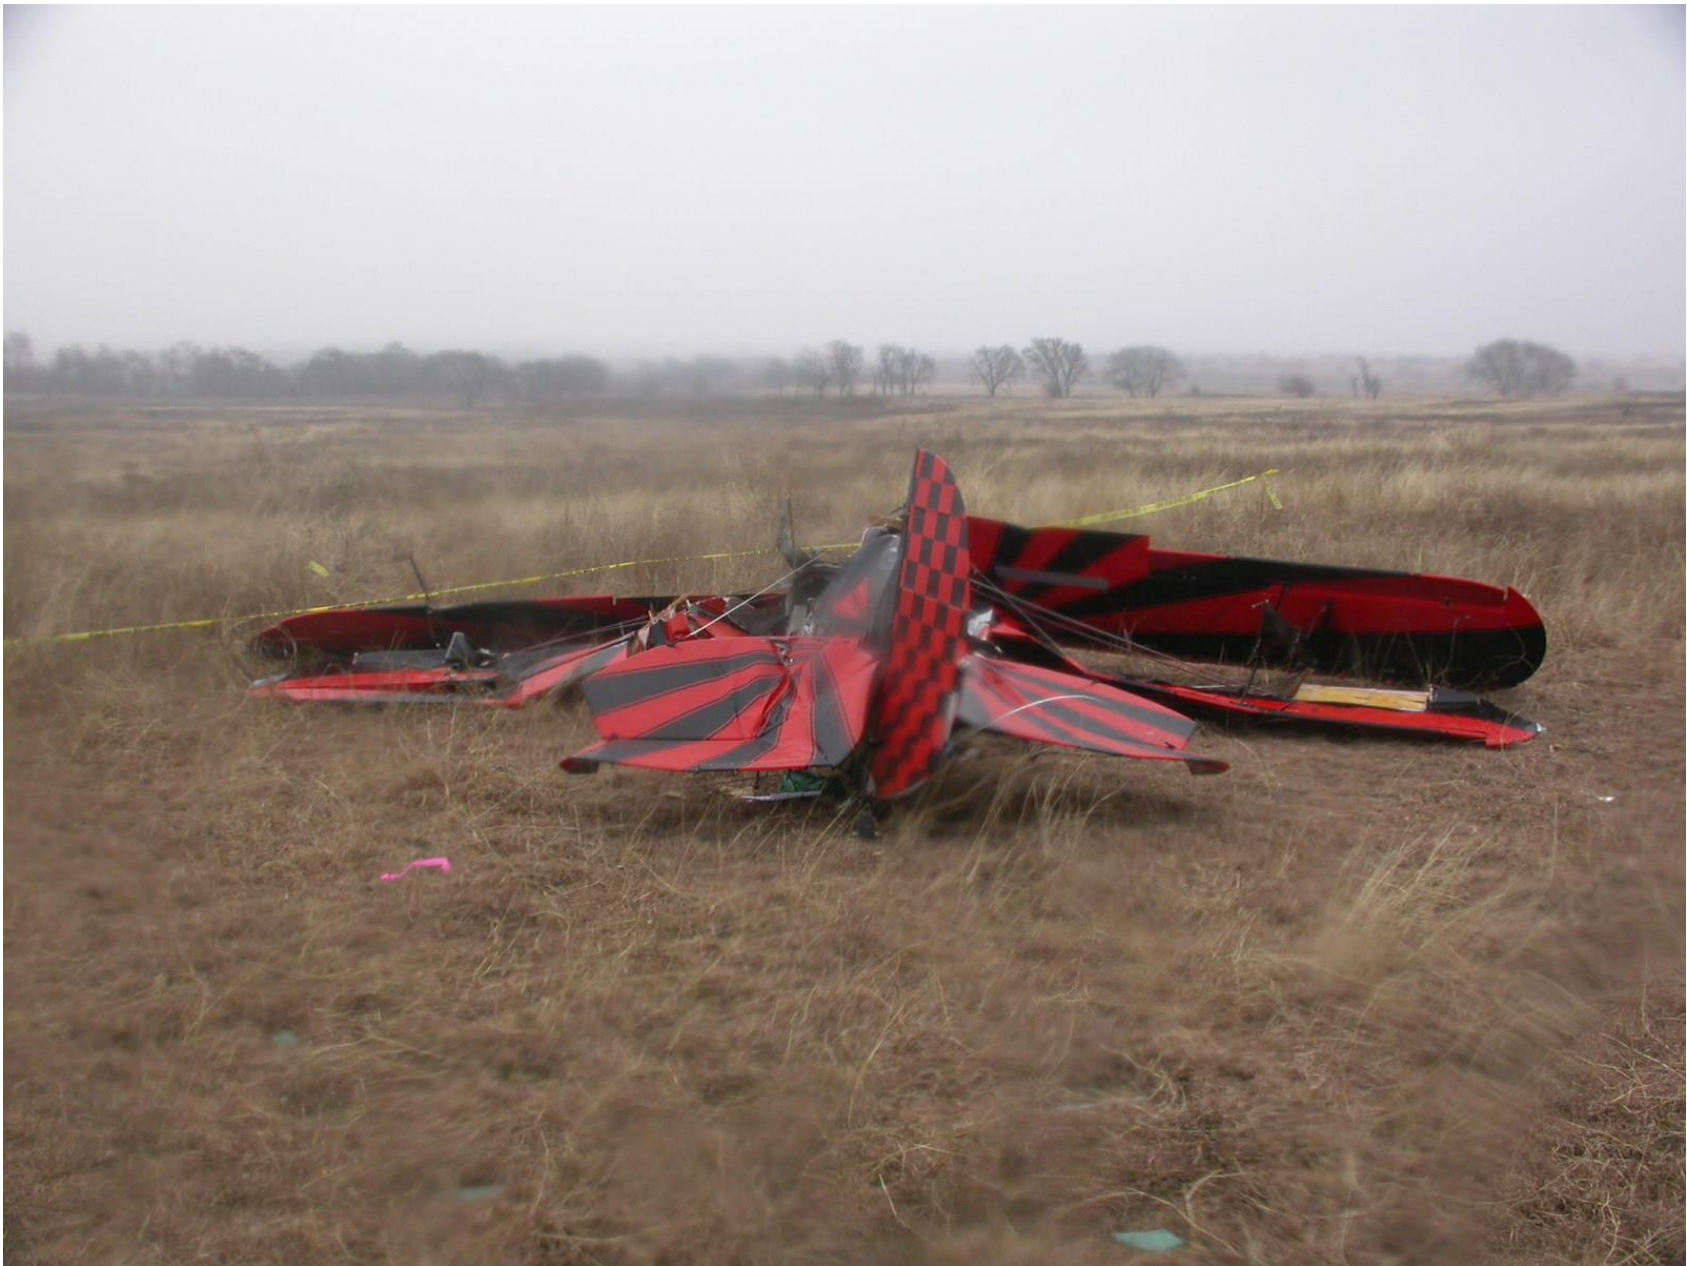
**Photo 3 – View of the wreckage from the rear of the aircraft**

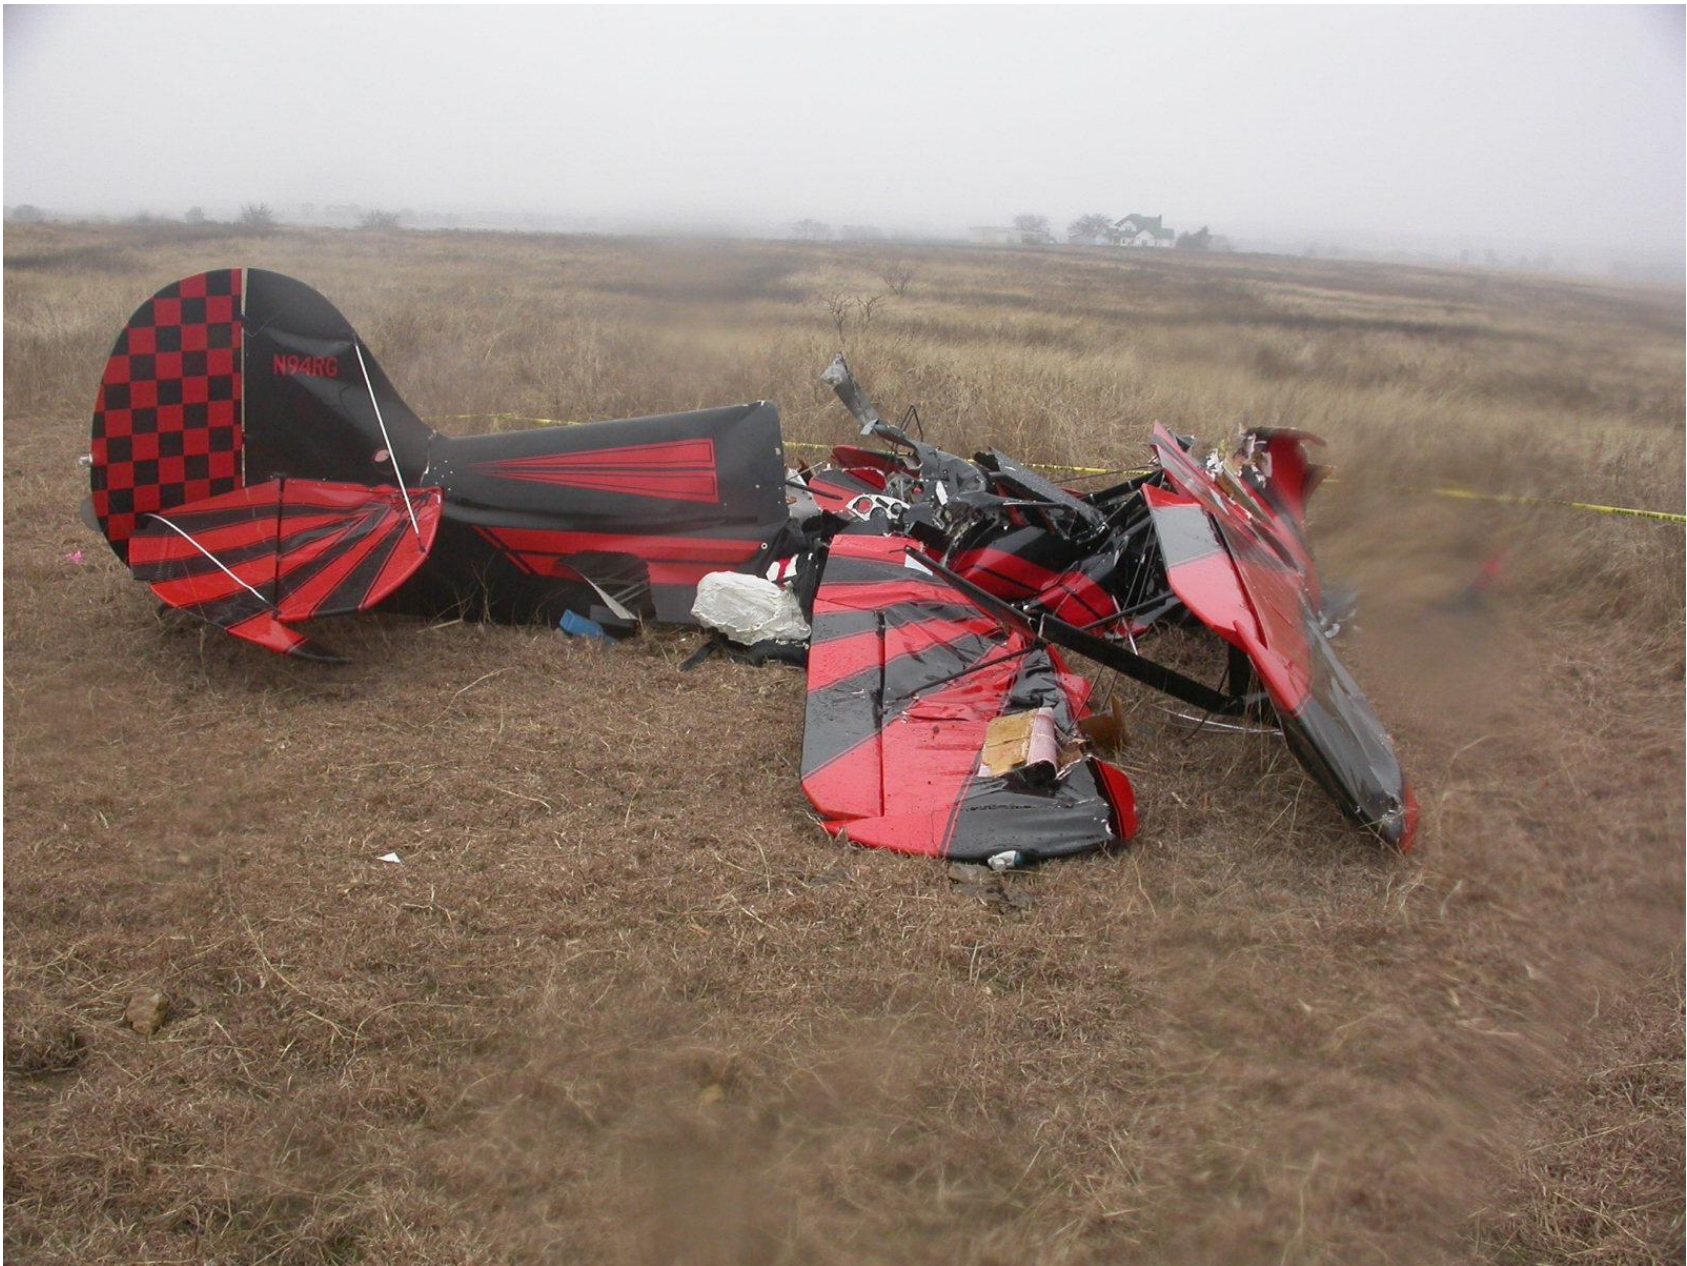
**Photo 4 – View of the wreckage from the right of the aircraft**

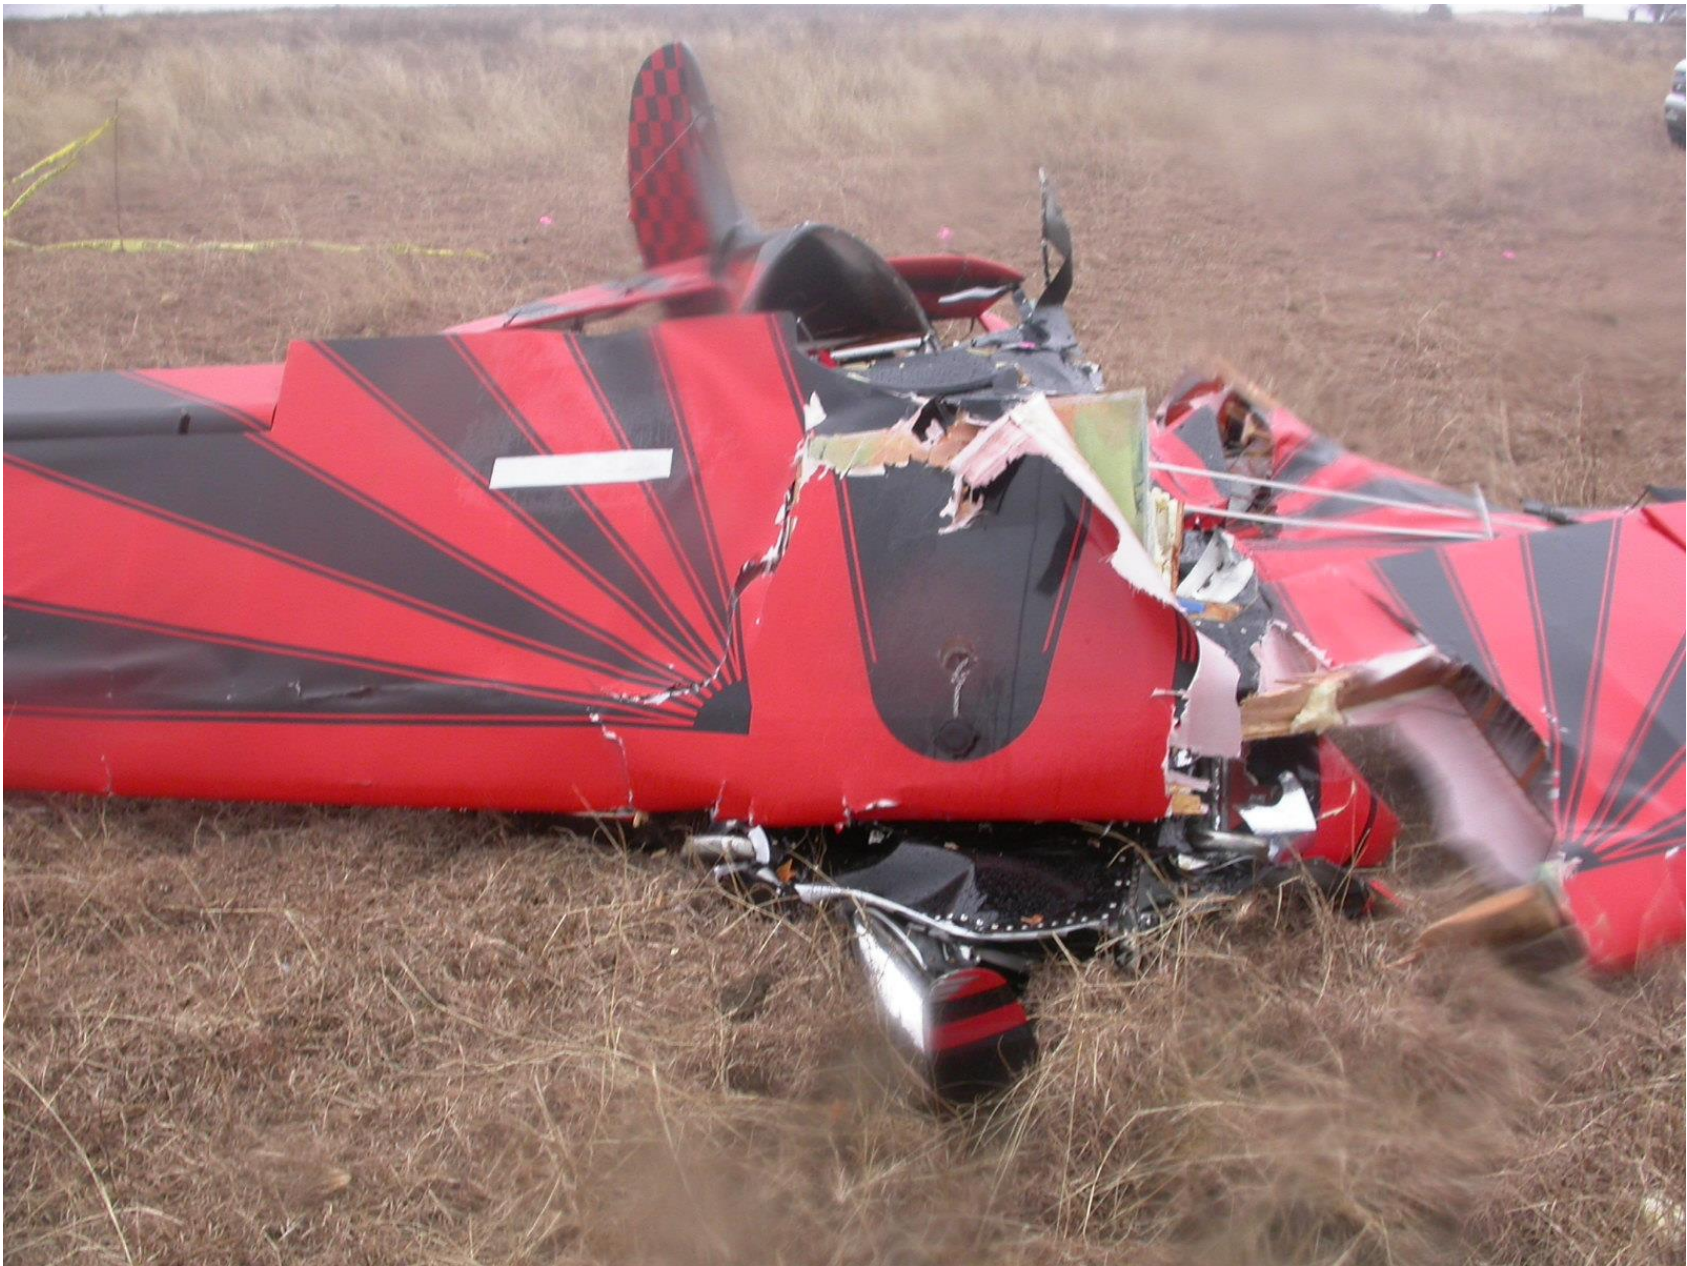
**Photo 5 – View of one of the propeller blades that is visible at the accident site**

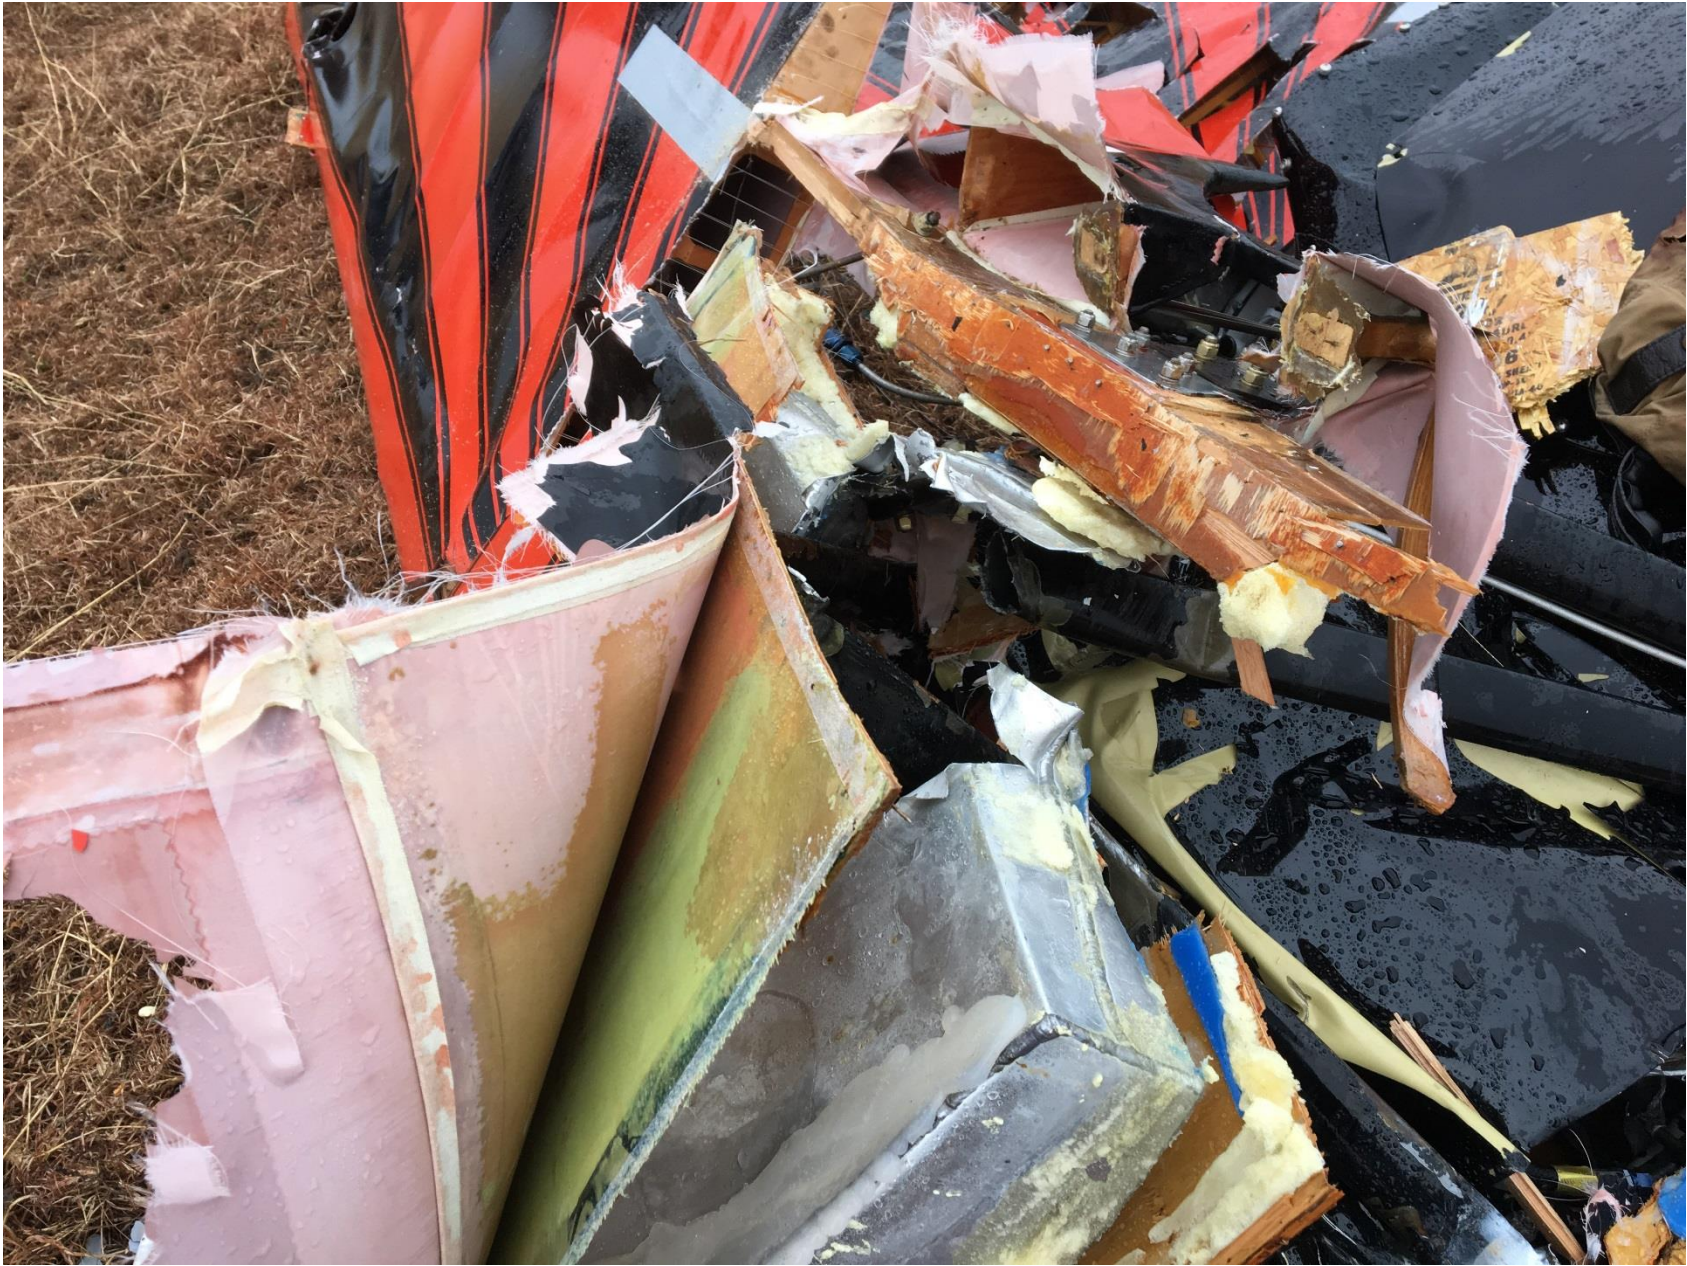
**Photo 6 – View of the rear wing spar separated from the middle wing section**

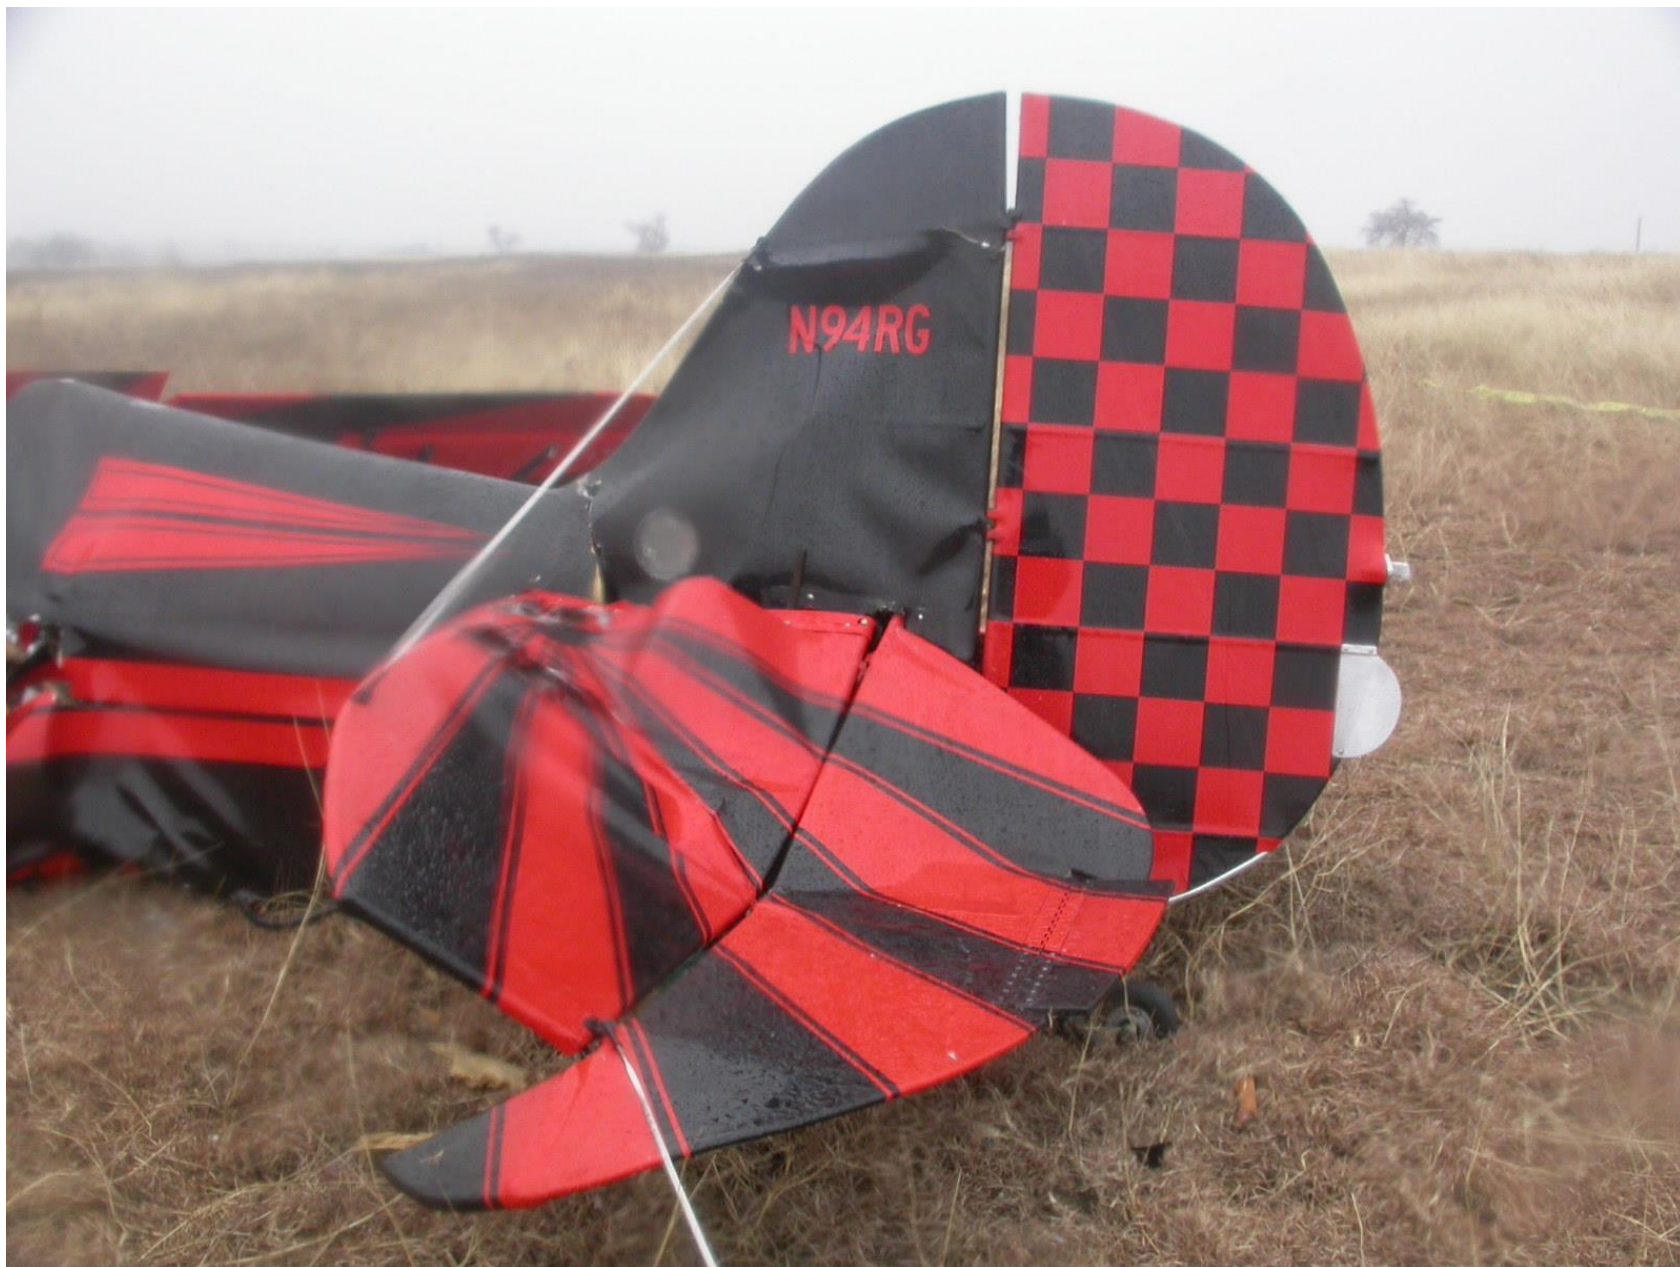
**Photo 7 – View of the left side of the empennage**

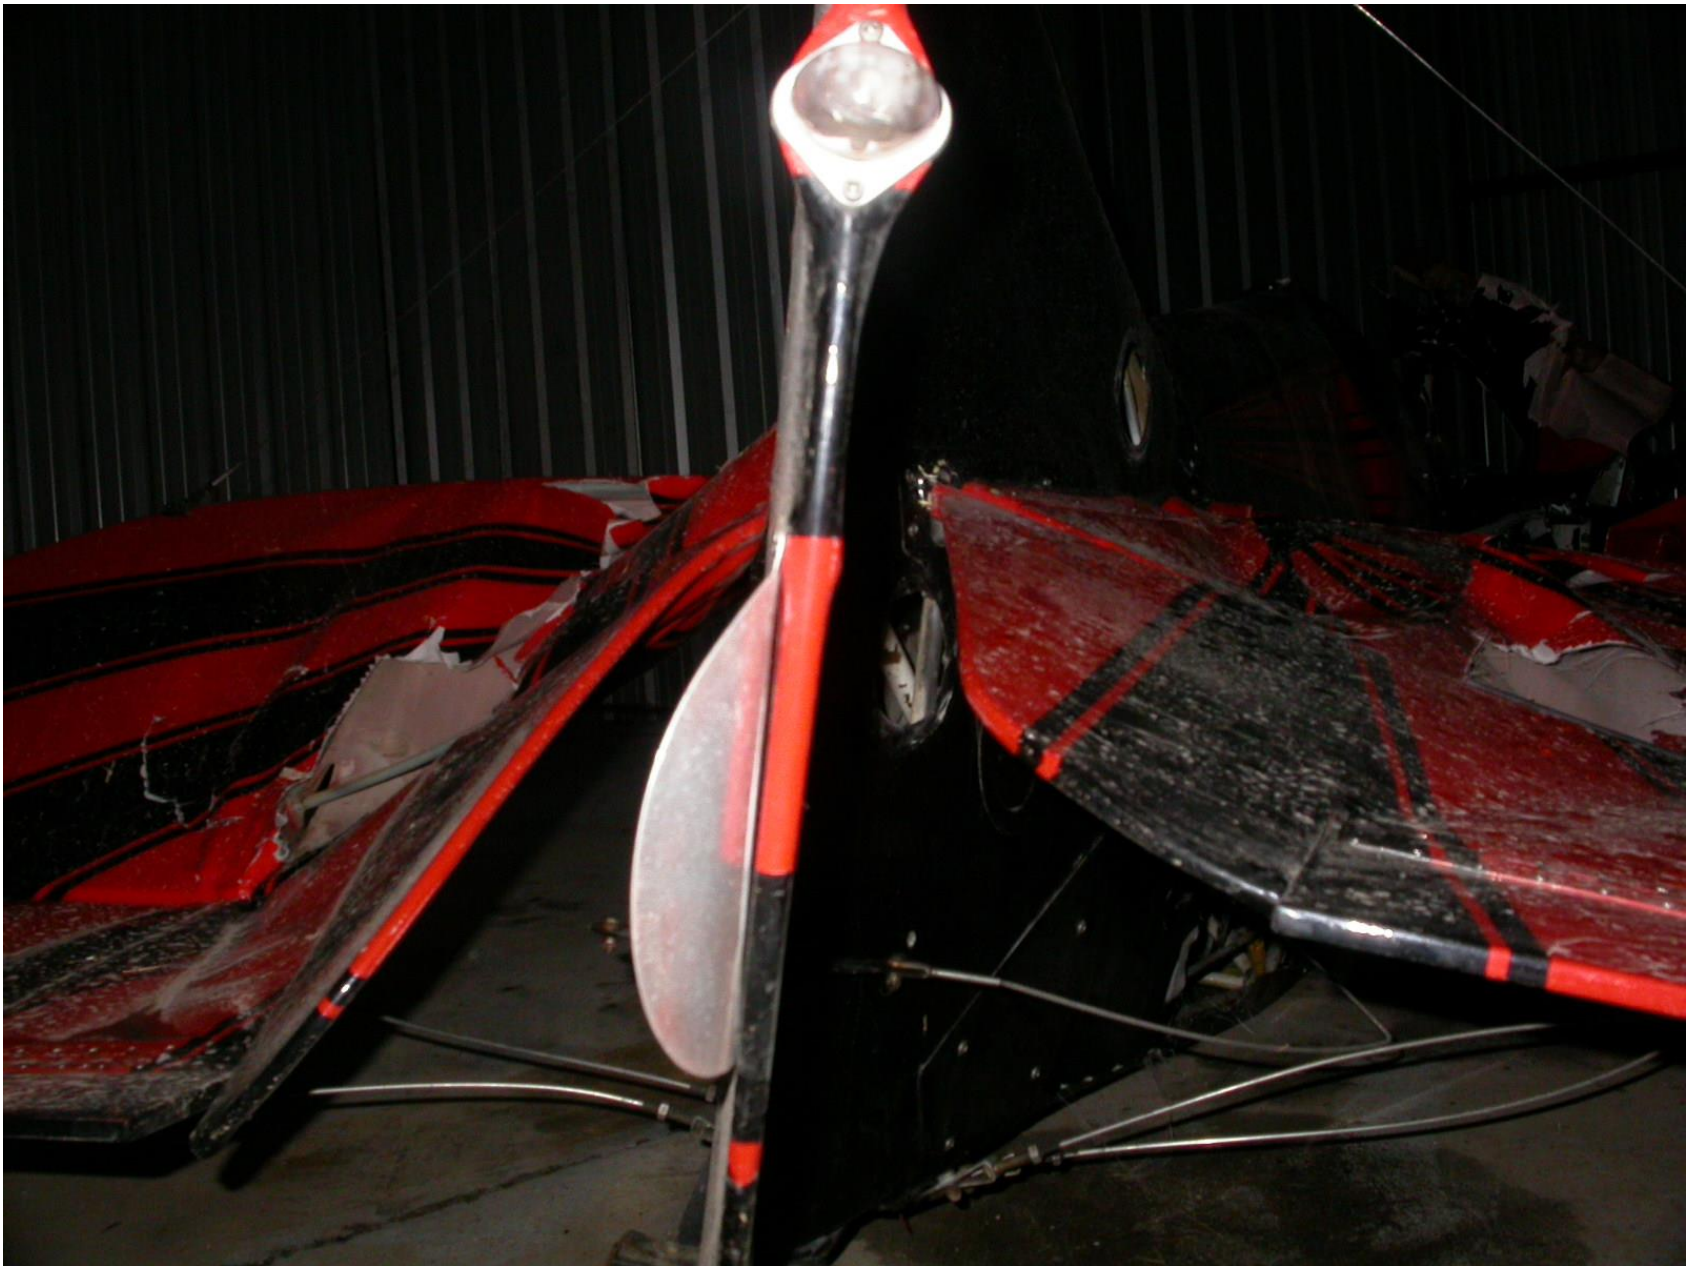
**Photo 8 – Close-up view of the rudder trim tab**

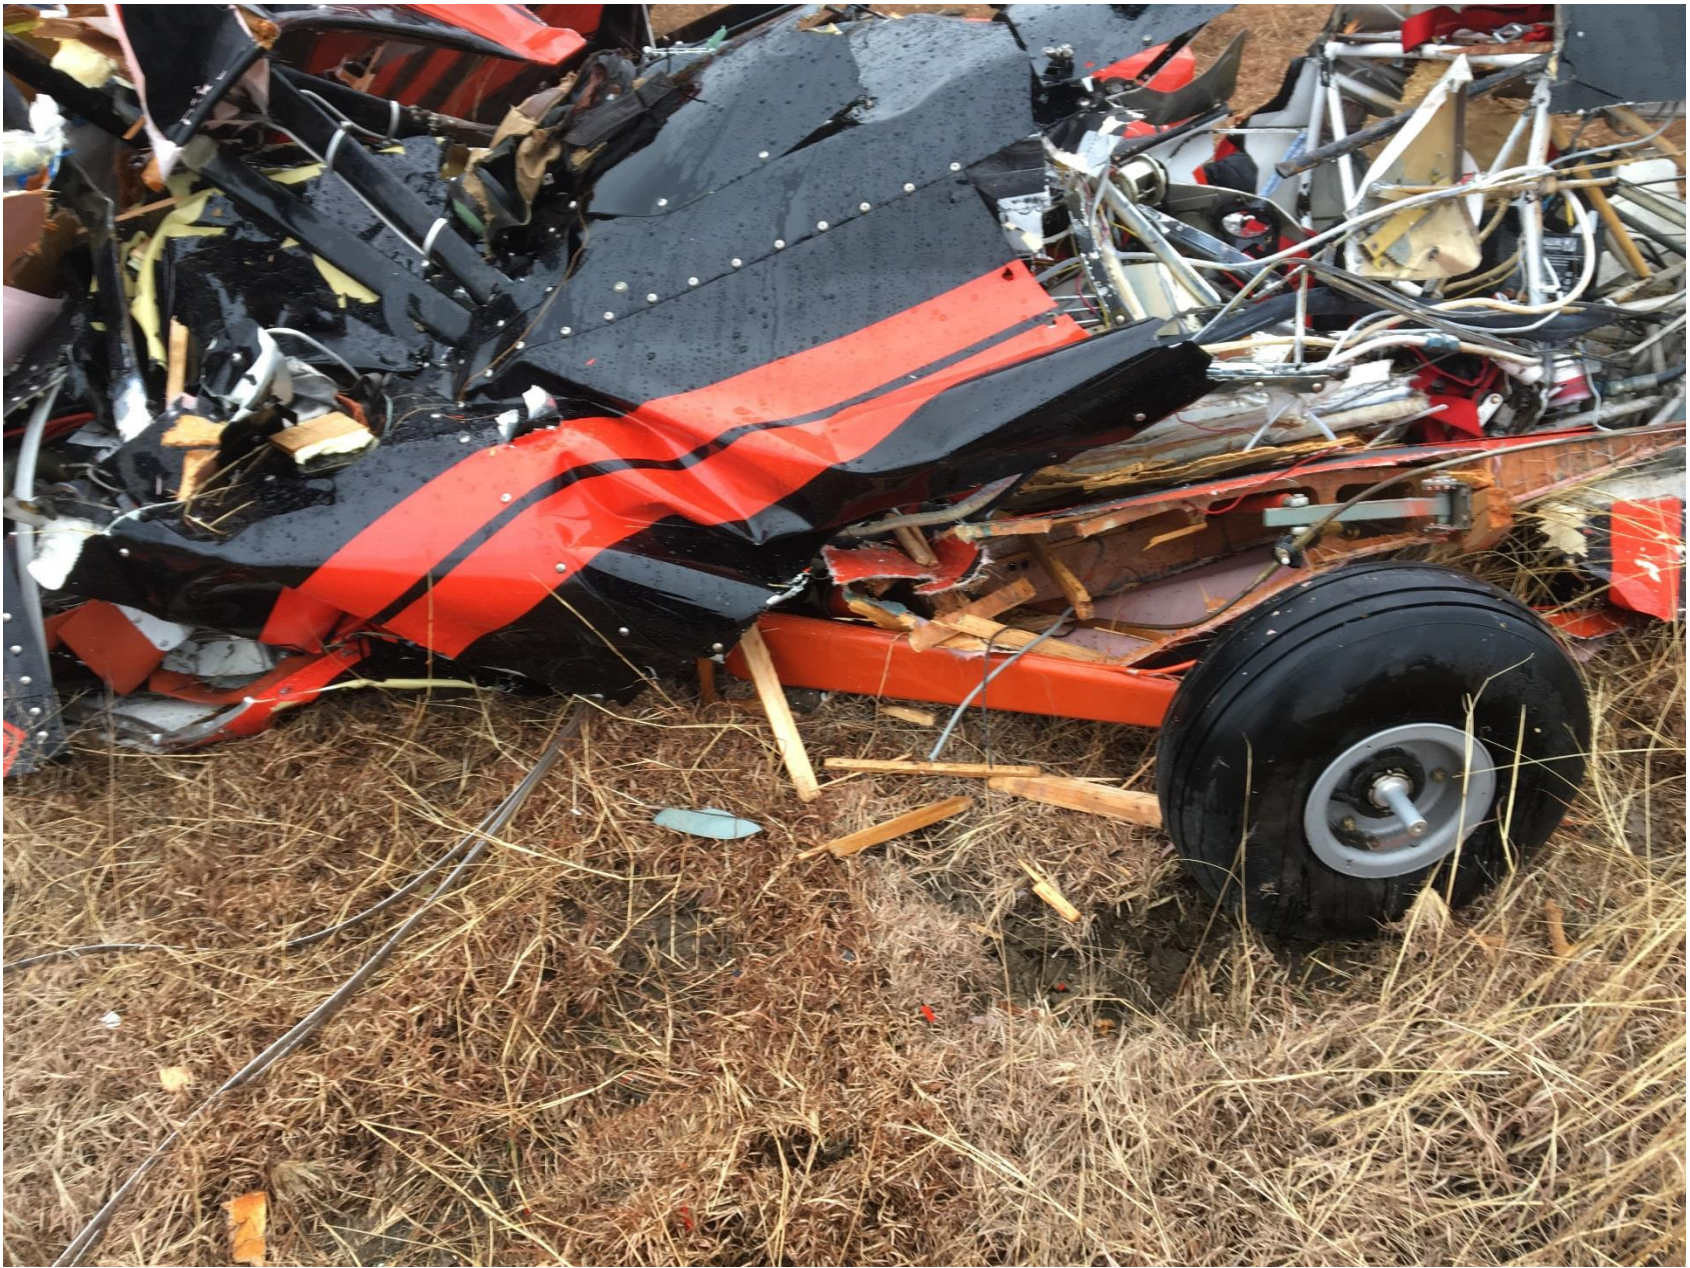
**Photo 9 – View of the left main gear collapsed to the rear**

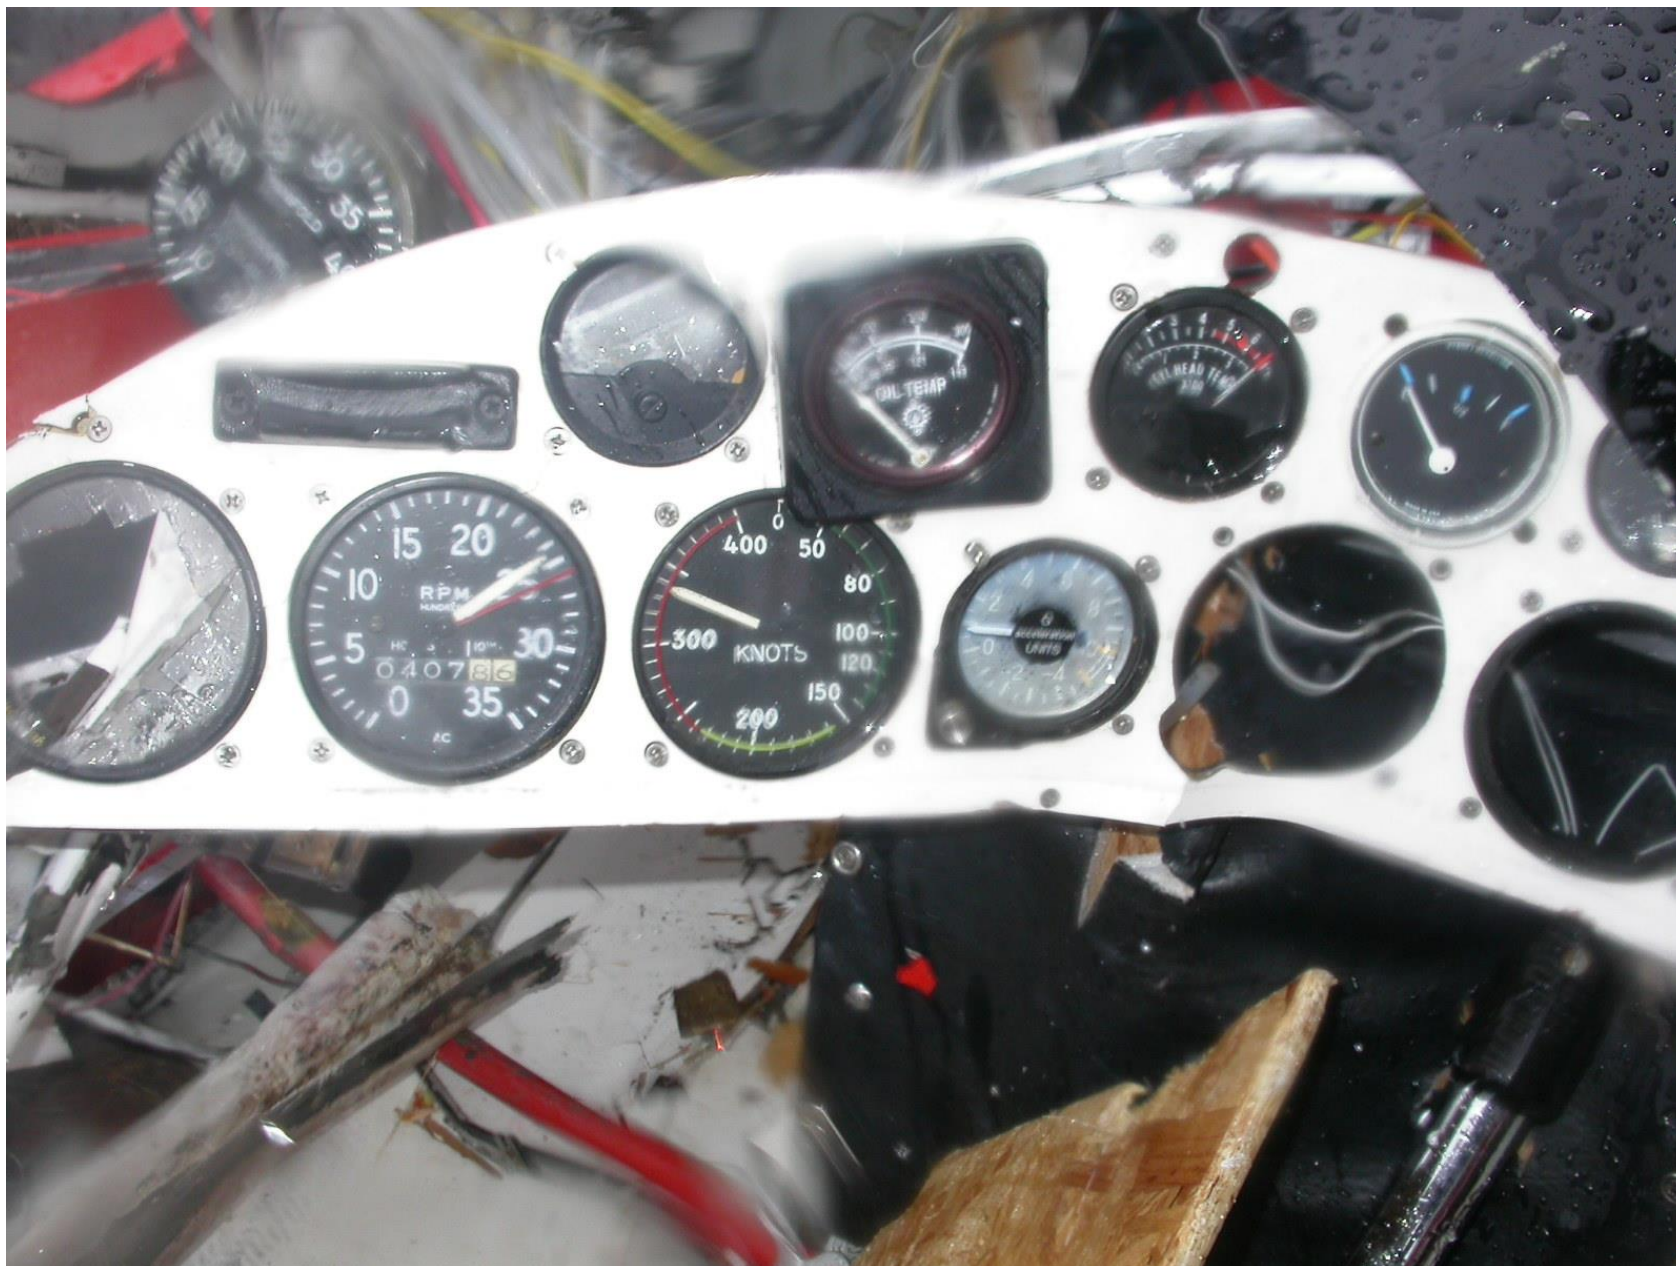
**Photo 10 – View of the cockpit instruments**
