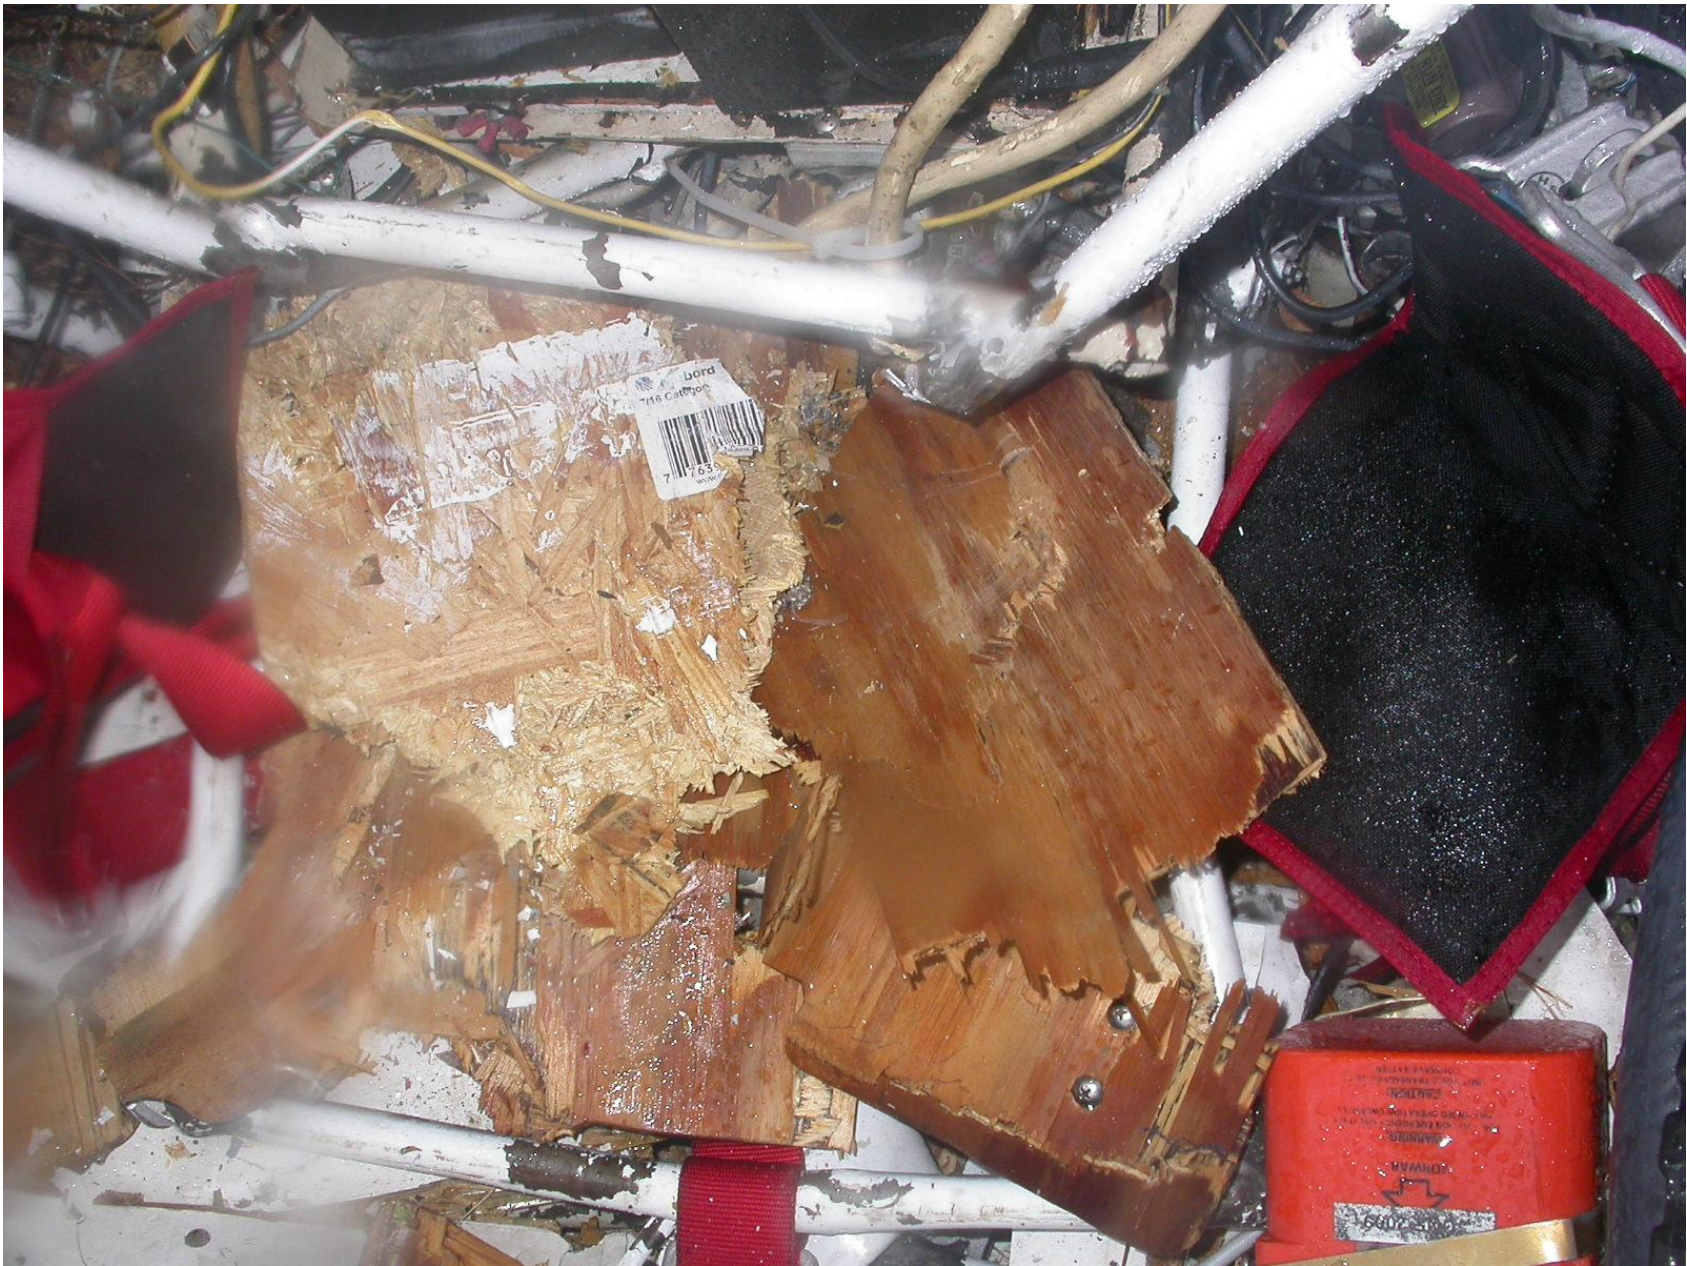
**Photo 11 – View of the fractured plywood floorboards under the rear pilot's seat**

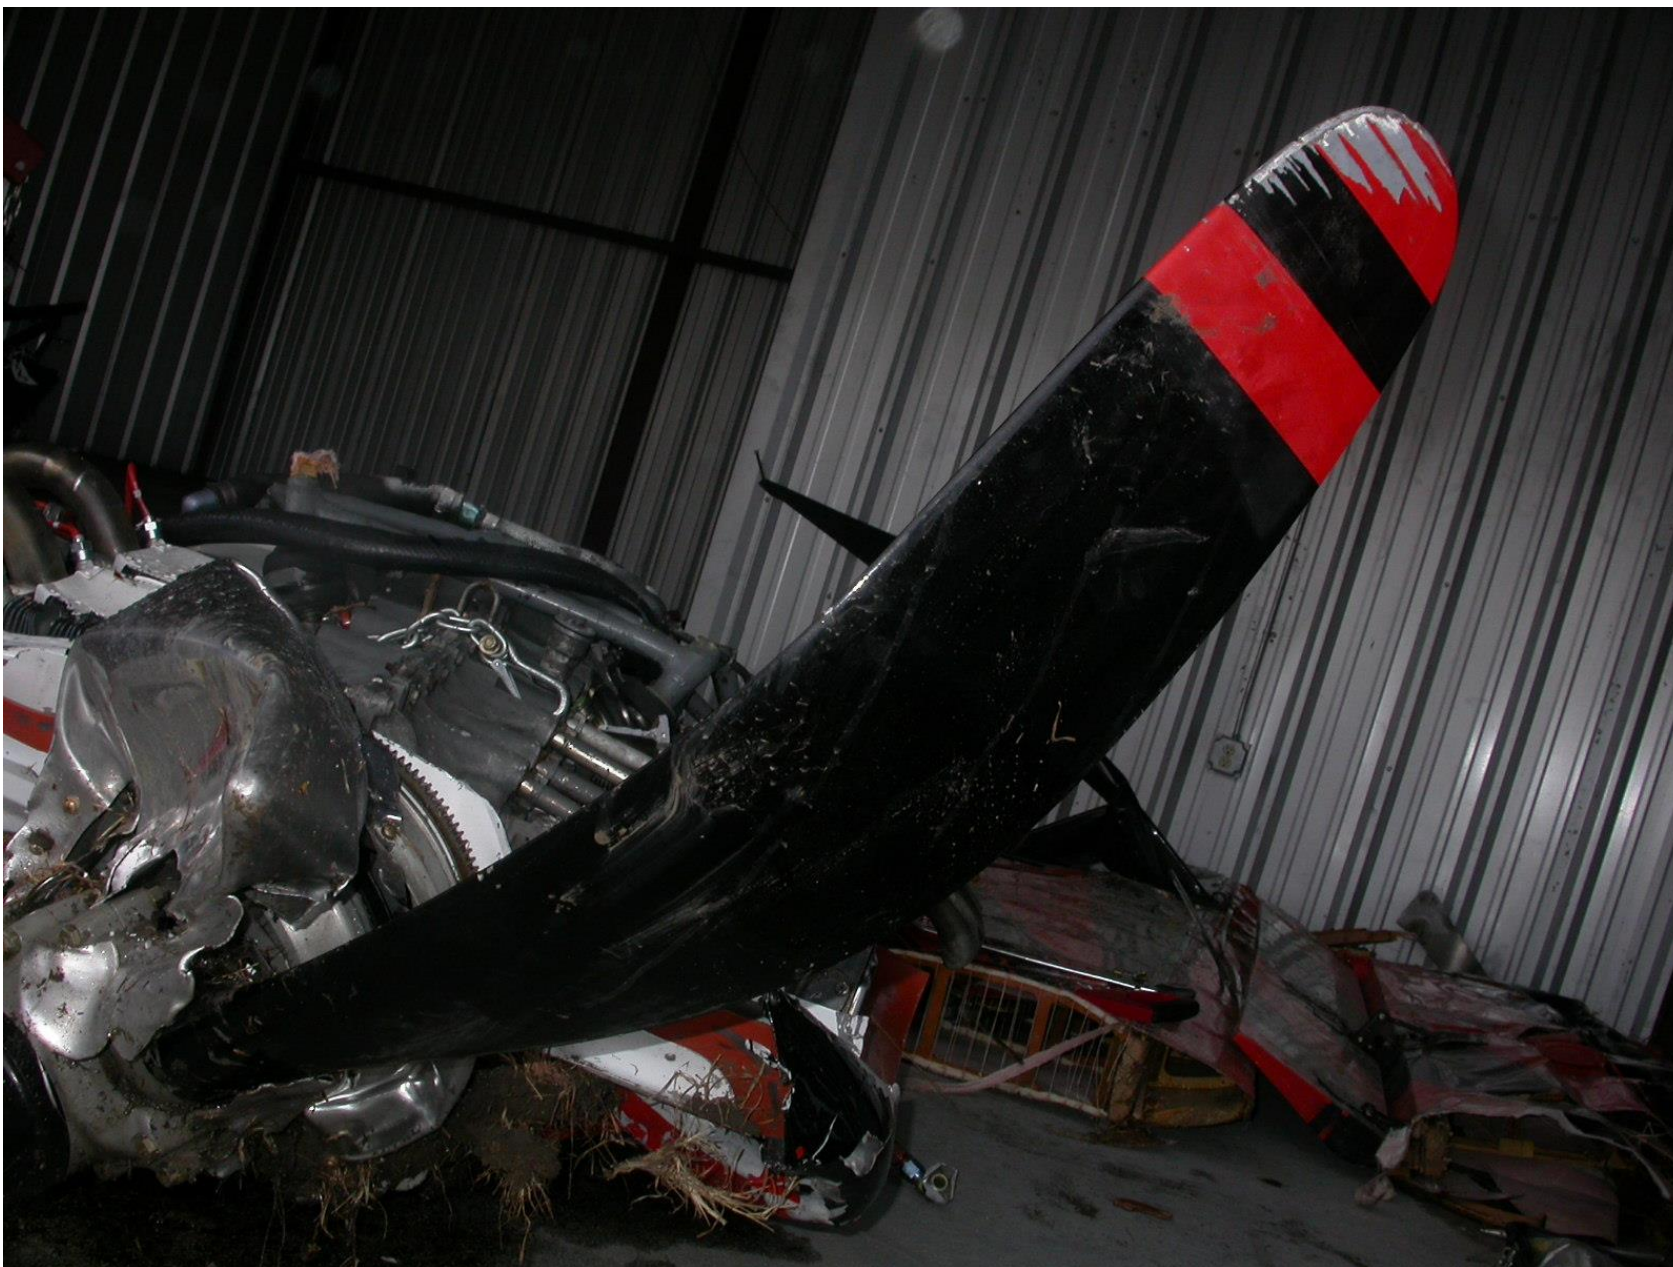
**Photo 12 – View of one of the propeller blades**

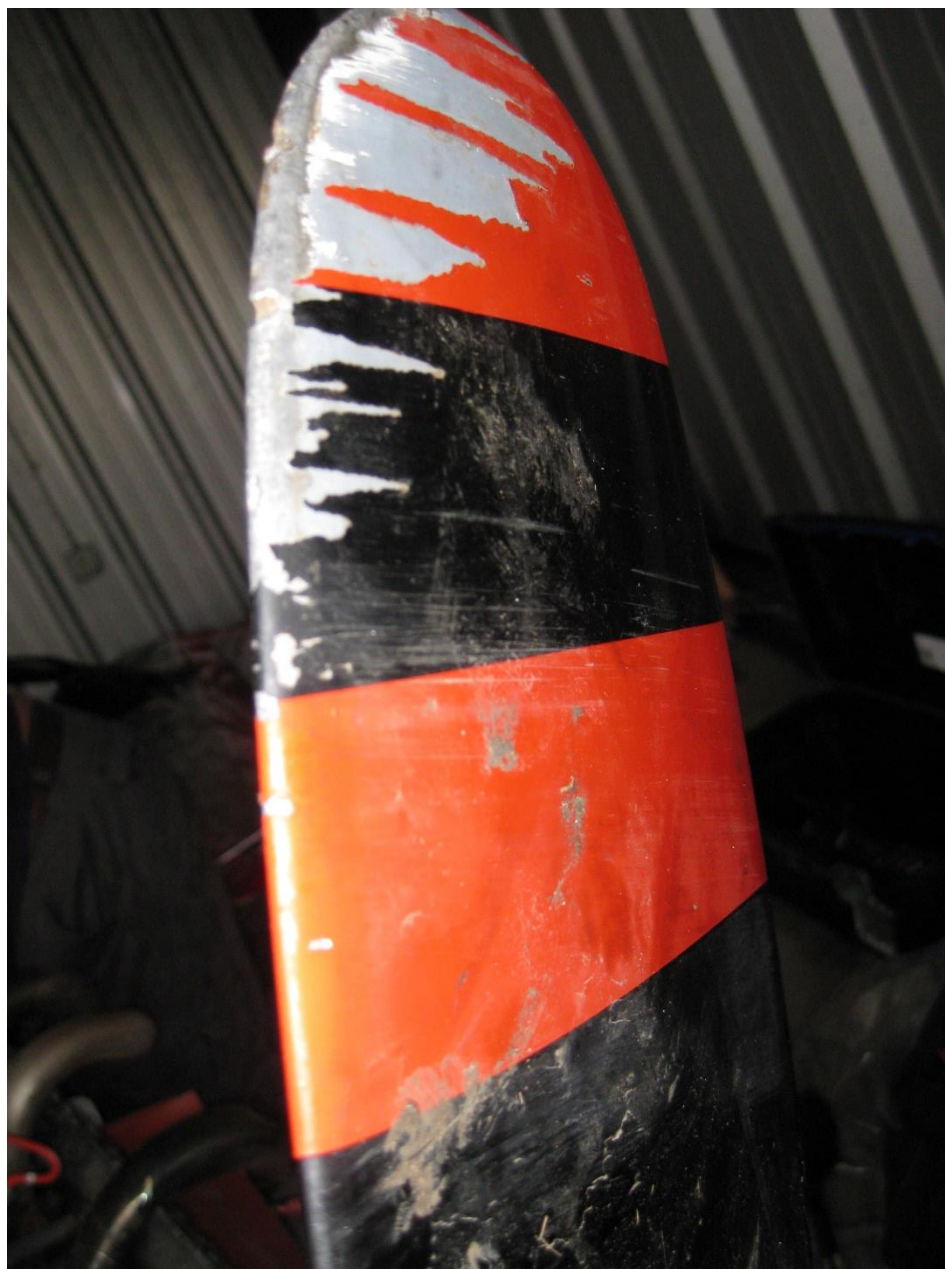
**Photo 13 – View of some blade tip damage**

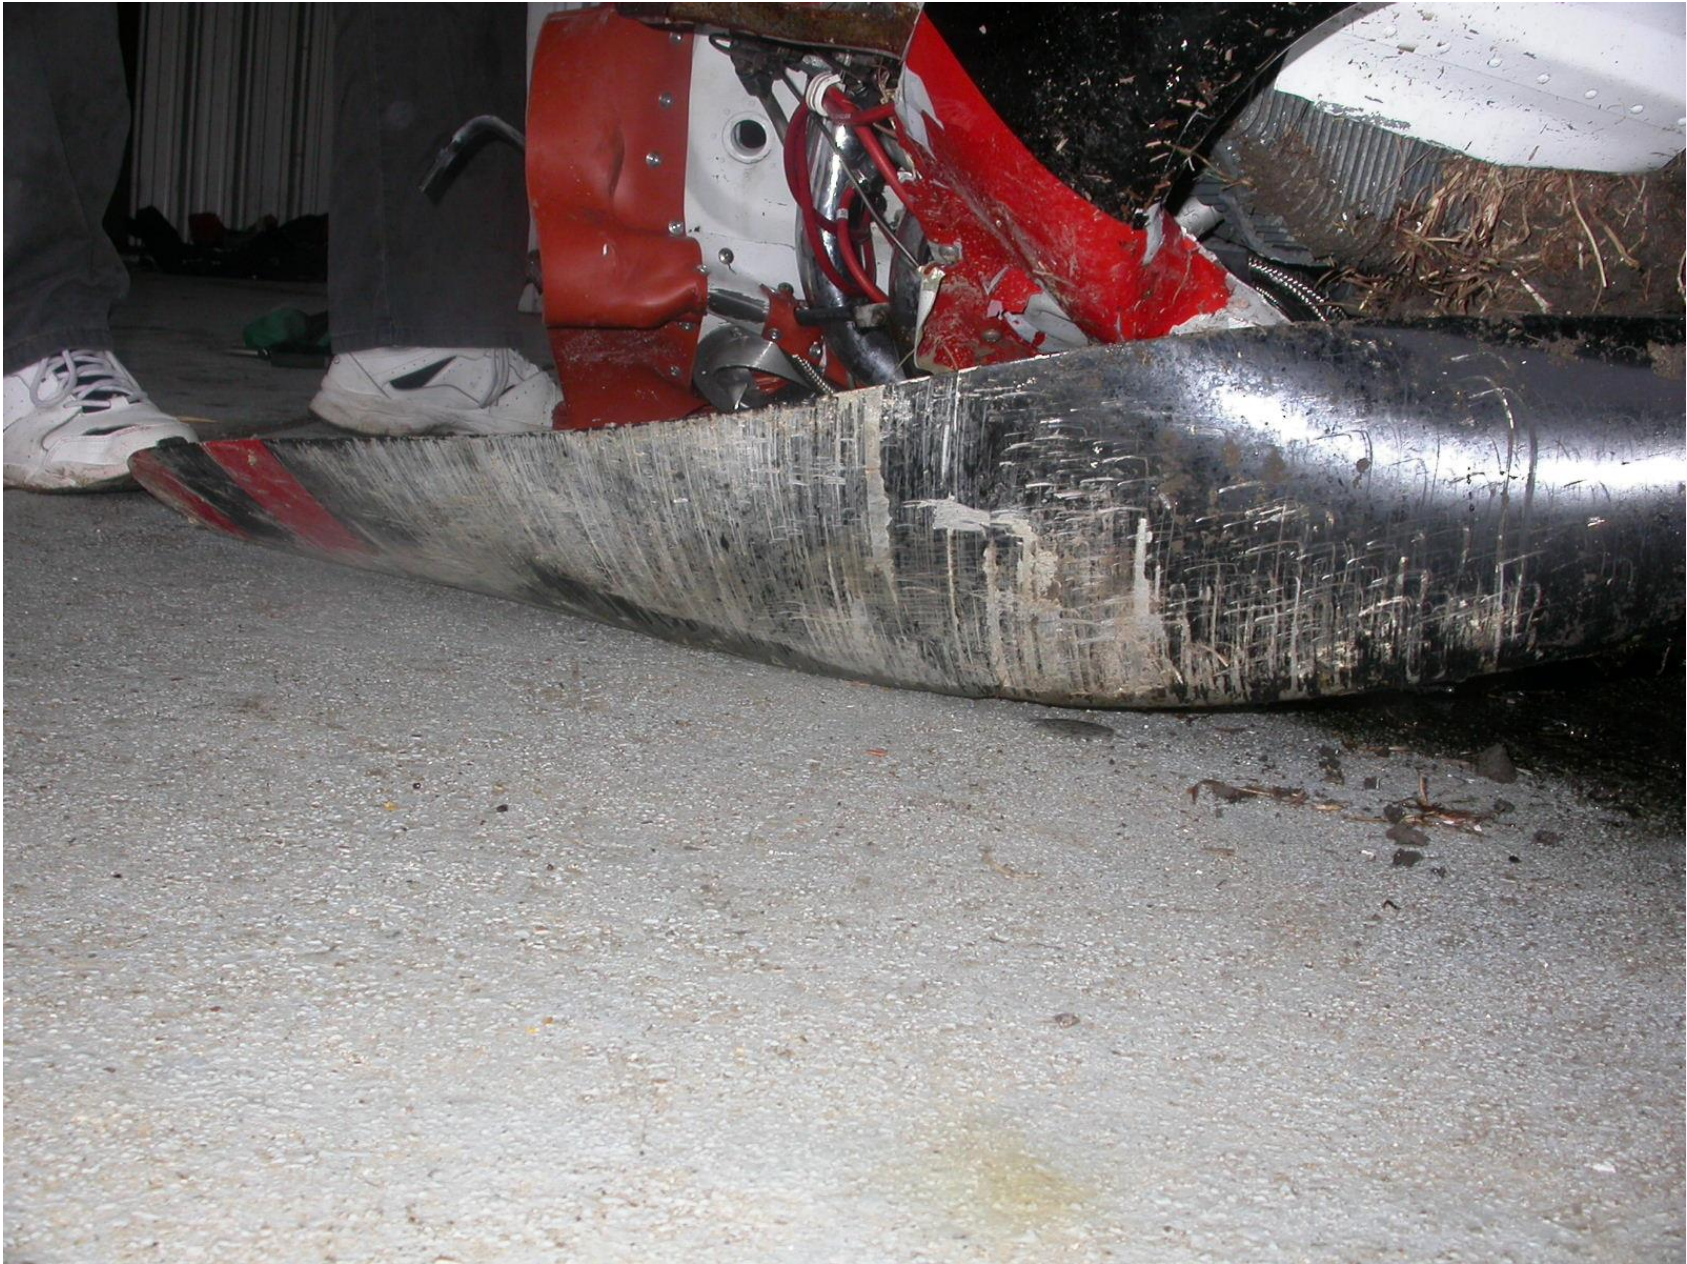
**Photo 14 – View of the damage to the other blade**

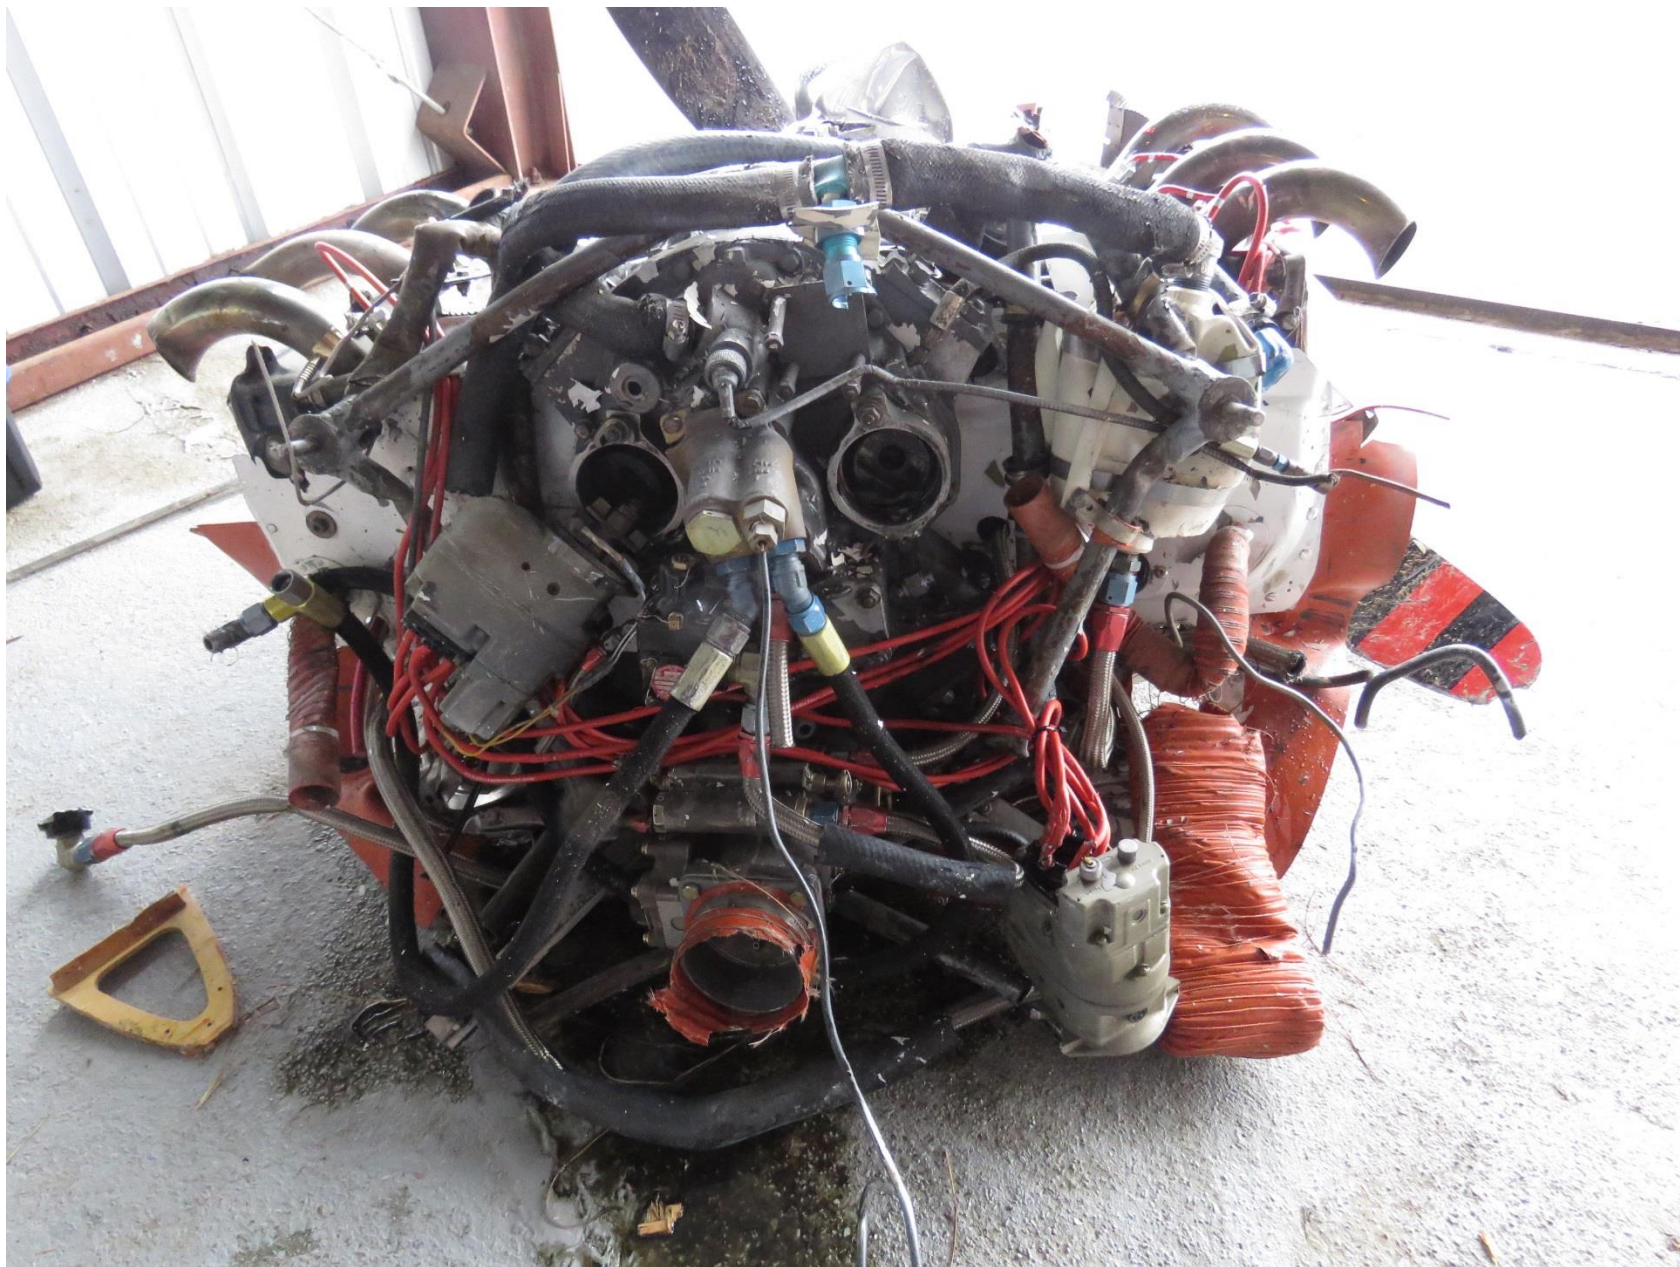
**Photo 15 – View of the rear of the engine**

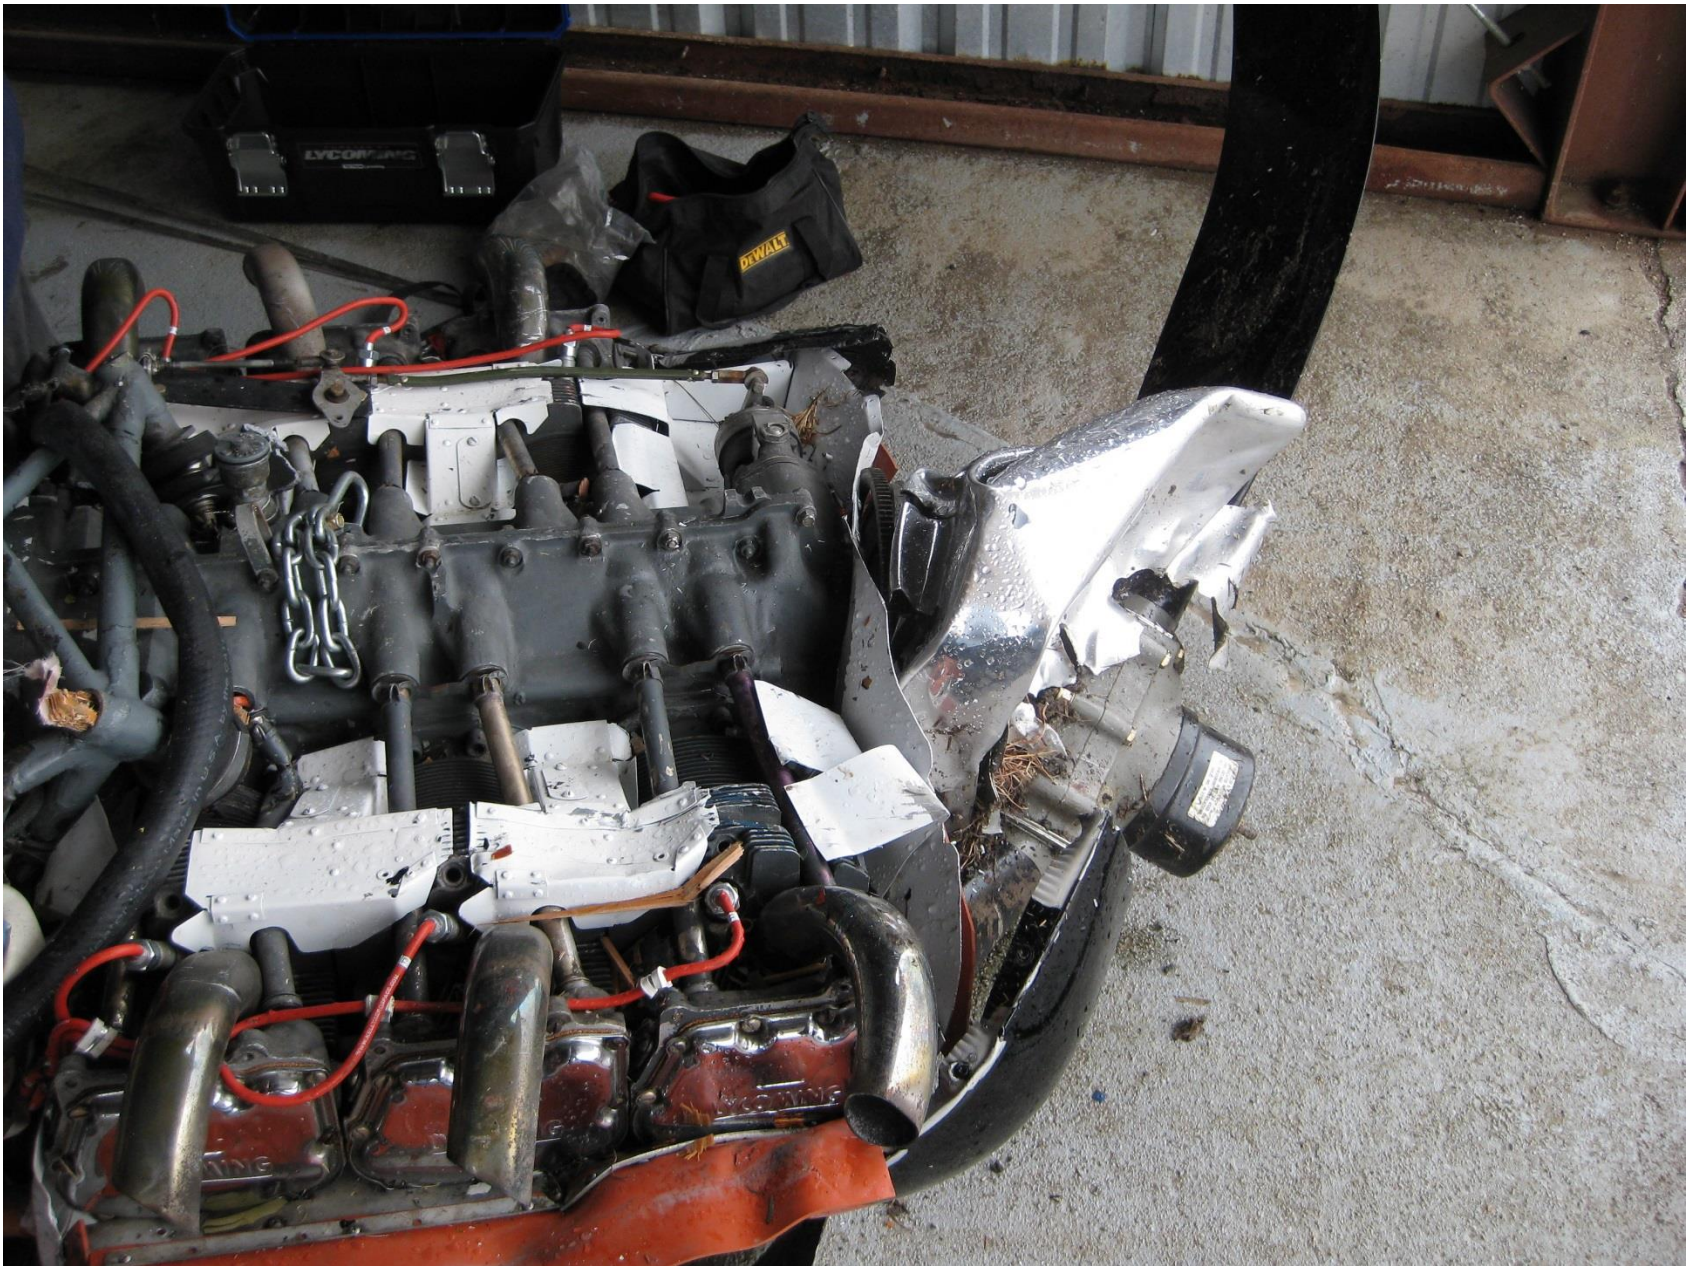
**Photo 16 – View of the top of the engine and propeller**
