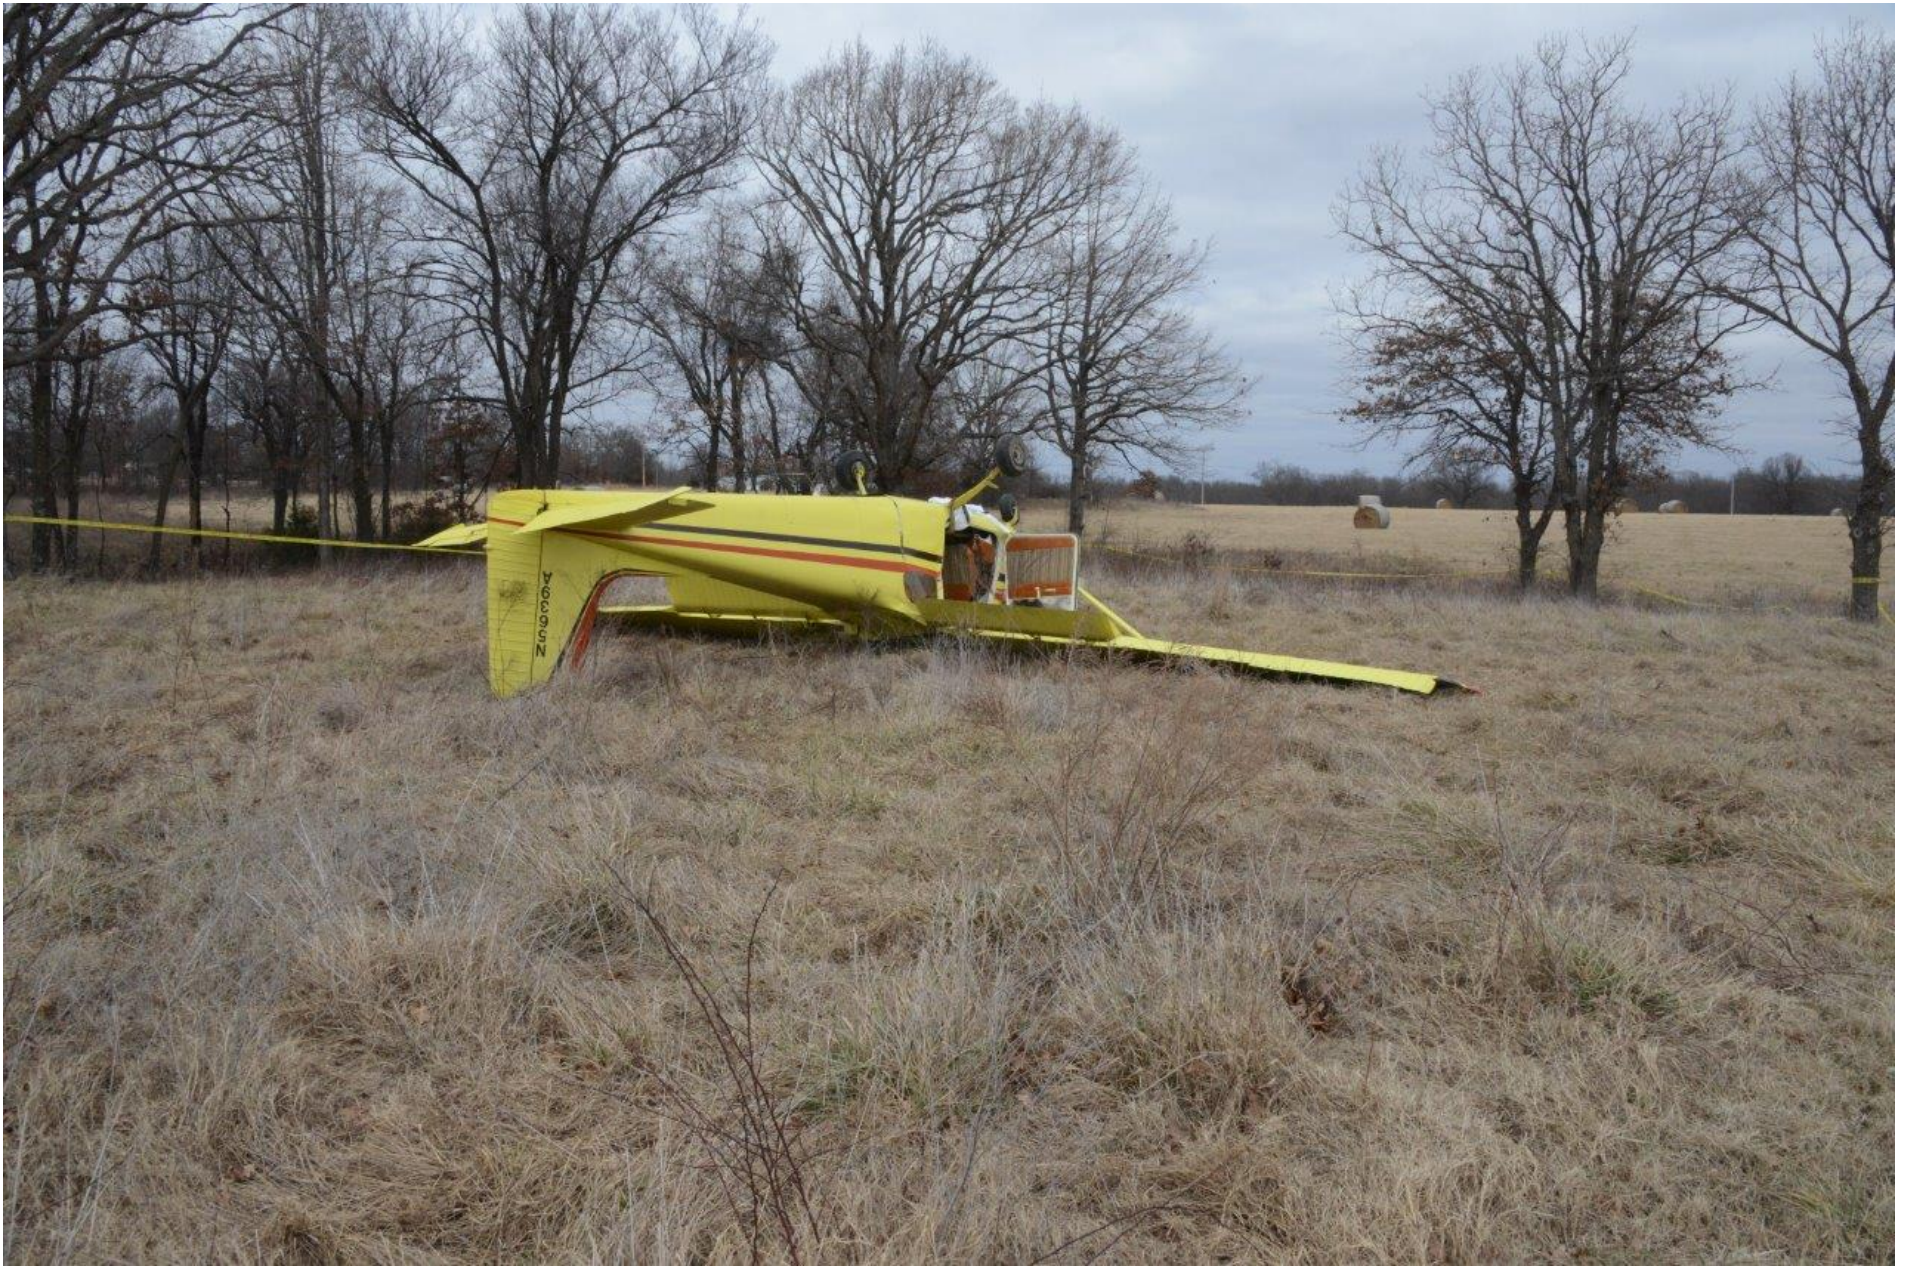
**Photo 1 – View of the left side of the inverted airplane at the accident site.**

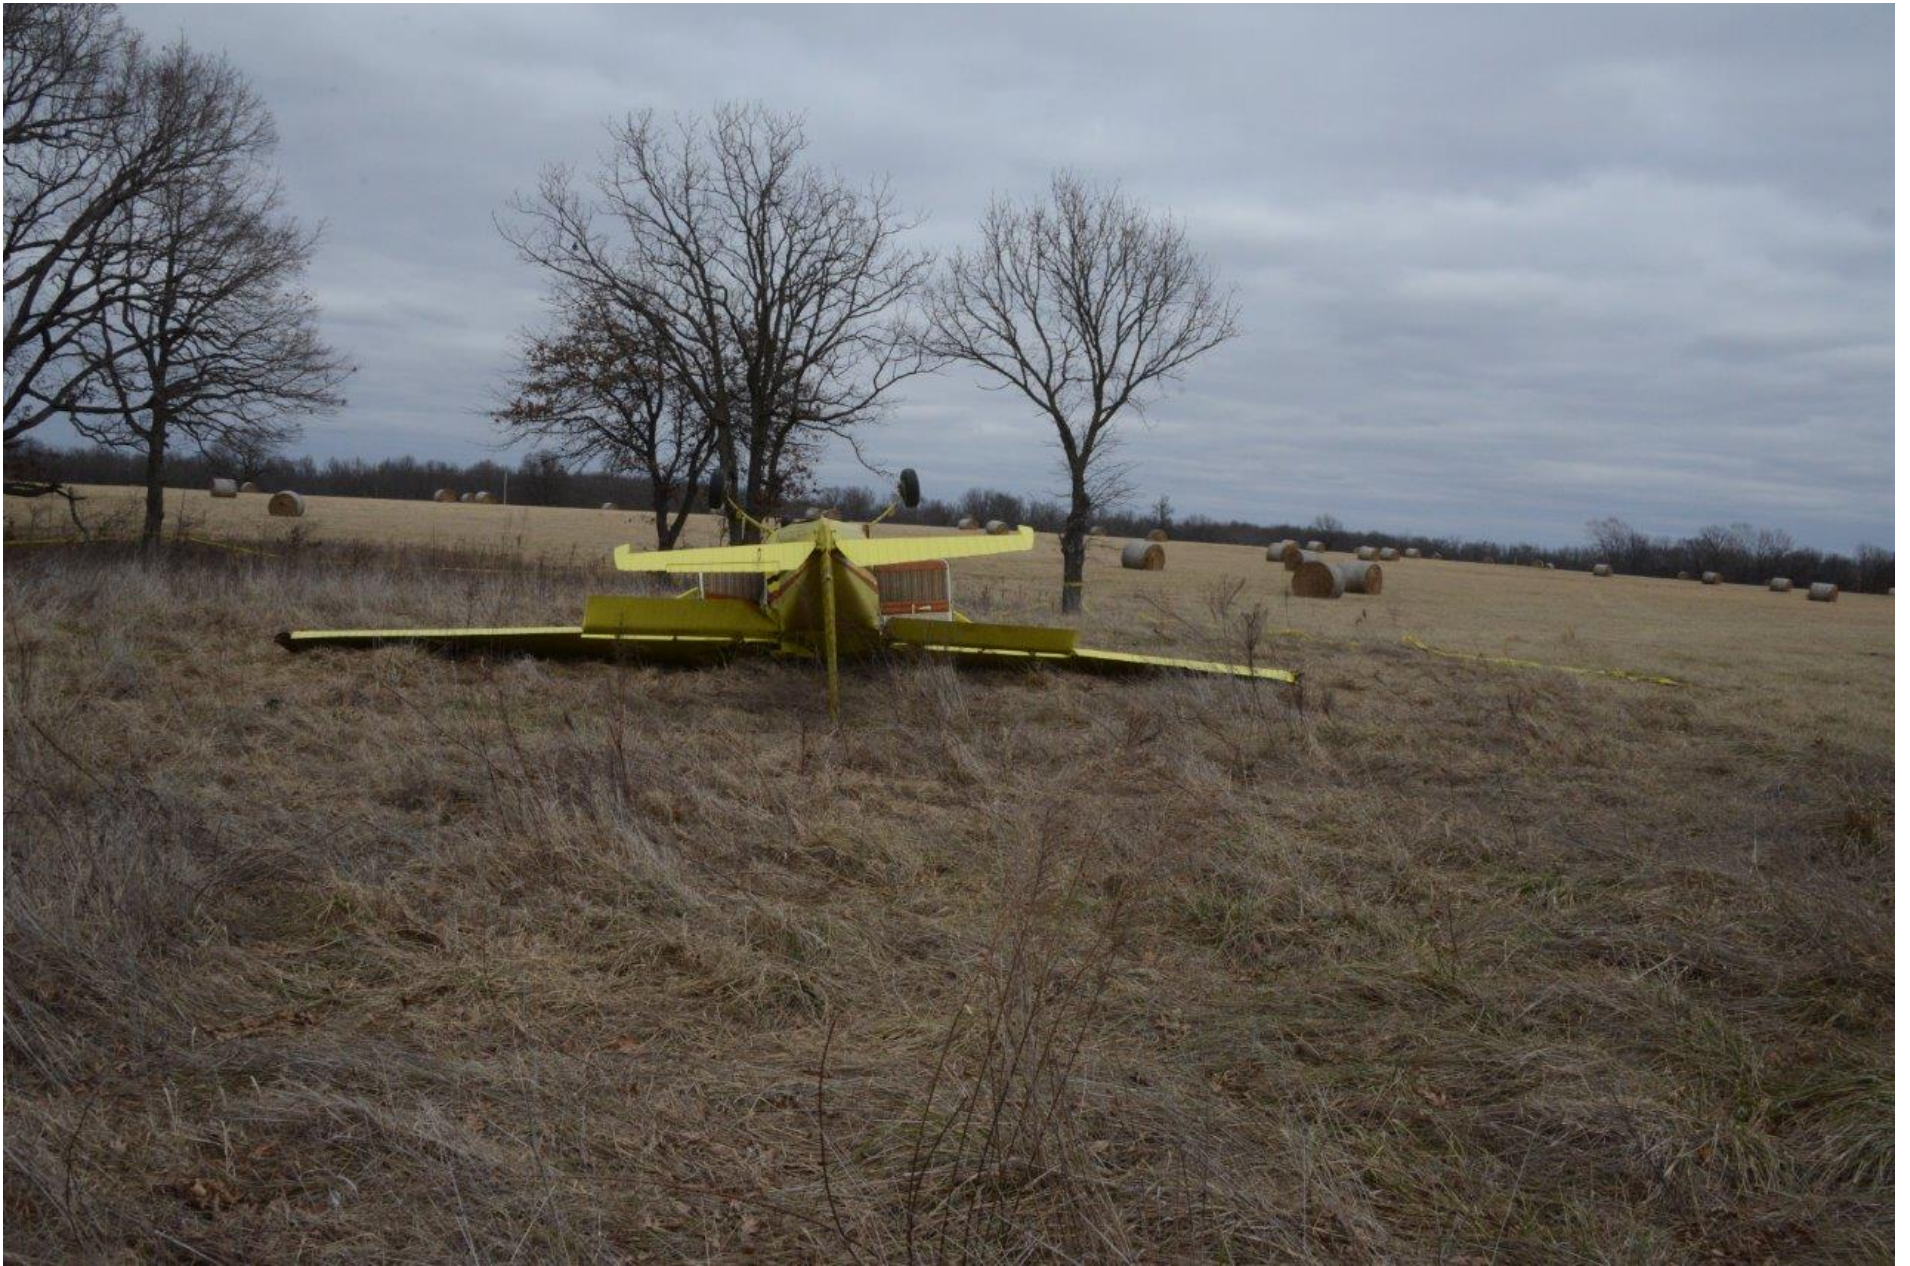
**Photo 2 - View of the aft side of the inverted airplane at the accident site.**

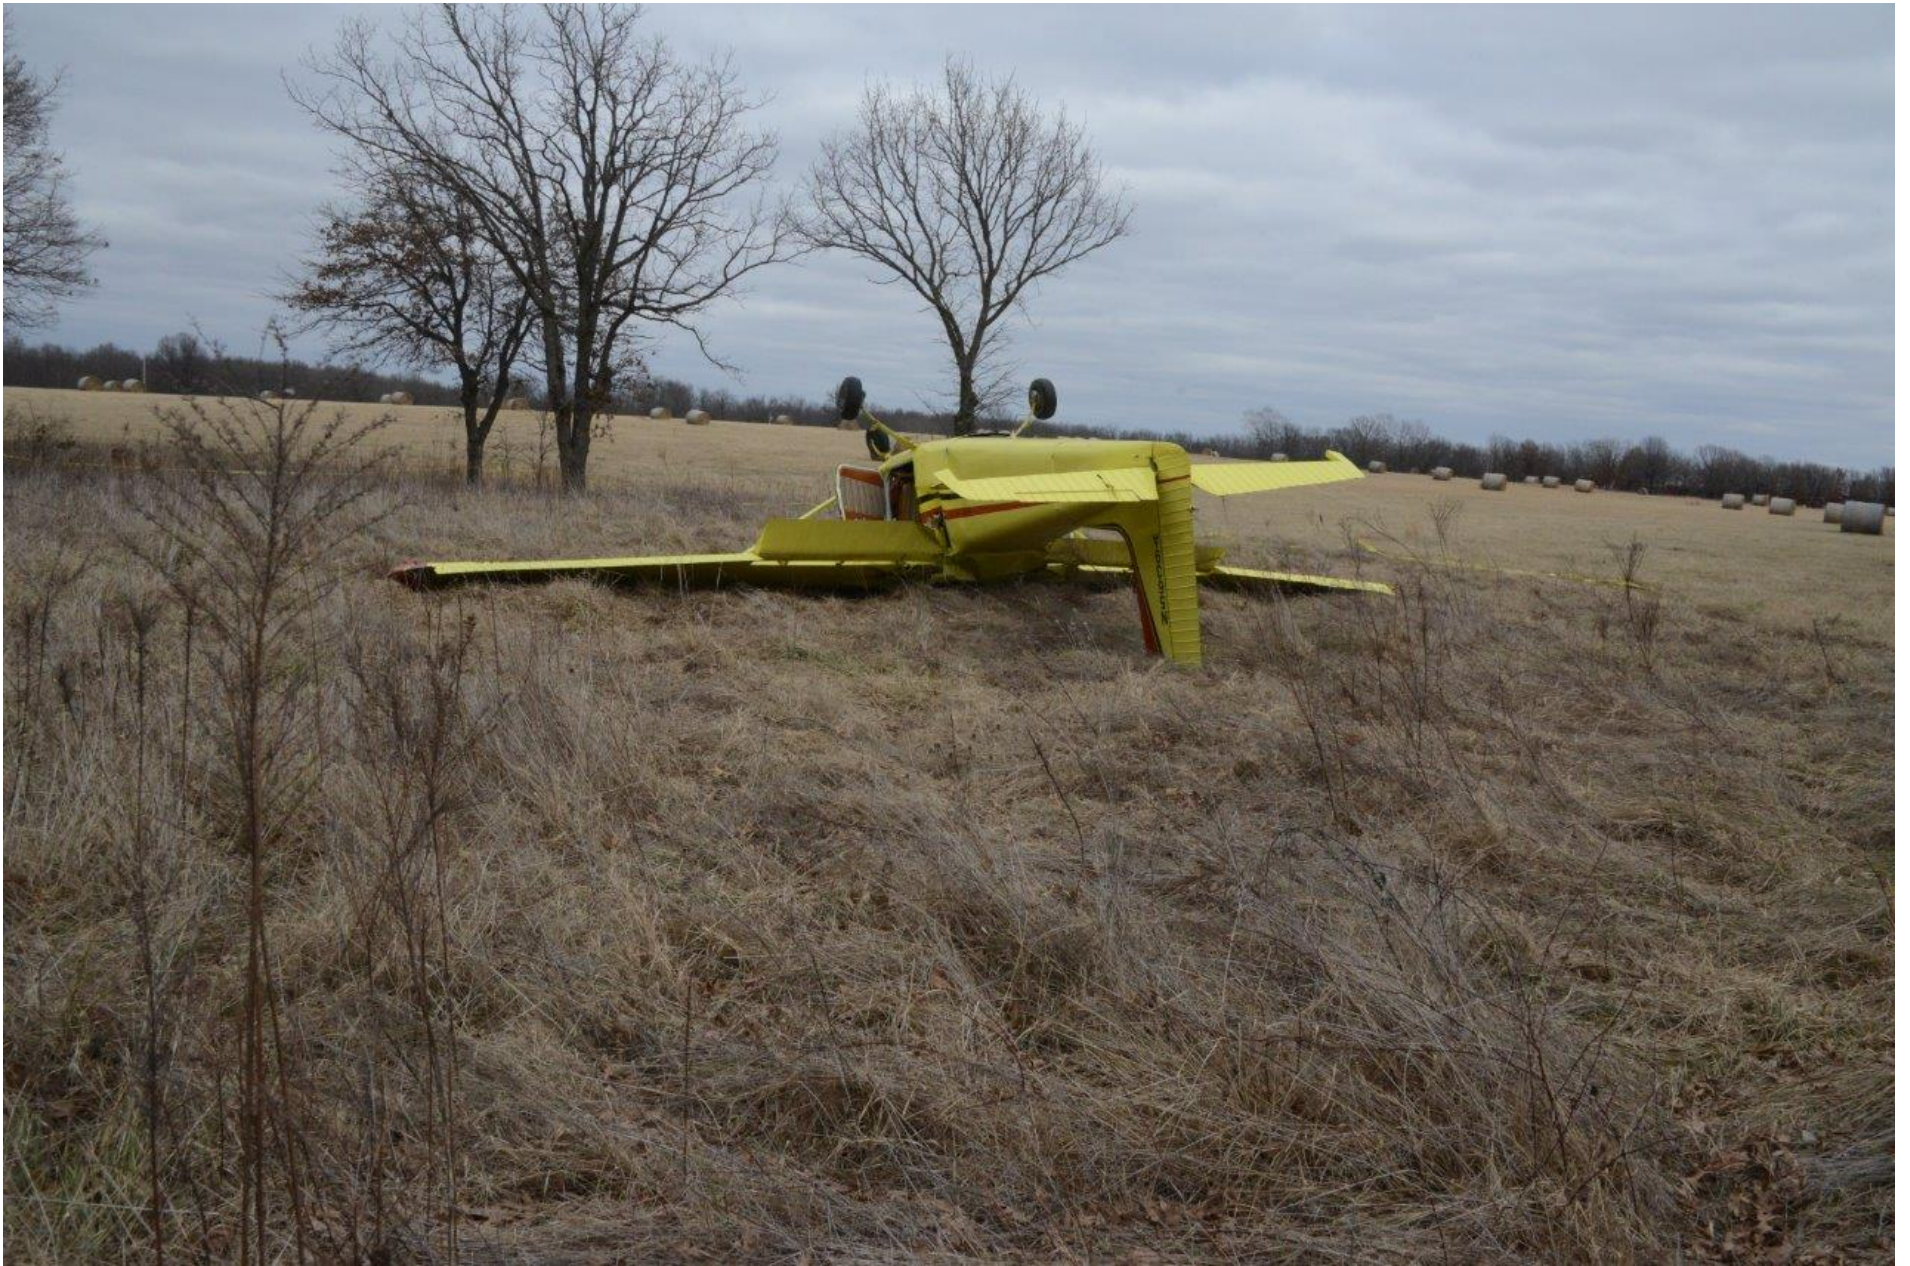
**Photo 3 - View of the right/aft side of the inverted airplane at the accident site.**

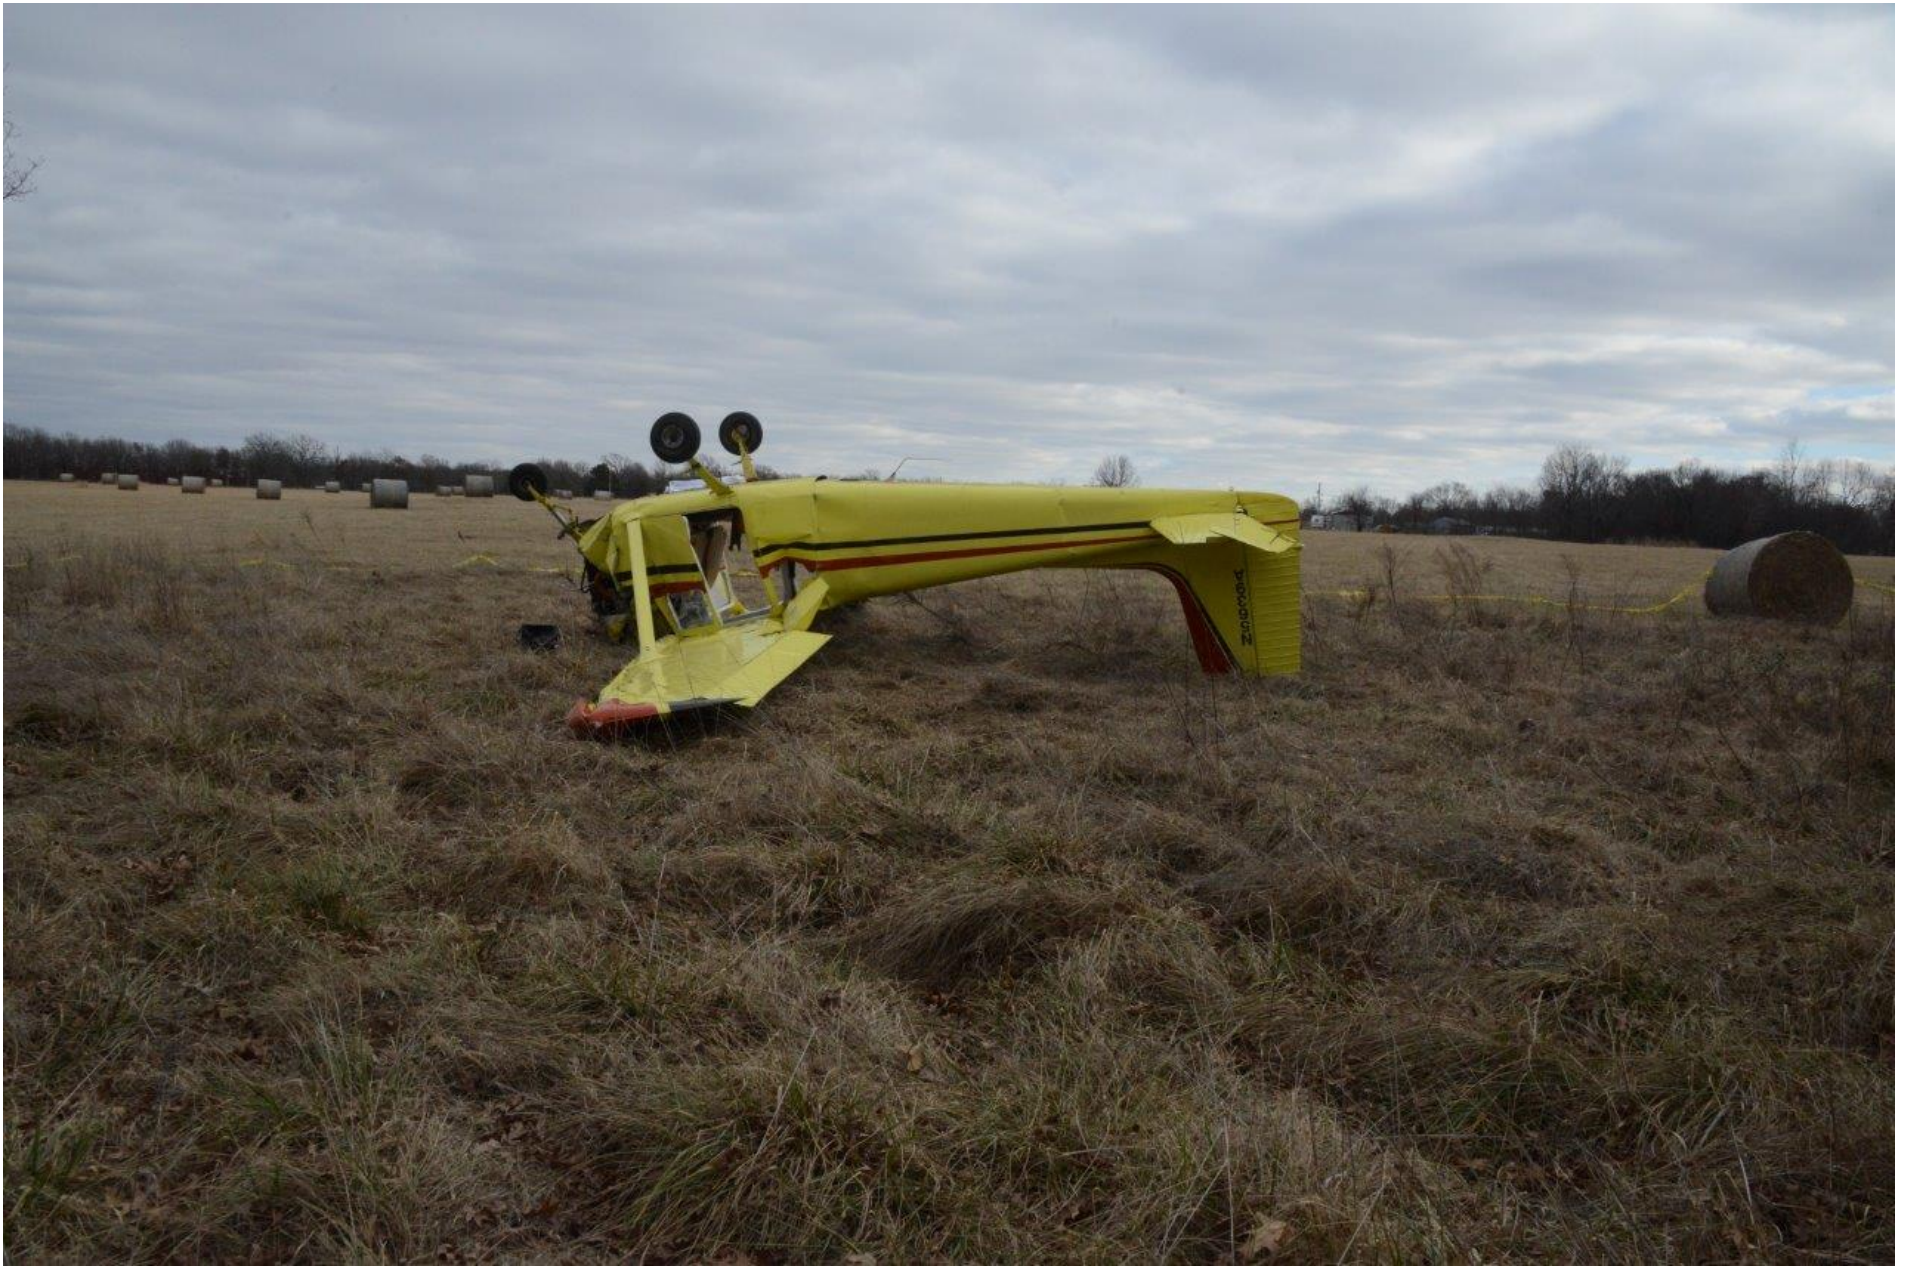
**Photo 4 - View of the right side of the inverted airplane at the accident site.**

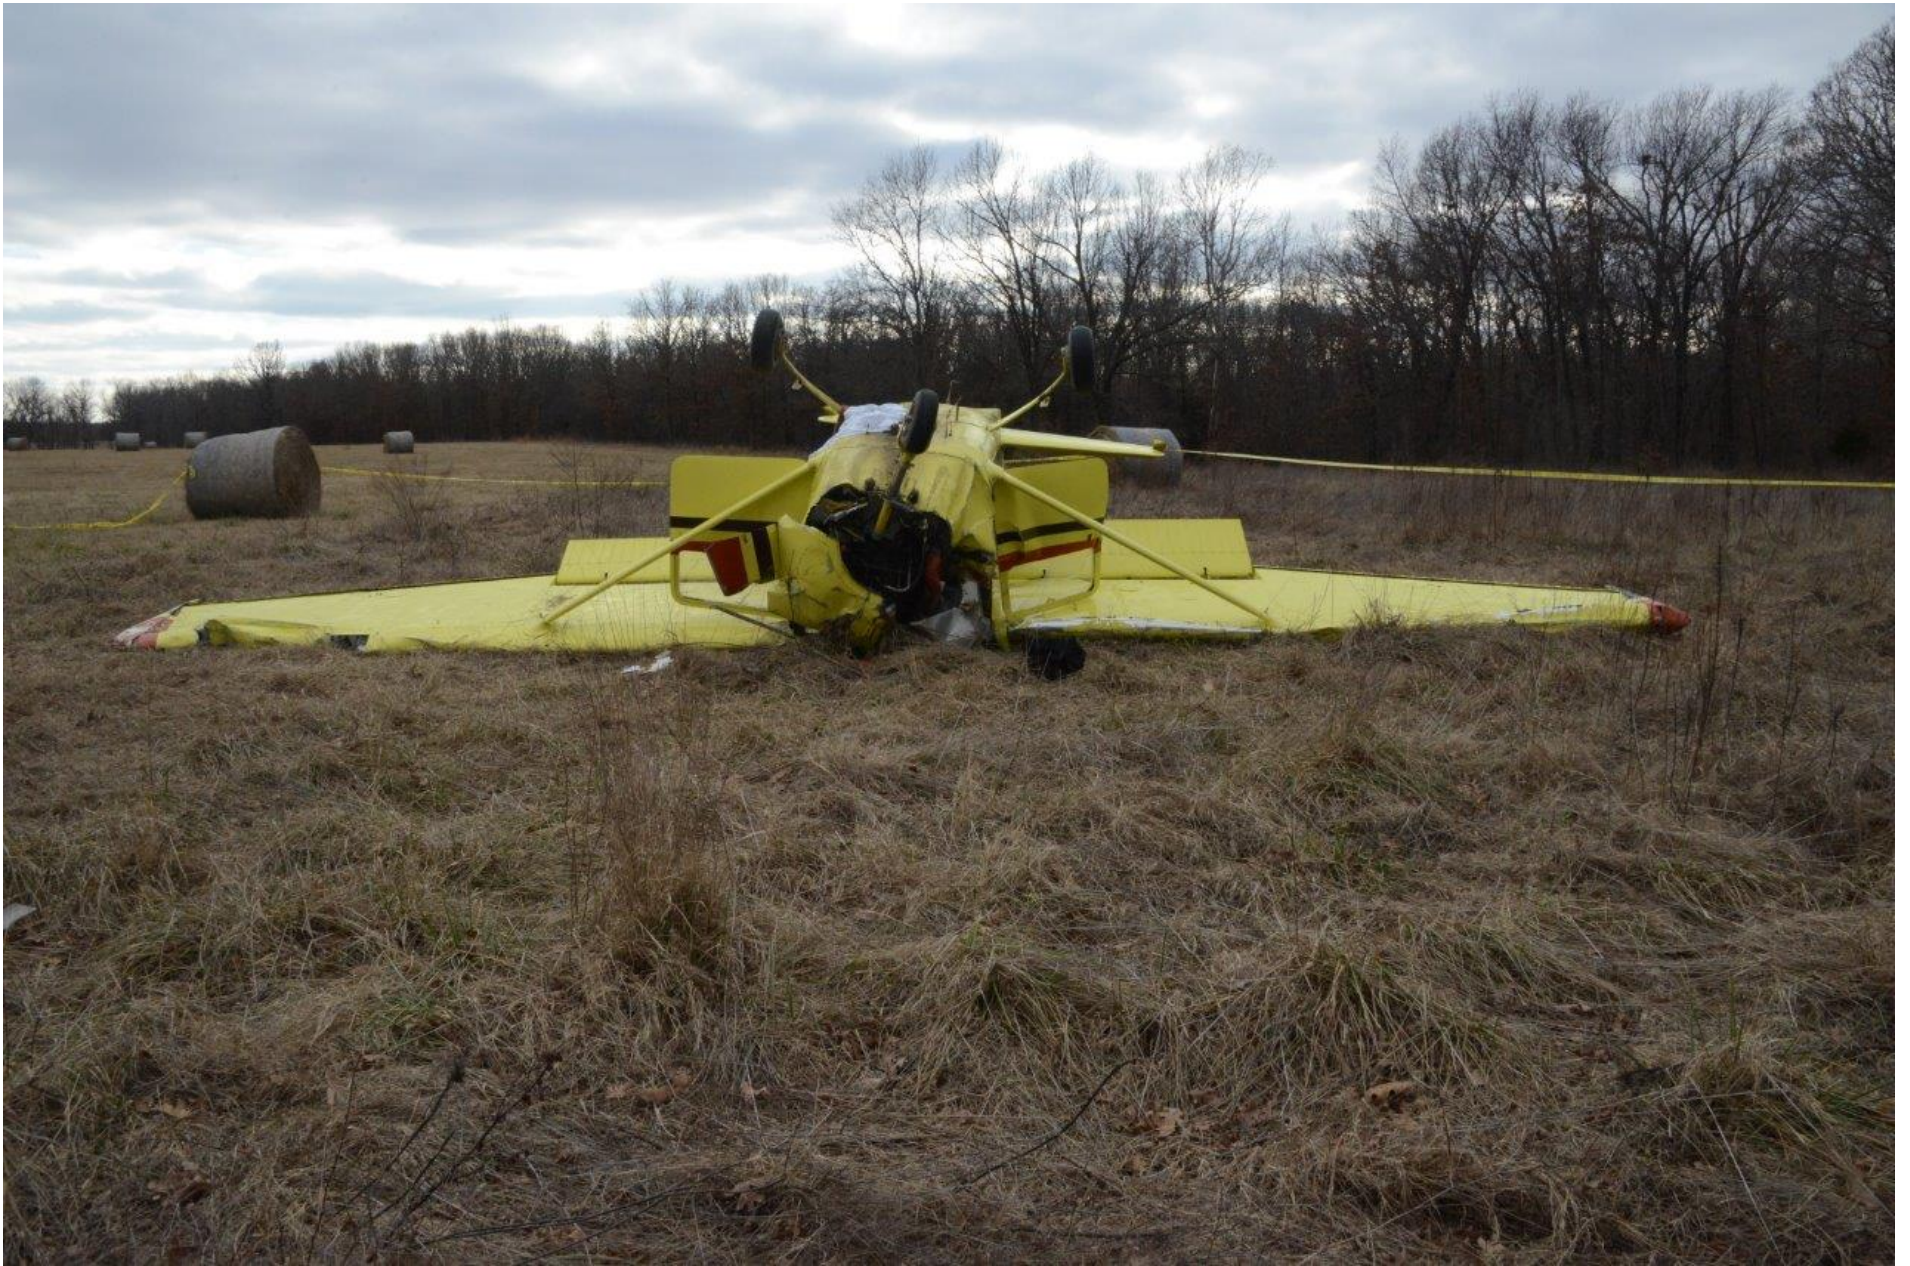
**Photo 5 - View of the front side of the inverted airplane at the accident site.**

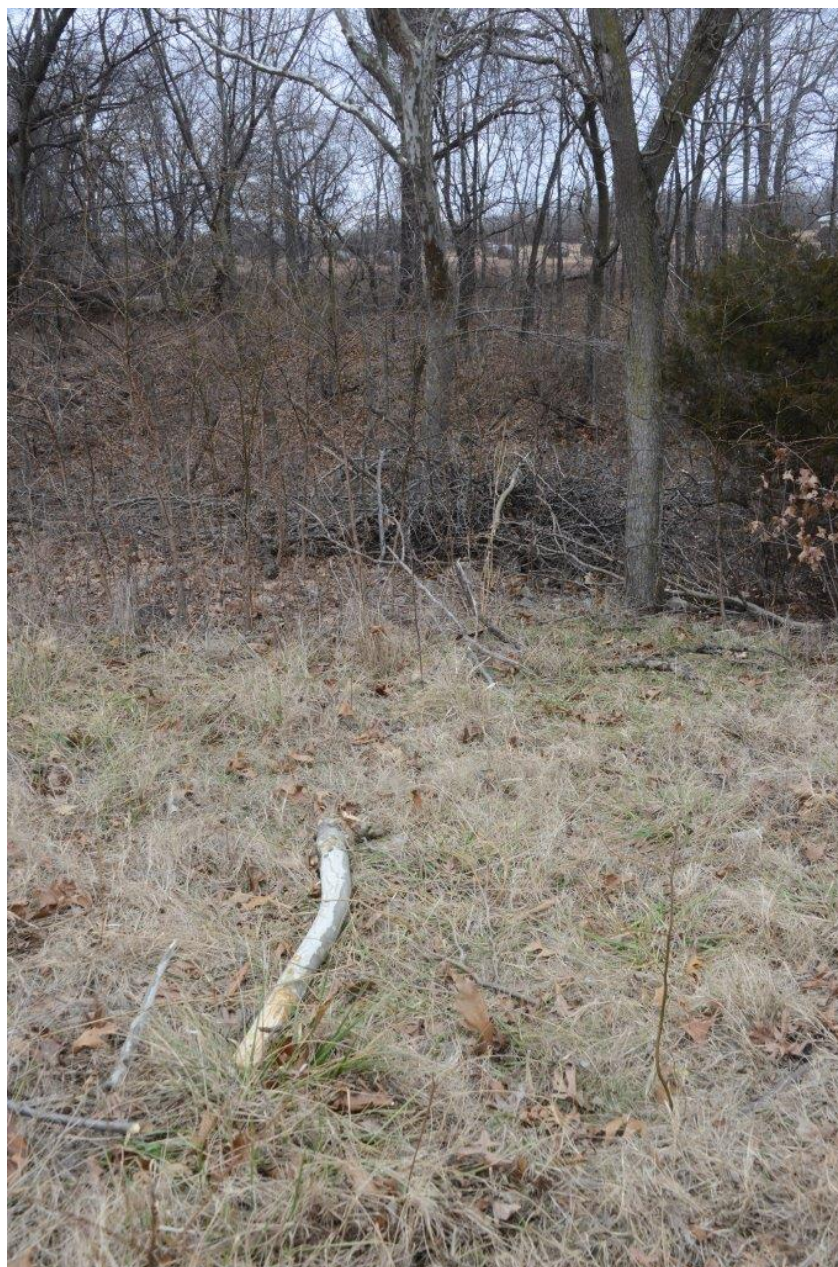
**Photo 6 - View of trees and broken branches on the ground.**

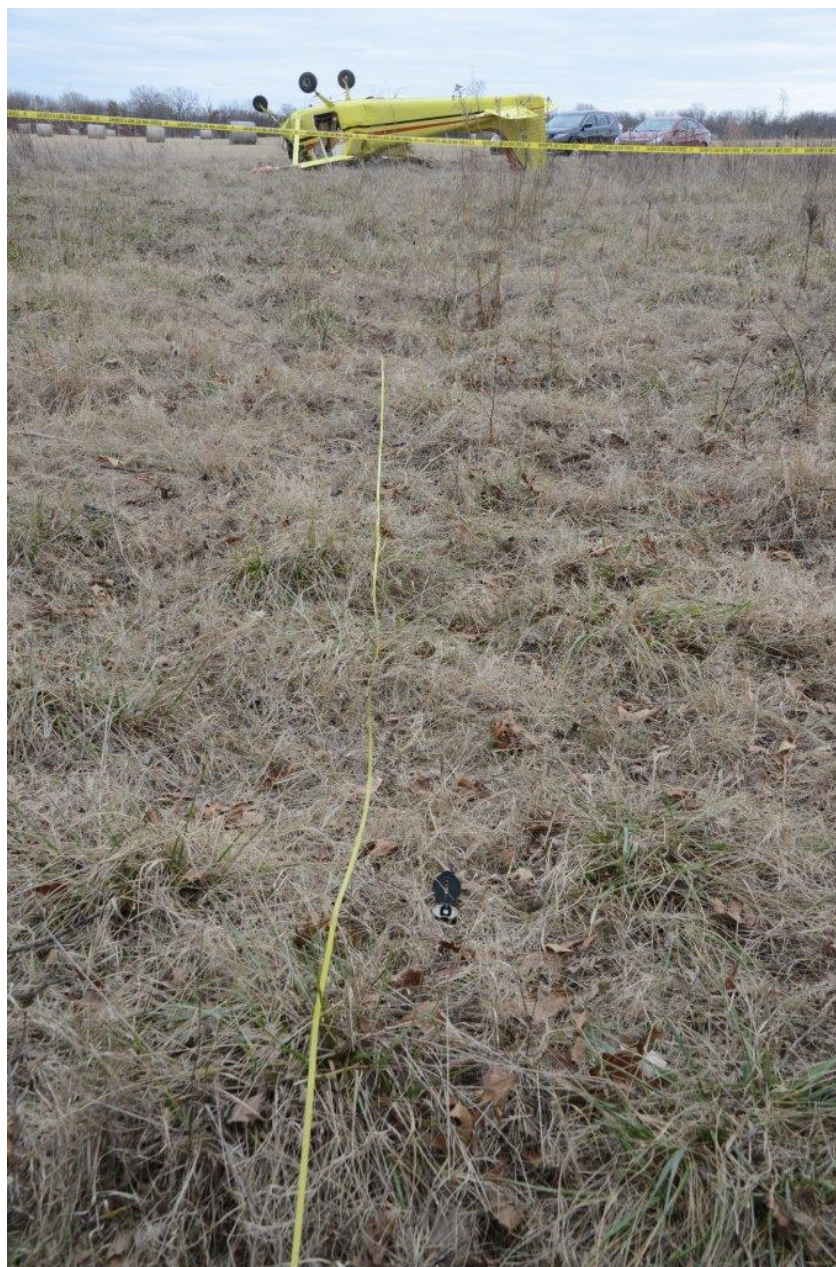
**Photo 7 - View of terrain from the broken branches towards the inverted wreckage.**

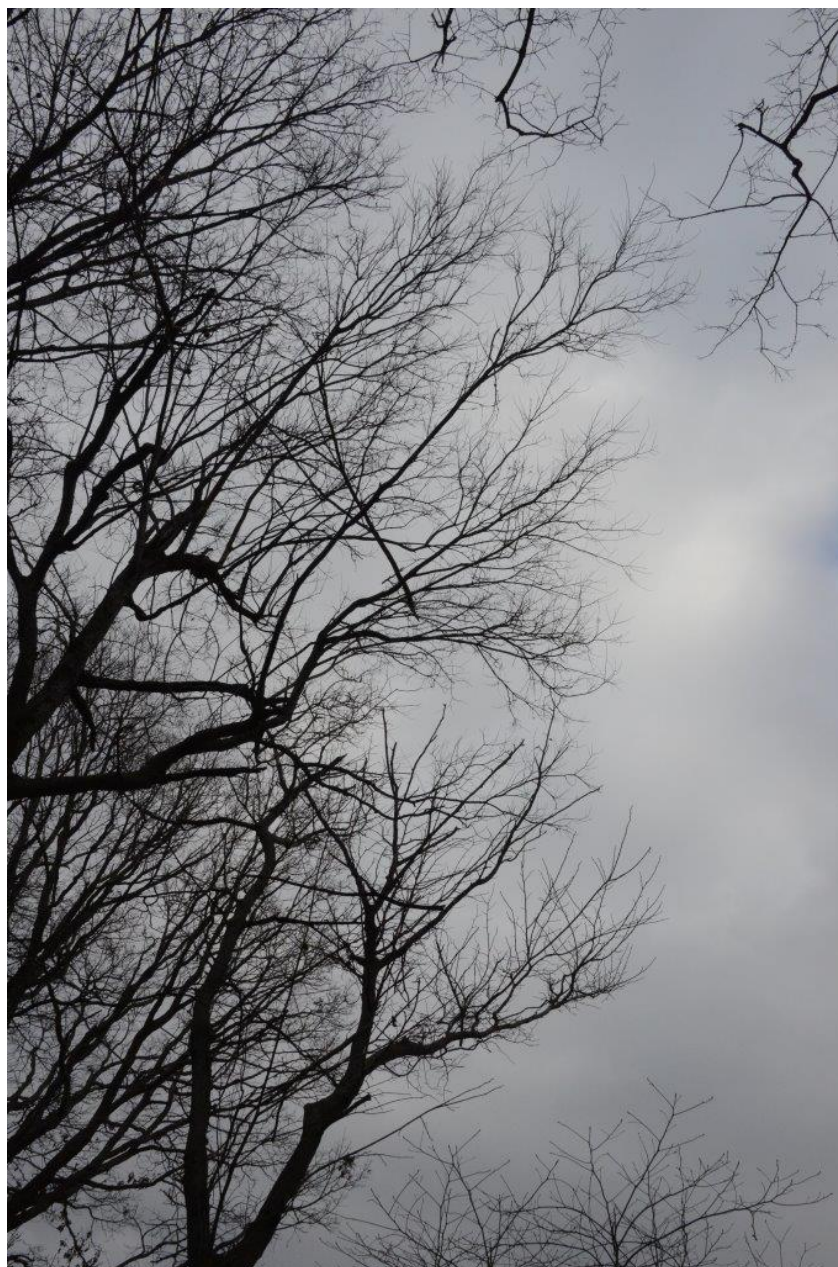
**Photo 8 - View of broken branches aloft in a tree.**

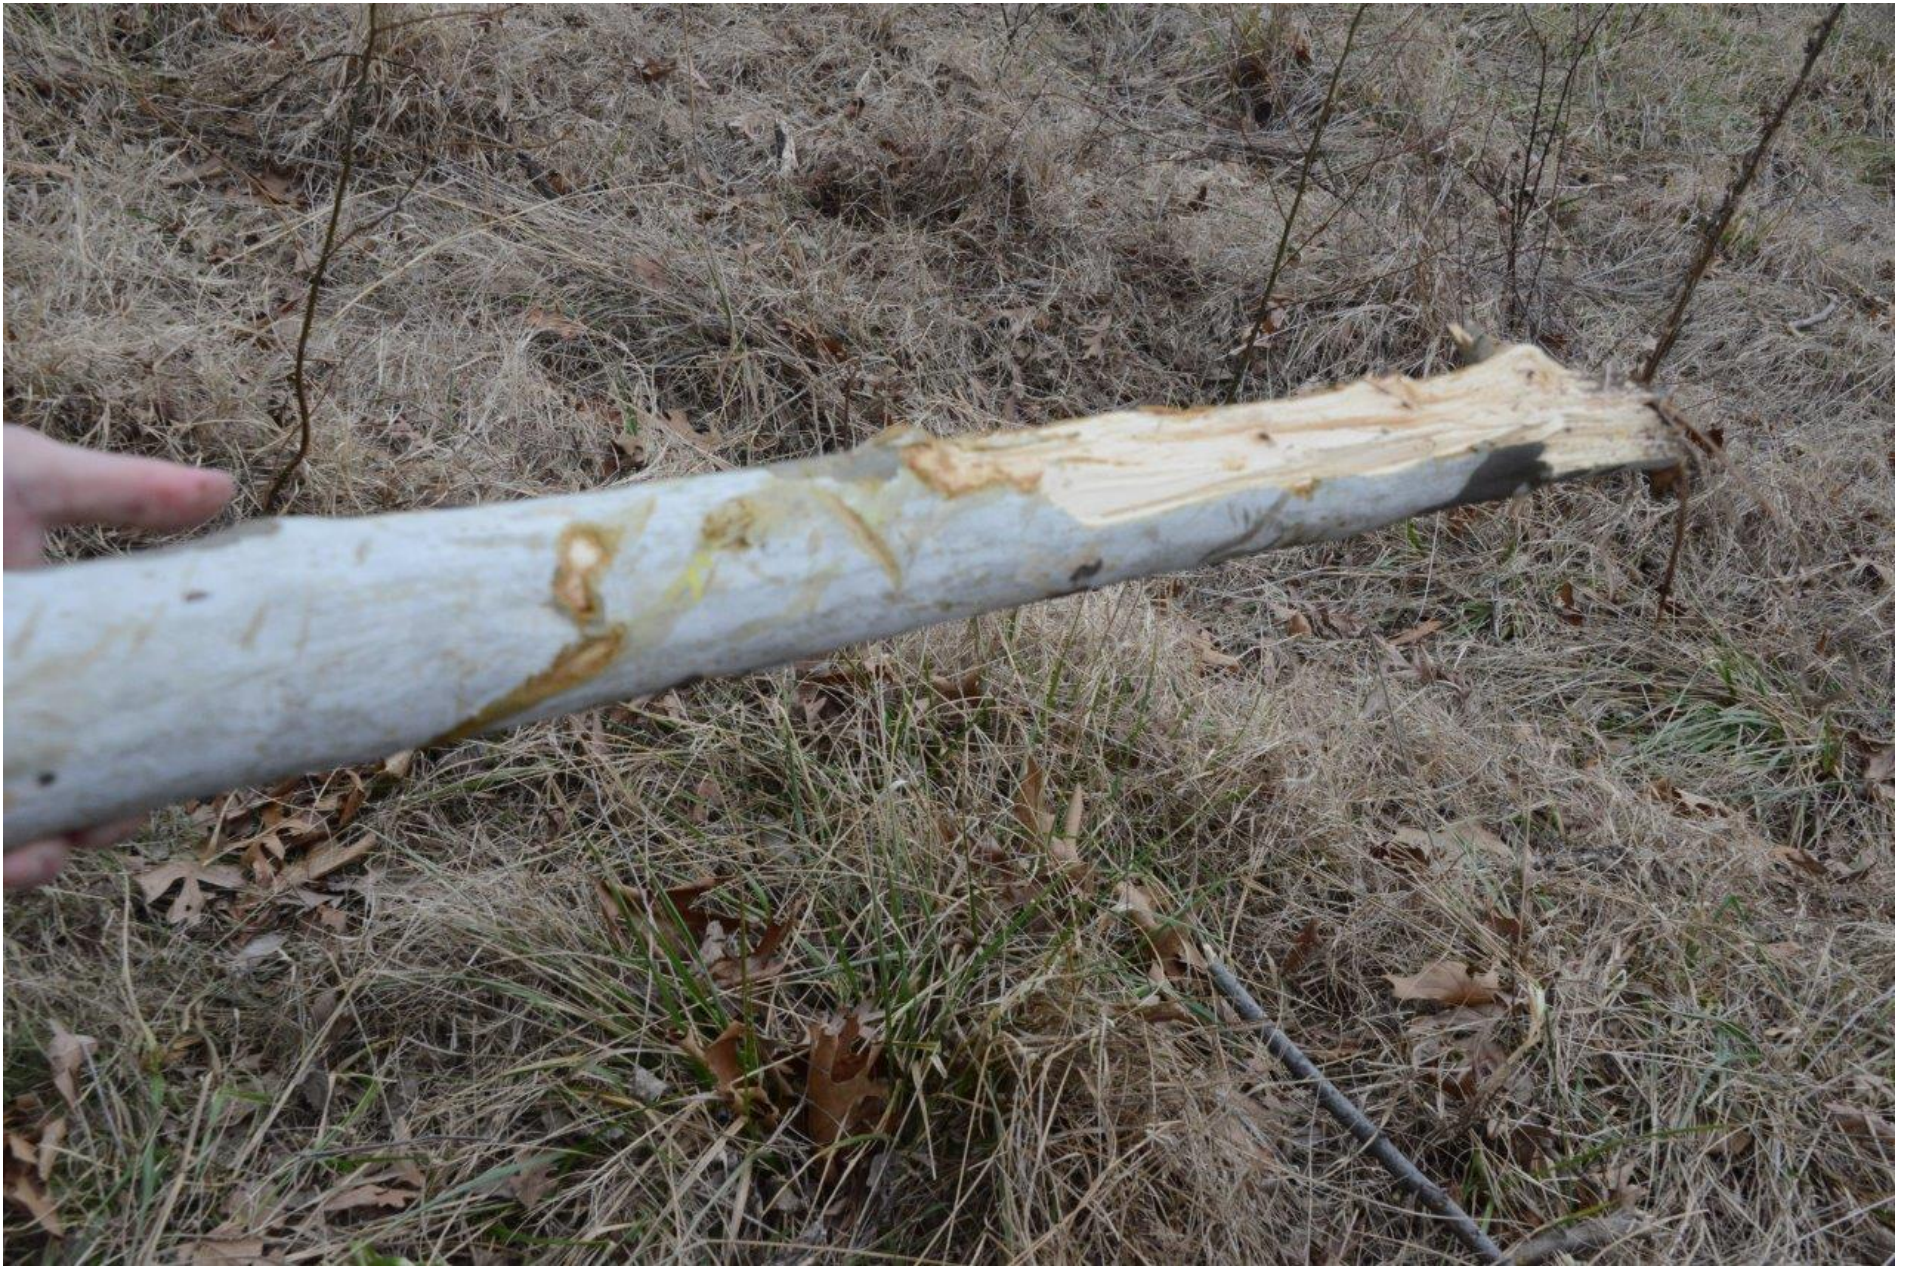
**Photo 9 - View of a broken tree limb with a recent separation.**

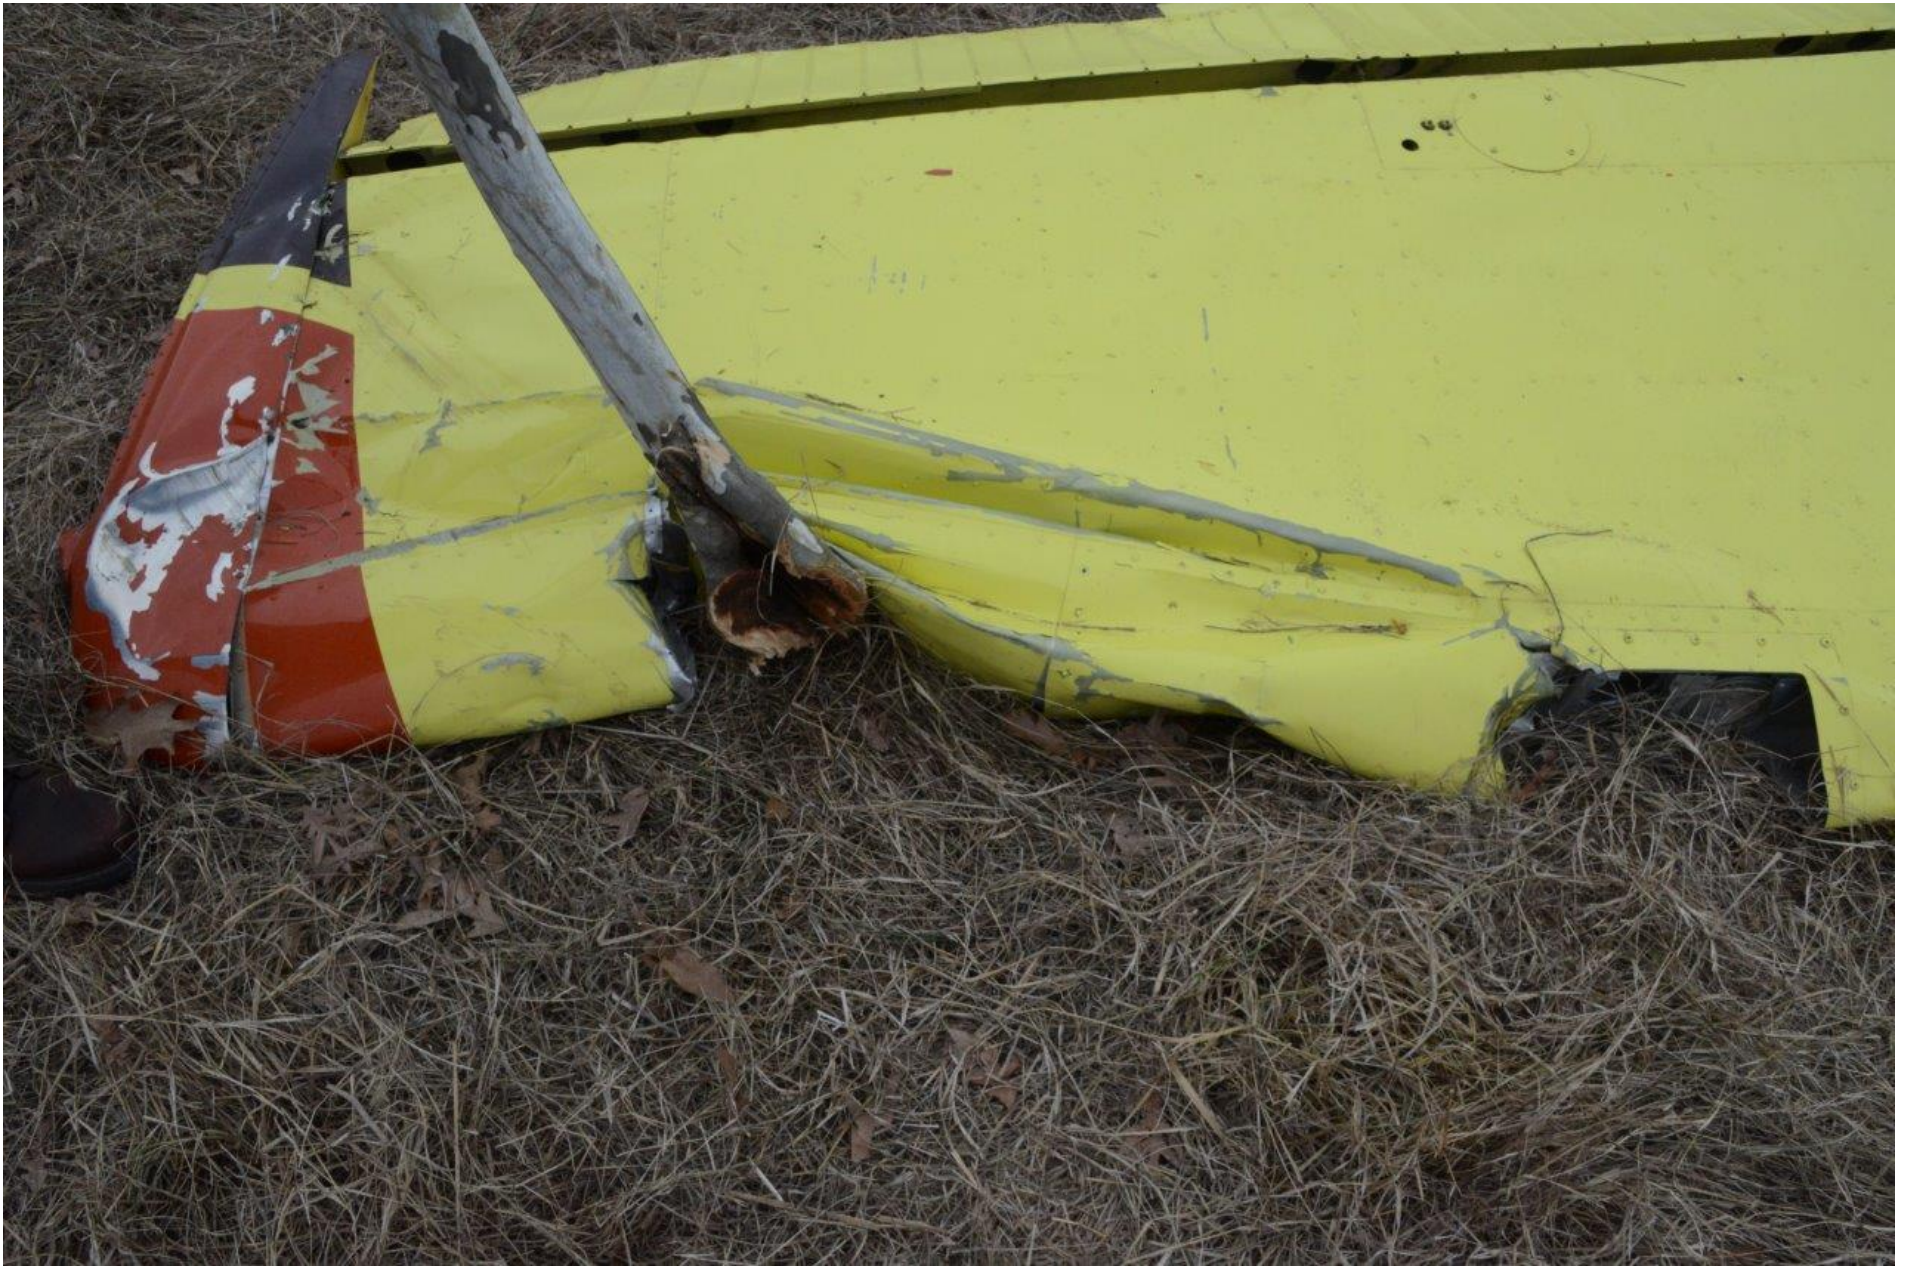
**Photo 10 - View of a broken tree limb placed within the semicircular depression on the leading edge of the left wing.**

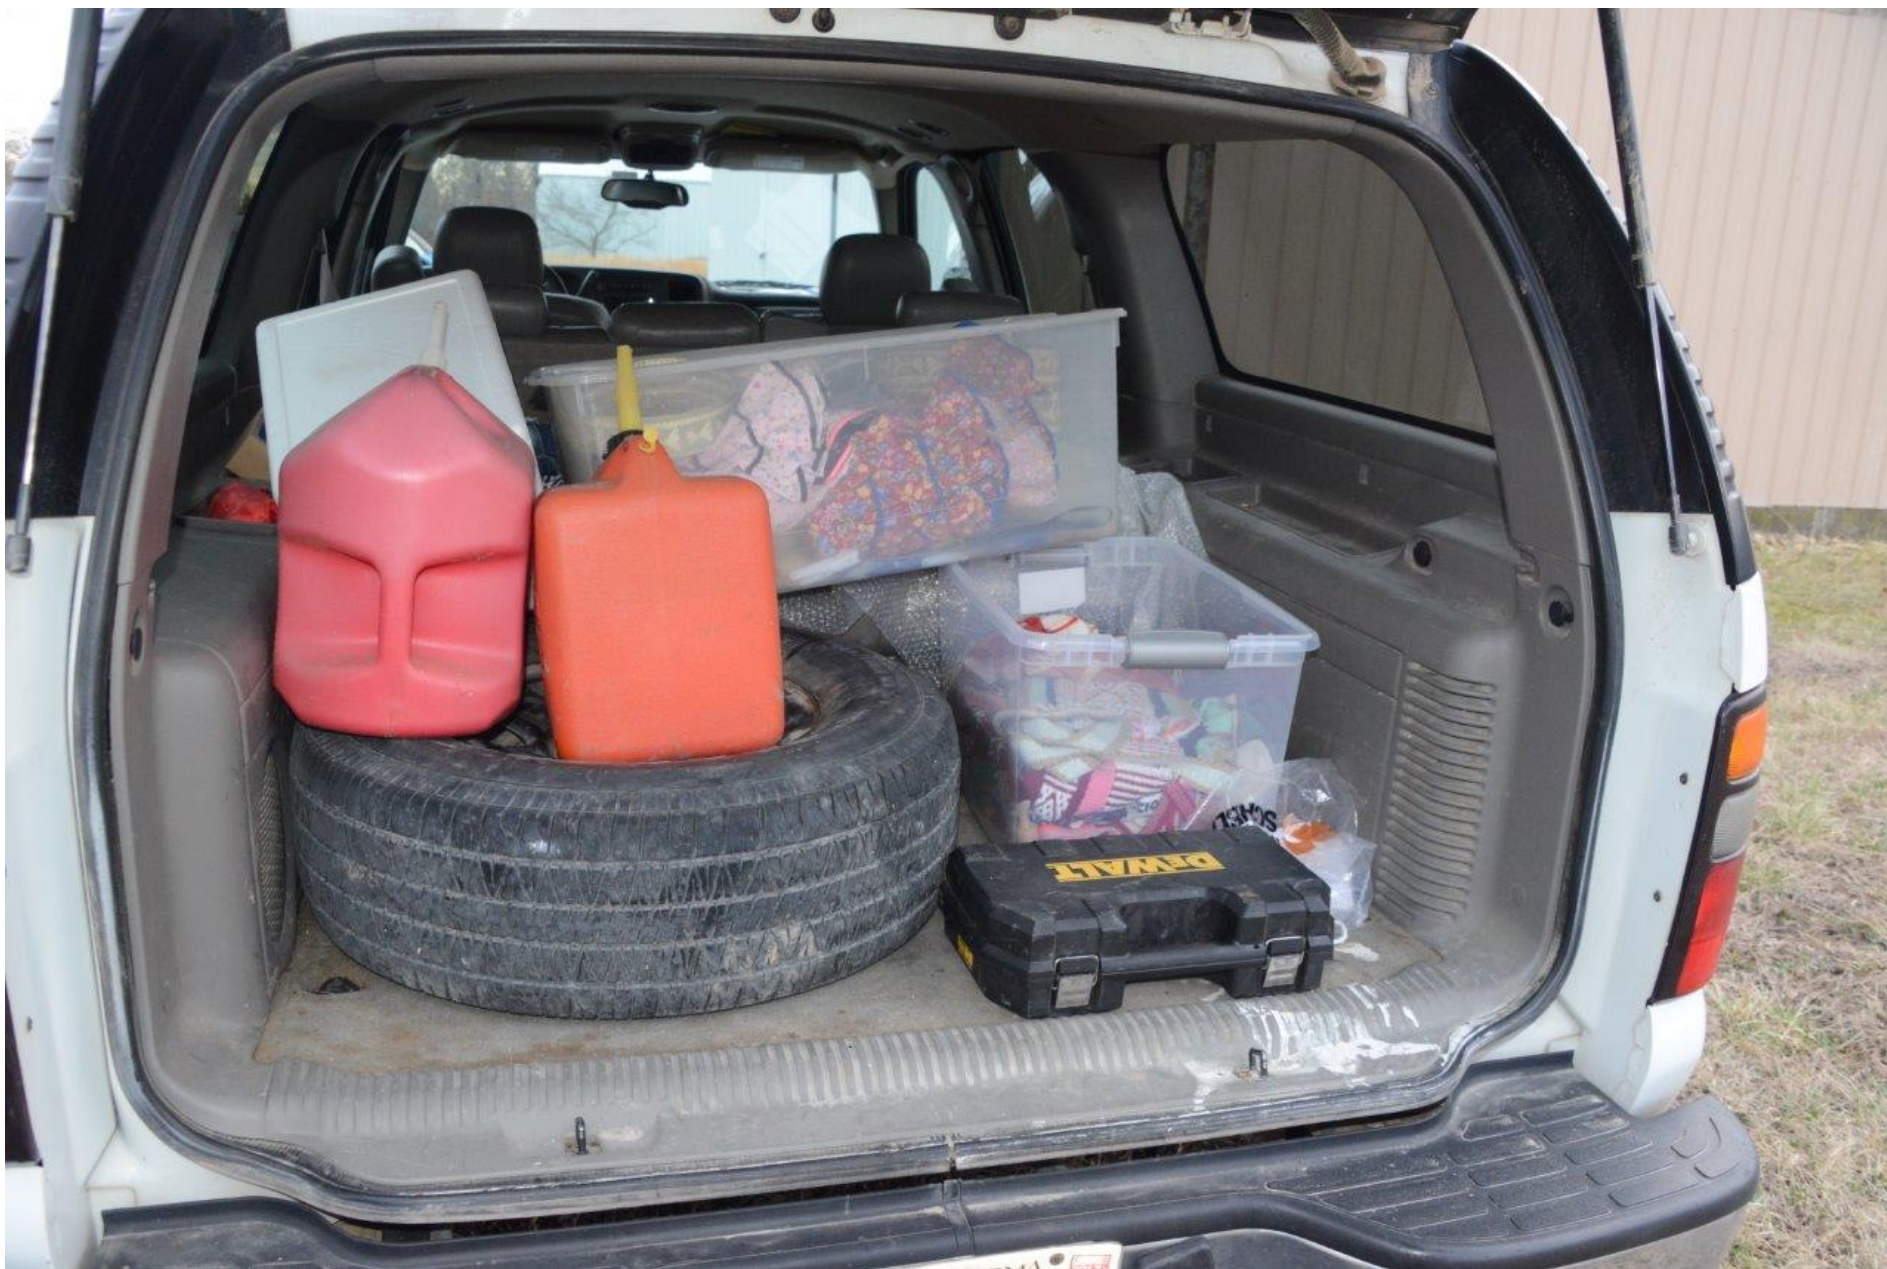
**Photo 11 - Fuel containers observed in the pilot's vehicle.**
