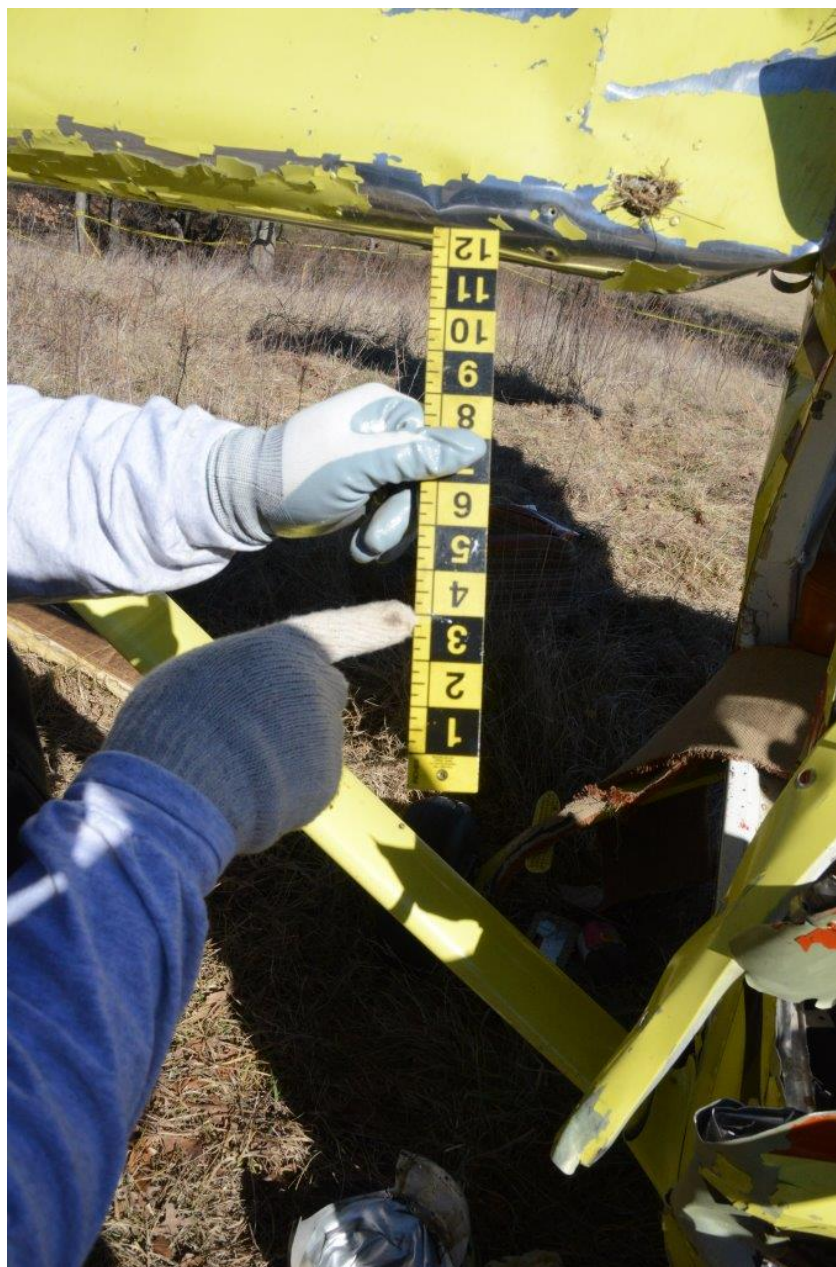
**Photo 12 - Fuel level measured in the right wing.**

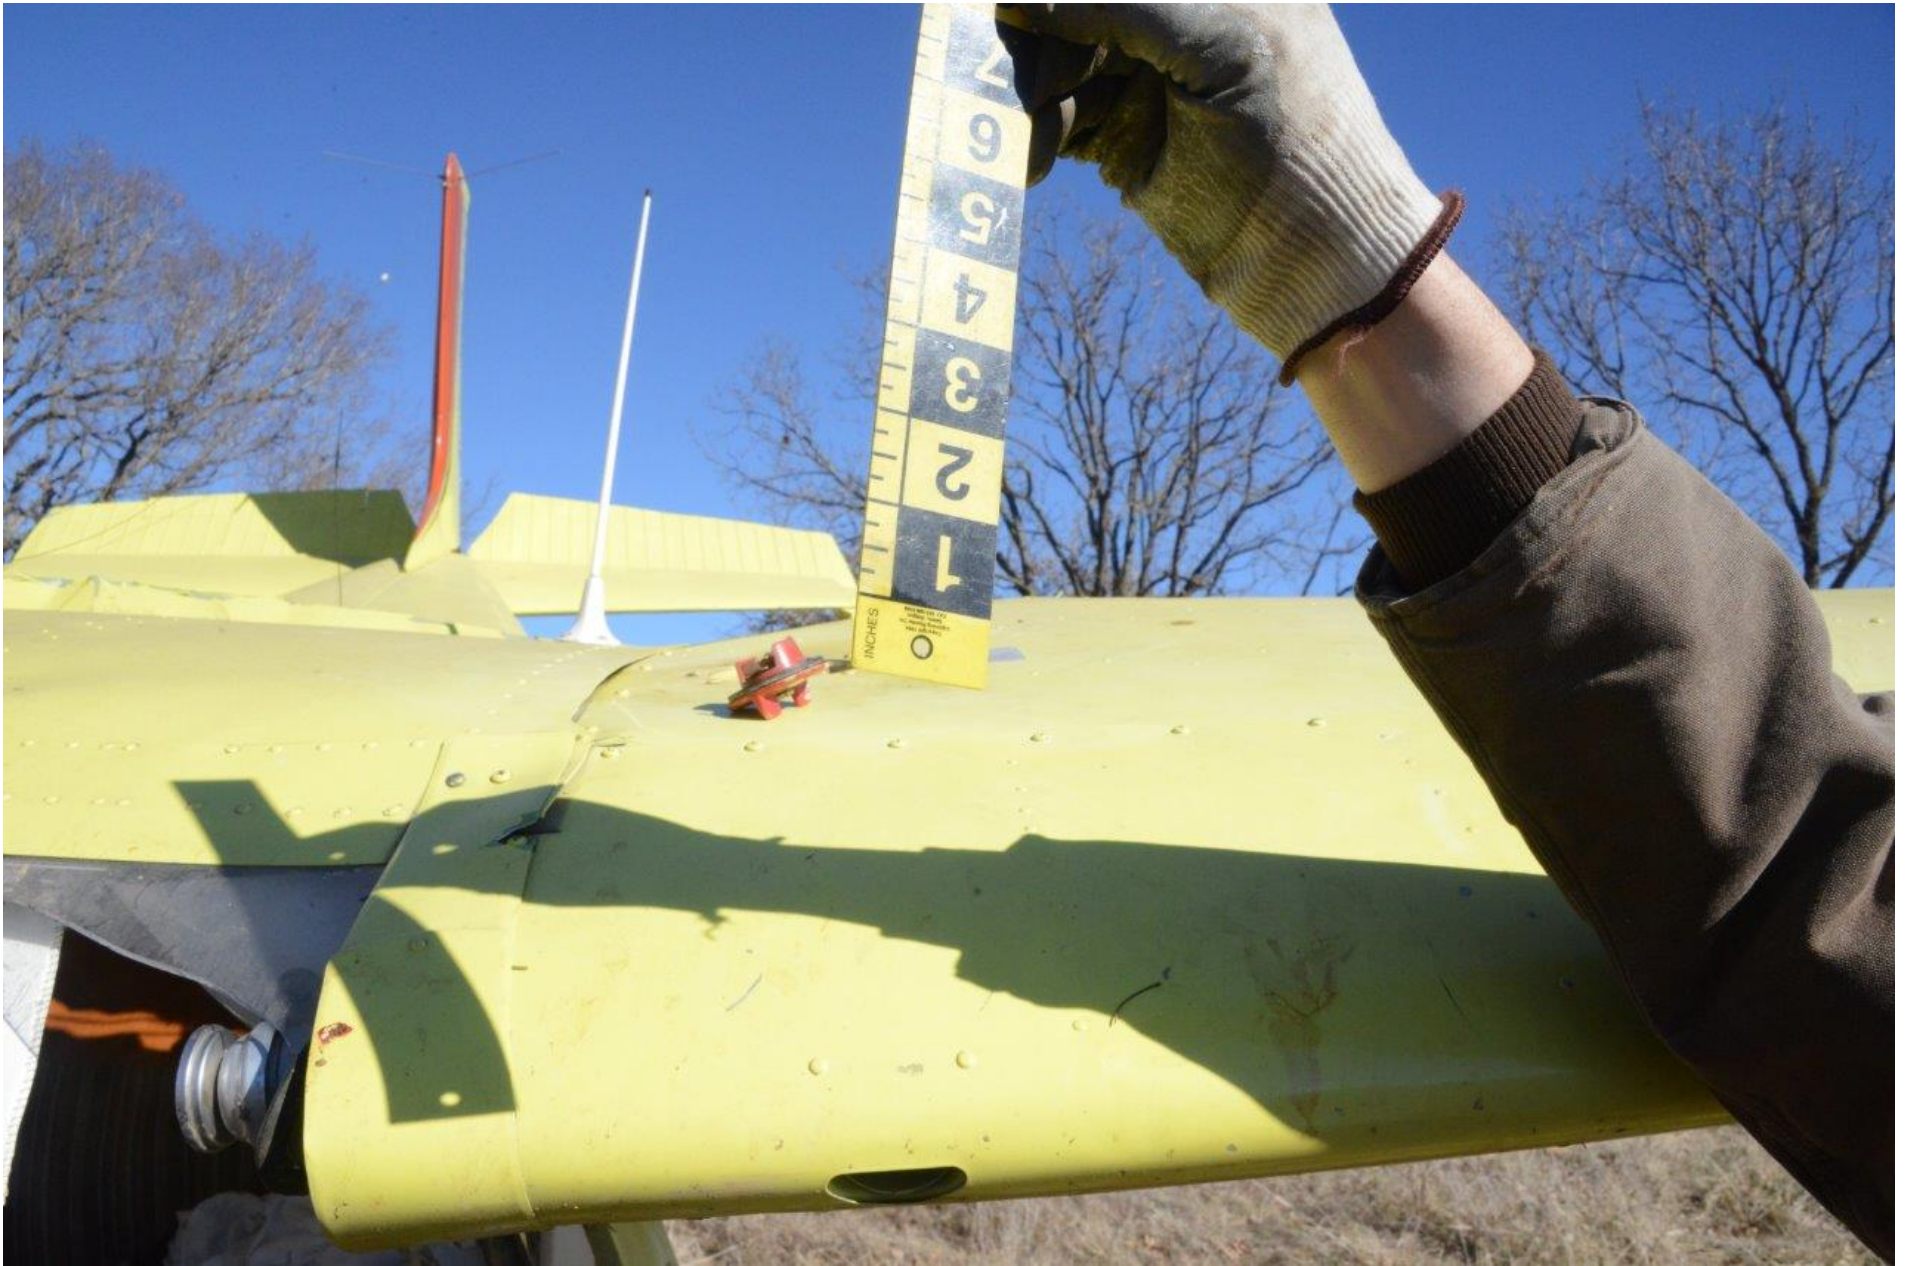
**Photo 13 - Fuel level measured in the left wing.**

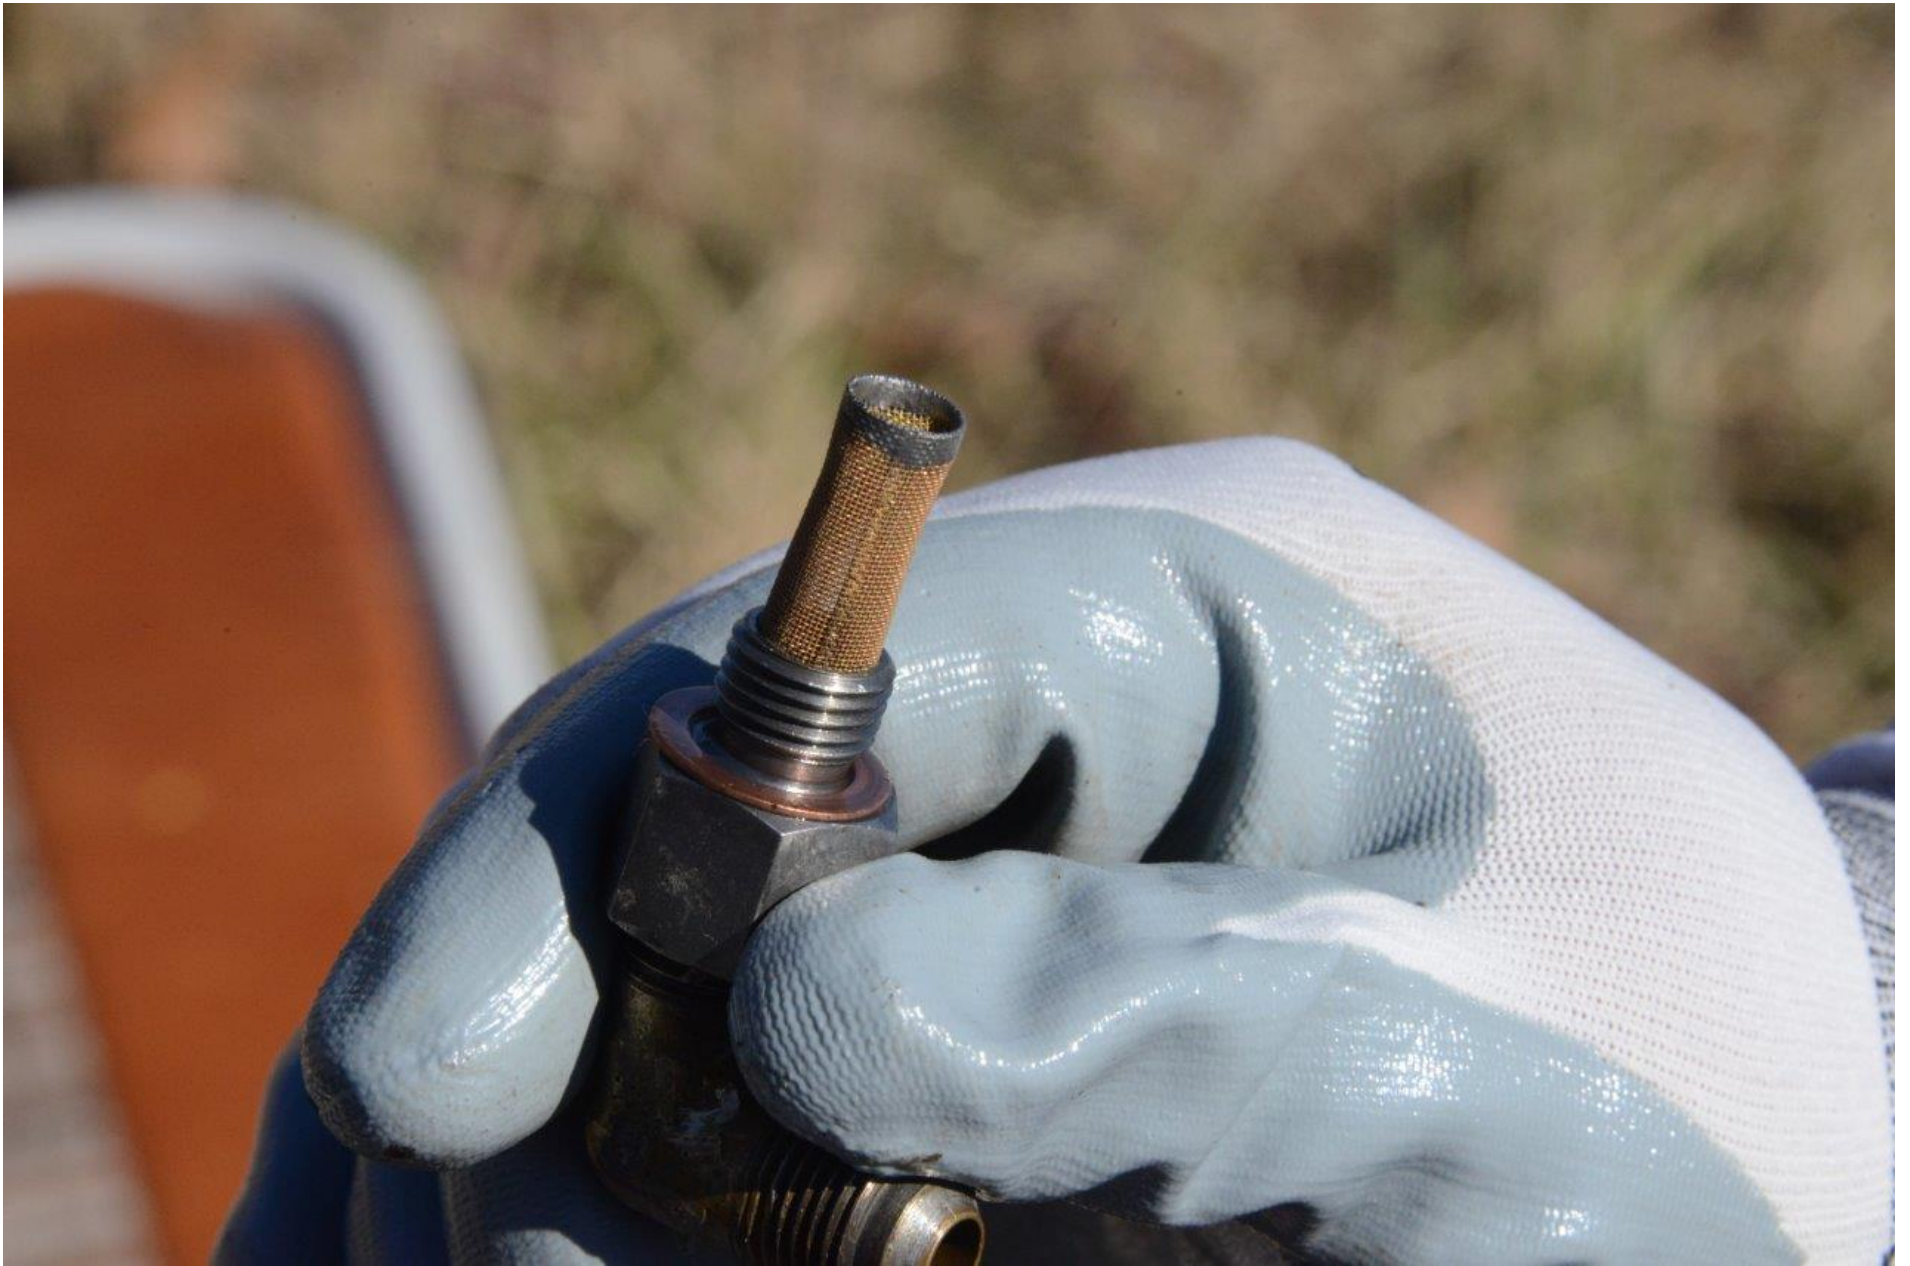
**Photo 14 - View of the carburetor fuel screen.**

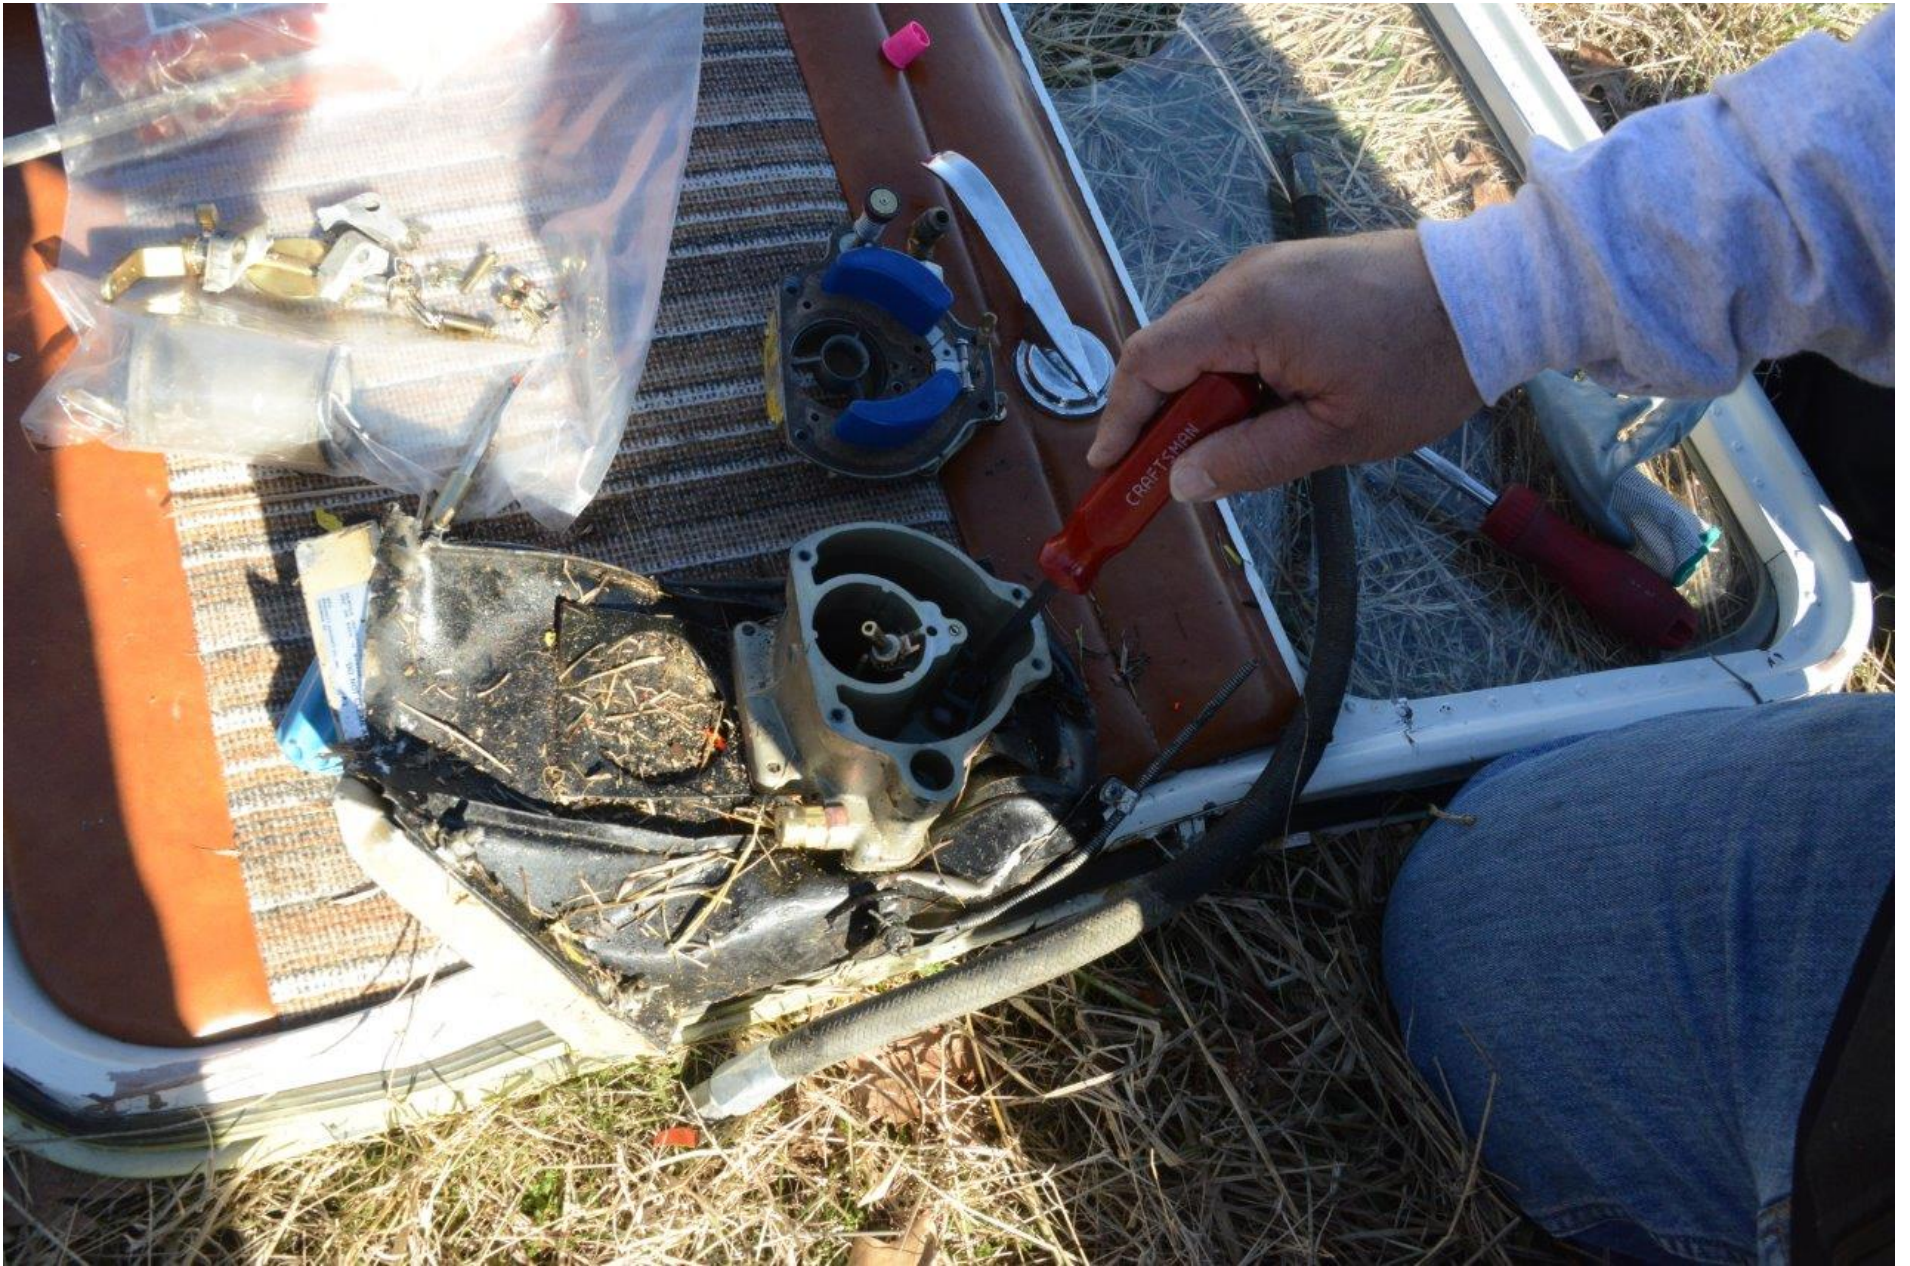
**Photo 15 - View of testing for water in the liquid observed in the carburetor bowl.**

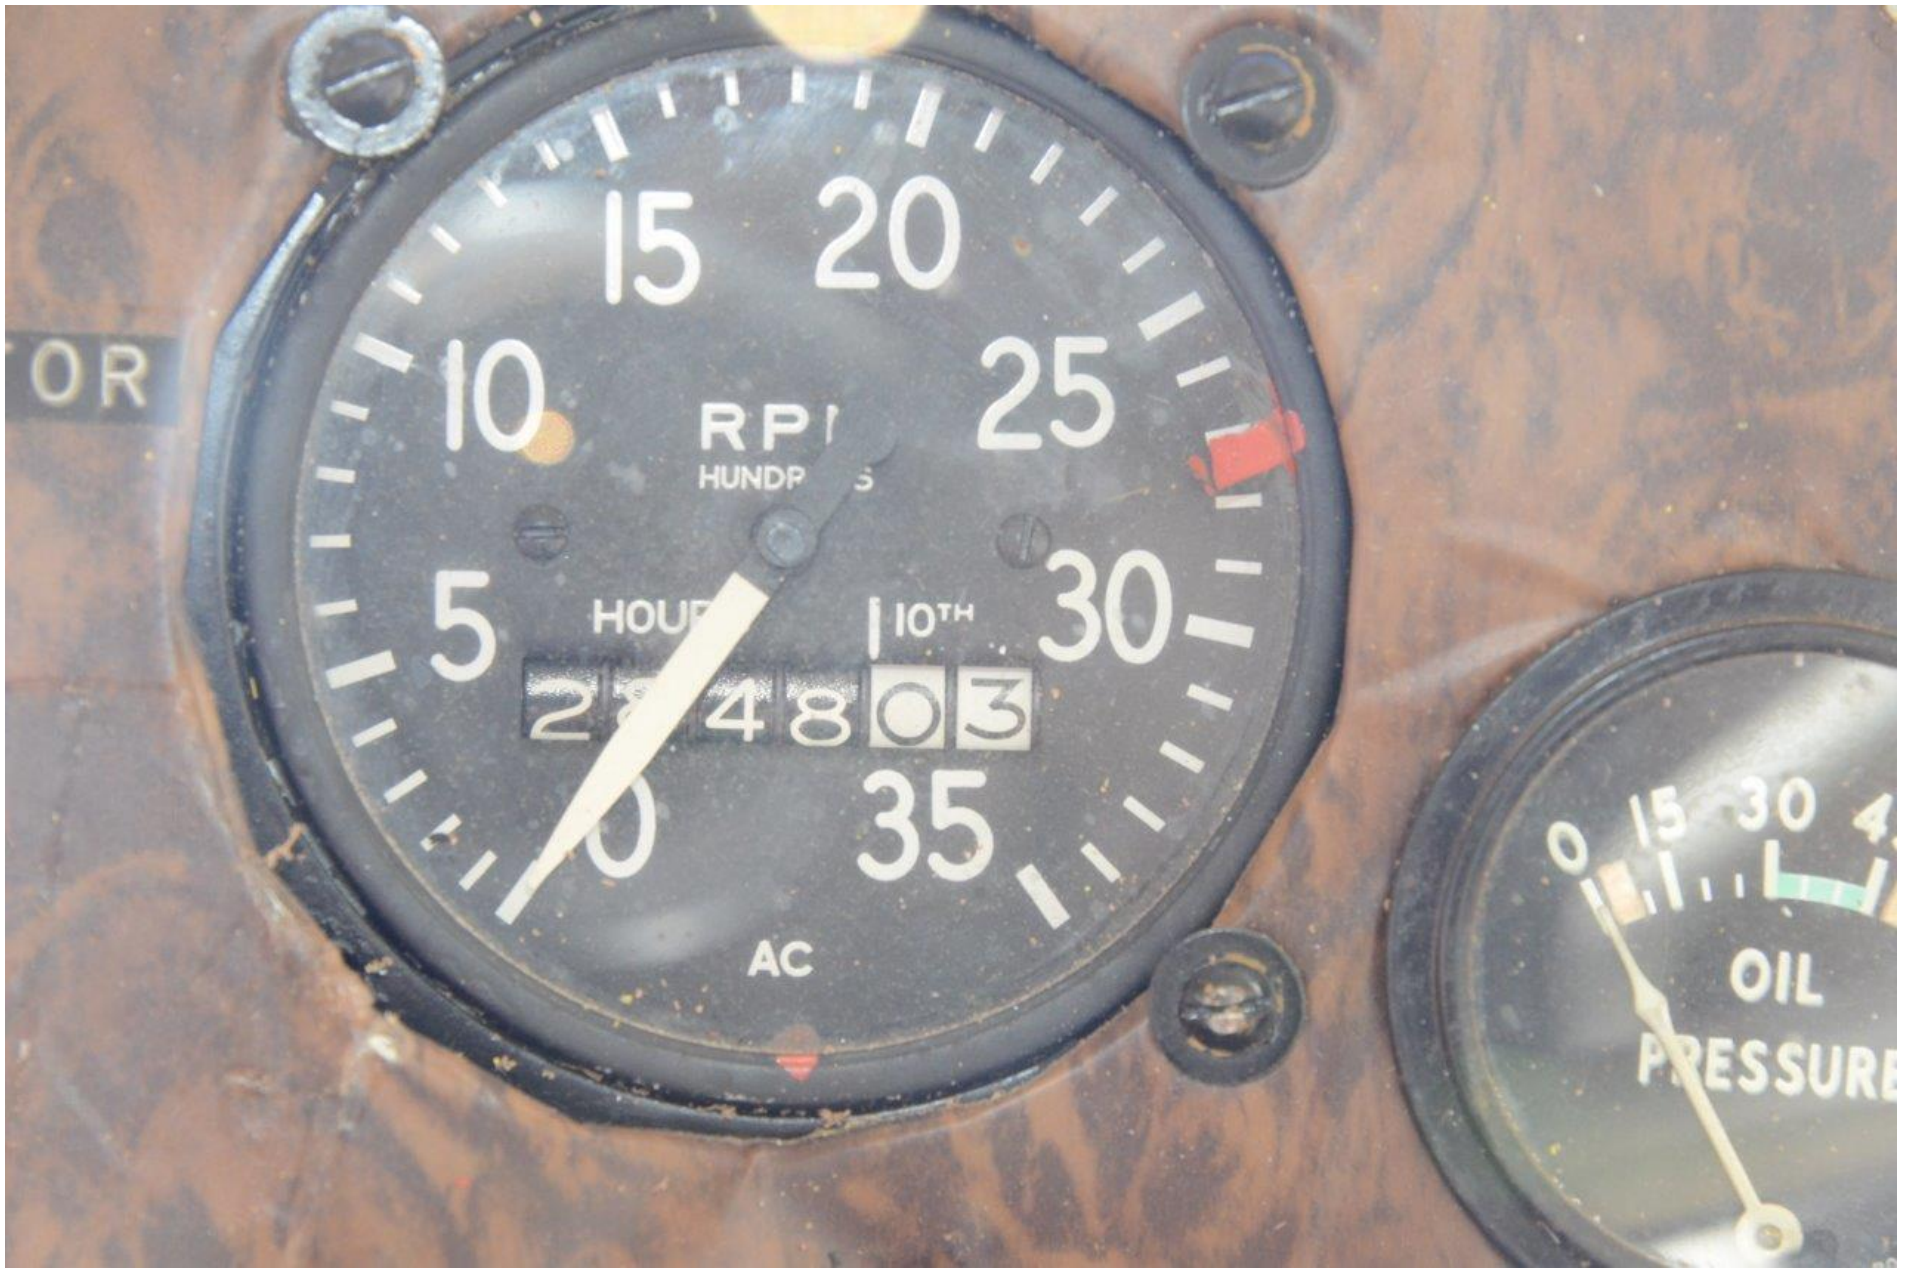
**Photo 16 - View of the tachometer showing an indication of 2848.03 hours.**

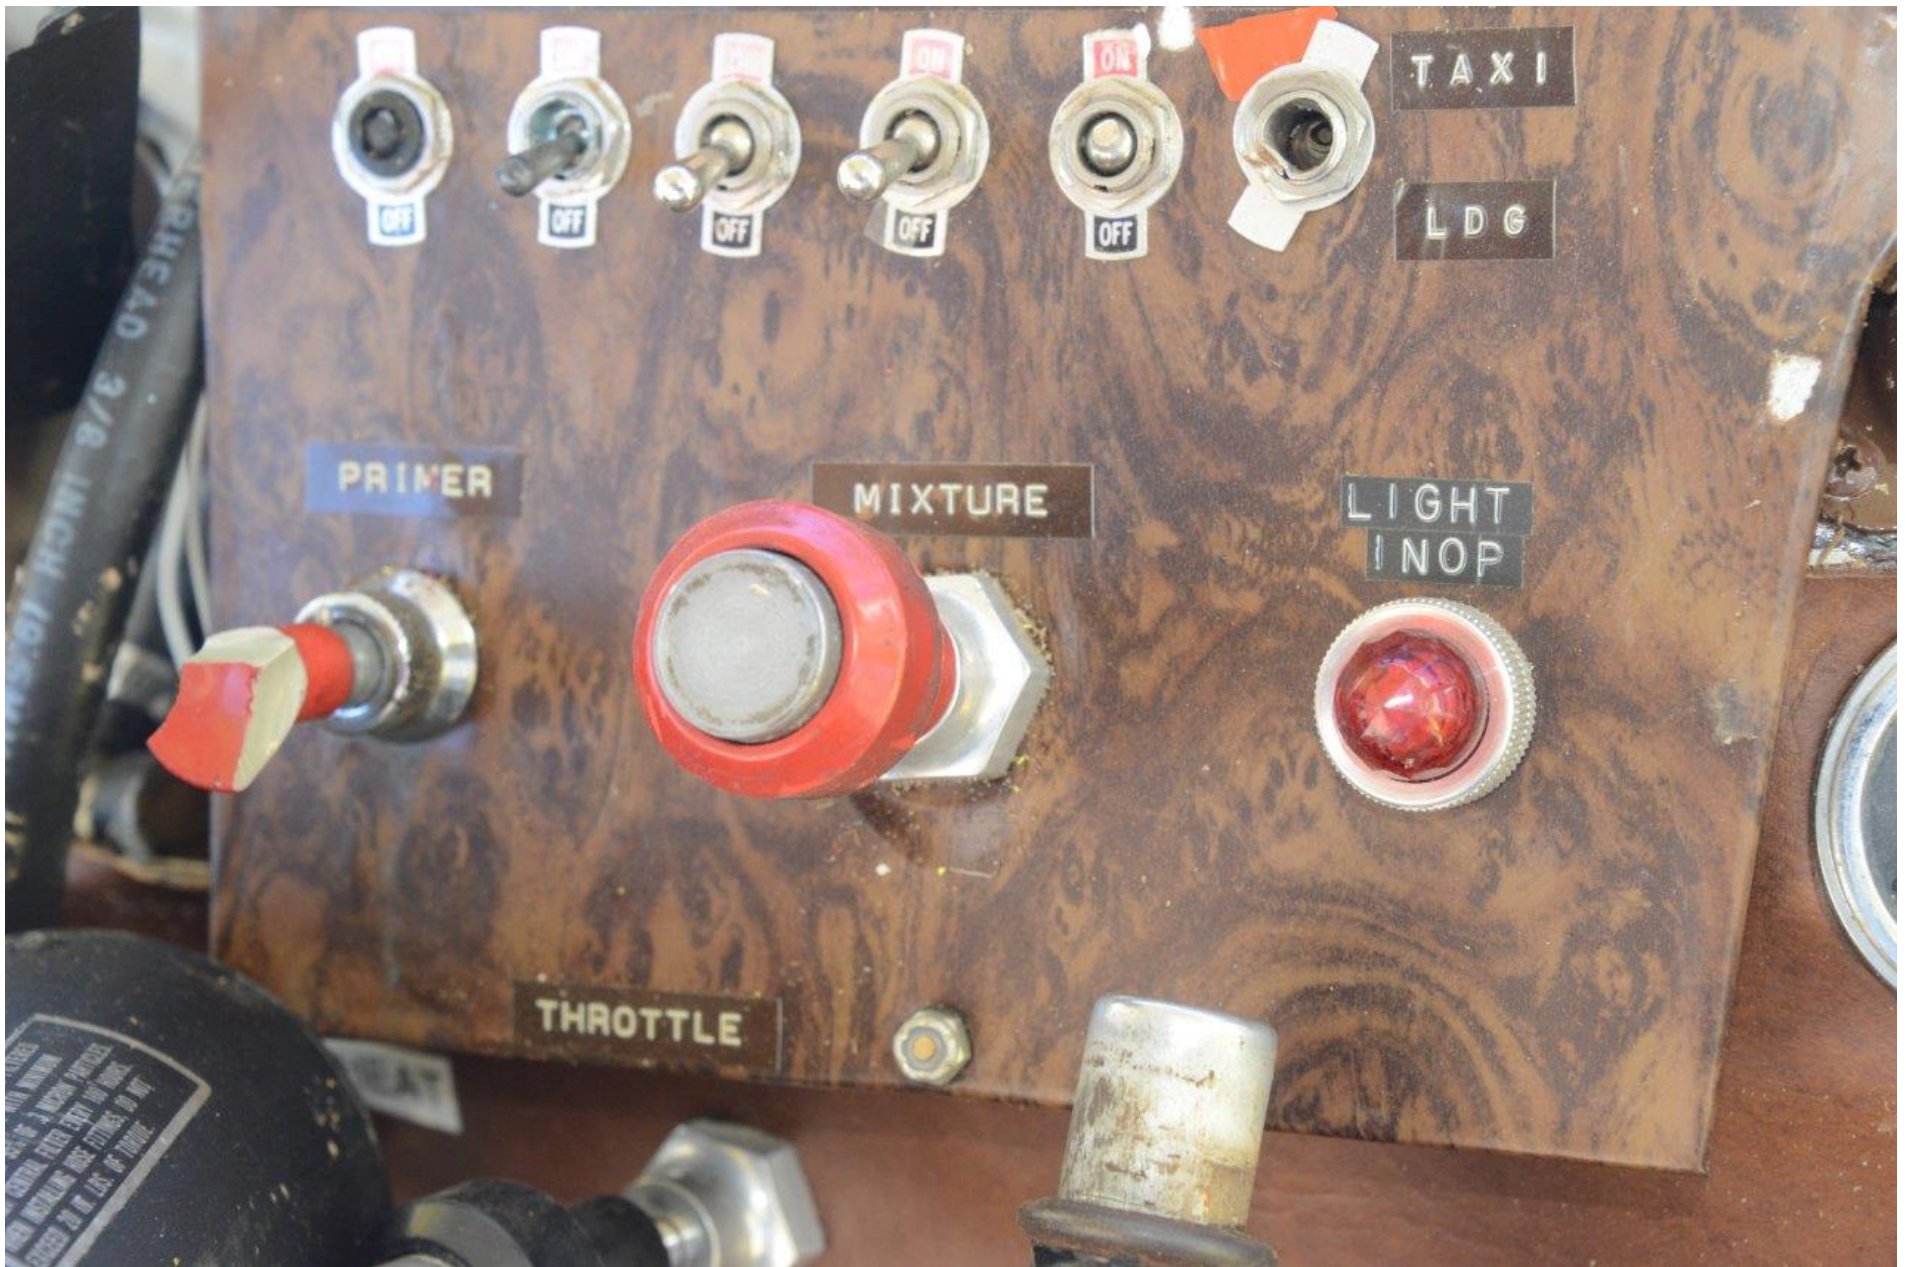
Photo 17 - View of the engine controls and the primer.

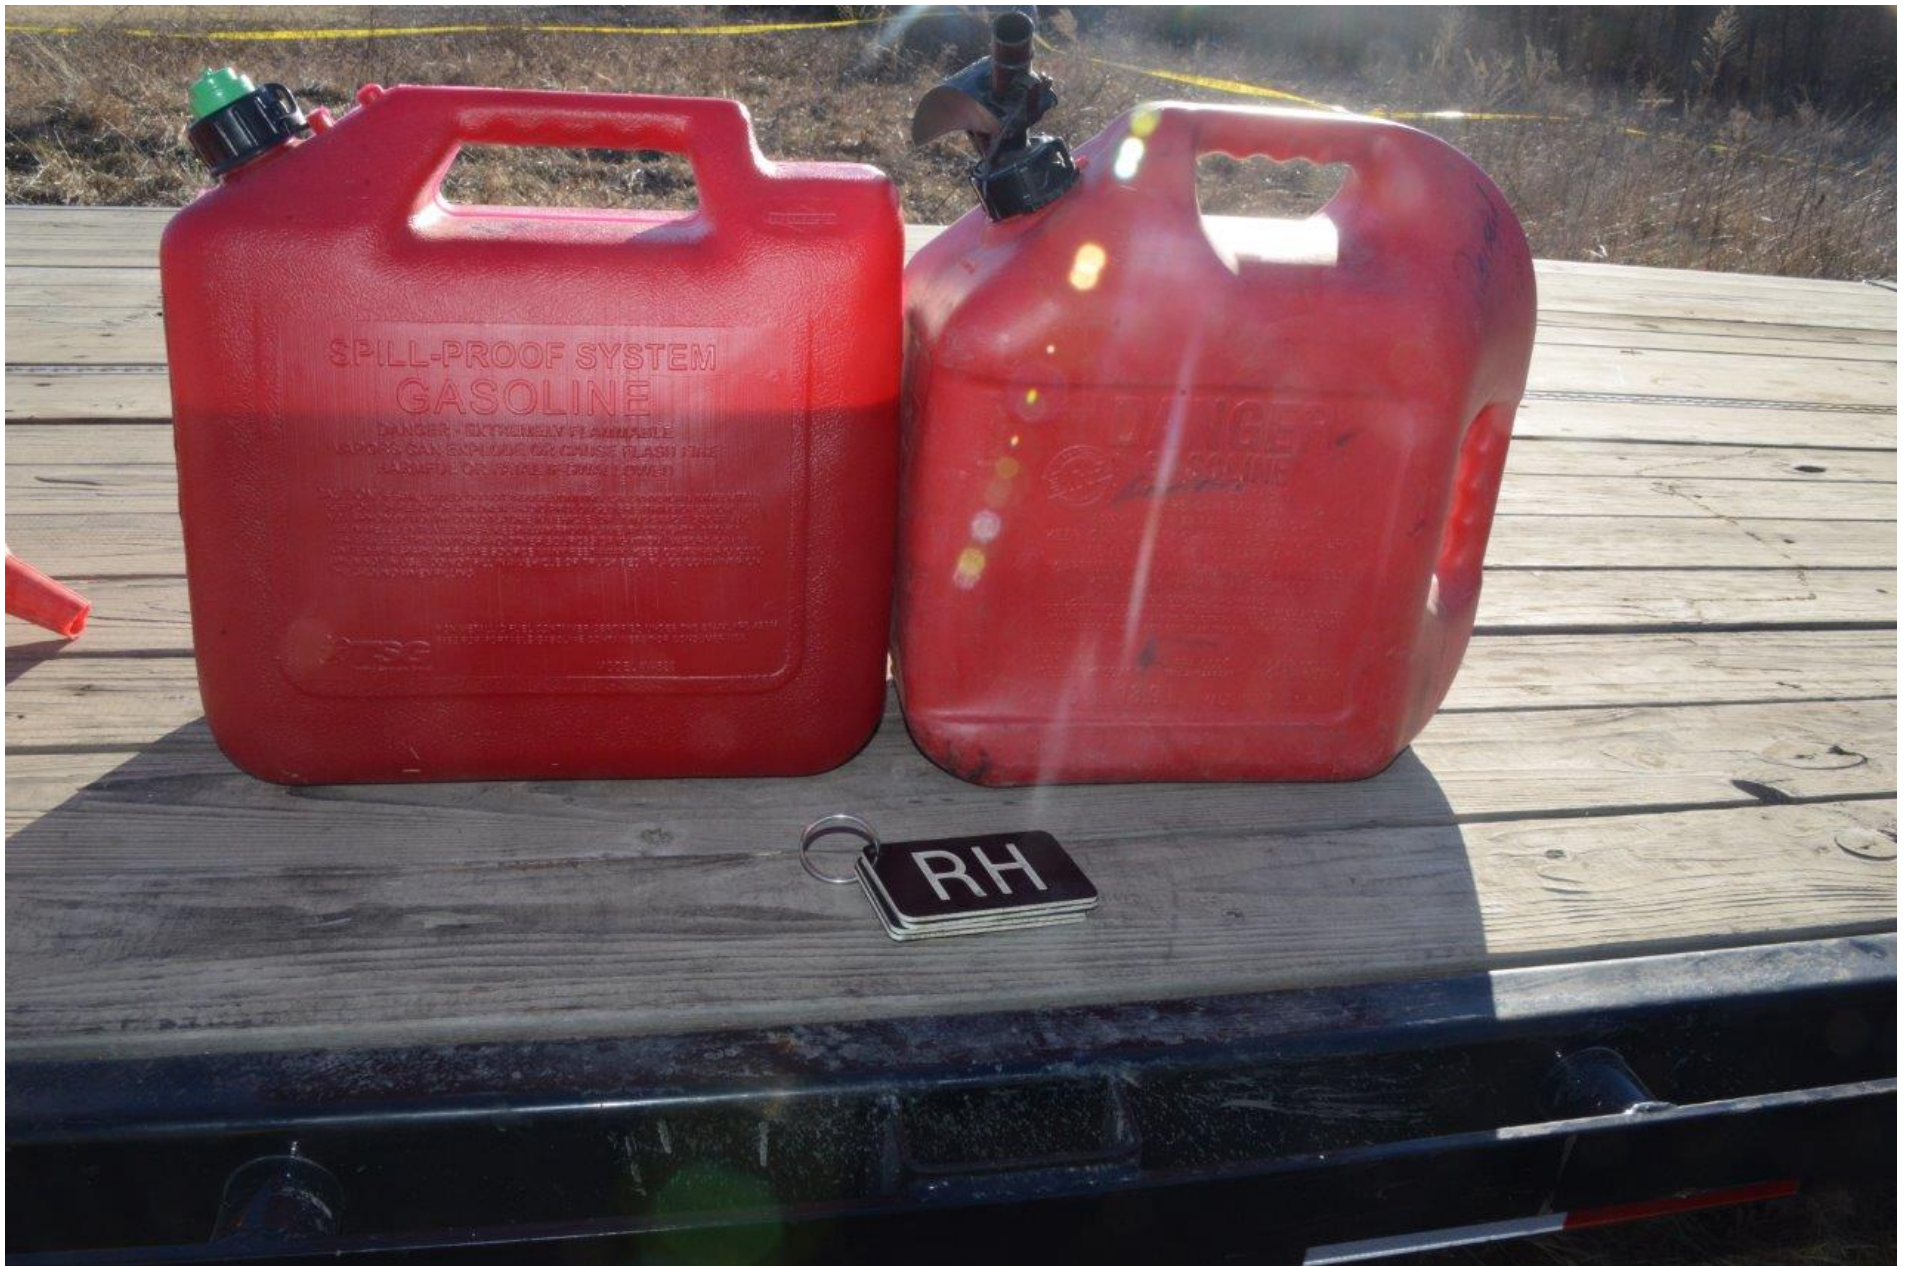
**Photo 18 - View of recovered fuel from the right fuel tank.**

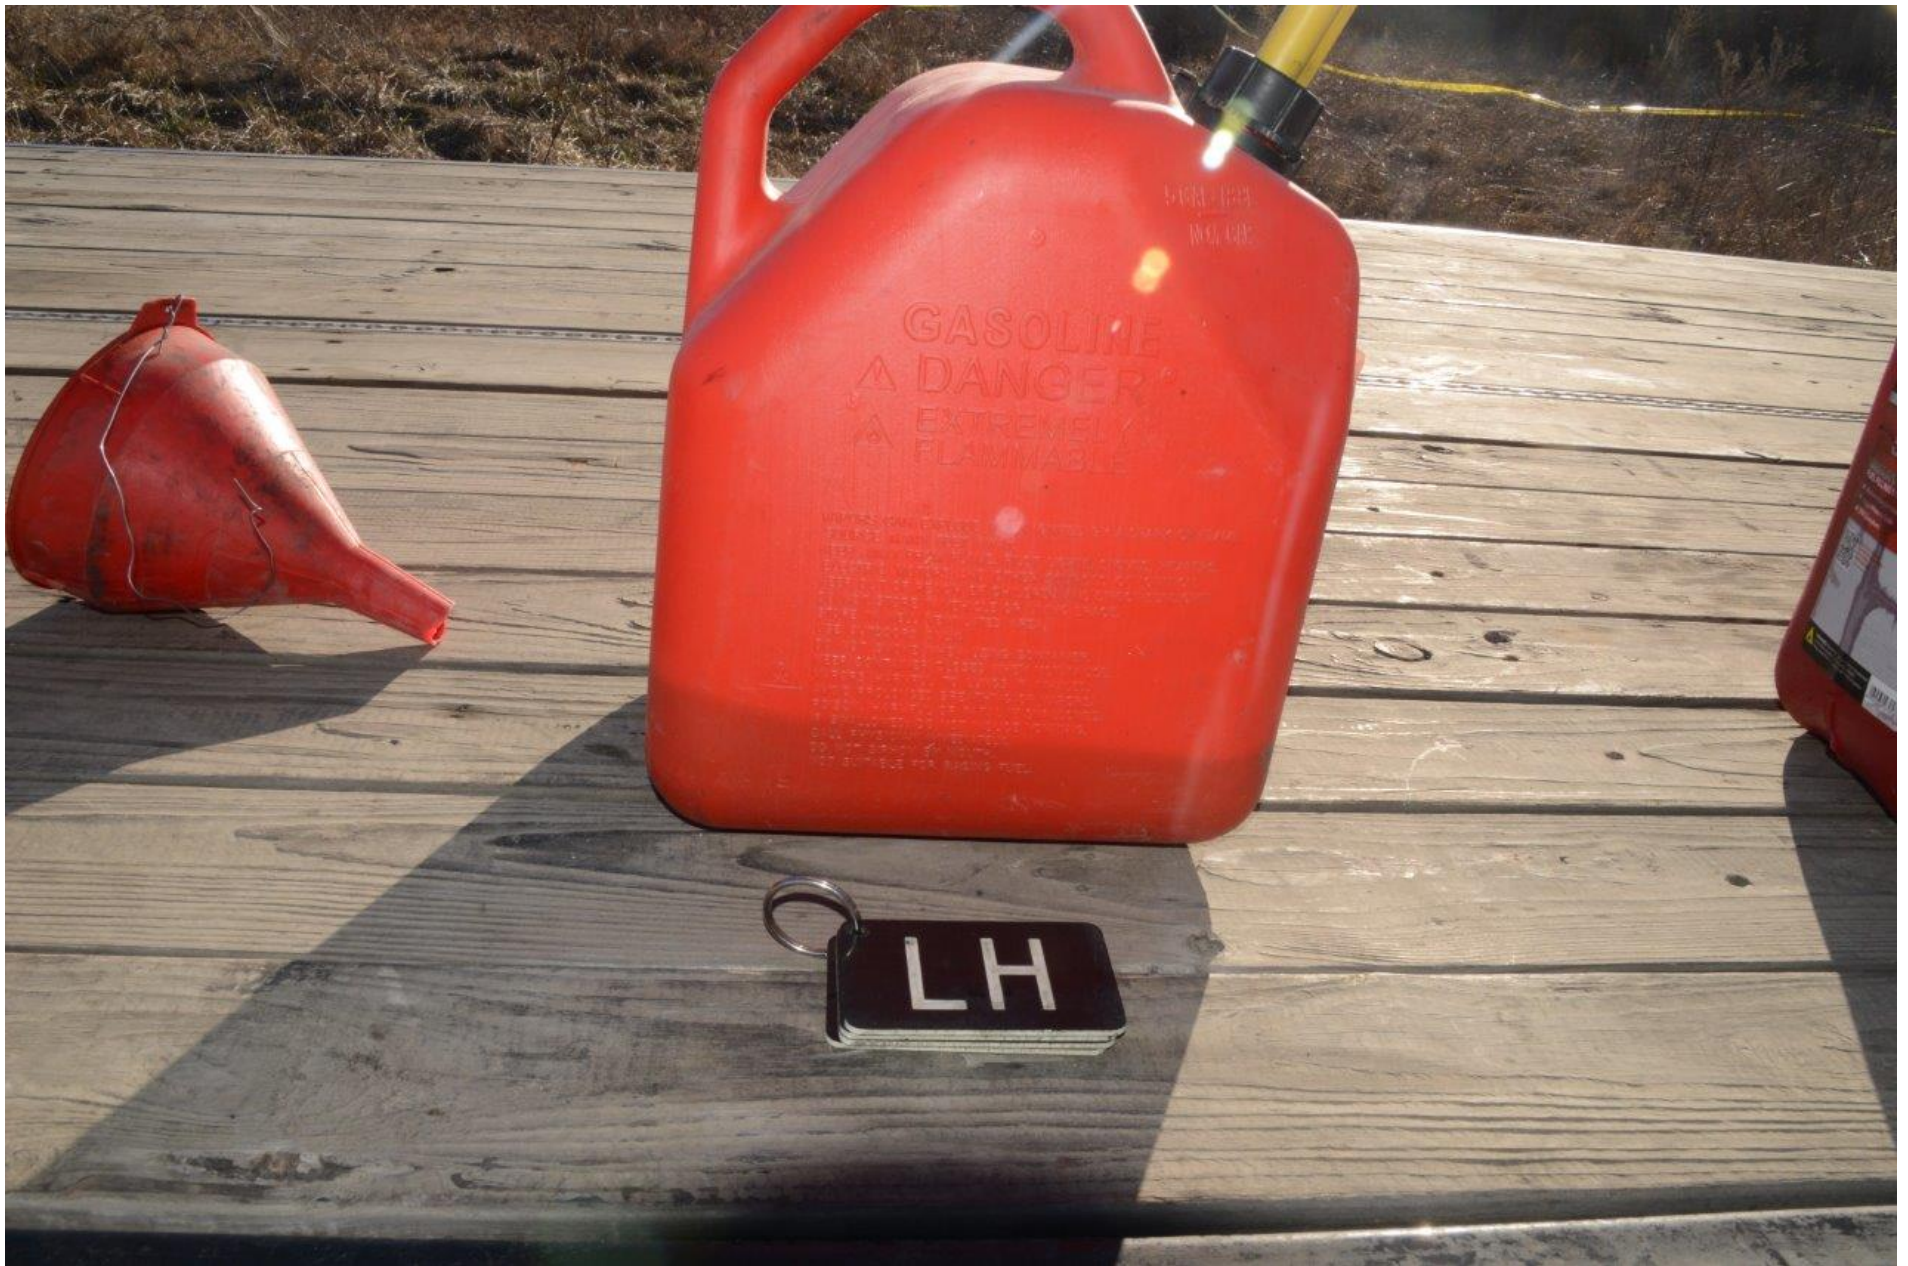
**Photo 19 - View of recovered fuel from the left fuel tank.**

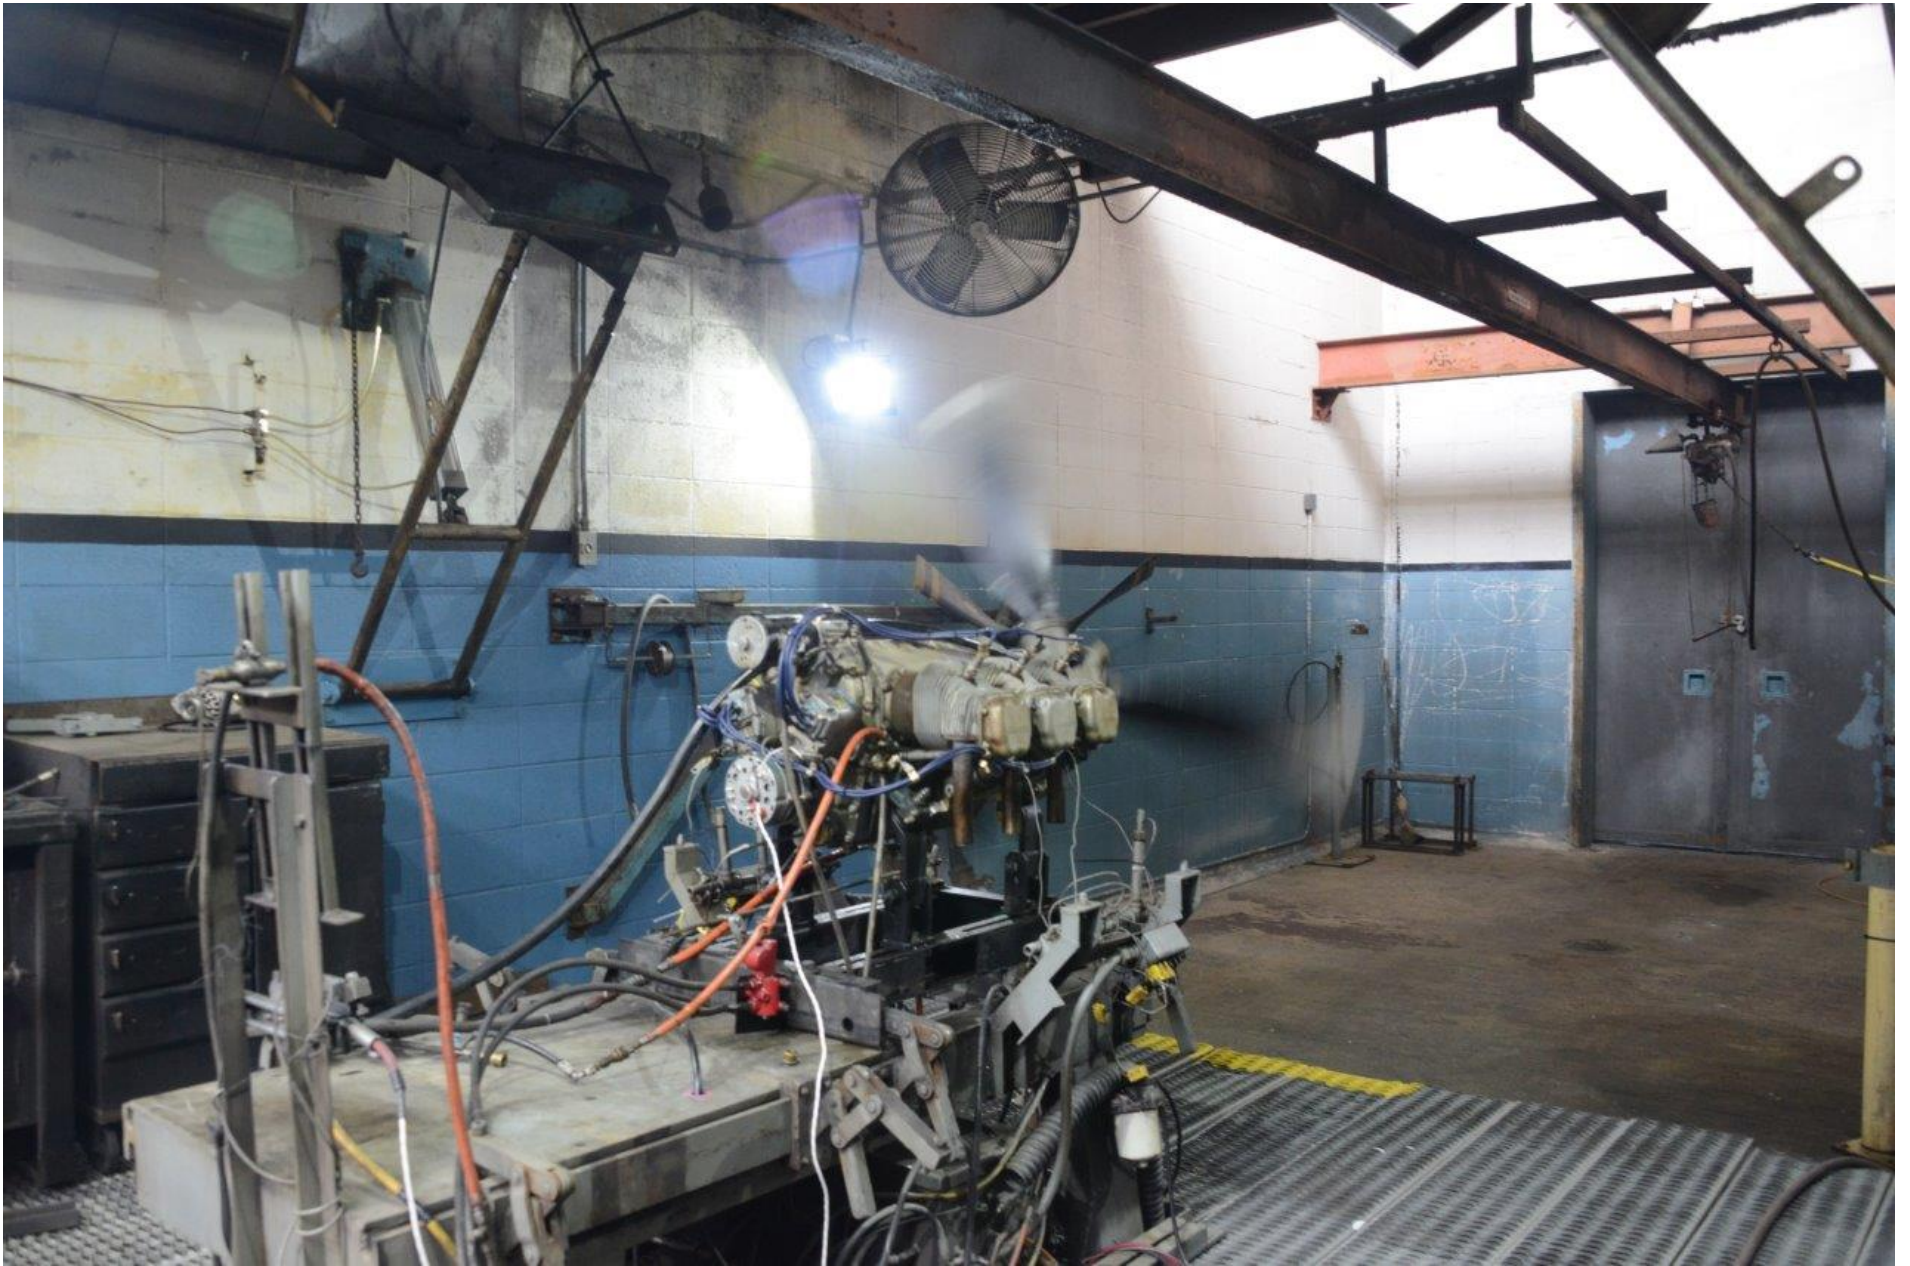
**Photo 20 - View of the accident engine operational during an engine run.**
