# Republic Helicopter Salvage Job

CODA Echoscope 3D Multibeam Survey

February 8, 2017

T&T Marine Salvage

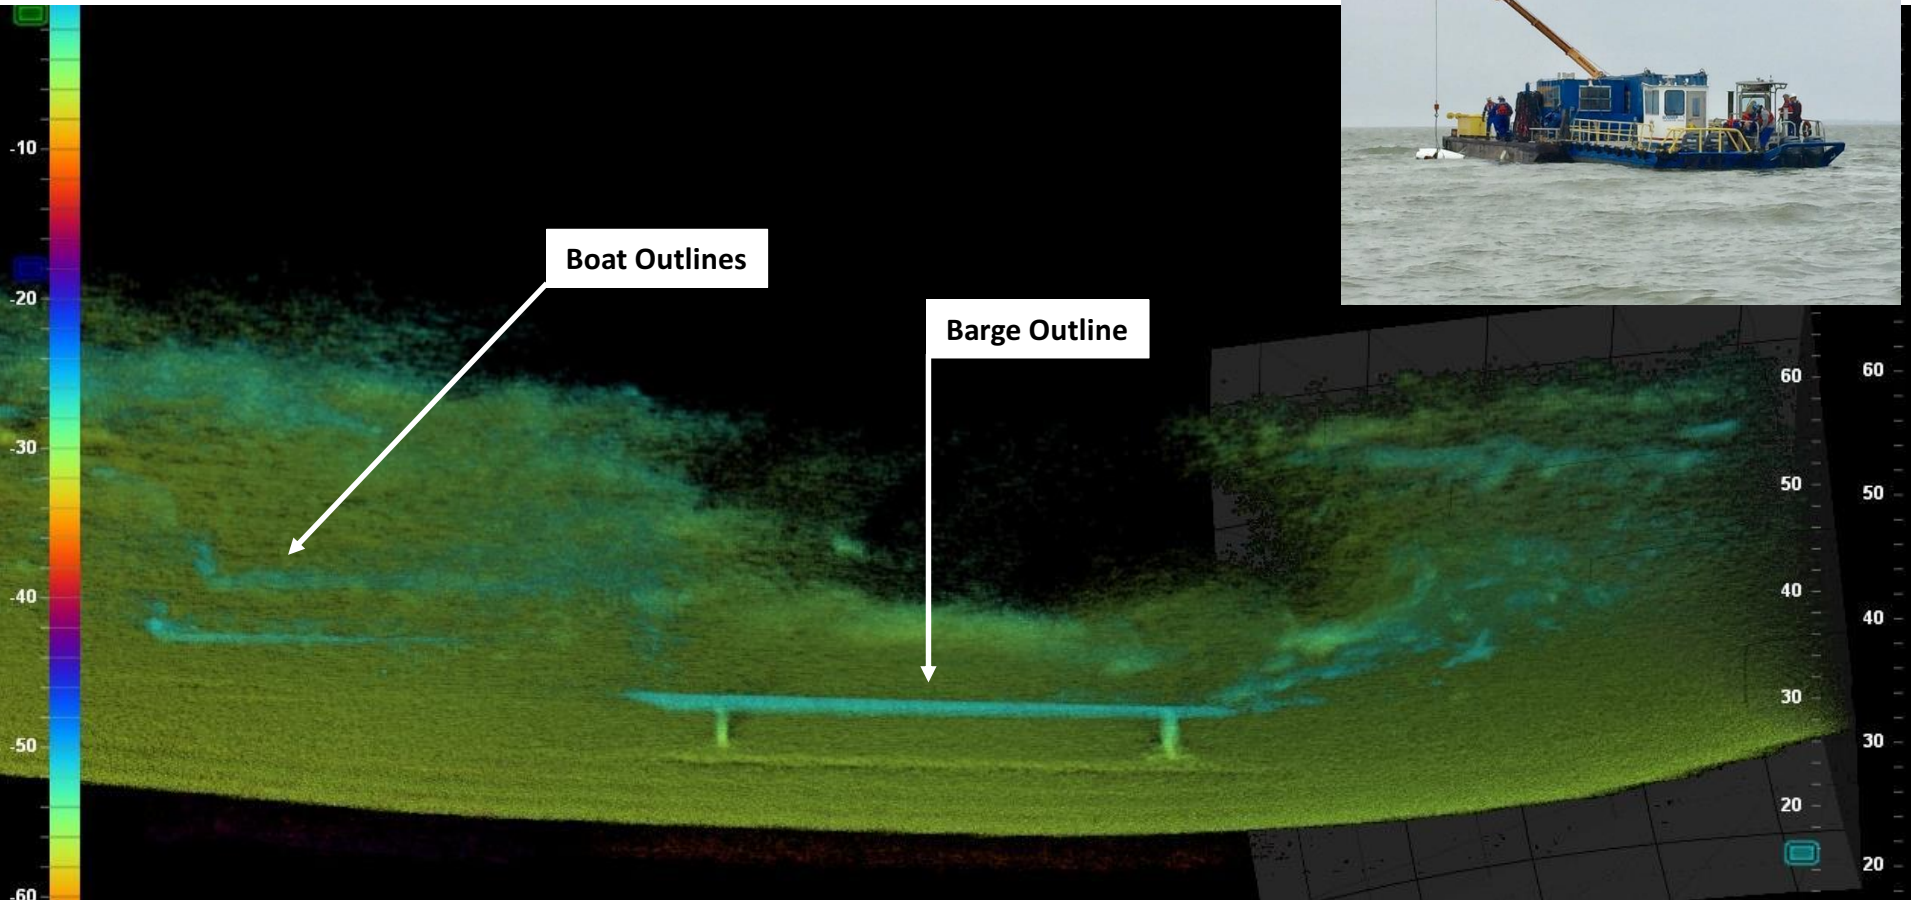
Platform

Visual Inspection Findings: Footing spuds and base of crane barge. The outline of the 2 assist boats is also visible.

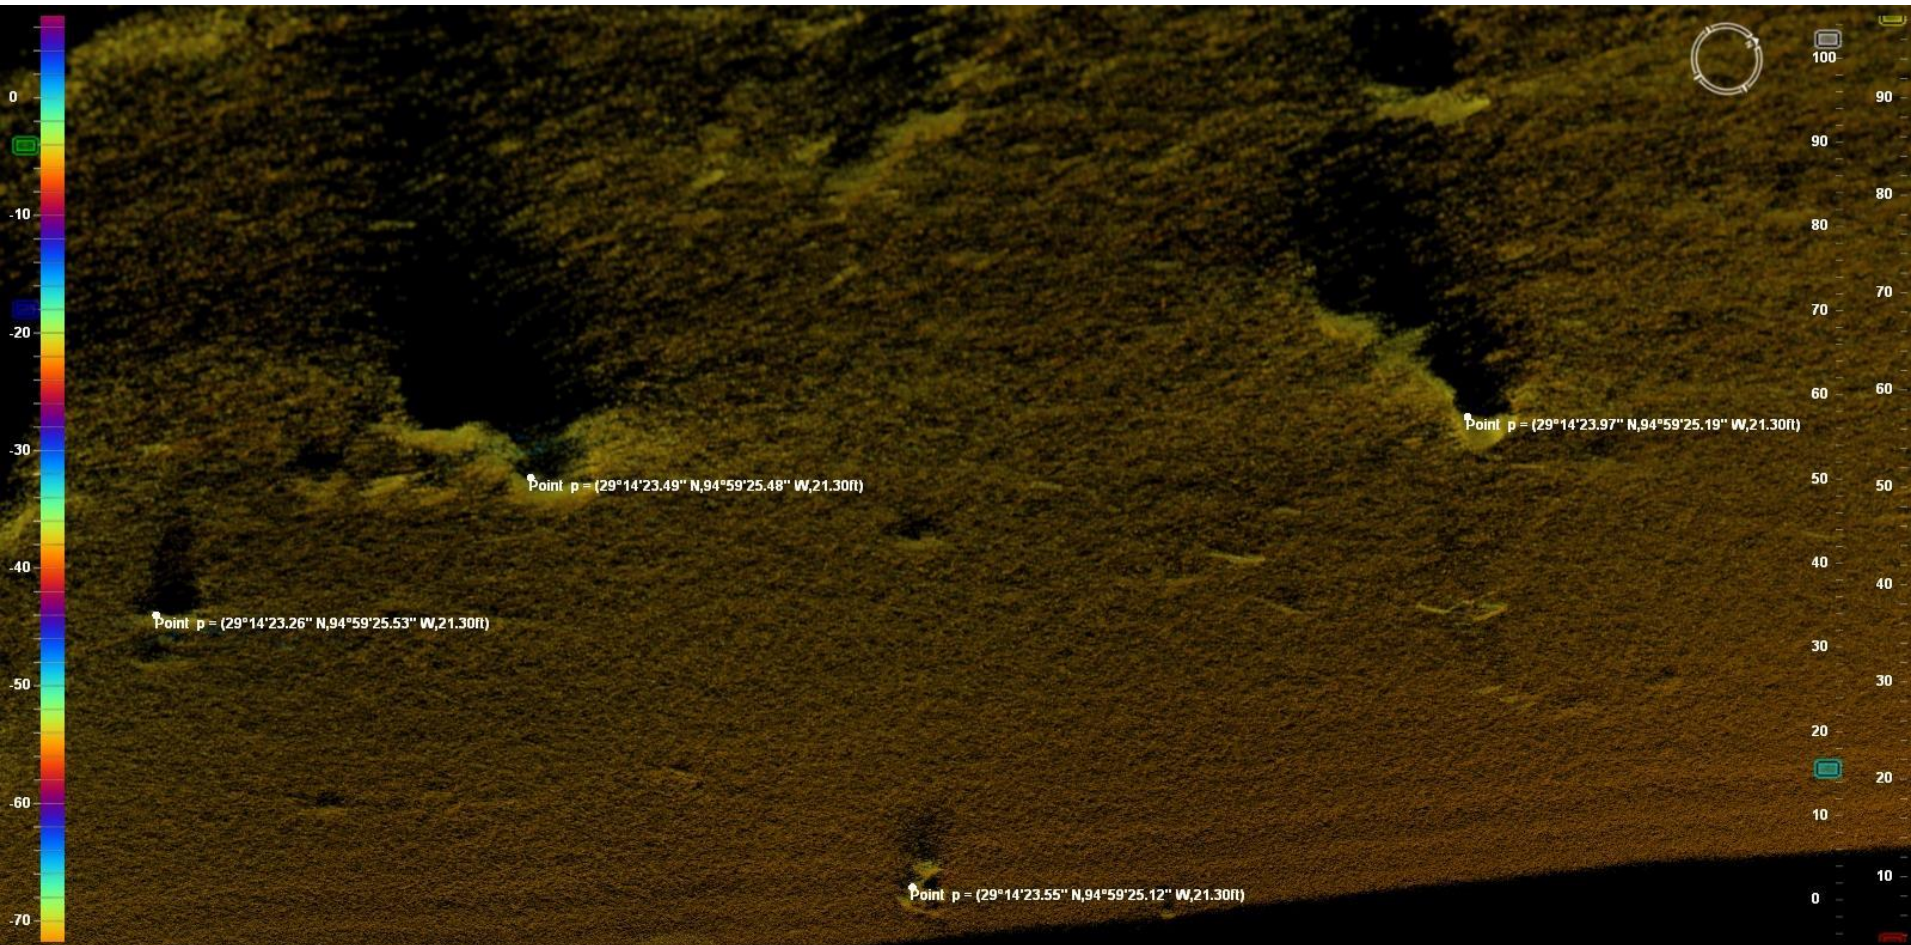
This view shows the same objects as the last slide but with their geographic coordinates listed.

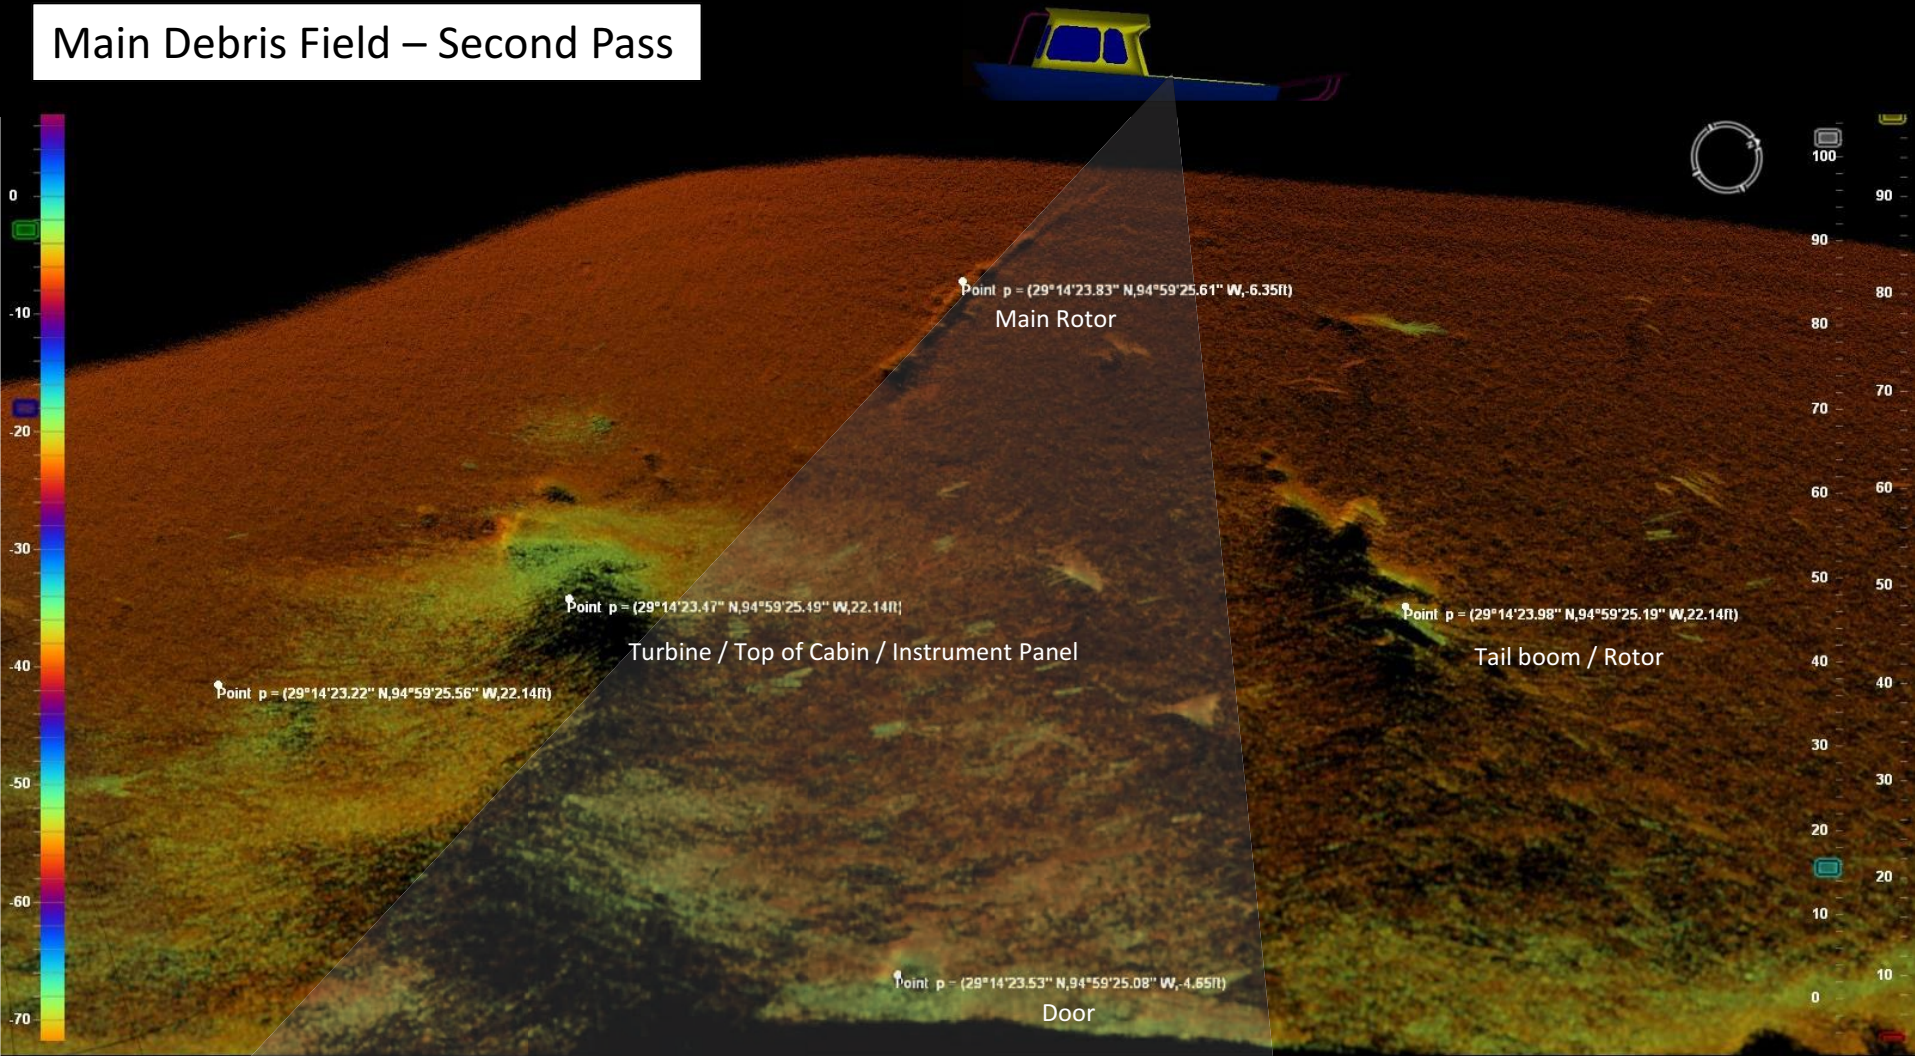
Here the boat is travelling SW and is looking off to the port side (SE). The image has been rotated so that it is the same configuration as the previous slides. Now you can see that the object that was likely the propeller can be seen.

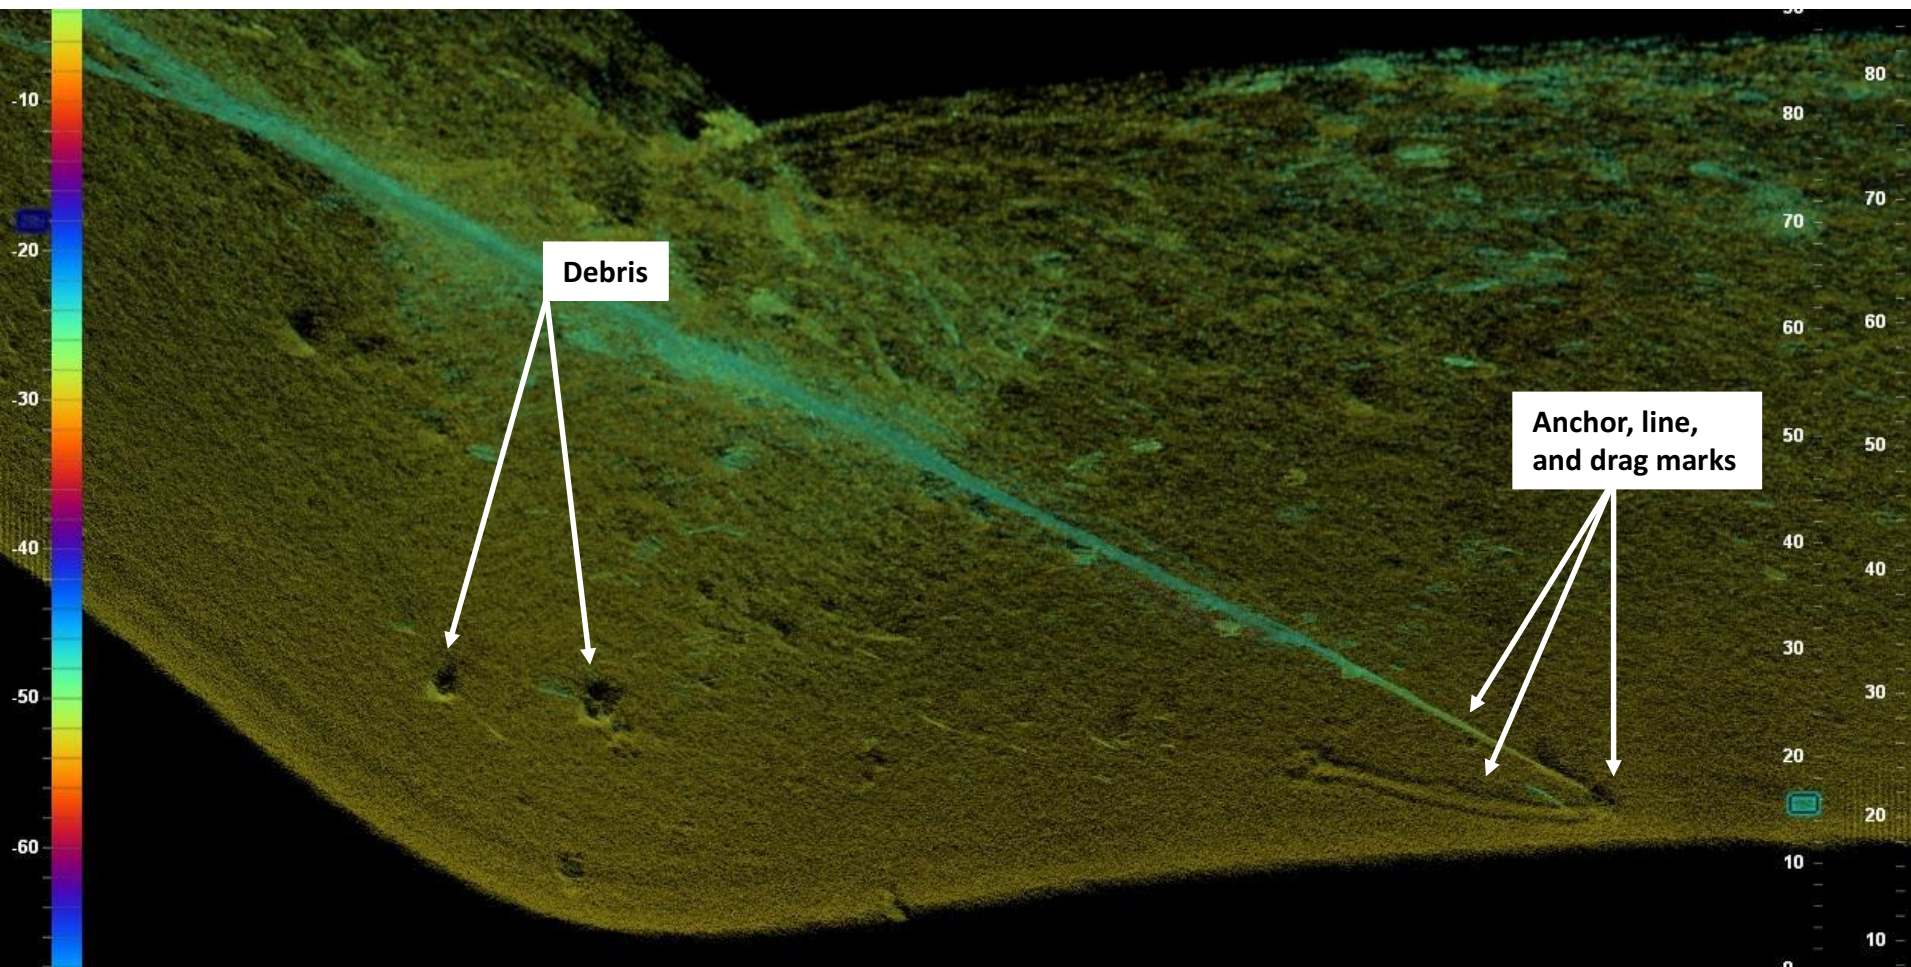
Visual Inspection Findings: Saw some small debris pieces around the vicinity of the anchored boom.
