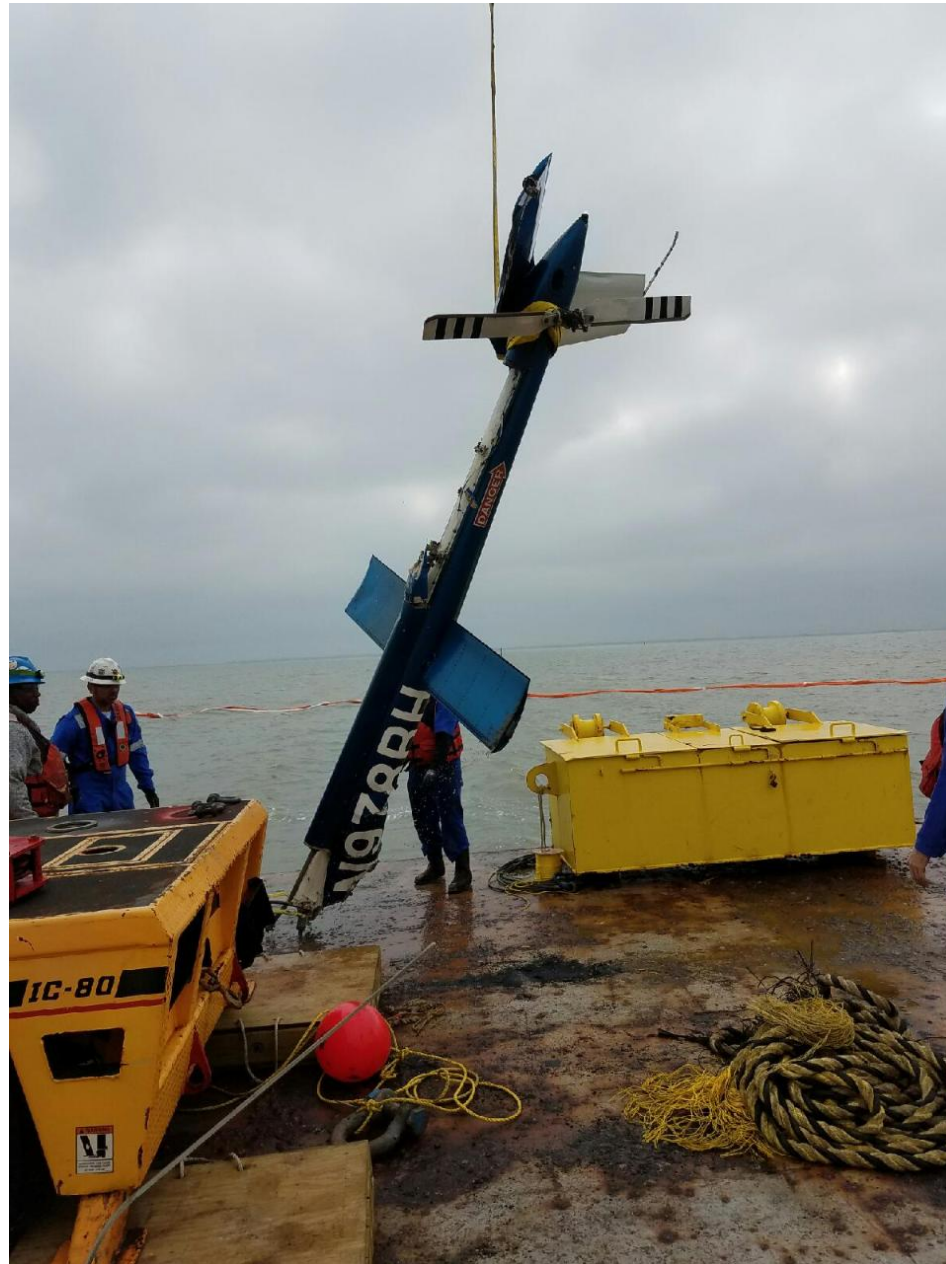
**Photo 1 – The tail boom being recovered from the waters of West Bay, Galveston, Texas.**

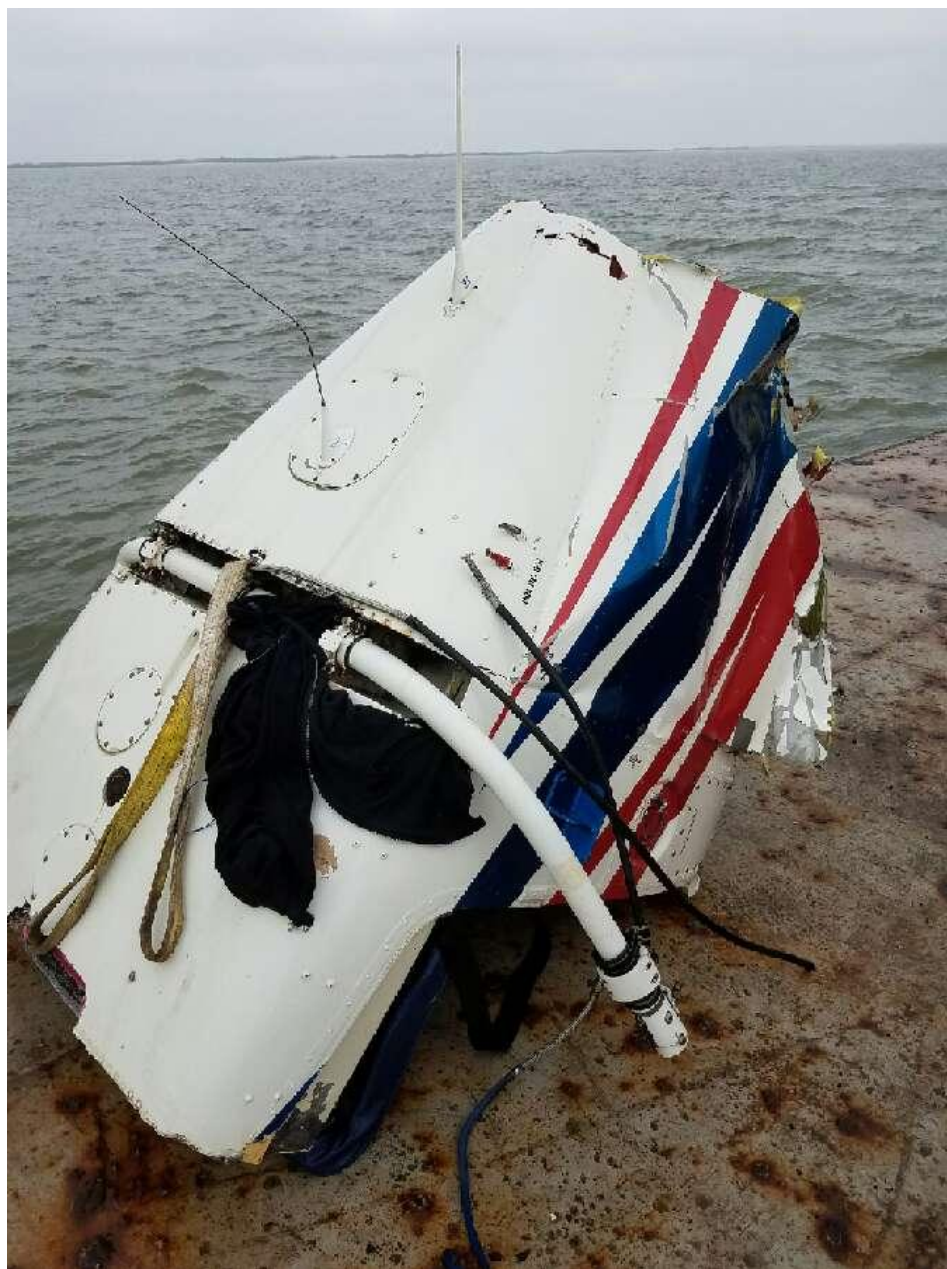
**Photo 2 – Bottom portion of fuselage and landing skid after recovery from West Bay.**

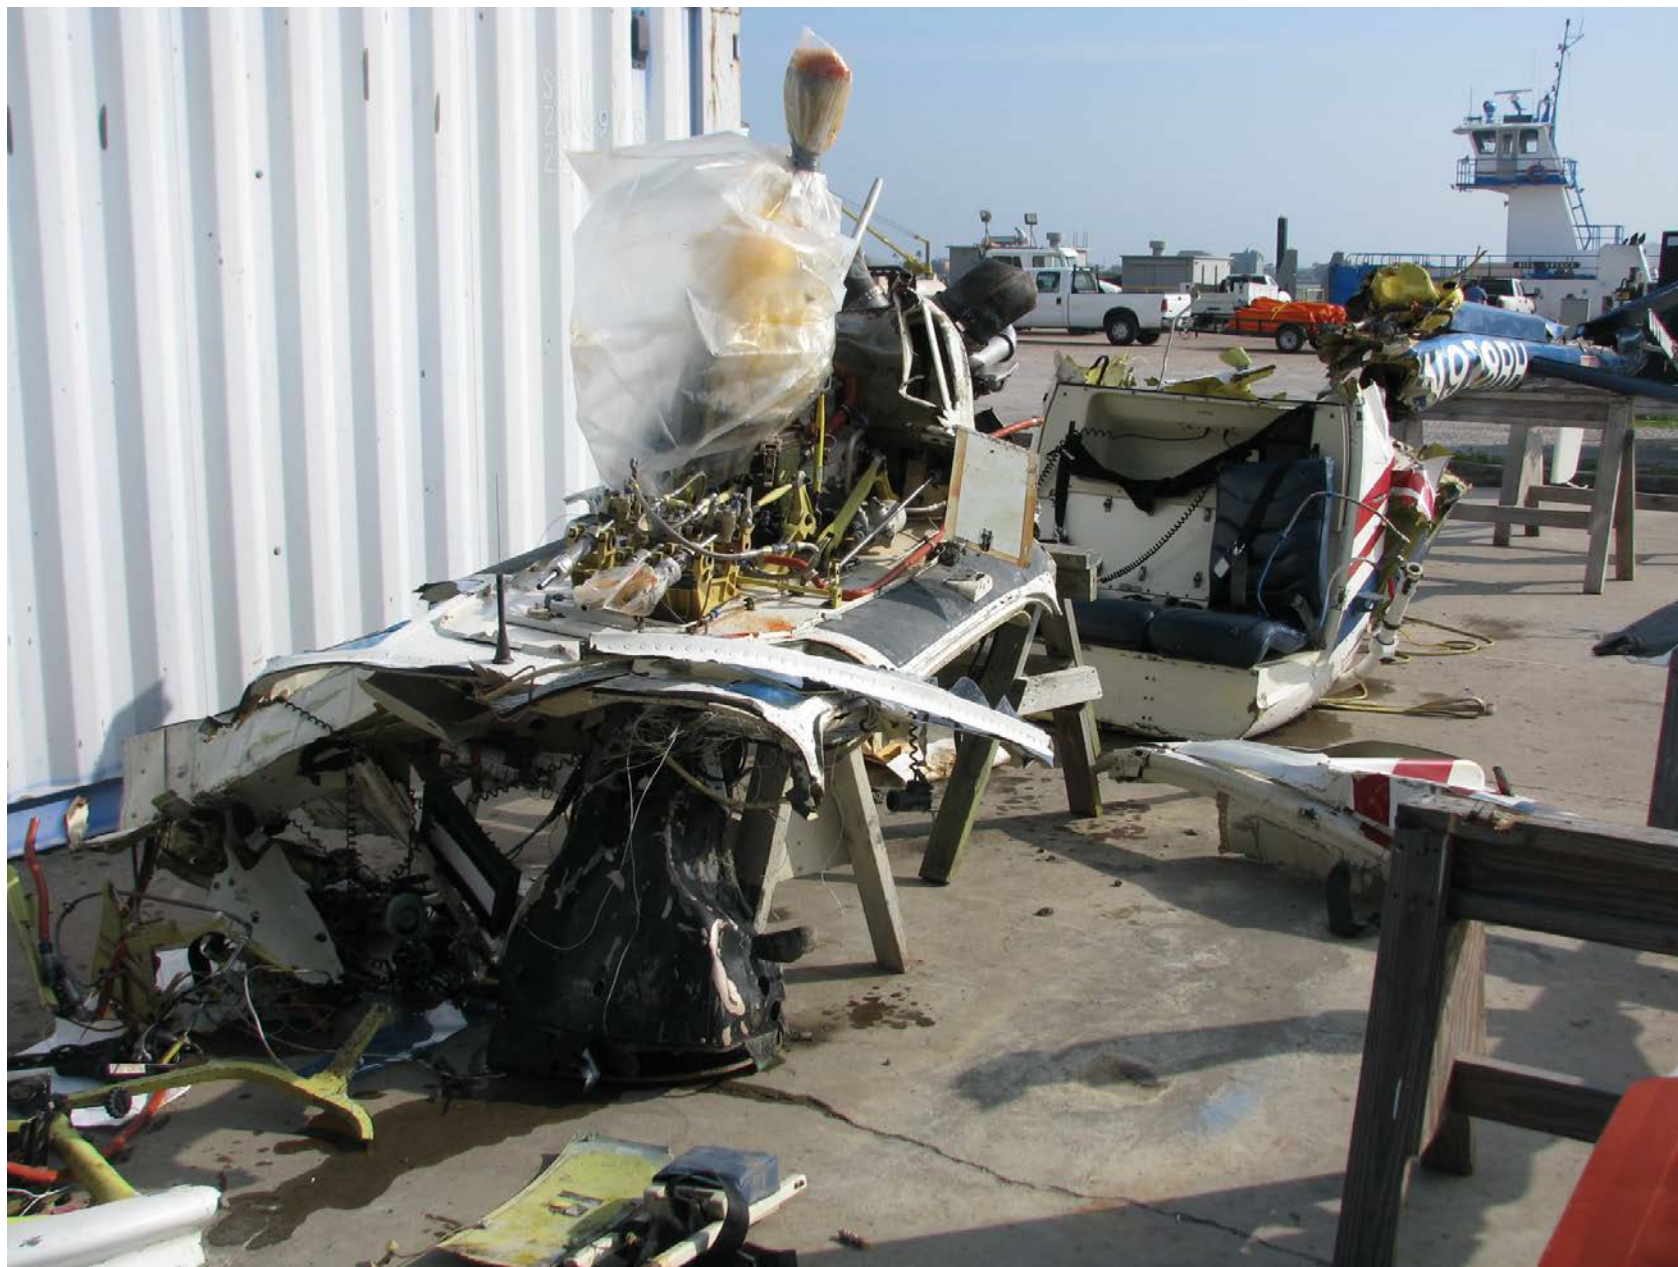
**Photo 3 – Forward portion of wreckage laid out at T&T Marine Salvage, Teichman Point, Galveston, Texas.**

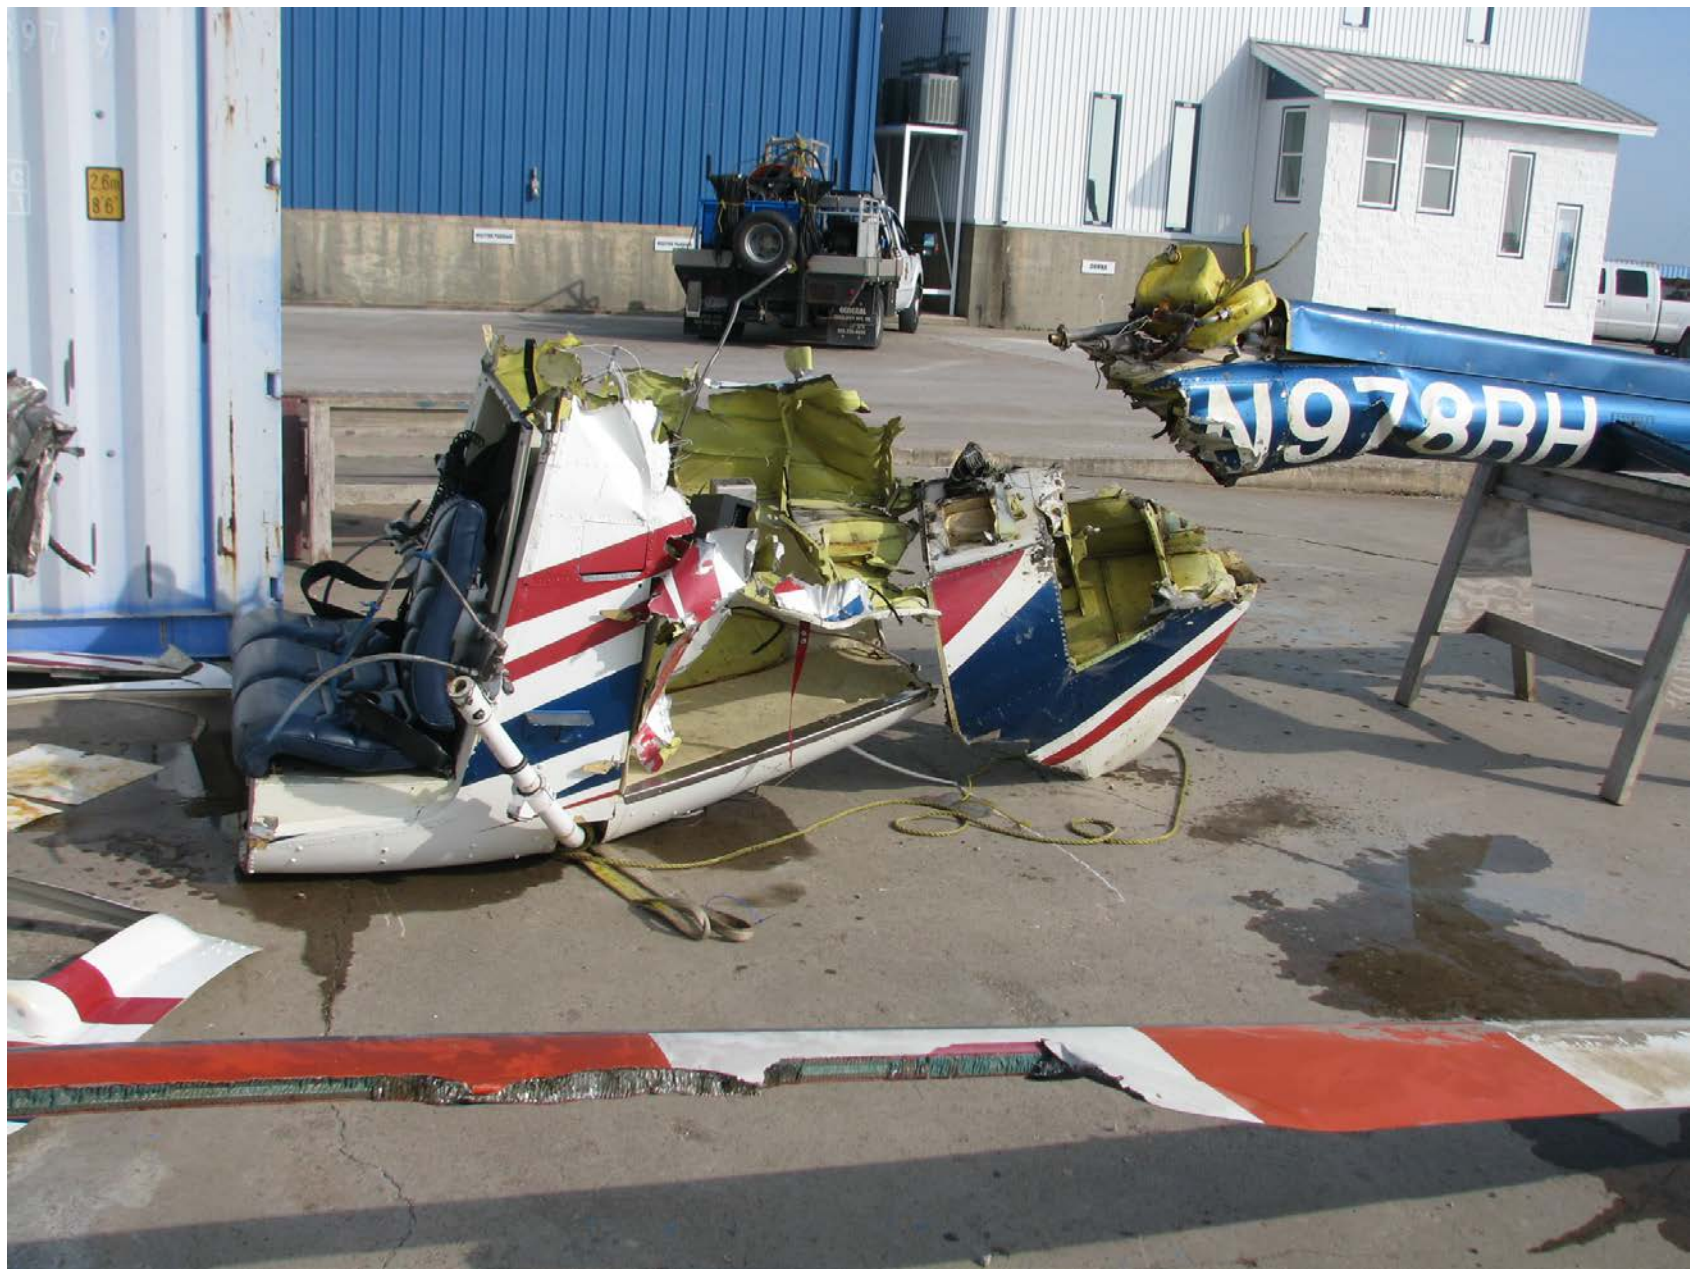
**Photo 4 – Aft portion of wreckage being laid out at T&T Marine Salvage, Teichmam Point, Galveston, Texas.**

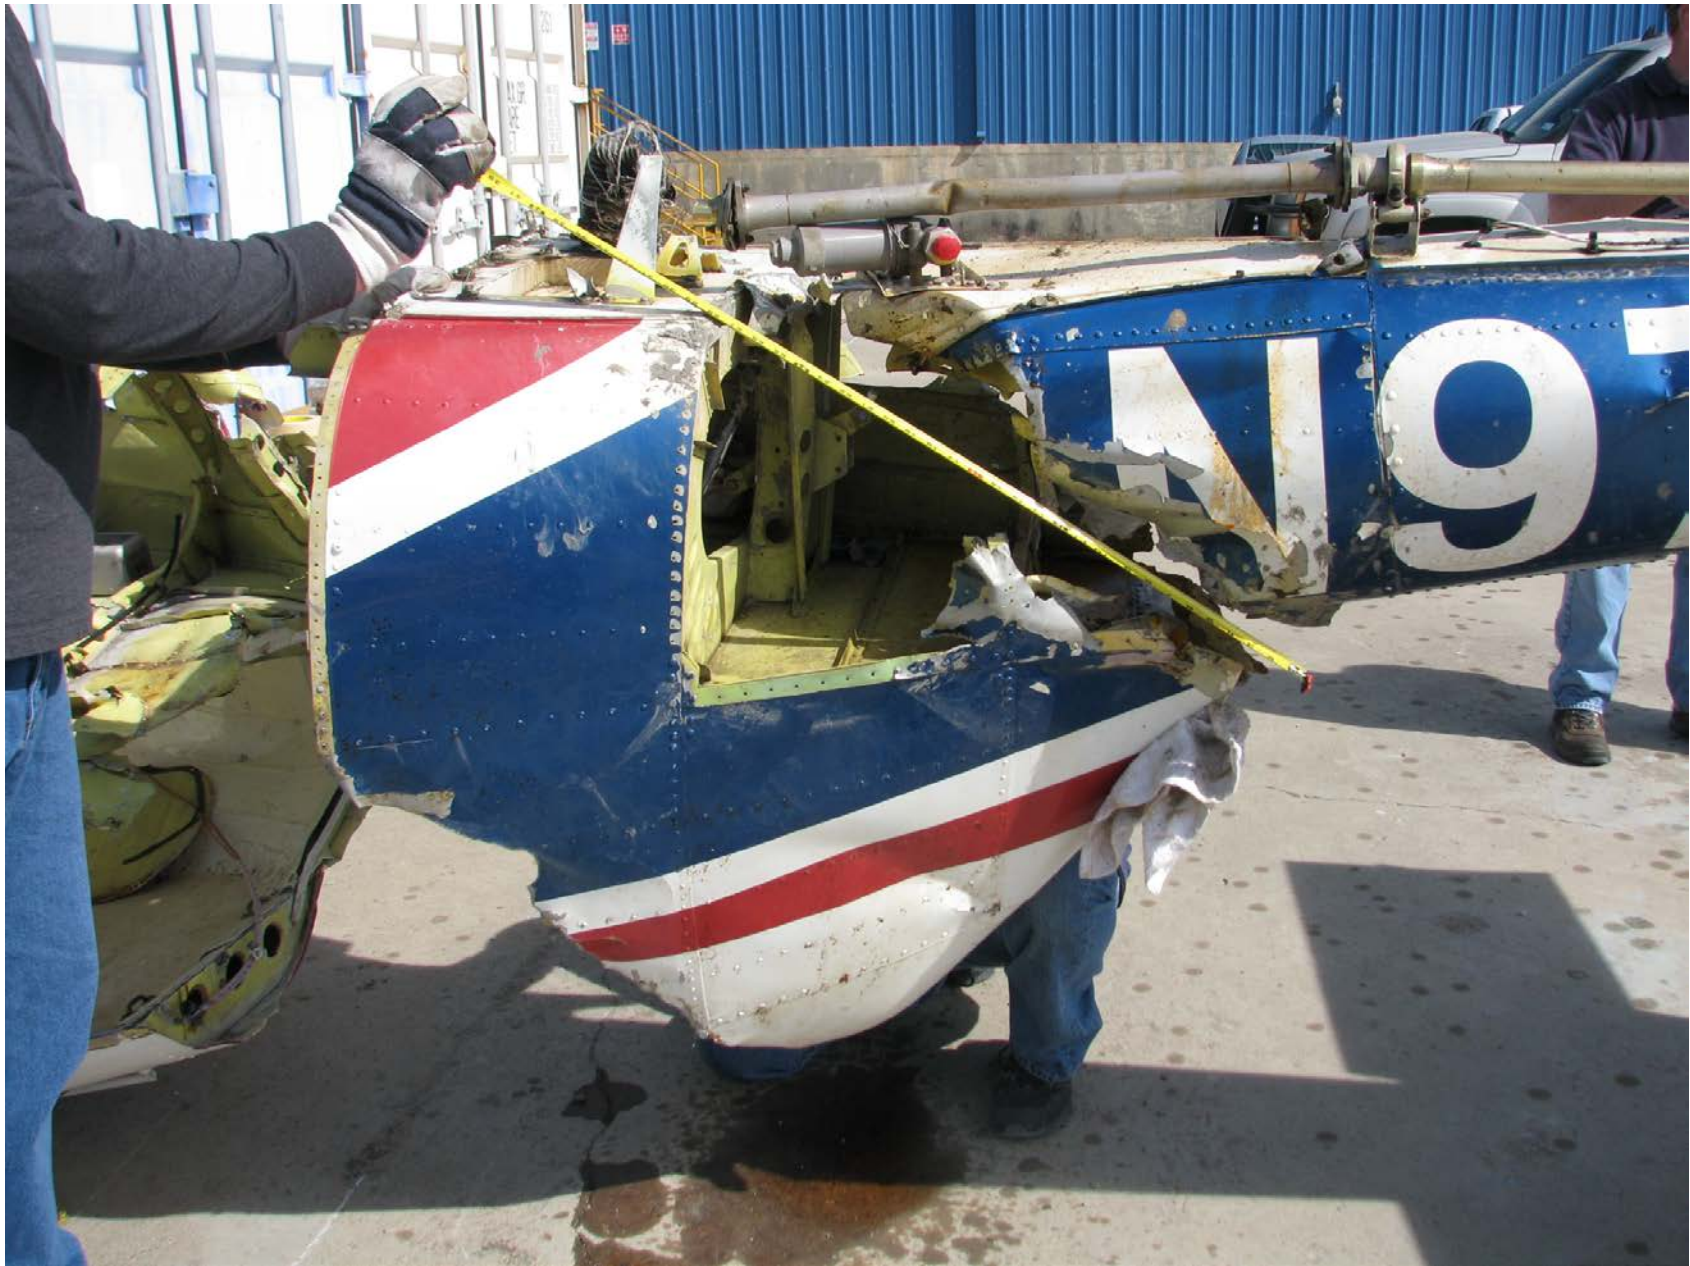
**Photo 5 – Measuring the angle of a main rotor blade strike at the aft baggage compartment-tail boom.**

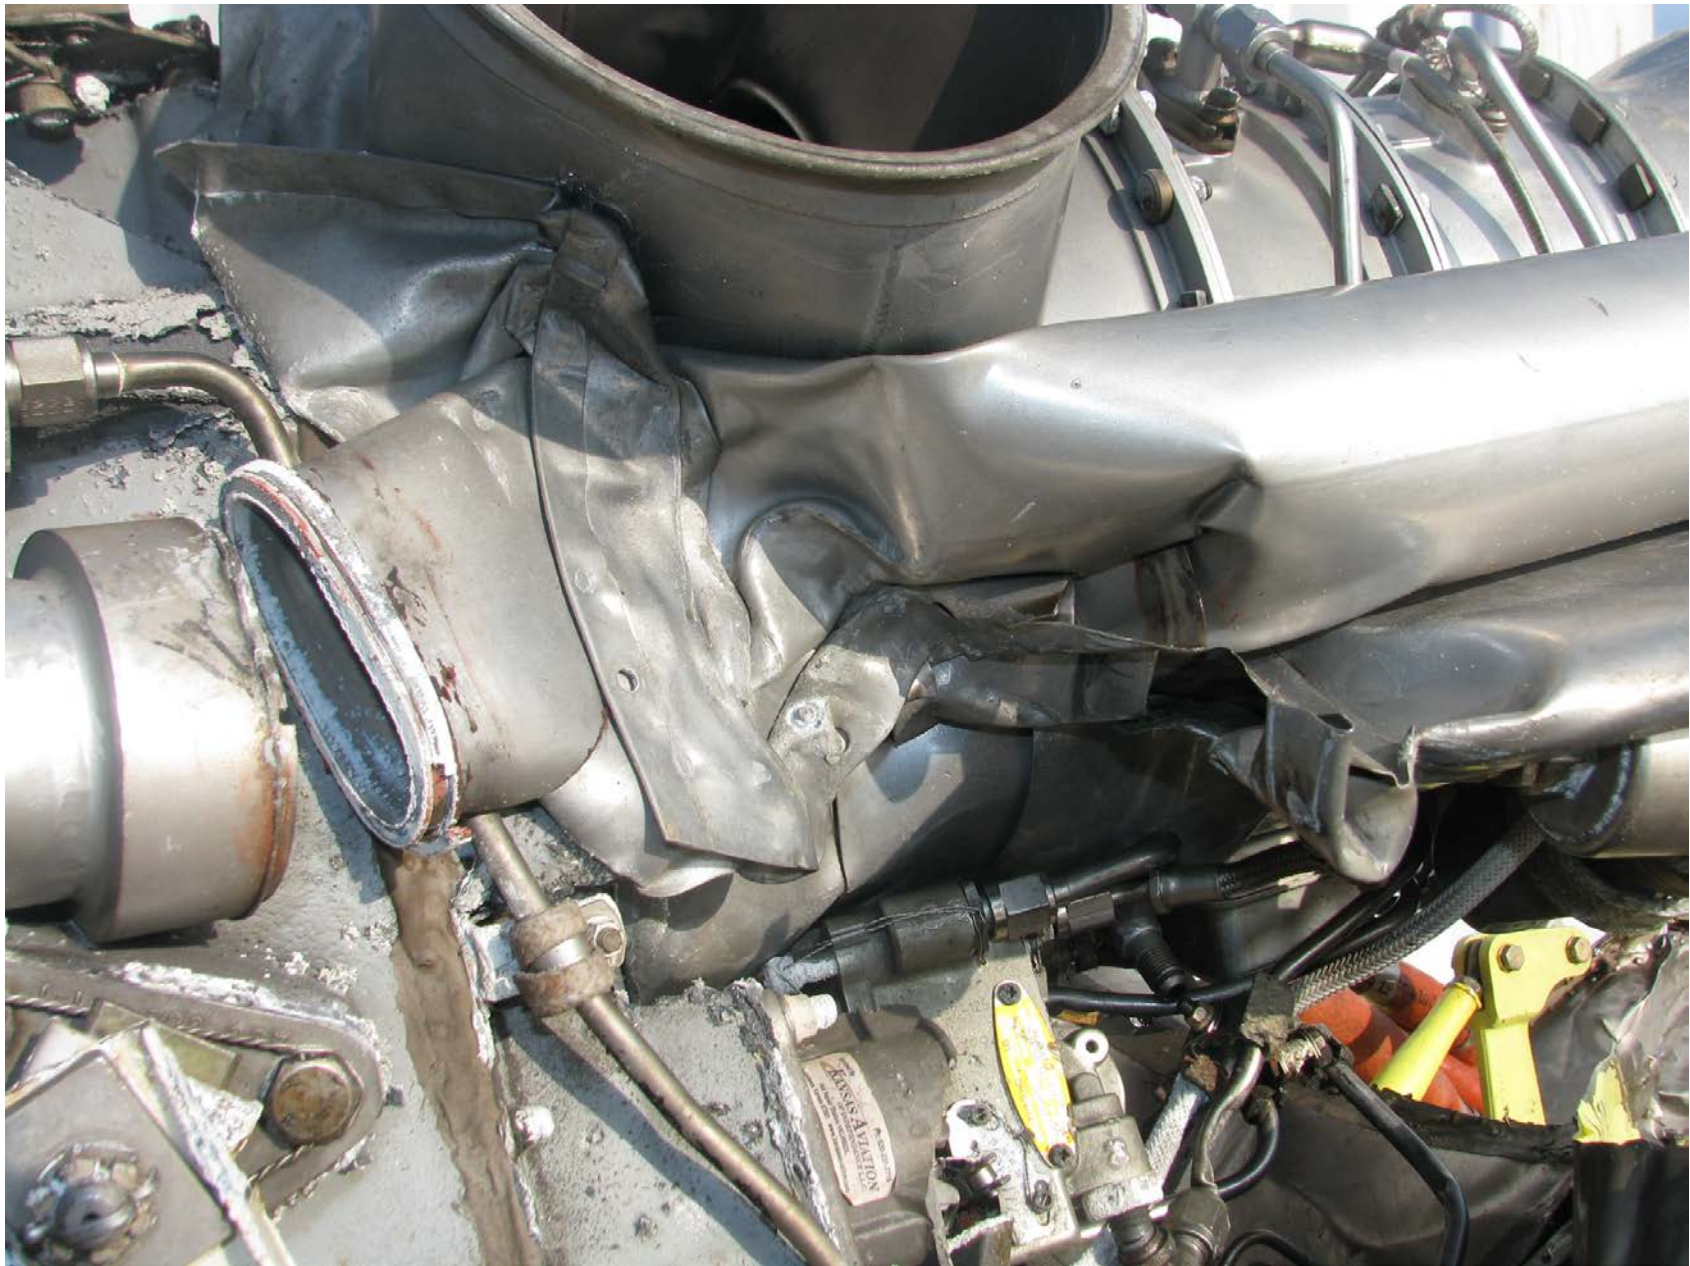
**Photo 6 – Main rotor blade strike on the left side of the engine.**

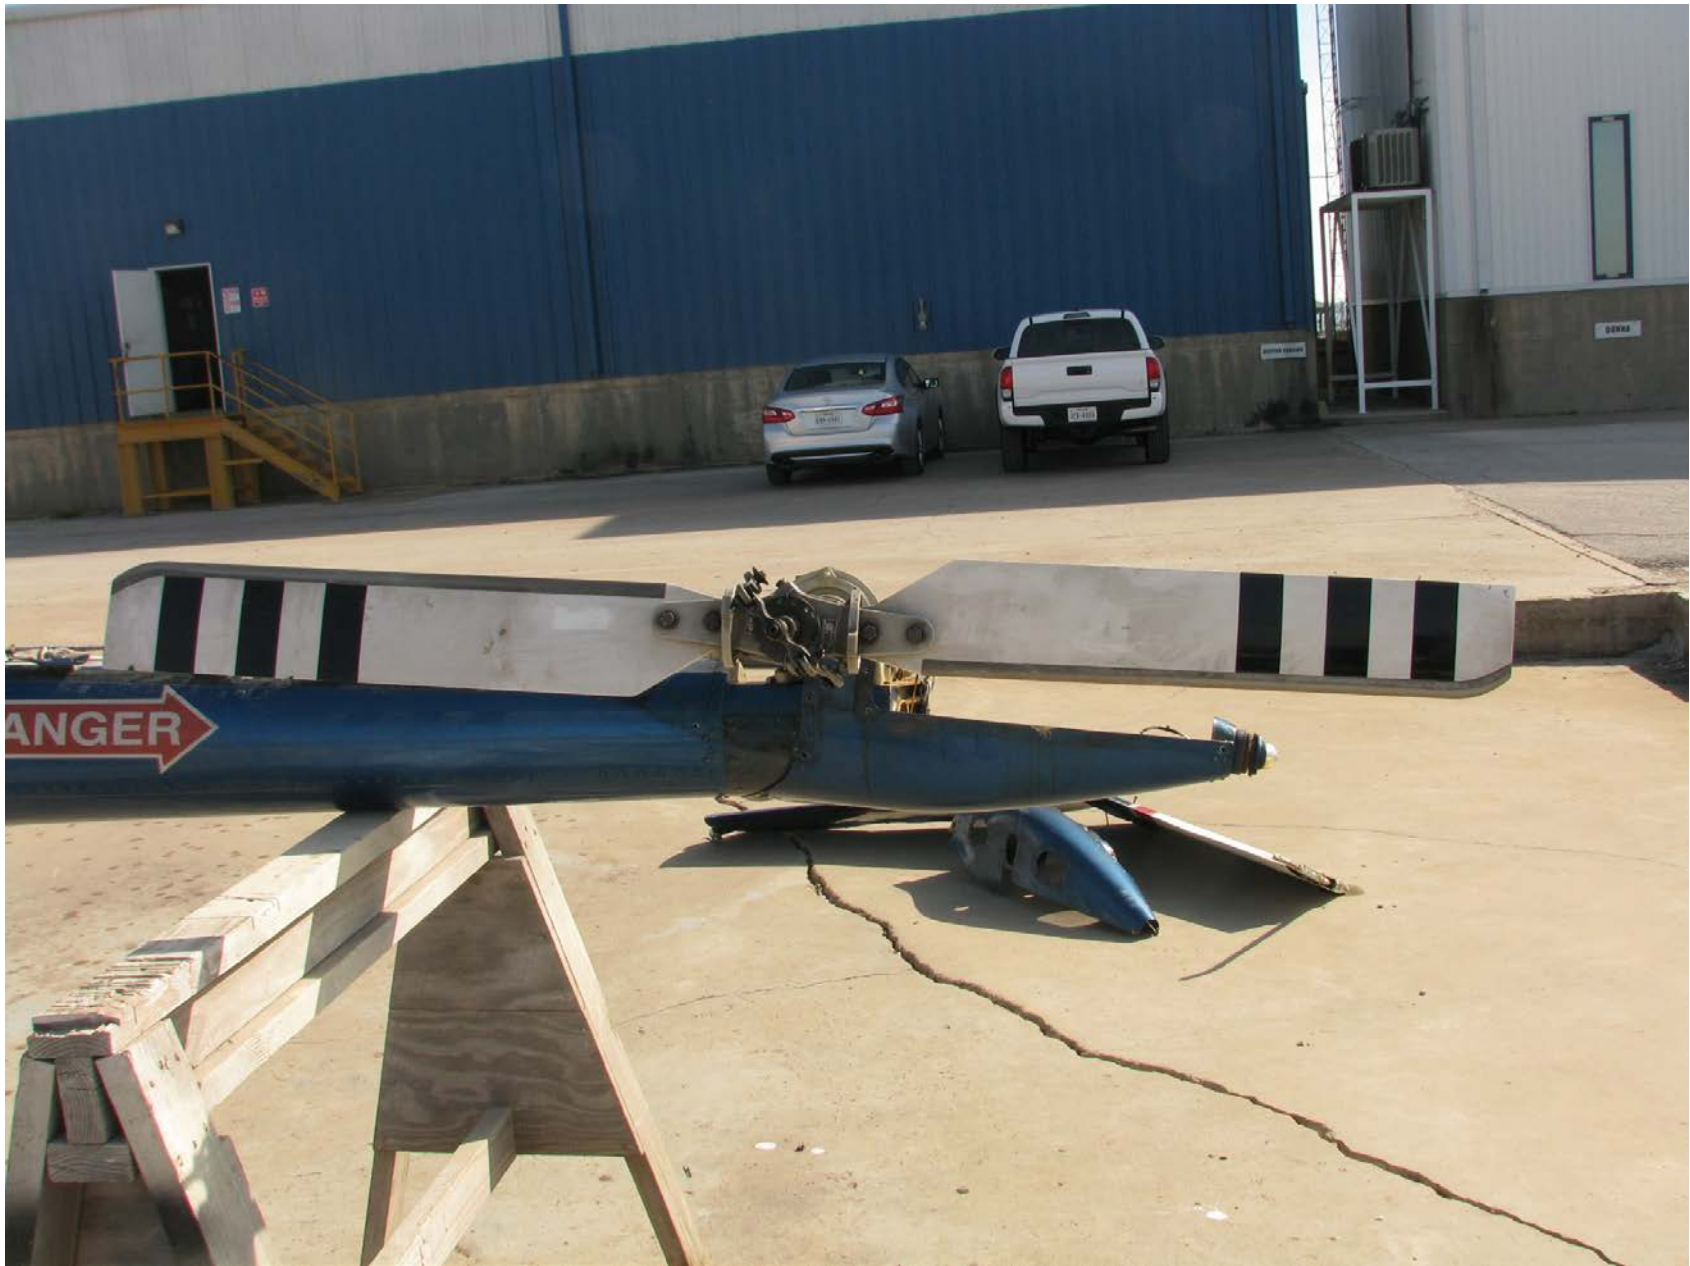
**Photo 7 – Aft tail boom, tail rotor hub, and tail rotor blades were undamaged.**

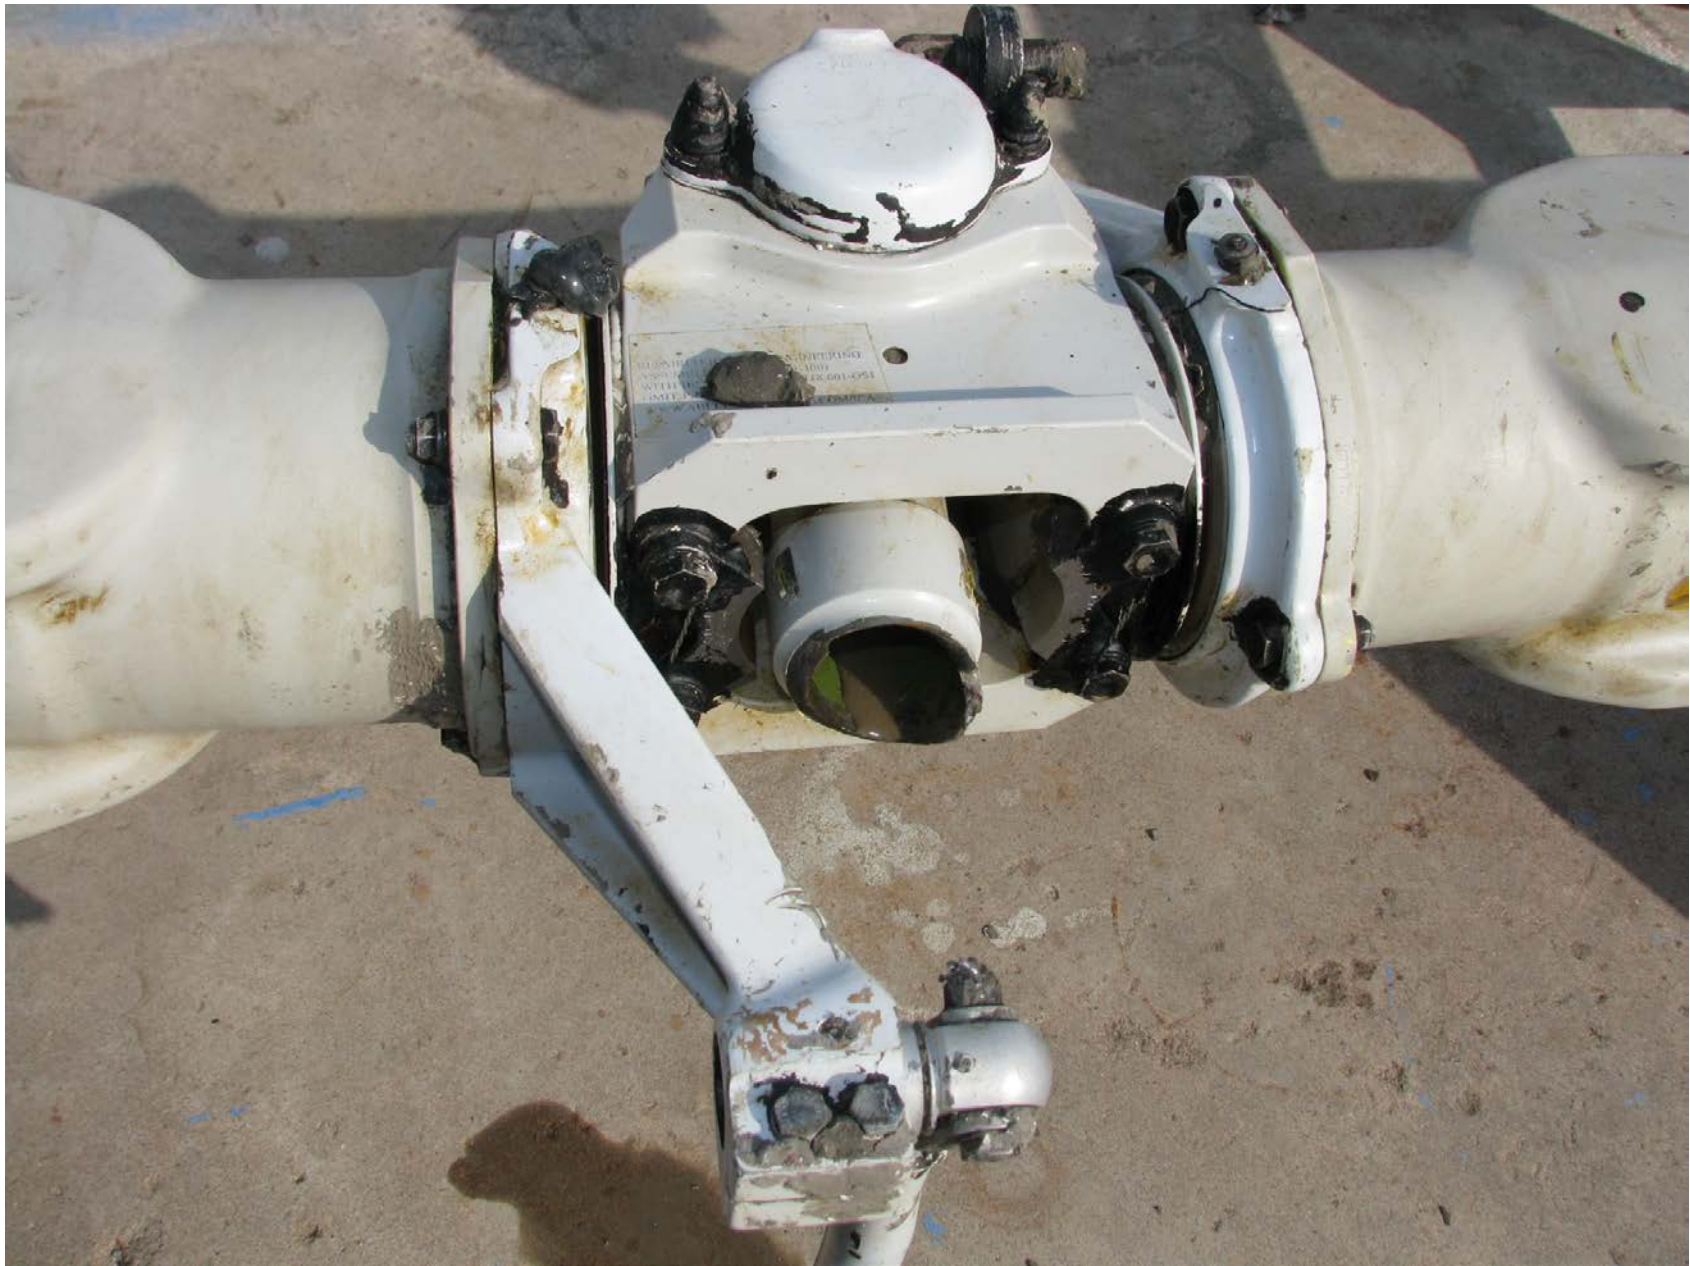
**Photo 8 – Main rotor hub bore evidence of torsional overload and mast rubbing.**
