# NATIONAL TRANSPORTATION SAFETY BOARD

## MATERIALS LABORATORY FACTUAL REPORT

Report No. 18-037

Place : Chetek, Wisconsin  
Date : May 24, 2017  
Vehicle : Piper J3C-65, N35132  
NTSB No. : CEN17FA196  
Investigator : Jennifer Rodi, AS-CEN

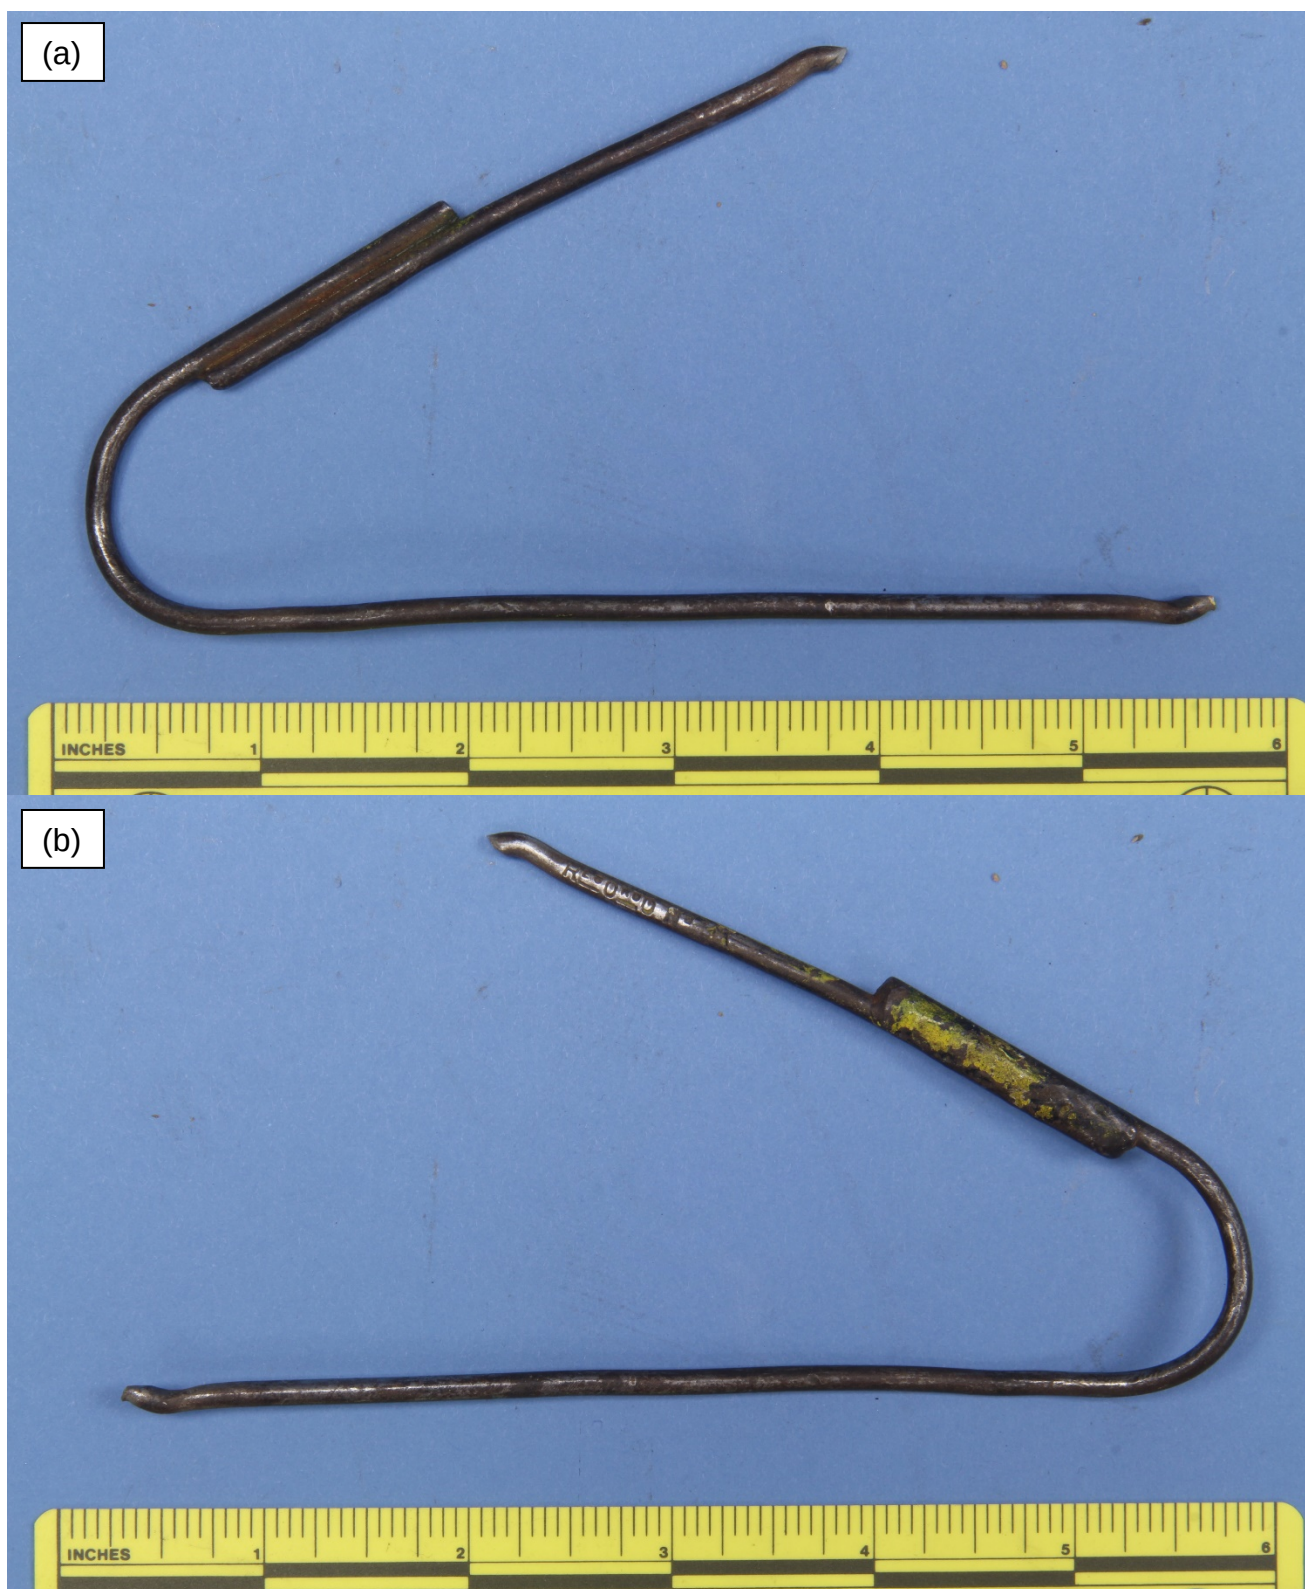
The rear seat lapbelt wire brackets are shown in Figure 1 and Figure 2, as received. The left bracket had fractured in two places, labeled the "flat side" and "bent side" fractures for the purpose of this report. These labels were consistent with the sides of the bracket where they were located. In Figure 1, the flat side fracture was the lower fracture, and the bent side fracture was the upper fracture. The mating fractures were not received.

Figure 1 – The fractured wire bracket, viewed from (a) the observe and (b) the reverse side. The bracket had fractured in two places, labeled “flat side” fracture (lower) and “bent side” fracture (upper).

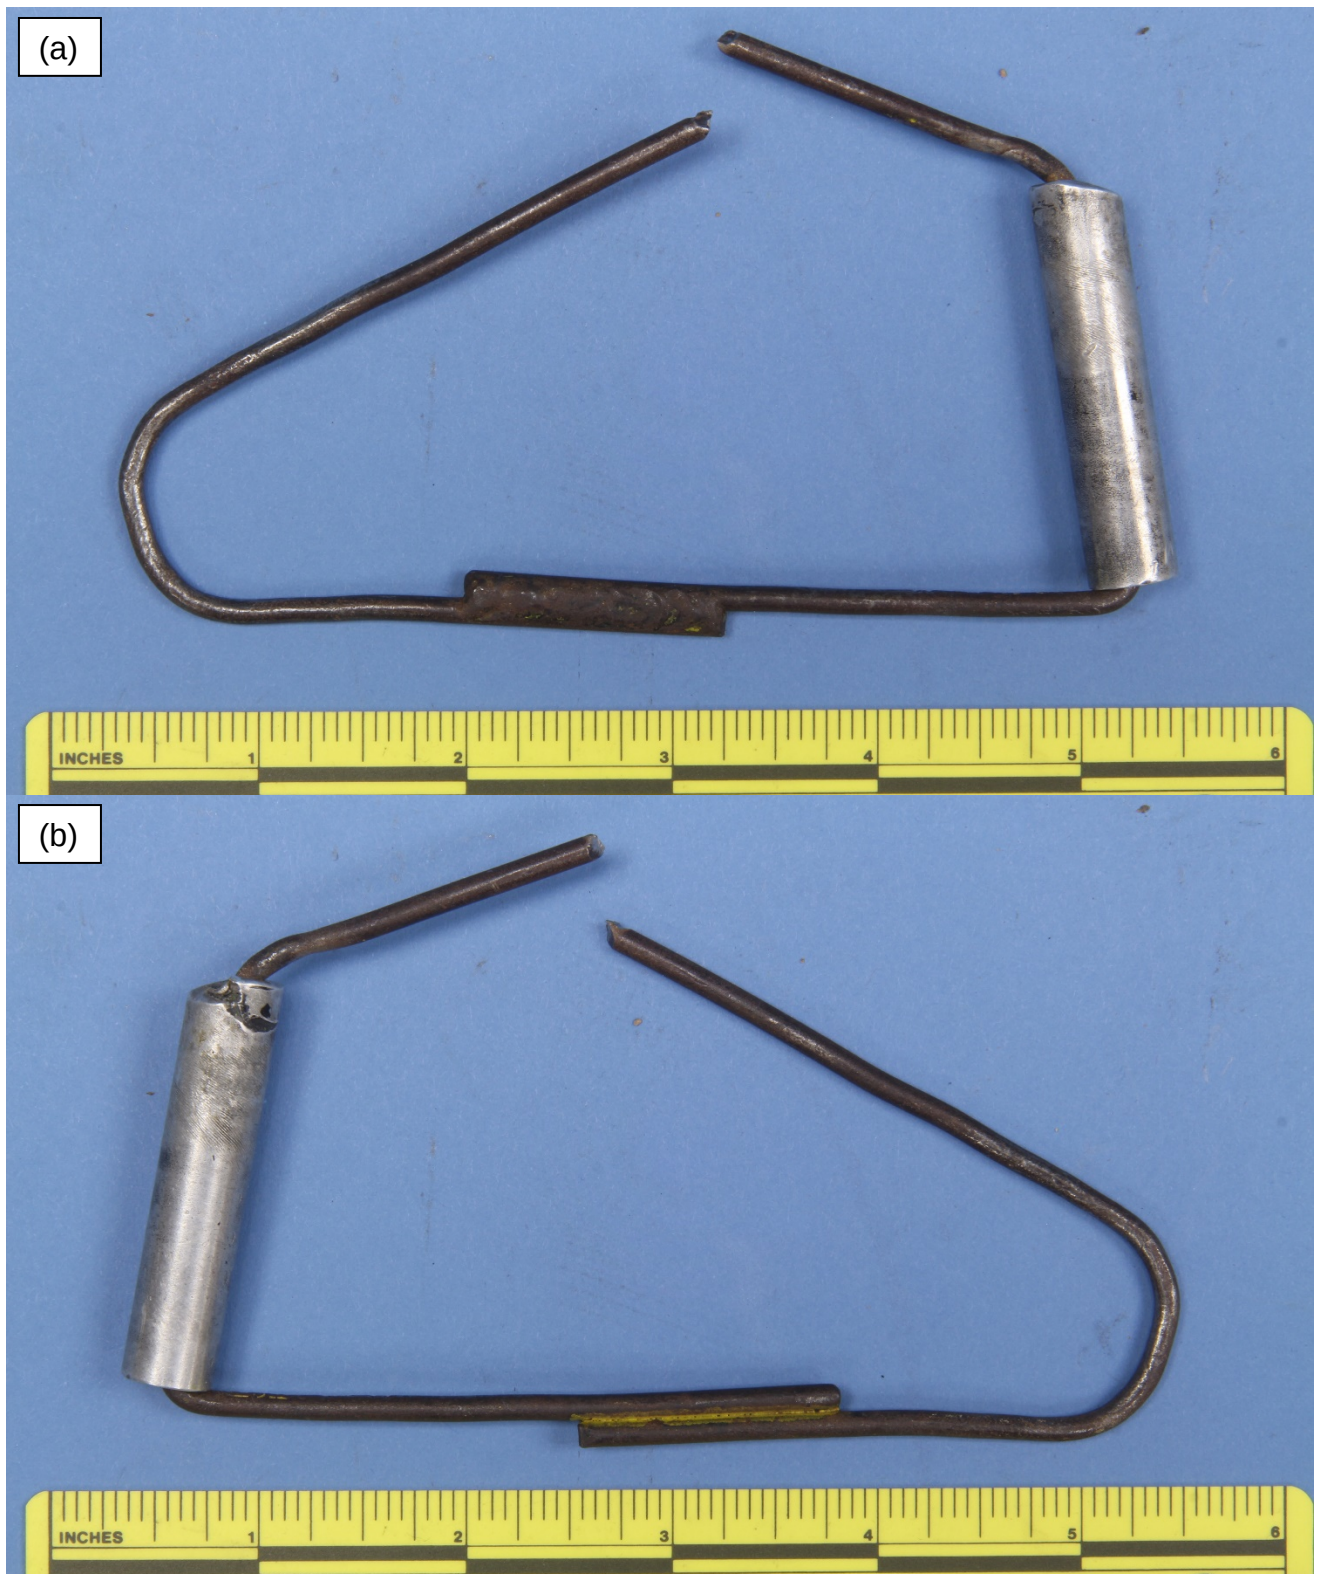
Figure 2 shows the right side rear seat lapbelt wire bracket, used as an exemplar in this investigation. This bracket was cut prior to receipt, as seen in the upper portion of Figure 2. This bracket also had a metallic cylindrical sheath affixed. This bracket and the fractured bracket were essentially sections of wire bent into shape, and then butt welded on one side.

Figure 2 – The exemplar right side wire bracket as received viewed from (a) the obverse and (b) the reverse side. The upper bent portion had been cut prior to receipt.

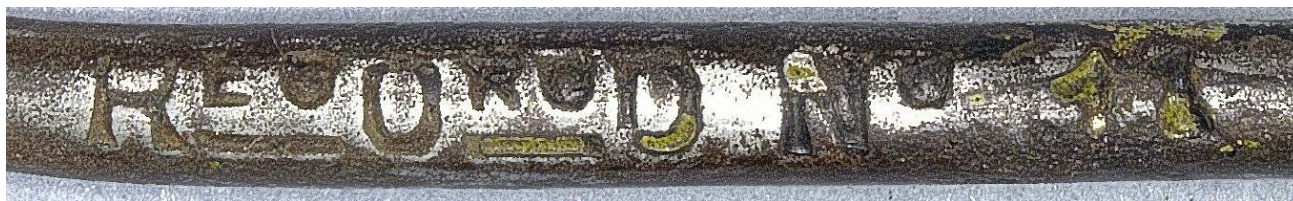
Figure 3 shows the markings on the fractured bracket stating, "RegOroD No. 11". The right side bracket did not exhibit any visible markings or identification marks.

Figure 3 – View of the markings on the side of the fractured wire bracket.

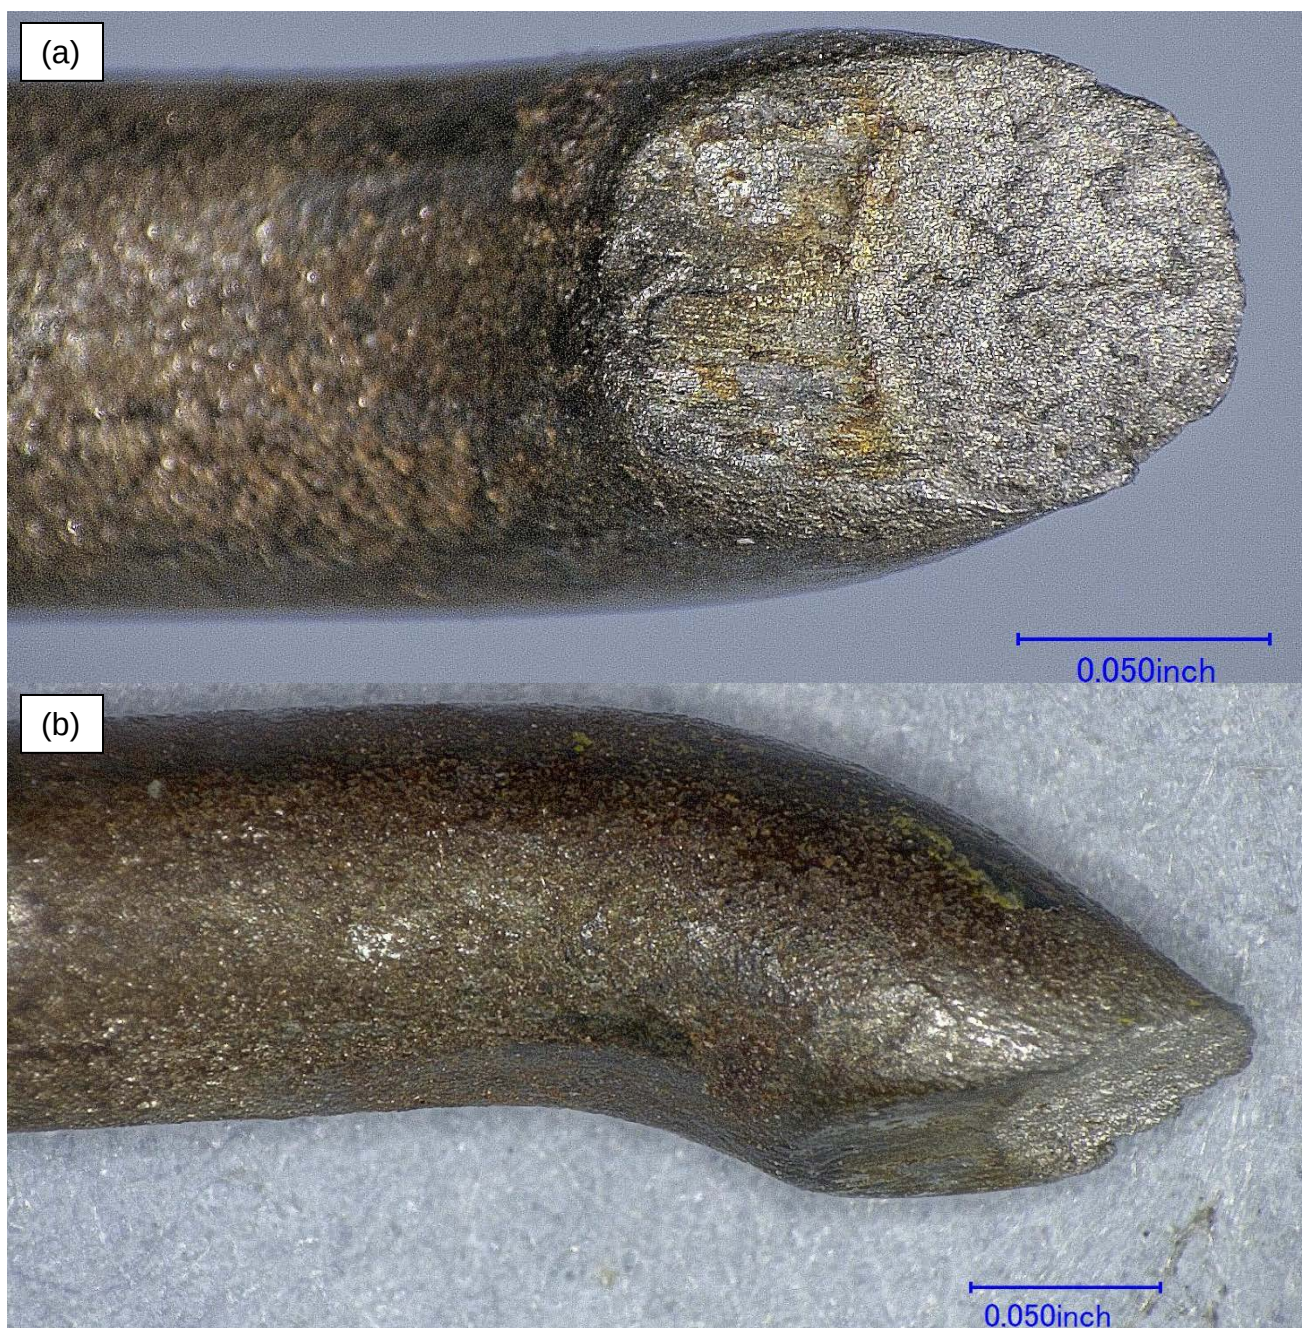
Figure 4 shows the bent side (upper) fracture surface, viewed from end on and from the side. This fracture surface was located 0.05 inches from the bend on the bracket rod (see Figure 4b). The fracture surface exhibited two distinct regions visually. Approximately one third of this fracture surface appeared darker and flatter. This region exhibited features consistent with having been smeared and rubbed. Near this portion of the fracture surface, a portion of the wire, seen facing down in Figure 4b, appeared flattened and smoothed, consistent with rubbing or contact with another object.

The other two thirds of the bent side fracture surface appeared shinier in luster and rougher in texture. The area of the wire adjacent to the fracture surface exhibited plastic deformation. These features were consistent with fracture from overstress.

Figure 4 – The bent side fracture (upper fracture in Figure 1) viewed (a) end on, showing two visually distinct regions and (b) from the side.

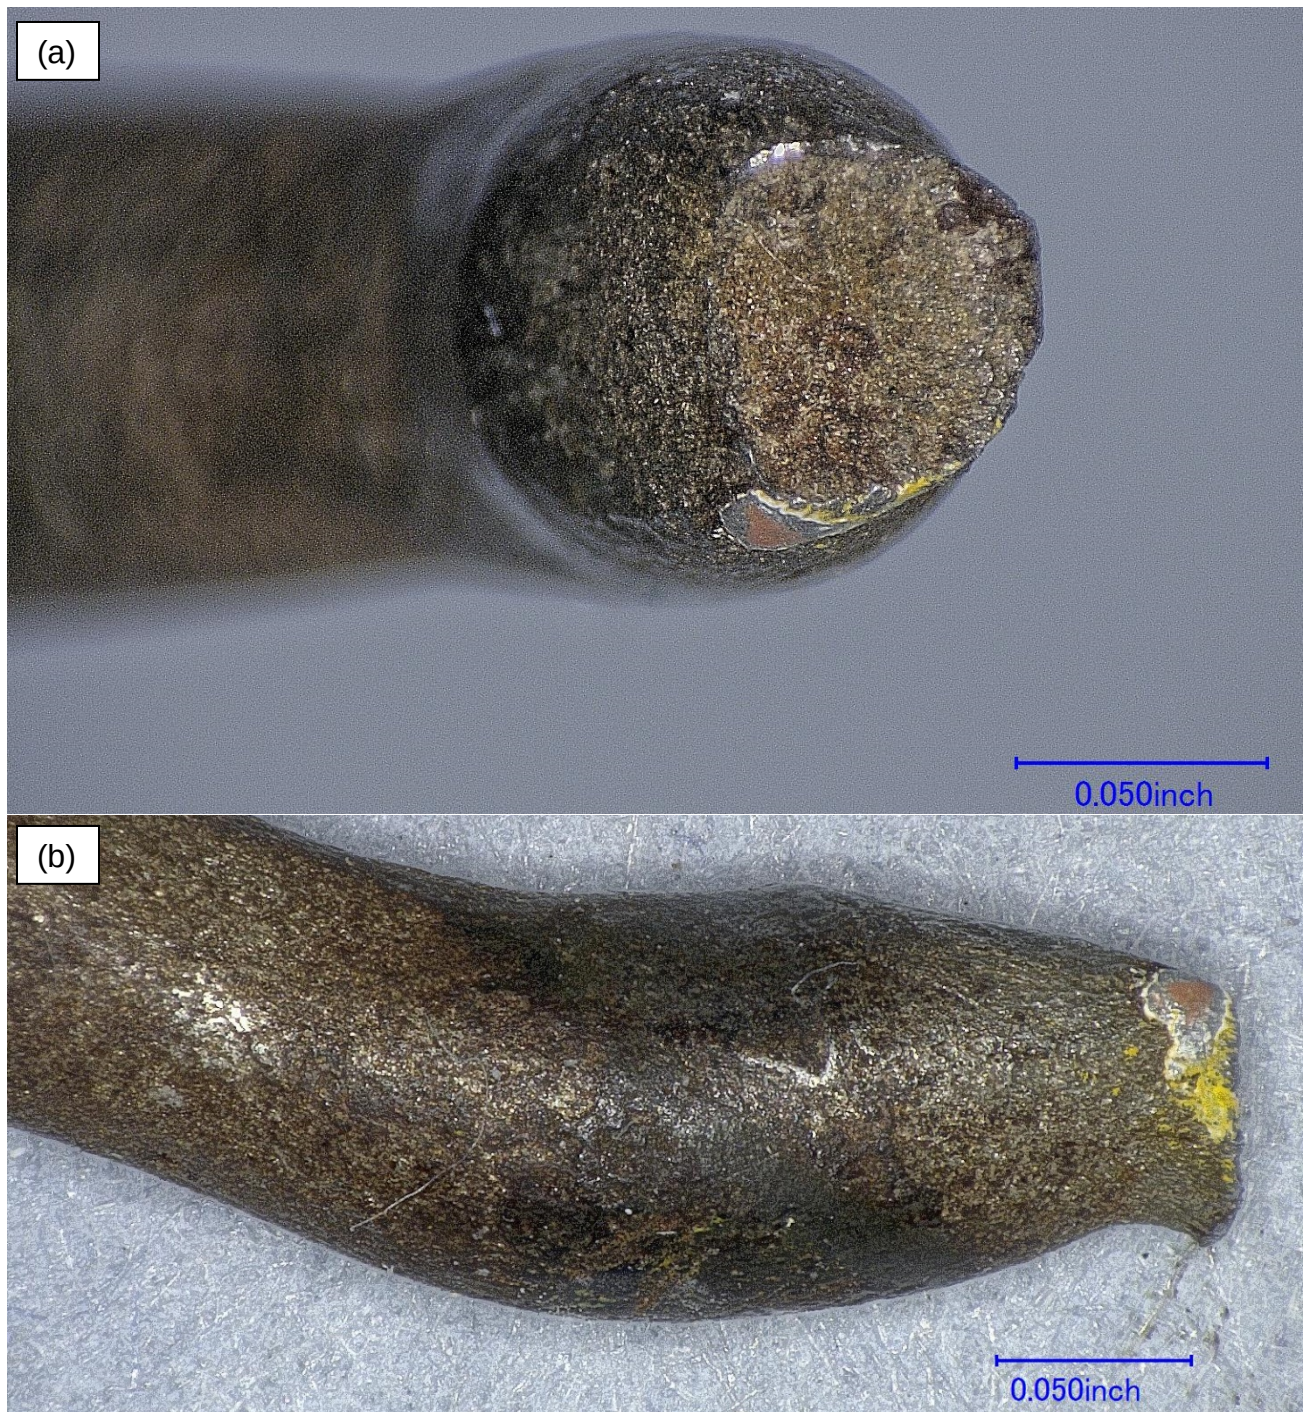
Figure 5 shows the flat side fracture surface, viewed end on and from the side. The fracture surface exhibited shear lips around the edges of the fracture surface, exhibiting a general cup shape. The portions of the wire adjacent the fracture surface exhibited plastic deformation such as necking. A portion of the wire adjacent to the fracture surface (facing upward in Figure 5b) was flatter and smoother than the rest of the wire. This flatter section was located on part of the fracture surface.

Figure 5 – The flat side fracture (lower fracture in Figure 1) viewed (a) end on, showing two visually distinct regions and (b) from the side.

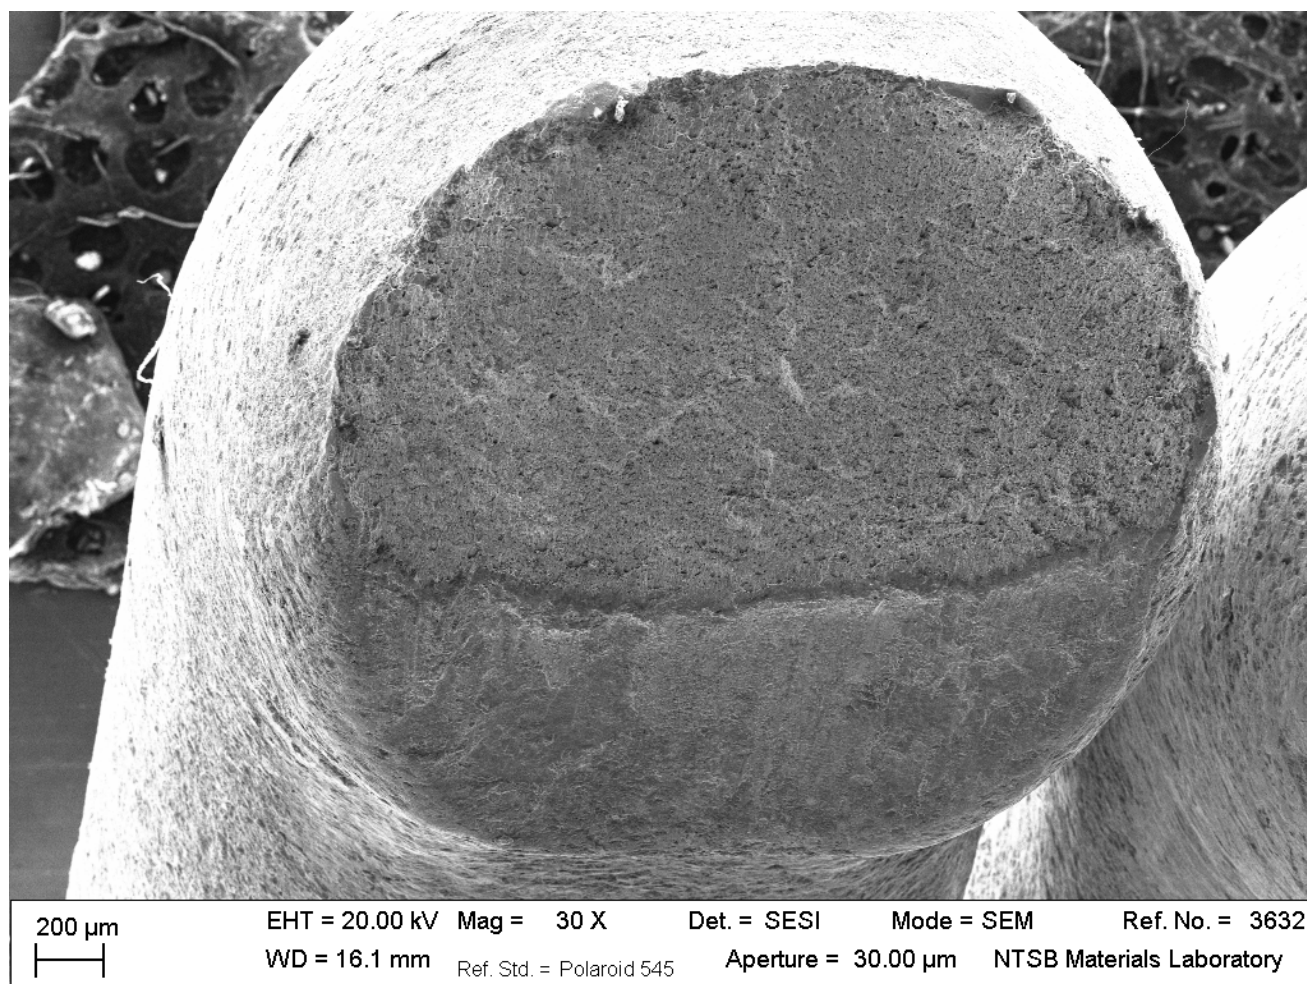
Figure 6 – Secondary electron (SE) micrograph showing the bent side fracture surface.

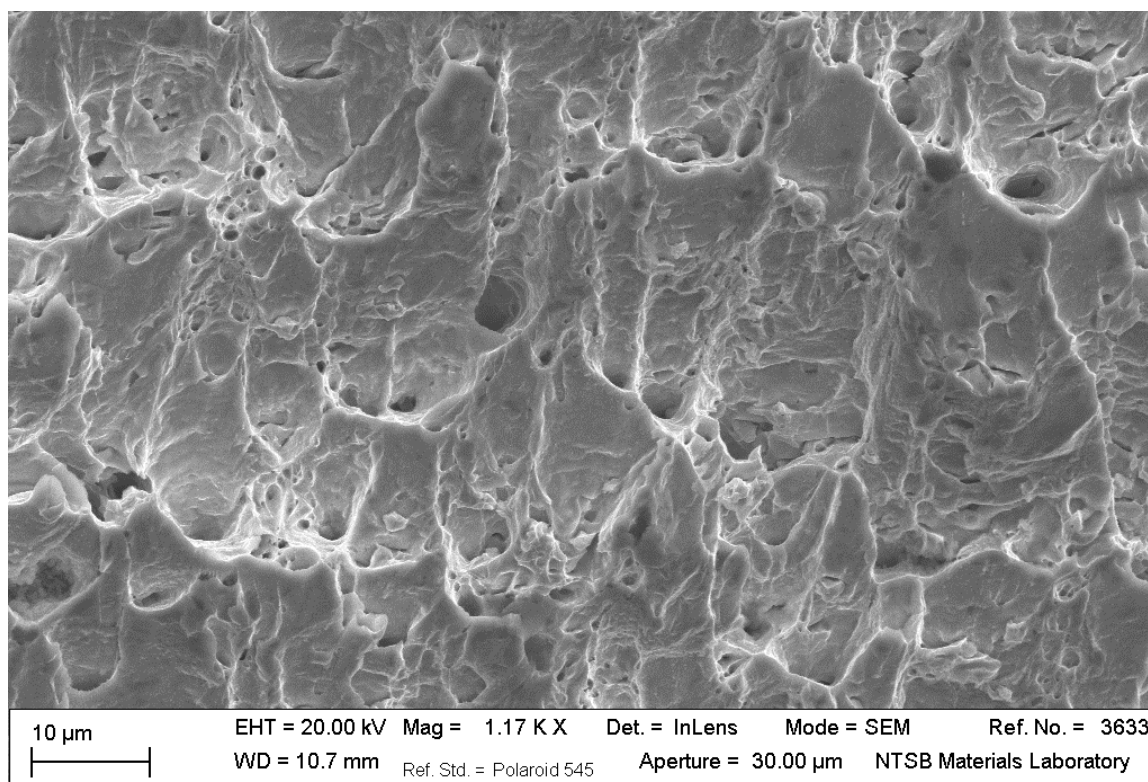
The fracture surfaces were examined using a scanning electron microscope (SEM). Figure 6 shows the face of the bent side fracture surface. As viewed in the visual examination, much of the fracture surface exhibited dimple rupture, generally oriented in a slanted direction (Figure 7). This feature was consistent with fracture from overstress in shear. The other third of the bent side fracture surface exhibited features consistent with rubbing and smearing, as typified in Figure 8.

Figure 7 – SE micrograph showing a typical portion in the upper region of the Figure 6 fracture surface, showing dimple rupture.

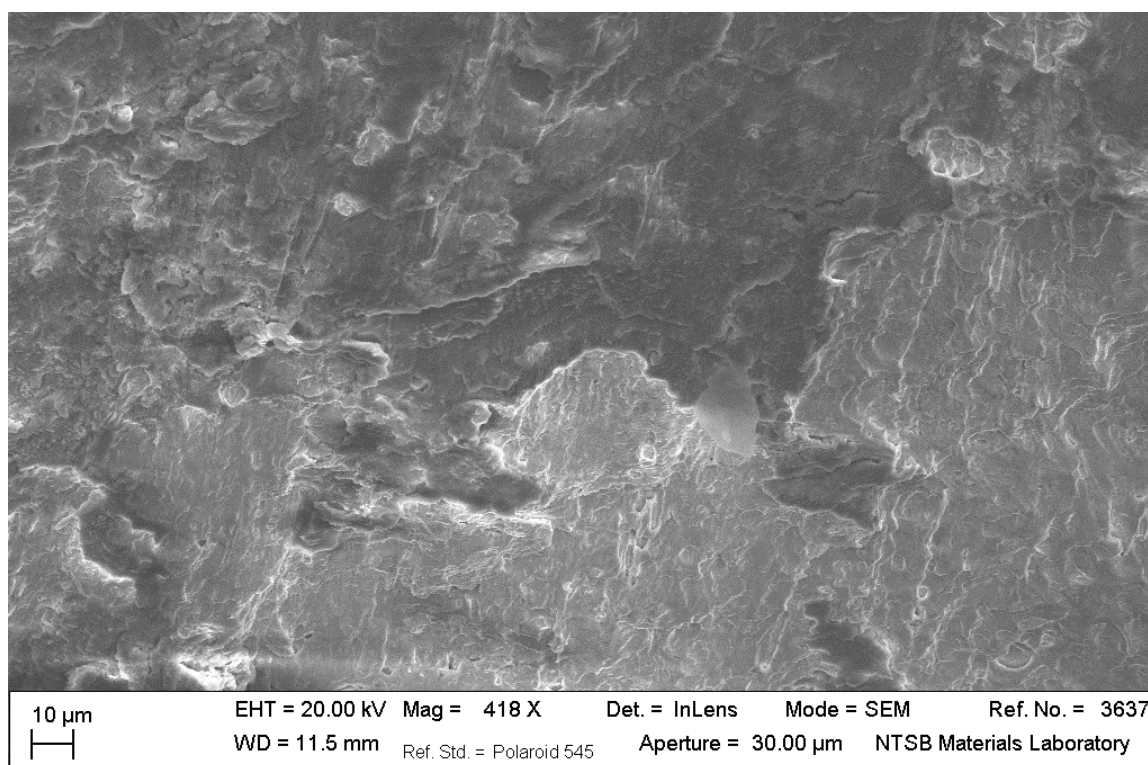
Figure 8 – SE micrograph of the lower region of the Figure 6 fracture surface, showing smearing and rub marks.

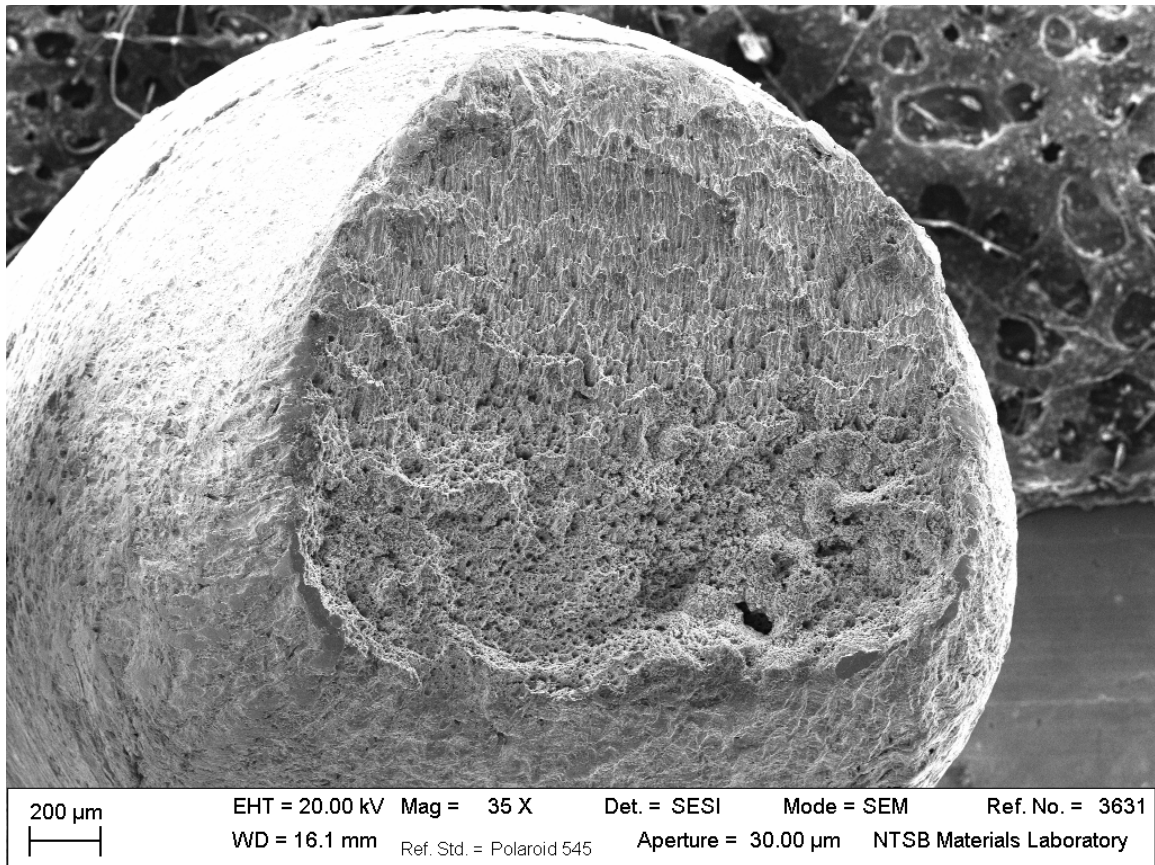
Figure 9 – SE micrograph showing the flat side fracture surface.

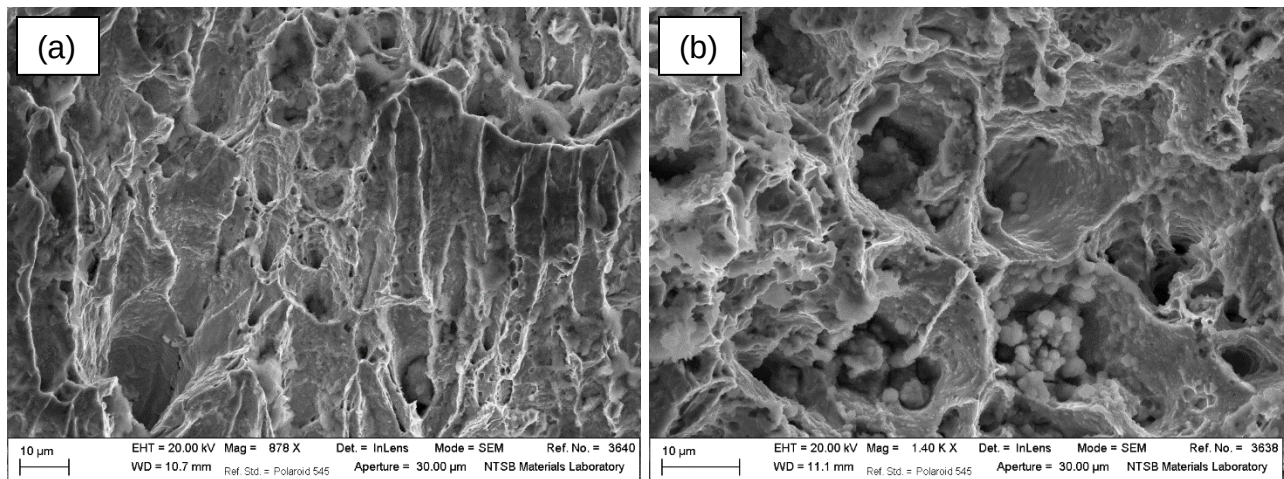
Figure 9 shows the fracture surface of the flat side of the bracket. As shown in Figure 10, this fracture surface exhibited dimple rupture, consistent with overstress fracture. Half of the fracture surface dimple features were oriented normal to the fracture surface (Figure 10b) and the other were oriented at an angle (Figure 10a).

Figure 10 – SE micrographs of the bent side fracture features showing (a) slanted dimple rupture in the upper portion Figure 9 and (b) normal oriented dimple rupture in the lower portion of Figure 9.

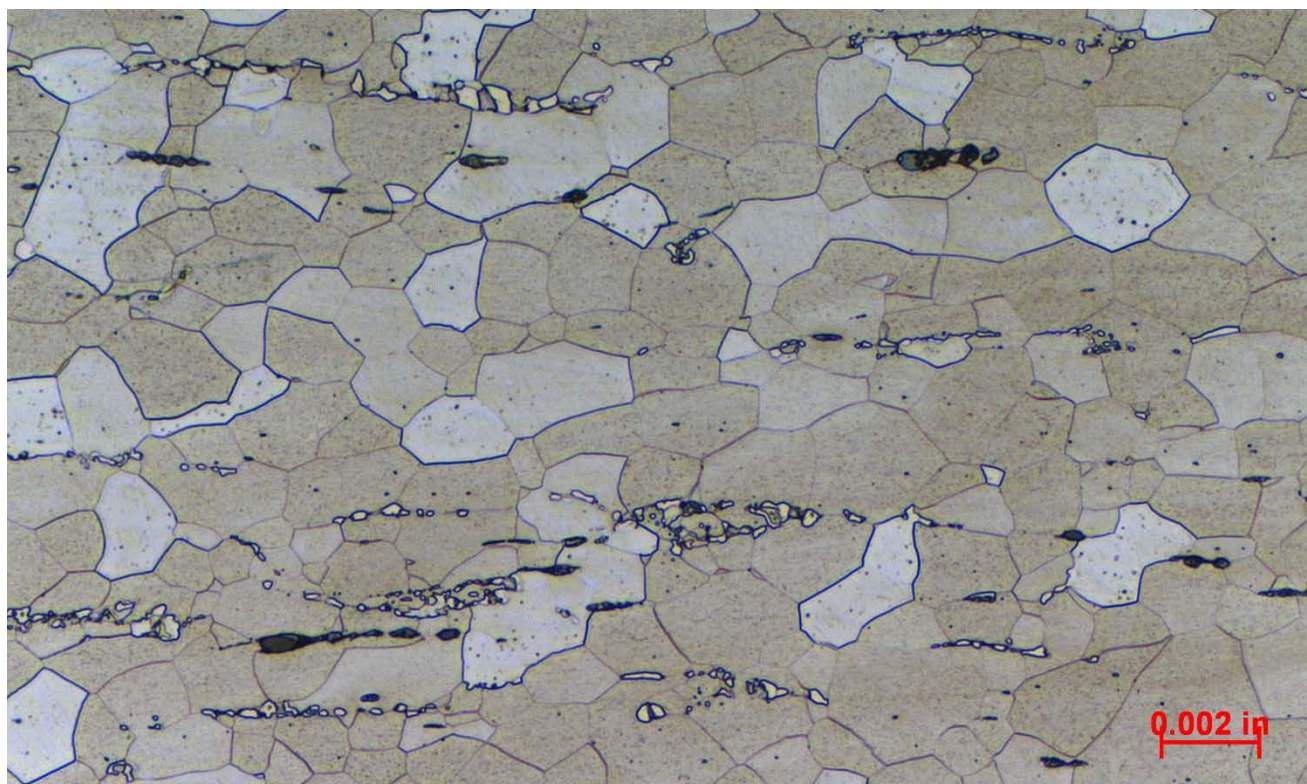
Figure 11 shows a typical area of the bracket microstructure. The microstructure, oriented with the rolling/longitudinal direction running left and right in the figure, was consistent throughout. The microstructure consisted of equiaxed grains, with multiple inclusions present. These inclusions were consistent with manganese sulfide phases typical of this steel alloy.

Figure 11 – Bright field (BF) optical micrograph of a typical portion of the bracket microstructure, oriented in the longitudinal direction (~500X, etched 2% Nital).

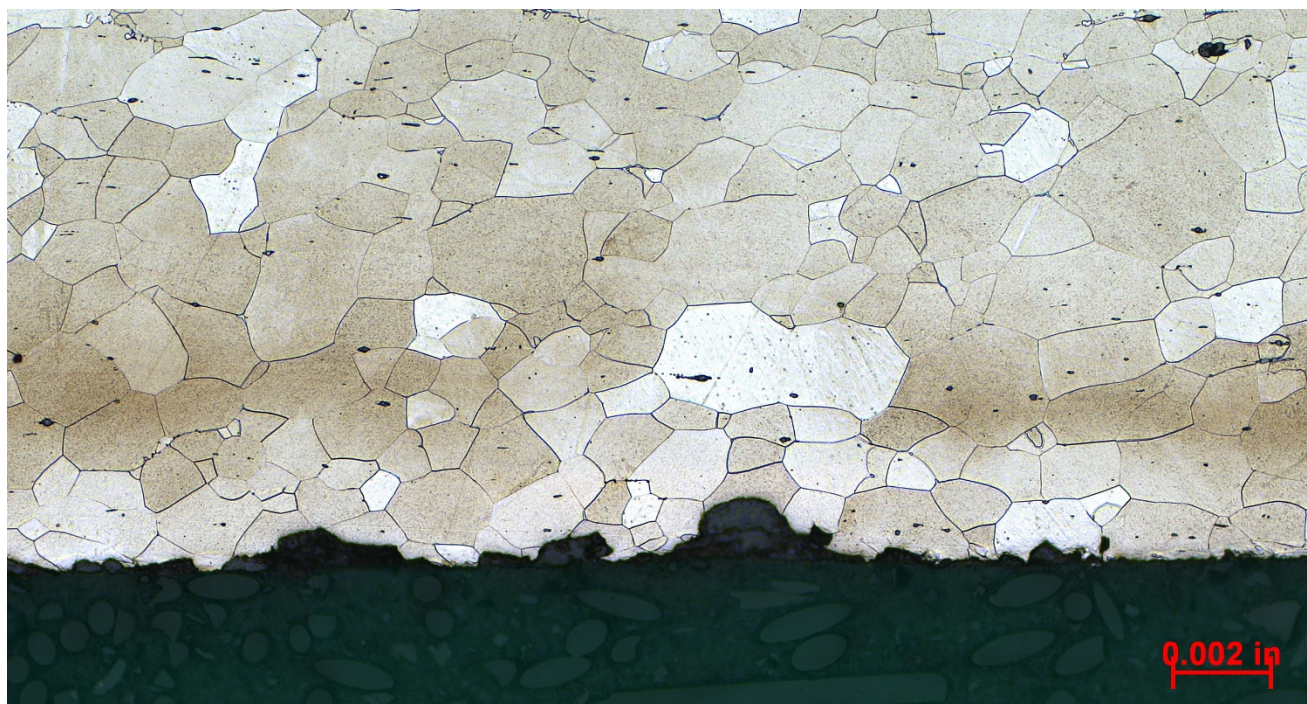
A typical area of the surface of the wire bracket cross section is illustrated in Figure 12. The surface often exhibited pits that contained corrosion products (dark features in Figure 12). Examination of these corrosion products using EDS found them to be consistent with iron oxide.

Figure 12 – BF optical micrograph of the surface of the wire bracket showing corrosion pitting on the surface.
