# The National Transportation Safety Board

Office of Aviation Safety  
Central Region  
Memorandum for the Record  
Recovered Parts Examination  
CEN17FA248  
Catawba Wisconsin  
July 1 2017

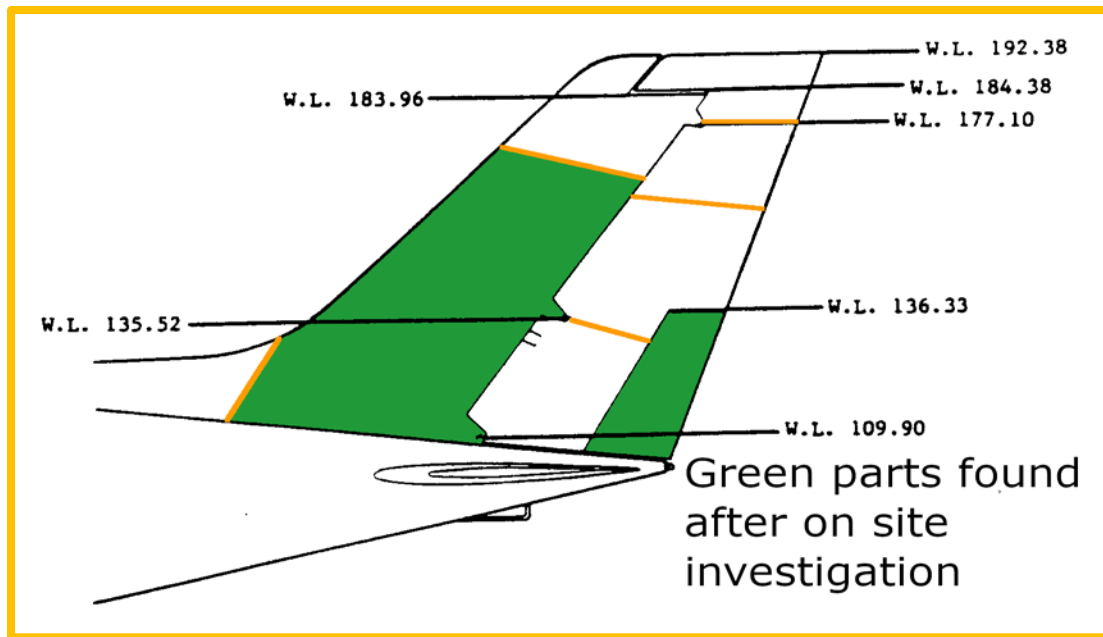
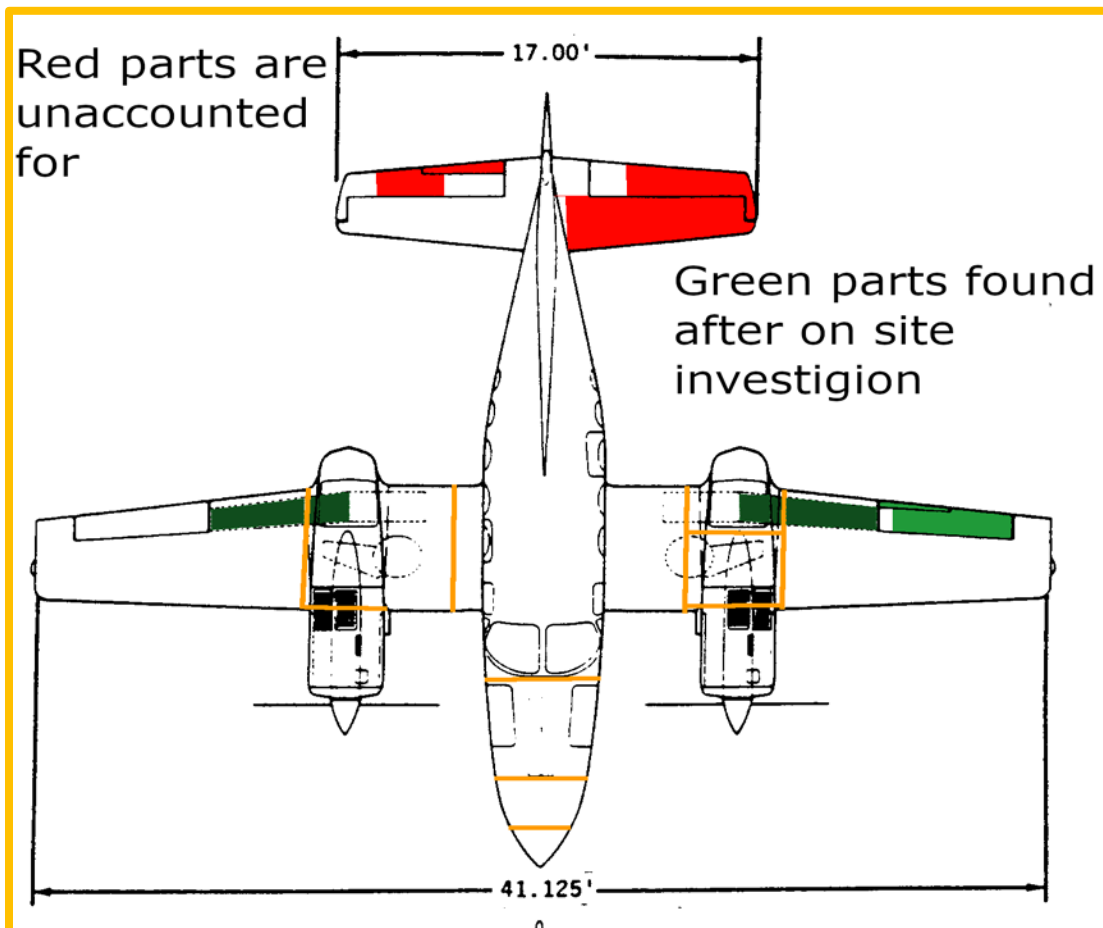
The recovered components from the sheriff included the vertical stabilizer, two flaps, the left aileron, the rudder trim tab, cowlings/nacelle pieces from both engines, two nose baggage doors, a portion of the right magneto from the left engine, a piece of the propeller governor, and pieces of the radome. Their description is below and illustrated in green in Figures 1 and 2.

The vertical stabilizer (11-16-17) was marked "55B" in grey and blue paint. The upper portion, starting about waterline 160, separated and the sheet metal was torn in that location. The leading edge contained the rubber deice boot; the boot was torn at the upper separation point and was otherwise unremarkable. The lower sheet metal along the lower leading edge was torn on the right side. Both turnbuckles for the cable control remained attached and were damaged. The trim tab actuator remained attached. The actuator measured at 2 in. consistent with 0° to 5° tab left or neutral trim.

The rudder trim tab (1-16-17) included the entire hinge. The sheet metal was torn on both sides and bent to the right at midspan.

Flap A consisted of two pieces. Piece A1 (11-2-17) was about 40 in. at its longest point along the leading edge and about 25 in. at the trailing edge. The sheet metal was torn at a 45° angle. The leading edge of the piece had the push/pull tube still attached. The sheet metal was torn in this area. Piece A2 (5-6-18) was about 19 in. along the leading edge and about 31 in. at the trailing edge above the stiffener. The trailing edge stiffener for the entire flap assembly remained attached. The sheet metal was torn at a 45° angle which corresponded to the tear on piece A1.

Flap B (11-2-17) was bent about midspan. The sheet metal was torn in several locations along the leading edge; both at the bend and adjacent to the push/pull tube attach bracket. The tube was separated. The separation signatures were consistent with overload.

The left aileron (10-16-17) assembly included the trim tab. The left aileron (10-16-17), sans about 12 inches of the inboard piece, exhibited crushing along the leading edge. The static wick remained attached at the trailing edge. The trim tab separated at the hinge and was bent and twisted.
