## **NATIONAL TRANSPORTATION SAFETY BOARD**

# **ENGINE EXAMINATION**

**CEN17FA248**

Location: Continental Motors, Inc (CMI)  
Date: Week of July 9, 2018  
Aircraft: Cessna 421, N2655B  
NTSB IIC: Alex Lemishko

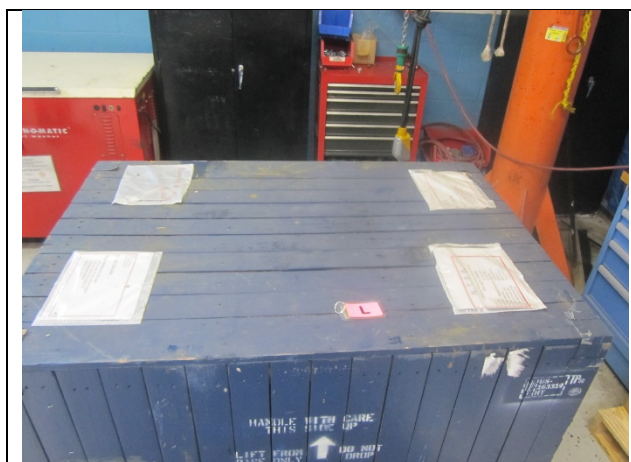
| | <p>Shipping container; left engine noted</p> |

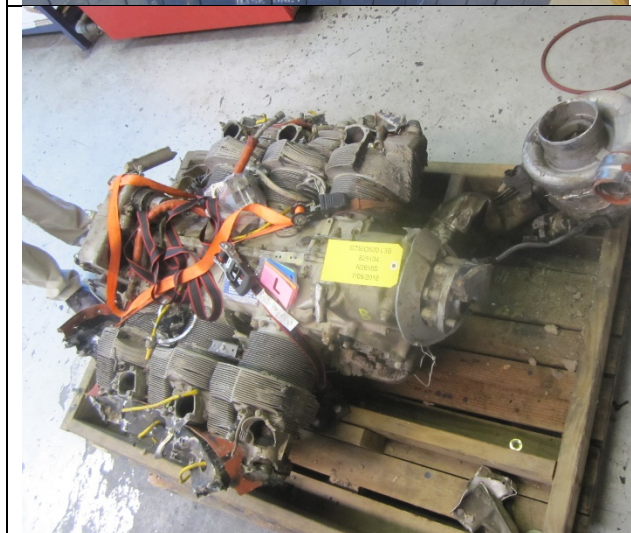
| | <p>Engine as received; from shipping container.</p> <p>Turbocharger was in the shipping container.</p> <p>Heavy damage impact damage is noted to the engine. Also must of the induction system (located top of the engine) was not in the shipping container. Assumed these components were not recovered/identified on site.</p> |

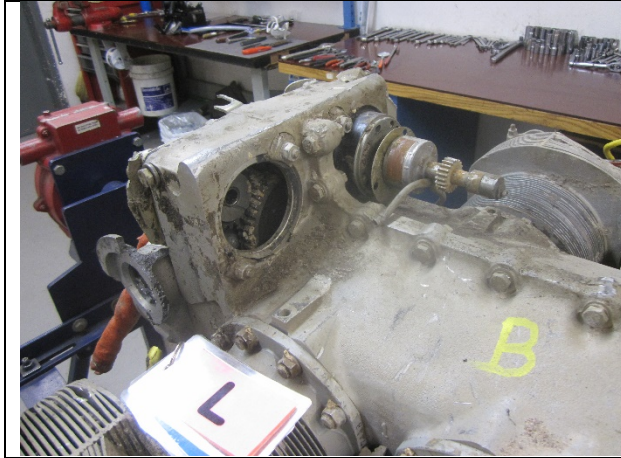
Only part of the two magnetos, remained.  
A detailed examination of the ignition system  
was not possible.

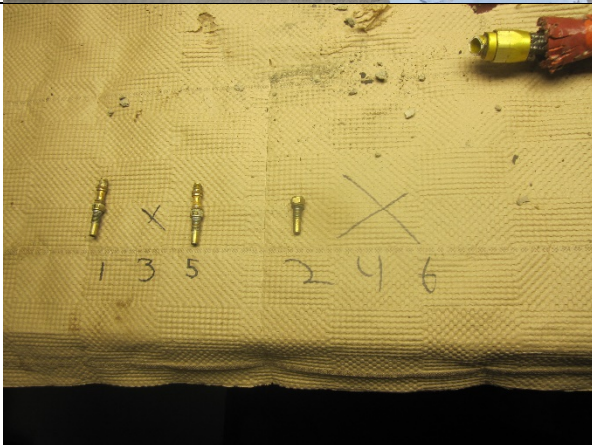
Remints of fuel injectors

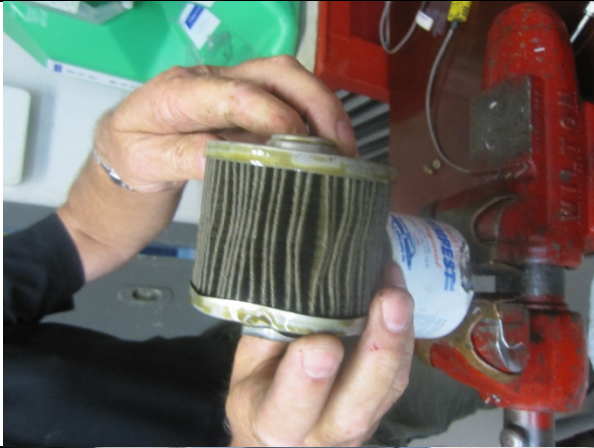
Oil filter was cut open, and inspected for contaminants.

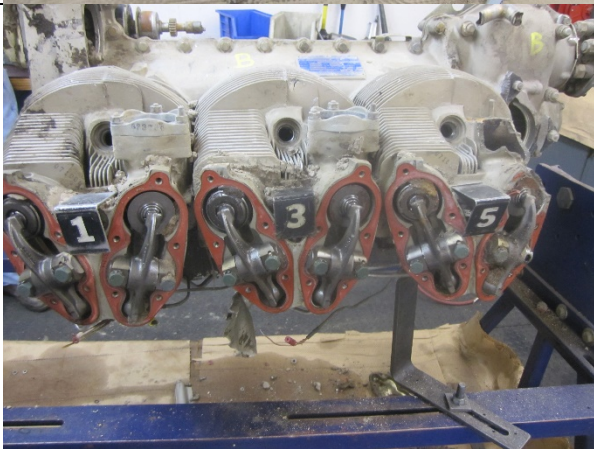
Both left and right side valve covers were removed: no abnormalities noted with valve train

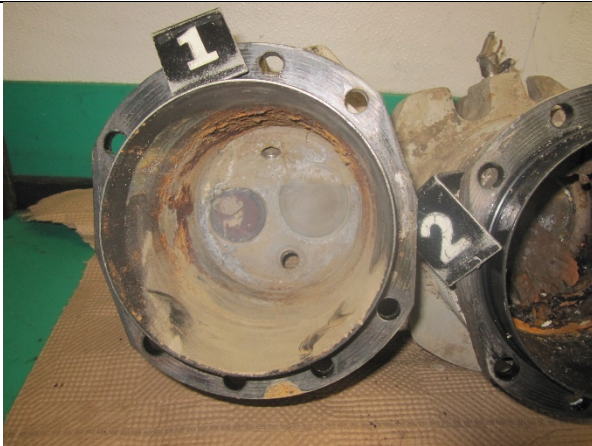
Cylinder 1: Engine was exposed to water, after accident; otherwise, no pre-impact anomalies noted.

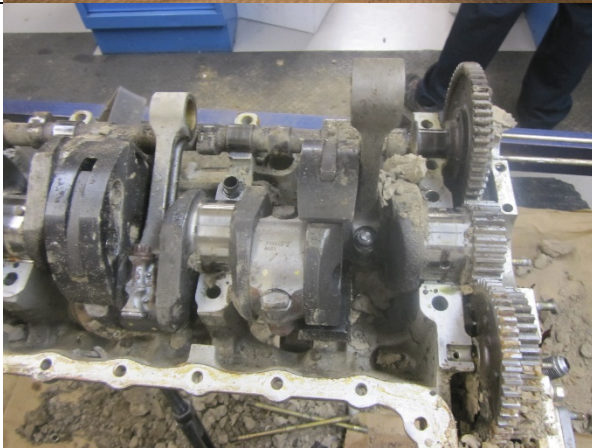
Case was opened. Crankshaft, cam, and rods were visible. Dried mud is noted throughout the engine.

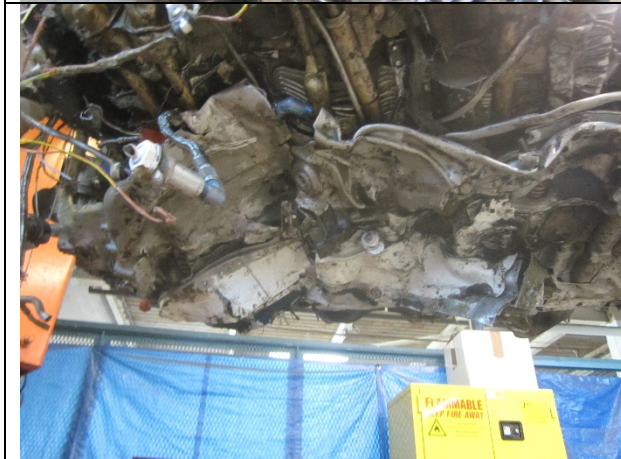
Heavy impact damage is noted to the bottom of the engine.

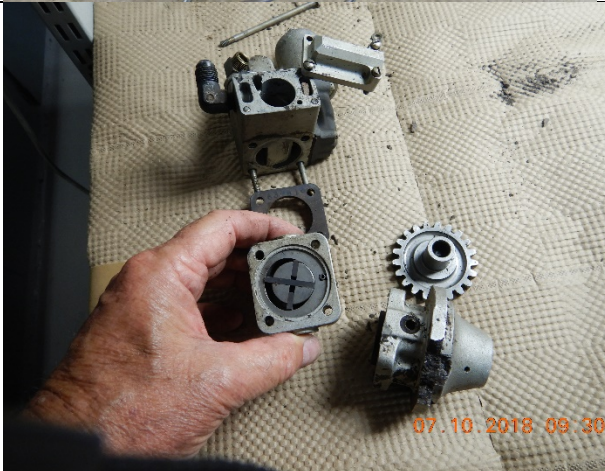
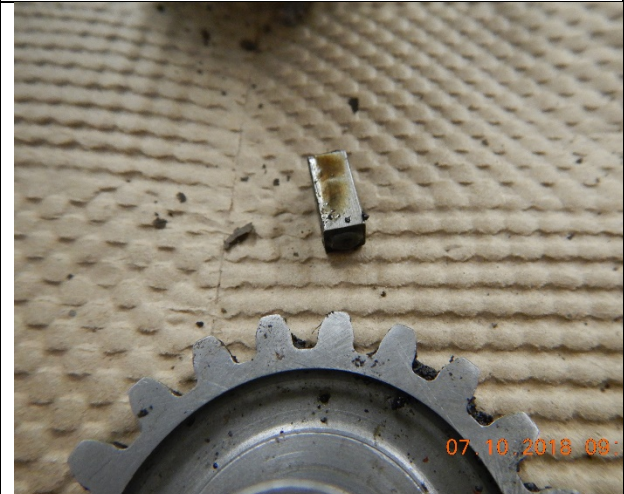
Fuel pump; the drive shaft, "shear pin" was broken.

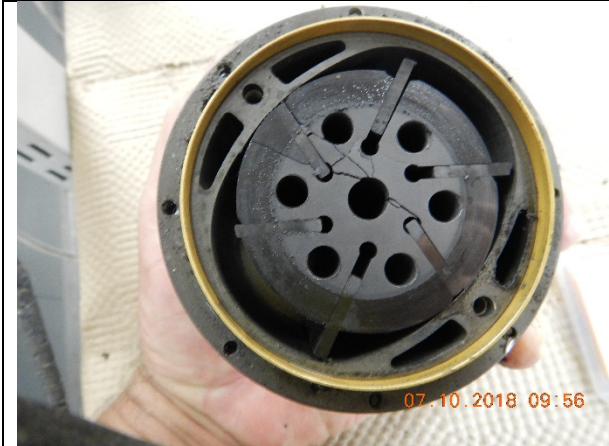
The vacuum pump was disassembled. The rotor was cracked, but the vanes were in place.

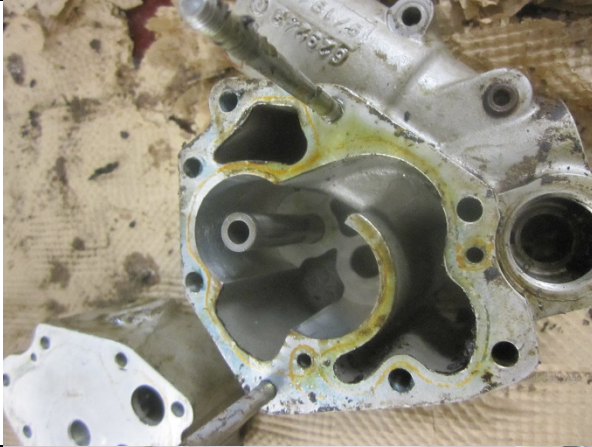
Oil pump: no evidence of hard metal passage.

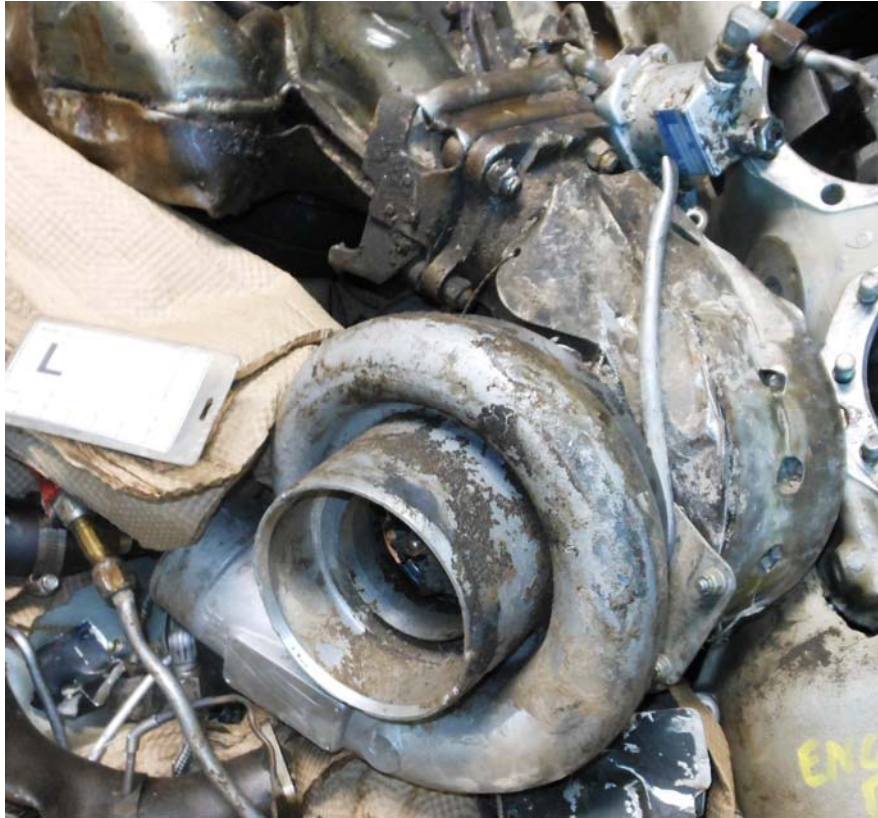
Photo #1 – Left turbo

The left turbocharger data plate was torn from the unit during the inflight breakup or impact. It’s serial number and service history are unknown. The compressor housing backplate was fractured and fragmented; the compressor housing was displaced and contacting the compressor wheel. There was a large amount of mud, dirt and debris packed into the compressor and turbine areas.

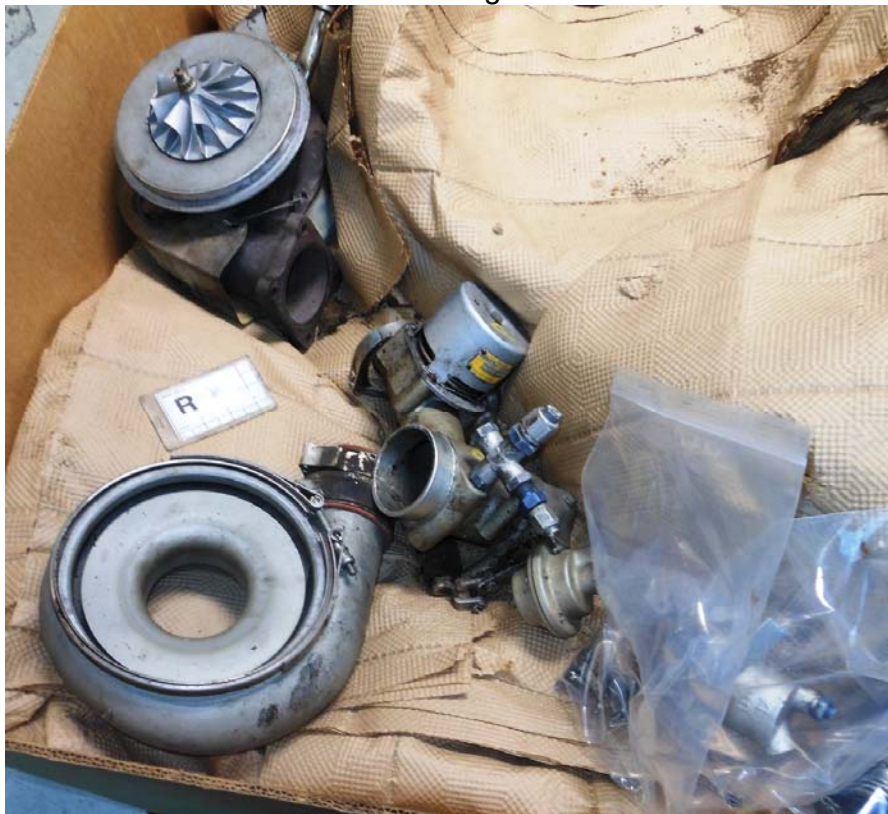
Photo #2 – Right turbo

The right turbocharger had a yellow “field overhaul” data tag with “Rajay/Kelly Aerospace” names presented. This data tag indicates the turbocharger was overhauled by a repair station at some date prior to approximately September 2010. The name of the repair station and the precise date may be available in the engine logbooks. The compressor housing had separated from the turbocharger assembly during the inflight breakup or impact; the V-band clamp was still in place and secured. All of the intake and exhaust ducting was removed. The turbine blanket was still in place and a mounting bracket was still attached. The oil supply line was removed and the oil drain line was still attached. The compressor backplate had one visible fracture/crack extending from the center to the edge.

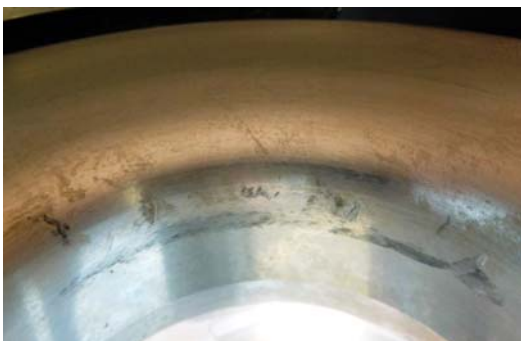
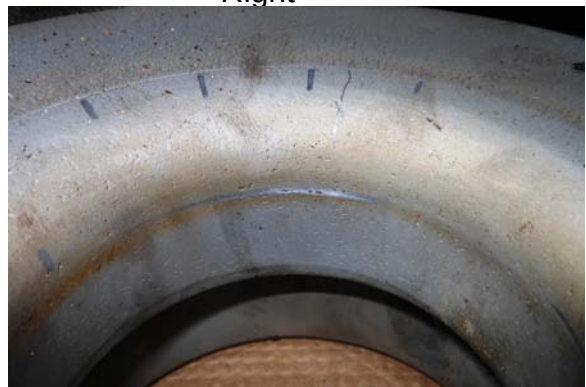
Photo #5 – Compressor housing rub and wheel impact marks

5. There were also what appeared to be stationary blade impact marks on both compressor housings. Both compressor wheels had blade impact damage indicating contact with the housing.

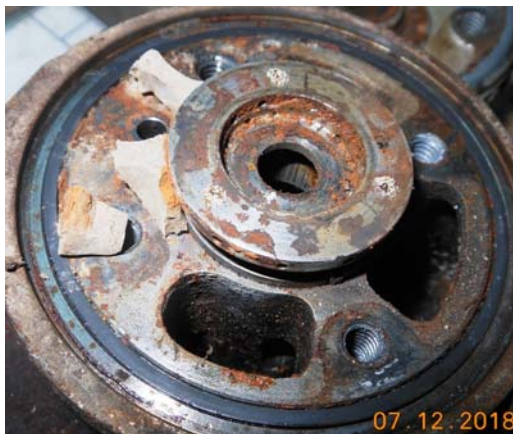
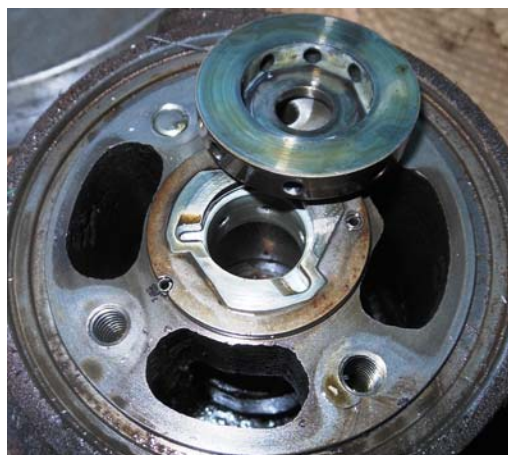
Photo #7 – Thrust bearing/collar condition  
Left Right  
(note silt deposits on left)

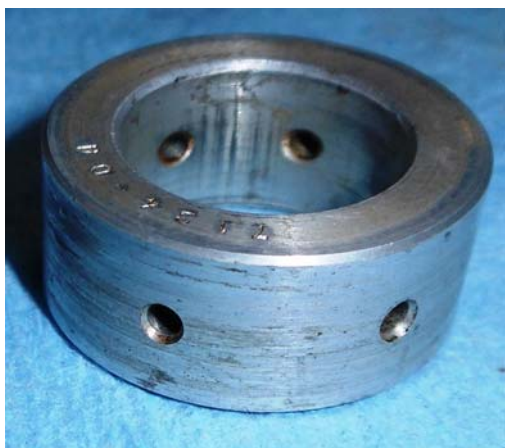
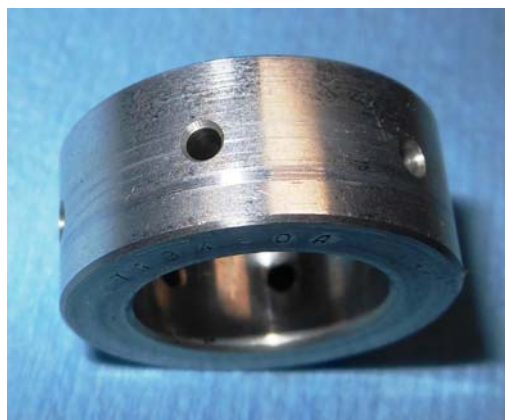
10. The compressor-end bearings appeared to have normal wear; radial holes clear and chamfers visible indicating sufficient lubrication.
11. All piston rings on both turbochargers (compressor and turbine sides) were free of excessive coking, and free to expand and rotate in the grooves.

Photo #8 – Compressor-end bearing condition  
Left Right

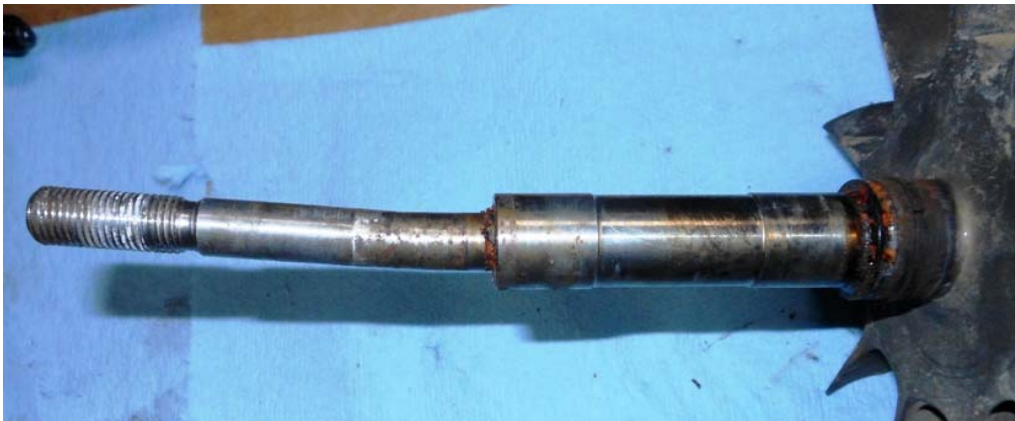
Photo #10 – Left shaft bent

13. The left rotating shaft was bent and the bend was consistent with the compressor housing/backplate and wheel impact damage.

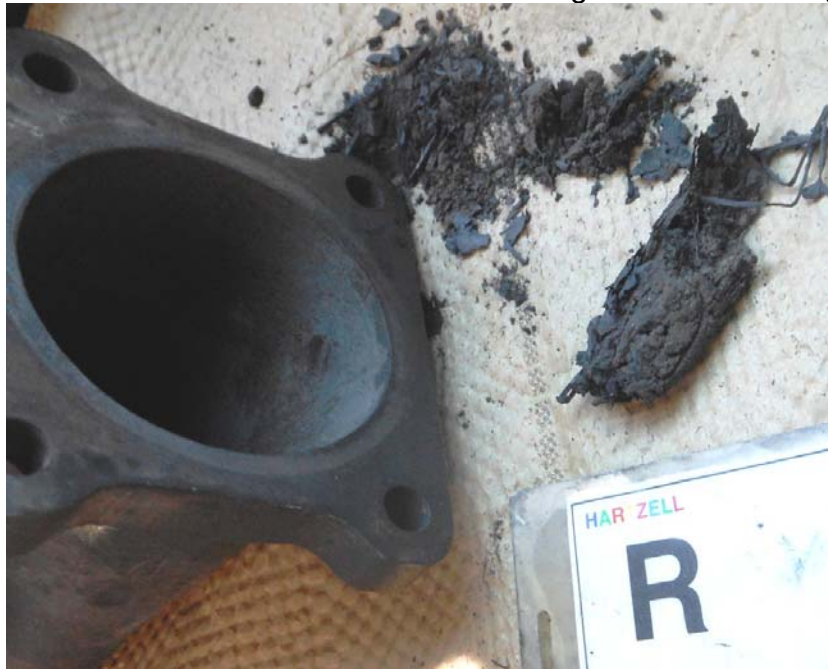
Photo #12 – Charred/burnt debris from right turbine housing

14. When viewing the internal cavity of the Center Housings after disassembly, the following was observed:
  - a. There was evidence of sufficient oil/lubrication
  - b. There was NO evidence of coking
  - c. There was NO evidence of excessive heat.
  - d. There was NO evidence of FOD in the oil prior to impact with terrain.
  - e. There was NO evidence of lubrication blockage prior to impact with terrain and all oil passages and radial holes were clear.
15. The left turbocharger Center Housing had silt and water damage/corrosion suggesting it was submerged in water or water saturated soil for a period of time.
16. The right turbocharger turbine housing had burnt/charred vegetation-type debris suggesting the housing was hot when it impacted terrain (Photo #12)

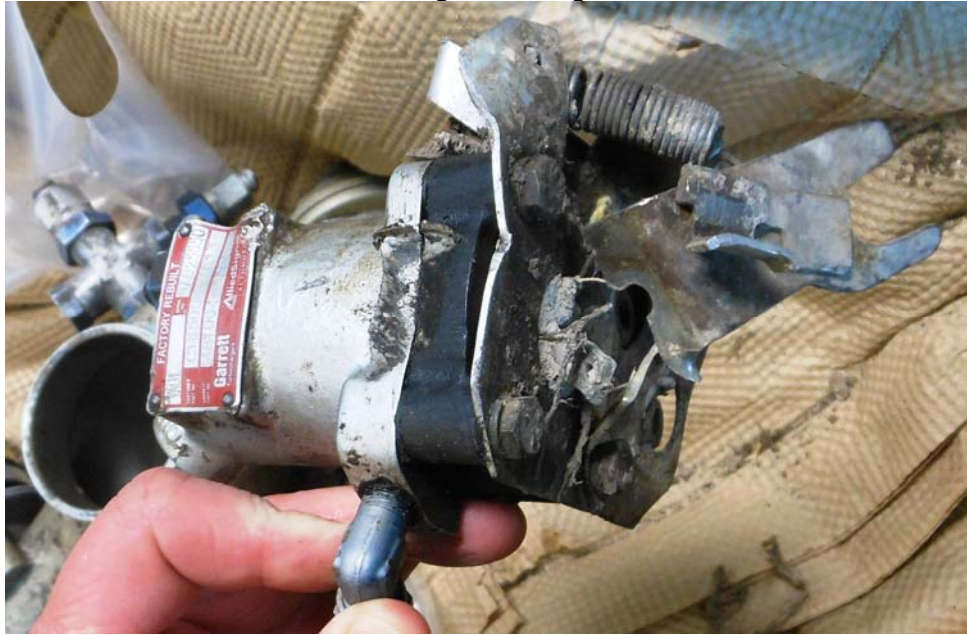
Photo #13 – Right wastegate actuator

The right wastegate actuator was fracture-separated from the wastegate assembly and the body was dented/impact damaged.

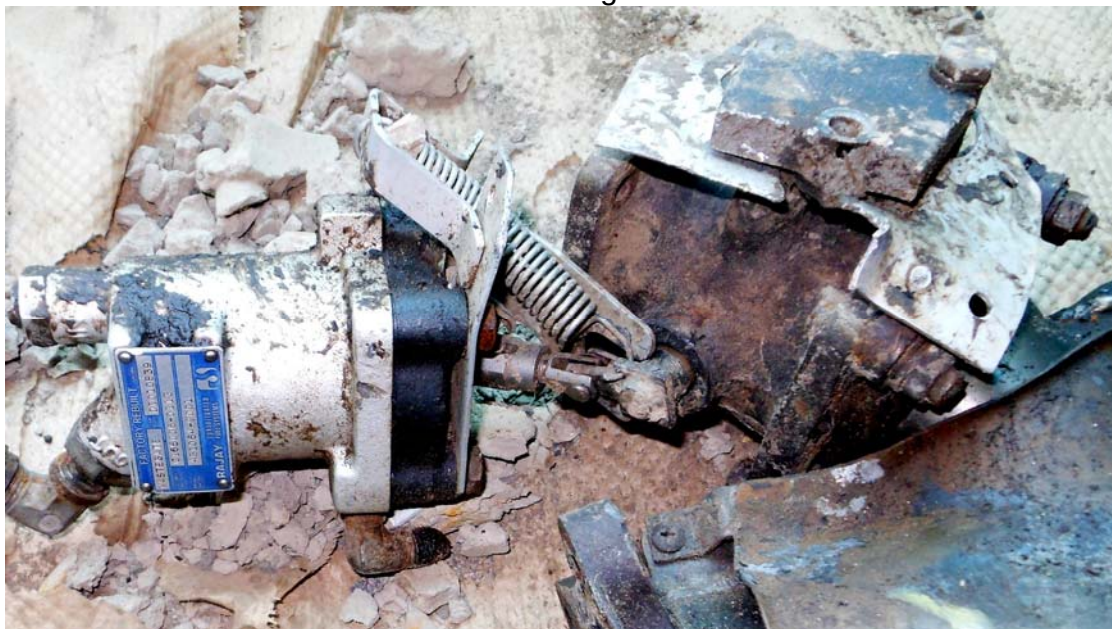
Photo #16 – Left wastegate and actuator

The left wastegate actuator mount was fracture-separated from the wastegate valve but the actuator shaft remained attached to the valve shaft.
