**NATIONAL TRANSPORTATION SAFETY BOARD**  
**Office of Aviation Safety**  
**Washington, D.C. 20594**

**AIRWORTHINESS GROUP CHAIRMAN'S FACTUAL REPORT**

**NTSB No: CEN17FA252**

Operator: Air Methods Corporation  
Aircraft: Airbus Helicopters Deutschland MBB-BK117 B-2, Registration N238BK  
Location: Perryville, Missouri  
Date: July 1, 2017  
Time: 2036 central daylight time

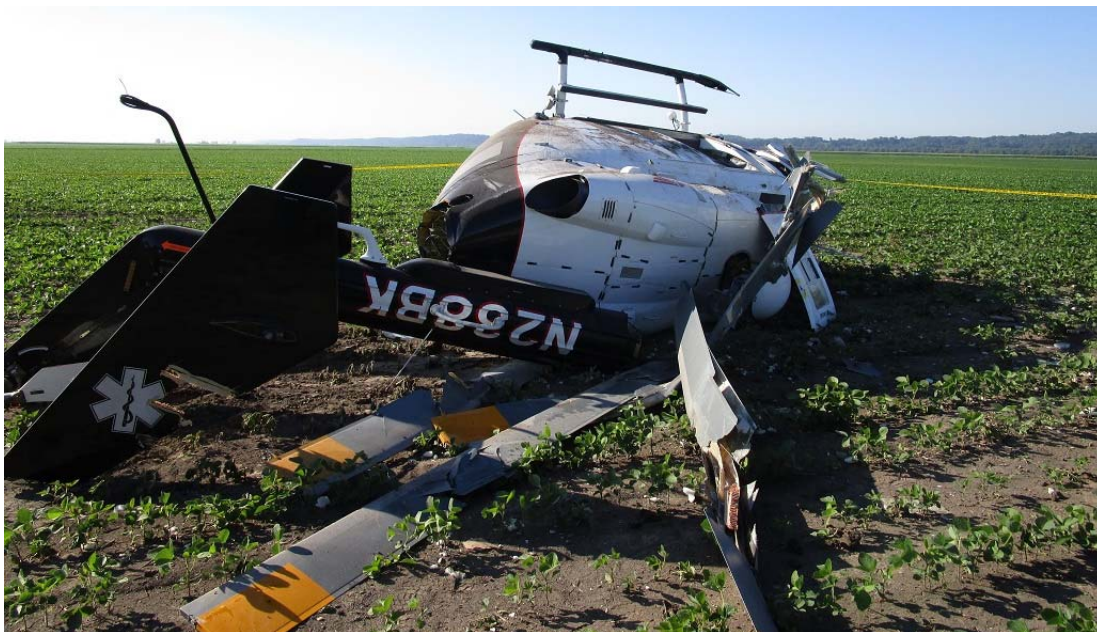
**Figure 3. The accident helicopter at the accident site. (courtesy of the FAA)**

The tail boom and empennage had separated from the main fuselage but were located immediately adjacent to the main fuselage. The tail boom and empennage came to rest inverted. The tail rotor and tail rotor gearbox remained attached to the vertical fin. One of the two tail rotor blades exhibited a broomstrawed appearance and the other appeared relatively intact. Three of the four main rotor blades appeared to be underneath the main fuselage with their tip ends generally pointed in the aft direction. The fourth main rotor blade tip end was generally pointed to the 4 o'clock direction.

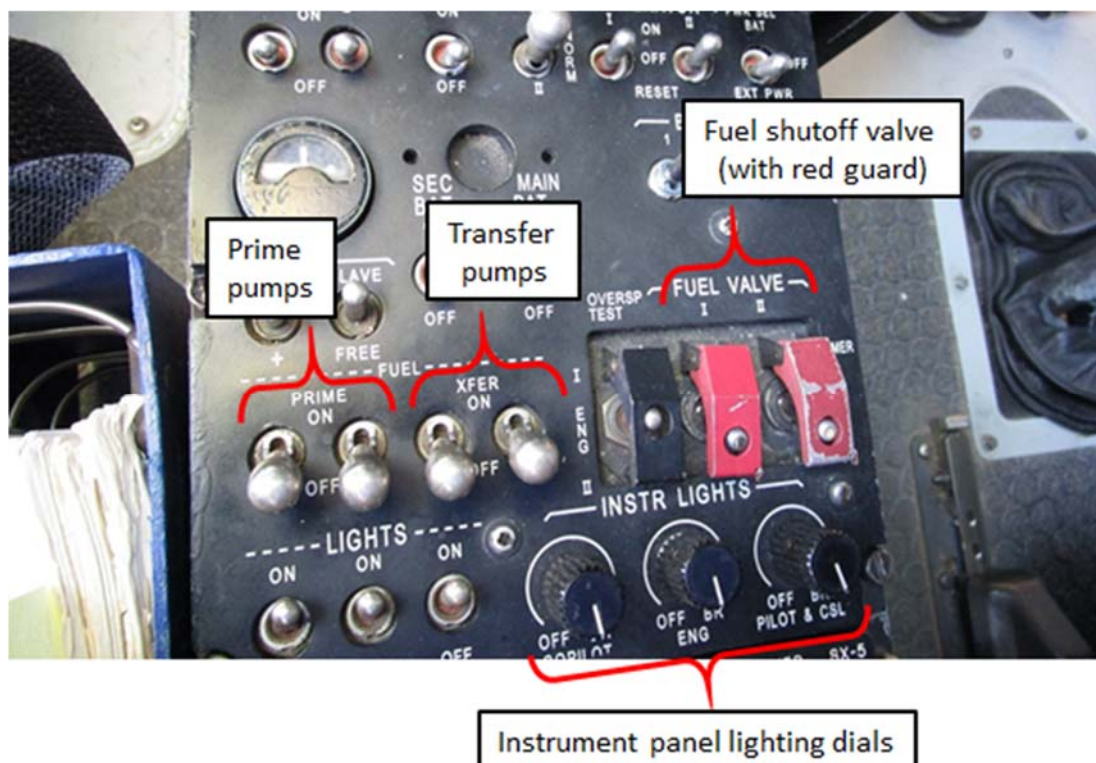
**Figure 3. The center console containing the fuel prime pump, fuel transfer pump, and fuel shutoff valve switches as well as the instrument lighting dials. (courtesy of the FAA)**

Photos from inside the cockpit showed the two fuel prime pump and the two fuel transfer pump switches were in the “off” position (**Figure 3**). The two fuel shutoff valve switches were in the “open” position and the switch guards remained “closed”. The position, anti-collision, and strobe light switches were found in the “on” position. The copilot, engine, and pilot instrument panel lighting dials (rotary switches) were set to the “BR” (bright) position.<sup>5</sup> According to Air Methods representatives, after the helicopter was moved upright, the forward battery was reconnected and the annunciator panel and master warning light were dim. When the instrument panel lighting dials were set to the “off” position, all expected lights were illuminated. Additionally, the fuel gauges for the No. 1 and No. 2 supply tanks indicated zero and the main fuel tank indicated about 25 gallons. The forward battery was disconnected prior to relocation of the helicopter.

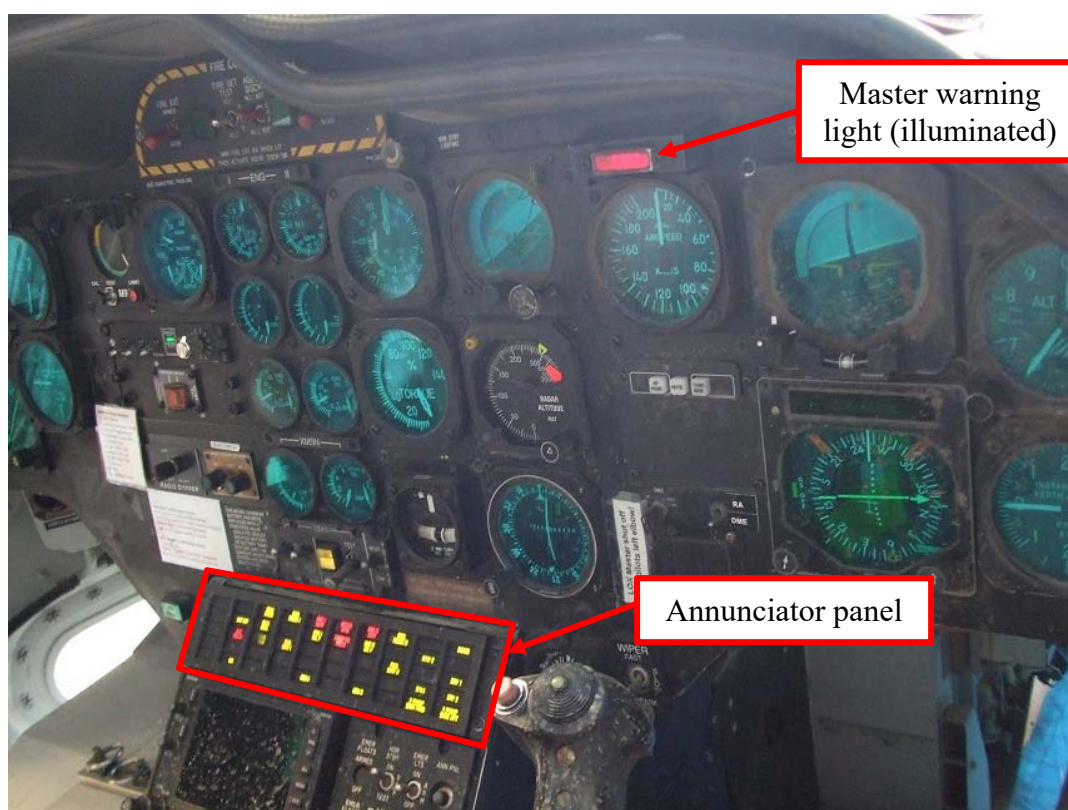
**Figure 4. The cockpit instrument panel after the master power switch was turned on.**

All three instrument panel lighting dials were observed to be in the “off” position. The forward and aft batteries were reconnected. The main and secondary battery switches and the master power switch were turned on. Several lights on the annunciator panel as well as both left and right master warning lights illuminated (**Figure 4**). Depressing the annunciator panel test button illuminated all advisory, caution, and warning lights on the annunciator except for one light bank located on the third column (from the left) and bottom row (**Figure 5**). The advisory, caution, and warning lights appeared bright with even illumination. The master warning light extinguished while it was depressed, but releasing the light resulted in it illuminating again.

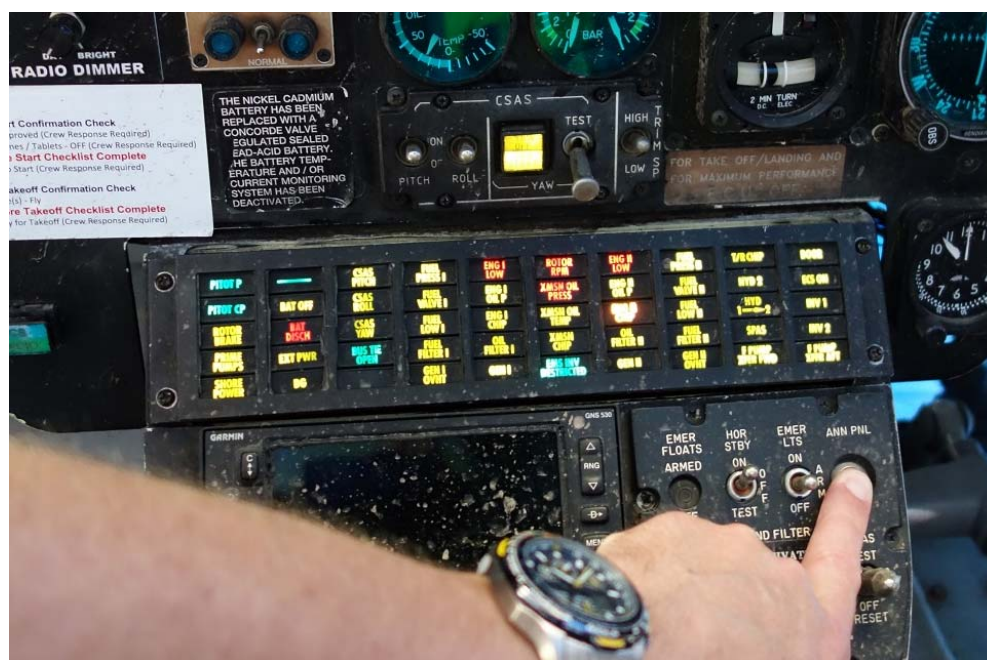
**Figure 5. The advisory, caution, and warning annunciator panel with the dimming function turned off and the annunciator panel test button depressed. (courtesy of Air Methods)**

Rotating the copilot instrument lighting dial resulted in no effect to the dimming of the annunciator lights as well as the master warning light. Rotating the engine and pilot instrument panel lighting dials resulted in dimming of the annunciator lights as well as the master warning light. When the annunciator lights were dimmed using the pilot instrument lighting dial and the annunciator panel test button was depressed, the following was observed (**Figure 6**):<sup>7</sup>

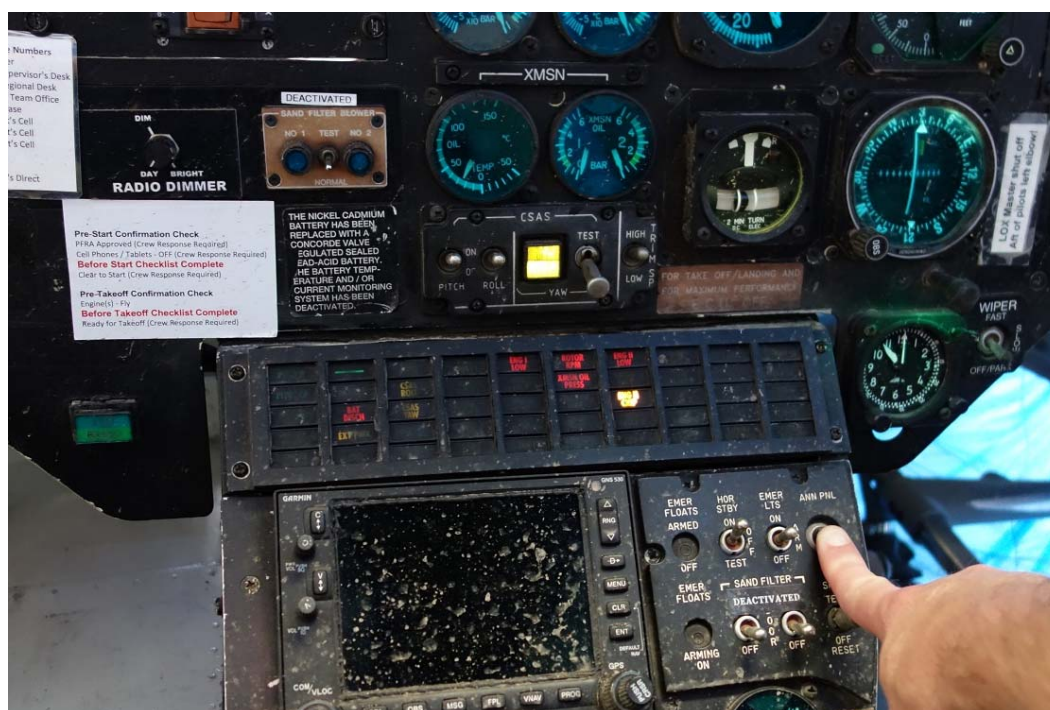
**Figure 6. The advisory, caution, and warning annunciator panel with the dimming function turned on and the annunciator panel test button depressed. (courtesy of Air Methods)**

- The “ENG I LOW”, “ROTOR RPM”, “ENG II LOW”, and “XMSN OIL PRESS” lights were dimmed but still visible.
- The “ENG II CHIP” light was at full brightness and visible.
- The “BAT DISCH”, “EXT PWR”, “CSAS ROLL”, and “CSAS YAW” lights were dimmed and partially visible.
- The remaining advisory, caution, and warning lights on the annunciator panel were not visible.
- The master warning light had dimmed to a level where its illumination was not readily distinguishable.

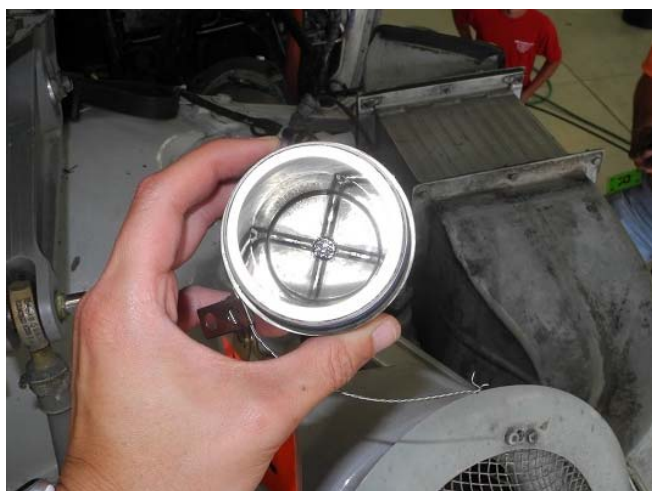
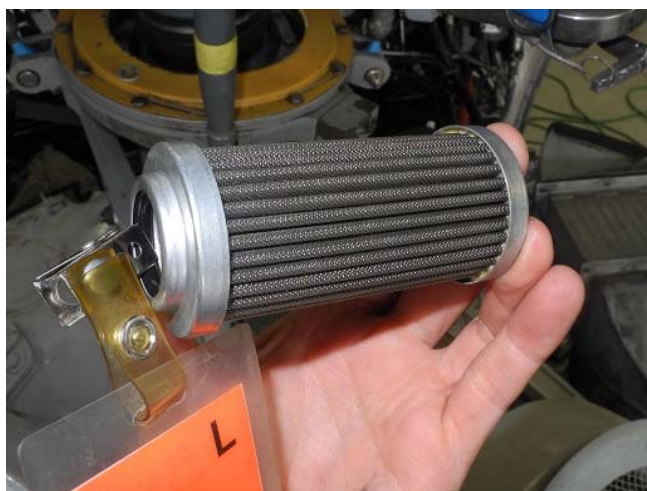
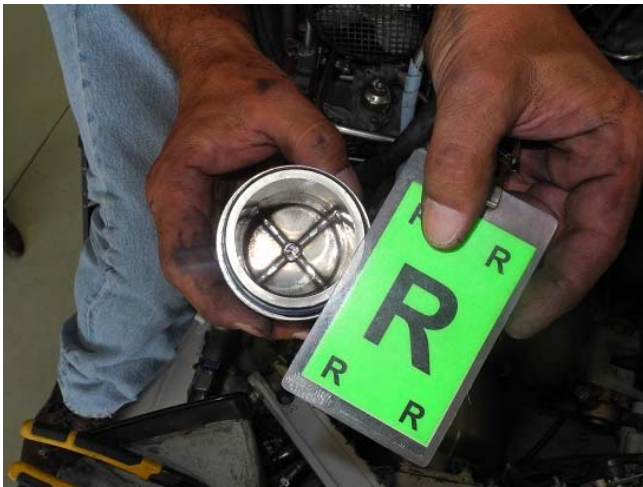
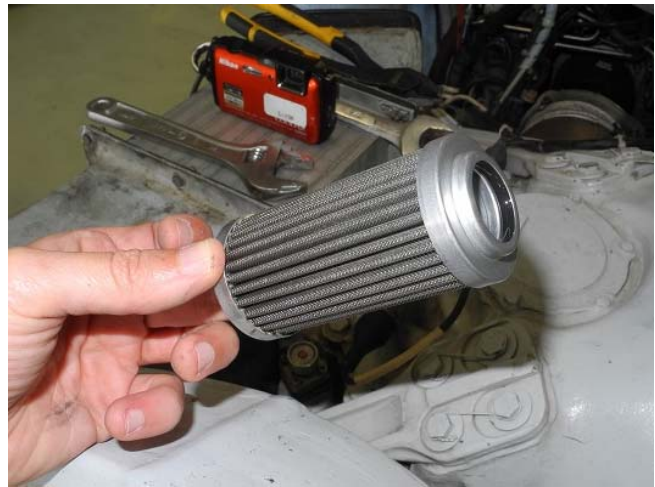
The Nos. 1 and 2 engine fuel filter bowl safety wiring remained intact. The safety wiring was removed and the filter bowls were unscrewed from their respective housings. The Nos. 1 and 2 engine fuel filter bowl revealed about 0.08 – 0.16 fluid ounces of fuel and the filter element was undamaged and clear of debris. (**Figures 7 through 10**)
