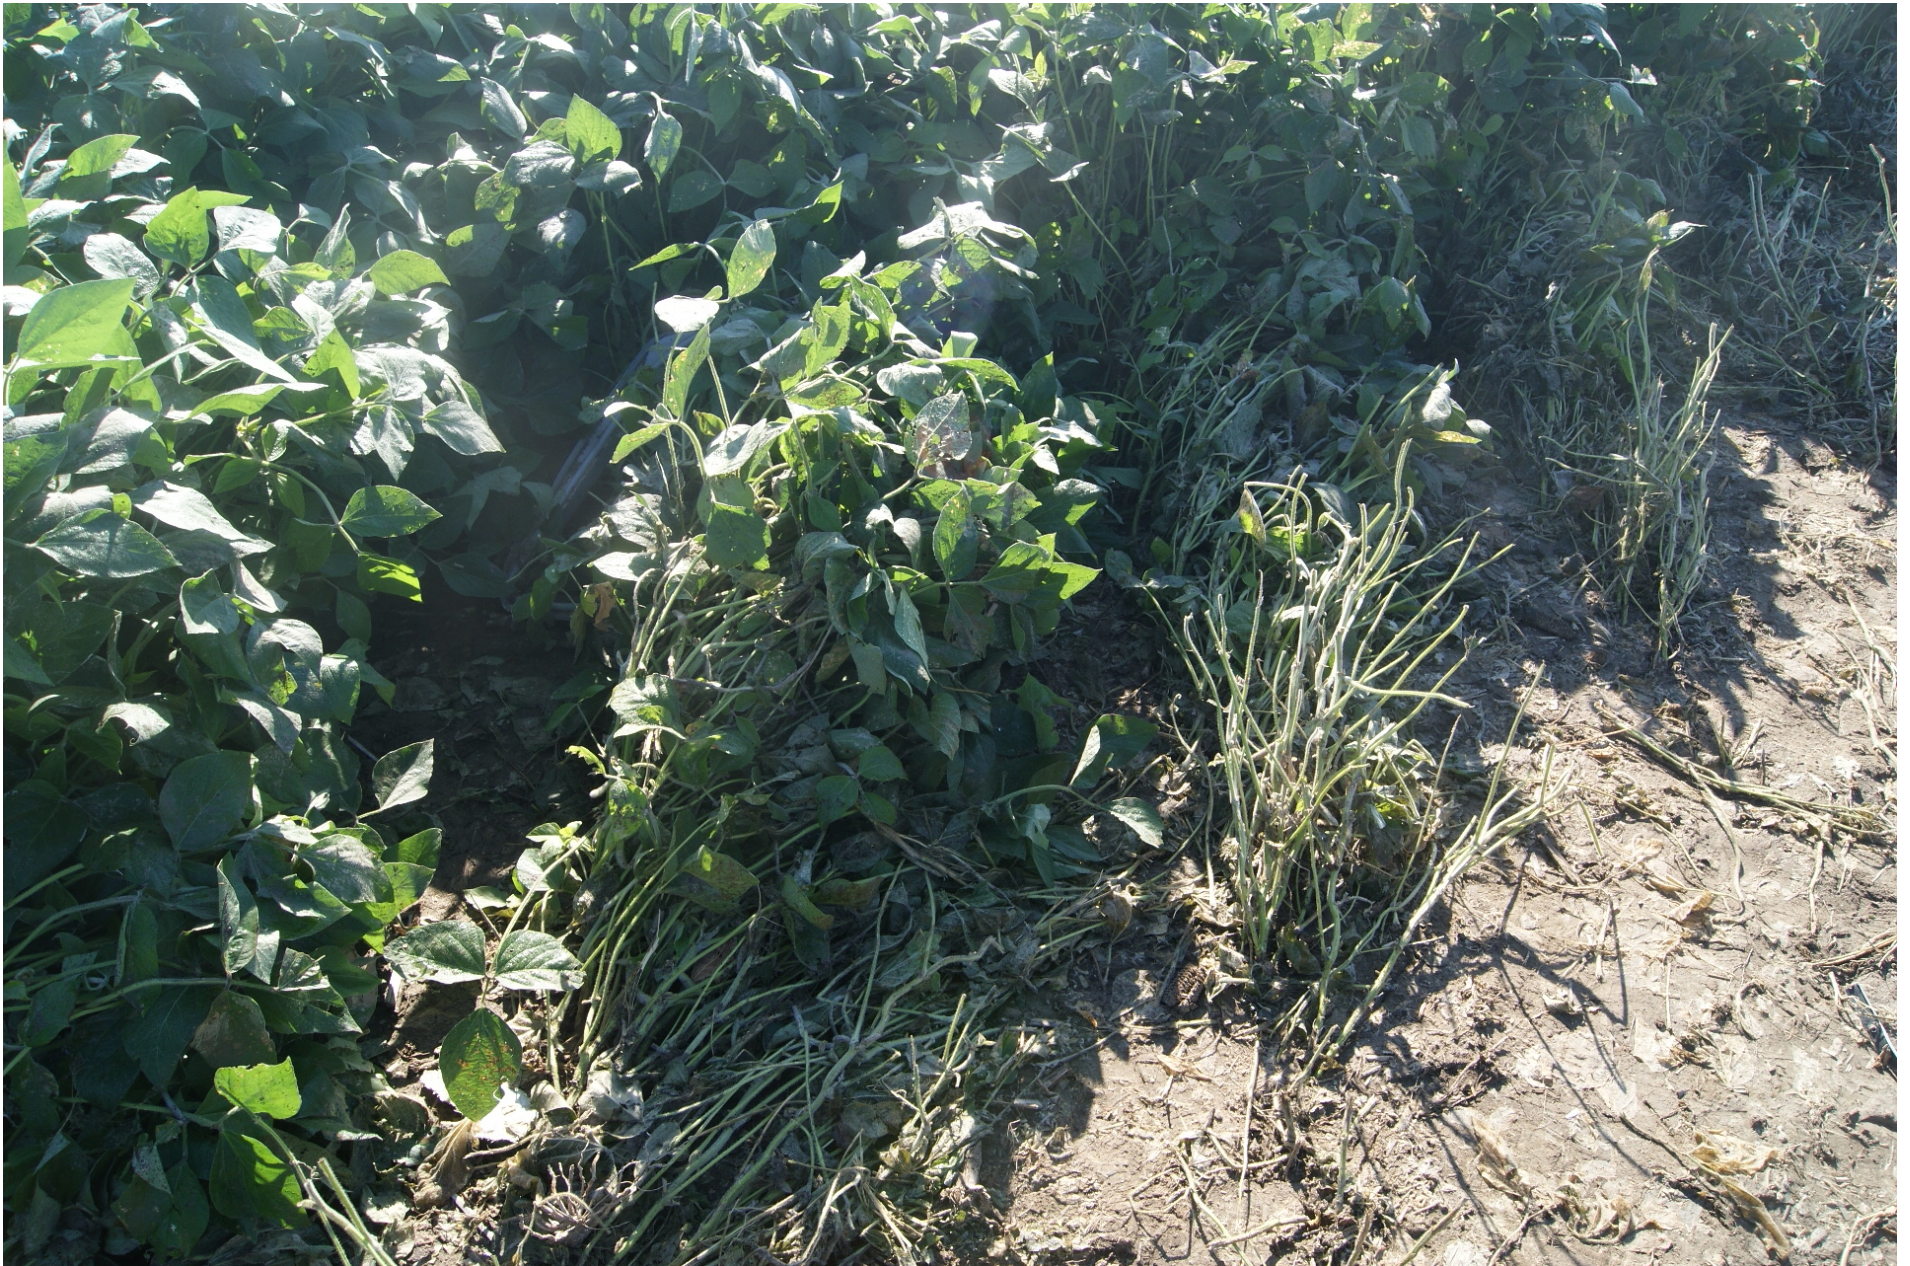
**Photo 1 – Green position light lens fragments were found at the beginning of a 35-foot long ground scar aligned on a magnetic course of 121°.**

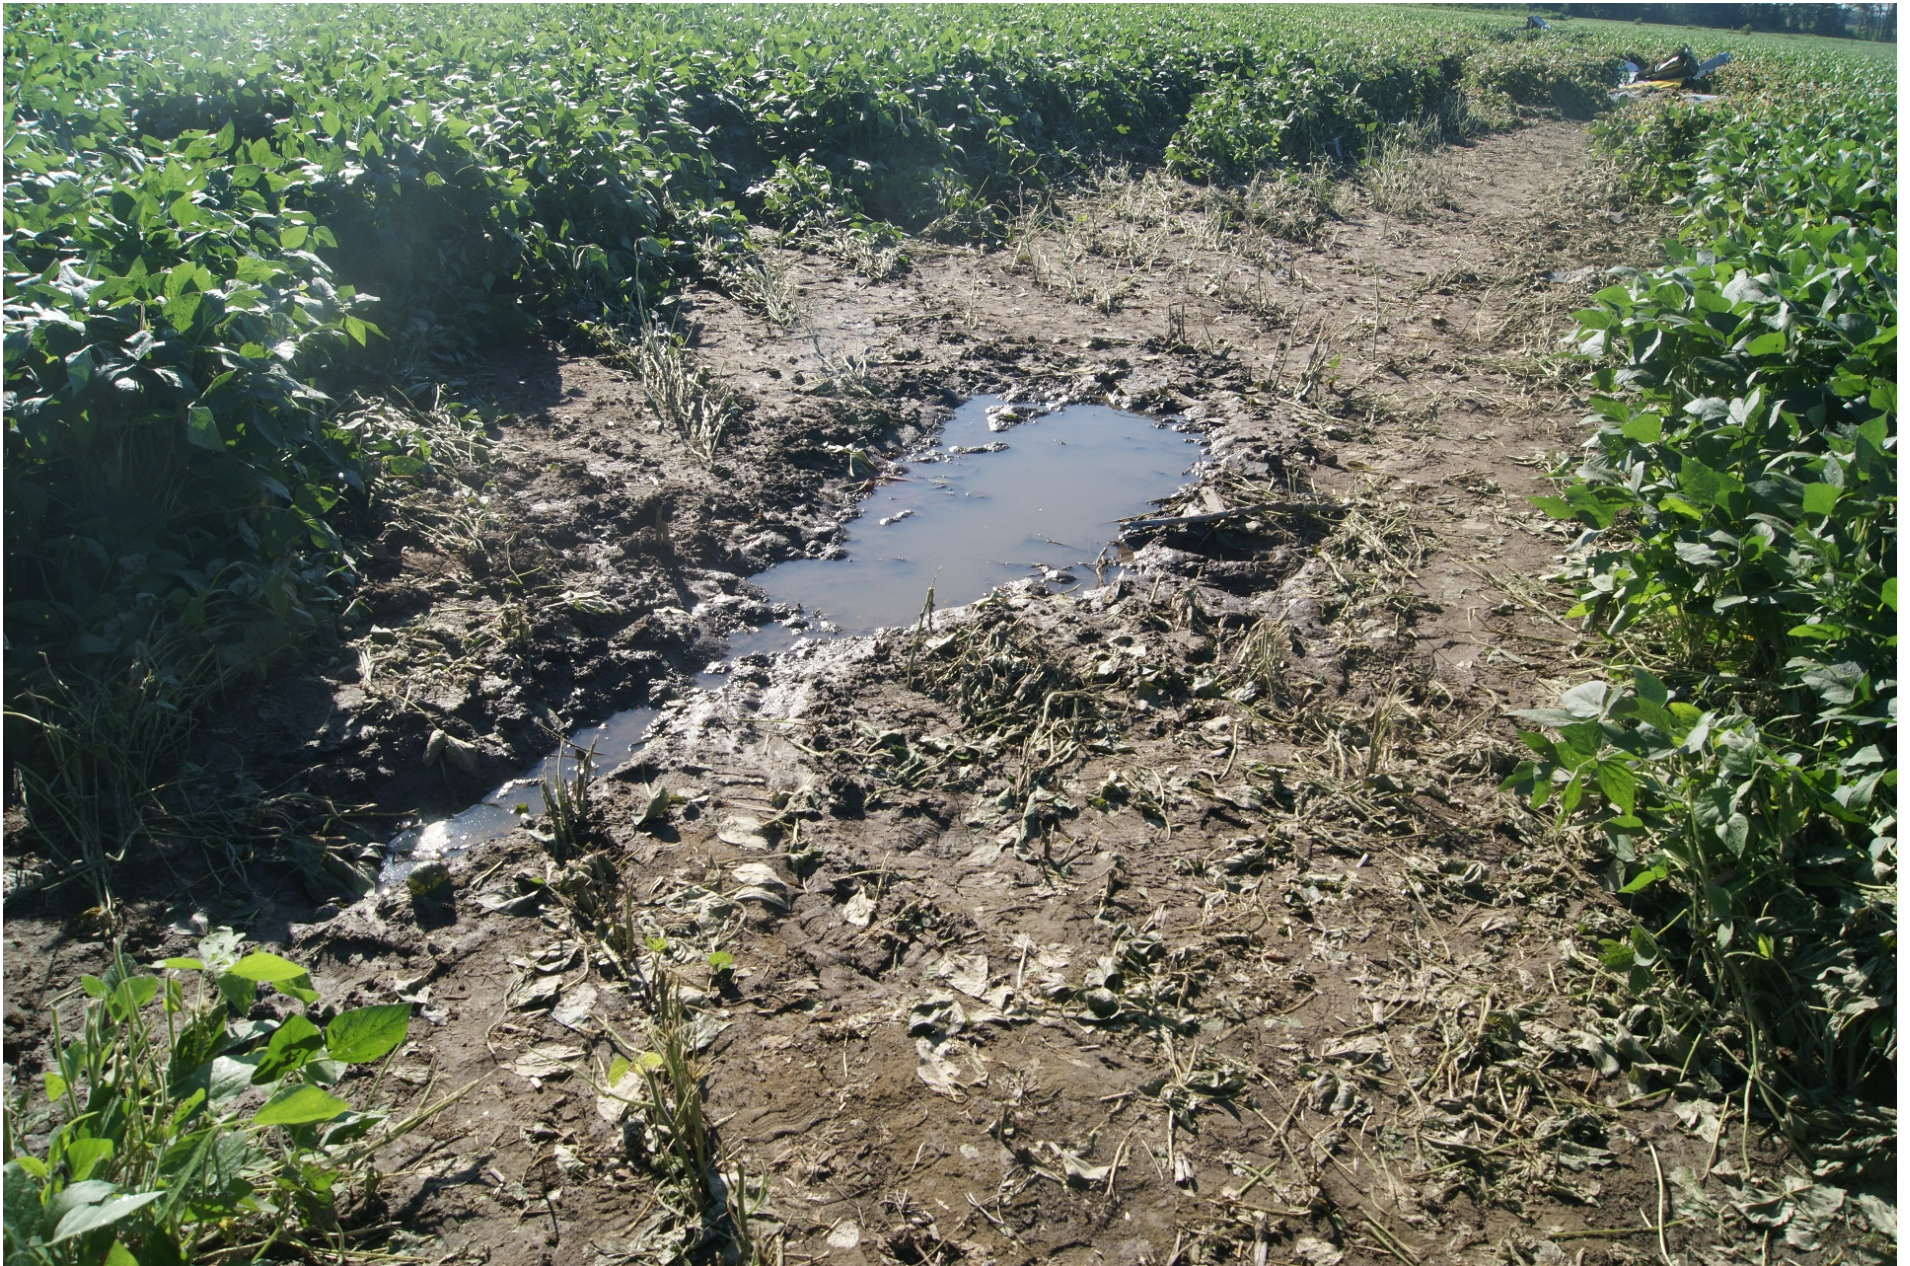
**Photo 2 – Water-filled impact crater.**

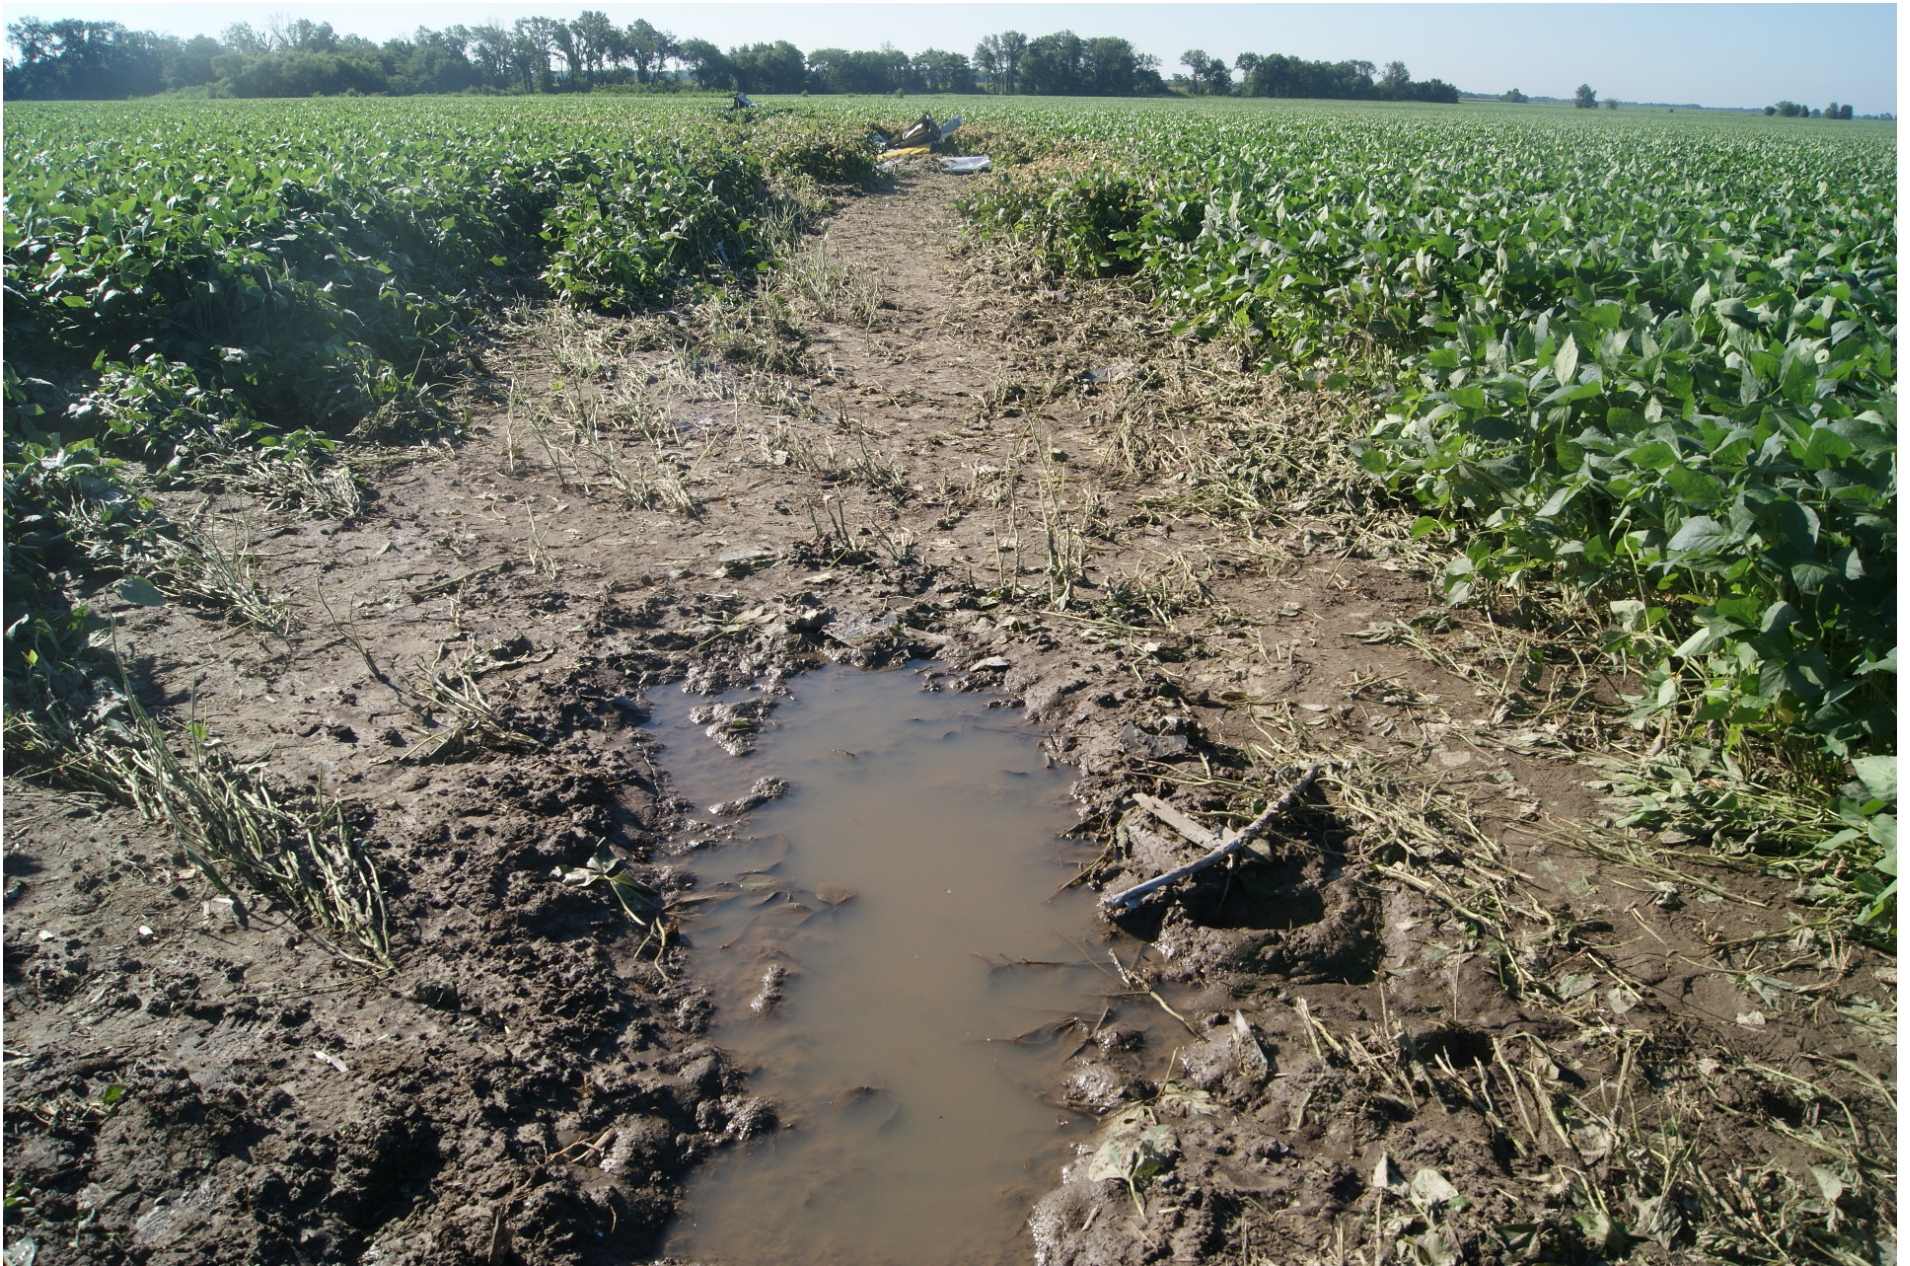
**Photo 3 – The debris path extended 250 feet on a magnetic course of 130°. Note a propeller blade next to the impact crater.**

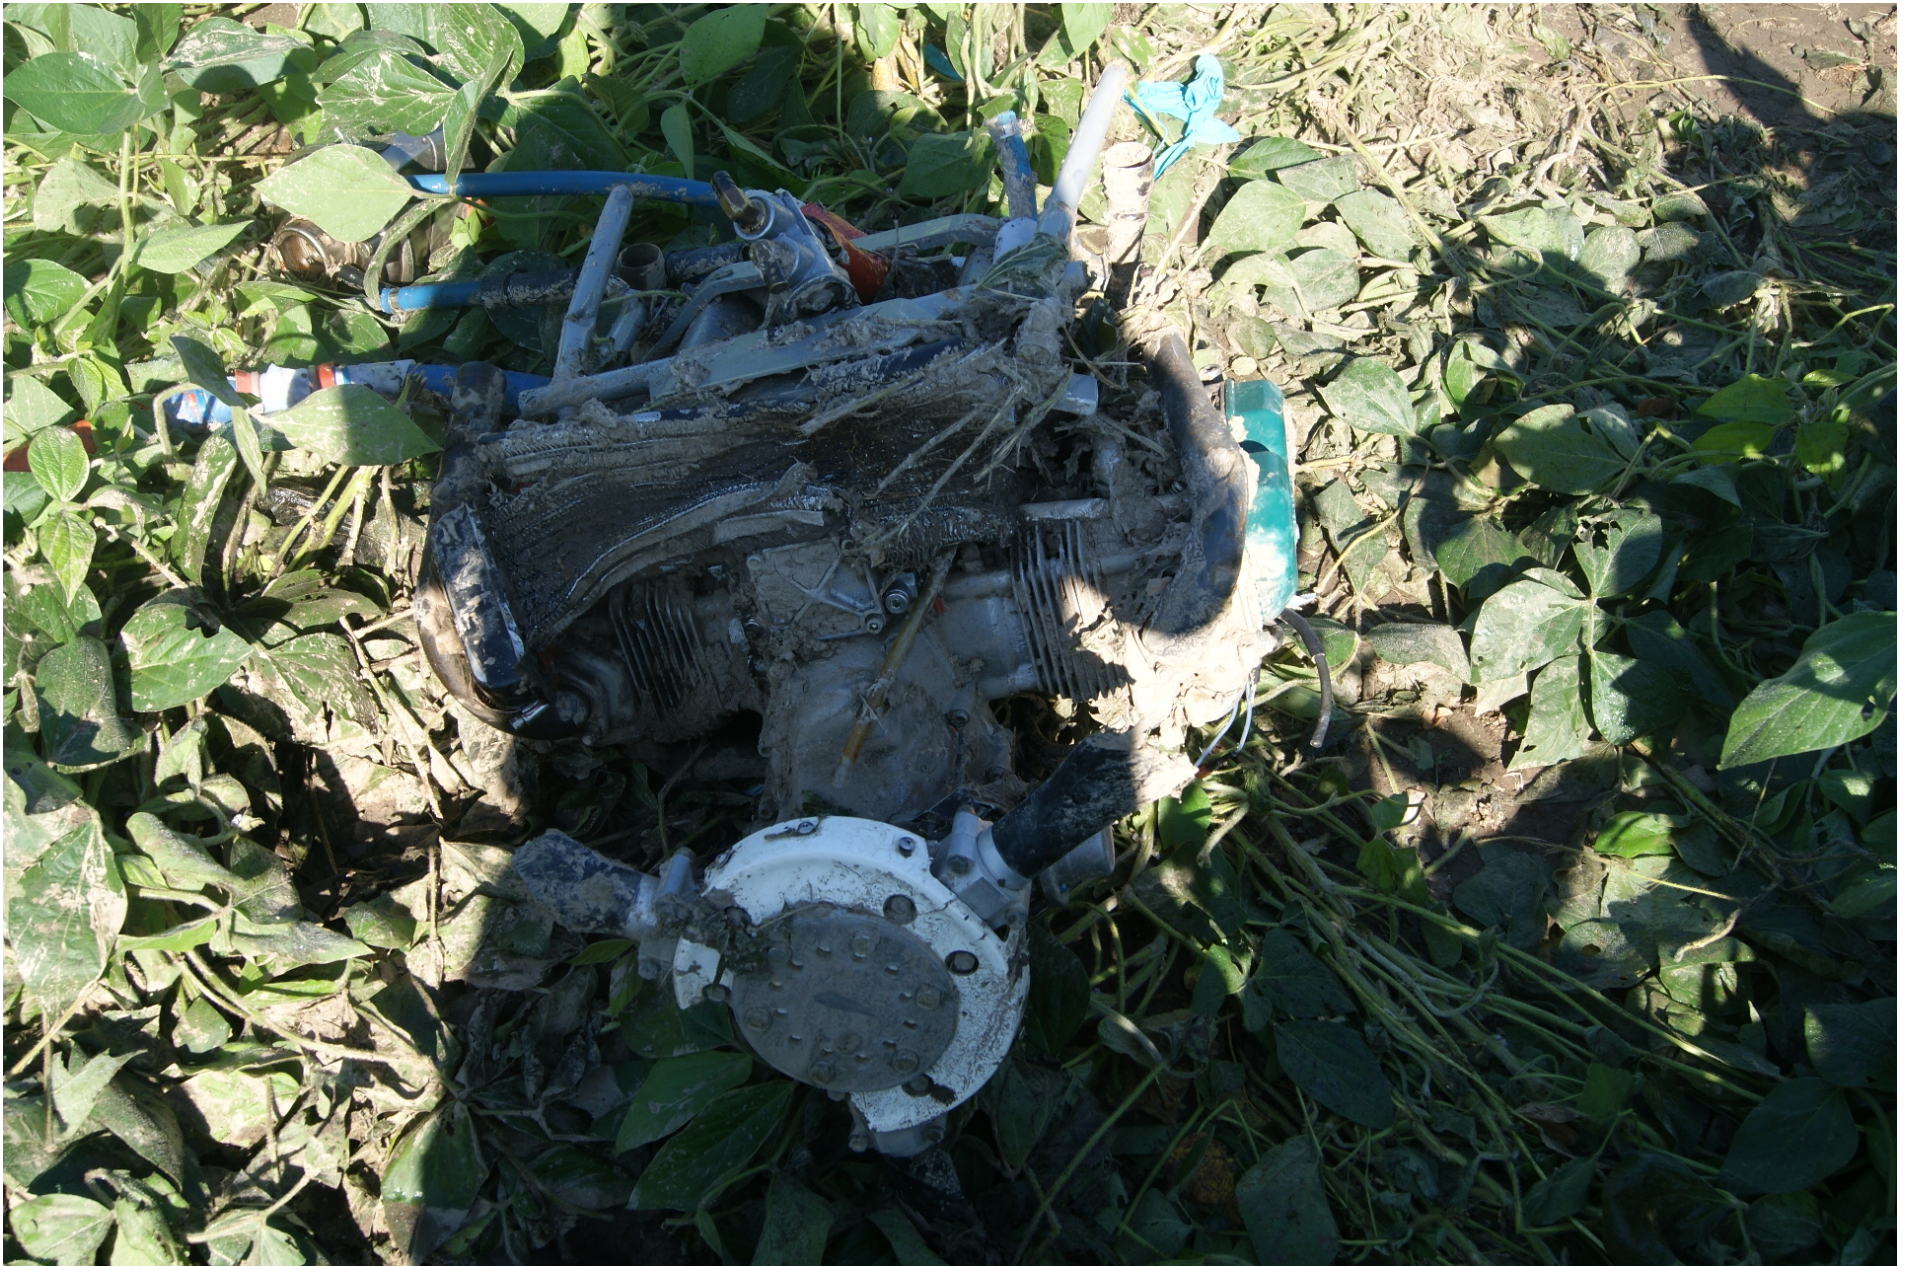
**Photo 8 – The engine. Note all three composite propeller blades have been severed.**
