## National Transportation Safety Board Aviation Accident Final Report

| <b>Location:</b> | Las Vegas, New Mexico | <b>Accident Number:</b> | CEN17FA315 |
| <b>Aircraft:</b> | Piper PA 22-150 | <b>Aircraft Damage:</b> | Substantial |

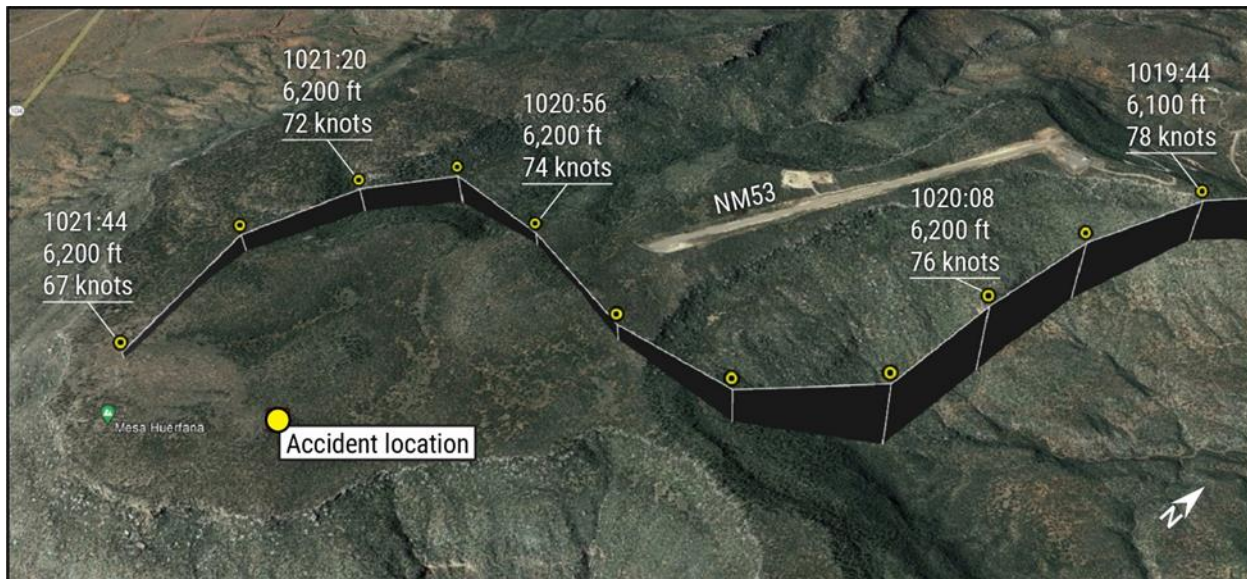
The airplane's flight track indicated that the pilot maneuvered the airplane into a "bowl" area that included the runway. Afterward, the pilot flew a right downwind leg and turned too closely onto the base leg to complete the base-to-final turn. As a result, the pilot made a 270° left turn inside the rim of the bowl area to align with the runway. As the pilot made the base-to-final turn, he again turned the airplane too closely to complete the turn, most likely because he allowed the bowl area to define the dimensions of the turn. Because of the unnecessary

The pilot was not in contact with air traffic control during the flight; however, a search of radar data found targets correlated to the accident airplane. The data captured the airplane as it departed from DHT and flew southwest until it passed Obar, New Mexico, when it turned west. After passing Bell Ranch, New Mexico, the airplane continued west, then northwest. The airplane made several large s-turns and flew east of San Miguel Ranch Airport (NM53) before turning north and continuing a right turn until radar contact was lost, as shown in the figure below. The last radar return was about 1.4 miles southwest of runway 4 at NM53. A search was initiated after the airplane was reported overdue, and the wreckage was located on August 11. The density altitude at the accident location was calculated to be about 8,500 ft.

**Figure.** Accident site in relation to flight track and runway.
