# National Transportation Safety Board

## Aviation Accident Final Report

| <b>Location:</b> | Ellabell, Georgia | <b>Accident Number:</b> | CEN17FA331 |
| <b>Aircraft:</b> | Beech A36 | <b>Aircraft Damage:</b> | Destroyed |

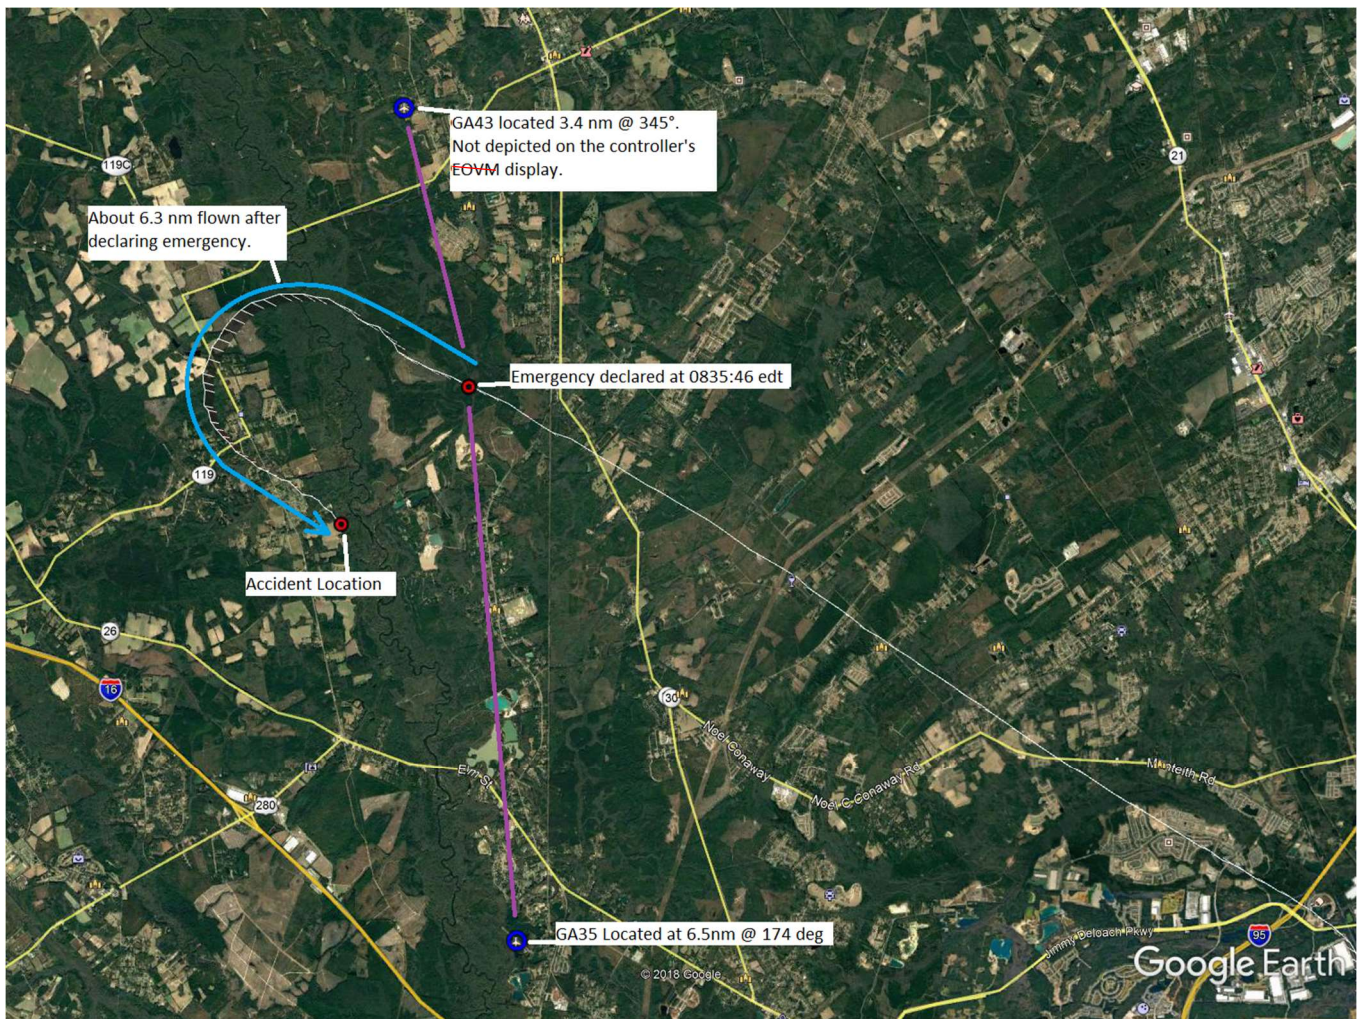
FAA published charts for the area showed that Briggs Field Airport (GA43), Guyton, Georgia, was about 3.4 miles away on a heading of 345° when the pilot reported the engine power loss, which would have required a 45° right turn toward GA43. GA43 was a private airstrip with a 2,300-ft long turf runway. Although GA35 was depicted on the air traffic controller's [emergency obstruction video map \(EOVM\)](#)[display map data](#) that was used in handling the accident flight, GA43 was not depicted. The figure shows the positions of the airports relative to the airplane's track.

Figure - Google Earth plot of the airplane's flight path (in white) along with the nearest alternate airports.

In response to questions from the NTSB, the airport GA43 was not depicted on the controller's video display because the air traffic facility was not aware the airport existed. After the accident, GA43, along

with several other small airports in the Savannah area, were added to the [EOVM display map data](#) at the SAV ATCT.
