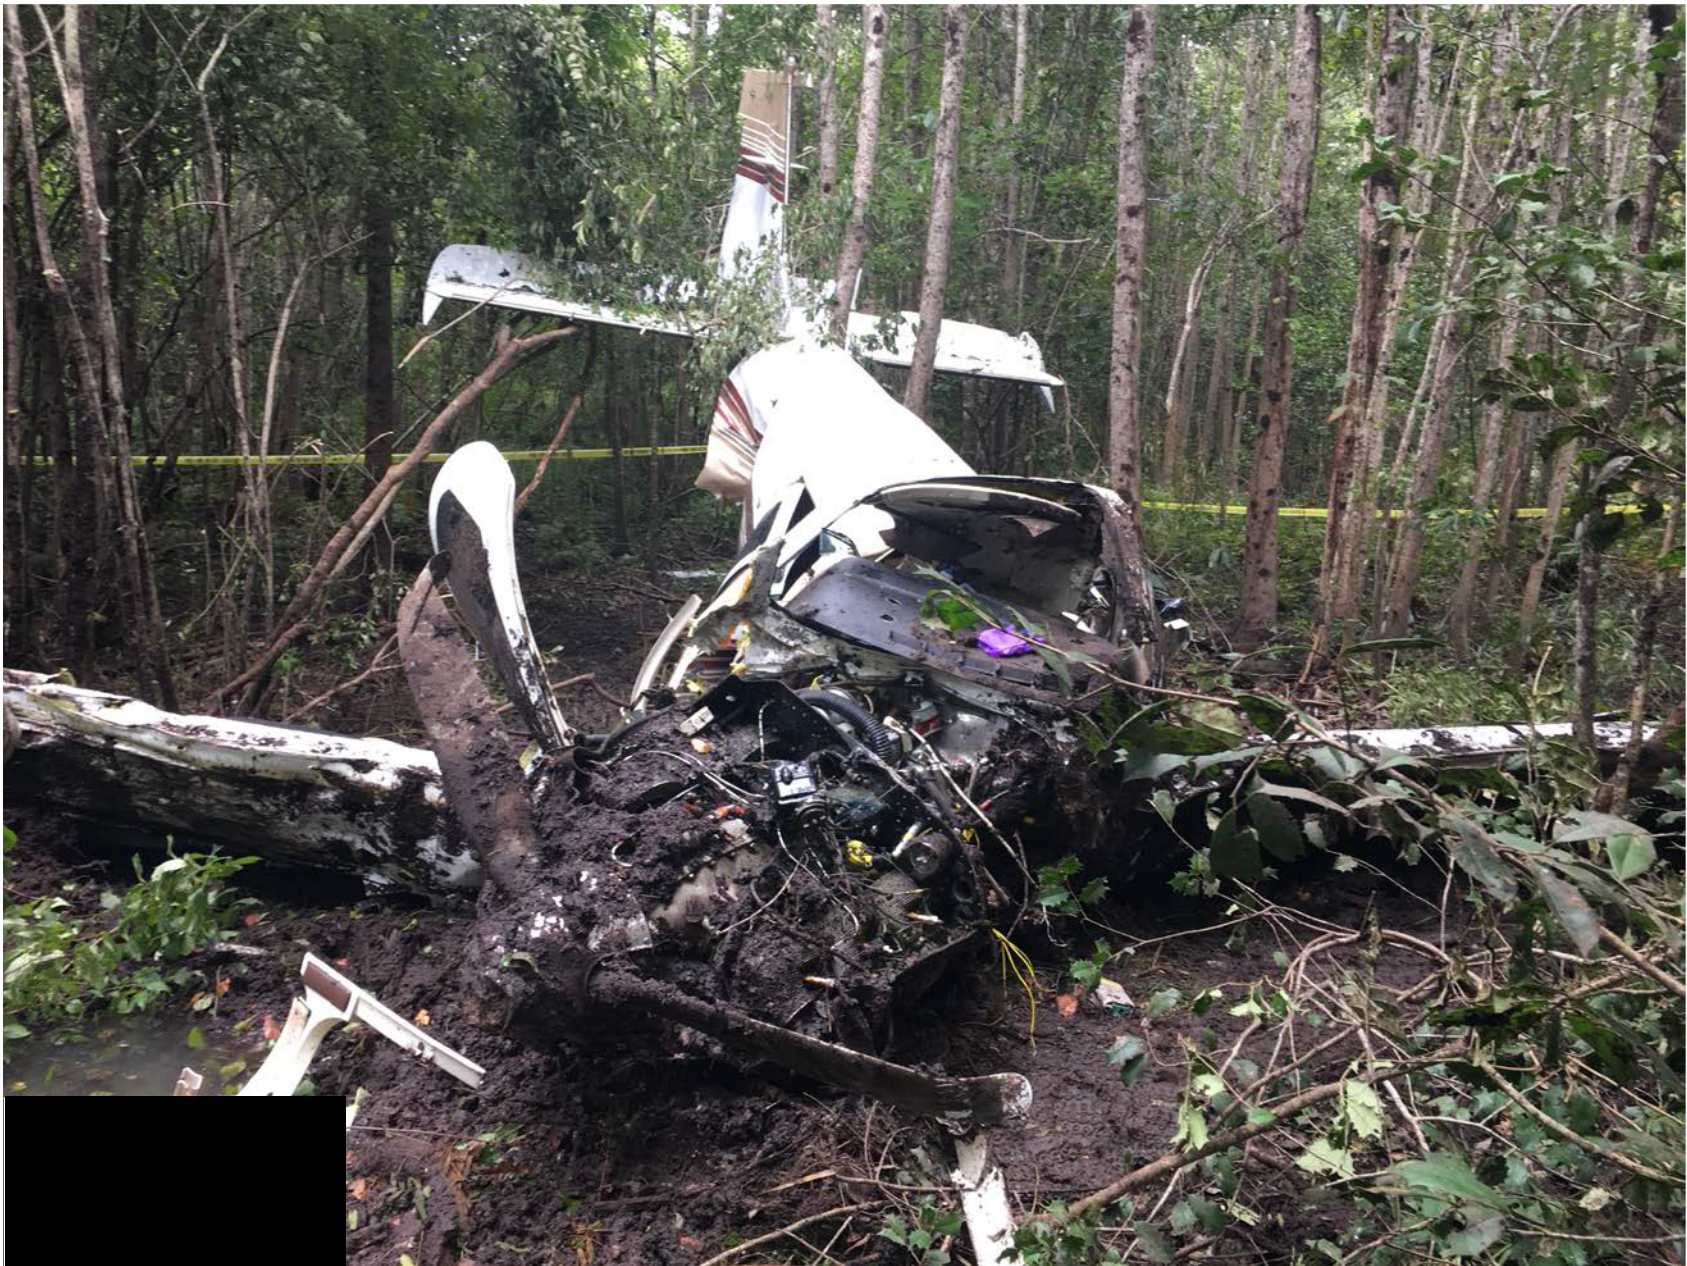
**Photo 1 – View of main wreckage from front**

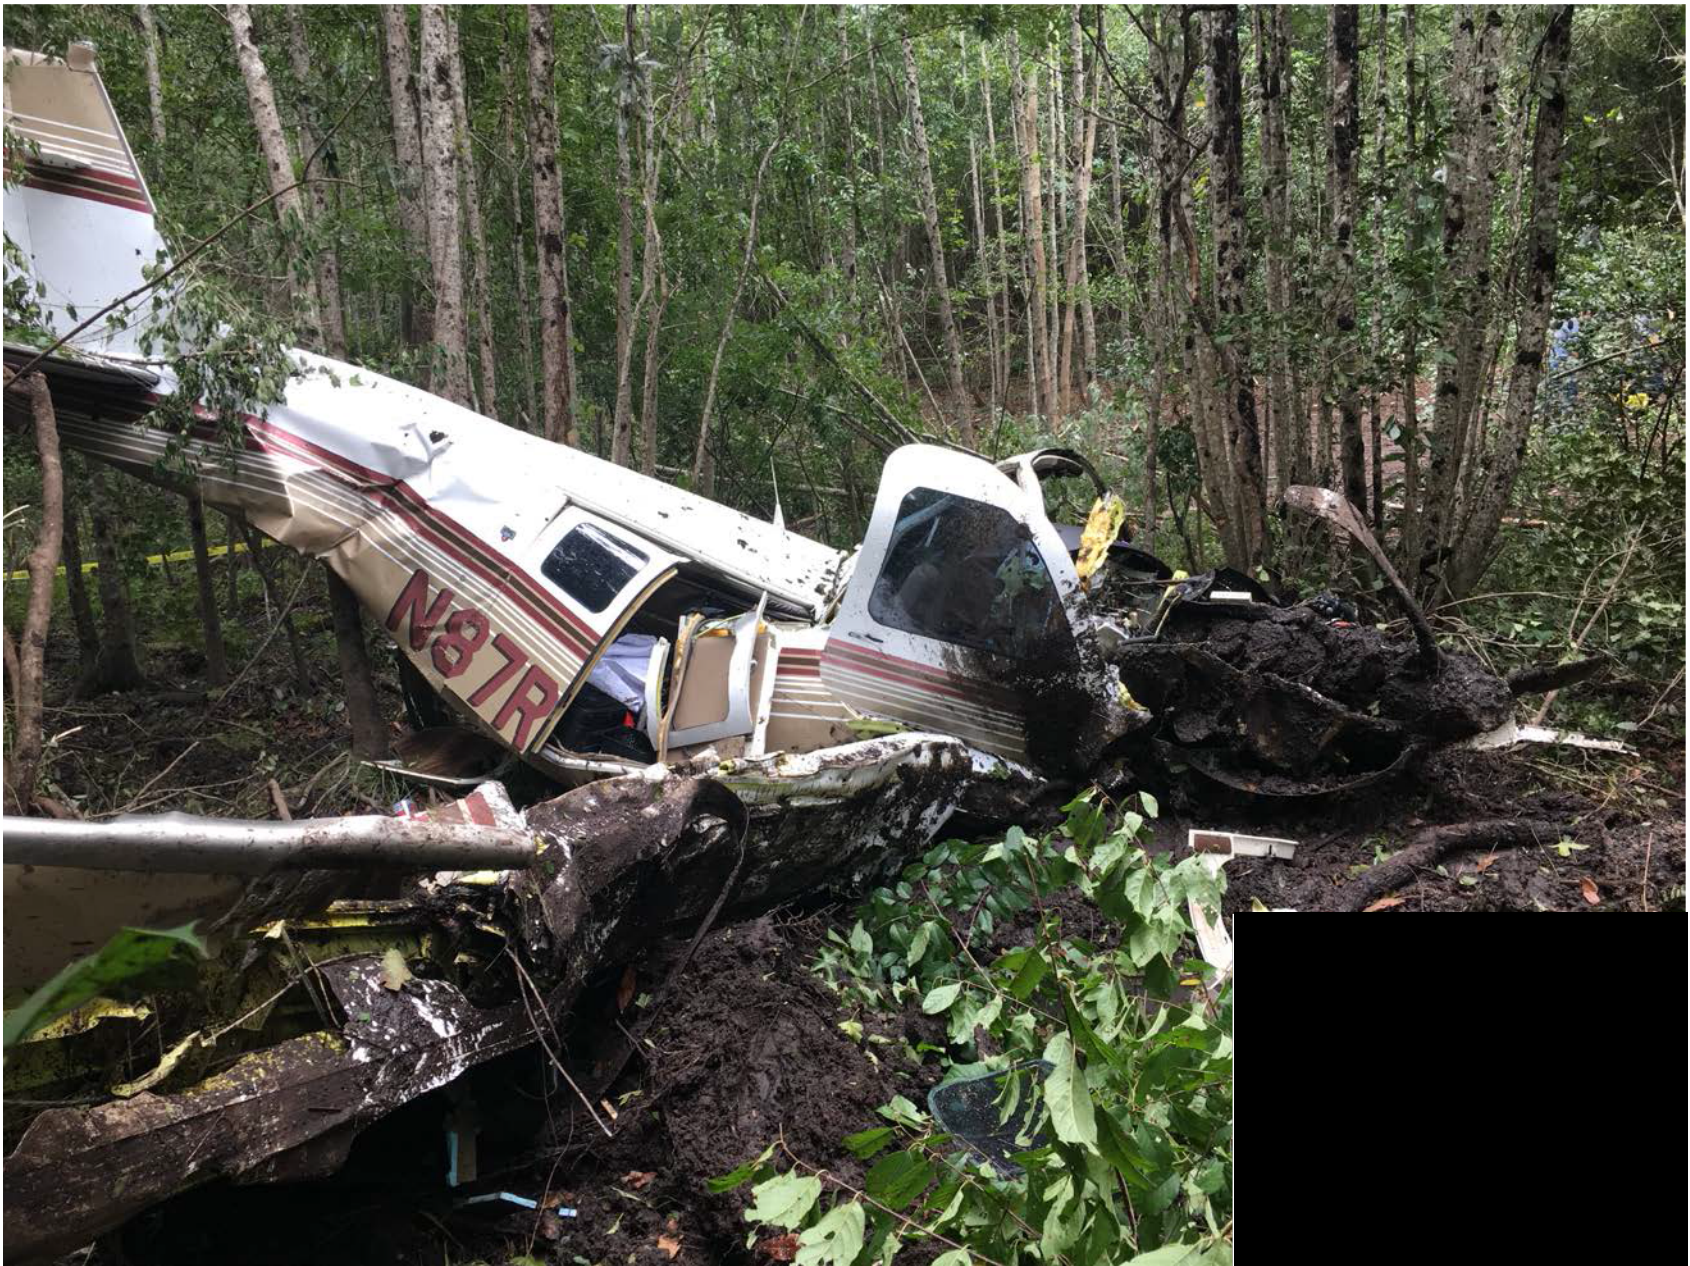
**Photo 2 – View of wreckage from right**

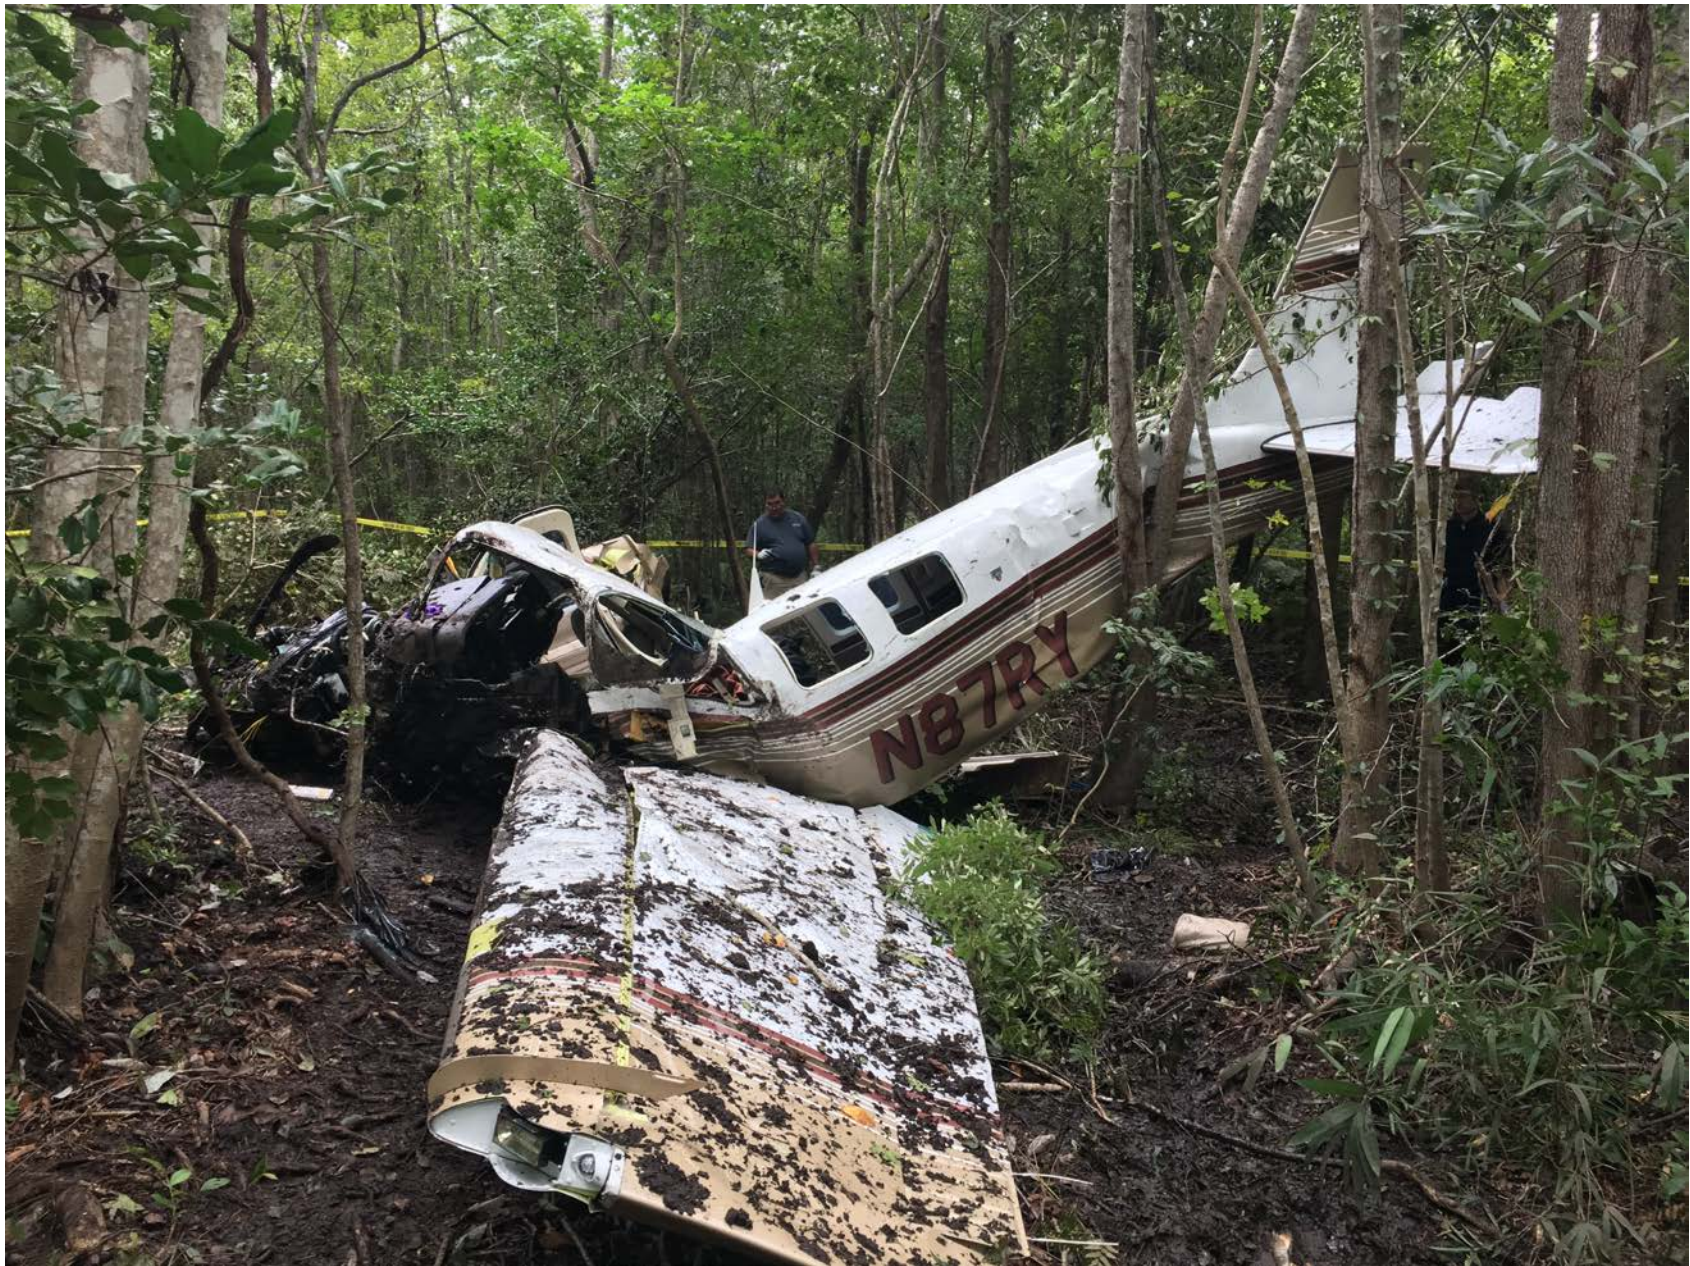
**Photo 3 – View of wreckage from left**

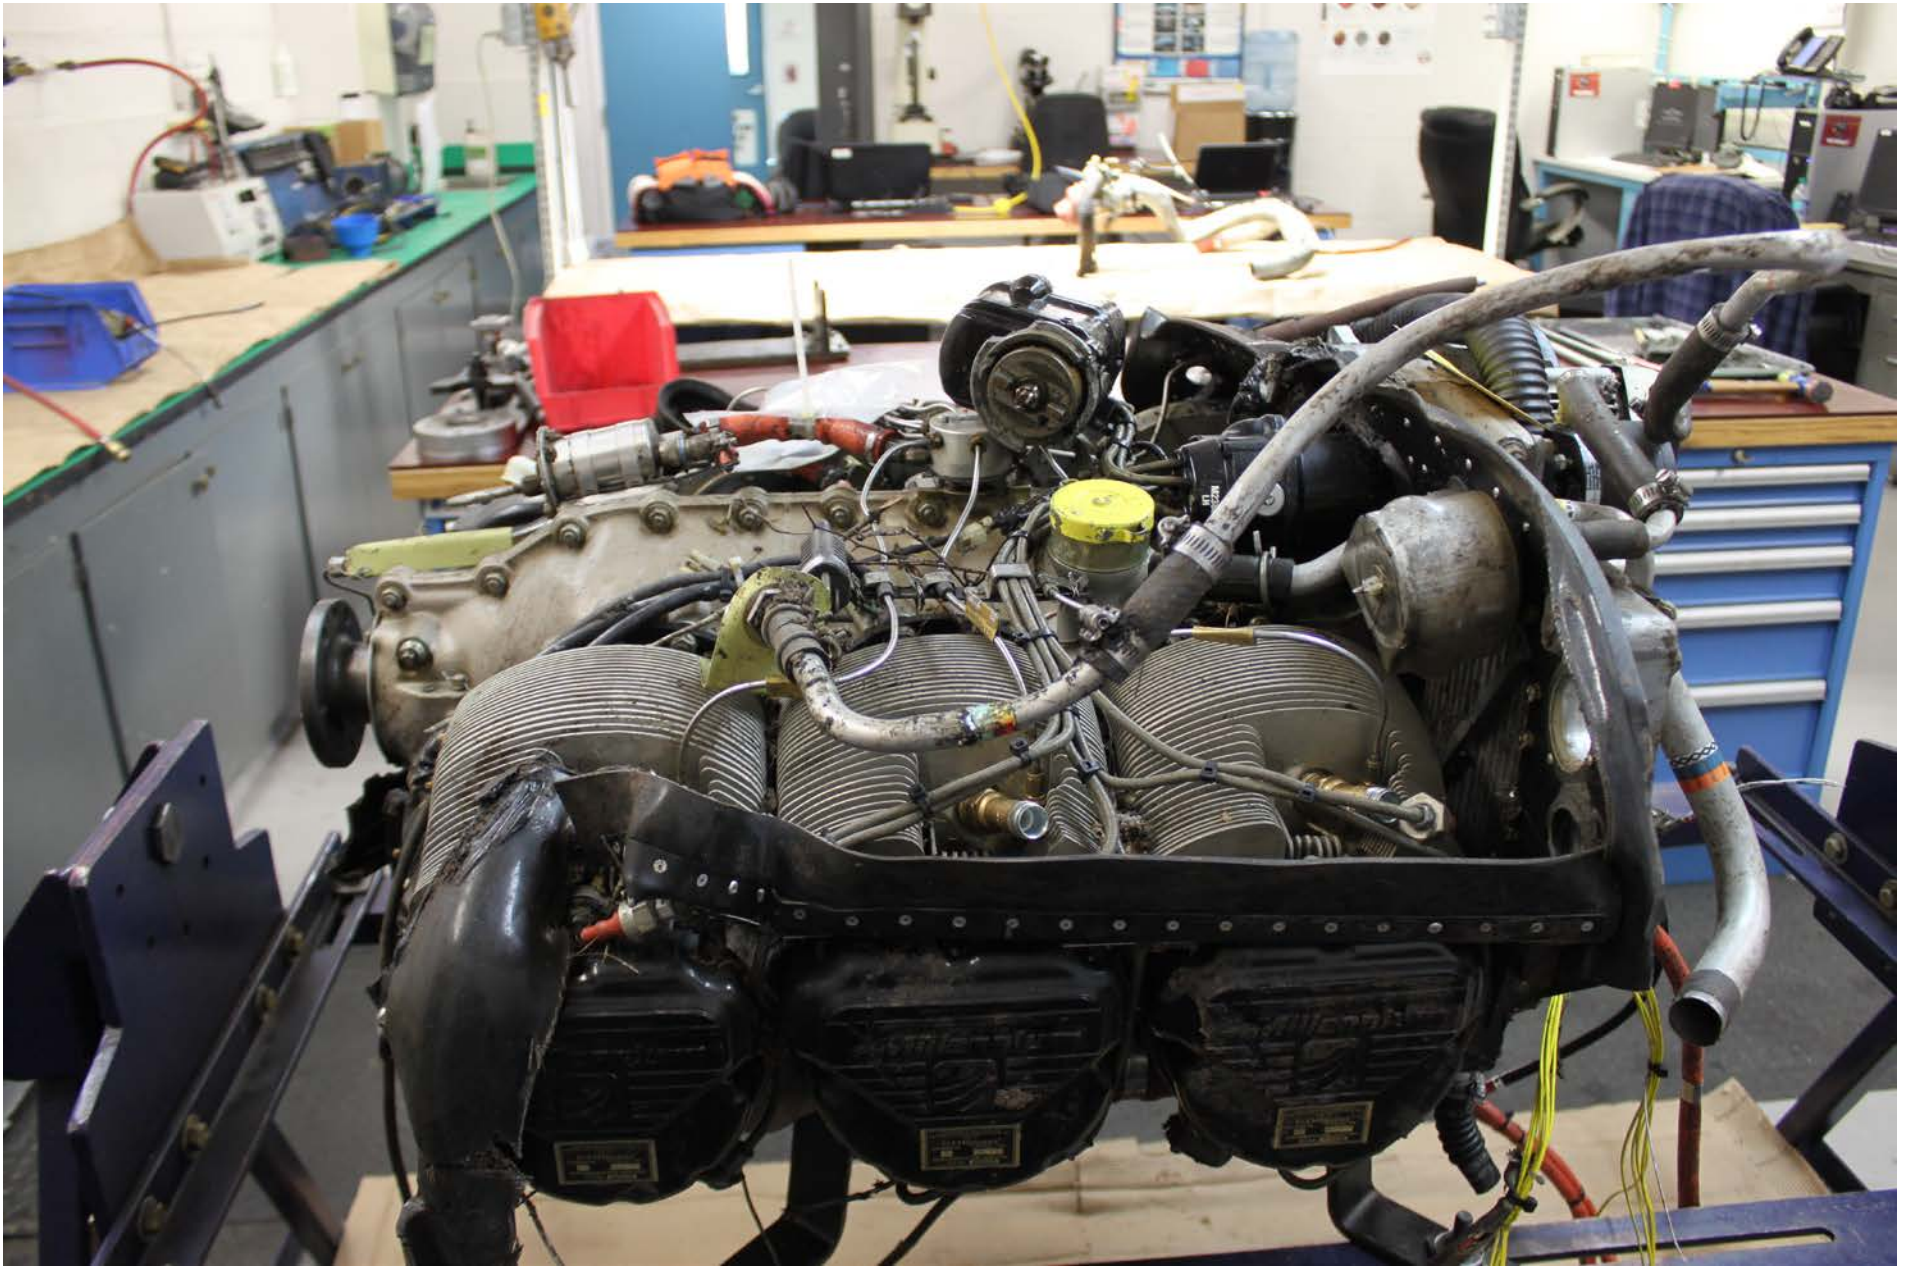
**Photo 4 – View of engine during disassembly**

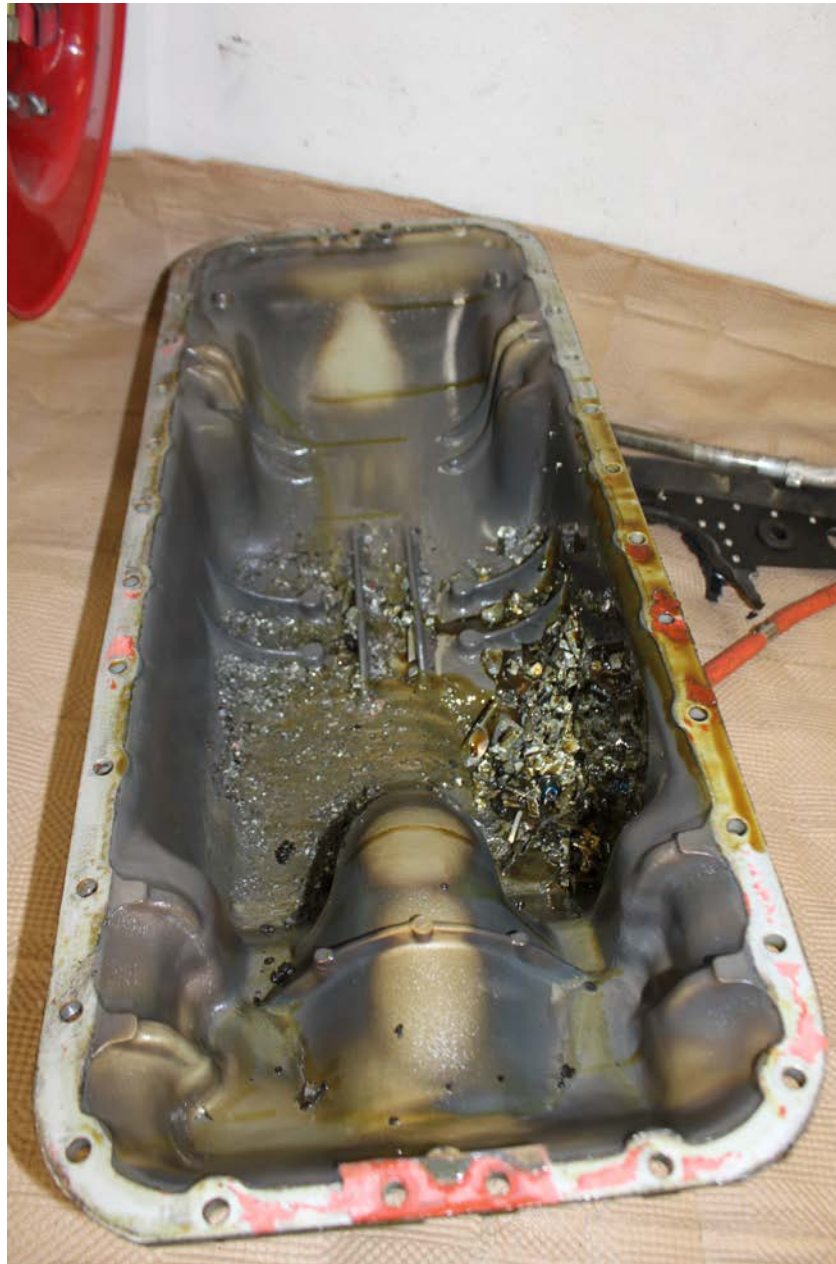
**Photo 5 – View of engine sump showing metal found on disassembly**

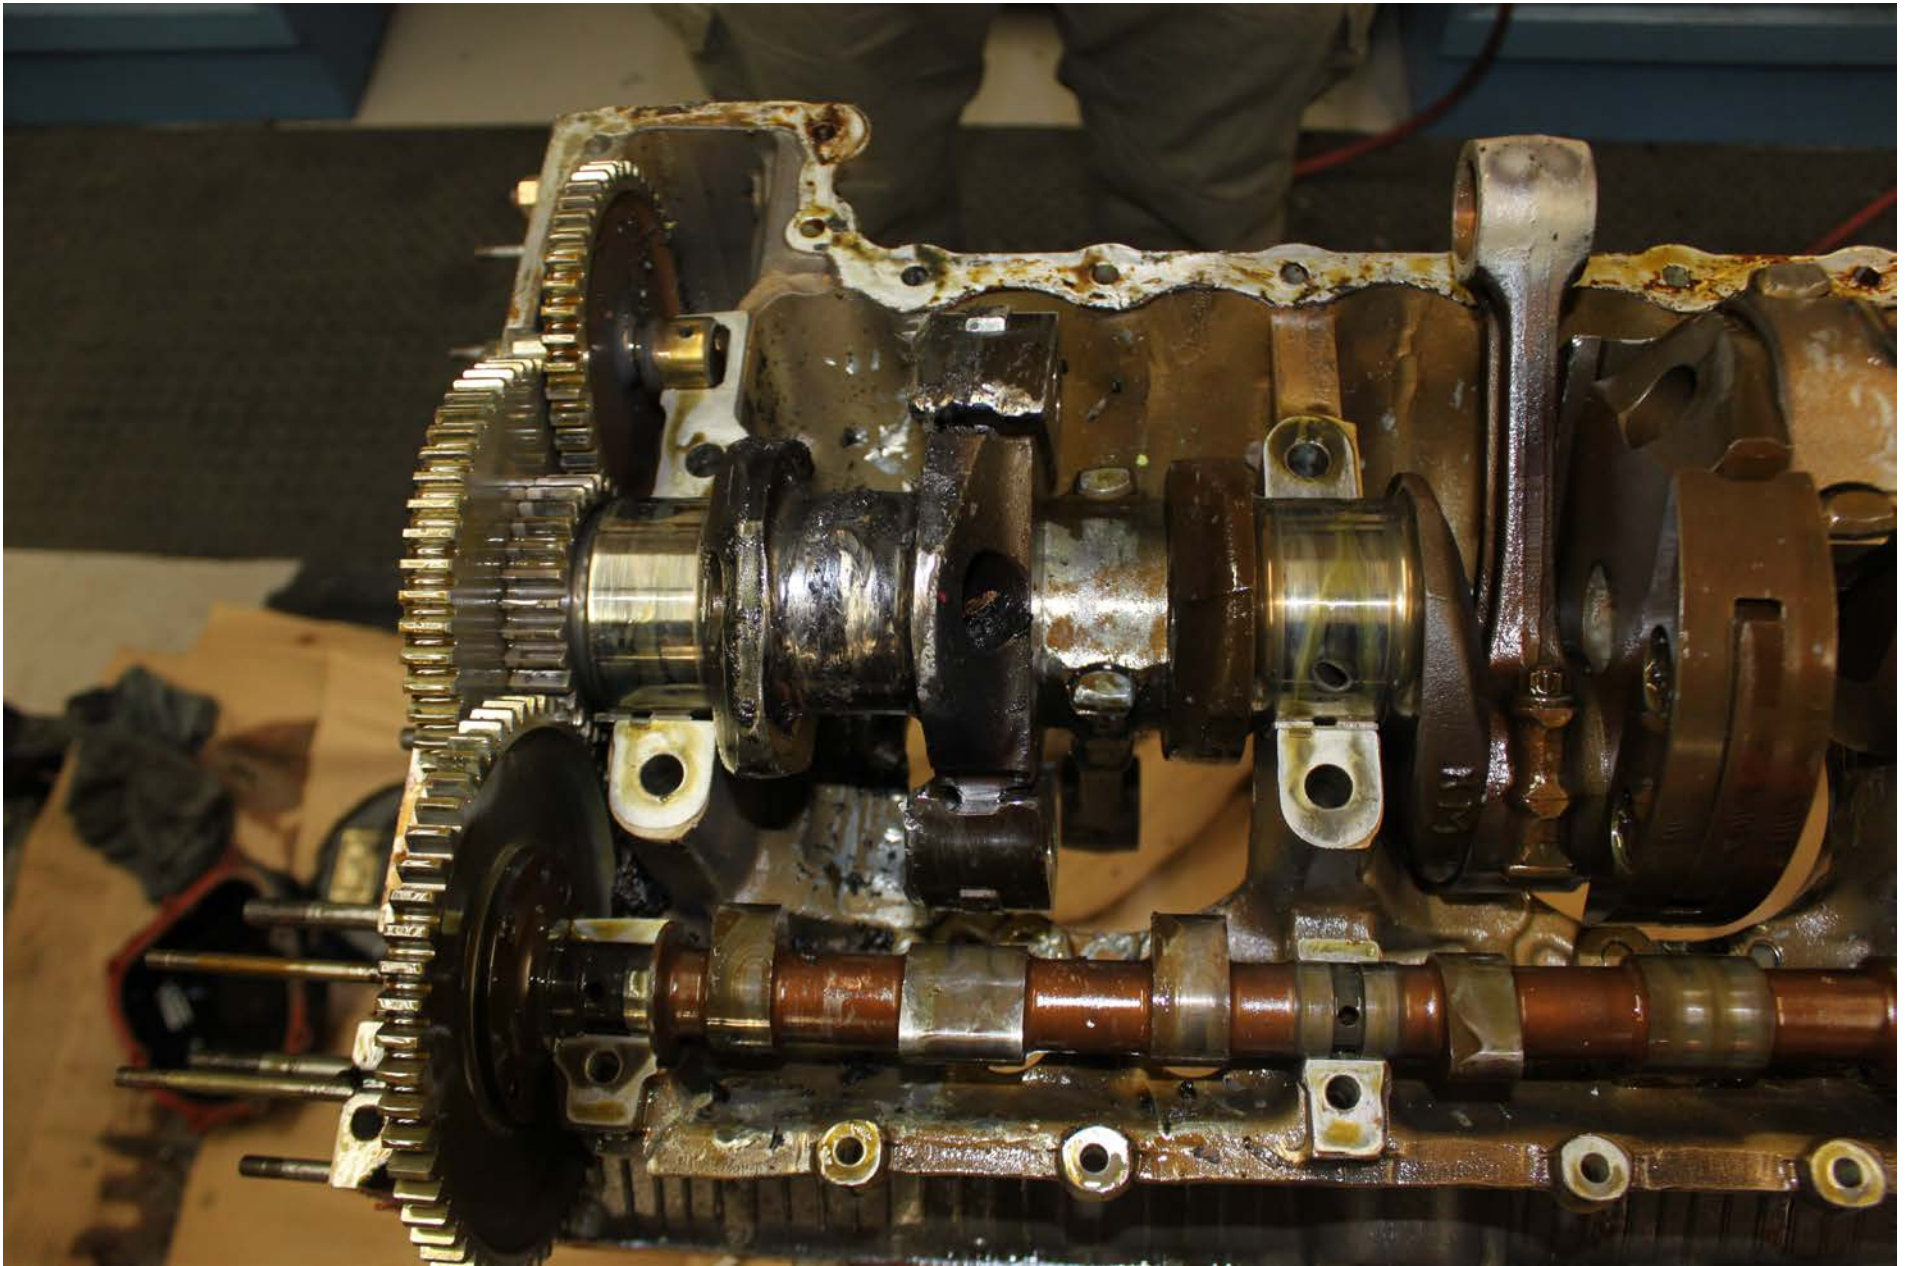
**Photo 6 – View of split engine case showing bearing as found on disassembly**

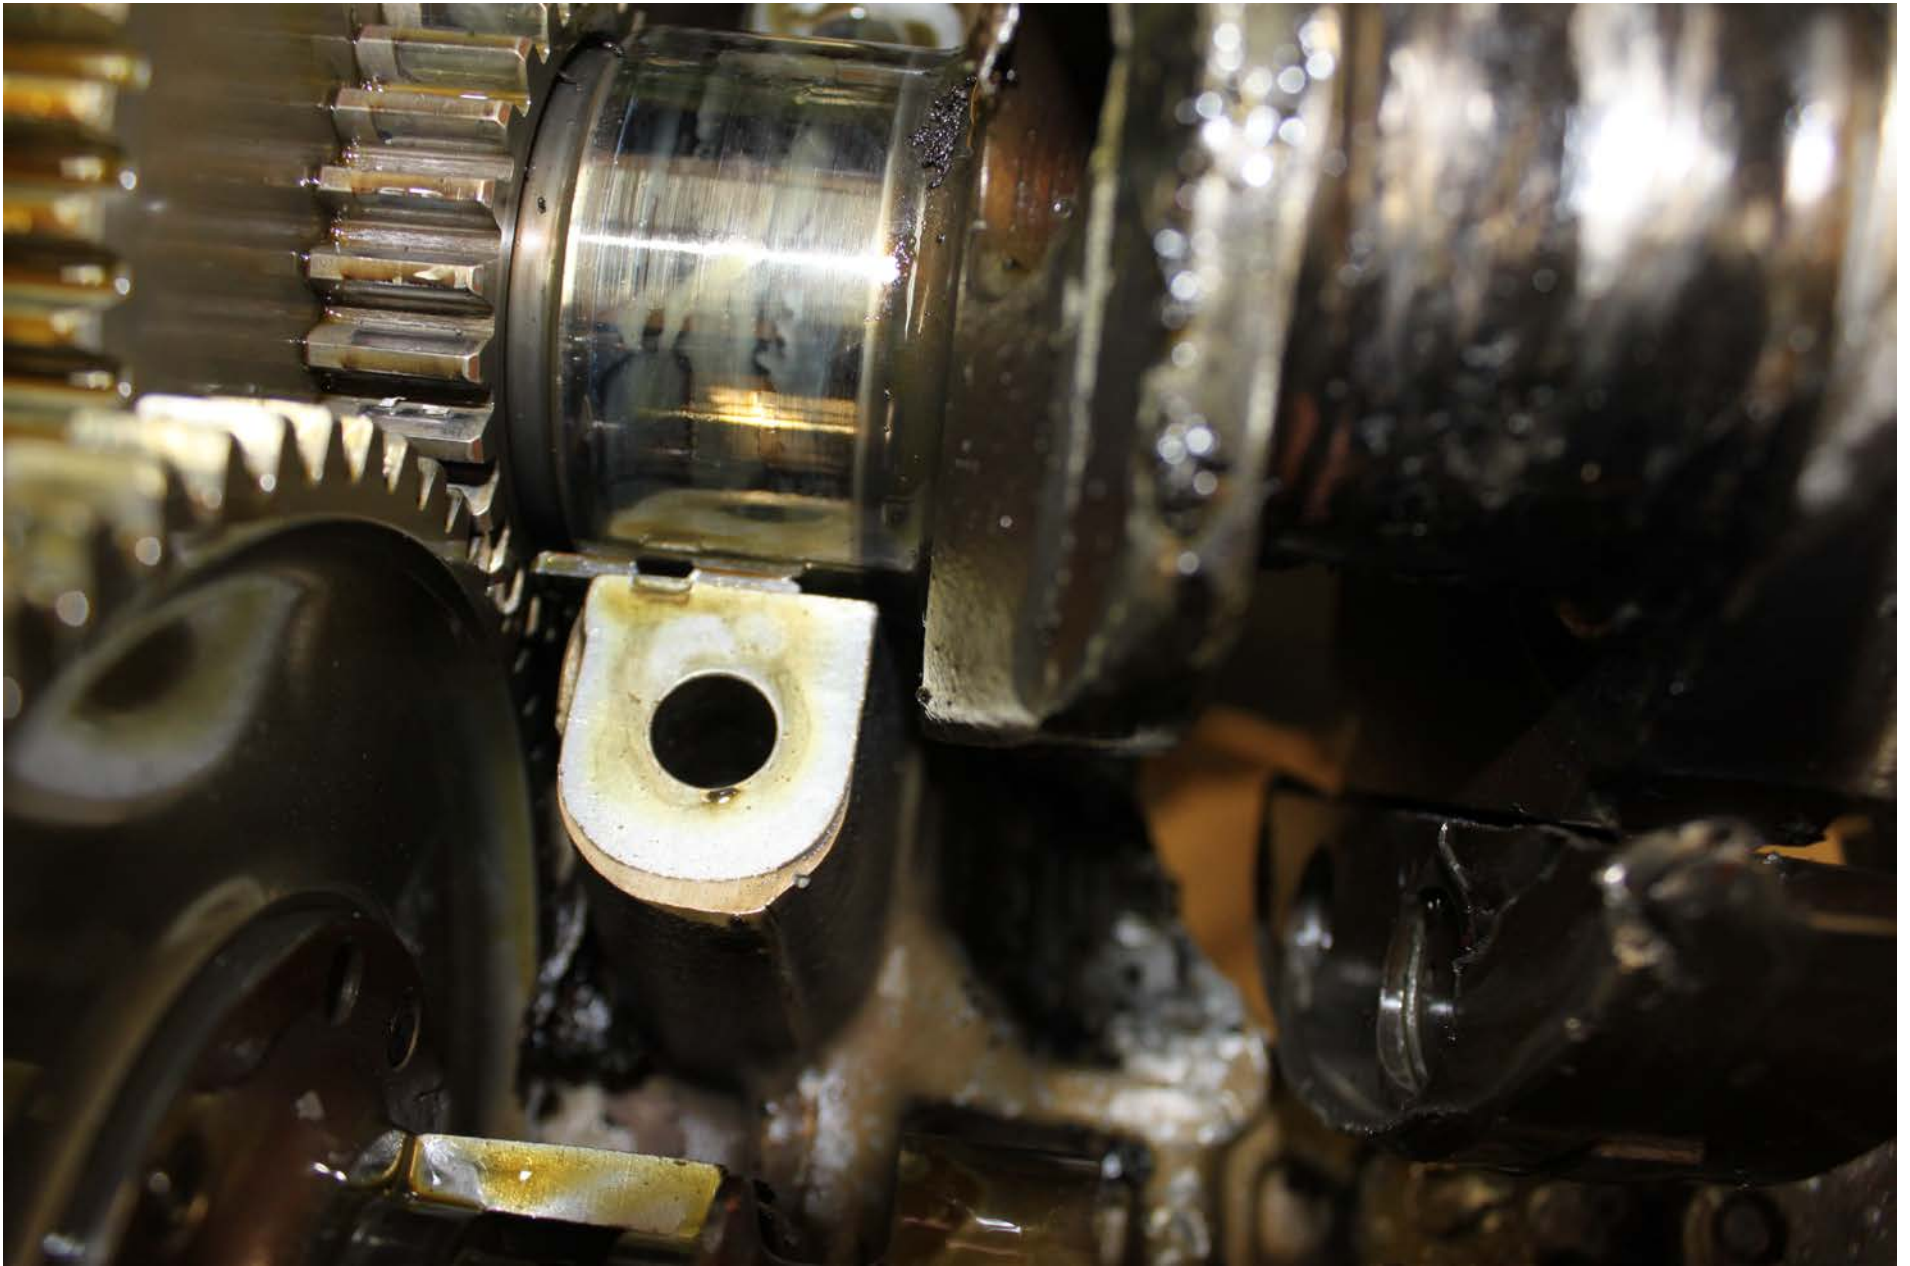
**Photo 7 – Close up showing shifted bearing**

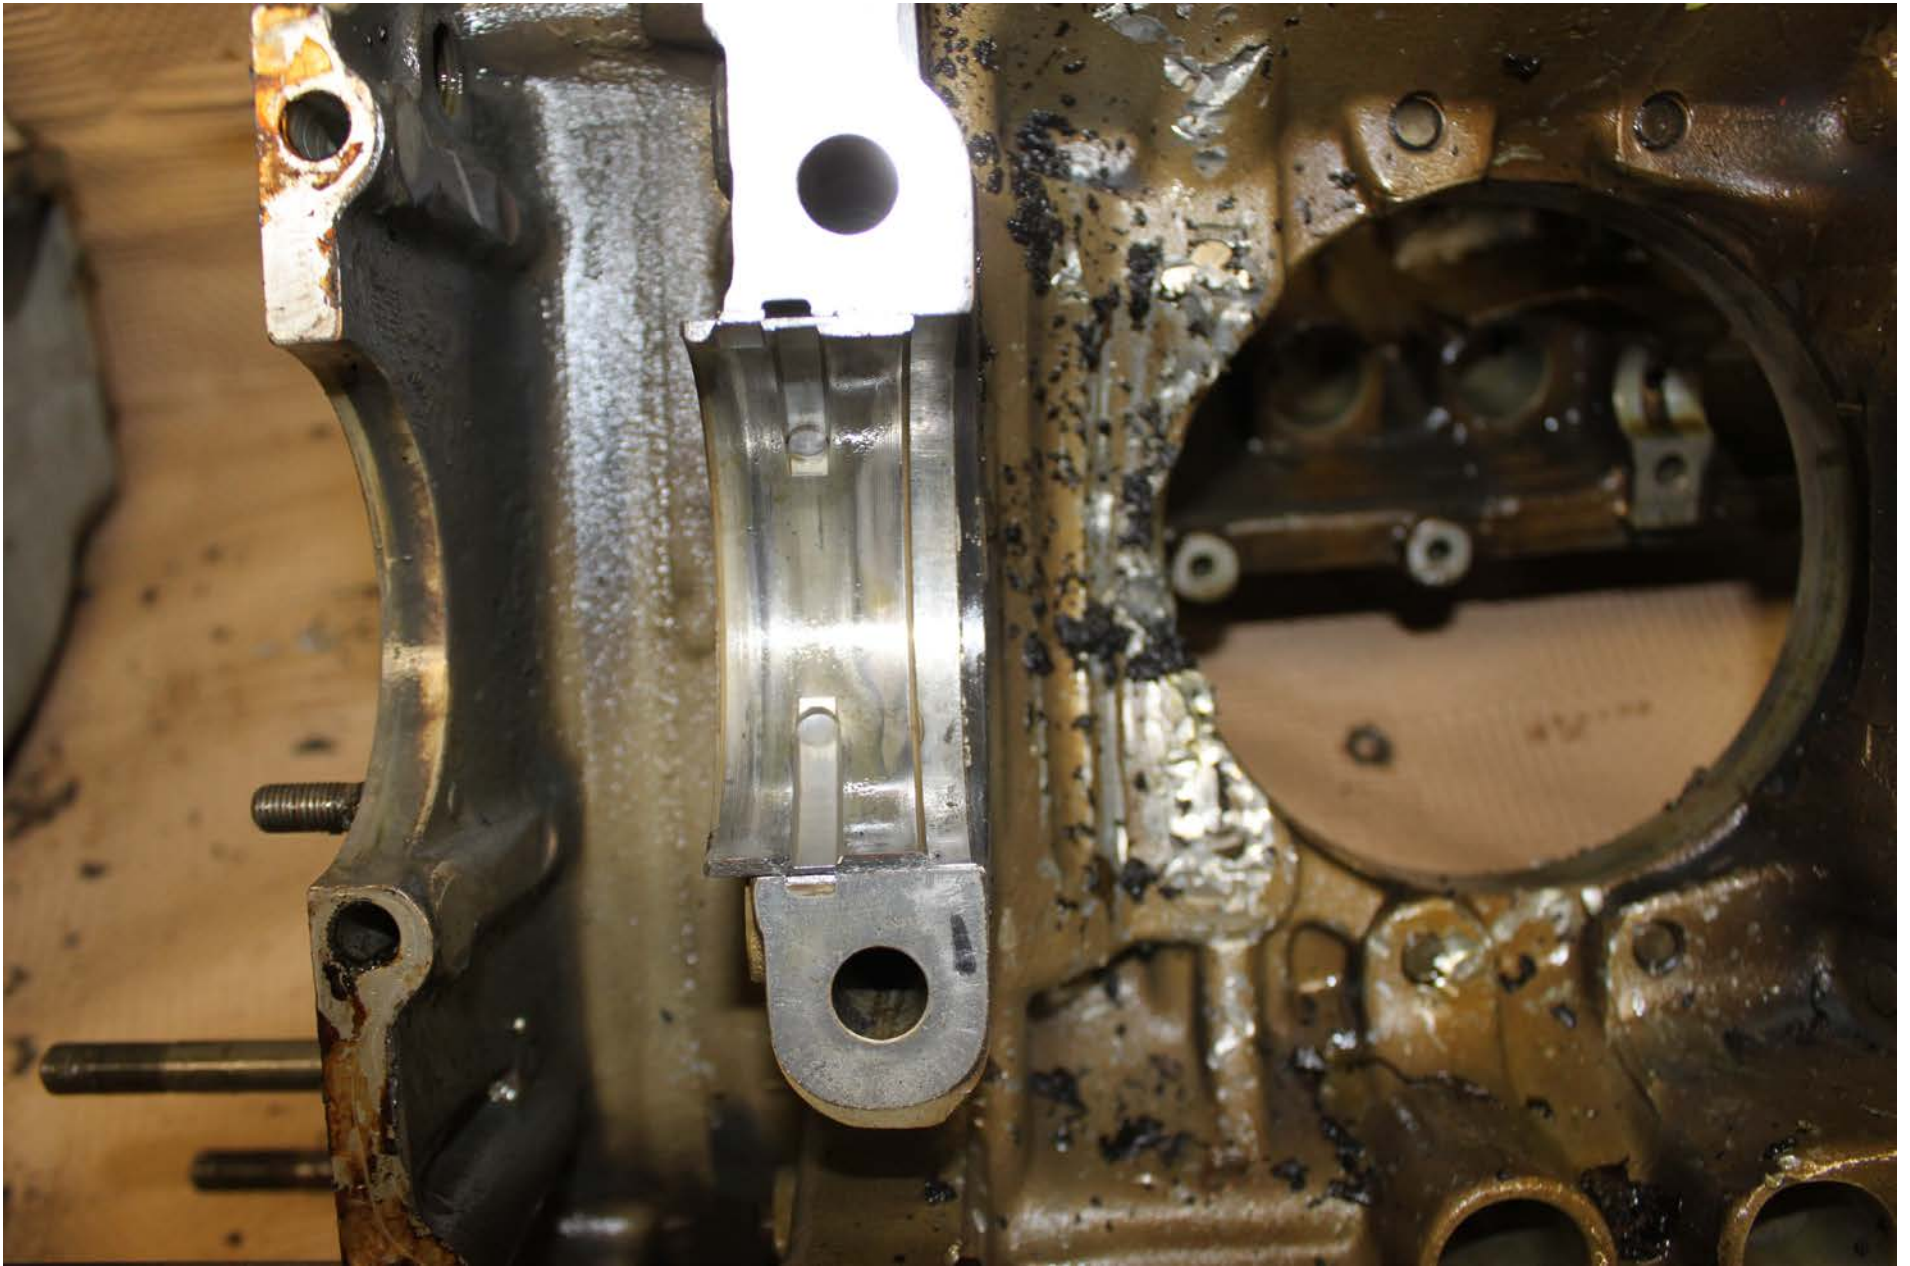
**Photo 8 – Close of up shifted bearing after crankshaft removal**
