# Continental Motors

## ENGINE RUN REPORT

| AIRCRAFT MAKE & MODEL | Cessna 180J |
| FILE NUMBER | 17-151 |

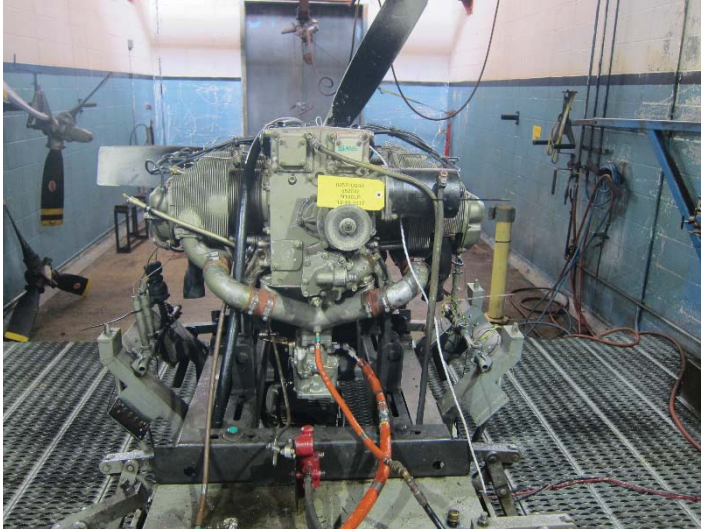
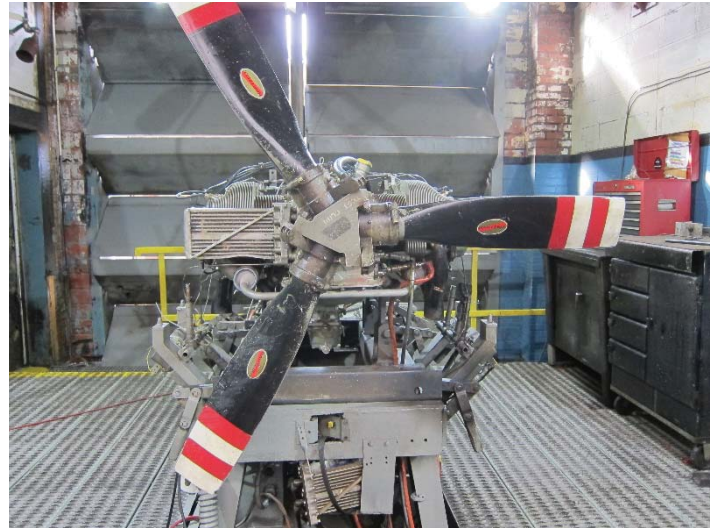
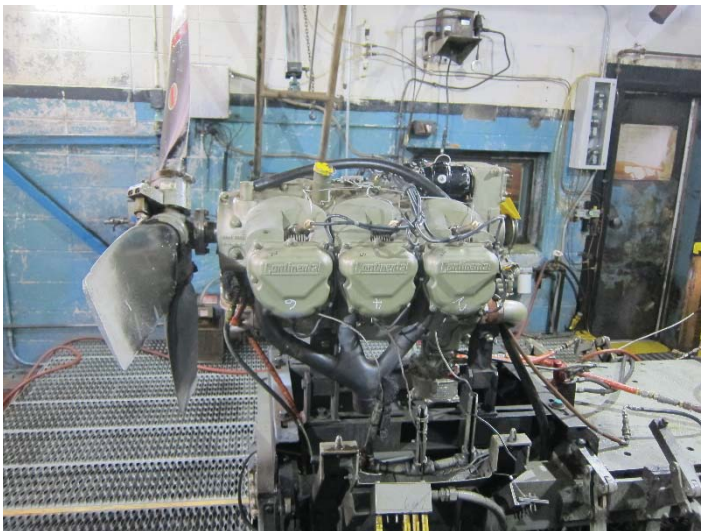
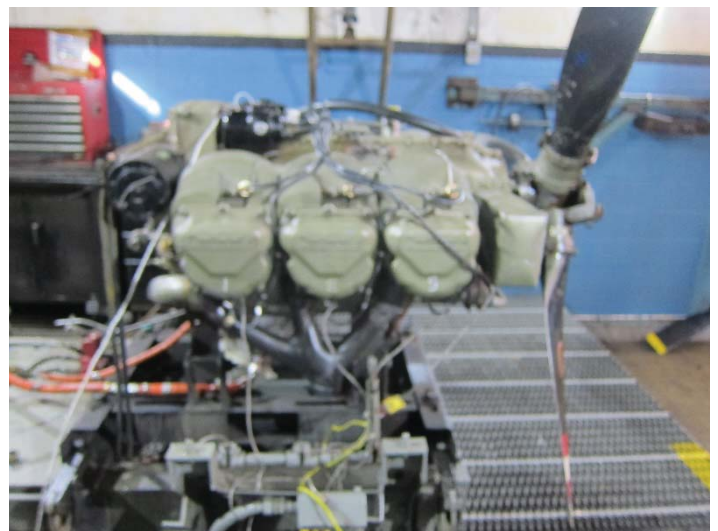
The engine started without hesitation or difficulty. The engine was run through various parameters at 5-minute intervals. Please see the engine test log for more details. The throttle was then moved rapidly from idle to full power on multiple occasions with no interruption or hesitation in power production. No pre-accident anomalies were noted during the engine run. An oil leak was noted, but was a result of a damaged exhaust pushrod and pushrod housing for cylinder #5. The pushrod housing damage was in the same area as the fractured engine mount and punctured oil sump.
