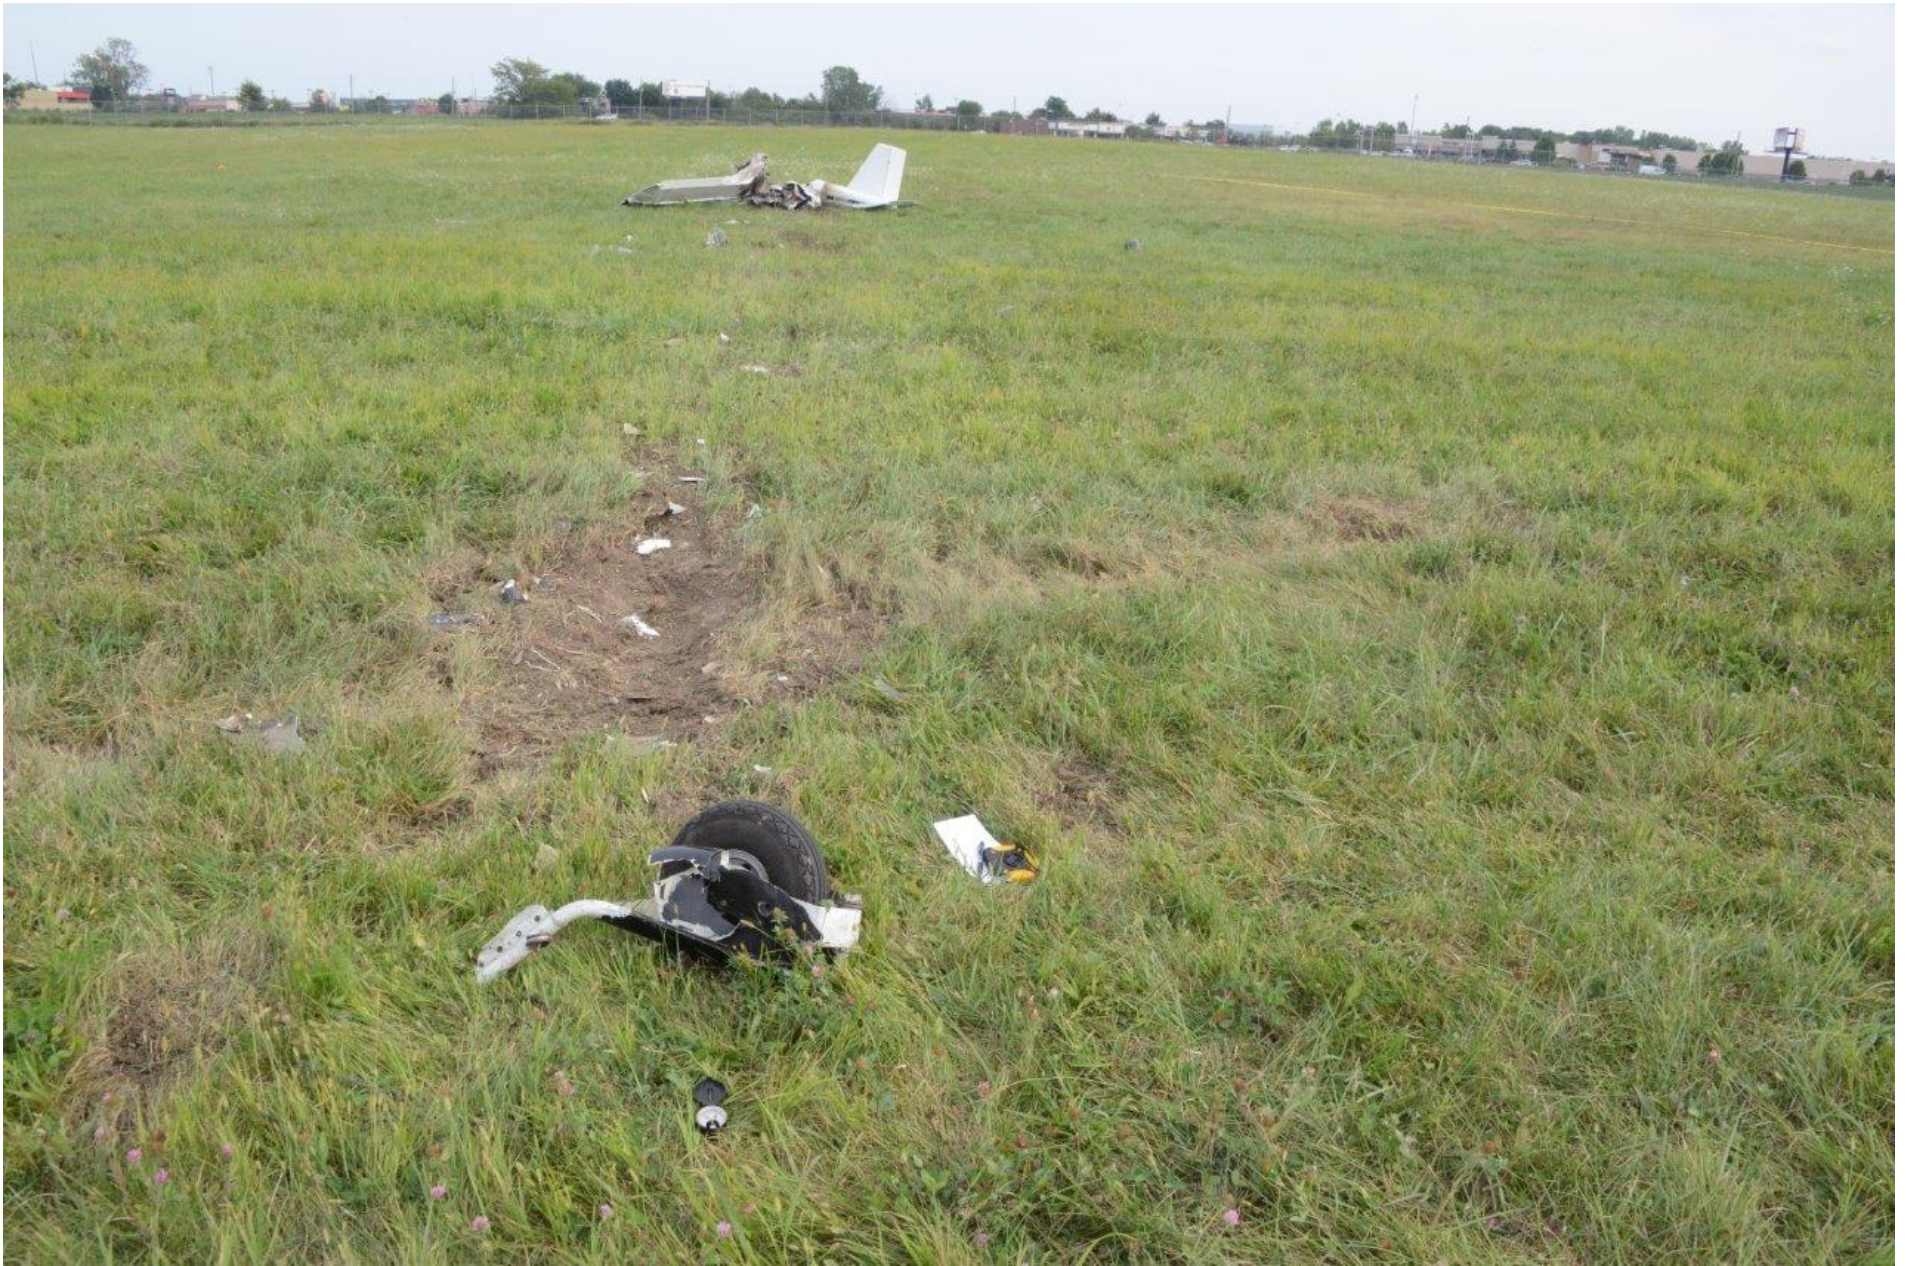
**Photo 1 – View of a debris path looking towards the main wreckage.**

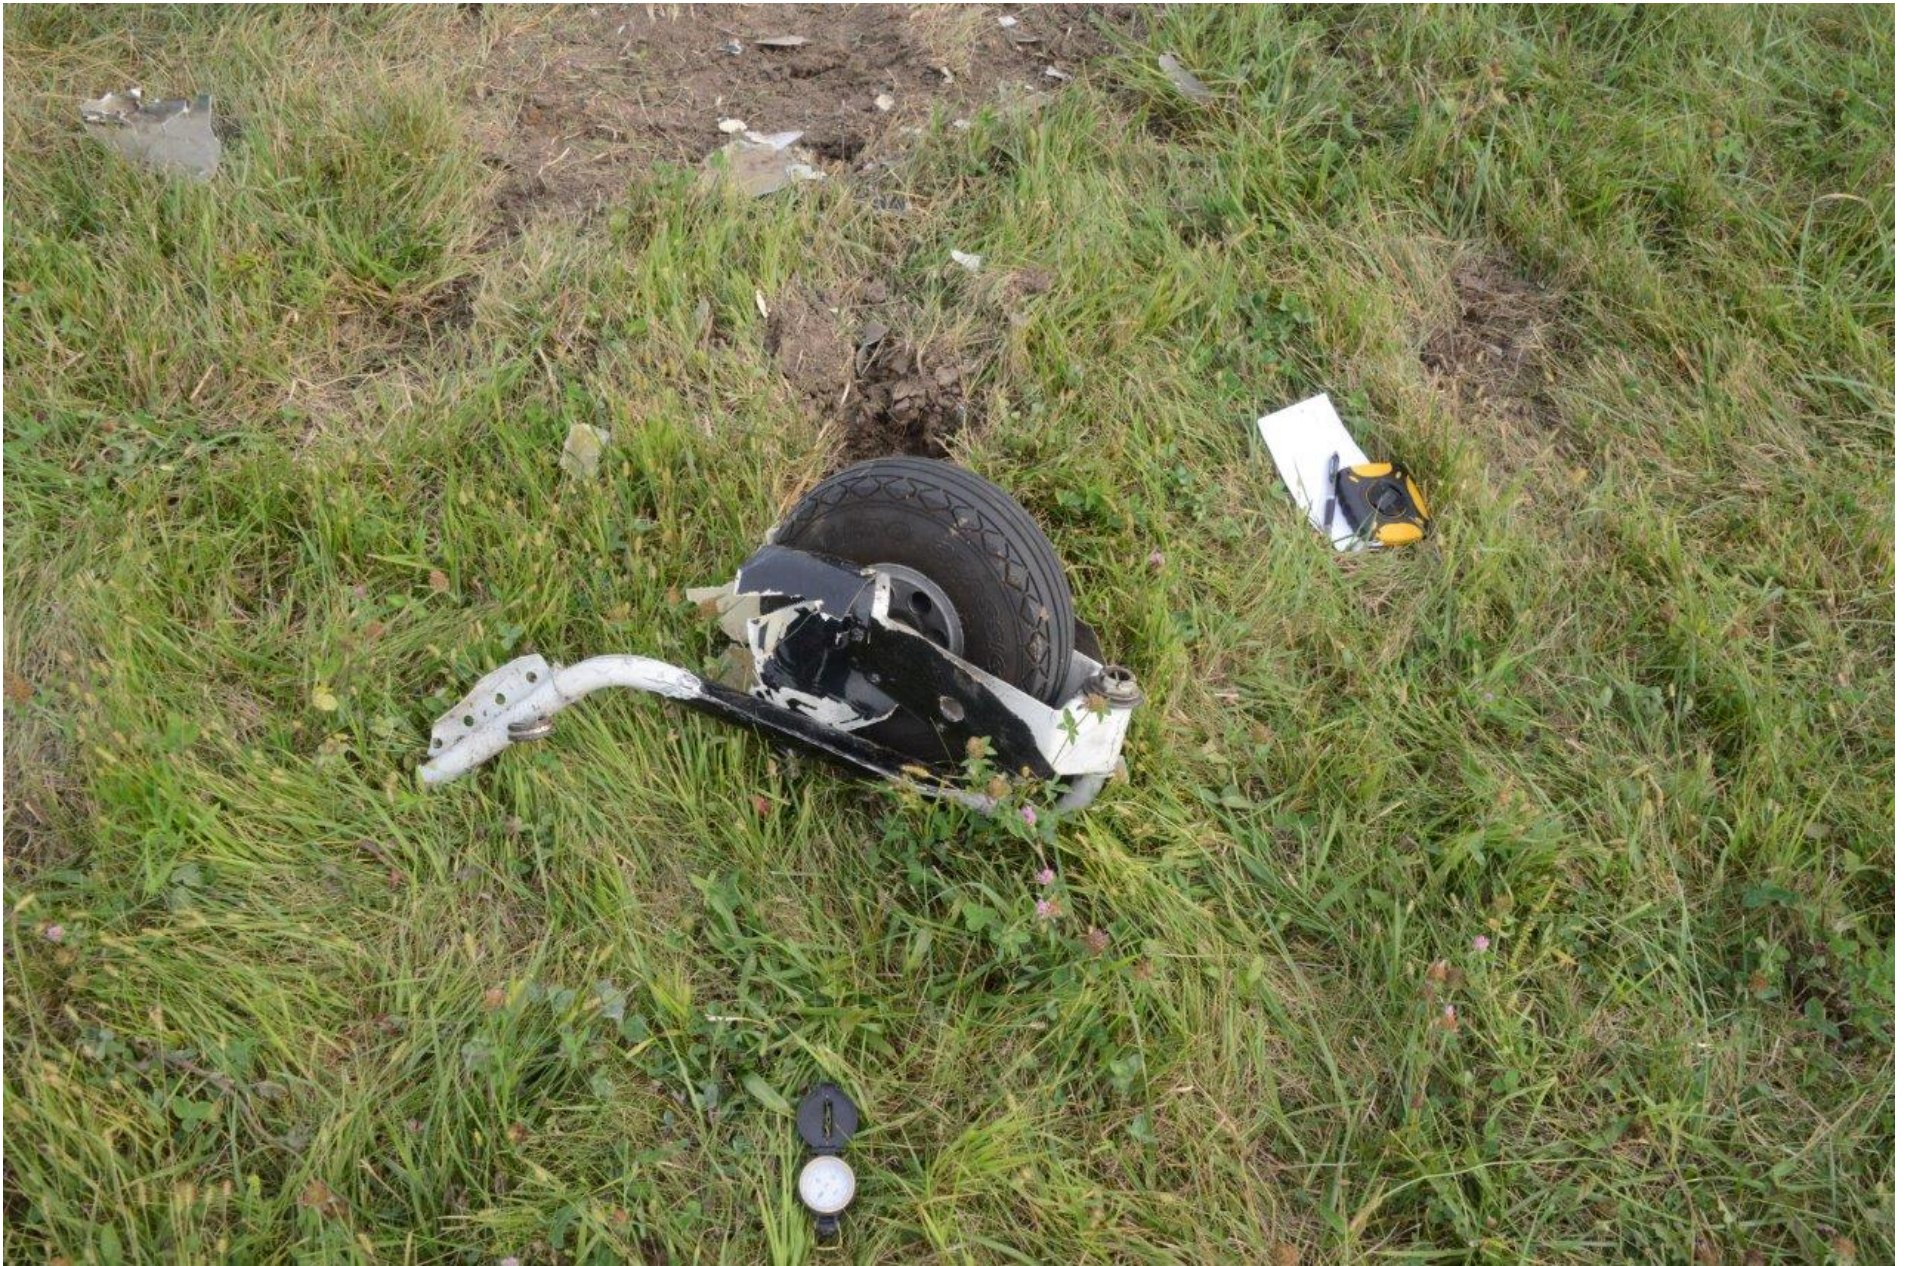
**Photo 2 – Close-up view of the separated nose landing gear and wheel in the debris path.**

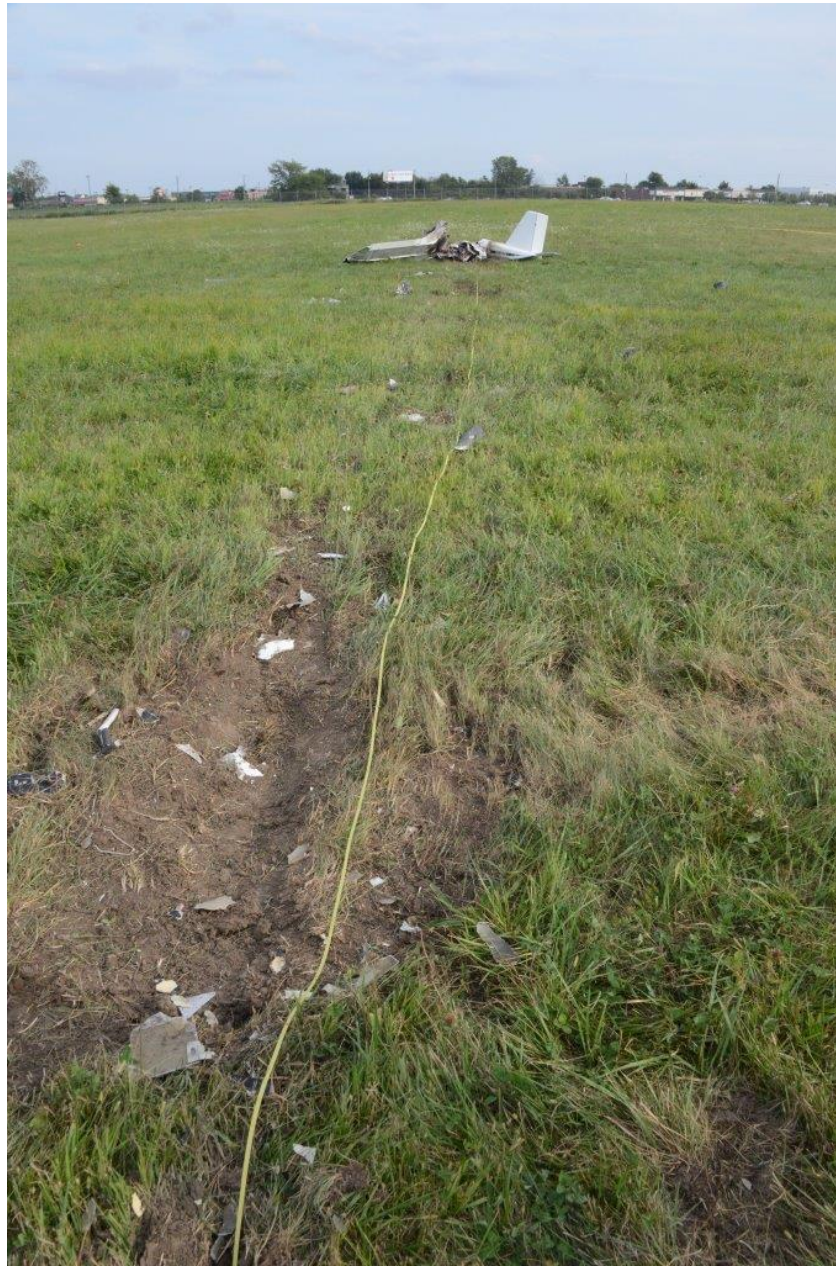
**Photo 3 - Close-up view of a ground scar in the debris path looking towards the main wreckage.**

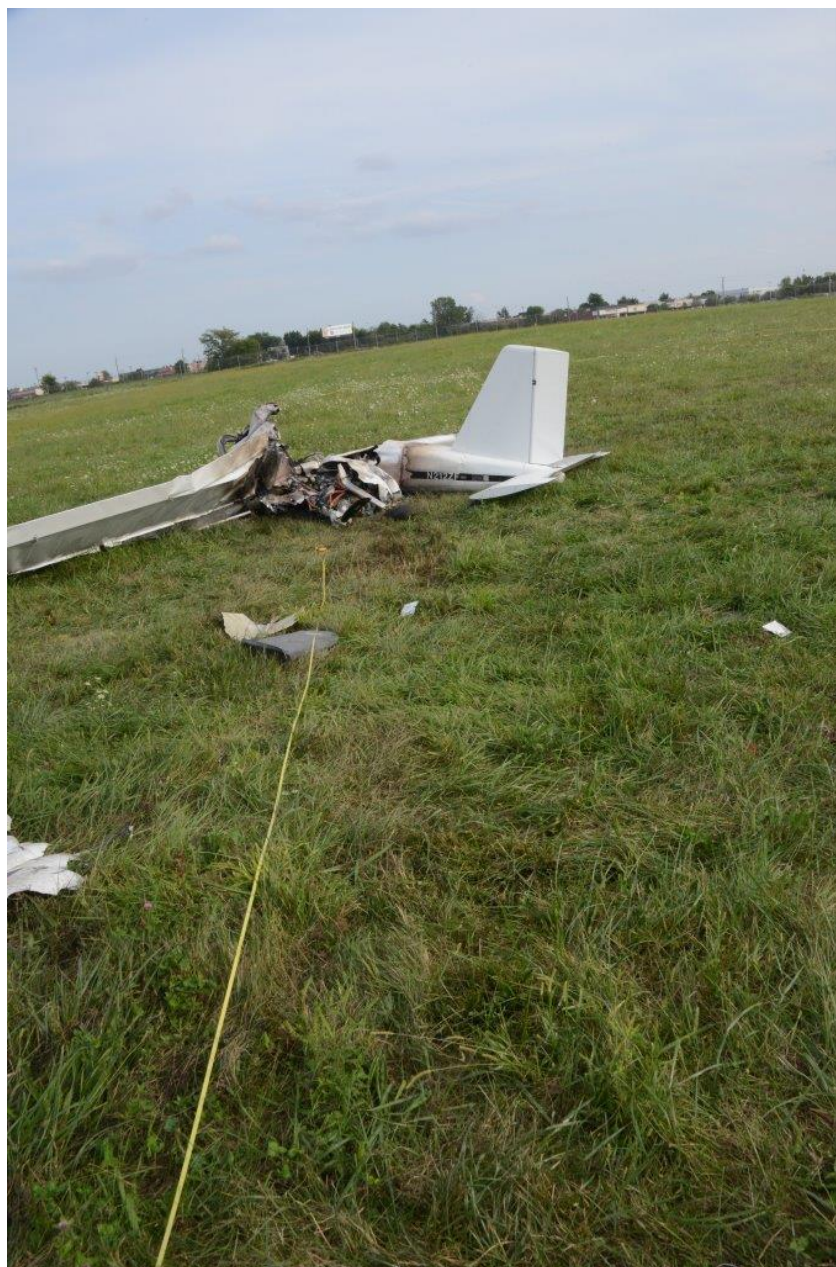
**Photo 4 - Quartering view of the left, rear side of the main wreckage.**

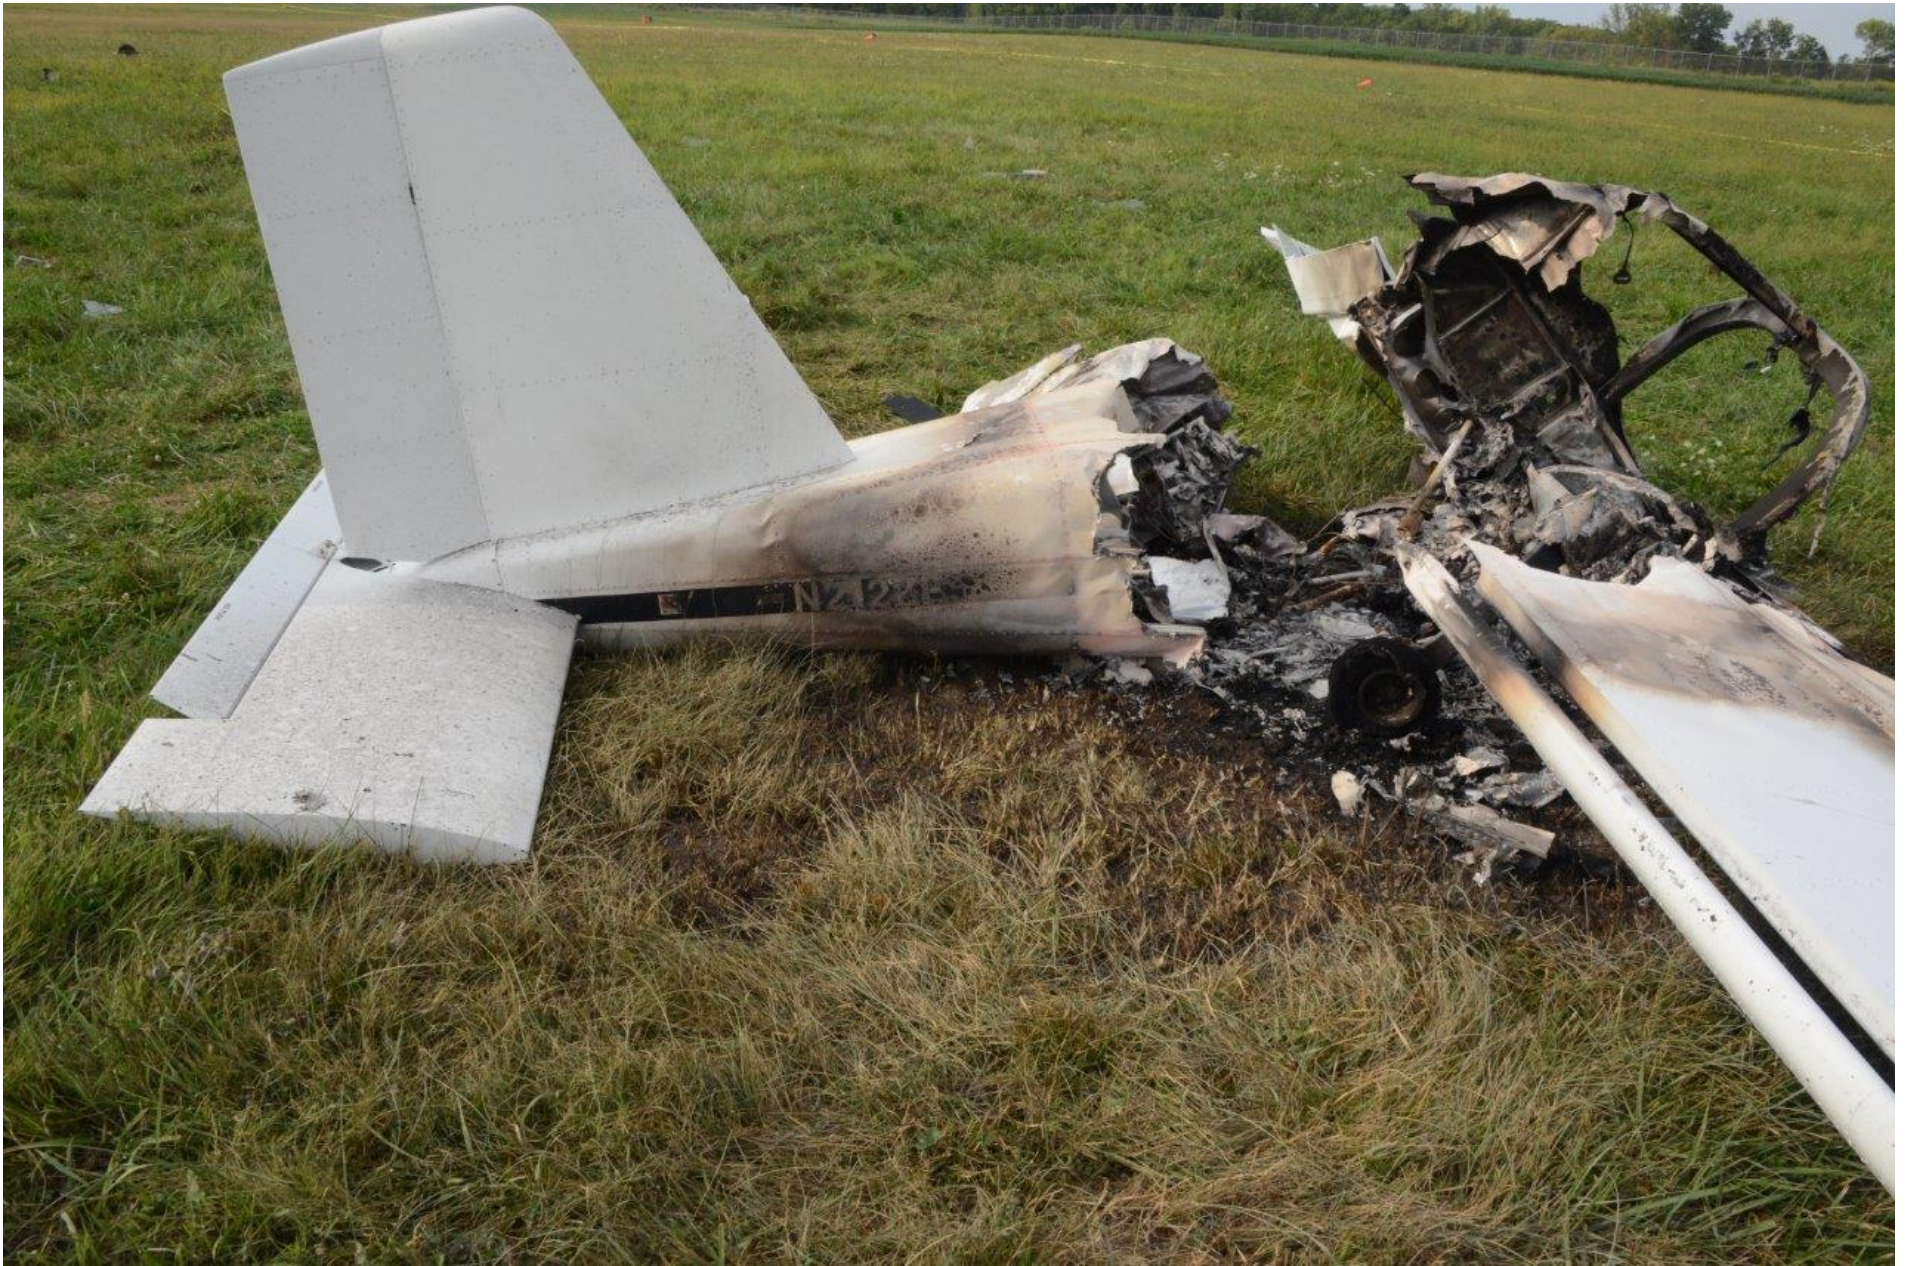
**Photo 5 - Quartering view of the right, rear side of the main wreckage.**

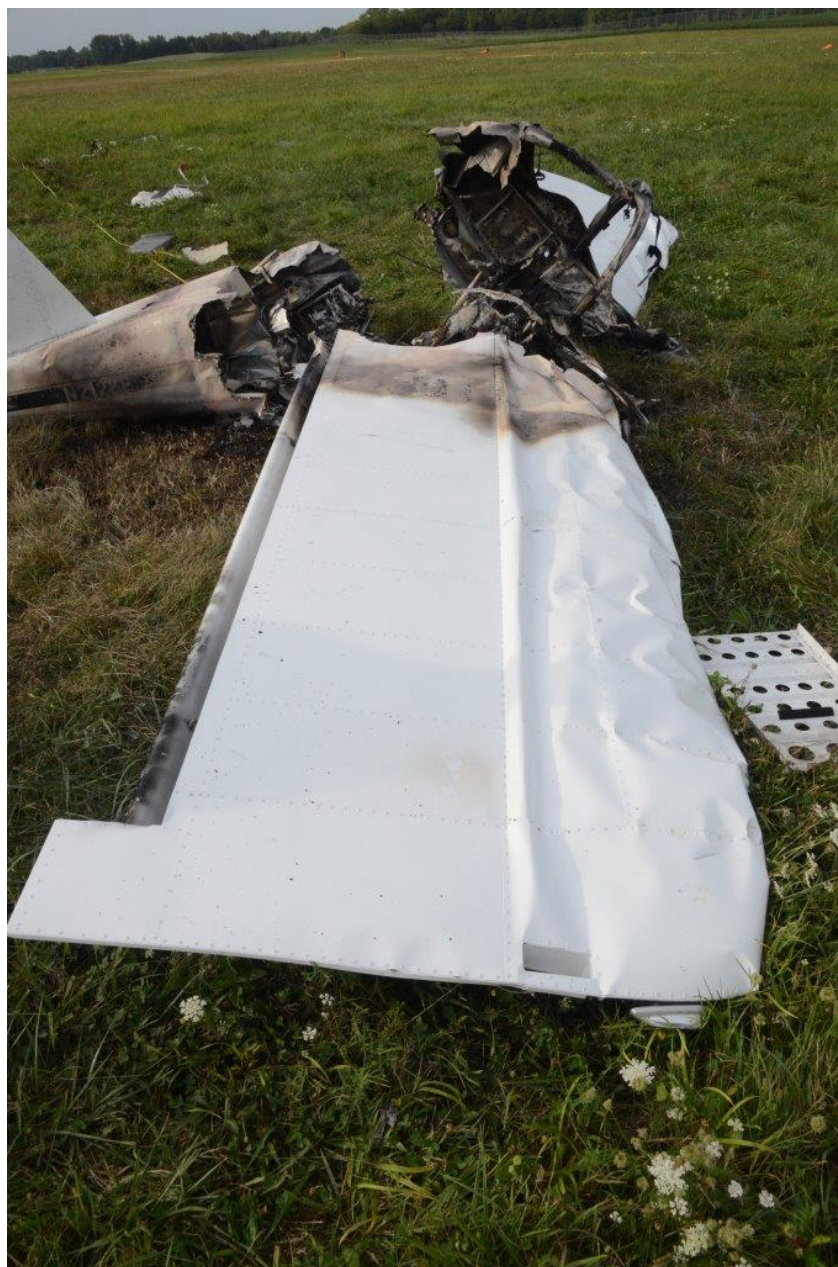
**Photo 6 - View of the right wing.**

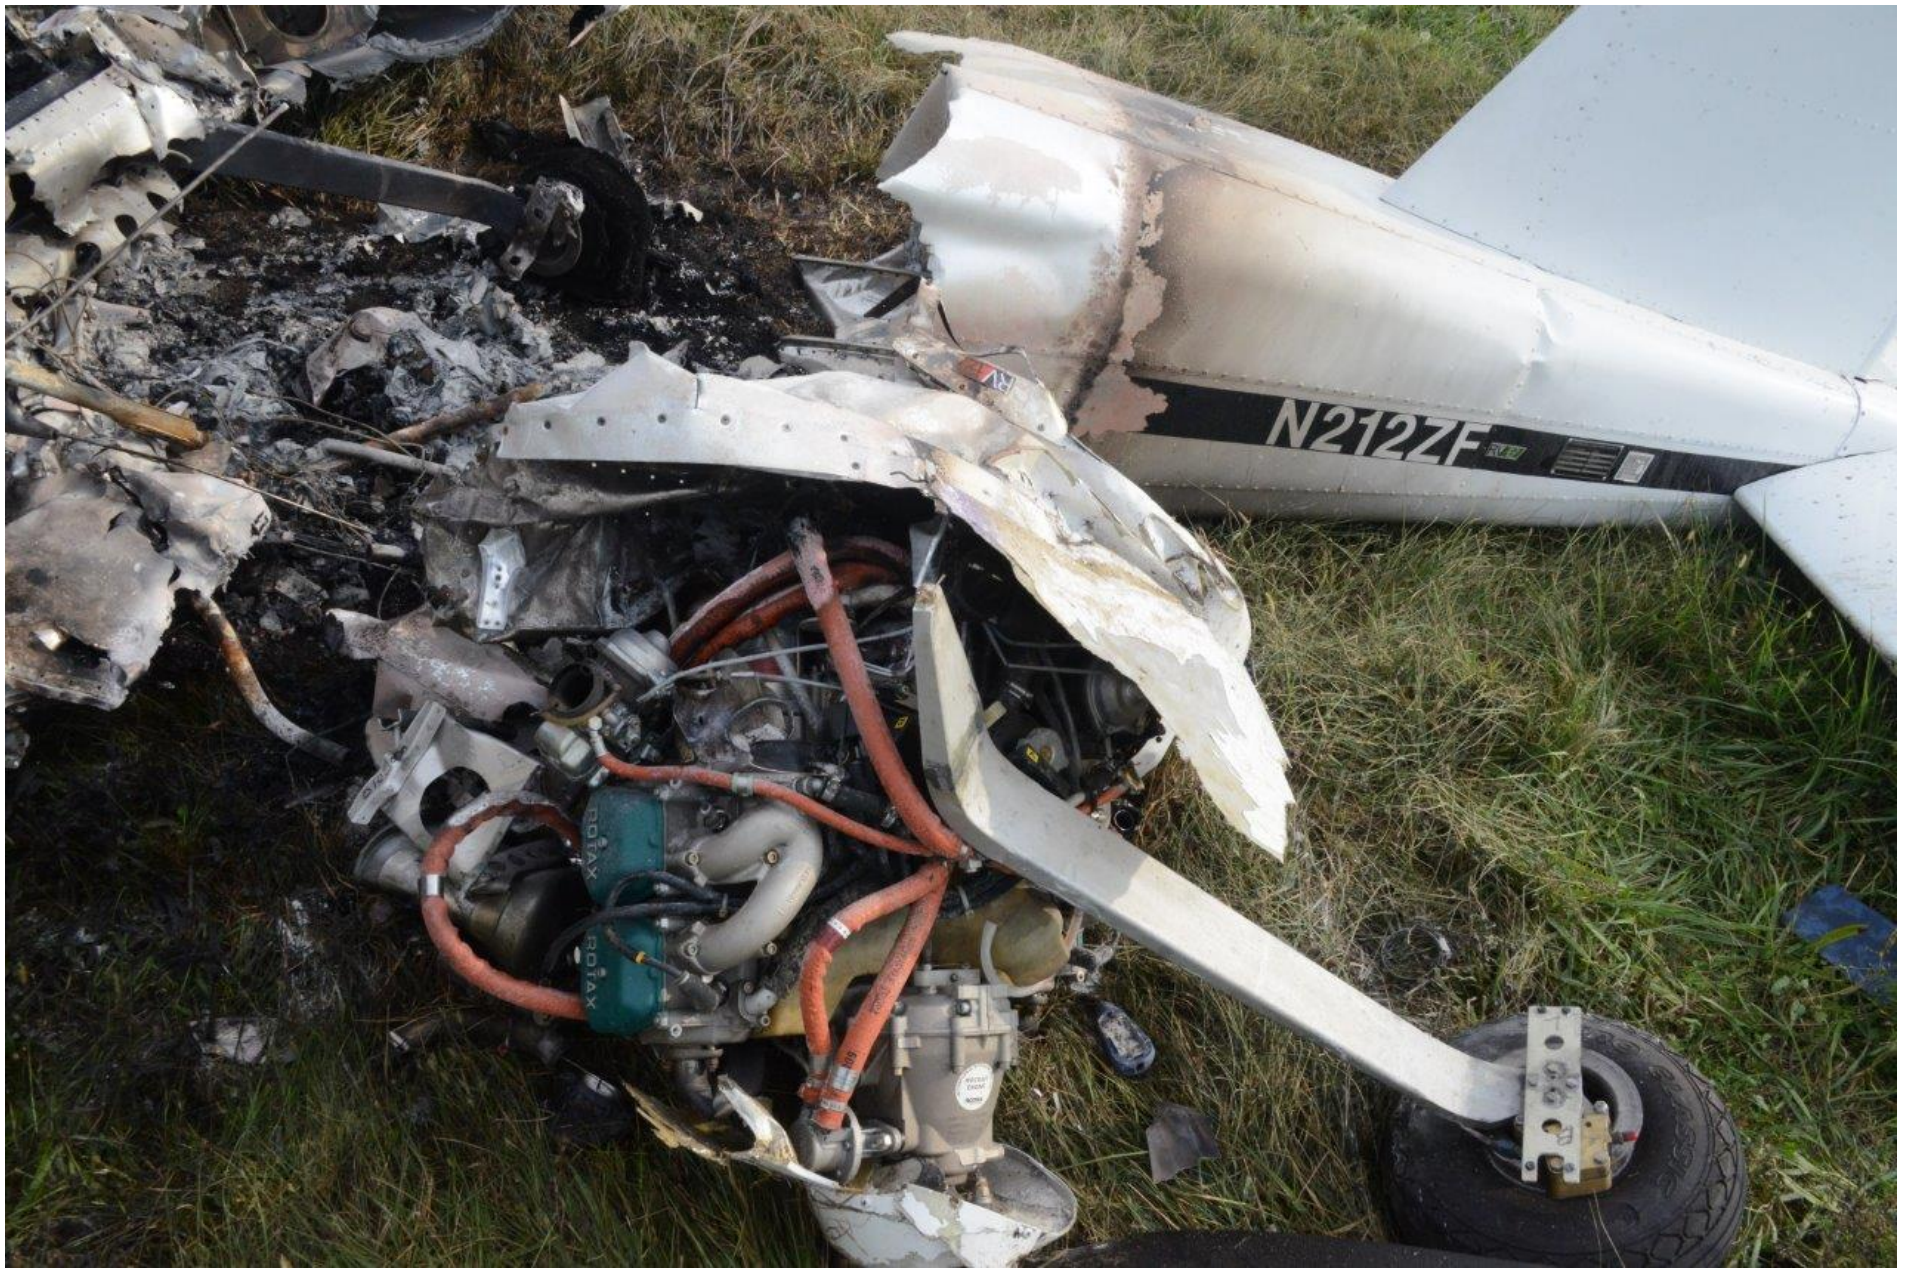
**Photo 7 - View of the engine.**

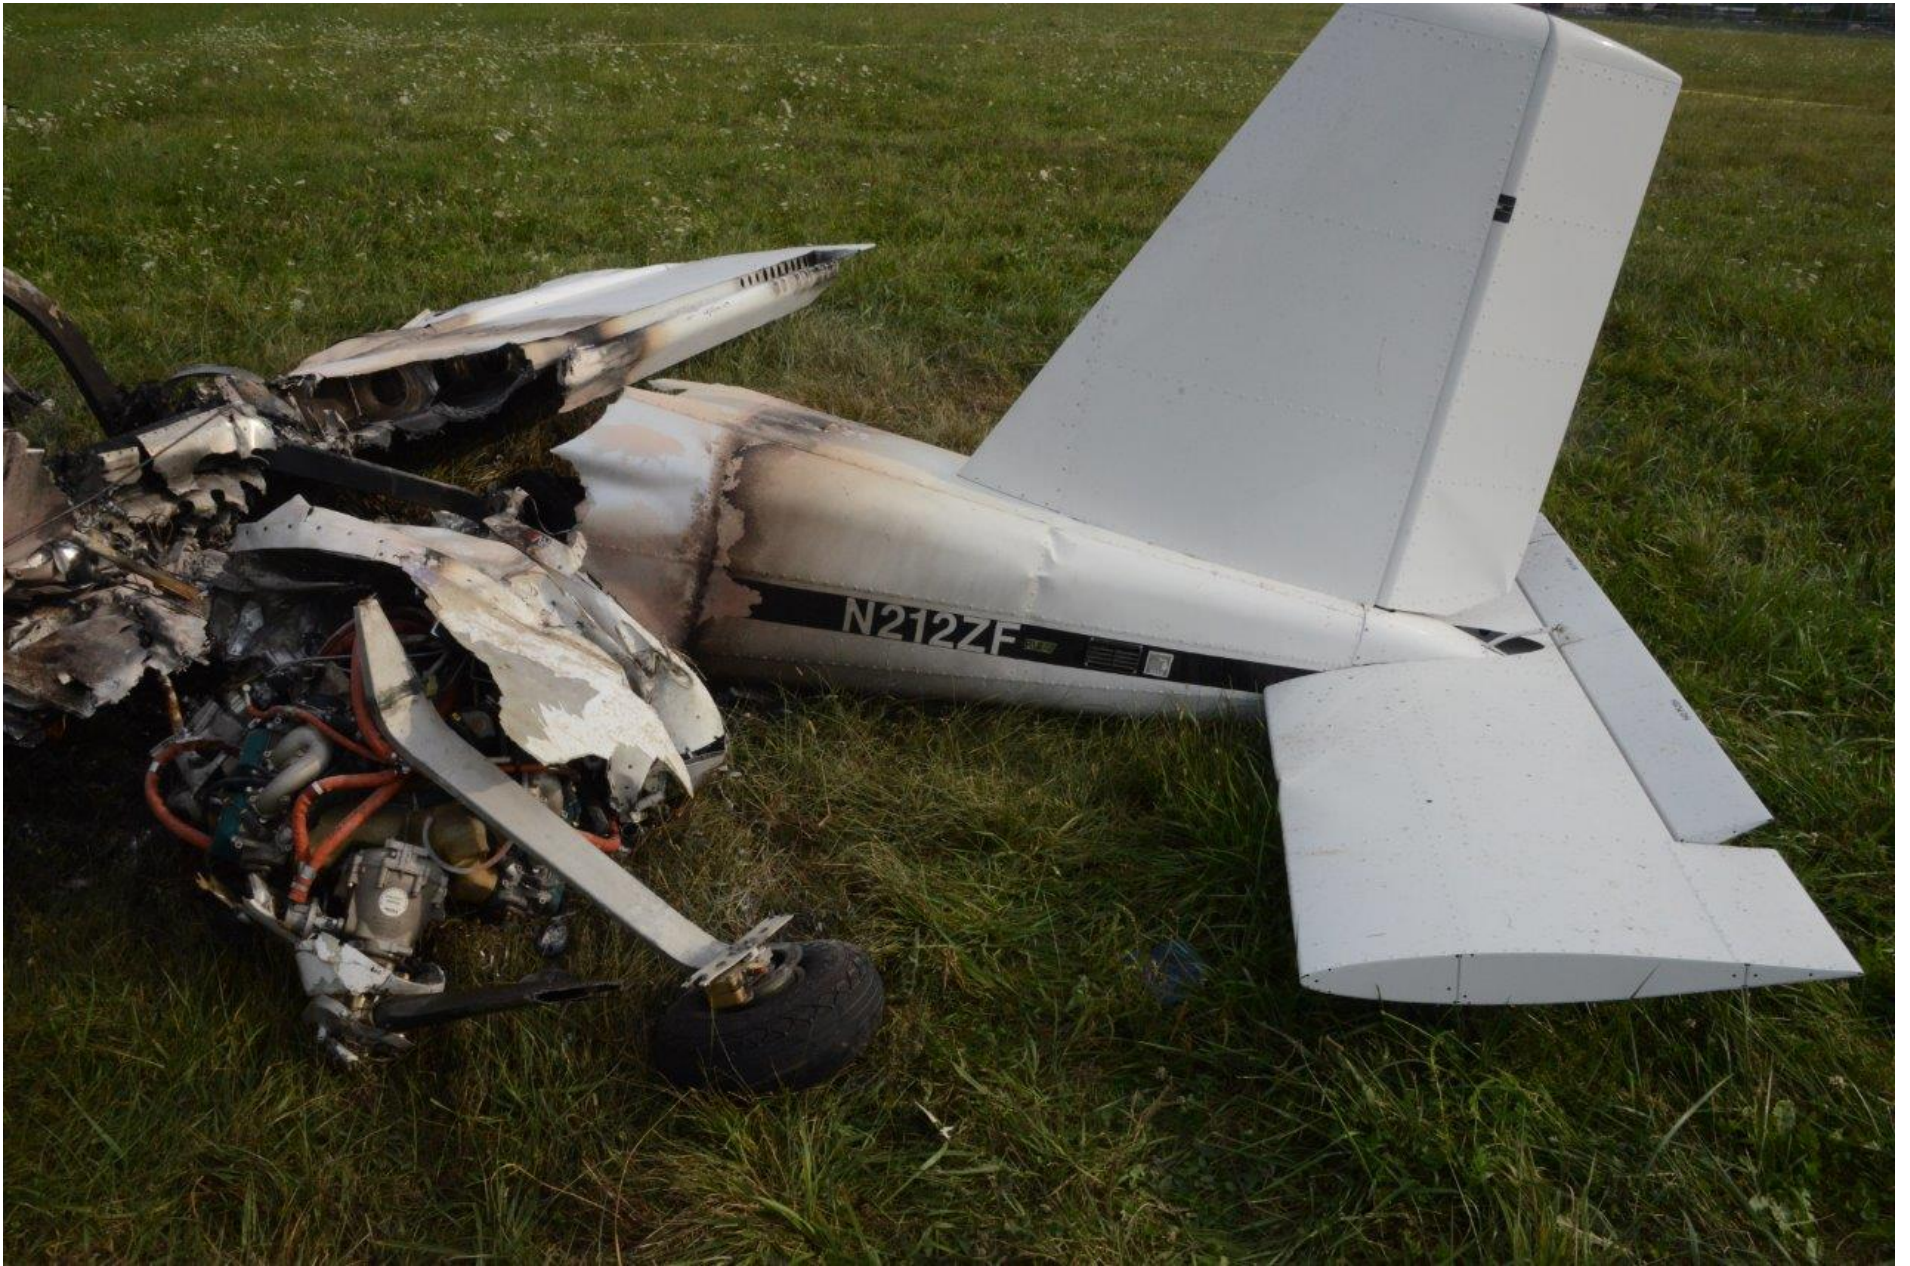
**Photo 8 - Close-up quartering view of the left, rear side of the main wreckage**

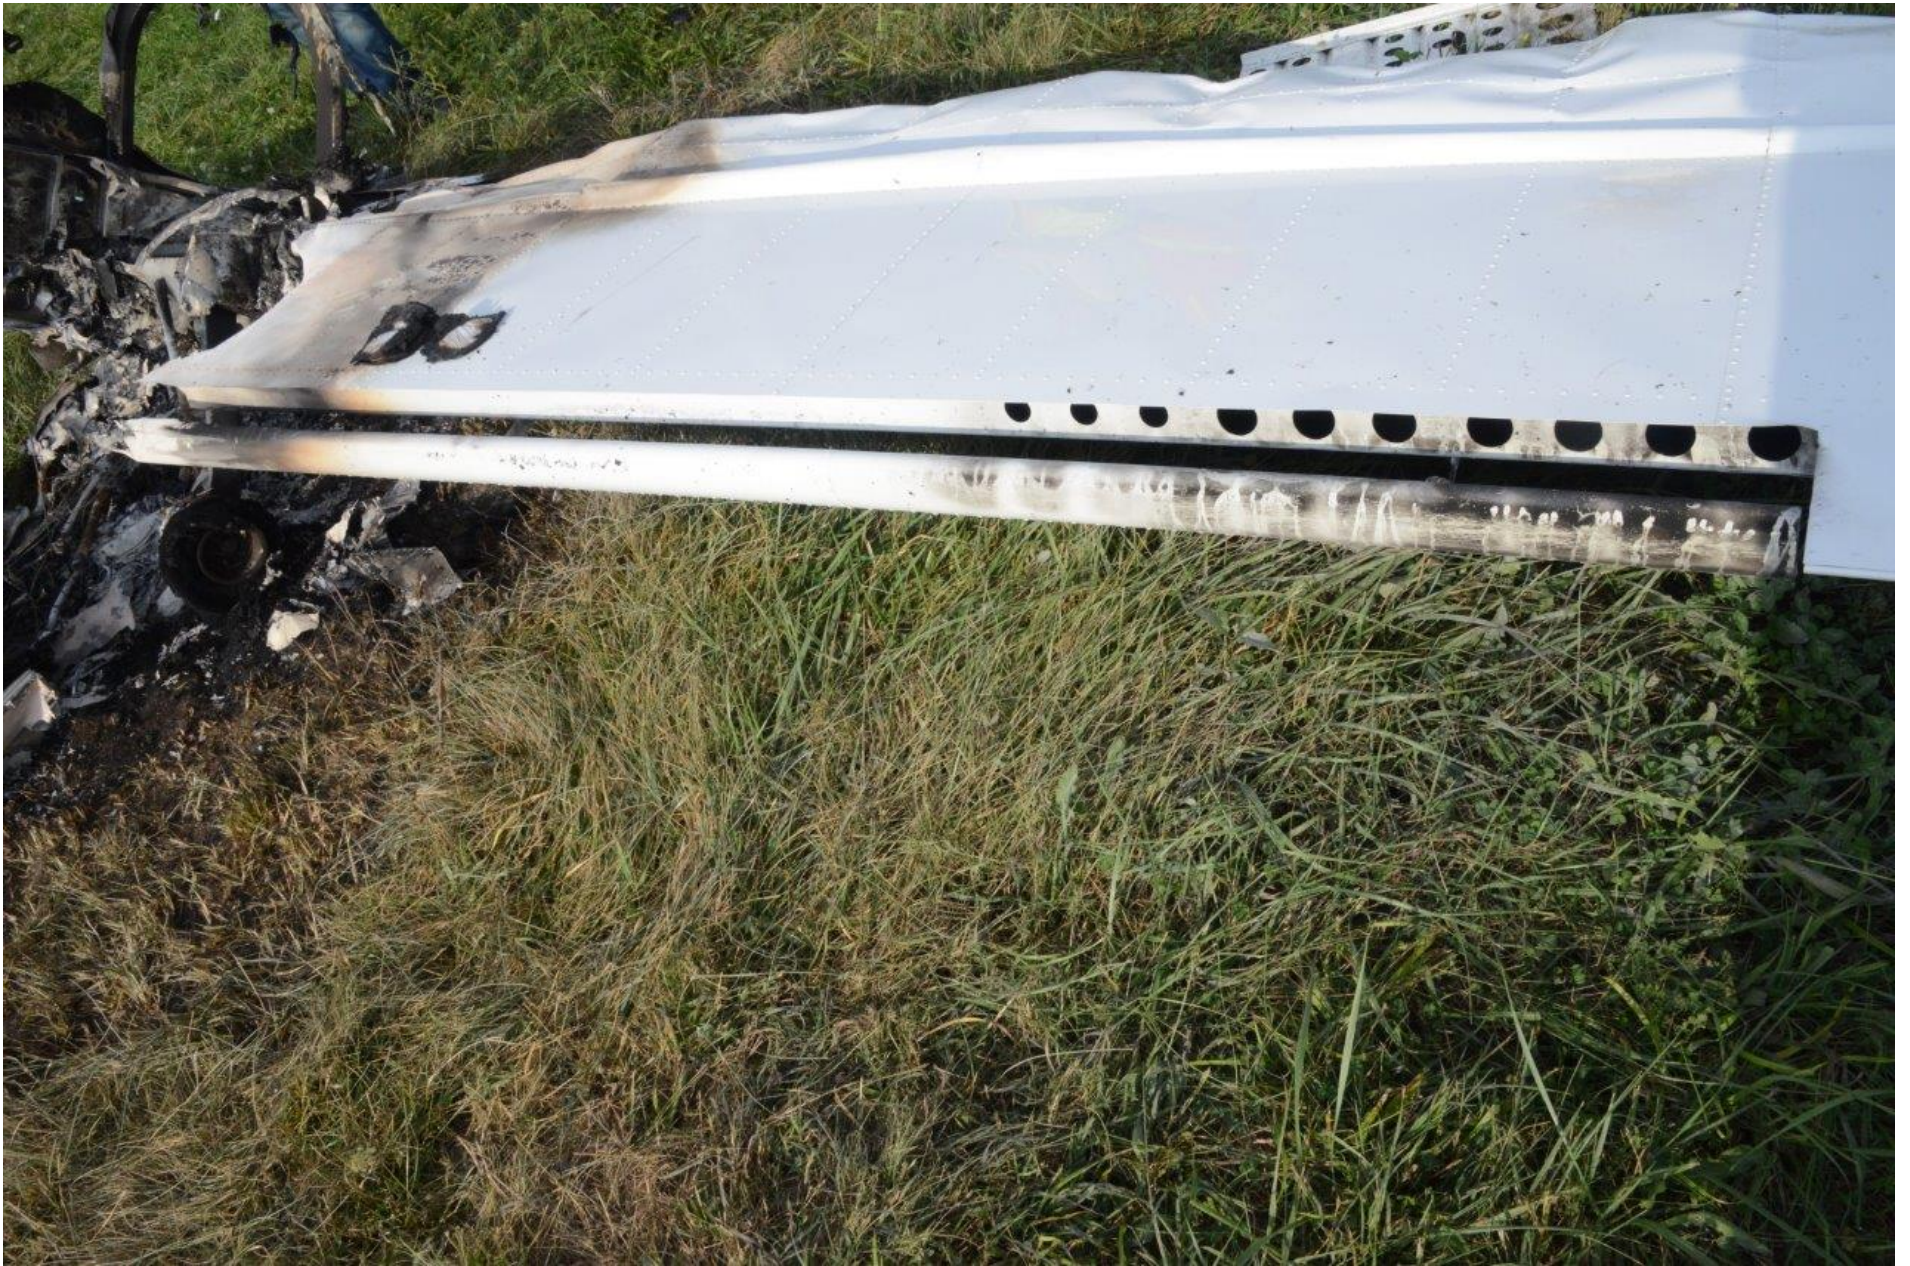
**Photo 9 - Close-up view of the inboard section of the right wing.**

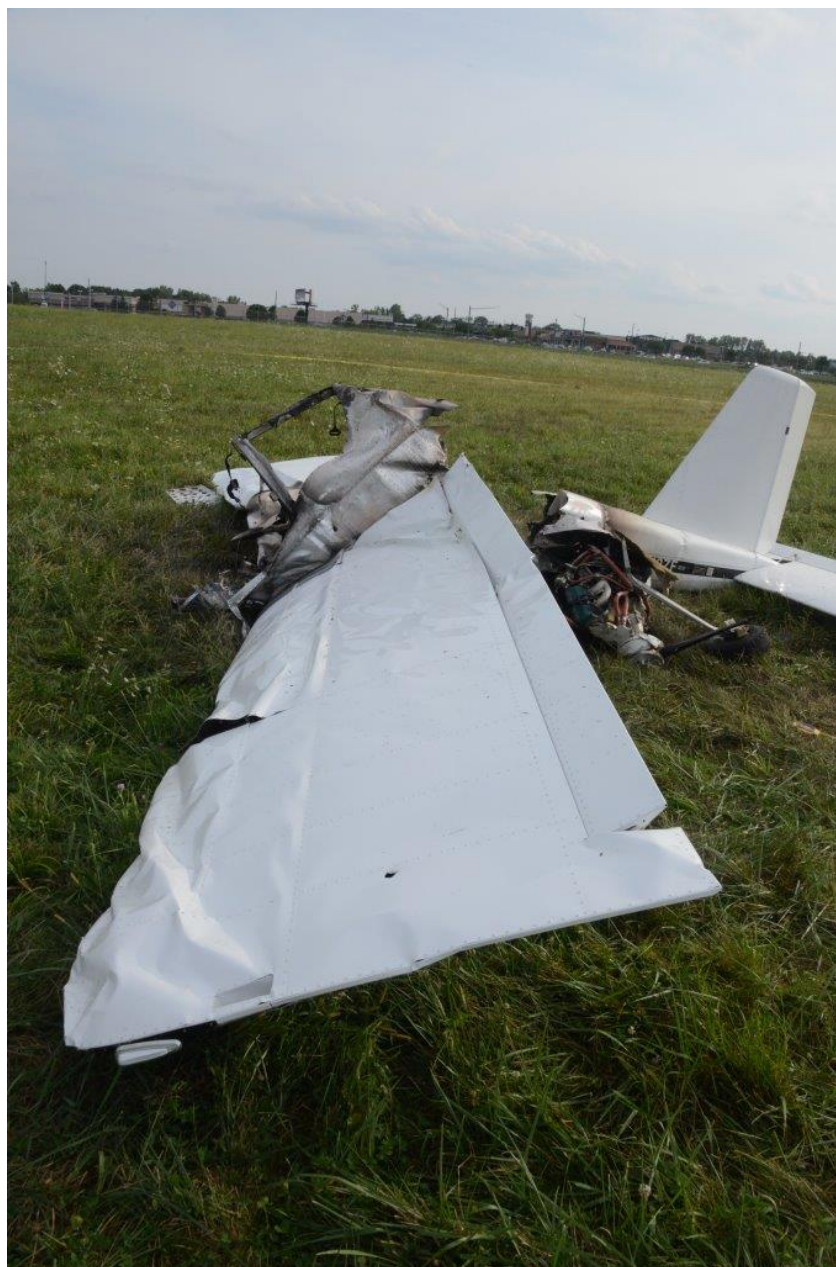
**Photo 10 - View of the left wing.**

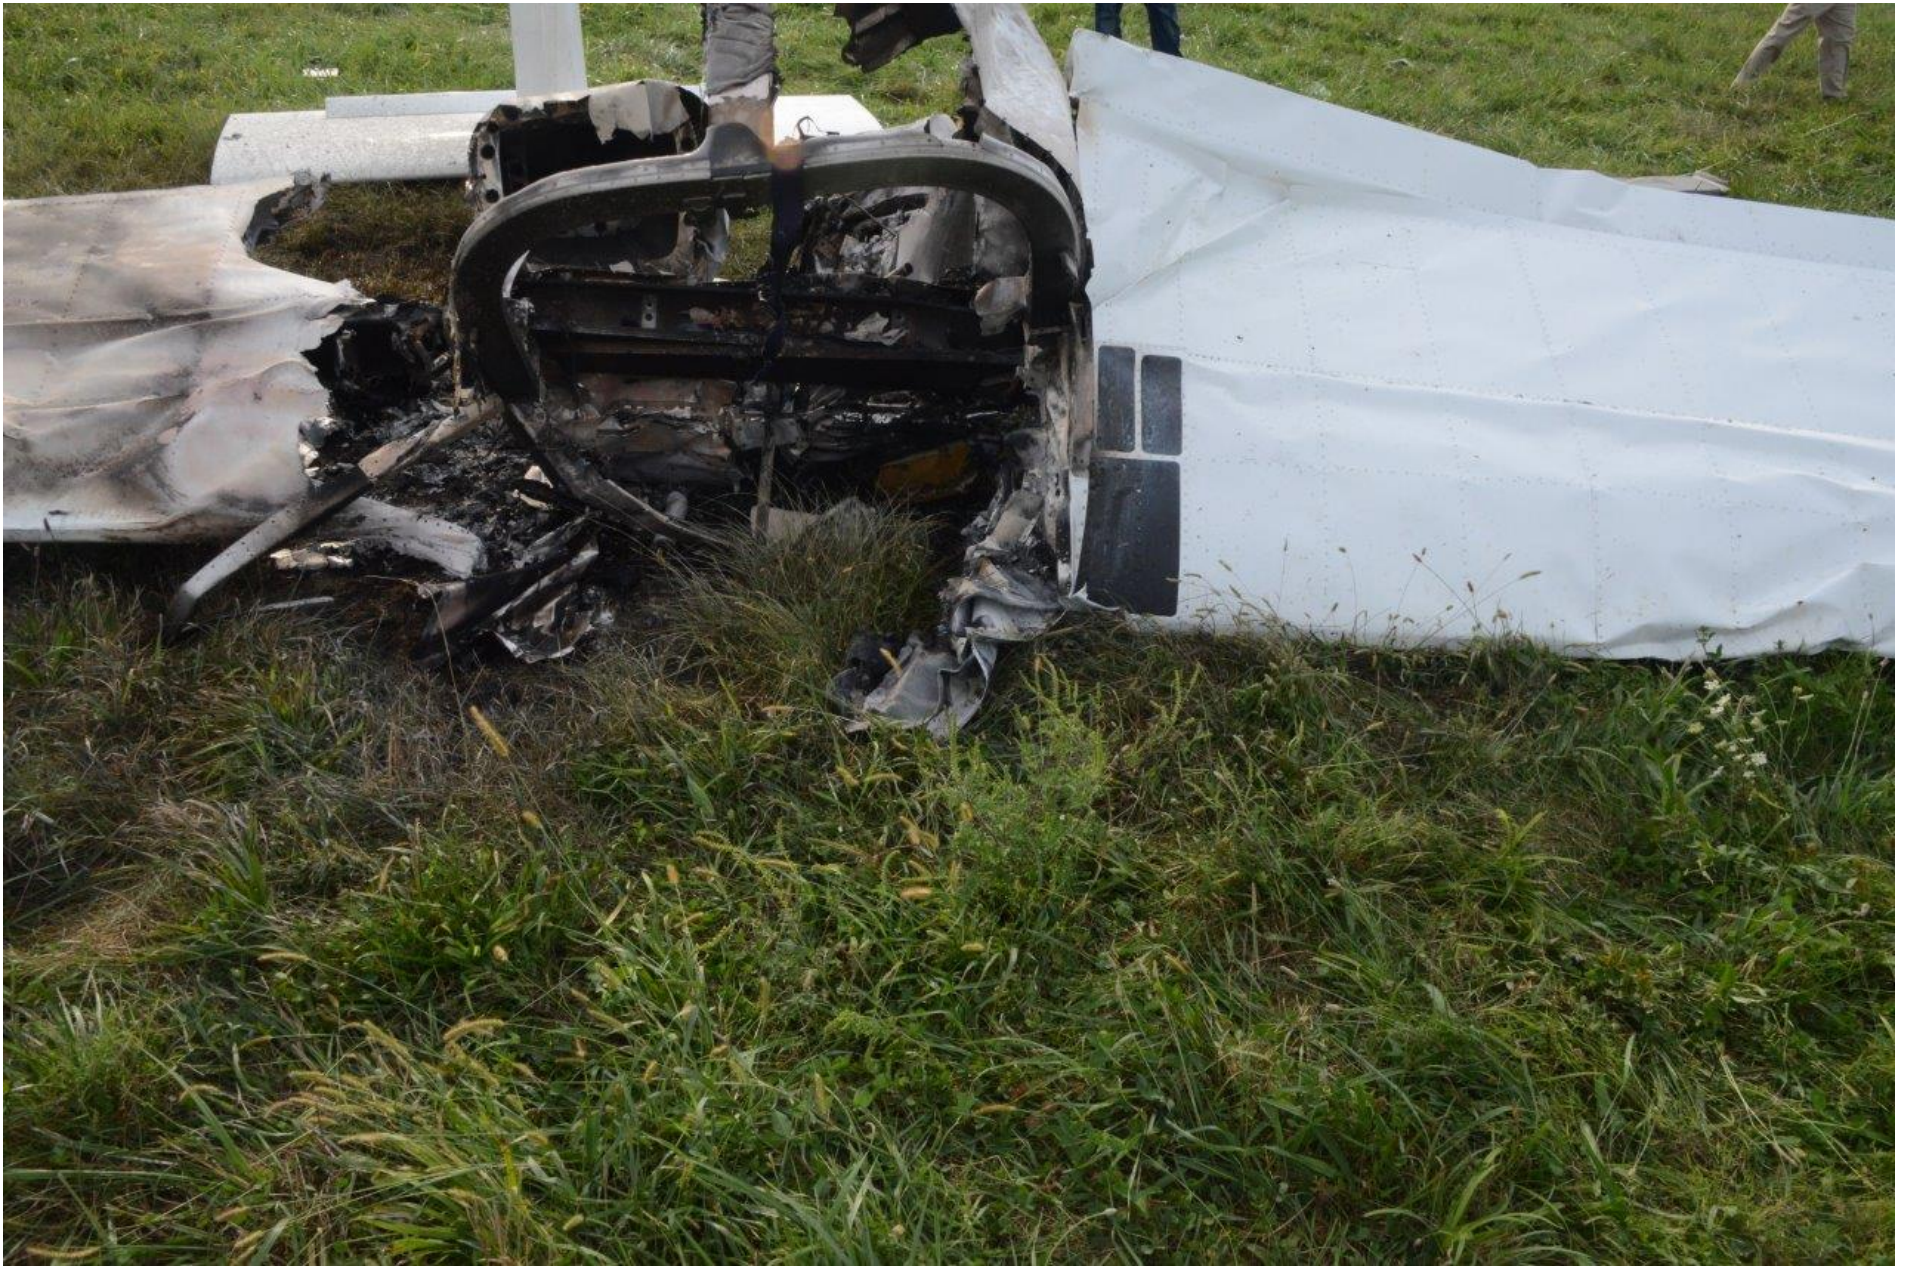
**Photo 11 - View of the roll bar frame between the wings.**

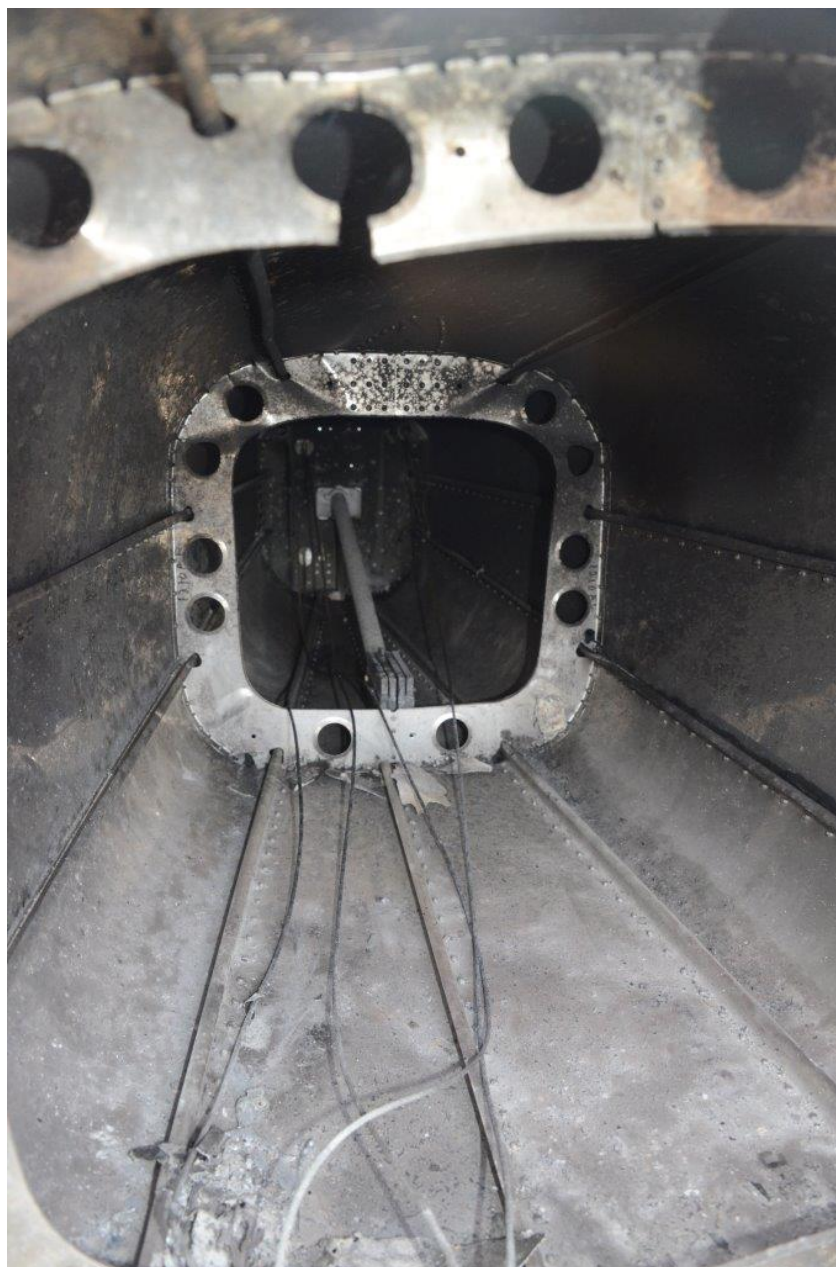
**Photo 12 - View of the control cables within the empennage.**
