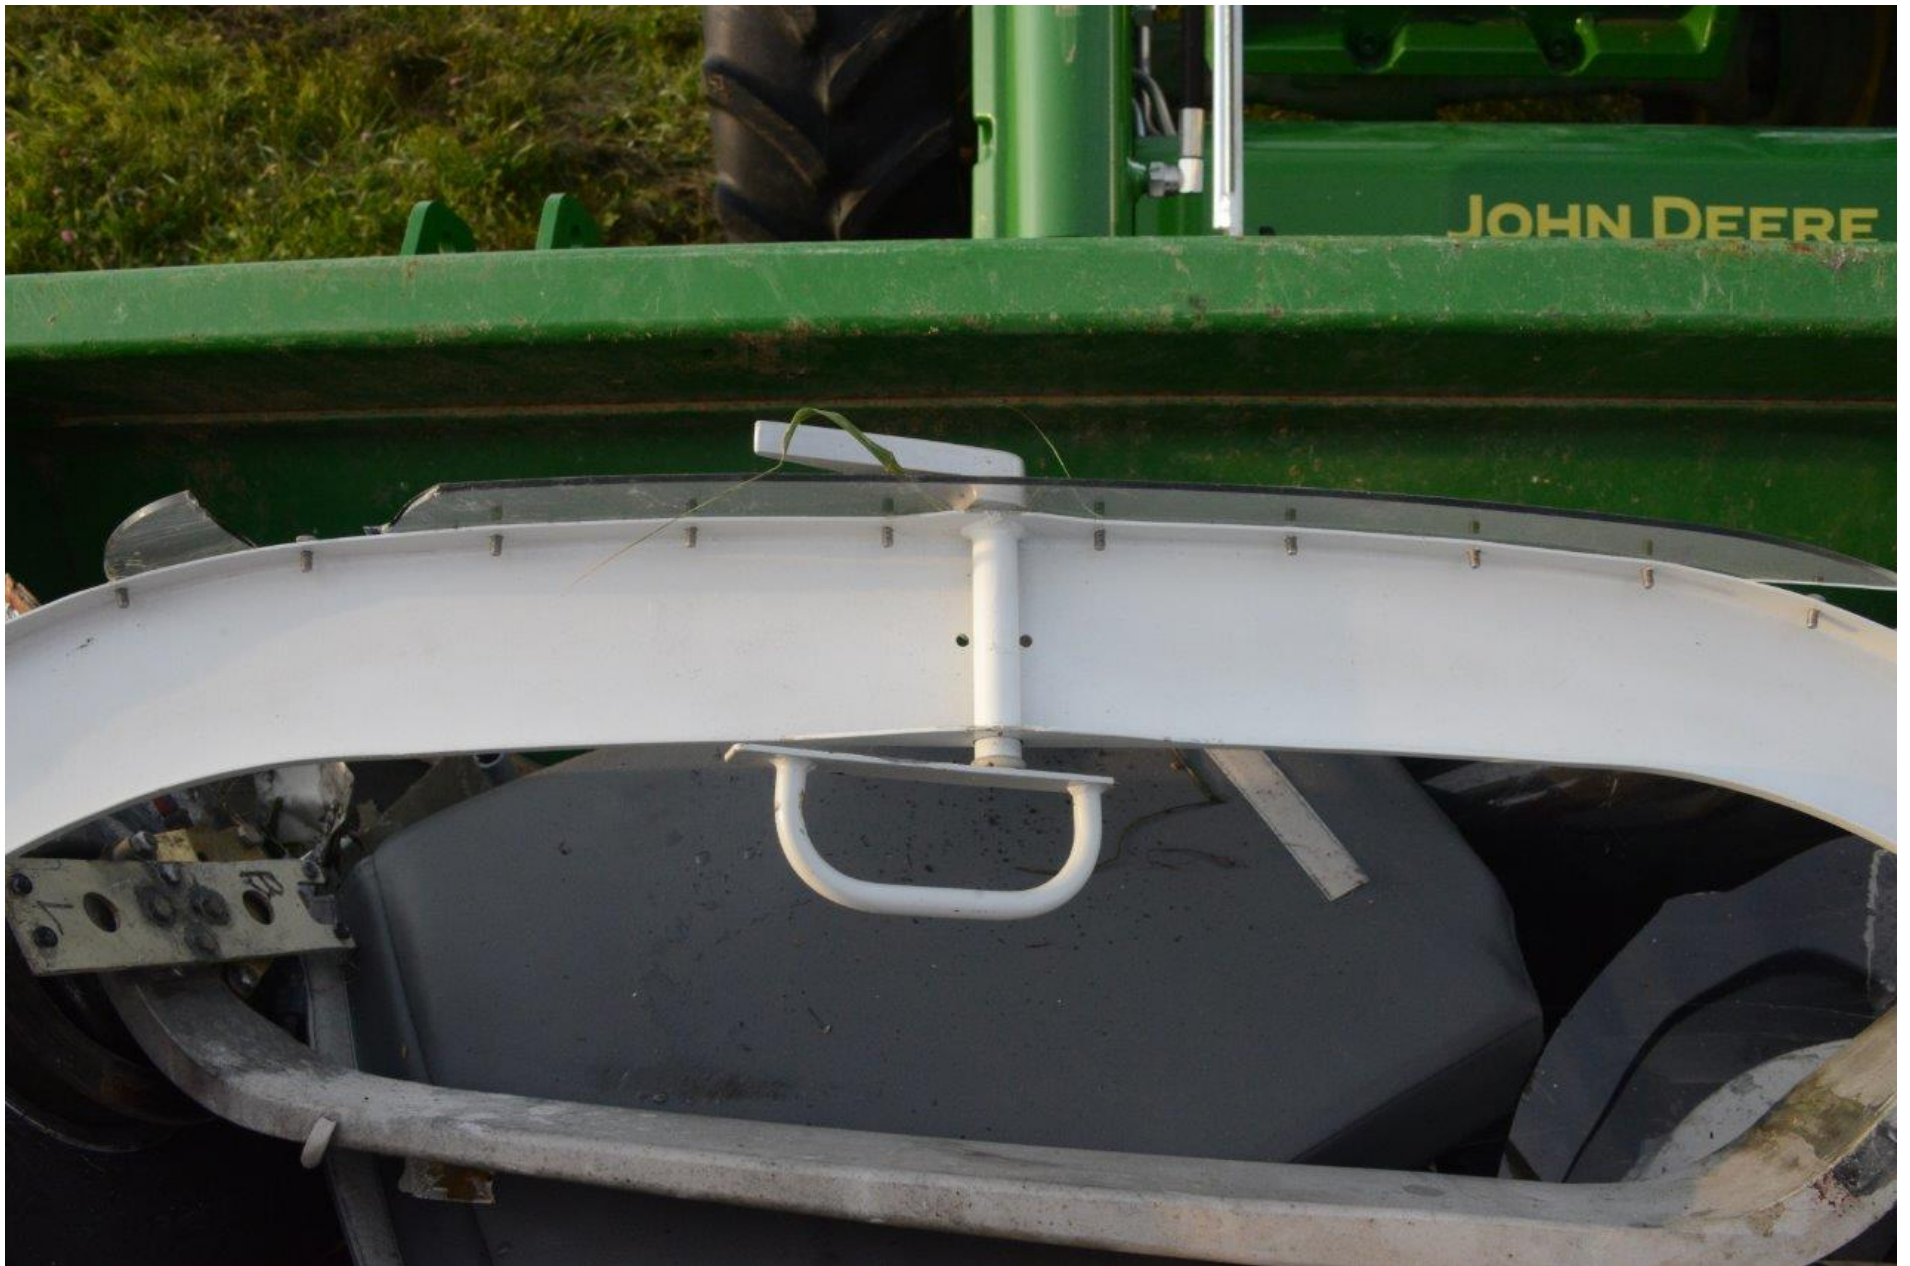
**Photo 13 - View of the canopy latch handle mechanism.**

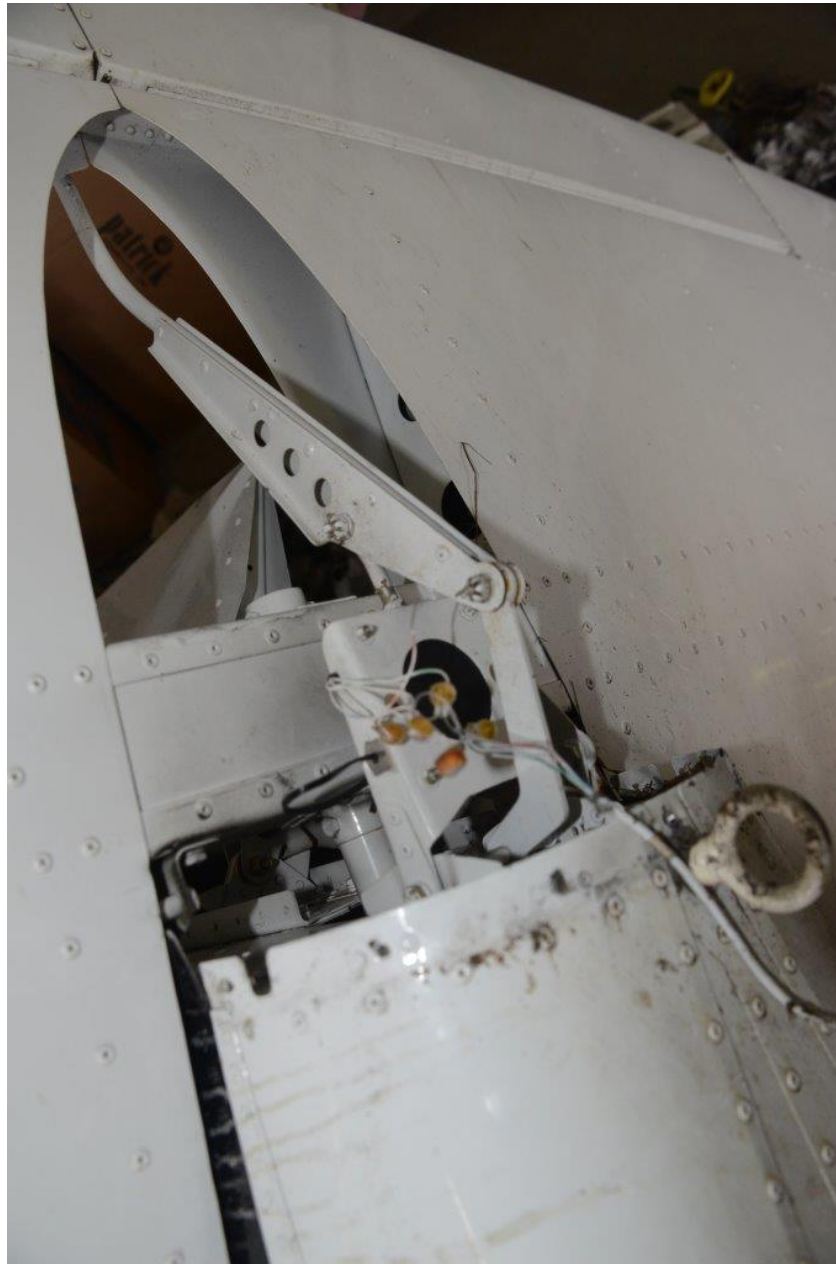
**Photo 14 - View of the elevator trim servo and linkage.**

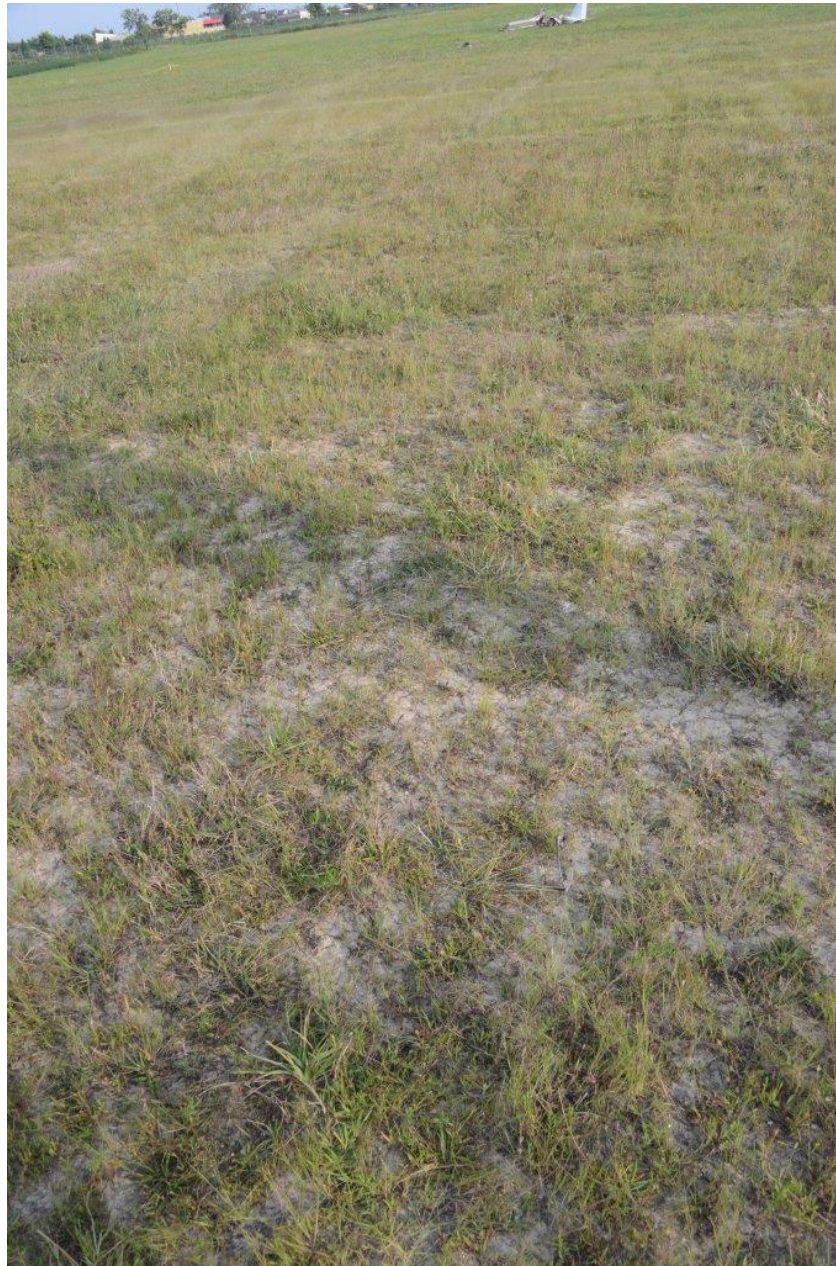
**Photo 15 - View of glasses resting in the grass in the foreground and the main wreckage in the background.**

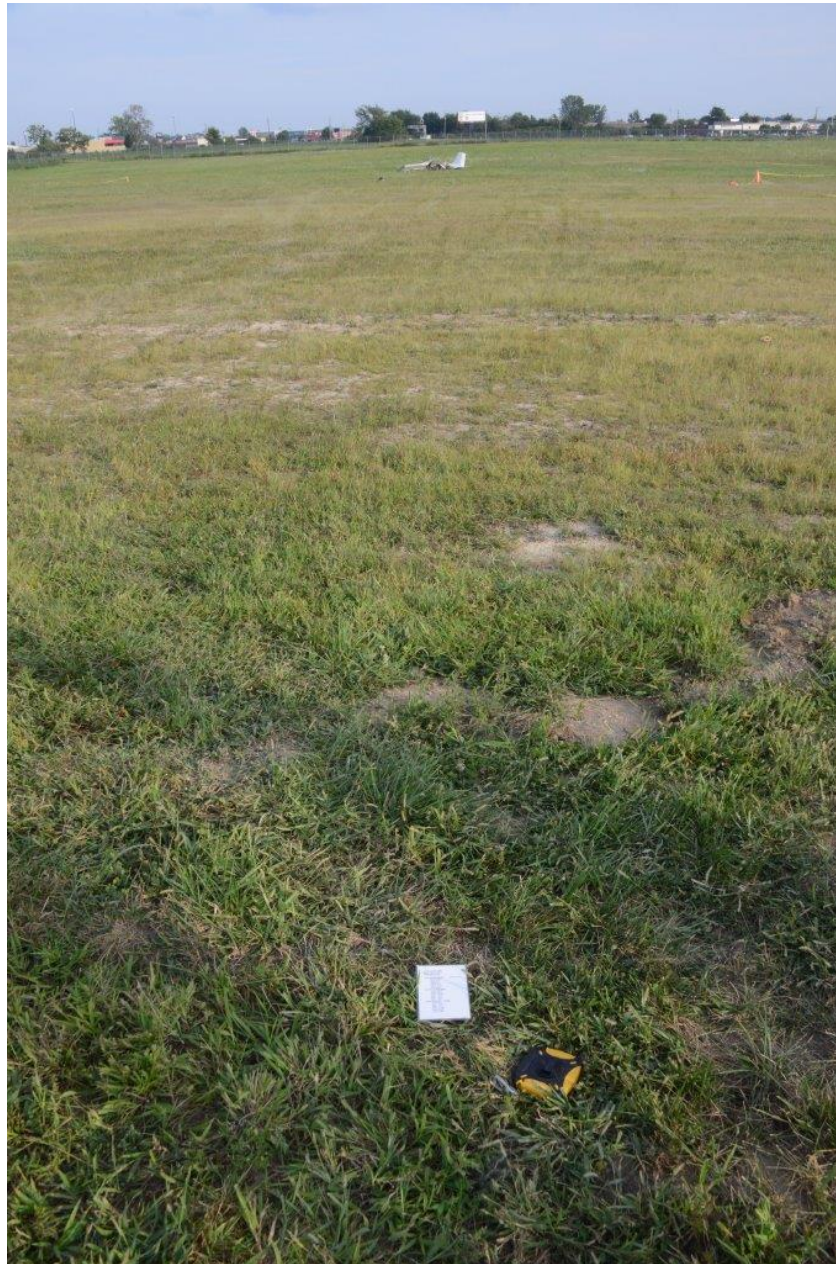
**Photo 16 - View of a checklist from the airplane resting in the grass in the foreground and the main wreckage in the background.**

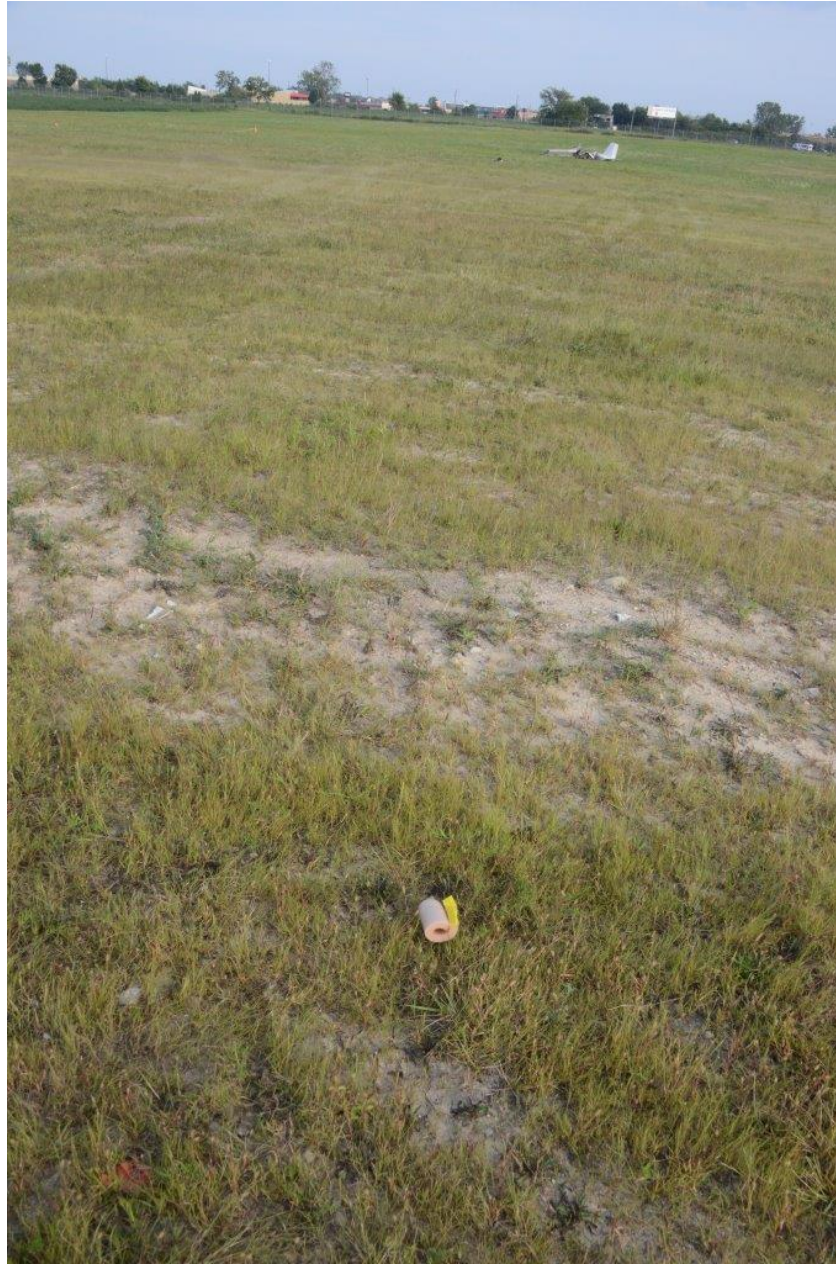
**Photo 17 - View of rolled foam resting in the grass in the foreground and the main wreckage in the background.**

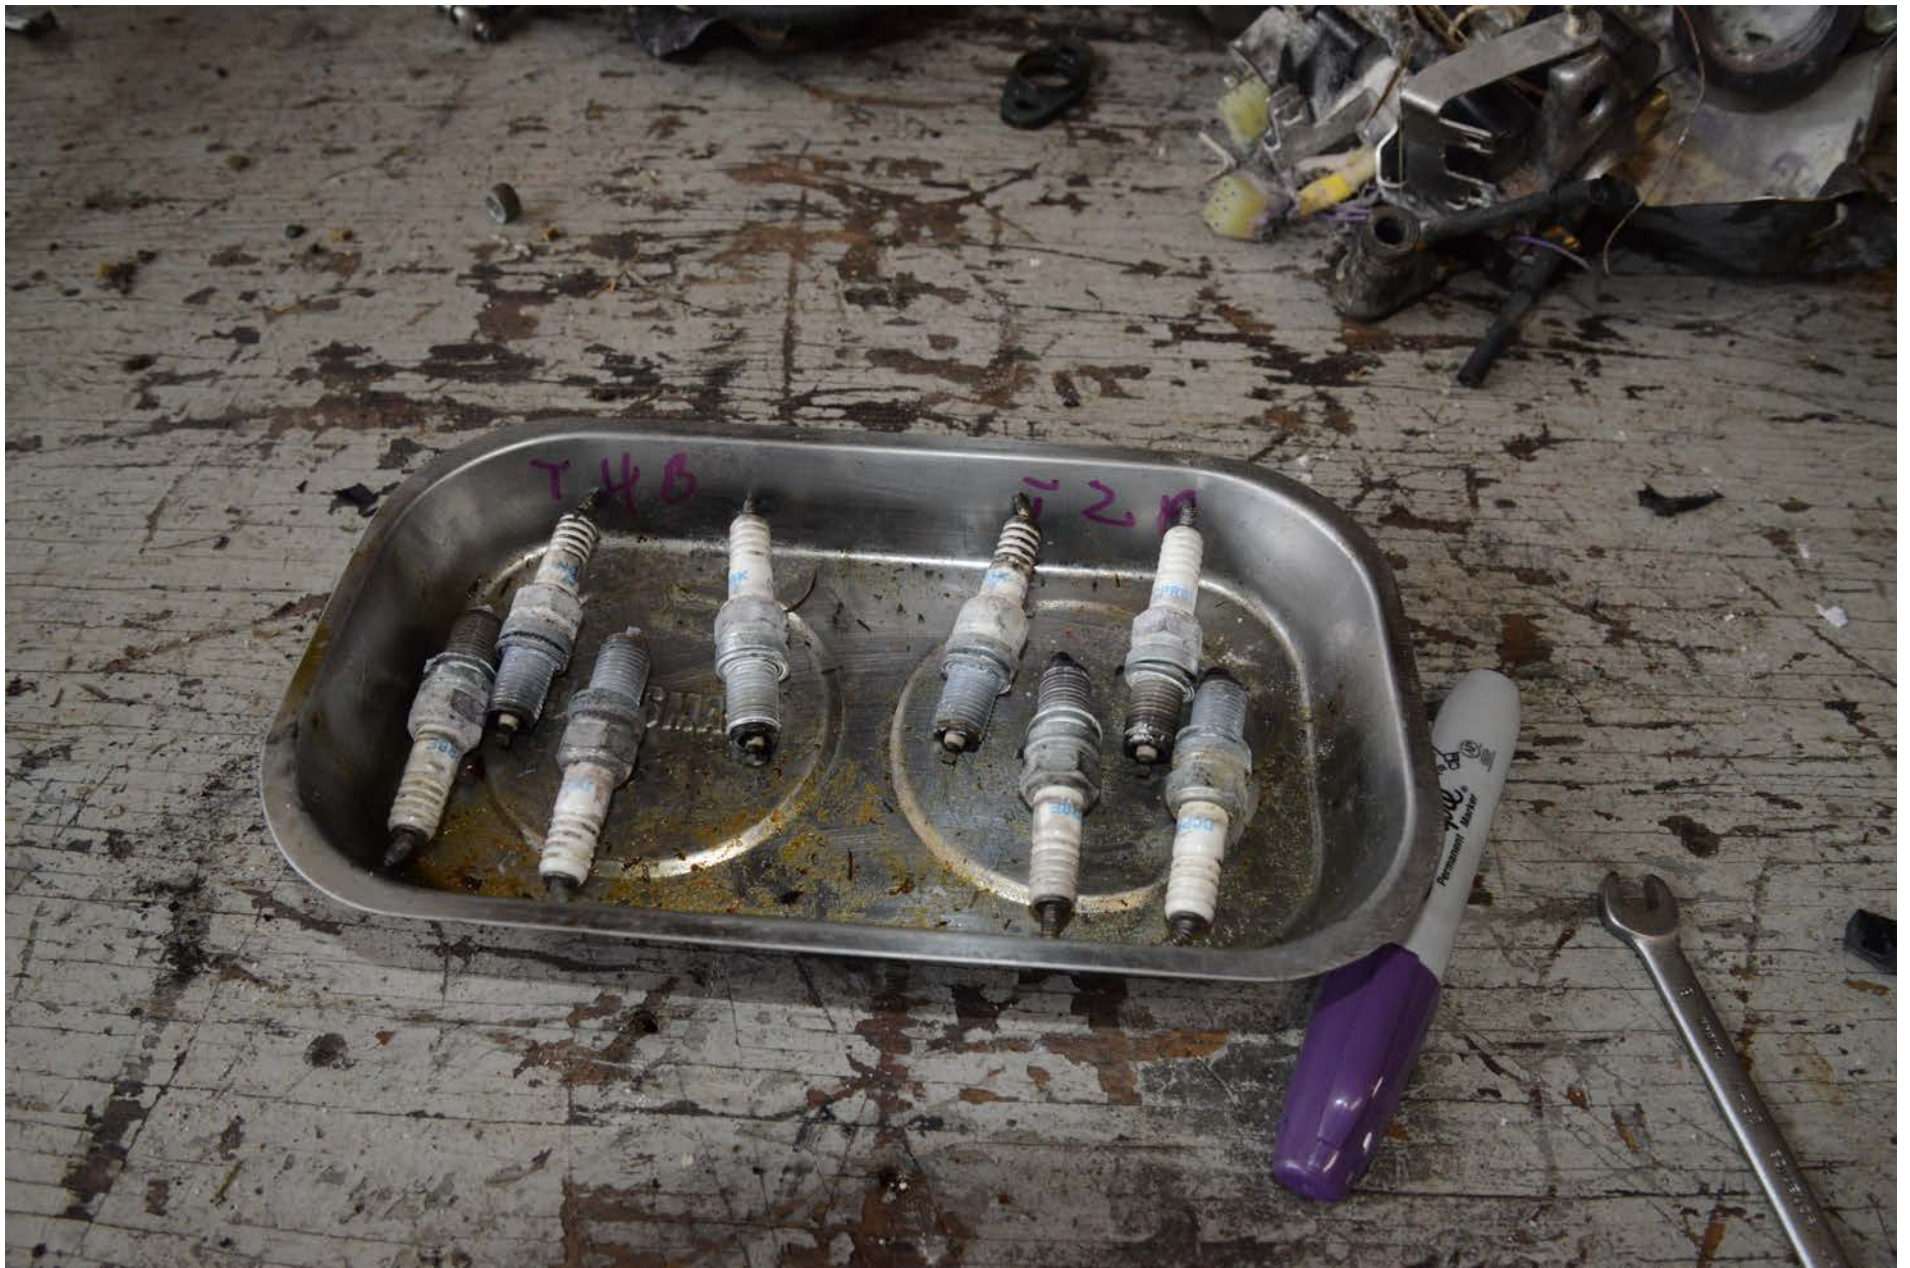
**Photo 18 - View of removed sparkplugs.**

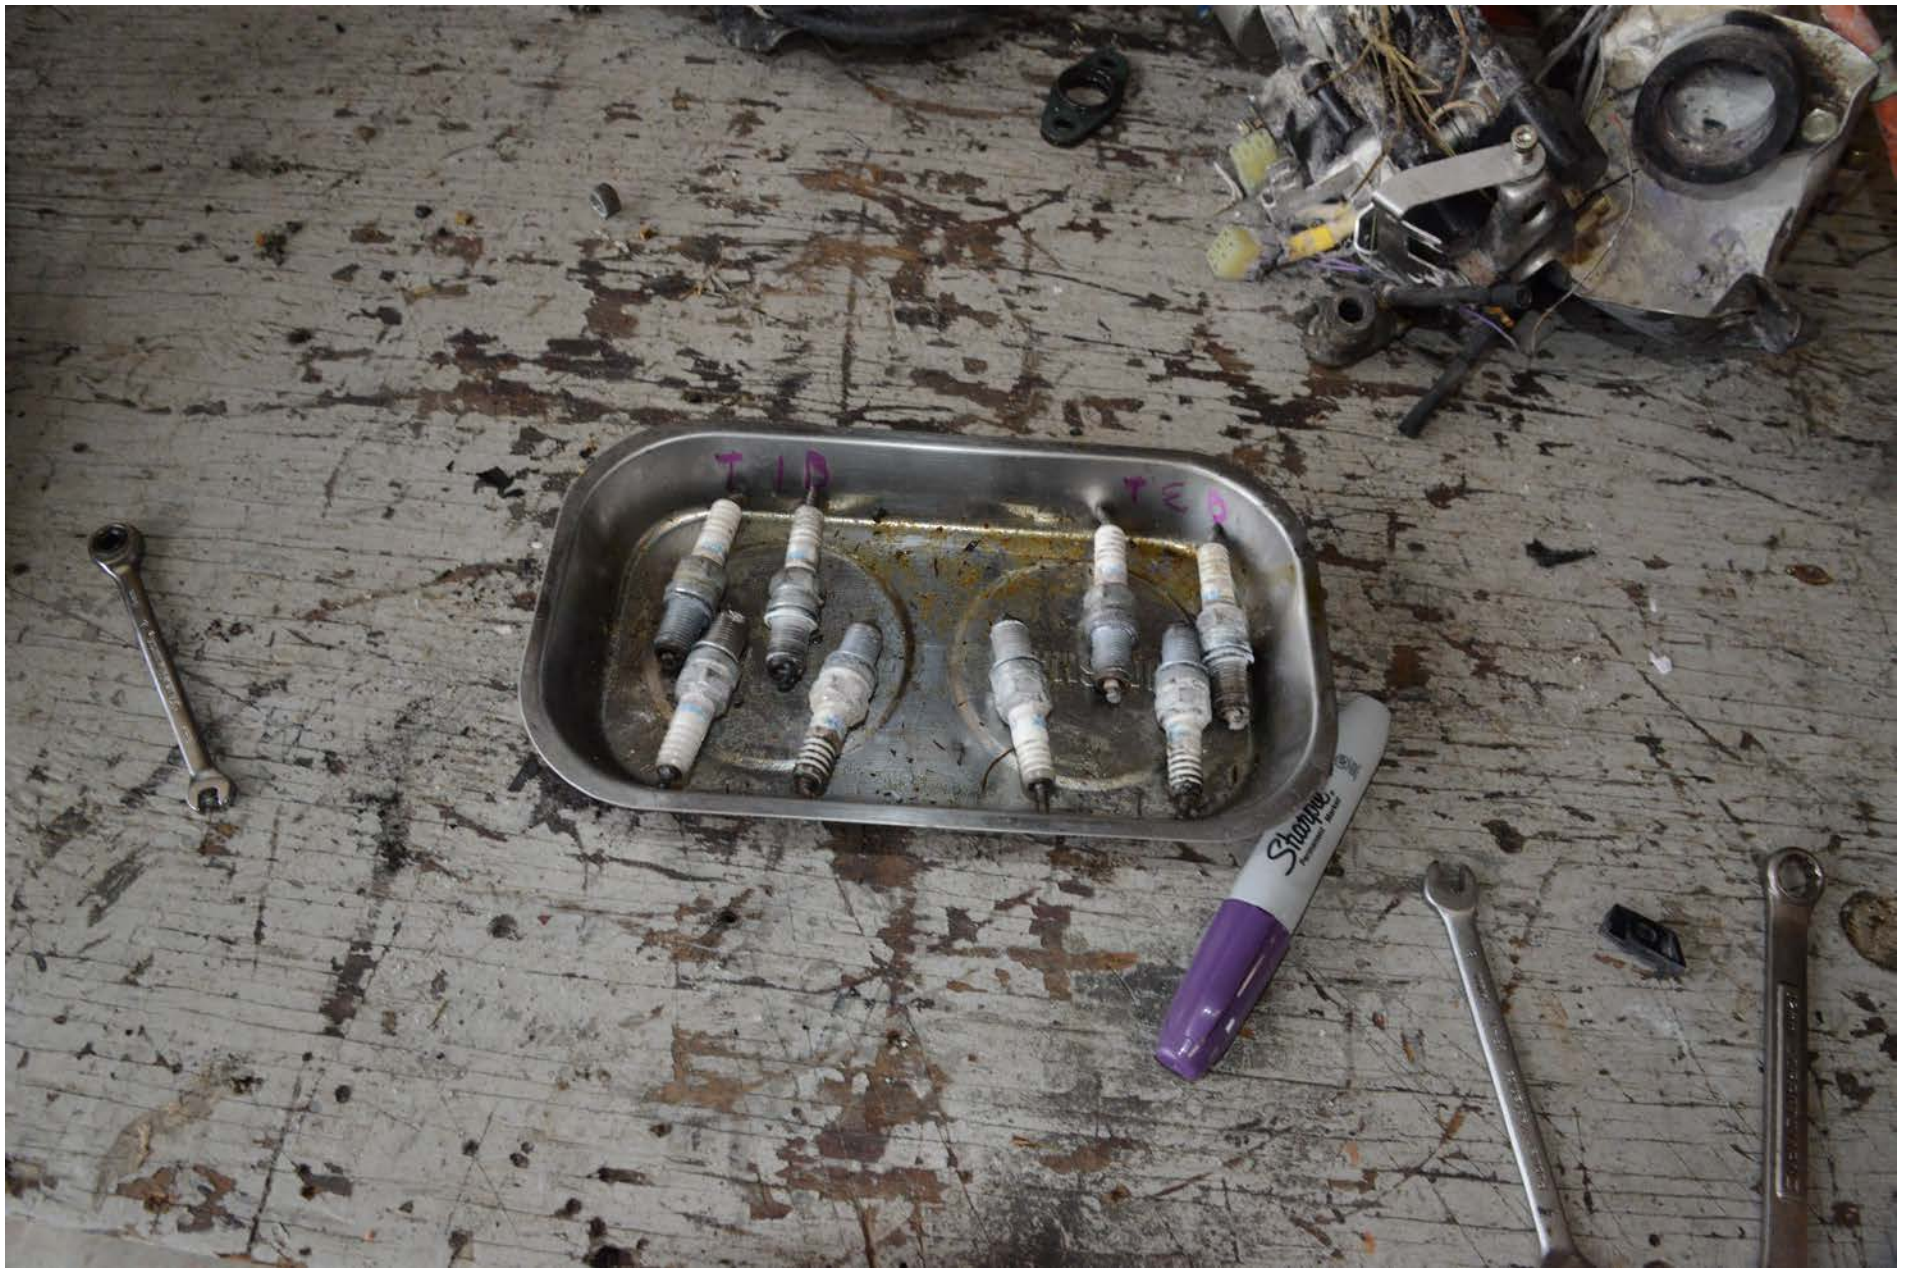
Photo 19 - View of removed sparkplugs.

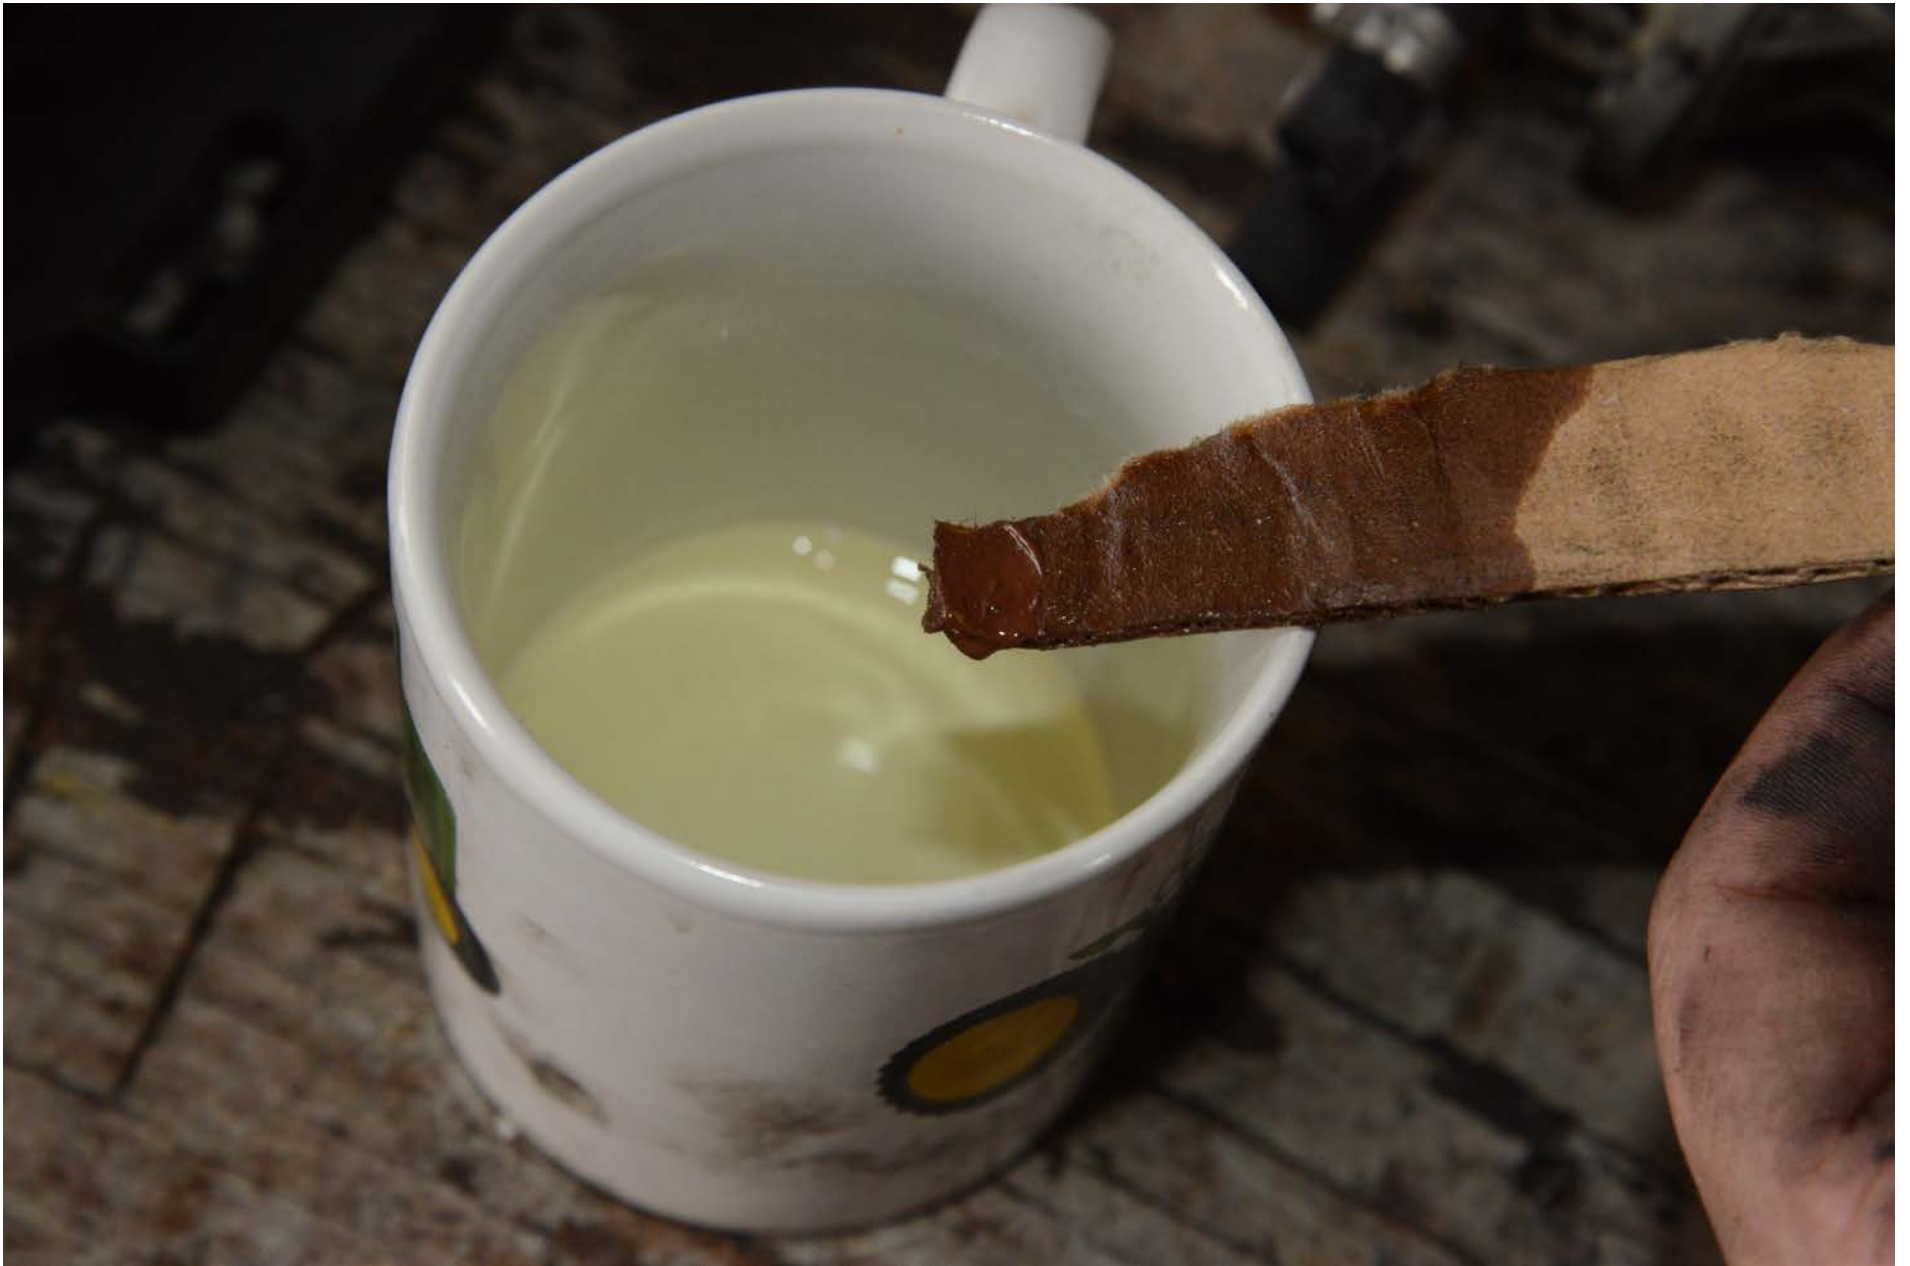
**Photo 20 - View of recovered fluid from an airplane carburetor and a water testing paste indication of no water present.**
