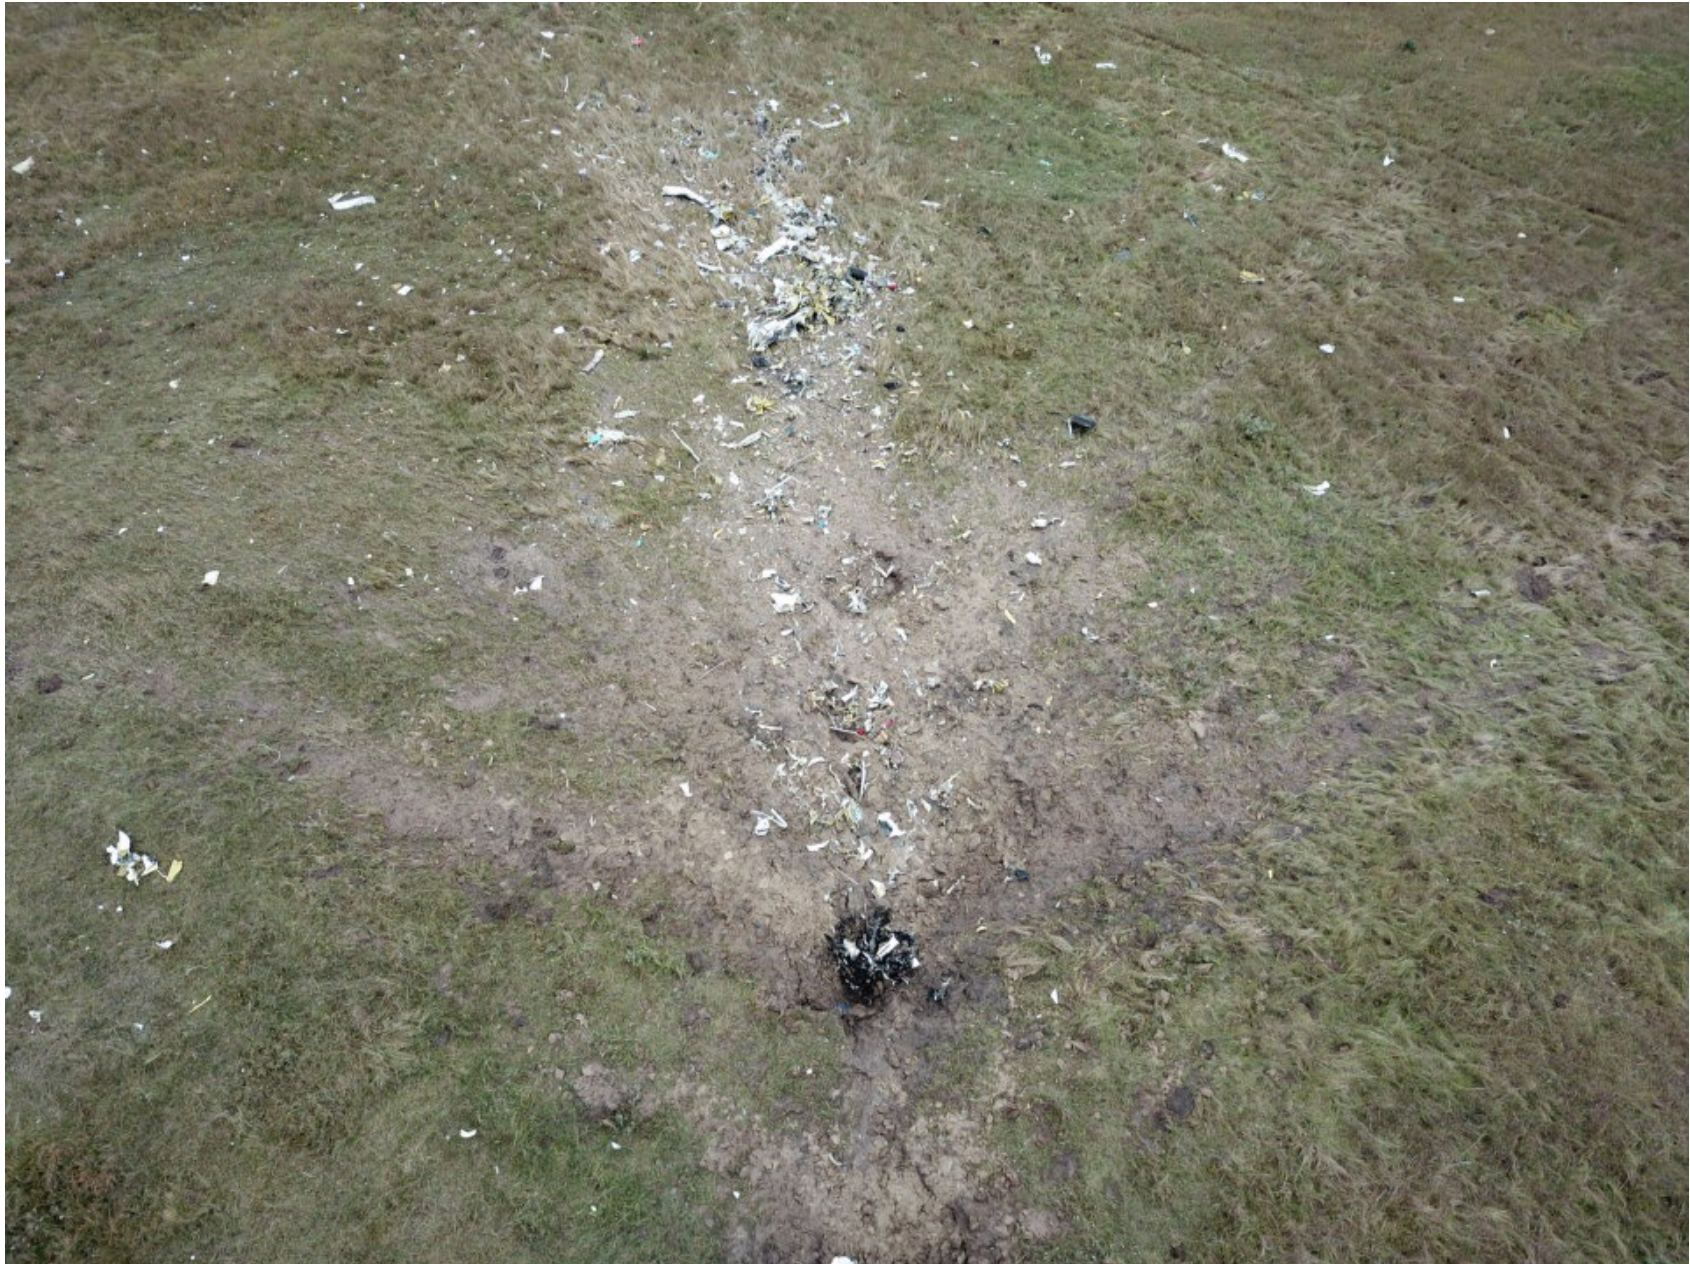
**Photograph 1 – Aerial View of Debris Field (Provided by Ainsworth Fire Department)**

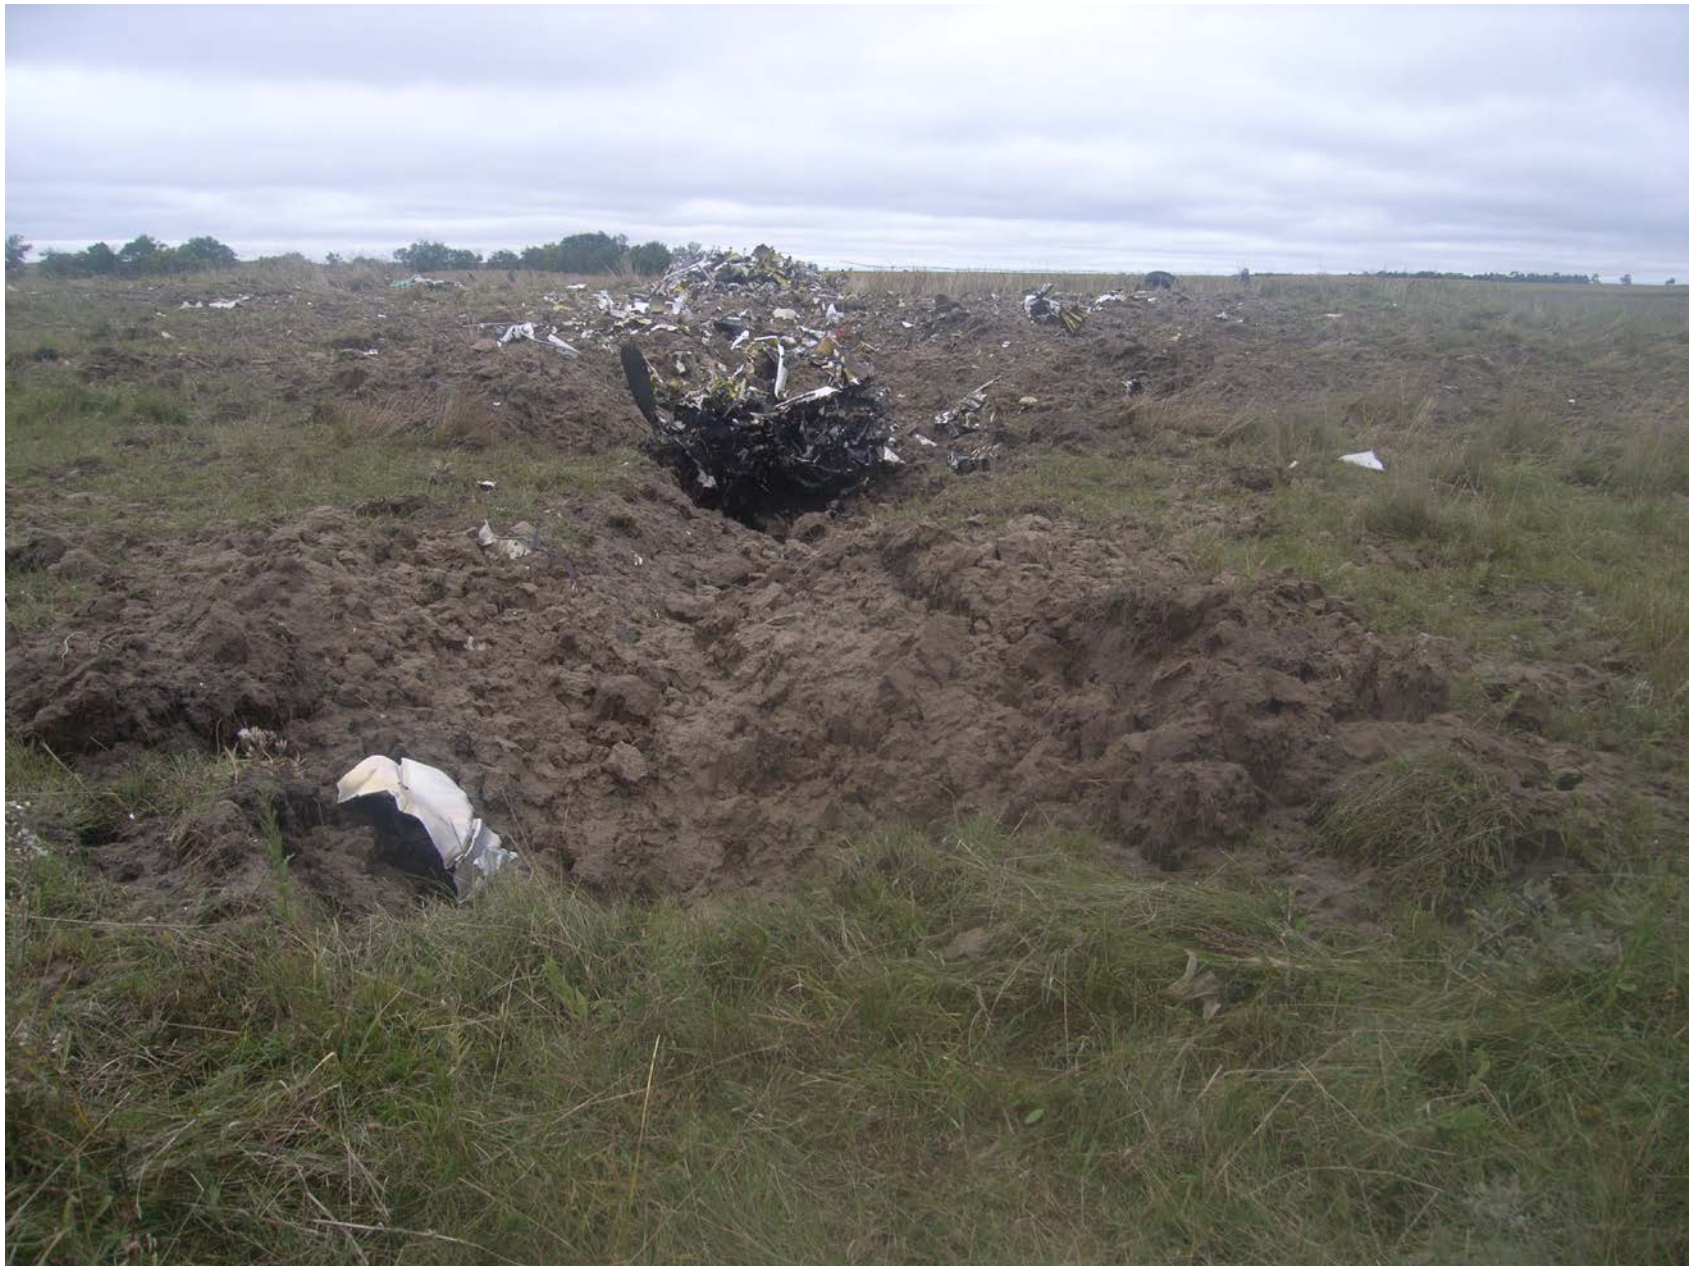
**Photograph 2 – Initial Impact Point and Left Engine**

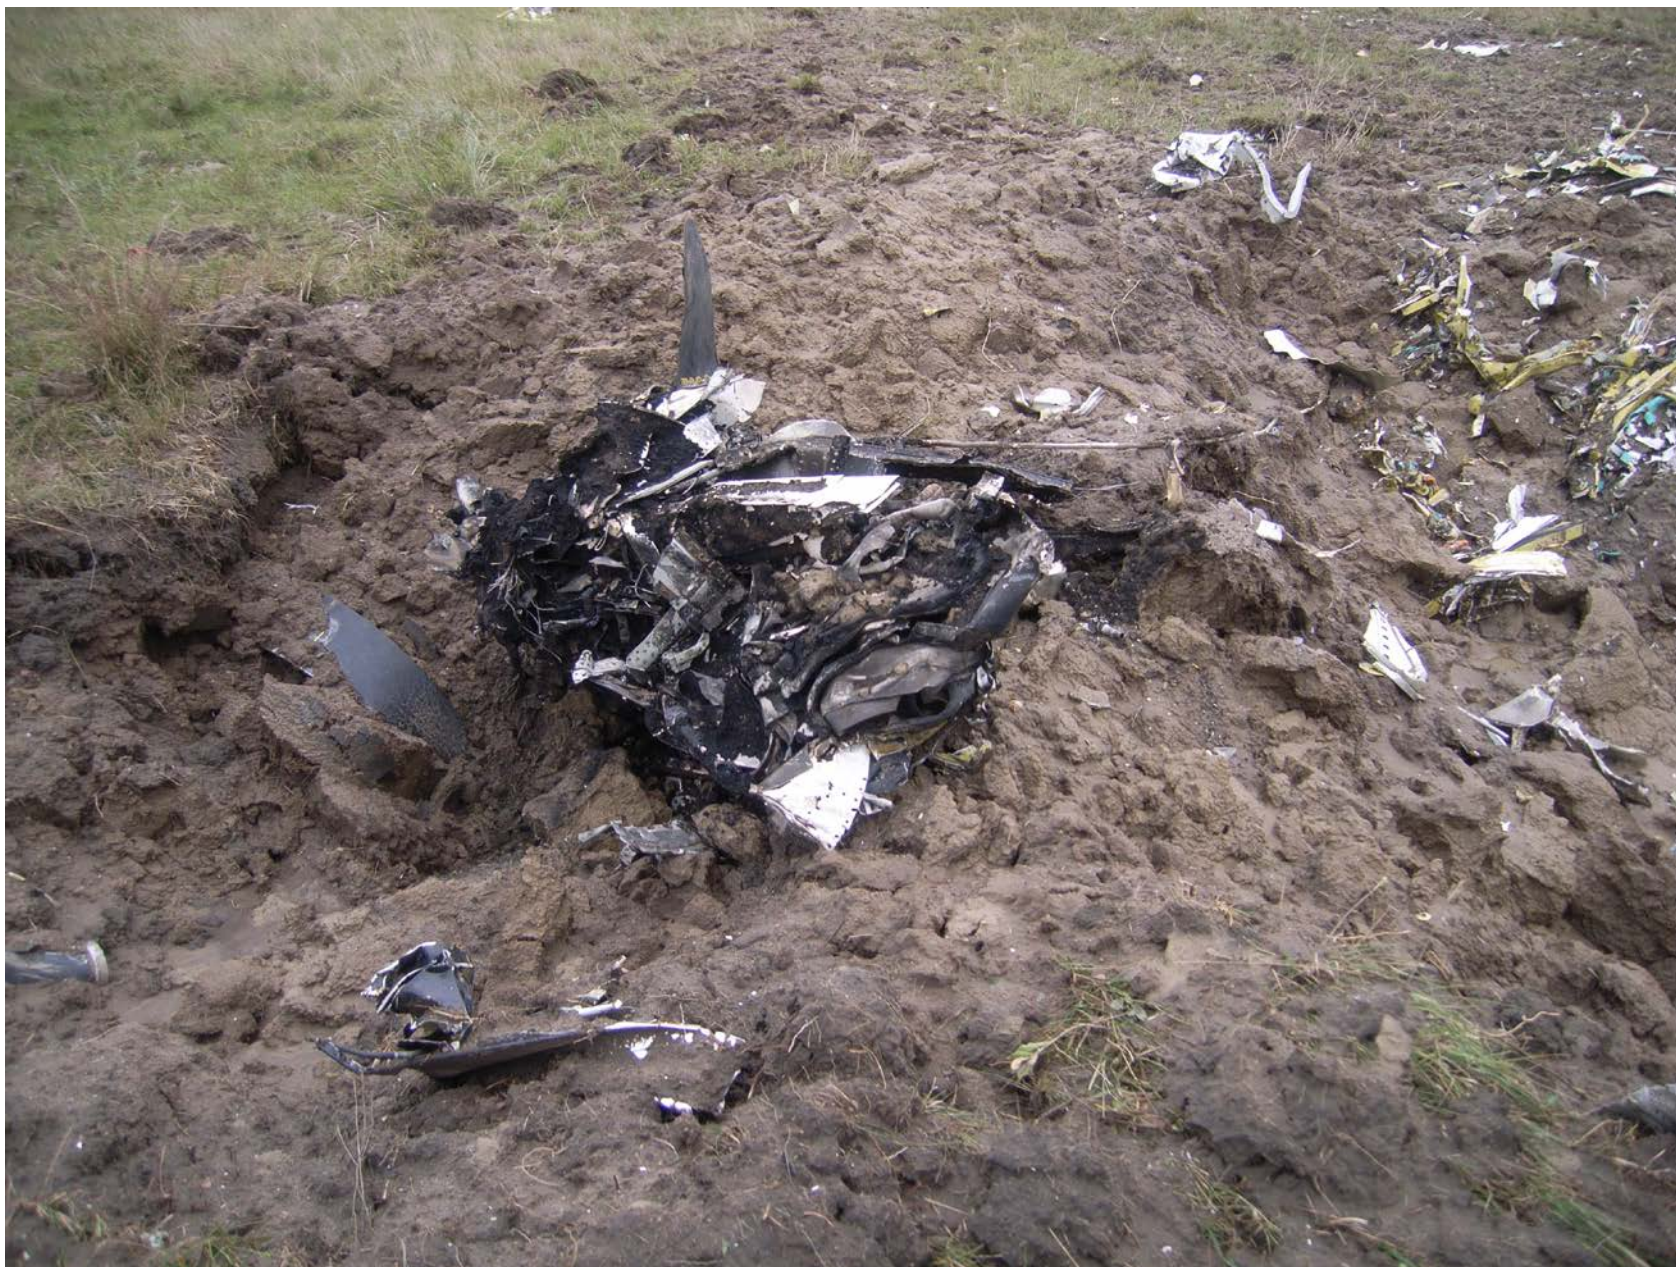
**Photograph 3 – Left Engine and Propeller Blades**

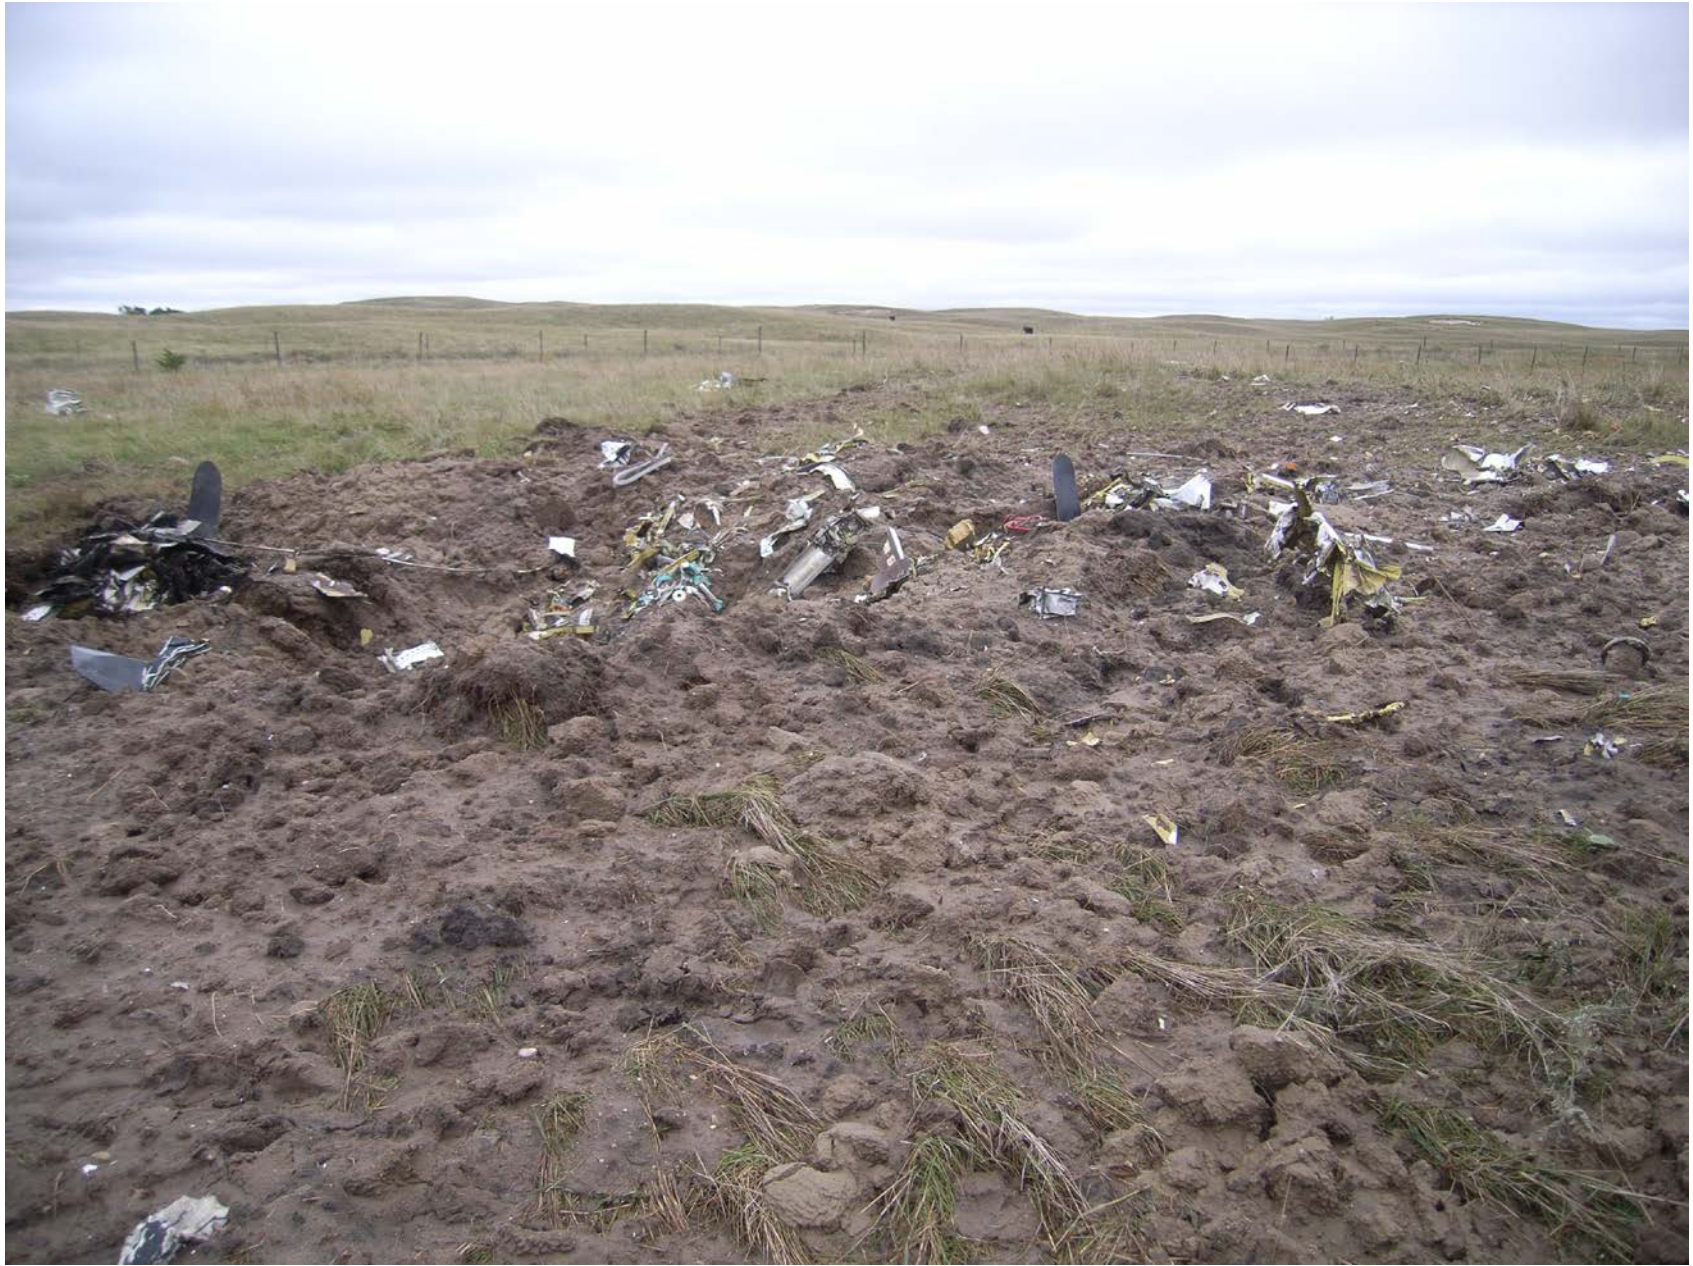
**Photograph 4 – Debris Field**

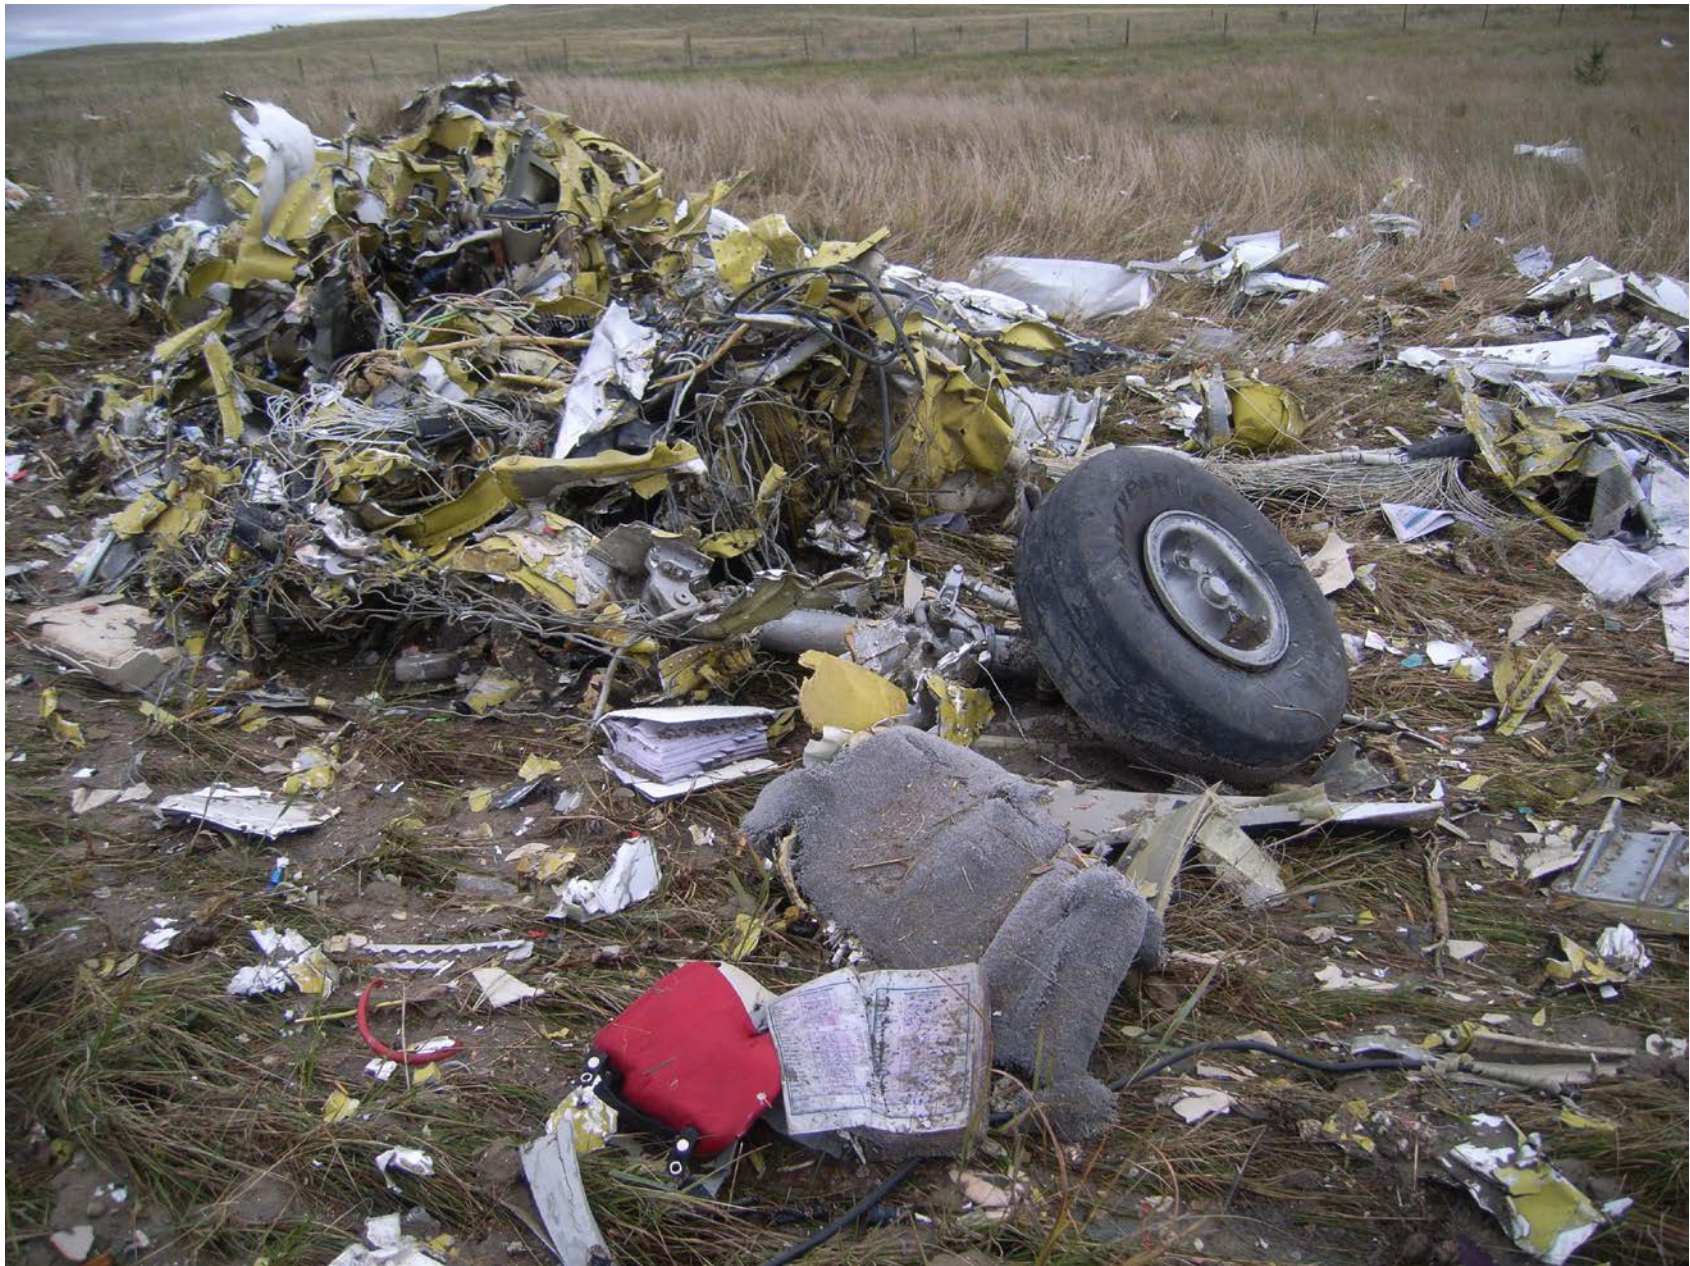
**Photograph 5 – Main Wreckage**
