# **N911MK – Serious Incident Investigation**

## **SafranHE Examinations Summary**

(SafranHE ref. RIs 2017/013)

| <b>INVESTIGATION REPORT</b> | <b>Preliminary</b> <input type="checkbox"/><br><b>Final</b> <input checked="" type="checkbox"/> |

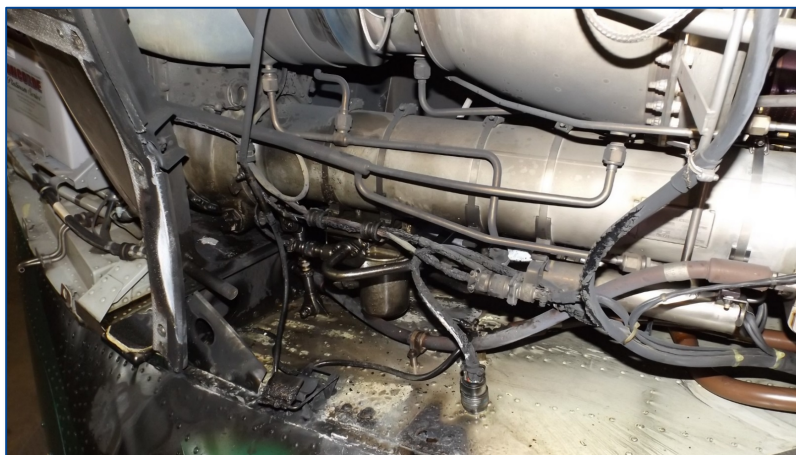
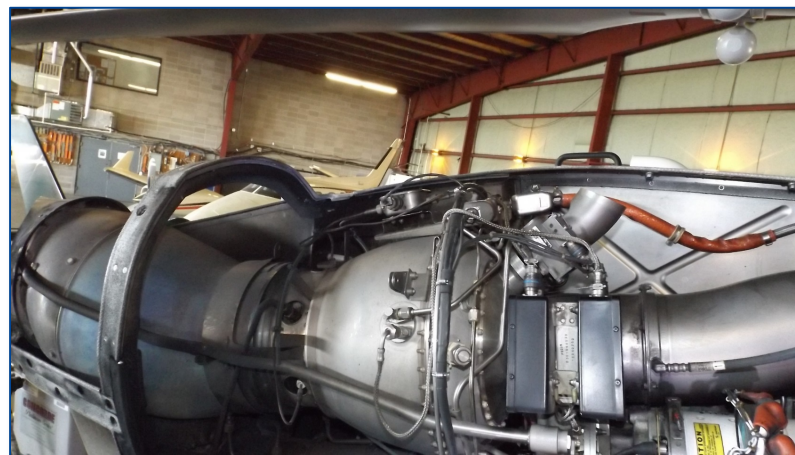
- Heat/fire damage limited to rear end of RH engine.
- Soot analysis confirmed an oil based fire.
- Stains of liquid splatter in lower part of engine.
- Heat/fire marks on lower part of hot section of RH engine.

**RH engine compartment condition after the event**

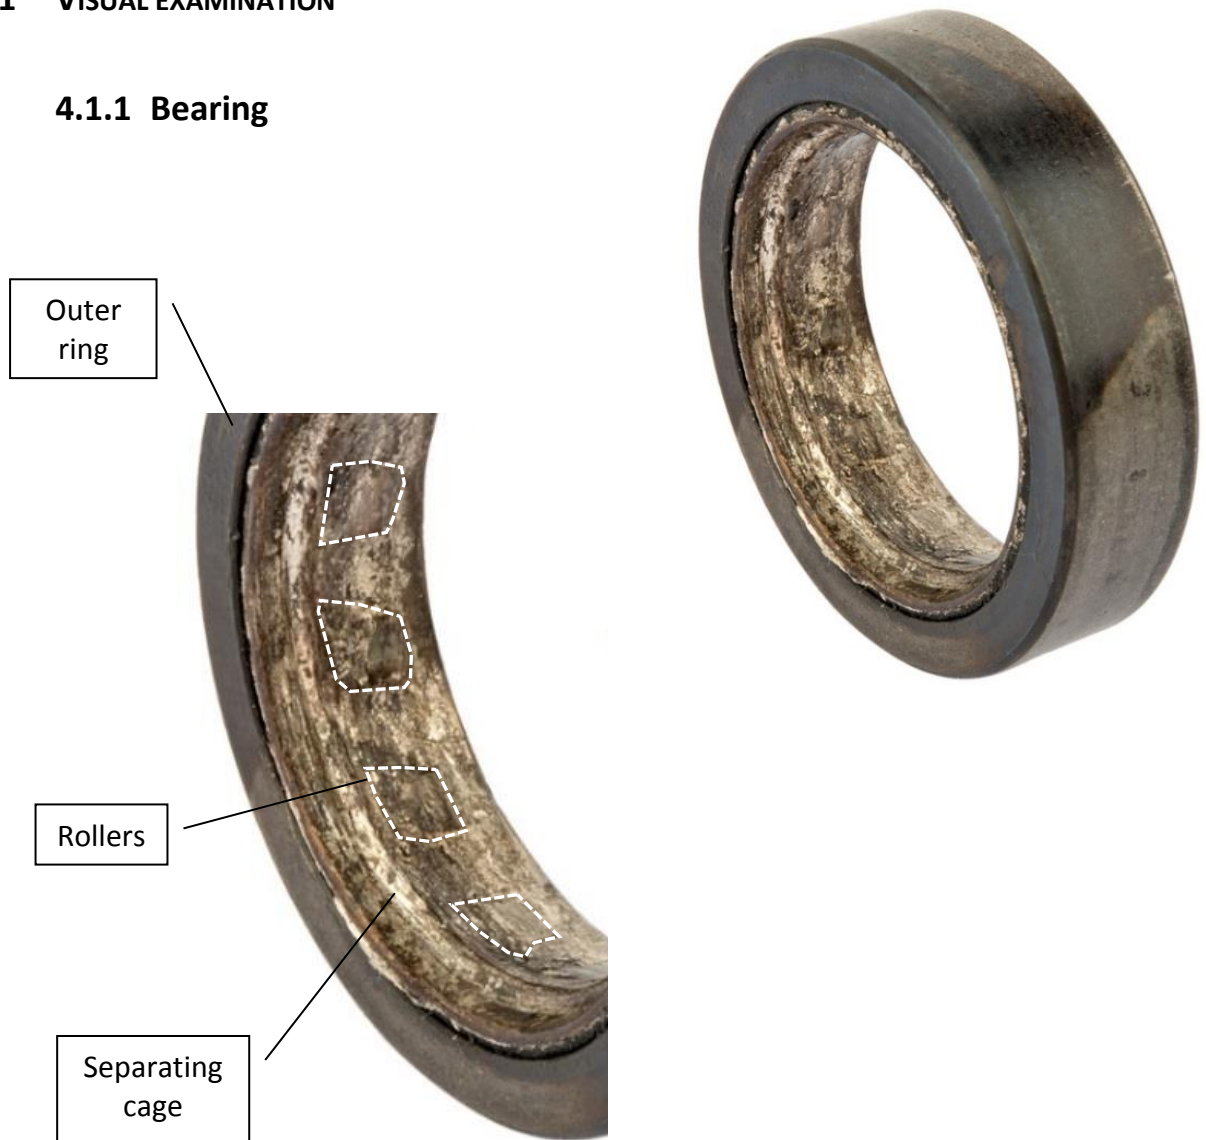
#### 4.1.1 Bearing

The bearing as received was totally blocked and could not rotate.

All the rollers, cage and outer ring were stuck together.

All the bearing's rollers were flattened and did not protrude from the separating cage any more. The outline of their shape could be guessed on the inner surface of the separating cage.

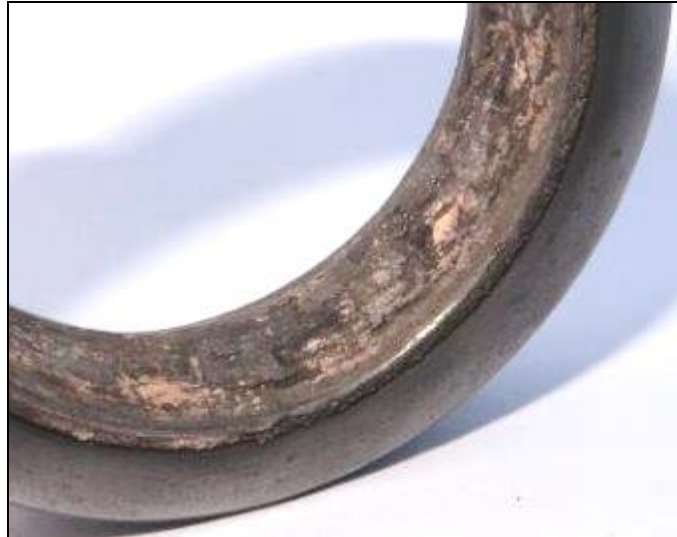
#### 4.1.2 Separating cage

The separating cage and the flattened rollers showed circular scoring marks consistent with rubbing against the rotating inner race. It also exhibited numerous impact marks and indentations consistent with contacts with debris during the rubbing with the rollers and the rubbing and rupture into several fragments of the inner race.

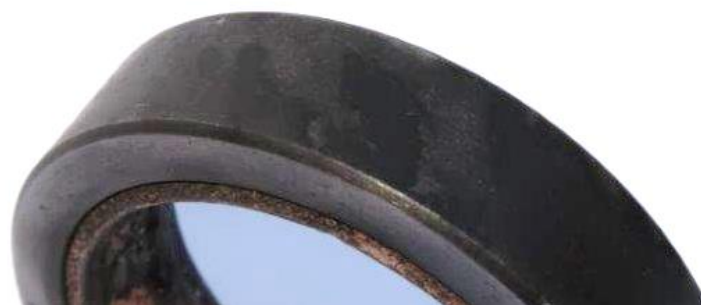
#### 4.1.3 Outer ring

The outer ring showed no indication of movement (rotation or displacement) against its support and was externally in good condition.

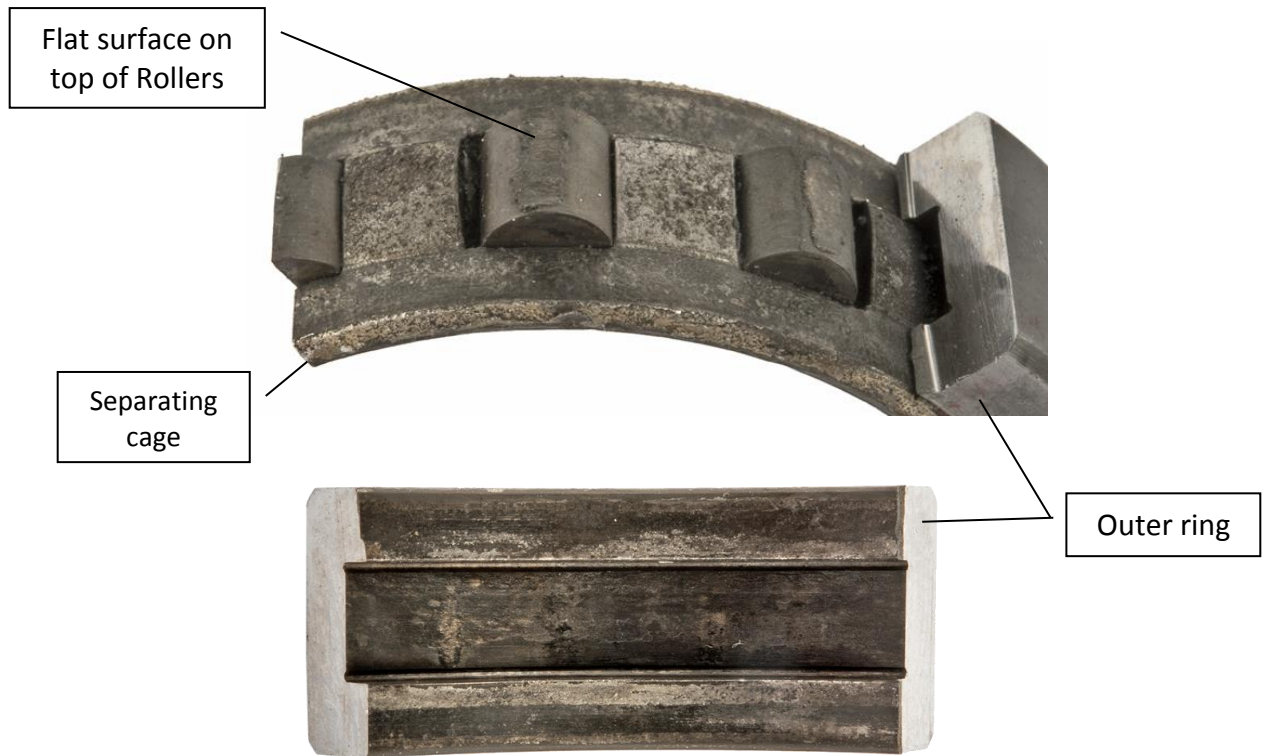
Once removed, the rollers appeared to have retained their cylindrical shape except for a flat surface where it came in contact with the race in the outer ring. The separating cage showed light circular scoring. Similarly, the race in the outer ring showed light circular scoring whilst retaining its shape. The small extent of the flat surfaces on the rollers and the light scoring on the separating cage and on the race of the outer ring indicate that once the rollers stopped rotating with respect to the separating cage, they initially skidded on both the inner and outer rings until the elevation of temperature produced by the friction led to expansion of the rollers and then their blockage against the flanks of the outer race.

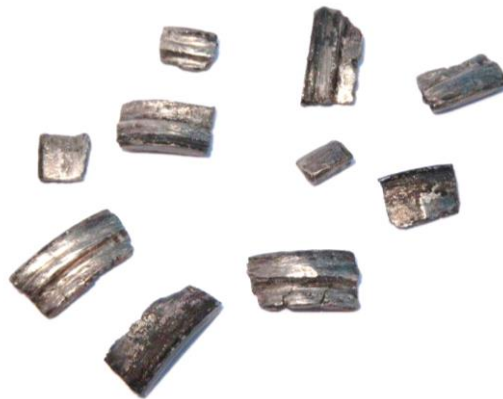
#### 4.1.4 Inner ring

The inner ring was broken into fragments, several of which could be recuperated.

The fragments exhibited traces of rotational scoring and metal ripping at the race's surface indicative of friction under a significant radial load.

Several fragments showed rectangular imprints left by the flattening rollers. These imprints indicate that a significant sudden radial load was applied to the inner ring whilst it was still on the shaft. The fragments had blunted and rounded edges due to contacts with surrounding parts or debris after the rupture of the ring.

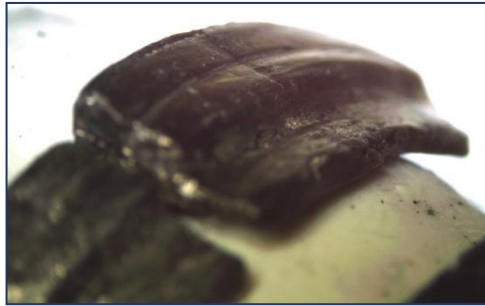
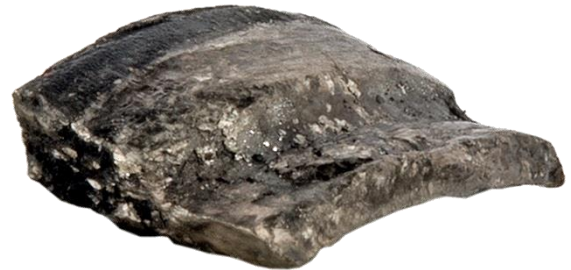
Imprint of roller

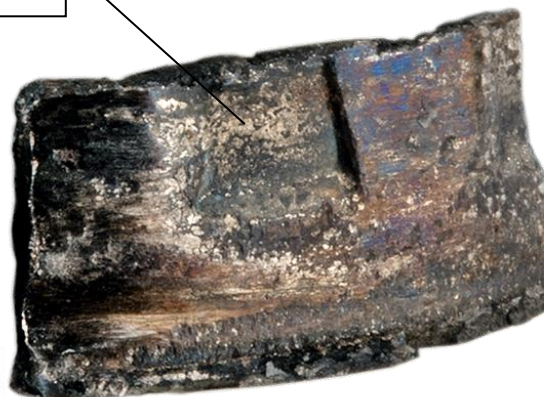
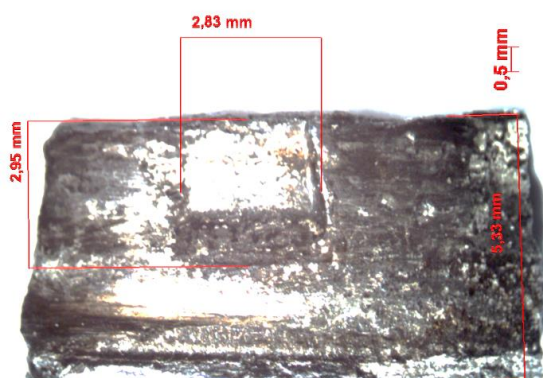
Imprint of rollers

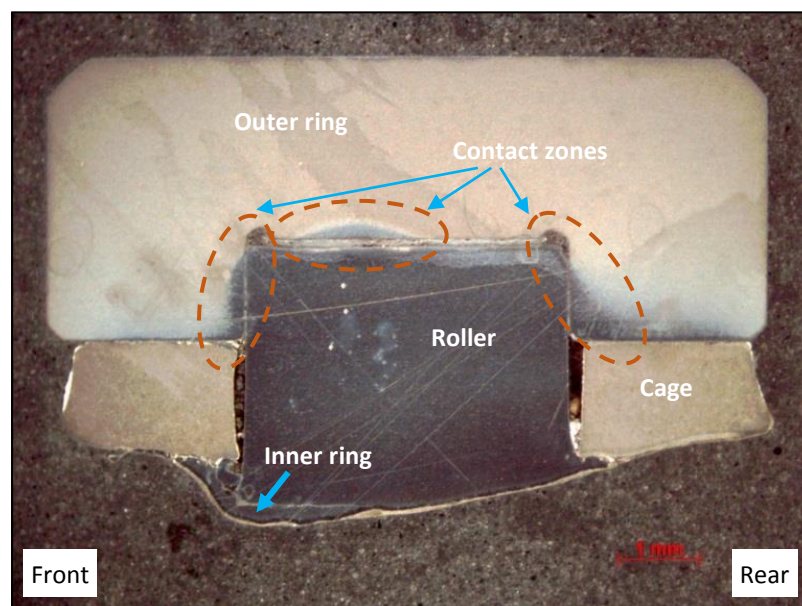
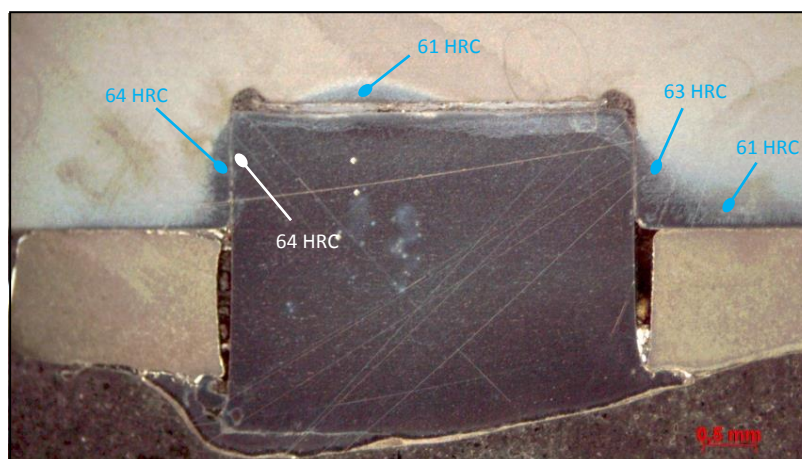
### 4.3 NITAL ETCHING

The NITAL etching revealed a different hue for the roller when compared with the outer ring. This is consistent with the hardness measurements (see next §).

It also revealed heat transfer zones where the rollers came in contact with the outer ring. When the rollers seized up, their temperature increased due to the friction with the rotating inner race and they expanded and came in contact with the outer ring (at the bottom of the race and against its inner walls) thus locking them in place with respect to the outer ring. The heat produced by the friction of the inner ring on the rollers was then transferred to the outer ring by conduction.

The different colorations indicate a metallurgical transformation of the materials under influence of the rising temperature coming from the friction of the rotating inner ring on the rollers.

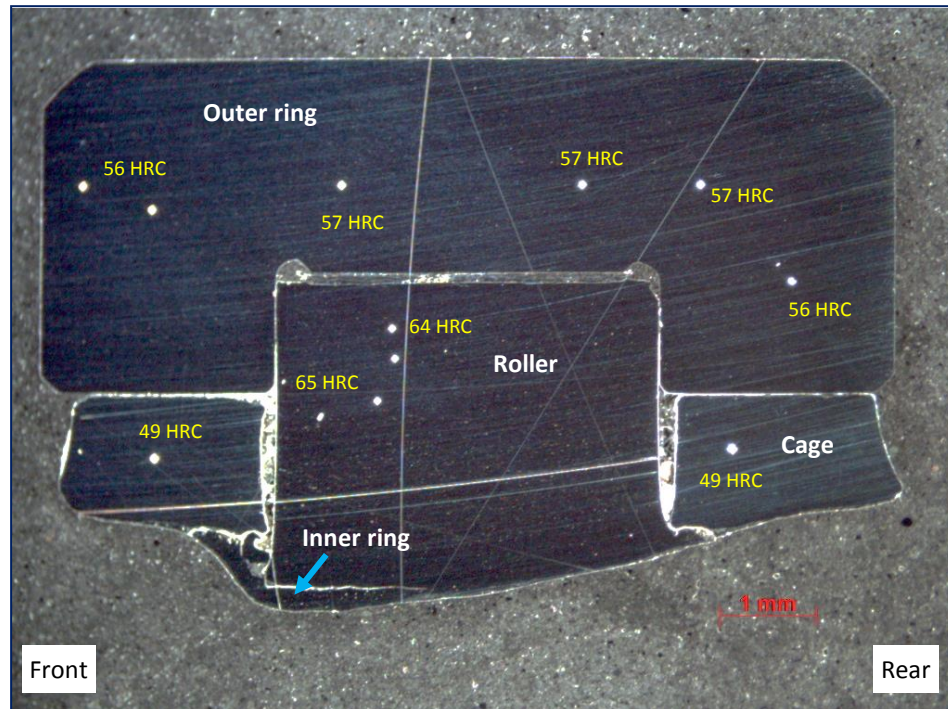
#### 4.4 HARDNESS MEASUREMENTS

The outer ring, the inner ring and the rollers are made of the same 80DVC40 (M50) alloy. Under rising temperature conditions, the hardness for this alloy initially drops. If the temperature keeps increasing, then the hardness increases again and can exceed the original hardness. In this instance, the rollers rubbed against the inner race and they lost material. The hardness measurements give a consistent information as they indicate that the temperature experienced by the rollers was higher than that experienced by the outer ring (except at the zones of contact where the hardness levels are similar). This information is also consistent with the NITAL etching checks (see § 4.3).

The cut section showed that some of the inner ring's material transferred to and adhered to the roller.
