## Analysis

On January 26, 2017, about 2145 central standard time, a Eurocopter Deutschland GMBH MBB-BK 117 C-2 helicopter, N911MK, sustained minor damage when it experienced an inflight engine fire and made an emergency landing at Joe Foss Field Airport (FSD), Sioux Falls, South Dakota. The airline transport pilot and two crewmembers were not injured. The helicopter was operated as a Title 14 *Code of Federal Regulations* Part 135 air ambulance flight.

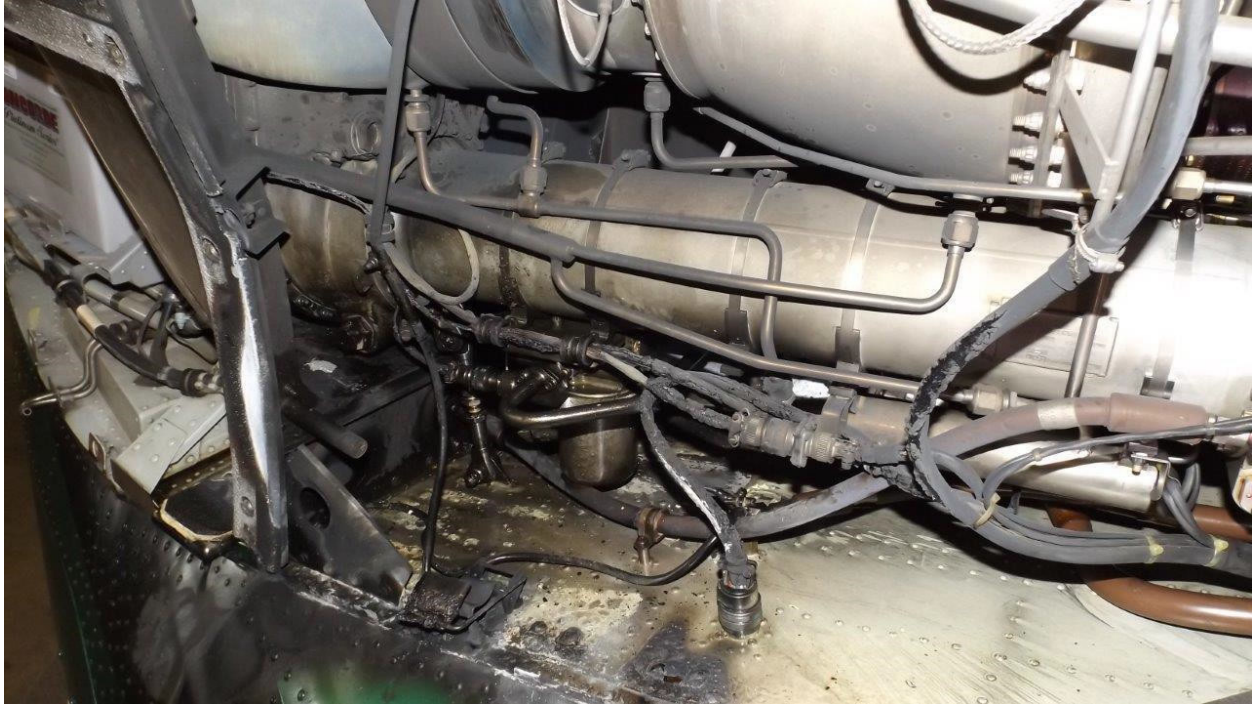
A post-incident examination of the helicopter revealed fire damage limited to the aft outboard section of the No. 2 engine deck and the aft section of the engine compartment and cowling. The engine cowling, the central wall, and upper heat shield sustained thermal damage. Local blistering to the engine deck paint and oil splatter on the deck floor was were observed. There was no evidence of a pool fire. The lower part of the engine was covered in oil residue with some thermal damage evident (Figure 1).

Figure 1. Engine deck thermal damage and oil residue

The No. 2 engine oil tank was 1 to 1.5 quarts low. The right side of the fuselage was streaked with oil and oil was noted on the tailboom. The engine's vent line and all oil lines were checked and found tight, not broken, and not cracked. The elastomer vent tube was still attached to the engine's vent line and to the 3-way union deck fitting.
